**Flood Control Project Maintenance
Levee Inspections**

Fall 2014 Levee Maintenance Deficiency Summary Report

Reclamation District No. 2031 Elliot

Levee Inspection Report By Mile - Fall 2014

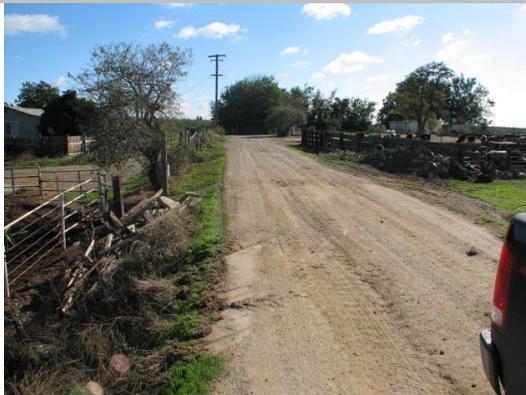
Photo 1 of 1 : FA_2014_RD2031_307_963_20141001_00039.jpg

Fall 2009 photo looking upstream at beginning of unit 1. Water side to the left.

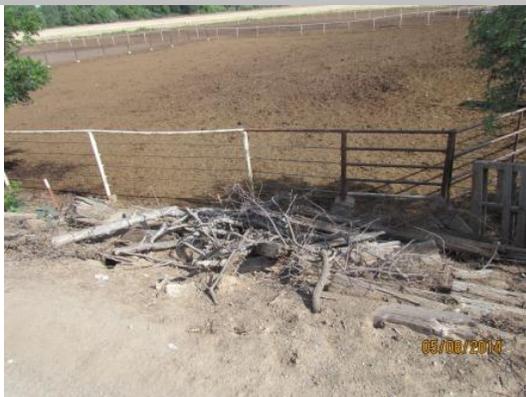
Photo 1 of 1 : FA_2014_RD2031_307_122_20141001_00034.jpg

LM Start	0.04	Rating **	U	Issue No.	122
LM End	0.04	Issue Type +	En	Location *	WS
Category	Earthen Levee		GPS Latitude/Longitude		
			Start	End	
Item	Encroachments		37.710016 °	37.710016 °	
			-121.155803 °	-121.155803 °	
DWR ID	DWR_RD2031_01_s_2014_122				
Action/Comments					
Debris

View of the pipe of debris on the waterside levee slope.

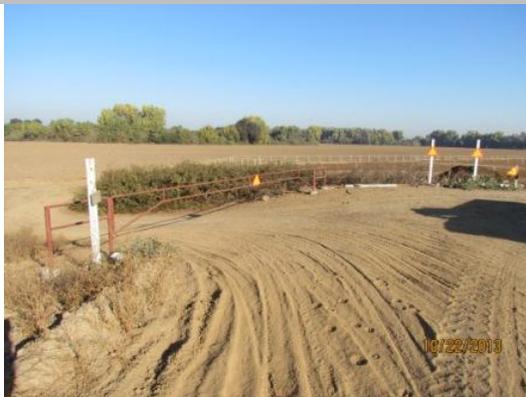
Photo 1 of 1 : FA_2014_RD2031_307_50_20141001_00032.jpg

LM Start	0.06	Rating **	M	Issue No.	50
LM End	0.06	Issue Type +	En	Location *	WS
Category	Earthen Levee		GPS Latitude/Longitude		
			Start	End	
Item	Encroachments		37.709950 °	37.709950 °	
			-121.156540 °	-121.156540 °	
DWR ID	DWR_RD2031_01_f_2013_50				
Action/Comments					
Fence Inspector Comments: Unpermitted gates at waterside levee hinge.

View of the gate at the waterside levee hinge.

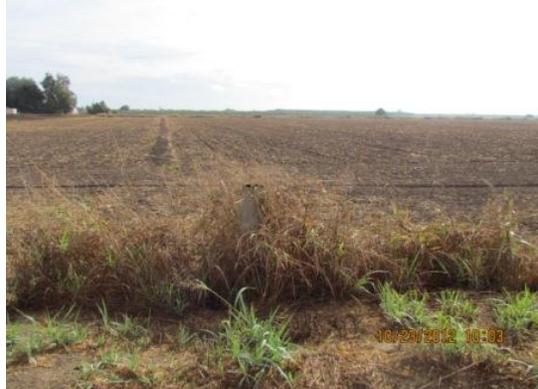
Photo 1 of 1 : FA_2014_RD2031_307_30_20141001_00020.jpg

View of the pipe in landward slope of levee facing downstream.

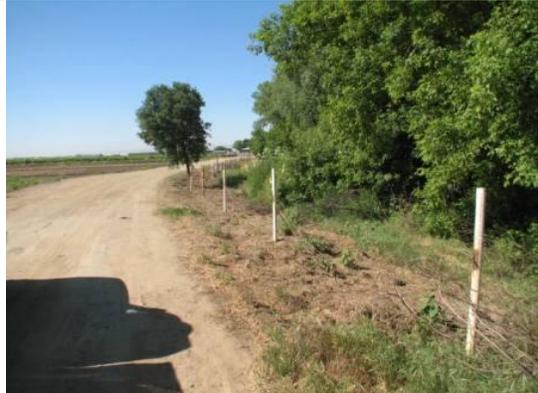
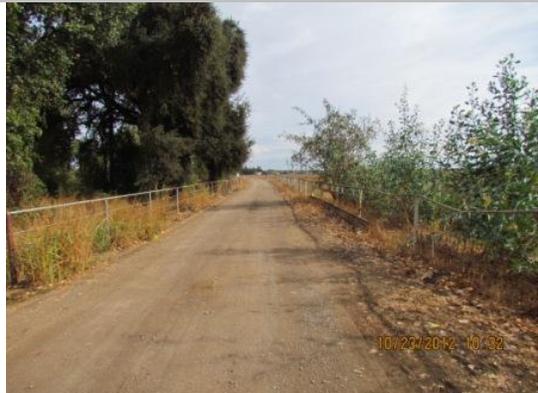
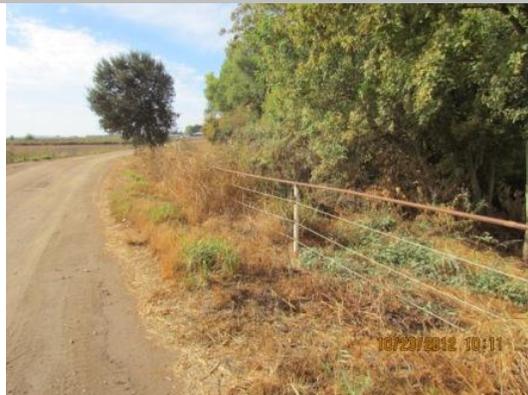
LM Start	0.34	Rating **	U	Issue No.	7
LM End	0.52	Issue Type +	En	Location *	WS
Category	Earthen Levee		GPS Latitude/Longitude		
			Start	End	
Item	Encroachments		37.706148 °	37.704030 °	
			-121.157975 °	-121.159653 °	
DWR ID	DWR_RD2031_01_s_2012_7				
Action/Comments					
Fence Inspector Comments: Fence appears to be completed without CVFPB approval.

05/10/2011 Fence on waterside prevents access to waterside slope.

View of fence obstructing access to waterside slope. Facing upstream.

View of fence on waterside slope facing downstream.

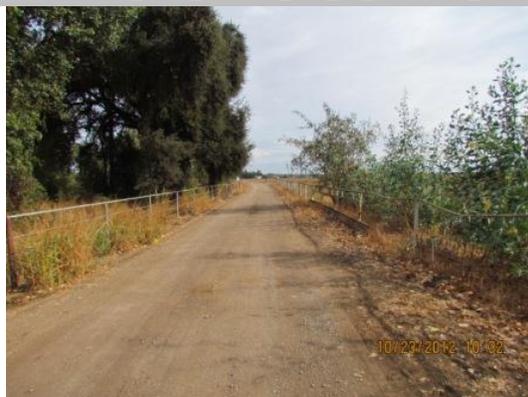
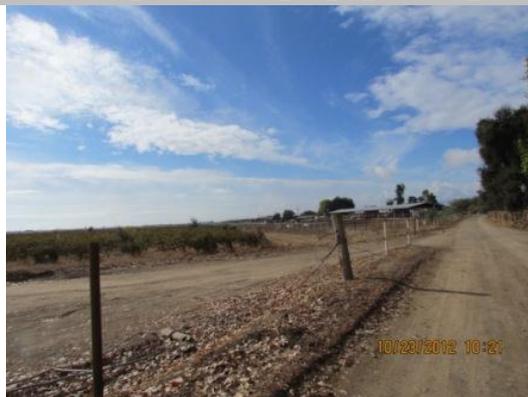
LM Start	0.45	Rating **	U	Issue No.	14
LM End	0.52	Issue Type +	En	Location *	LS
Category	Earthen Levee		GPS Latitude/Longitude		
			Start	End	
Item	Encroachments		37.704927 °	37.703788 °	
			-121.158860 °	-121.159923 °	
DWR ID	DWR_RD2031_01_f_2012_14				
Action/Comments					
Fence Inspector Comments: It appears the fence was completed without CVFPB approval.

View of fence on landside levee shoulder obstructing access to landside slope. Facing upstream.

View of fence on landside levee shoulder facing downstream.

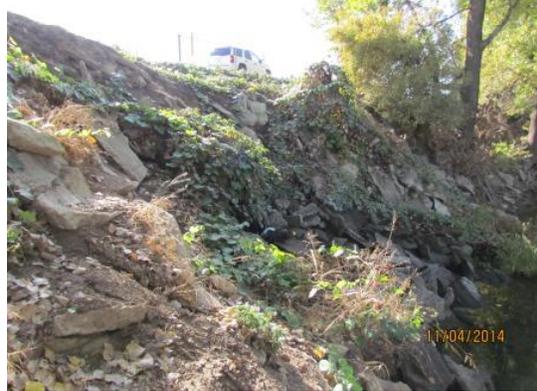
Photo 1 of 1 : FA_2014_RD2031_307_32_20141104_00057.jpg

View of canal outlet on waterward slope facing downstream.

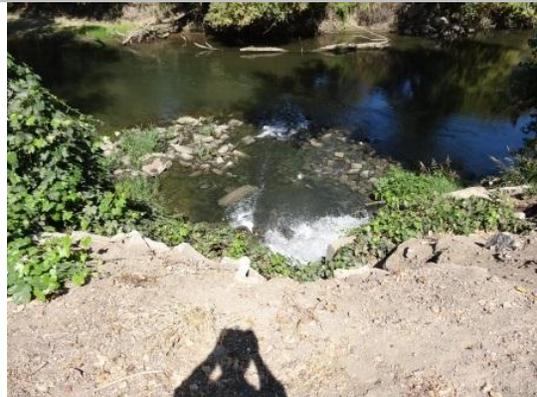
Photo 1 of 1 : SJR2014_RD2031U01RM0.48_1.jpg

LM Start	0.47	Rating **	M	Issue No.	1
LM End	0.50	Issue Type +	Ma	Location *	WS
Category	Supplemental		GPS Latitude/Longitude		
			Start	End	
Item	DWR Erosion Survey		37.704740 °	37.704740 °	
			-121.159140 °	-121.159140 °	
DWR ID					
Action/Comments					
Inspector Comments: 07/31/2014: No significant change observed. 09/10/2013: No significant change observed. 07/18/2012: No significant change observed. 08/18/2011: No significant change observed on site. Debris that blocks the irrigation outlet is visible. 10/19/2010: No significant change observed on site. Sloughing of the bank is occurring adjacent to an irrigation outlet structure. There is moderate to heavy vegetation along the bank that is well established. Broken chunks and slabs of concrete are used as rip rap and line the outside of the irrigation outlet structure. However, much of the rip rap along the slope is sloughing and could possibly lead to future slope instability. 08/05/2010: Recommended as a local maintenance issue, per CLRO. 08/20/2009: No major change observed since last visit; 1 inch fissure cracks developing on the slope; rip rap is showing signs of sloughing; recommend as local maintenance issue; site was previously rated "U". 2008: No change from previous year; irrigation outlet located on site; rip rap placed on river bank. 09/06/2007: Near agricultural diversion; only 3' landside height differential. [2014 Site ID:RD2031U01RM0.48]

Looking down at the site. The irrigation outlet is operating. Debris is visible at the outlet.

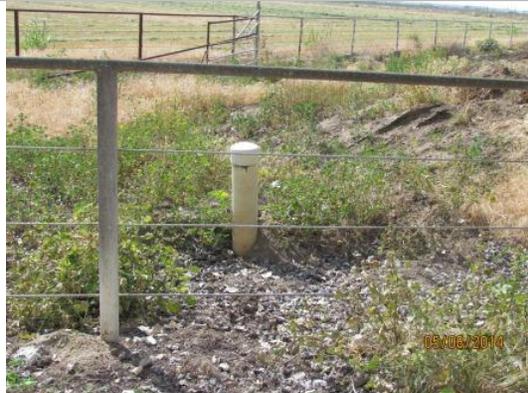
Photo 1 of 1 : FA_2014_RD2031_307_125_20141001_00035.jpg

View of the PVC standpipe at the landside levee toe.

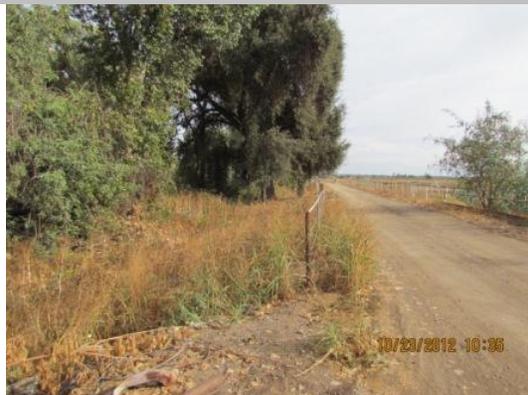
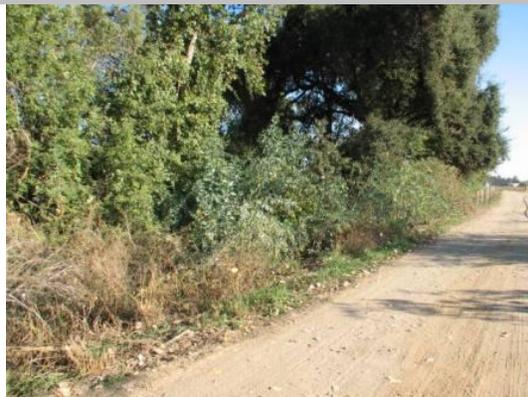
LM Start	0.52	Rating **	M	Issue No.	2
LM End	0.52	Issue Type +	Ma	Location *	WS
Category	Earthen Levee		GPS Latitude/Longitude		
			Start	End	
Item	Vegetation		37.704050 °	37.704050 °	
			-121.159578 °	-121.159578 °	
DWR ID	DWR_RD2031_01_s_2012_2				
Action/Comments					
Remove the wild growth other than native grasses from the levee slopes.

View of vegetation on waterside slope. Facing upstream.

10/26/2011 Updated photo of waterside vegetation.

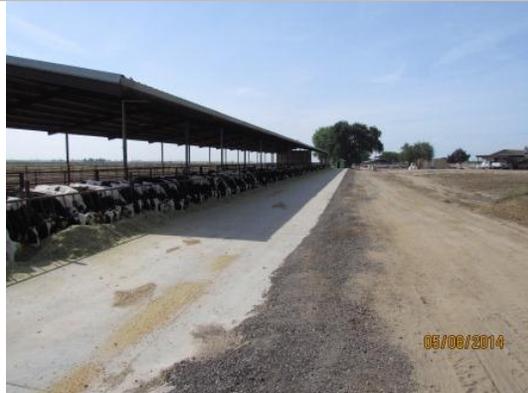
Photo 1 of 1 : FA_2014_RD2031_307_969_20141001_00040.jpg

View of the new coral at the landside levee slope and toe.

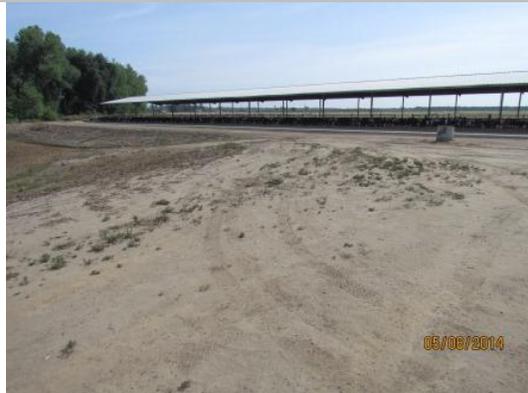
Photo 1 of 1 : FA_2014_RD2031_307_126_20141001_00036.jpg

LM Start	0.57	Rating **	M	Issue No.	126
LM End	0.57	Issue Type +	En	Location *	WS
Category	Earthen Levee		GPS Latitude/Longitude		
			Start	End	
Item	Encroachments		37.703394 °	37.703394 °	
			-121.159713 °	-121.159713 °	
DWR ID	DWR_RD2031_01_s_2014_126				
Action/Comments					
Material Inspector Comments: Levee built up with material from adjacent field. Unpermitted. The landowner has contacted CVFPB and started the permitting process.

View of the material placed on the waterside levee slope to build up the levee and increase the levee crown.

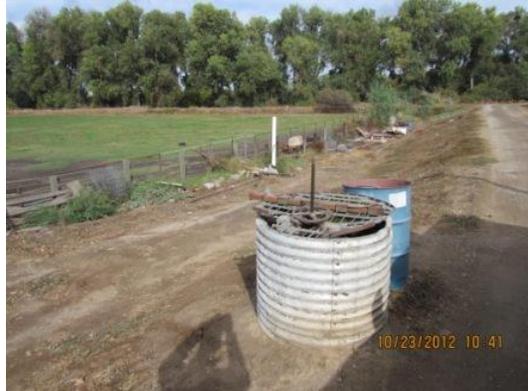
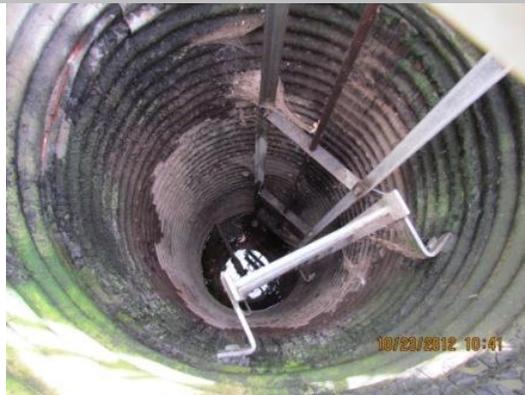
LM Start	0.57	Rating **	A/W	Issue No.	16
LM End	0.57	Issue Type +	En	Location *	WS
Category	Earthen Levee		GPS Latitude/Longitude		
			Start	End	
Item	Encroachments		37.703120 °	37.703120 °	
			-121.159798 °	-121.159798 °	
DWR ID	DWR_RD2031_01_f_2012_16				
Action/Comments					
Pipe Inspector Comments: It appears that the pipe is in good condition and slide gate is operational.

View of the pipe gate valve location.

View of slide gate and access ladder. Gate appears to be in good condition.

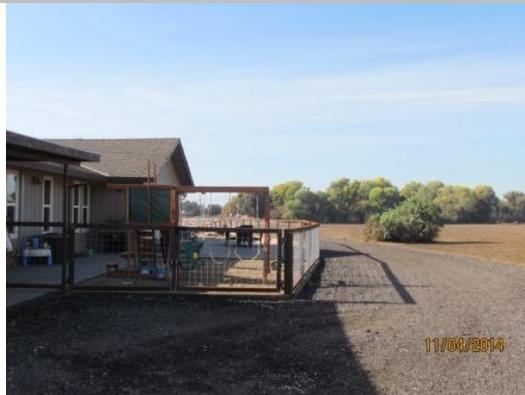
Photo 1 of 1 : FA_2014_RD2031_307_58_20141104_00058.jpg

LM Start	0.59	Rating **	M	Issue No.	58
LM End	0.64	Issue Type +	En	Location *	LS
Category	Earthen Levee		GPS Latitude/Longitude		
			Start	End	
Item	Encroachments		37.703186 °	37.702786 °	
			-121.160211 °	-121.160628 °	
DWR ID	DWR_RD2031_01_f_2014_58				
Action/Comments					
Fence Inspector Comments: Unpermitted fence on landside levee hinge.

View of the unpermitted fence on the landside levee hinge.

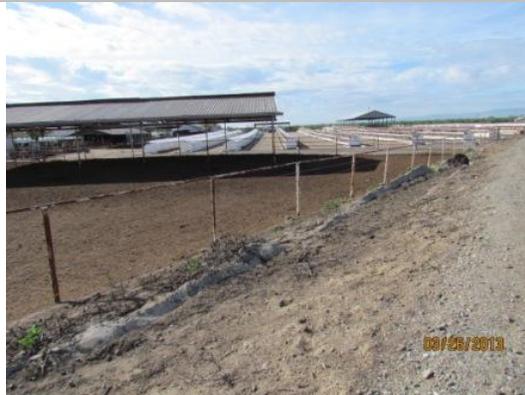
Photo 1 of 1 : FA_2014_RD2031_307_4_20141001_00006.jpg

LM Start	0.64	Rating **	M	Issue No.	4
LM End	0.71	Issue Type +	En	Location *	LS
Category	Earthen Levee		GPS Latitude/Longitude		
			Start	End	
Item	Encroachments		37.702814 °	37.701875 °	
			-121.160562 °	-121.161670 °	
DWR ID	DWR_RD2031_01_s_2012_4				
Action/Comments					
Fence

View of the fence at the landside levee toe.

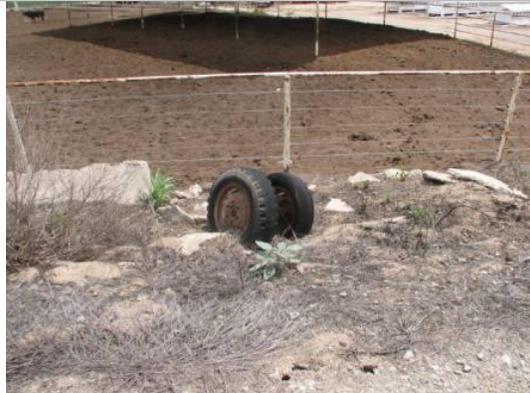
Photo 1 of 1 : FA_2014_RD2031_307_35_20141001_00023.jpg

View of tractor wheels on landward slope. 05/02/2012

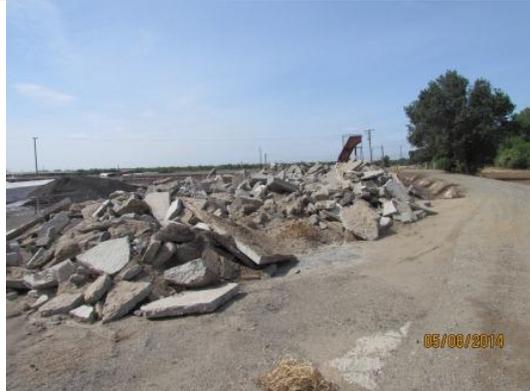
Photo 1 of 1 : FA_2014_RD2031_307_127_20141001_00037.jpg

LM Start	0.71	Rating **	U	Issue No.	127
LM End	0.71	Issue Type +	En	Location *	LS
Category	Earthen Levee		GPS Latitude/Longitude		
			Start	End	
Item	Encroachments		37.702051 °	37.702051 °	
			-121.161502 °	-121.161502 °	
DWR ID	DWR_RD2031_01_s_2014_127				
Action/Comments					
Material Inspector Comments: Remove concrete stockpile from the levee toe easement.

View of the concrete debris stockpiled at the landside levee toe.

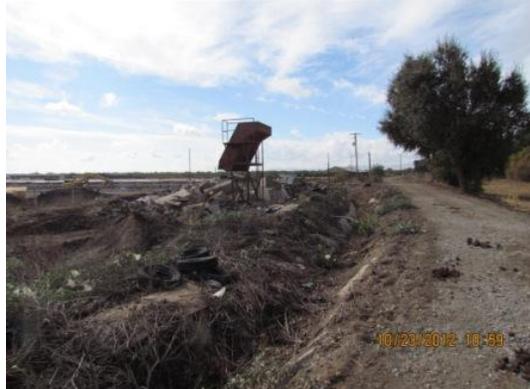
Photo 1 of 1 : FA_2014_RD2031_307_972_20141001_00041.jpg

LM Start	0.72	Rating **	M	Issue No.	972
LM End	0.77	Issue Type +	En	Location *	LS
Category	Earthen Levee		GPS Latitude/Longitude		
			Start	End	
Item	Encroachments		37.701906 °	37.701370 °	
			-121.161661 °	-121.161986 °	
DWR ID	DWR_RD2031_01_s_2012_972				
Action/Comments					
Ditch

View of the ditch on landside levee toe, facing downstream.

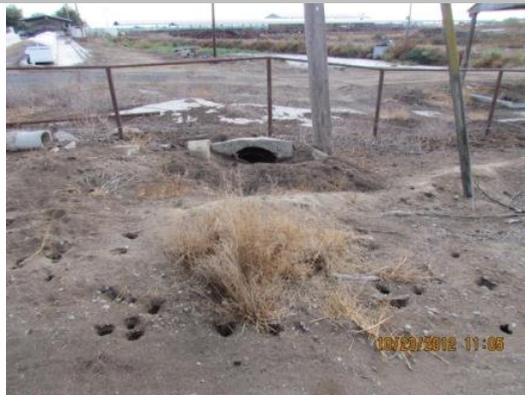
Photo 1 of 1 : FA_2014_RD2031_307_36_20141001_00024.jpg

View of rodent burrows on landside slope.

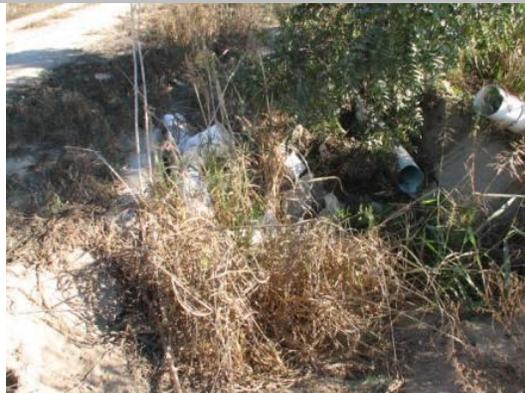
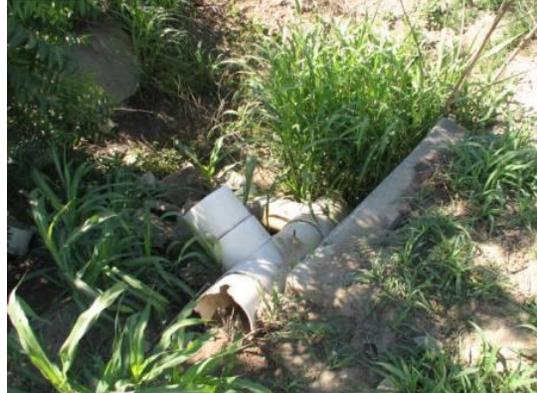
10/26/2011 Updated photo of PVC pipe pieces obstructing drain pipe, issue remains from Spring 2011 inspection.

05/10/2011 PVC pipe pieces are obstructing opening to drain pipe.

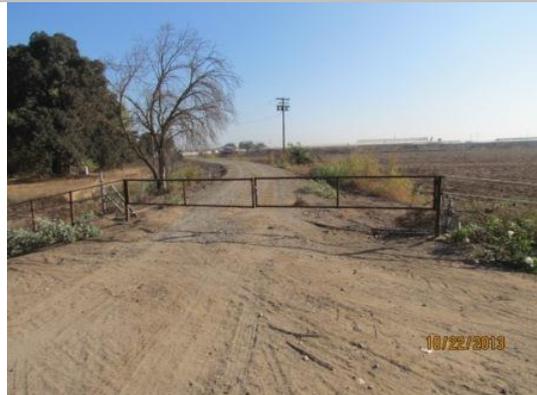
Photo 1 of 1 : FA_2014_RD2031_307_51_20141001_00033.jpg

View of the gate across levee crown.

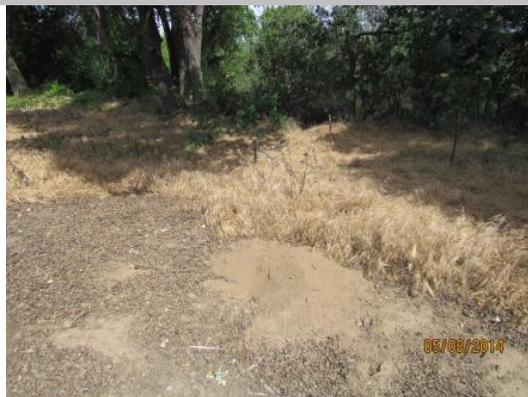
Photo 1 of 1 : FA_2014_RD2031_307_128_20141001_00038.jpg

View of the rodent hole on the waterside levee slope.

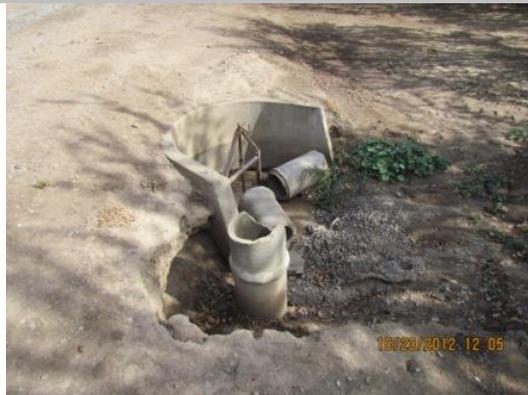
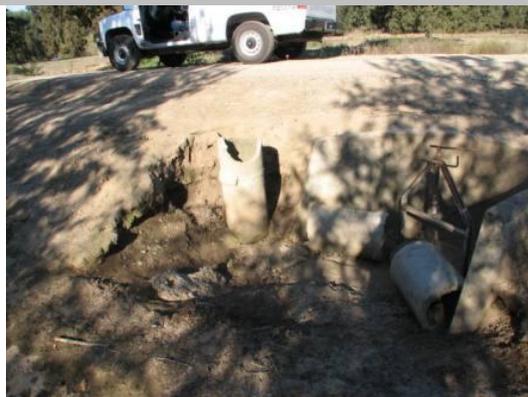
View of the erosion site on landside slope, facing upstream.

10/26/2011 Active erosion into the levee prism around irrigation standpipe.

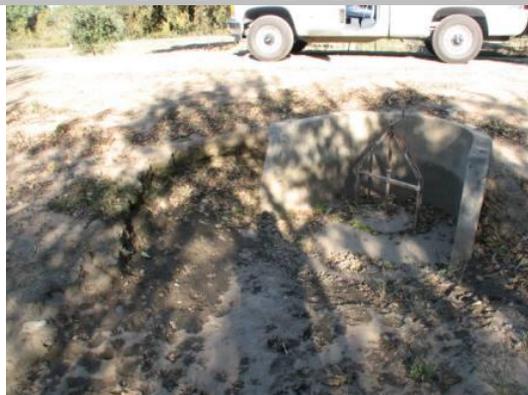
Photo 1 of 1 : FA_2014_RD2031_307_8_20141001_00010.jpg

10/26/2011 Active erosion shown around irrigation inlet.

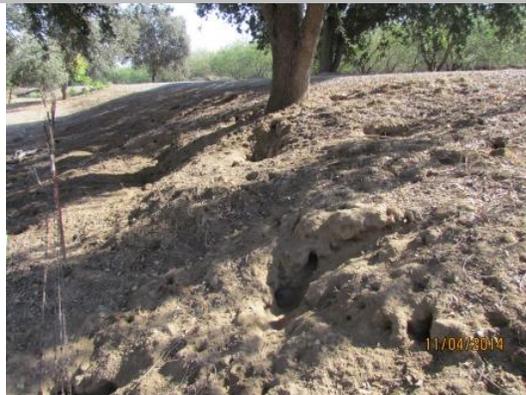
Photo 1 of 1 : FA_2014_RD2031_307_52_20141104_00059.jpg

View of the multiple large rodent hole in the waterside levee slope.

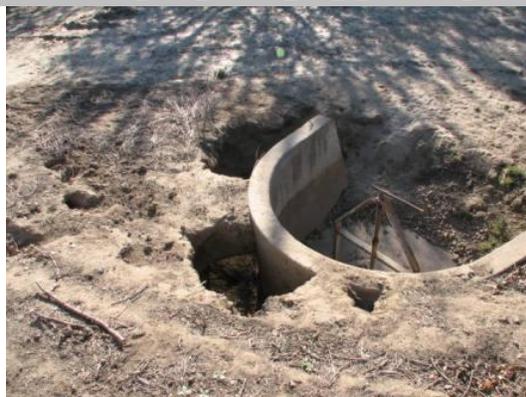
Photo 1 of 1 : FA_2014_RD2031_307_9_20141001_00011.jpg

10/26/2011 Active erosion into levee prism around irrigation inlet.

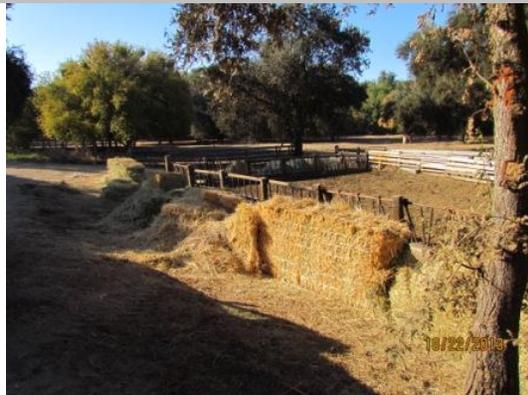
Photo 1 of 1 : FA_2014_RD2031_307_37_20141001_00025.jpg

View of the hay bails at the landside levee toe.

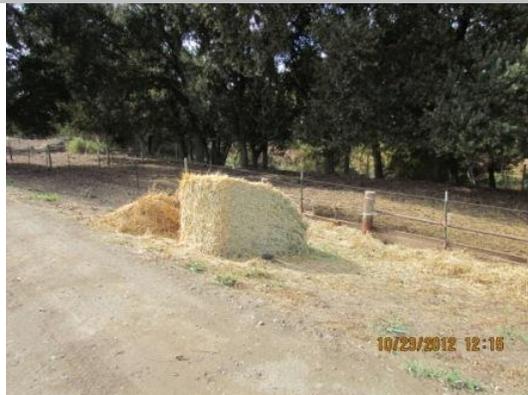
Photo 1 of 1 : FA_2014_RD2031_307_39_20141001_00026.jpg

View of hay bales at toe of levee on waterward side, facing downstream.
05/02/2012

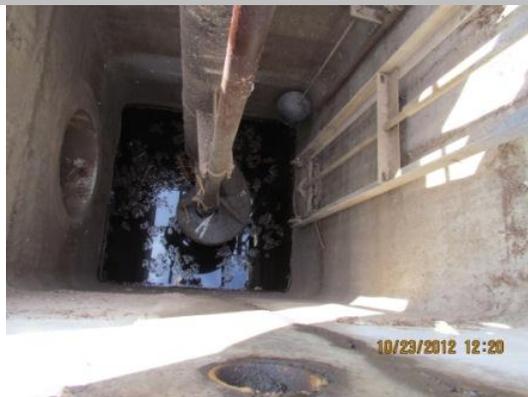
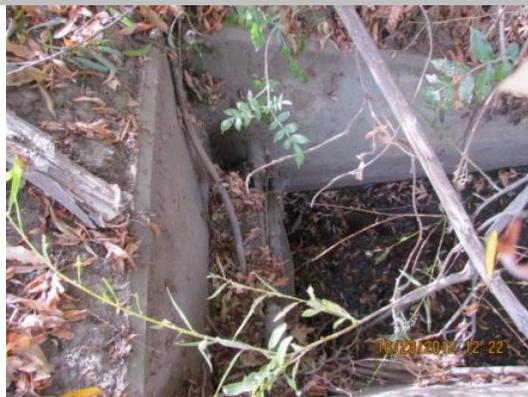
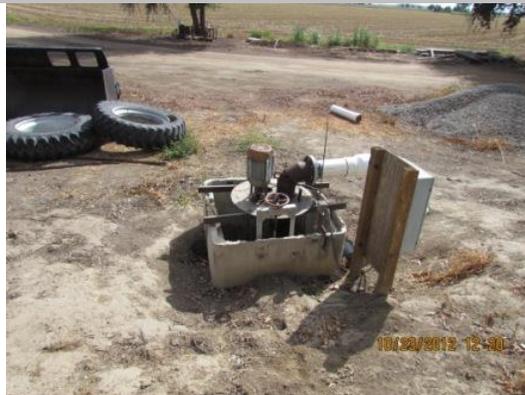
View of the closed slide gate.

View of closed flap gate on waterside.

View of the slide gate lever and well.

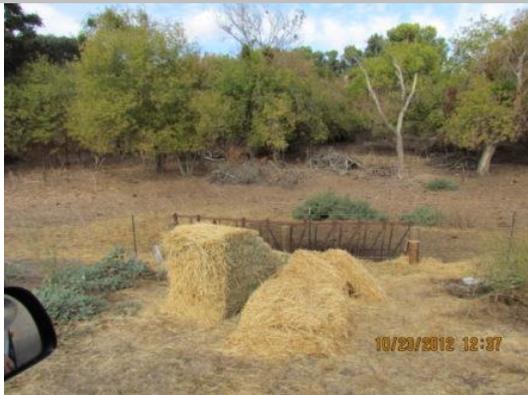
Photo 1 of 1 : FA_2014_RD2031_307_45_20141001_00031.jpg

View of hay bales at toe of levee on waterward side, facing downstream.

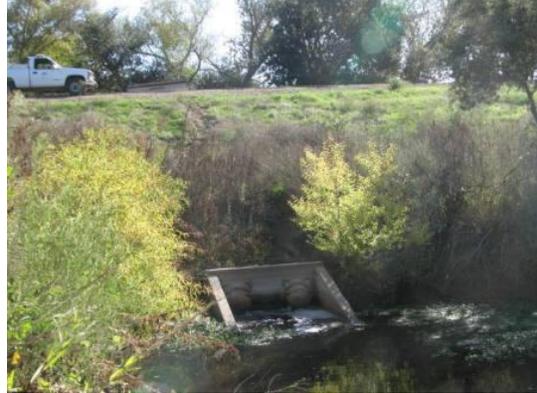
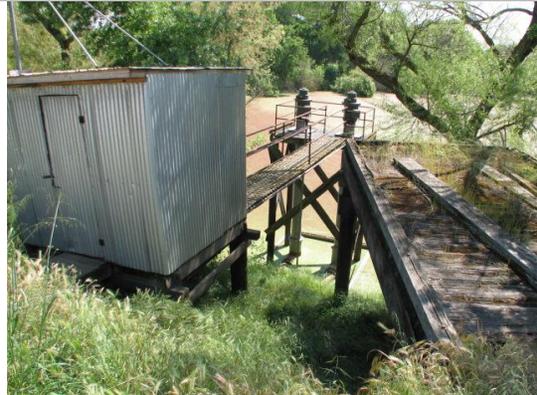
10/26/2011 Flap gates on landside.

Drainage discharge pumps and housing on steep waterside slope.

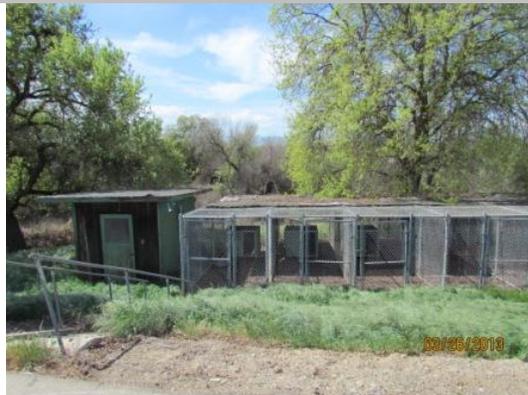
Photo 1 of 1 : FA_2014_RD2031_308_8_20141001_00005.jpg

View of the structure at the waterside levee toe.

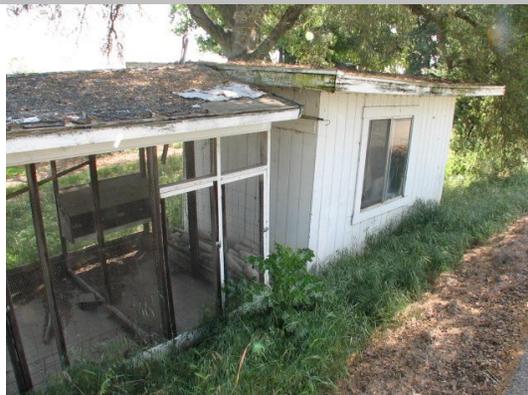
Photo 1 of 1 : FA_2014_RD2031_308_4_20141001_00004.jpg

Small structure on levee slope.

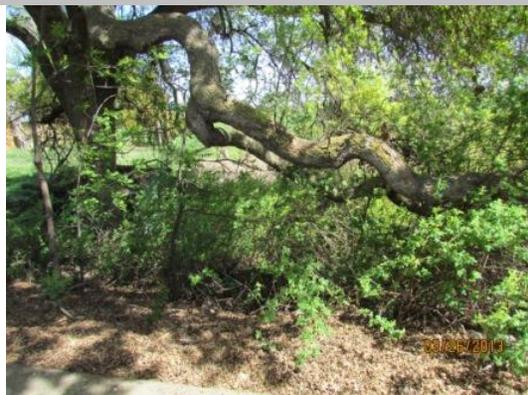
Photo 1 of 1 : FA_2014_RD2031_308_15_20141001_00010.jpg

View of the tree limb obstructing visibility and access to the landside levee slope.

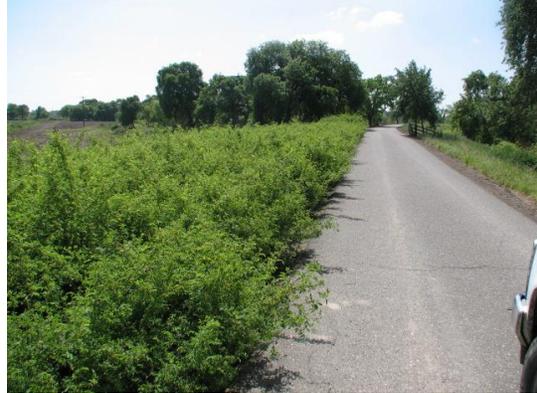
Photo 1 of 1 : FA_2014_RD2031_308_965_20141001_00014.jpg

Wild rose on levee slope.

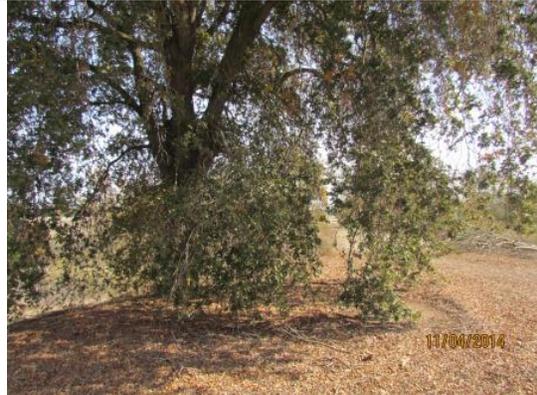
Photo 1 of 1 : FA_2014_RD2031_308_25_20141104_00026.jpg

View of the overgrown tree obstructing visibility and access of the landside levee slope.

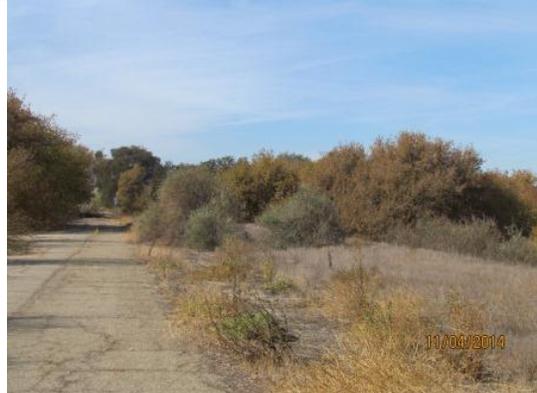
Photo 1 of 1 : FA_2014_RD2031_308_21_20141104_00025.jpg

View of overgrown vegetation on the levee crown.

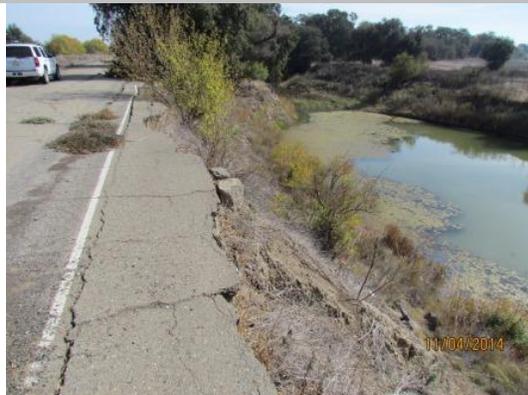
Photo 1 of 1 : FA_2014_RD2031_308_26_20141104_00027.jpg

View of the caving bank on the waterside facing upstream.

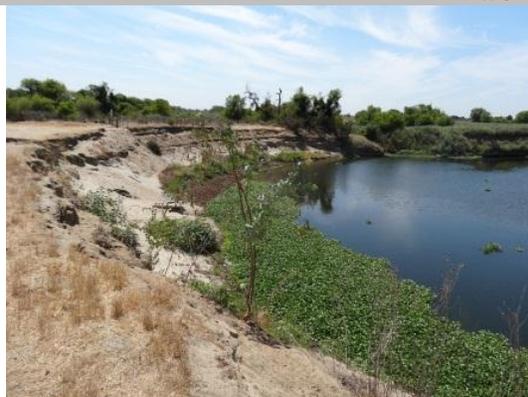
Photo 1 of 1 : SJR2014_RD2031U02RM78.7_1.jpg

Looking downstream. The erosion has progressed toward levee.

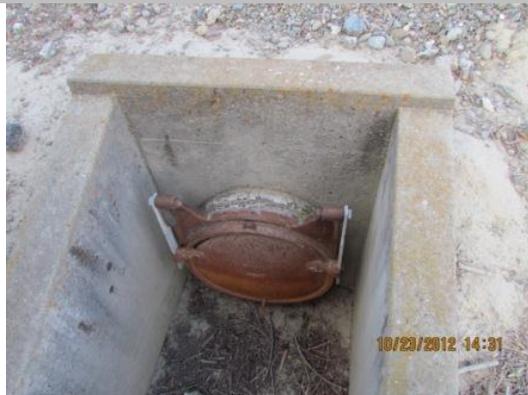
Photo 1 of 1 : FA_2014_RD2031_308_22_20141001_00012.jpg

View of the closed flap gate on waterside.

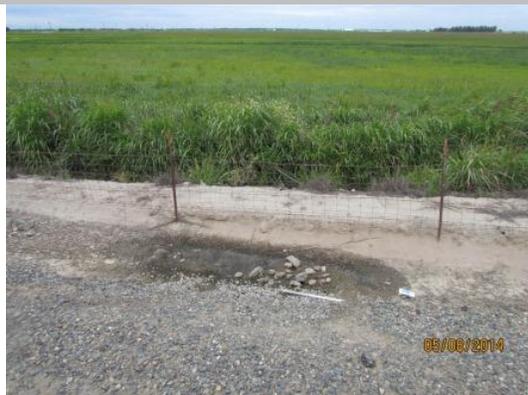
Photo 1 of 1 : FA_2014_RD2031_308_18_20141001_00011.jpg

View of the seepage at the landside levee toe.

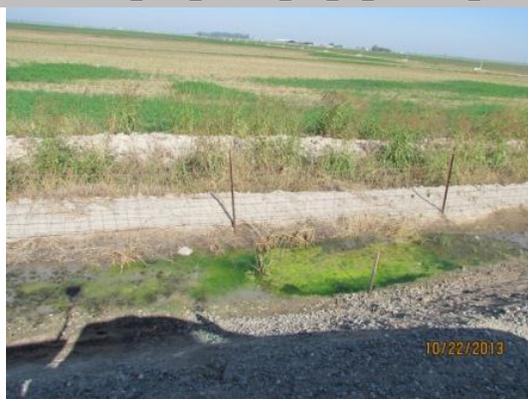
Photo 1 of 1 : FA_2014_RD2031_308_10_20141001_00008.jpg

View of the seepage area at the landside levee toe.
