**Flood Control Project Maintenance
Levee Inspections**
LMA District Cover Sheet
Spring 2010 Levee Inspection Results

Reclamation District No. 2031 Elliot

**Flood Control Project Maintenance
Levee Inspections
Unit Cover Sheet
Spring 2010 Levee Inspection Results
Reclamation District No. 2031 Elliot**

Waterway		Bank	Unit Miles
Unit No. 01 Stanislaus River		Left	7.15

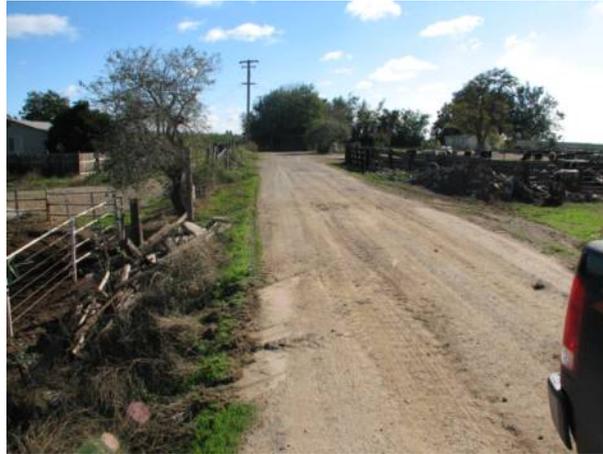
Levee Mile Report Line	1
Start Levee Mile	0.00
End Levee Mile	0.07
Location	Water Side
Category	Earthen Levee
Item	Encroachments
Fall 2009 photo looking upstream at beginning of unit 1. Water side to the left.	
jpaasch_s_20100330_164.jpg

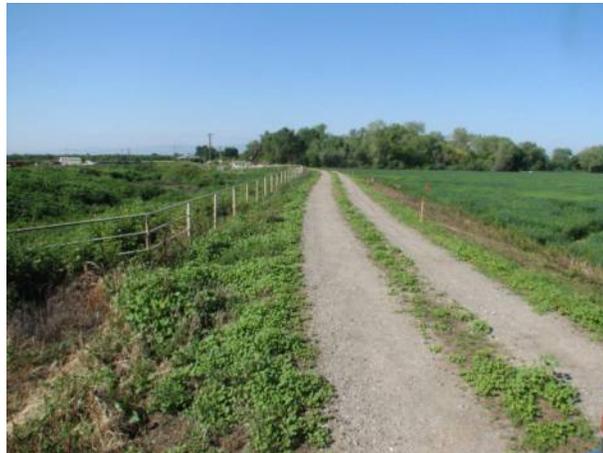
Levee Mile Report Line	3
Start Levee Mile	0.06
End Levee Mile	0.62
Location	Water Side
Category	Earthen Levee
Item	Vegetation
Annual grasses on levee slope.	
jpaasch_s_20100426_305.jpg

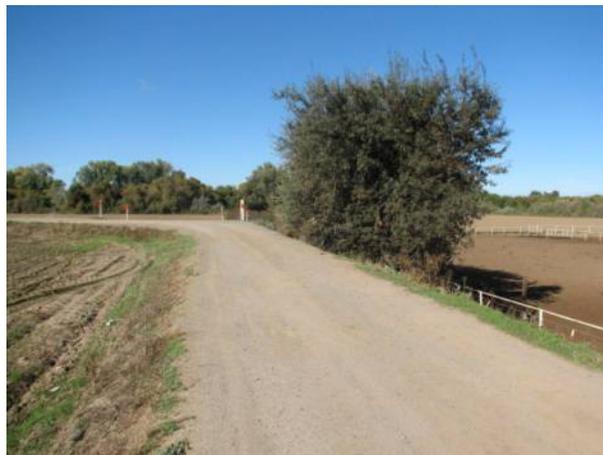
Levee Mile Report Line	4
Start Levee Mile	0.07
End Levee Mile	0.07
Location	Water Side
Category	Earthen Levee
Item	Vegetation
Fall 2009 photo of vegetation and trees on water side slope.	
jpaasch_s_20100330_165.jpg

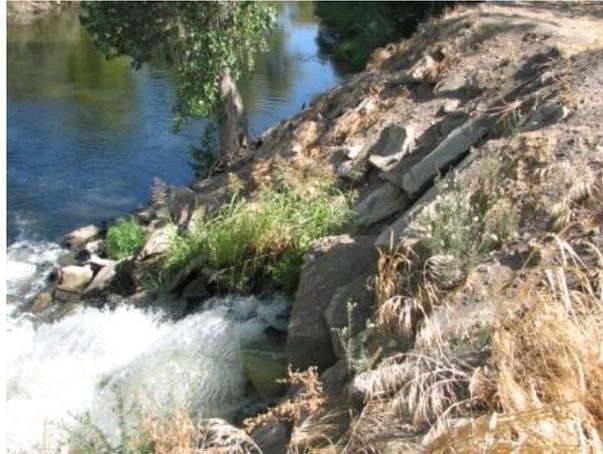
Levee Mile Report Line	6
Start Levee Mile	0.47
End Levee Mile	0.50
Location	Water Side
Category	Supplemental
Item	DWR Erosion Survey
<p>2009: No major changes observed; 1" fissure cracks developing on the slope; rip rap is showing signs of sloughing; recommend as local maintenance issue, per CLRO CES Evaluation 2008 Report; site was previously rated "U" [2009 SiteID:RD2031U1RM0.48]</p>	
<p>SJR2009_LM0.48U1 082009E.JPG</p>

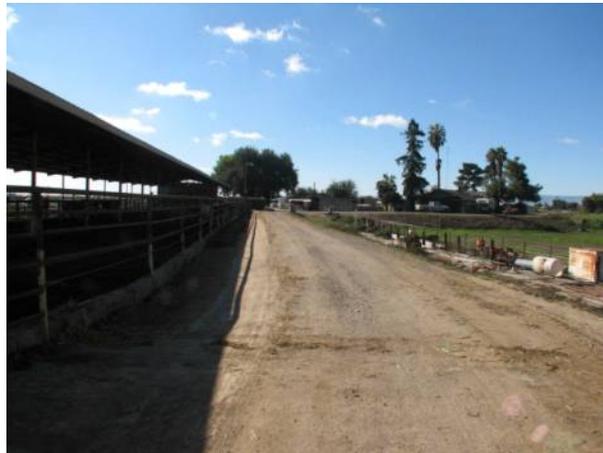
Levee Mile Report Line	9
Start Levee Mile	0.55
End Levee Mile	0.65
Location	Land Side
Category	Earthen Levee
Item	Encroachments
<p>Fall 2009 photo of livestock pens and house on landside slope.</p>	
<p>jpaasch_s_20100330_167.jpg</p>

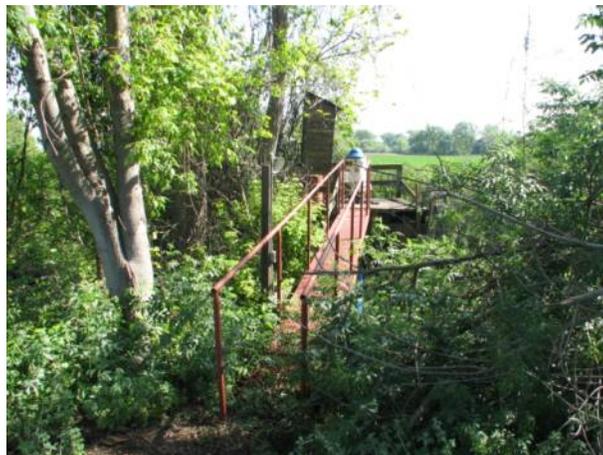
Levee Mile Report Line	22
Start Levee Mile	1.27
End Levee Mile	1.27
Location	Water Side
Category	Earthen Levee
Item	Encroachments
<p>Irrigation intake pump and pipe.</p>	
<p>jpaasch_s_20100426_306.jpg</p>

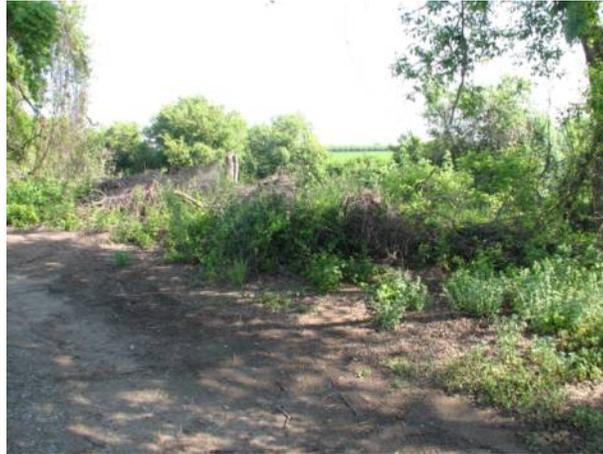
Levee Mile Report Line	23
Start Levee Mile	1.27
End Levee Mile	1.27
Location	Water Side
Category	Earthen Levee
Item	Vegetation
Vegetation on waterside slope and crown.	
jpaasch_s_20100426_307.jpg

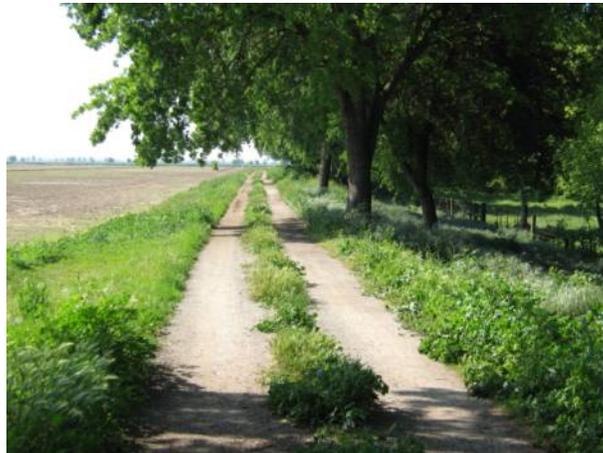
Levee Mile Report Line	29
Start Levee Mile	1.89
End Levee Mile	3.54
Location	Water Side
Category	Earthen Levee
Item	Vegetation
Annual grasses and weeds on levee slopes.	
jpaasch_s_20100426_308.jpg

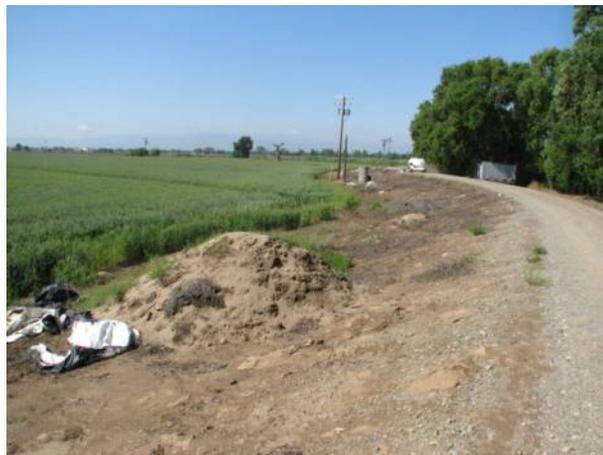
Levee Mile Report Line	35
Start Levee Mile	3.58
End Levee Mile	3.70
Location	Land Side
Category	Earthen Levee
Item	Encroachments
Piles of sand and material on levee slope should be removed.	
jpaasch_s_20100426_310.jpg

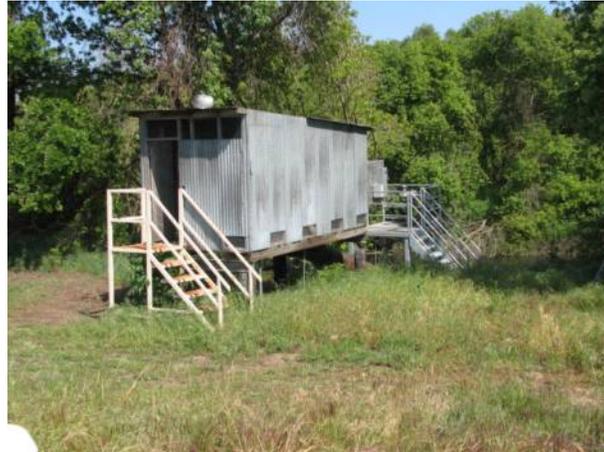
Levee Mile Report Line	36
Start Levee Mile	3.72
End Levee Mile	3.72
Location	Water Side
Category	Earthen Levee
Item	Encroachments
Irrigation intake on waterside berm.	
jpaasch_s_20100426_309.jpg

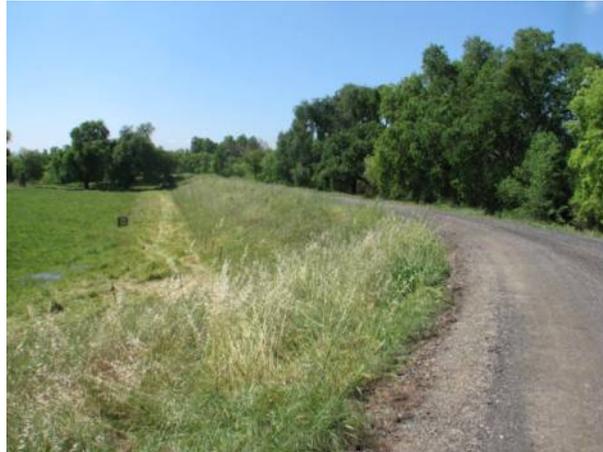
Levee Mile Report Line	1
Start Levee Mile	0.00
End Levee Mile	1.90
Location	Land Side
Category	Earthen Levee
Item	Vegetation
Annual grass on levee slope.	
jpaasch_s_20100426_311.jpg

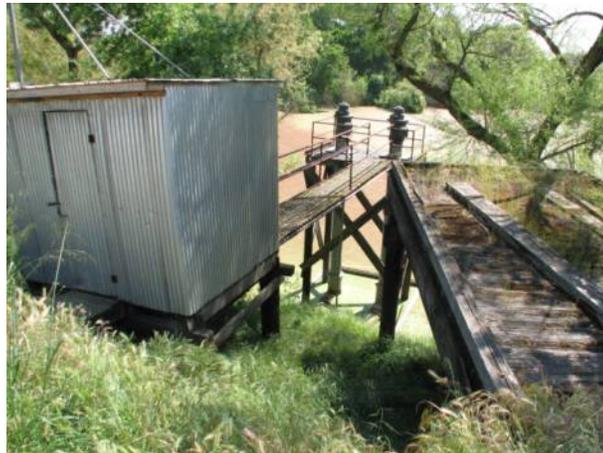
Levee Mile Report Line	4
Start Levee Mile	0.22
End Levee Mile	0.22
Location	Land Side
Category	Earthen Levee
Item	Encroachments
Drainage discharge. Pumps on landside. Pipes penetrate through base of levee.	
jpaasch_s_20100426_312.jpg

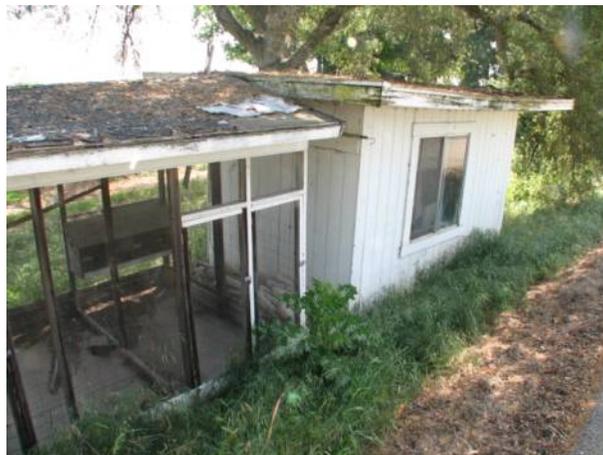
Levee Mile Report Line	5
Start Levee Mile	1.36
End Levee Mile	1.36
Location	Land Side
Category	Earthen Levee
Item	Encroachments
Small structure on levee slope.	
jpaasch_s_20100426_313.jpg

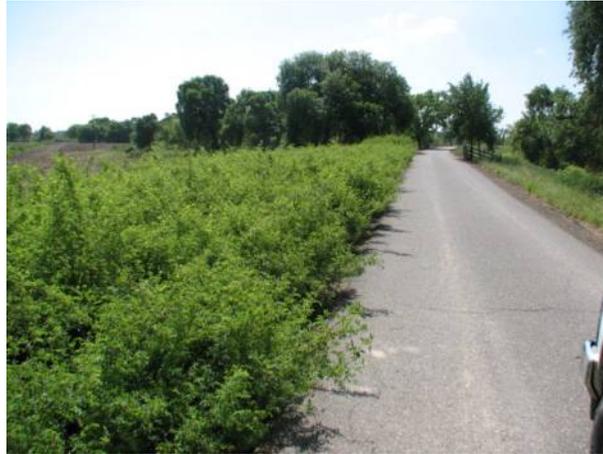
Levee Mile Report Line	6
Start Levee Mile	1.45
End Levee Mile	1.45
Location	Land Side
Category	Earthen Levee
Item	Encroachments
Wild rose on levee slope.	
jpaasch_s_20100426_314.jpg
