**Flood Control Project Maintenance
Levee Inspections**
LMA District Cover Sheet
Spring 2015 Levee Inspection Results

Reclamation District No. 2031 Elliot

Spring 2015 Levee Inspection Results

Waterway		Bank	Unit Miles
Unit No. 01 Stanislaus River		Left	7.07

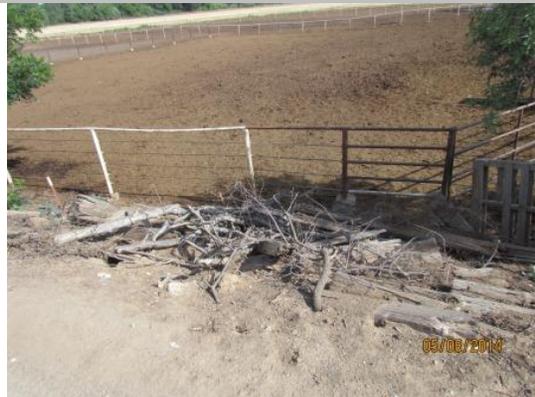
Photo 1 of 1 : SP_2015_RD2031_307_122_20150317_00032.jpg

LM Start	0.02	Rating **	U	Issue No.	122
LM End	0.02	Issue Type +	En	Location *	WS
Category	Earthen Levee		GPS Latitude/Longitude		
			Start	End	
Item	Encroachments		37.710016 °	37.710016 °	
			-121.155803 °	-121.155803 °	
DWR ID	DWR_RD2031_01_s_2015_122				
Action/Comments					
Debris

View of the pipe of debris on the waterside levee slope.

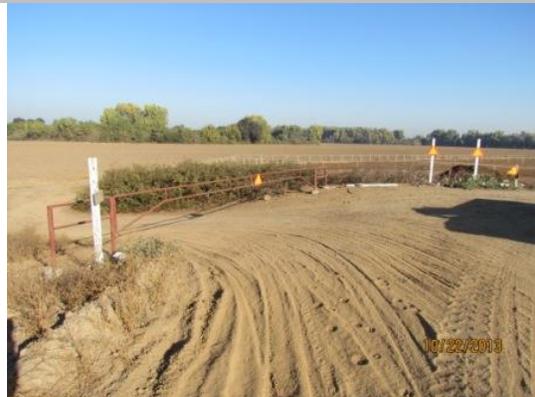
Photo 1 of 1 : SP_2015_RD2031_307_50_20150317_00028.jpg

LM Start	0.06	Rating **	M	Issue No.	50
LM End	0.06	Issue Type +	En	Location *	WS
Category	Earthen Levee		GPS Latitude/Longitude		
			Start	End	
Item	Encroachments		37.709950 °	37.709950 °	
			-121.156540 °	-121.156540 °	
DWR ID	DWR_RD2031_01_f_2013_50				
Action/Comments					
Fence Inspector Comments: Unpermitted gates at waterside levee hinge.

View of the gate at the waterside levee hinge.

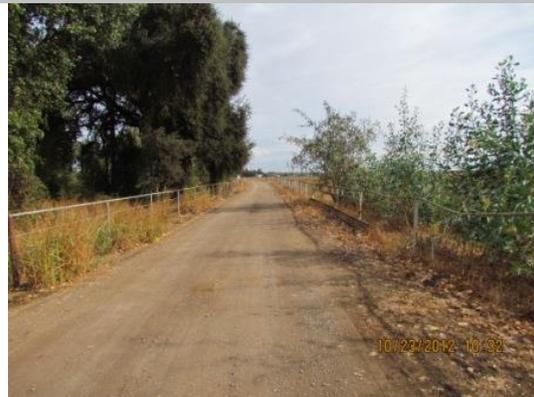
Photo 1 of 2 : SP_2015_RD2031_307_14_20150317_00012.jpg

LM Start	0.44	Rating **	U	Issue No.	14
LM End	0.53	Issue Type +	En	Location *	LS
Category	Earthen Levee			GPS Latitude/Longitude	
				Start	End
Item	Encroachments			37.704927 °	37.703788 °
				-121.158860 °	-121.159923 °
DWR ID	DWR_RD2031_01_f_2012_14				
Action/Comments					
Fence Inspector Comments: It appears the fence was completed without CVFPB approval.

View of fence on landside levee shoulder obstructing access to landside slope. Facing upstream.

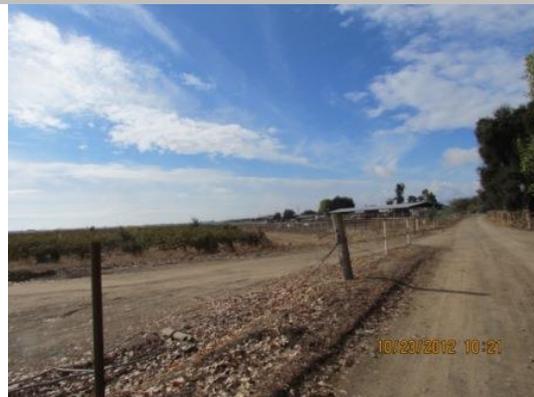
Photo 2 of 2 : SP_2015_RD2031_307_14_20150317_00013.jpg

View of fence on landside levee shoulder facing downstream.

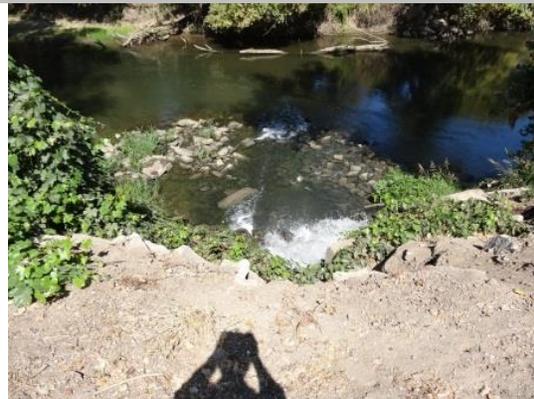
Photo 1 of 1 : SP_2015_RD2031_307_1_20150317_00001.jpg

LM Start	0.46	Rating **	M	Issue No.	1
LM End	0.46	Issue Type +	Ma	Location *	WS
Category	Supplemental			GPS Latitude/Longitude	
				Start	End
Item	DWR Erosion Survey			37.704740 °	37.704740 °
				-121.159140 °	-121.159140 °
DWR ID	DWR_RD2031_01_s_2015_1				
Action/Comments					
Inspector Comments: 07/31/2014: No significant change observed. 09/10/2013: No significant change observed. 07/18/2012: No significant change observed. 08/18/2011: No significant change observed on site. Debris that blocks the irrigation outlet is visible. 10/19/2010: No significant change observed on site. Sloughing of the bank is occurring adjacent to an irrigation outlet structure. There is moderate to heavy vegetation along the bank that is well established. Broken chunks and slabs of concrete are used as rip rap and line the outside of the irrigation outlet structure. However, much of the rip rap along the slope is sloughing and could possibly lead to future slope instability. 08/05/2010: Recommended as a local maintenance issue, per CLRO. 08/20/2009: No major change observed since last visit; 1 inch fissure cracks developing on the slope; rip rap is showing signs of sloughing; recommend as local maintenance issue; site was previously rated "U". 2008: No change from previous year; irrigation outlet located on site; rip rap placed on river bank. 09/06/2007: Near agricultural diversion; only 3' landside height differential. [2014 Site ID:RD2031U01RM0.48]

Looking down at the site. The irrigation outlet is operating. Debris is visible at the outlet.

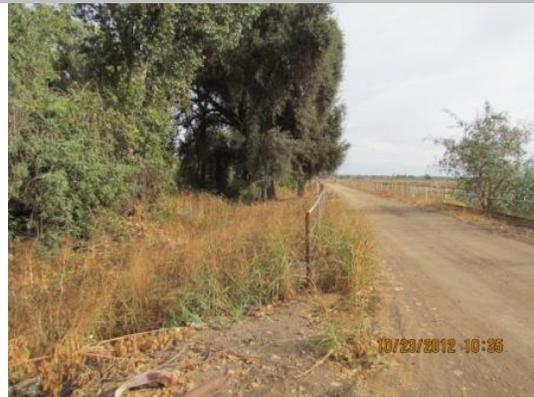
Photo 1 of 2 : SP_2015_RD2031_307_2_20150317_00002.jpg

LM Start	0.51	Rating **	M	Issue No.	2
LM End	0.51	Issue Type +	Ma	Location *	WS
Category	Earthen Levee			GPS Latitude/Longitude	
				Start	End
Item	Vegetation			37.704050 °	37.704050 °
				-121.159578 °	-121.159578 °
DWR ID	DWR_RD2031_01_s_2012_2				
Action/Comments					
Remove the wild growth other than native grasses from the levee slopes. Inspector Comments: Remove vegetation 20 feet away from the levee crown.

View of vegetation on waterside slope. Facing upstream.

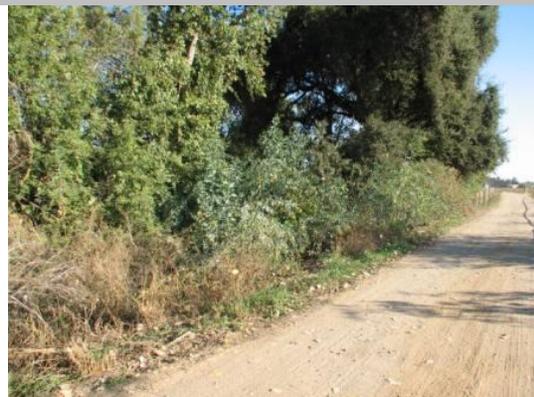
Photo 2 of 2 : SP_2015_RD2031_307_2_20150317_00003.jpg

10/26/2011 Updated photo of waterside vegetation.

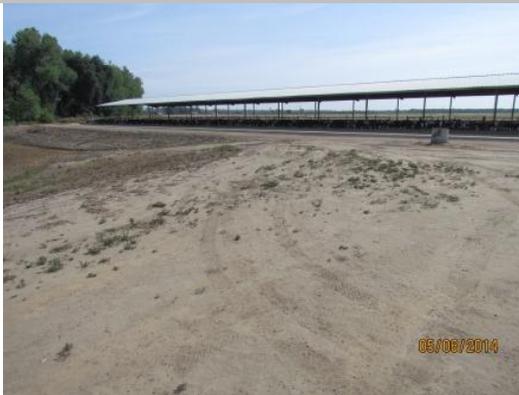
Photo 1 of 1 : SP_2015_RD2031_307_126_20150317_00034.jpg

LM Start	0.56	Rating **	M	Issue No.	126
LM End	0.56	Issue Type +	En	Location *	WS
Category	Earthen Levee		GPS Latitude/Longitude		
			Start	End	
Item	Encroachments		37.703394 °	37.703394 °	
			-121.159713 °	-121.159713 °	
DWR ID	DWR_RD2031_01_s_2014_126				
Action/Comments					
Material Inspector Comments: Levee built up with material from adjacent field. Unpermitted. The landowner has contacted CVFPB and started the permitting process.

View of the material placed on the waterside levee slope to build up the levee and increase the levee crown.

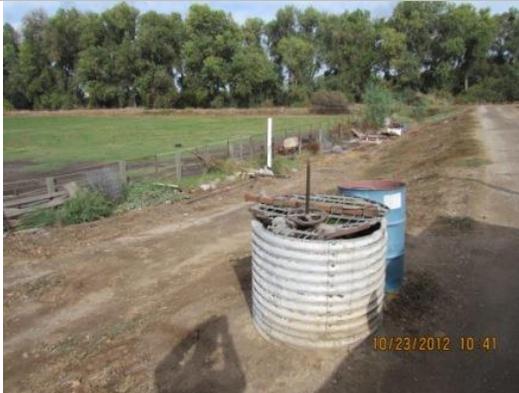
Photo 1 of 2 : SP_2015_RD2031_307_16_20150317_00014.jpg

LM Start	0.58	Rating **	A/W	Issue No.	16
LM End	0.58	Issue Type +	En	Location *	WS
Category	Earthen Levee		GPS Latitude/Longitude		
			Start	End	
Item	Encroachments		37.703120 °	37.703120 °	
			-121.159798 °	-121.159798 °	
DWR ID	DWR_RD2031_01_f_2012_16				
Action/Comments					
Pipe Inspector Comments: It appears that the pipe is in good condition and slide gate is operational.

View of the pipe gate valve location.

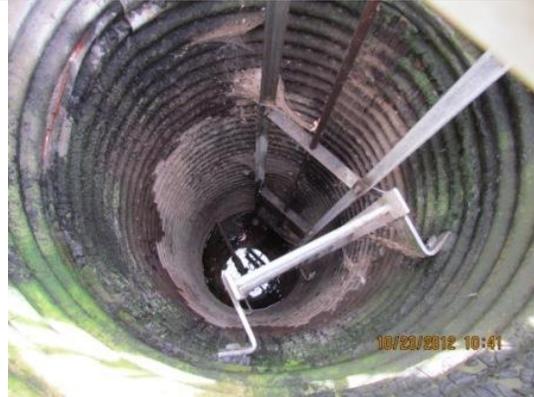
Photo 2 of 2 : SP_2015_RD2031_307_16_20150317_00015.jpg

LM Start	0.58	Rating **	A/W	Issue No.	16 (cont)
LM End	0.58	Issue Type +	En	Location *	WS
Category	Earthen Levee			GPS Latitude/Longitude	
				Start	End
Item	Encroachments			37.703120 °	37.703120 °
				-121.159798 °	-121.159798 °
DWR ID	DWR_RD2031_01_f_2012_16				
Action/Comments					
Pipe Inspector Comments: It appears that the pipe is in good condition and slide gate is operational.

View of slide gate and access ladder. Gate appears to be in good condition.

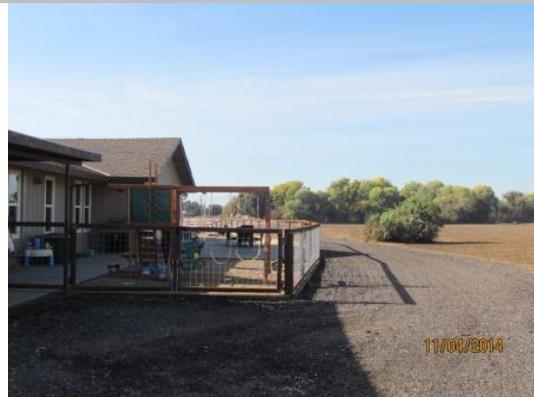
Photo 1 of 1 : SP_2015_RD2031_307_58_20150317_00031.jpg

LM Start	0.60	Rating **	M	Issue No.	58
LM End	0.63	Issue Type +	En	Location *	LS
Category	Earthen Levee			GPS Latitude/Longitude	
				Start	End
Item	Encroachments			37.703186 °	37.702786 °
				-121.160211 °	-121.160628 °
DWR ID	DWR_RD2031_01_f_2014_58				
Action/Comments					
Fence Inspector Comments: Unpermitted fence on landside levee hinge.

View of the unpermitted fence on the landside levee hinge.

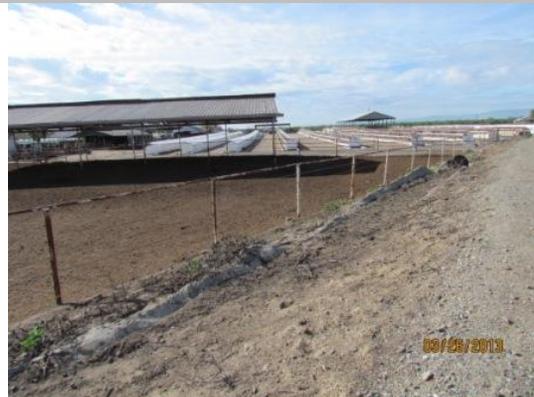
Photo 1 of 1 : SP_2015_RD2031_307_4_20150317_00006.jpg

LM Start	0.63	Rating **	M	Issue No.	4
LM End	0.72	Issue Type +	En	Location *	LS
Category	Earthen Levee			GPS Latitude/Longitude	
				Start	End
Item	Encroachments			37.702814 °	37.701875 °
				-121.160562 °	-121.161670 °
DWR ID	DWR_RD2031_01_s_2012_4				
Action/Comments					
Fence

View of the fence at the landside levee toe.

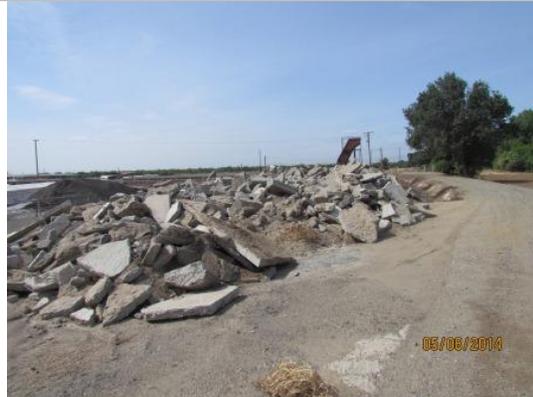
Photo 1 of 1 : SP_2015_RD2031_307_127_20150317_00035.jpg

LM Start	0.71	Rating **	U	Issue No.	127
LM End	0.71	Issue Type +	En	Location *	LS
Category	Earthen Levee		GPS Latitude/Longitude		
			Start	End	
Item	Encroachments		37.702051 °	37.702051 °	
			-121.161502 °	-121.161502 °	
DWR ID	DWR_RD2031_01_s_2014_127				
Action/Comments					
Material Inspector Comments: Remove concrete stockpile from the levee toe easement.

View of the concrete debris stockpiled at the landside levee toe.

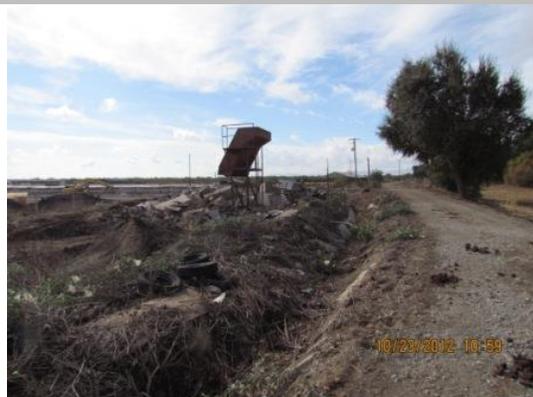
Photo 1 of 1 : SP_2015_RD2031_307_972_20150317_00039.jpg

LM Start	0.72	Rating **	M	Issue No.	972
LM End	0.76	Issue Type +	En	Location *	LS
Category	Earthen Levee		GPS Latitude/Longitude		
			Start	End	
Item	Encroachments		37.701906 °	37.701370 °	
			-121.161661 °	-121.161986 °	
DWR ID	DWR_RD2031_01_s_2012_972				
Action/Comments					
Ditch

View of the ditch on landside levee toe, facing downstream.

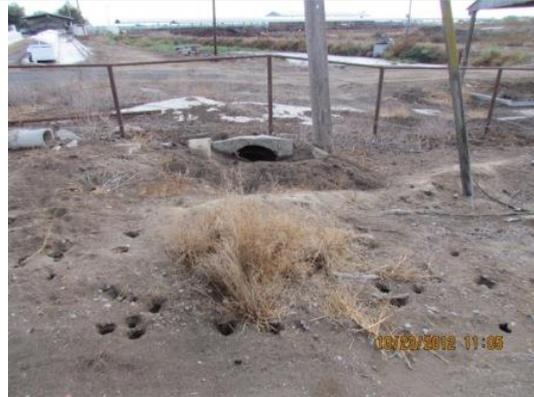
Photo 1 of 1 : SP_2015_RD2031_307_36_20150317_00021.jpg

View of rodent burrows on landside slope.

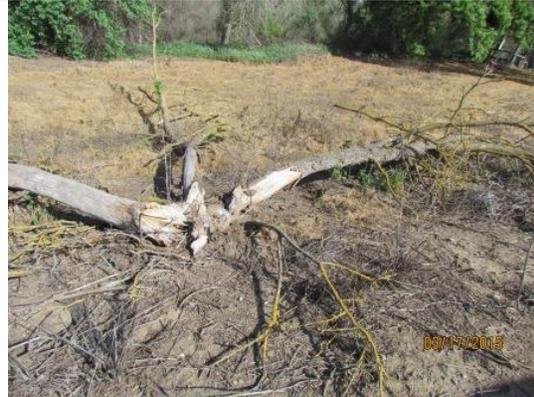
Photo 1 of 1 : SP_2015_RD2031_307_49_20150330_00052.jpg

View of the tree stump on the waterside levee slope.

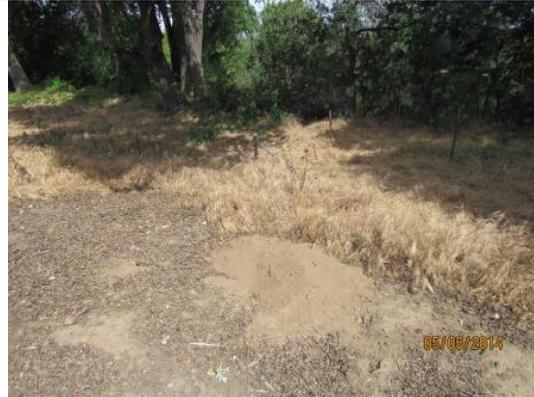
Photo 1 of 1 : SP_2015_RD2031_307_128_20150317_00036.jpg

View of the rodent hole on the waterside levee slope.

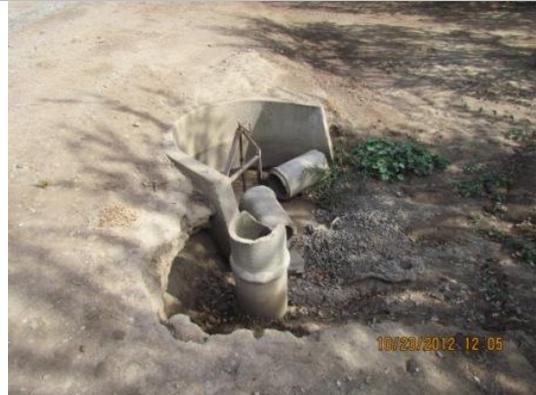
Photo 1 of 2 : SP_2015_RD2031_307_3_20150317_00004.jpg

View of the erosion site on landside slope, facing upstream.

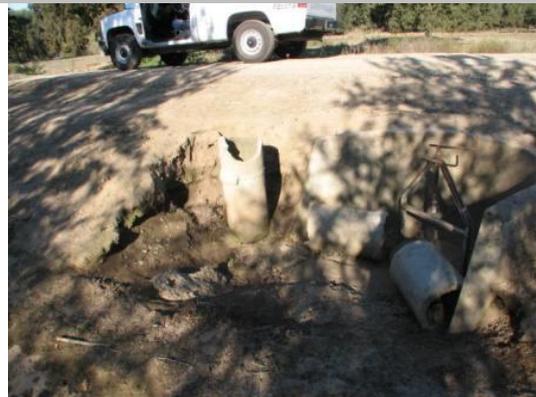
Photo 2 of 2 : SP_2015_RD2031_307_3_20150317_00005.jpg

10/26/2011 Active erosion into the levee prism around irrigation standpipe.

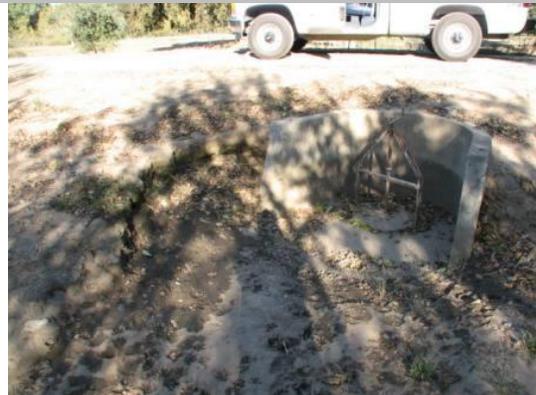
Photo 1 of 1 : SP_2015_RD2031_307_8_20150317_00010.jpg

10/26/2011 Active erosion shown around irrigation inlet.

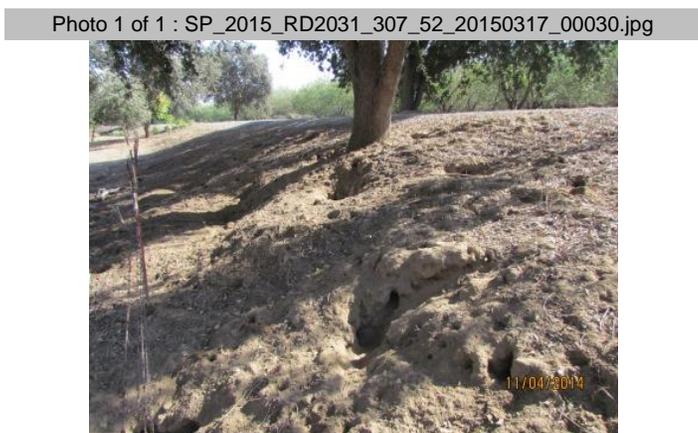
LM Start	1.62	Rating **	A/W	Issue No.	52
LM End	1.62	Issue Type +	Ma	Location *	WS
Category	Earthen Levee		GPS Latitude/Longitude		
			Start	End	
Item	Animal Control		37.698334 °	37.698334 °	
			-121.175176 °	-121.175176 °	
DWR ID	DWR_RD2031_01_f_2013_52				
Action/Comments					
No rodents visible, but rodent burrows visible; need to backfill and compact or grout burrows.

View of the multiple large rodent hole in the waterside levee slope.

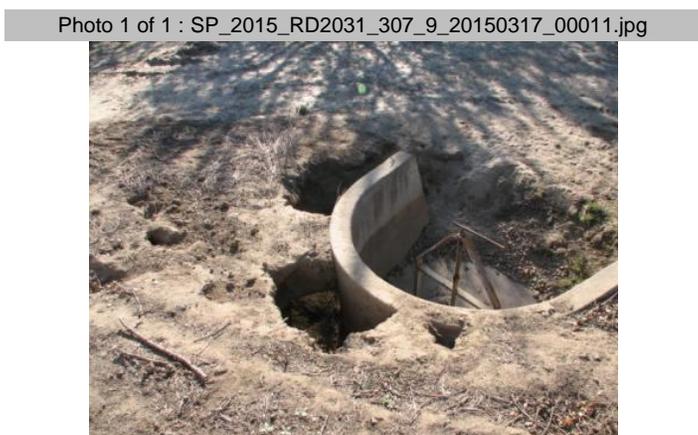
LM Start	1.63	Rating **	M	Issue No.	9
LM End	1.63	Issue Type +	Ma	Location *	LS
Category	Earthen Levee		GPS Latitude/Longitude		
			Start	End	
Item	Erosion / Bank Caving		37.698208 °	37.698208 °	
			-121.175400 °	-121.175400 °	
DWR ID	DWR_RD2031_01_s_2012_9				
Action/Comments					
Note and monitor erosion site. Inspector Comments: Active erosion around irrigation inlet in levee prism.

10/26/2011 Active erosion into levee prism around irrigation inlet.

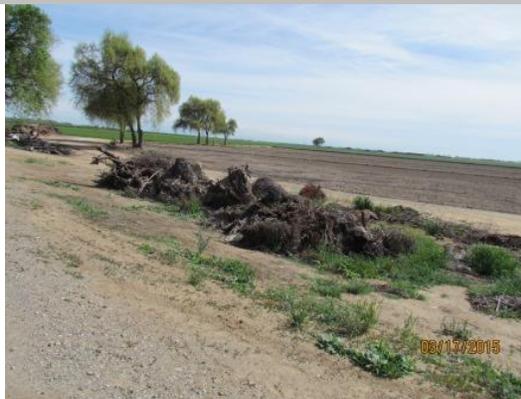
Photo 1 of 1 : SP_2015_RD2031_307_53_20150330_00053.jpg

View of the debris at the landside levee toe.

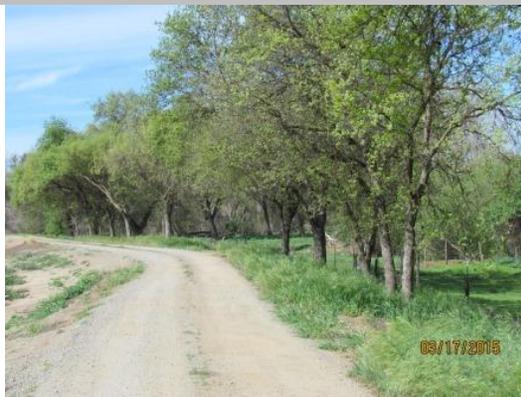
Photo 1 of 1 : SP_2015_RD2031_307_54_20150330_00054.jpg

View of the vegetation on the levee slope.

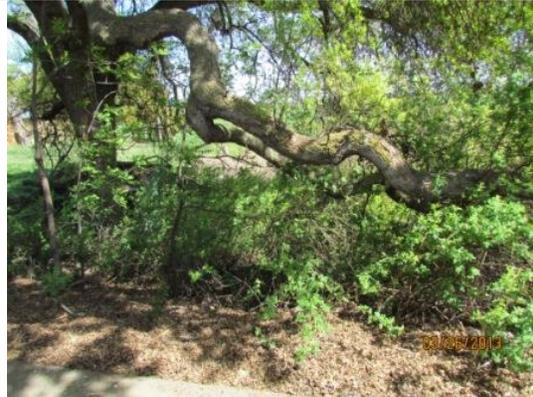
Photo 1 of 1 : SP_2015_RD2031_308_15_20150317_00007.jpg

View of the tree limb obstructing visibility and access to the landside levee slope.

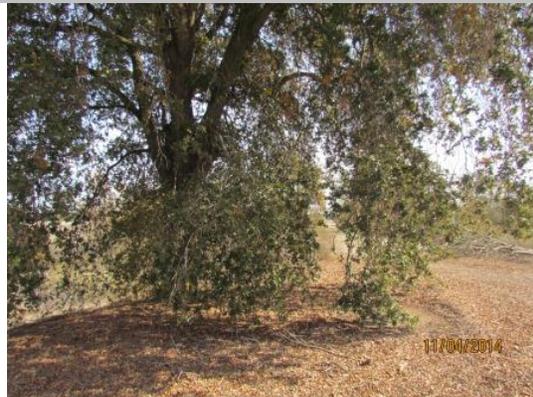
Photo 1 of 1 : SP_2015_RD2031_308_25_20150317_00010.jpg

View of the overgrown tree obstructing visibility and access of the landside levee slope.

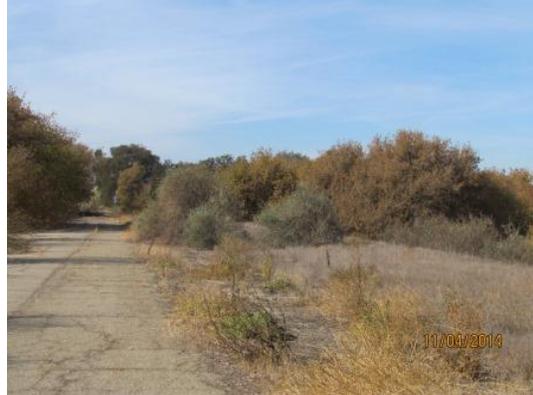
Photo 1 of 1 : SP_2015_RD2031_308_21_20150317_00008.jpg

View of overgrown vegetation on the levee crown.

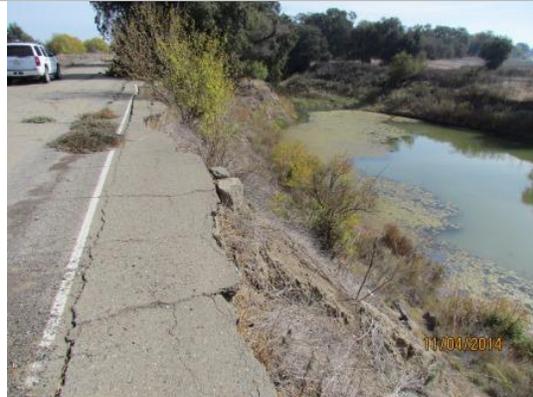
Photo 1 of 1 : SP_2015_RD2031_308_26_20150317_00011.jpg

View of the caving bank on the waterside facing upstream.

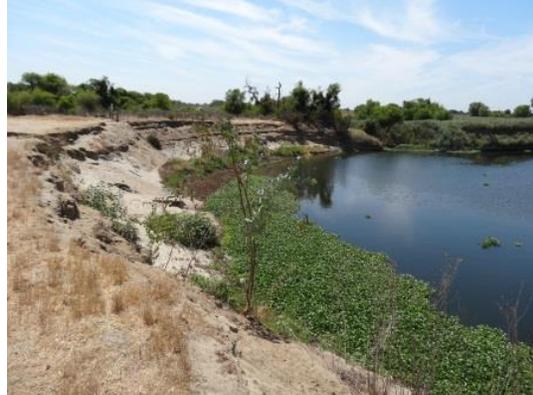
Photo 1 of 1 : SP_2015_RD2031_308_1_20150317_00001.jpg

Looking downstream. The erosion has progressed toward levee.

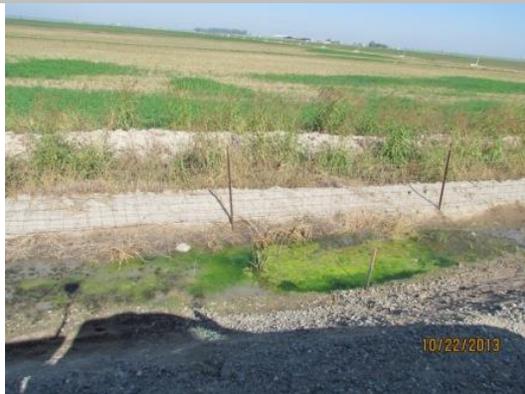
Photo 1 of 1 : SP_2015_RD2031_308_10_20150317_00006.jpg

View of the seepage area at the landside levee toe.
