**Flood Control Project Maintenance
Levee Inspections**

Fall 2013 Levee Maintenance Deficiency Summary Report

Sacramento River Basin

Reclamation District No. 2035 Conaway

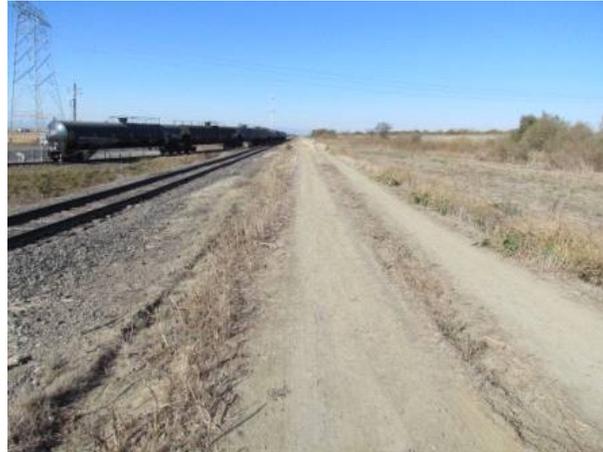
| LMR No. | Levee Mile | | Category | Item | * Location | + Rating | Action/Comment | GPS Latitude/Longitude | | Issue No. Photo |
|---|---|---|---|---|---|---|---|--|---|---|
| 5 | 0.01 | 2.00 | Earthen Levee | Vegetation | | LS A/W Ma | V1 : Control annual grass and weeds on the levee slopes and easements. | 38.677368 ° 38.677175 ° -121.709713 ° -121.672947 ° | 10 Y | |

This photo was taken from the levee crown facing west looking down the landward slope at acceptable vegetation control. Fall 2013.

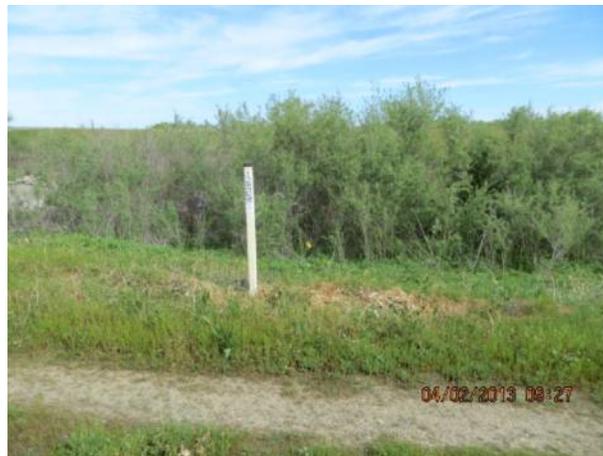
| Levee Mile Report Line | 8 |

| LMR No. | Levee Mile | | Category | Item | * Location | + Rating | Action/Comment | GPS Latitude/Longitude | | Issue No. Photo |
|---|---|---|---|---|---|---|---|--|---|---|
| 8 | 0.03 | 0.03 | Supplemental | DWR UCIP Field Study | | WS M En | Inspector Comments: FS_ID:16063 EP_NO: N/A Repair Type: Non-Urgent Crossing Status: Indicator Found UCIP Comments: No permit identified for this crossing. FIELD_STRUCT_DESC: Gas line of an unknown diameter through the levee at an unknown depth. Gas line markers on both sides of levee. FS Date: 4/2/2013 | 38.677362 ° -121.709327 ° 38.677362 ° -121.709327 ° | 6 Y | |

Gasline marker on WS shoulder.

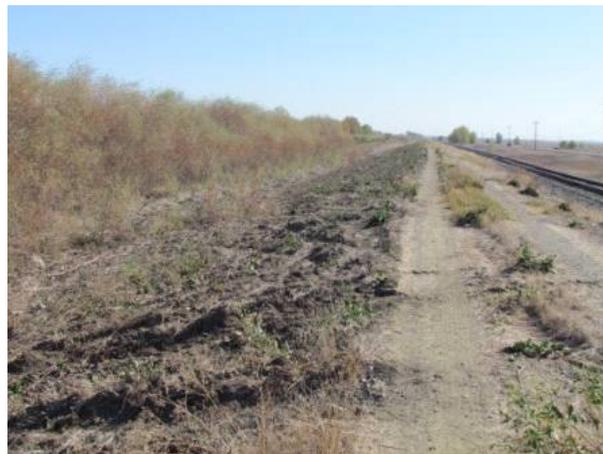
| Levee Mile Report Line | 9 |

| LMR No. | Levee Mile | | Category | Item | * Location | + Rating | Action/Comment | GPS Latitude/Longitude | | Issue No. Photo |
|---|---|---|---|---|---|---|---|--|---|---|
| 9 | 0.03 | 2.00 | Earthen Levee | Encroachments | | WSA/W Ma | AT : Agricultural tilling Inspector Comments: Discing on the waterward slope can lead to erosion. | 38.677347 ° 38.677175 ° -121.709285 ° -121.672945 ° | 11 Y | |

This photo was taken from the levee crown facing east looking at discing on the waterward slope. Fall 2013.

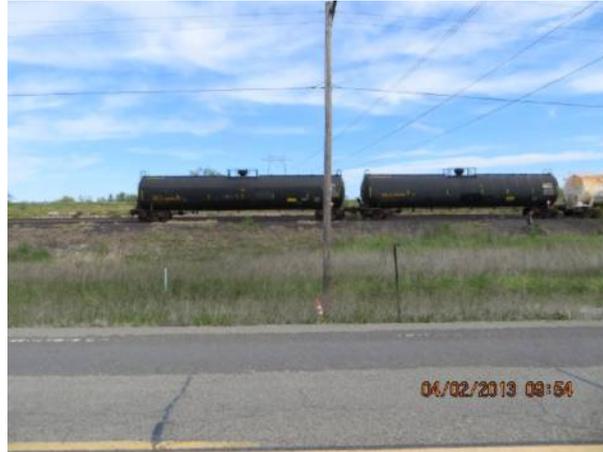
| 11 | 1.85 | 1.85 | Supplemental | DWR UCIP Field Study | WS | M En | Inspector Comments: FS_ID:10913 EP_NO: 13201 Repair Type: Non-Urgent Crossing Status: Indicator Found UCIP Comments: Pipe needs to be properly marked or abandoned. FIELD_STRUCT_DESC: 8-inch diameter casing through the levee 25-feet below the crown. 3-inch gas line through the casing with annular space filled with Bentonite. Possible vent for pipe on LS next to Old River Road. FS Date: 4/2/2013 | 38.677186 ° | -121.675277 ° | 7 Y |

| Vent pipe to right of JP next to Old River Road. | |

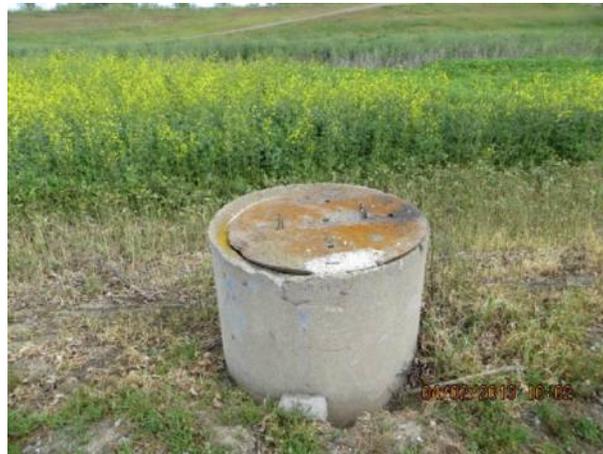
| Levee Mile Report Line | 12 |

| 12 | 1.91 | 1.91 | Supplemental | DWR UCIP Field Study | WS | M En | Inspector Comments: FS_ID:10914 EP_NO: 2544 Repair Type: Non-Urgent Crossing Status: Found UCIP Comments: Pipe appears to be abandoned as there is no pumphouse. Needs to be abandoned properly FIELD_STRUCT_DESC: 16-inch drainage pipe through levee 5.0 feet below crown. Pump on piling structure in drainage ditch on landward side. 36-inch concrete standpipe on waterward shoulder. (Permit No. 2544 - City of Woodland) FS Date: 4/2/2013 | 38.677175 ° | -121.674065 ° | 8 Y |

| 36-inch Concrete stand pipe on WS shoulder. | |

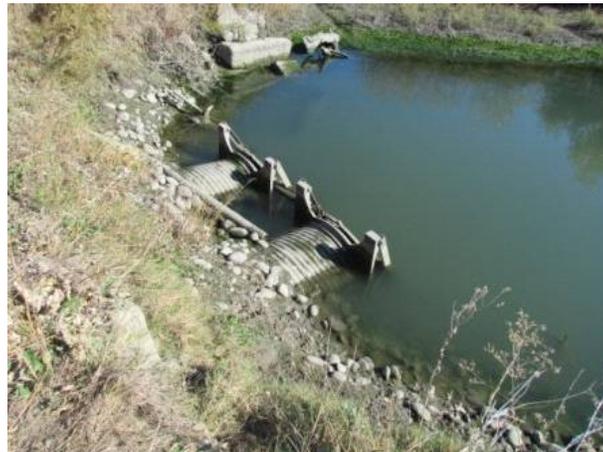
| Levee Mile Report Line | 13 |

| 13 | 2.00 | 2.00 | Earthen Levee | Encroachments | WSA/W | PI : Pipe En | Inspector Comments: Pipes at east end of unit now have flap gates installed but propped open with debris. | 38.677177 ° | 38.677177 ° | 13 Y |

| This photo was taken from the levee crown facing east at the intersection of unit 2 looking down at flap gates that are propped open with debris. Fall 2013. | |

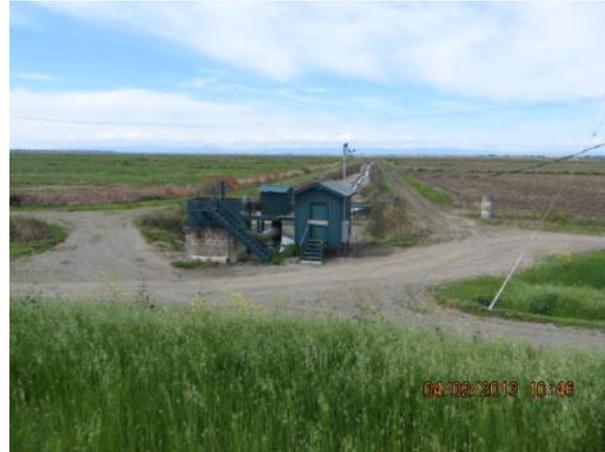
| Pumping plant off LS toe. | |

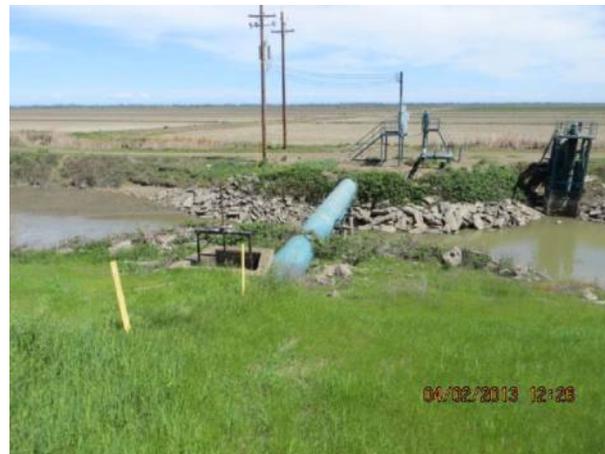
| Levee Mile Report Line | 5 |

| LMIR No. | Levee Mile | | Category | Item | Location | Rating | Action/Comment | GPS Latitude/Longitude | | Issue No. Photo |
|---|---|---|---|---|---|---|--|---|---|---|
| 5 | 1.70 | 1.70 | Supplemental | DWR UCIP Field Study | WS | U | Inspector Comments: FS_ID:11523 EP_NO: N/A Repair Type: Urgent Crossing Status: Found UCIP Comments: Pipe does not have appropriate cover and is marked as gasoline. Does not appear to be a permitted utility. FIELD_STRUCT_DESC: 4-inch steel pipe 3-inches below the crown with a 2-inch PVC pipe sleeved through it. FS Date: 4/2/2013 7:55:12 AM | 38.652721 ° 38.652721 ° | -121.667790 ° -121.667790 ° | 2 Y |

| Pipe with gasline markers on WS slope. | |

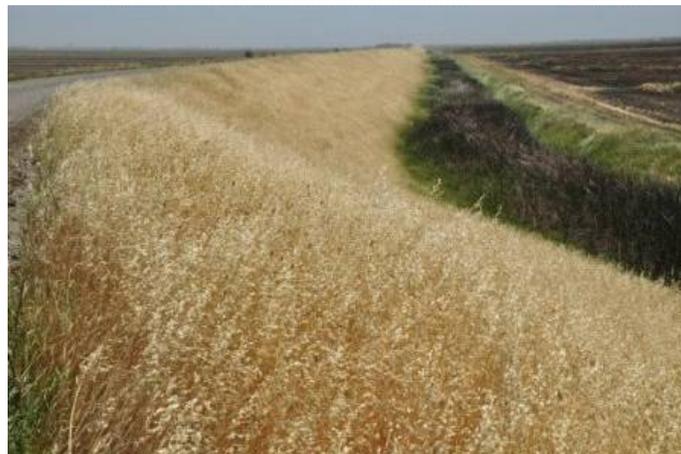
| Levee Mile Report Line | 7 |

| Drainage ditch at L/S levee toe. | |

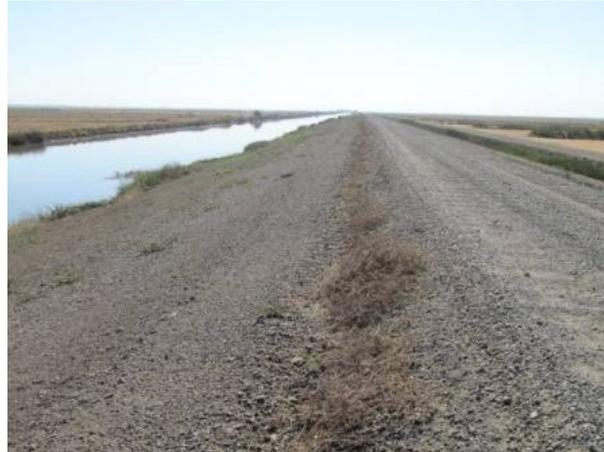
This photo was taken from the levee crown facing south looking down the waterward levee slope at acceptable vegetation. Fall 2013.

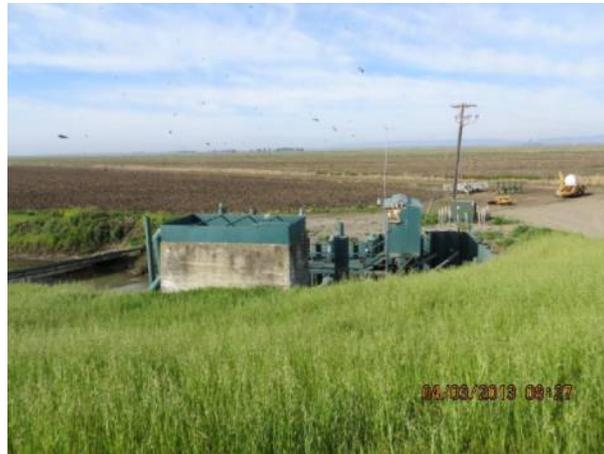
| Levee Mile Report Line | 13 |

| LMR No. | Levee Mile | | Category | Item | * Location | + Rating | Action/Comment | GPS Latitude/Longitude | | Issue No. Photo |
|---|---|---|---|---|---|---|--|---|---|---|
| 13 | 4.39 | 4.39 | Supplemental | DWR UCIP Field Study | LS | M En | Inspector Comments: FS_ID:10986 EP_NO: 1701 Repair Type: Non-Urgent Crossing Status: Found UCIP Comments: Animal activity at outlet causing damage to berm and undermining the pipe at the outlet headwall on WS toe. FIELD_STRUCT_DESC: 60-inch corrugated metal drain pipe through the levee 20.6 feet below the crown encased in 6-inches of reinforced concrete. Slide gate in 7-foot diameter C.M. pipe riser on waterward slope. Pumping plant with 6-pumps/pipes that discharge into a 4-ft by 18-ft surge box on the LS toe. (Permit No. 1701 - R.D. 2035) FS Date: 4/3/2013 | 38.618030 ° 38.618030 ° | -121.645192 ° -121.645192 ° | 12 Y |

Surge box and pumping plant on LS toe.

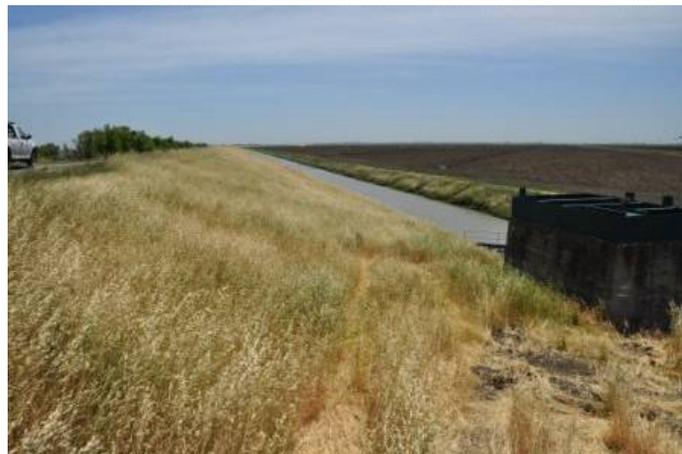
| Levee Mile Report Line | 15 |

Drainage ditch at L/S levee toe.

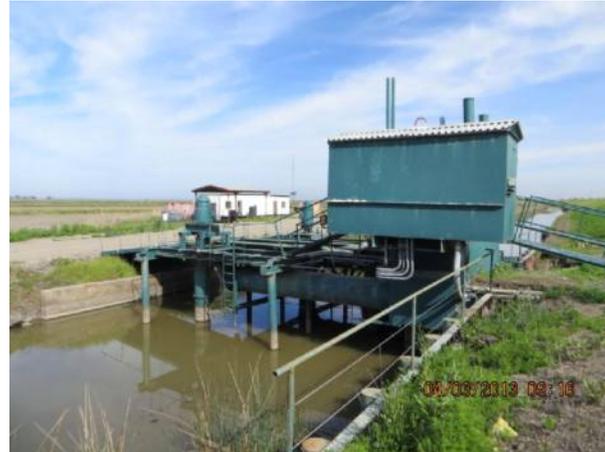
| Pumping plant on LS toe. | |

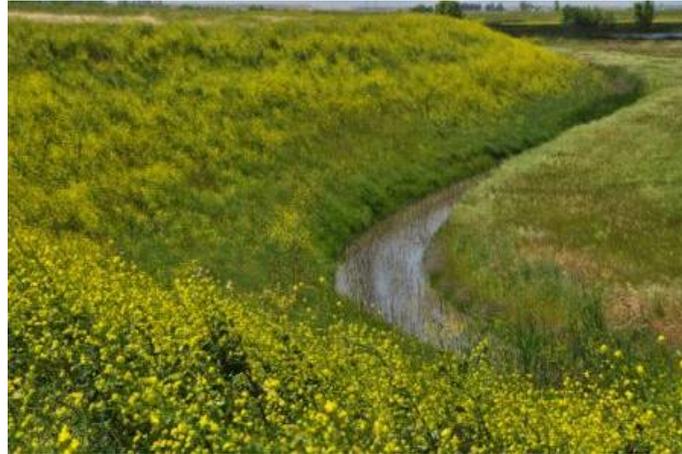
L/S drainage ditch at levee toe.

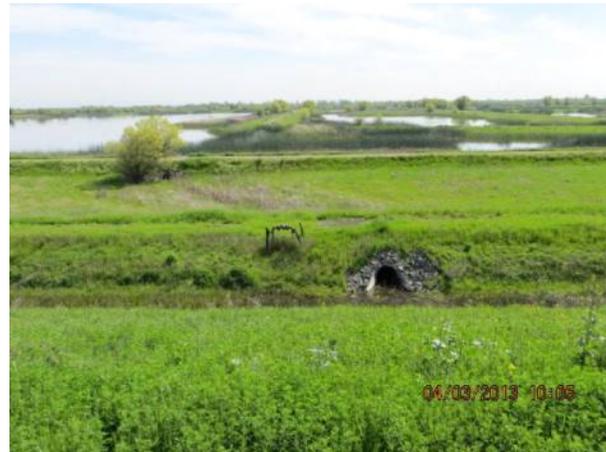
| Levee Mile Report Line | 4 |

| LMIR No. | Levee Mile | | Category | Item | Location | Rating | Action/Comment | GPS Latitude/Longitude | | Issue No. Photo |
|---|---|---|---|---|---|---|--|---|---|---|
| 4 | 0.80 | 0.80 | Supplemental | DWR UCIP Field Study | LS | M En | Inspector Comments: FS_ID:11007 EP_NO: 6123 Repair Type: Non-Urgent Crossing Status: Indicator Found UCIP Comments: Need to install gasoline markers through the levee if pipe is still active. FIELD_STRUCT_DESC: 4.5-inch Gas line through levee 2.5 feet below the crown. Pipe at vent visible off LS toe. (Permit No. 6123 - P.G.&E.) FS Date: 4/3/2013 | 38.581057 ° 38.581057 ° | -121.645142 ° -121.645142 ° | 1 Y |

Gasline vent off LS toe.

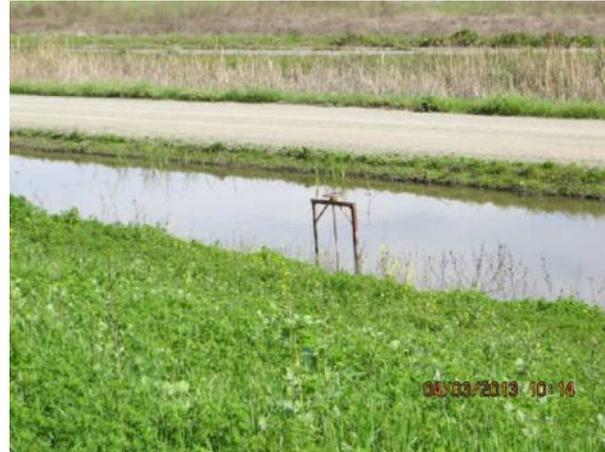
| Slide gate and headwall in canal at LS toe. | |

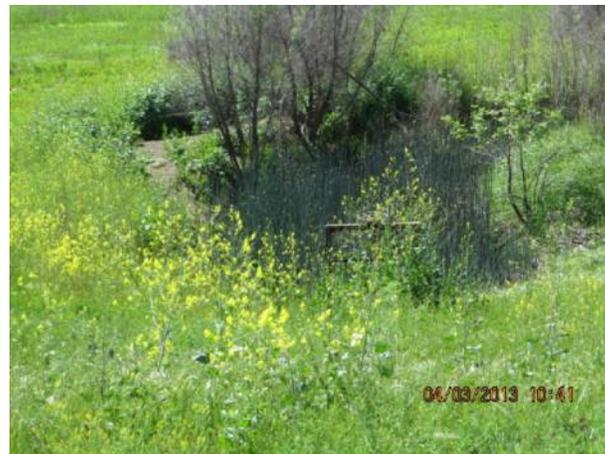
| Levee Mile Report Line | 6 |

| LMIR No. | Levee Mile | | Category | Item | Location | Rating | Action/Comment | GPS Latitude/Longitude | | Issue No. Photo |
|---|---|---|---|---|---|---|--|---|---|---|
| 6 | 2.16 | 2.16 | Supplemental | DWR UCIP Field Study | LS | M En | Inspector Comments: FS_ID:11011 EP_NO: N/A Repair Type: Non-Urgent Crossing Status: Found UCIP Comments: Debris and vegetation partially blocking inlet and outlet at both toes. FIELD_STRUCT_DESC: 48-inch corrugated metal pipe through levee 19.0 feet below crown, slide gate on both ends. Originally included in O+M manual (1952). FS Date: 4/3/2013 | 38.590934 ° 38.590934 ° | -121.658940 ° -121.658940 ° | 6 Y |

| Slide gate at WS toe showing excessive vegetation. | |

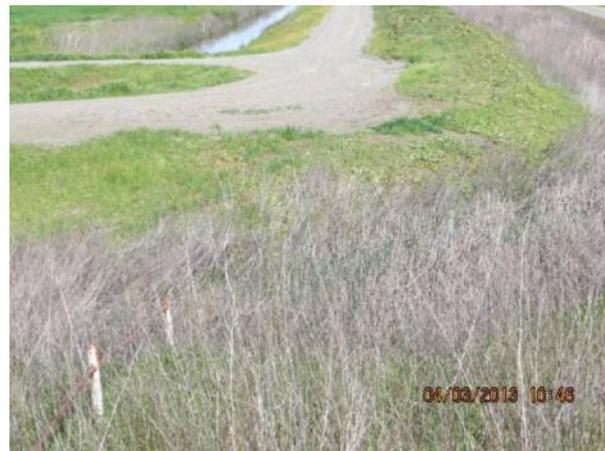
| Levee Mile Report Line | 7 |

| LMIR No. | Levee Mile | | Category | Item | * Location | ** Rating | Action/Comment | GPS Latitude/Longitude | | Issue No. Photo |
|---|---|---|---|---|---|---|---|---|---|---|
| 7 | 2.18 | 2.18 | Supplemental | DWR UCIP Field Study | LS | M En | Inspector Comments: FS_ID:11012 EP_NO: N/A Repair Type: Non-Urgent Crossing Status: Found UCIP Comments: Debris and vegetation partially blocking both ends of pipe. FIELD_STRUCT_DESC: 36-inch pipe through levee 18.0 feet below crown, slide gate on LS toe. Combination flap and slide gate on WS toe. Originally included in O+M manual. FS Date: 4/3/2013 | 38.590909 ° | -121.659311 ° | 7 Y |

| Headwall at bottom of fenceline on LS to.e | |

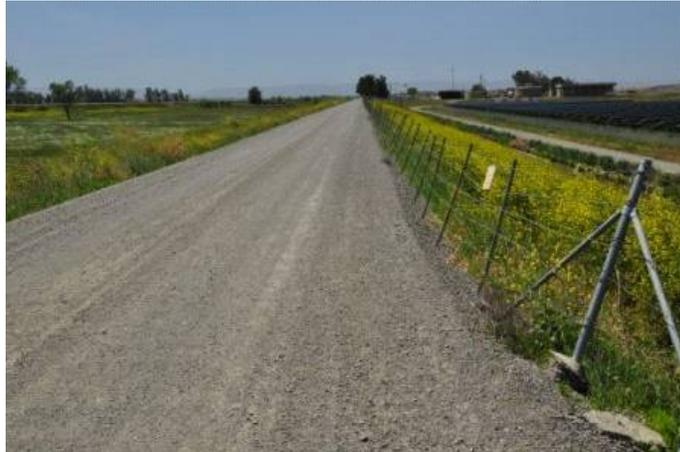
| Fence along L/S shoulder. | |
