**Flood Control Project Maintenance  
Levee Inspections**

**Fall 2014 Levee Maintenance Deficiency Summary Report**

**Reclamation District No. 2035 Conaway**

**Levee Inspection Report By Mile - Fall 2014**

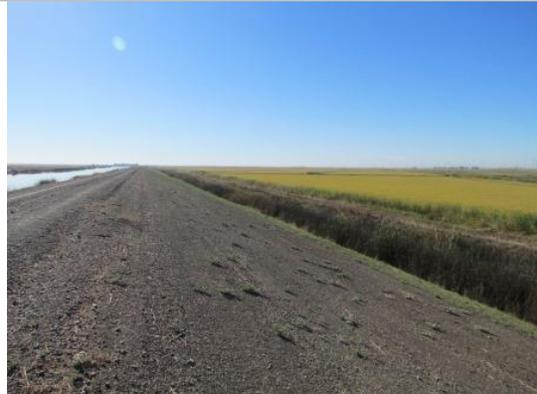
Photo 1 of 1 : FA\_2014\_RD2035\_239\_1\_20141013\_00003.jpg

LM Start	<b>2.16</b>	Rating **	A	Issue No.	<b>1</b>
LM End	<b>3.42</b>	Issue Type +	Ma	Location *	LS
Category	Earthen Levee		GPS Latitude/Longitude		
			Start	End	
Item	Vegetation		38.646063 °	38.646063 °	
			-121.666332 °	-121.666332 °	
DWR ID	DWR_RD2035_02_f_2014_1				
Action/Comments					
Control annual grass and weeds on the levee slopes and easements.

This photo was taken from the crown facing south looking down the landward levee slope at acceptable vegetation maintenance. Fall 2014.

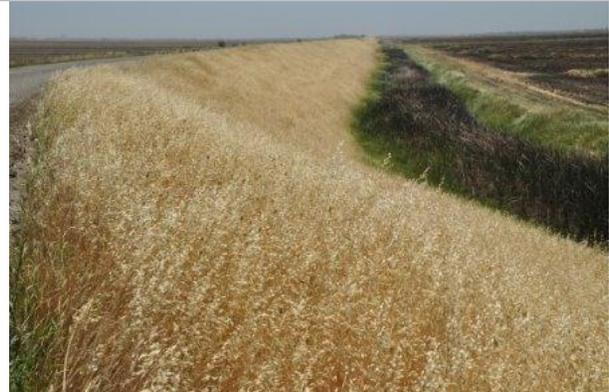
Photo 1 of 1 : FA\_2014\_RD2035\_239\_979\_20141008\_00002.jpg

LM Start	<b>2.16</b>	Rating **	M	Issue No.	<b>979</b>
LM End	<b>4.36</b>	Issue Type +	En	Location *	LS
Category	Earthen Levee		GPS Latitude/Longitude		
			Start	End	
Item	Encroachments		38.646063 °	38.623062 °	
			-121.666332 °	-121.648925 °	
DWR ID	DWR_RD2035_02_s_2012_979				
Action/Comments					
Ditch

Drainage ditch at L/S levee toe.

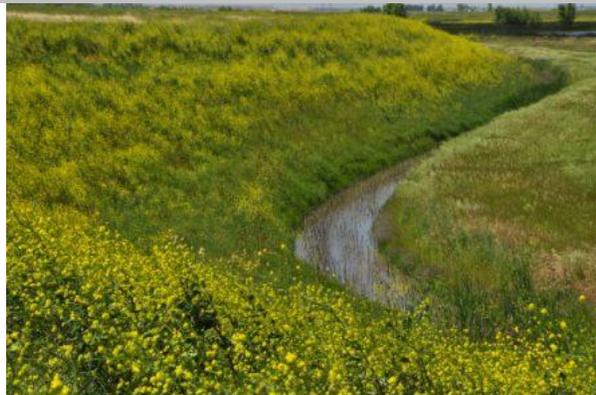
Photo 1 of 1 : FA\_2014\_RD2035\_240\_973\_20141008\_00002.jpg

LM Start	<b>0.06</b>	Rating **	M	Issue No.	<b>973</b>
LM End	<b>2.15</b>	Issue Type +	En	Location *	LS
Category	Earthen Levee		GPS Latitude/Longitude		
			Start	End	
Item	Encroachments		38.575615 °	38.590919 °	
			-121.636680 °	-121.658682 °	
DWR ID	DWR_RD2035_03_s_2012_973				
Action/Comments					
Ditch

L/S drainage ditch at levee toe.

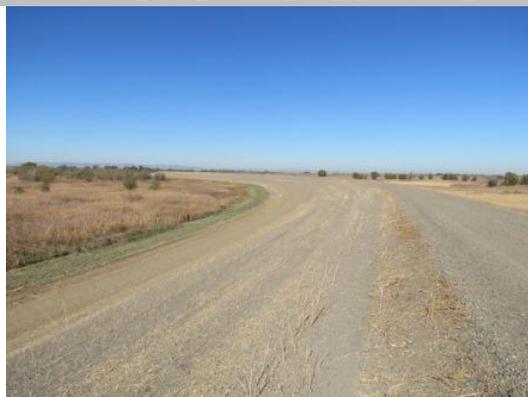
Photo 1 of 1 : FA\_2014\_RD2035\_240\_1\_20141013\_00003.jpg

LM Start	<b>0.08</b>	Rating **	A	Issue No.	<b>1</b>
LM End	<b>0.08</b>	Issue Type +	Ma	Location *	WS
Category	Earthen Levee		GPS Latitude/Longitude		
			Start	End	
Item	Vegetation		38.575615 °	38.575615 °	
			-121.659942 °	-121.659942 °	
DWR ID	DWR_RD2035_03_f_2014_1				
Action/Comments					
Control annual grass and weeds on the levee slopes and easements.

This photo was taken from the crown facing west looking down the waterward levee slope at acceptable vegetation maintenance. Fall 2014.

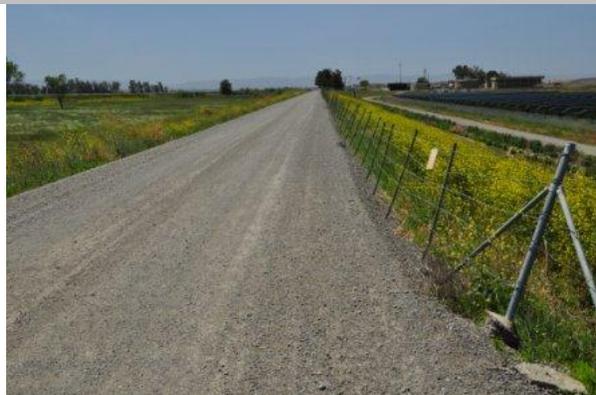
Photo 1 of 1 : FA\_2014\_RD2035\_240\_5\_20141008\_00001.jpg

LM Start	<b>2.22</b>	Rating **	M	Issue No.	<b>5</b>
LM End	<b>2.50</b>	Issue Type +	En	Location *	LS
Category	Earthen Levee		GPS Latitude/Longitude		
			Start	End	
Item	Encroachments		38.590893 °	38.590760 °	
			-121.659942 °	-121.665210 °	
DWR ID	DWR_RD2035_03_s_2013_5				
Action/Comments					
Fence

Fence along L/S shoulder.
