**Flood Control Project Maintenance  
Levee Inspections**

**Fall 2015 Levee Maintenance Deficiency Summary Report**

**Sacramento River Basin**

**Reclamation District No. 2035 Conaway**

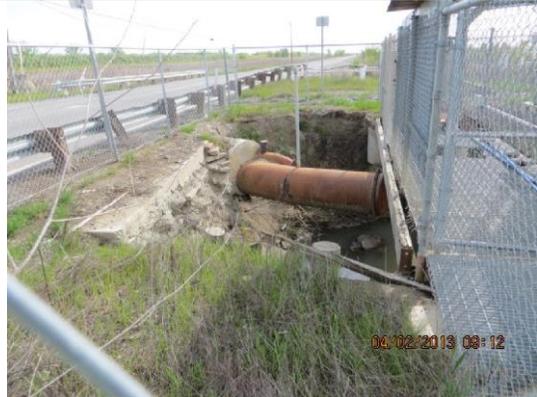
Photo 1 of 3 : UCIP\_FA\_2015\_0201.jpg

Inspector Comments: FS\_ID:41346  
 DS\_ID:17819  
 EP\_NO: 4363  
 FS\_HLM: 0.001  
 Repair Type: Non-Urgent  
 Crossing Status: Found  
 UCIP Comments: This pipe appears abandoned and if so should be done so properly.  
 FIELD\_STRUCT\_DESC: 36-inch Corrugated Metal Pipe through levee 7.8 feet below crown. Flap gate in 72-inch CMP riser at WS toe with abandoned pump platform on south side of East Main Street. A 30-inch welded steel pipe is sleeved through the 36-inch C.M. pipe and annular space grouted. (Permit No. 4363 - City of Woodland)  
 FS Date: 04/02/2013

Pipe with 30-inch grouted at 200-feet LS of toe.

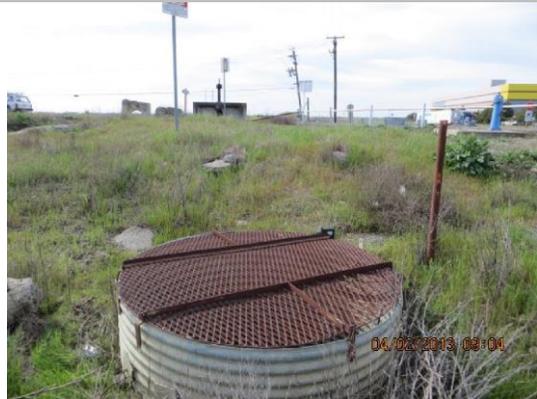
Photo 2 of 3 : UCIP\_FA\_2015\_0323.jpg

72-inch CMP riser on WS toe.

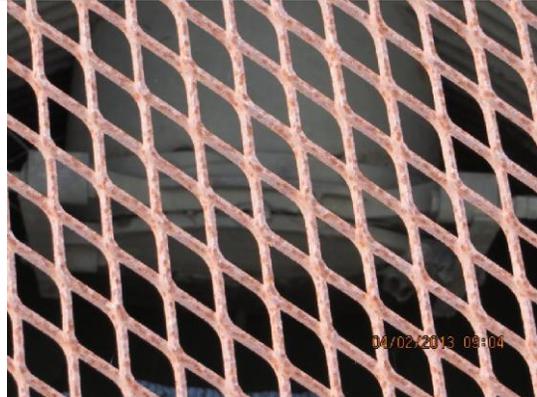
Photo 3 of 3 : UCIP\_FA\_2015\_0324.jpg

Flap gate and pipe at bottom of 72-inch CMP riser on WS toe.

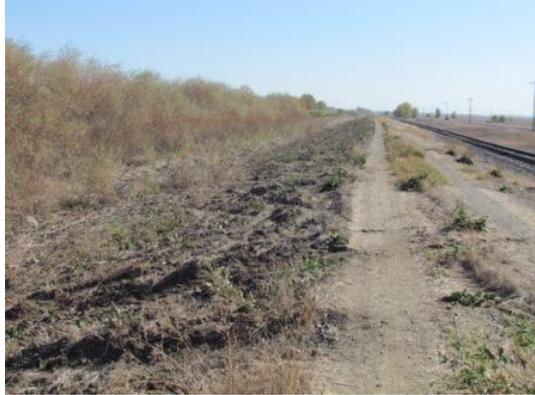
Photo 1 of 1 : FA\_2015\_RD2035\_238\_11\_20151030\_00001.jpg

This photo was taken from the levee crown facing east looking at discing on the waterward slope. Fall 2013.

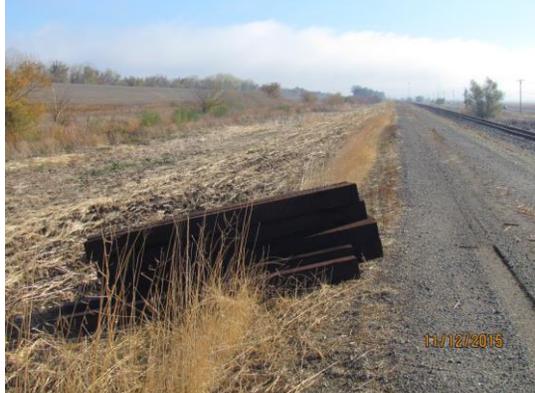
Photo 1 of 1 : FA\_2015\_RD2035\_238\_9\_20151113\_00006.jpg

LM Start	<b>0.70</b>	Rating **	M	Issue No.	<b>9</b>
LM End	<b>0.70</b>	Issue Type +	En	Location *	WS
Category	Earthen Levee		GPS Latitude/Longitude		
			Start	End	
Item	Encroachments		38.677316 °	38.677316 °	
			-121.697009 °	-121.697009 °	
DWR ID	DWR_RD2035_01_f_2015_9				
Action/Comments					
Debris

View of the wood blocks on the waterward side of the levee looking downstream. Fall 2015.

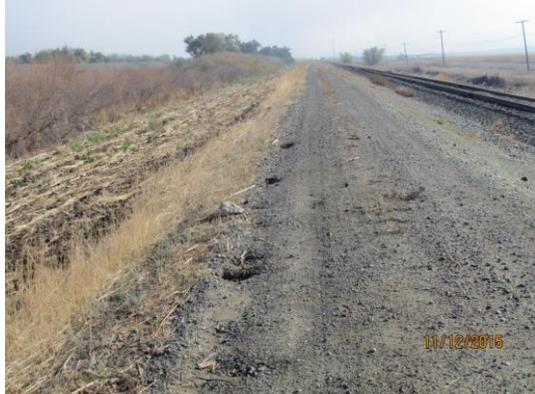
Photo 1 of 1 : FA\_2015\_RD2035\_238\_10\_20151113\_00007.jpg

LM Start	<b>1.11</b>	Rating **	M	Issue No.	<b>10</b>
LM End	<b>1.11</b>	Issue Type +	Ma	Location *	CR
Category	Earthen Levee		GPS Latitude/Longitude		
			Start	End	
Item	Animal Control		38.677271 °	38.677271 °	
			-121.689434 °	-121.689434 °	
DWR ID	DWR_RD2035_01_f_2015_10				
Action/Comments					
Repair the levee slope damaged by livestock and prevent large animal access. Inspector Comments: Ruts on crown could be caused by collapsed rodent holes.

View of the ruts that may be caused by collapsed rodent holes on the crown of the levee looking downstream. Fall 2015.

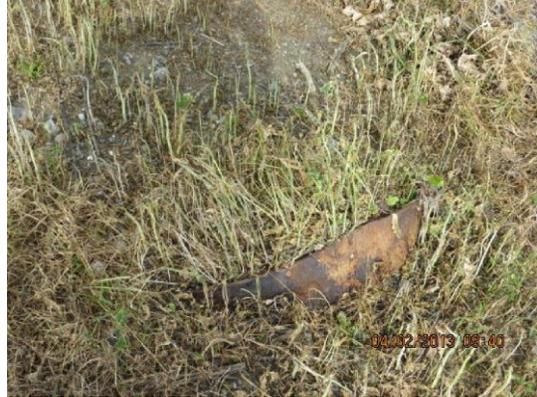
Photo 1 of 3 : UCIP\_FA\_2015\_0325.jpg

LM Start	<b>1.27</b>	Rating **	M	Issue No.	<b>15</b>
LM End	<b>1.27</b>	Issue Type +	En	Location *	CR
Category	Supplemental			GPS Latitude/Longitude	
				Start	End
Item	DWR UCIP Field Study			38.677249 °	38.677249 °
				-121.686358 °	-121.686358 °
DWR ID					
Action/Comments					
Inspector Comments: FS_ID:42012 DS_ID:17816 EP_NO: 12597 FS_HLM: 1.255 Repair Type: Non-Urgent Crossing Status: Found UCIP Comments: Pipe appears abandoned and if so should be done so properly. FIELD_STRUCT_DESC: 18-inch steel conductor pipe through the levee 3.4 feet below the crown. 10-inch steel pipe sleeved through the 18-inch steel conductor pipe annular space grouted. Siphon breaker on waterward shoulder in steel riser. (Permit No. 12597 - R.D. No. 2035) FS Date: 04/02/2013

Burried steel riser on WS shoulder

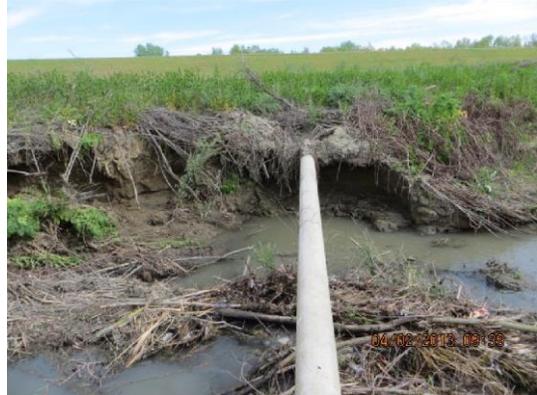
Photo 2 of 3 : UCIP\_FA\_2015\_0326.jpg

Exposed pipe at WS toe/stream.

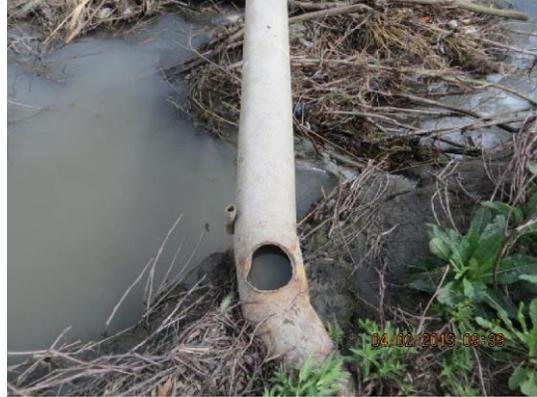
Photo 3 of 3 : UCIP\_FA\_2015\_0327.jpg

Exposed pipe at WS toe/stream.

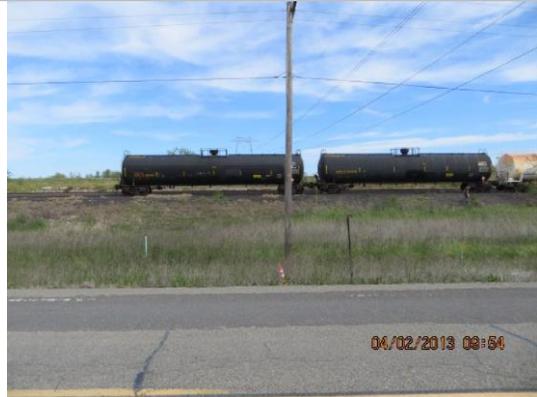
Photo 1 of 2 : UCIP\_FA\_2015\_0377.jpg

LM Start	<b>1.87</b>	Rating **	M	Issue No.	<b>16</b>
LM End	<b>1.87</b>	Issue Type +	En	Location *	CR
Category	Supplemental			GPS Latitude/Longitude	
				Start	End
Item	DWR UCIP Field Study			38.677186 °	38.677186 °
				-121.675277 °	-121.675277 °
DWR ID					
Action/Comments					
Inspector Comments: FS_ID:10913 DS_ID:17867 EP_NO: 13201 FS_HLM: 1.846 Repair Type: Non-Urgent Crossing Status: Indicator Found UCIP Comments: Pipe needs to be properly marked or abandoned. FIELD_STRUCT_DESC: 8-inch diameter casing through the levee 25-feet below the crown. 3-inch gas line through the casing with annular space filled with Bentonite. Possible vent for pipe on LS next to Old River Road. FS Date: 04/02/2013

Vent pipe to right of JP next to Old River Road.

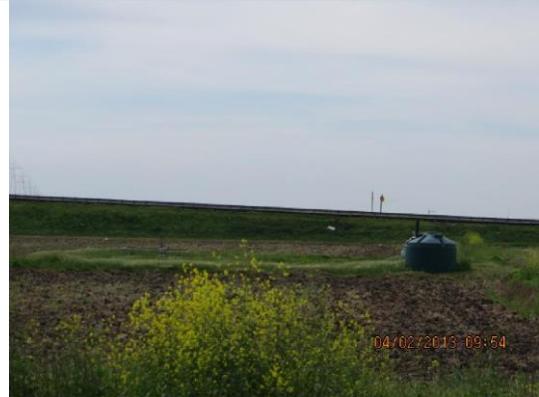
Photo 2 of 2 : UCIP\_FA\_2015\_0378.jpg

Natural gas well on south side of Old river road.

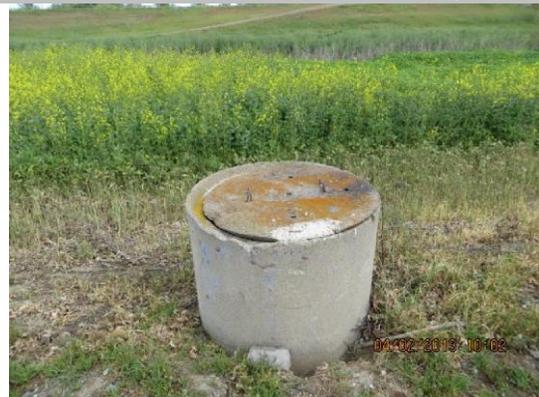
Photo 1 of 1 : UCIP\_FA\_2015\_0379.jpg

LM Start	1.94	Rating **	M	Issue No.	17	
LM End	1.94	Issue Type +	En	Location *	CR	
Category	Supplemental			GPS Latitude/Longitude		
			Start	End		
Item	DWR UCIP Field Study			38.677175 °	38.677175 °	
				-121.674065 °	-121.674065 °	
DWR ID						
Action/Comments						
Inspector Comments: FS_ID:10914 DS_ID:17817 EP_NO: 2544 FS_HLM: 1.91 Repair Type: Non-Urgent Crossing Status: Found UCIP Comments: Pipe appears to be abandoned as there is no pumphouse. Needs to be abandoned properly FIELD_STRUCT_DESC: 16-inch drainage pipe through levee 5.0 feet below crown. Pump on piling structure in drainage ditch on landward side. 36-inch concrete standpipe on waterward shoulder. (Permit No. 2544 - City of Woodland) FS Date: 04/02/2013

36-inch Concrete stand pipe on WS shoulder.

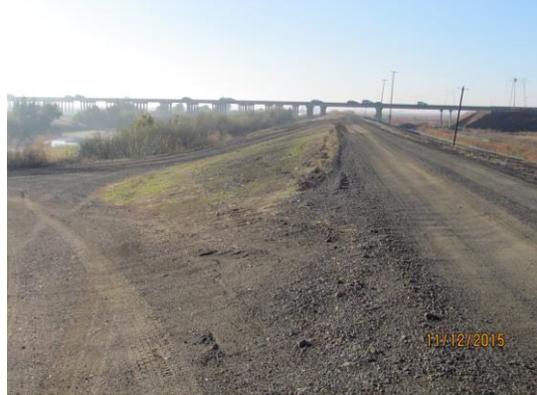
Photo 1 of 1 : FA\_2015\_RD2035\_239\_14\_20151113\_00007.jpg

LM Start	<b>0.08</b>	Rating **	A	Issue No.	<b>14</b>
LM End	<b>7.63</b>	Issue Type +	Ma	Location *	WS
Category	Earthen Levee			GPS Latitude/Longitude	
				Start	End
Item	Vegetation			38.676104 °	38.575386 °
				-121.672422 °	-121.635638 °
DWR ID	DWR_RD2035_02_f_2015_14				
Action/Comments					
Control annual grass and weeds on the levee slopes and easements. Inspector Comments: Levee slope has been burned and dragged.

View of the vegetation on the waterward side of the levee looking downstream. Fall 2015.

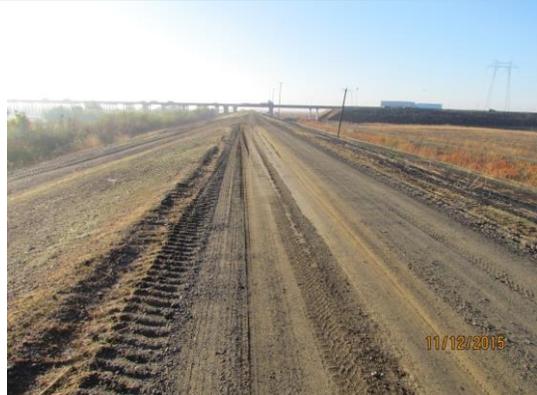
Photo 1 of 1 : FA\_2015\_RD2035\_239\_16\_20151113\_00008.jpg

LM Start	<b>0.10</b>	Rating **	M	Issue No.	<b>16</b>
LM End	<b>0.10</b>	Issue Type +	Ma	Location *	CR
Category	Earthen Levee			GPS Latitude/Longitude	
				Start	End
Item	Crown Surface / Depressions / Rutting			38.675761 °	38.675761 °
				-121.672347 °	-121.672347 °
DWR ID	DWR_RD2035_02_f_2015_16				
Action/Comments					
Add appropriate material and re-grade the levee to bring the crown above the design elevation.

View of the crown of the levee looking downstream. Fall 2015.

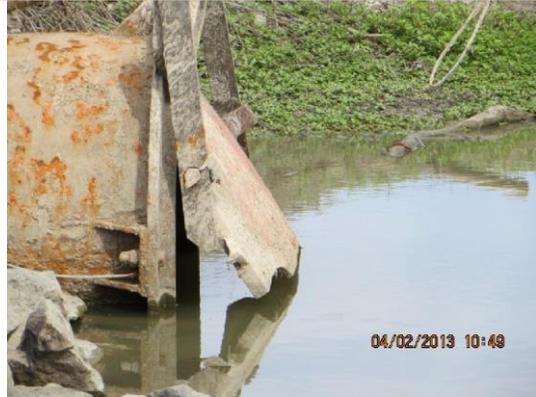
Photo 1 of 3 : UCIP\_FA\_2015\_0380.jpg

LM Start	<b>0.38</b>	Rating **	U	Issue No.	<b>980</b>
LM End	<b>0.38</b>	Issue Type +	En	Location *	WS
Category	Supplemental			GPS Latitude/Longitude	
				Start	End
Item	DWR UCIP Field Study			38.671813 °	38.671813 °
				-121.671581 °	-121.671581 °
DWR ID					
Action/Comments					
Inspector Comments: FS_ID:43083 DS_ID:17822 EP_NO: N/A FS_HLM: 0.373 Repair Type: Urgent Crossing Status: Found UCIP Comments: Flap gate broken in half on WS toe. Some erosion at headwalls on pumping plant. FIELD_STRUCT_DESC: 44-inch C.M. pipe through levee 22.0 feet below crown. Pump in drainage ditch at toe of landward slope, slide gate and flap gates in 5X9-foot concrete box. Flap gate on waterward end. 8-inch vent/standpipe at waterward toe. Originally included in O+M (1959). FS Date: 04/02/2013

Broken flap gate at WS toe.

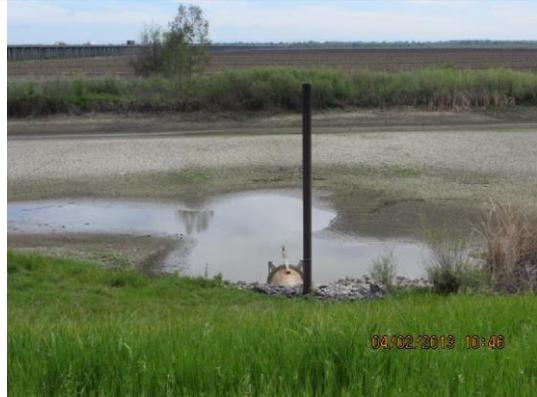
Photo 2 of 3 : UCIP\_FA\_2015\_0381.jpg

Pipe and flap gate with vent riser on WS toe.

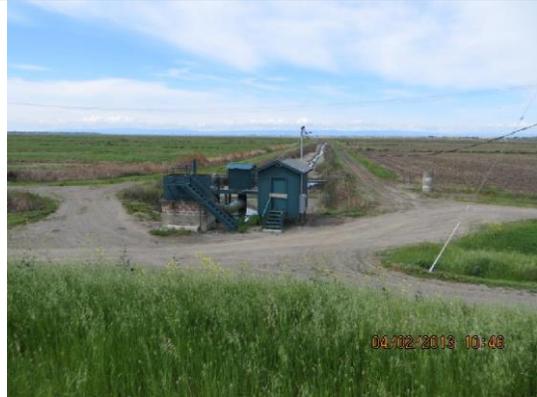
Photo 3 of 3 : UCIP\_FA\_2015\_0382.jpg

Pumping plant off LS toe.

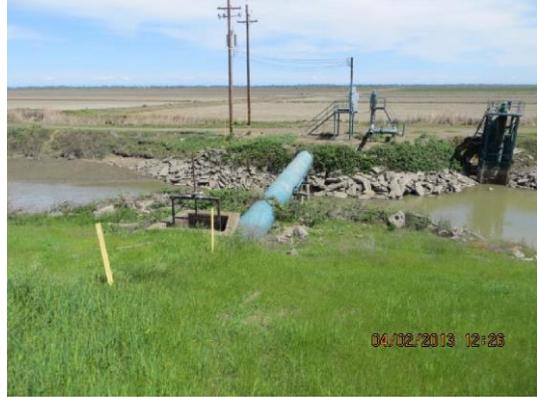
Photo 1 of 3 : UCIP\_FA\_2015\_0181.jpg

LM Start	<b>1.71</b>	Rating **	<b>U</b>	Issue No.	<b>981</b>
LM End	<b>1.71</b>	Issue Type +	<b>En</b>	Location *	<b>WS</b>
Category	Supplemental			GPS Latitude/Longitude	
				Start	End
Item	DWR UCIP Field Study			38.652721 °	38.652721 °
				-121.667790 °	-121.667790 °
DWR ID					
Action/Comments					
Inspector Comments: FS_ID:11523 DS_ID:22956 EP_NO: N/A FS_HLM: 1.695 Repair Type: Urgent Crossing Status: Found UCIP Comments: Pipe does not have appropriate cover and is marked as gasoline. Does not appear to be a permitted utility. FIELD_STRUCT_DESC: 4-inch steel pipe 3-inches below the crown with a 2-inch PVC pipe sleeved through it. FS Date: 04/02/2013

Pipe with gasoline markers on WS slope.

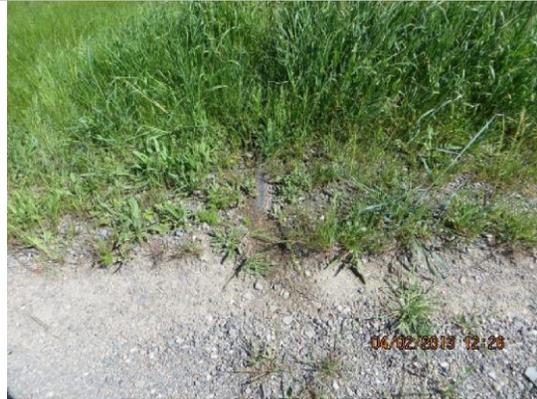
Photo 2 of 3 : UCIP\_FA\_2015\_0182.jpg

Pipe on WS shoulder.

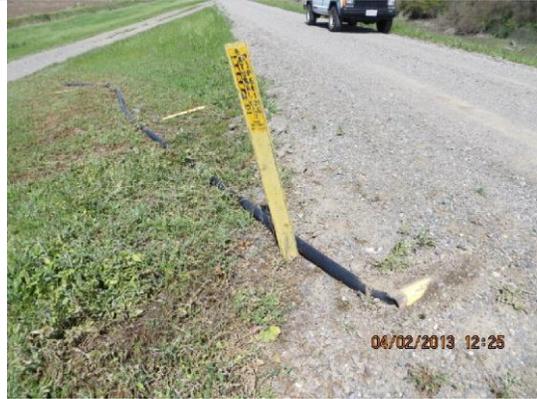
Photo 3 of 3 : UCIP\_FA\_2015\_0183.jpg

Pipe crossing with gasline marker on LS shoulder.

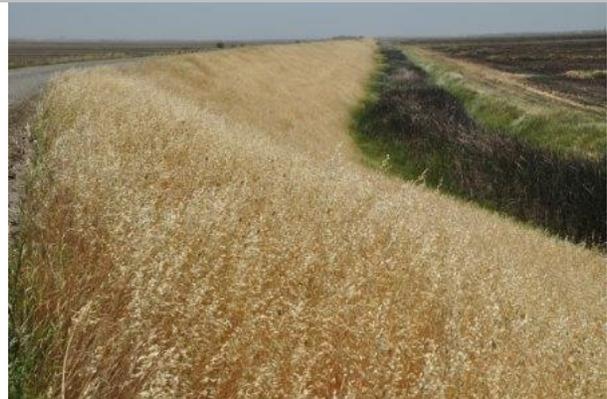
Photo 1 of 2 : FA\_2015\_RD2035\_239\_979\_20151030\_00002.jpg

Drainage ditch at L/S levee toe.

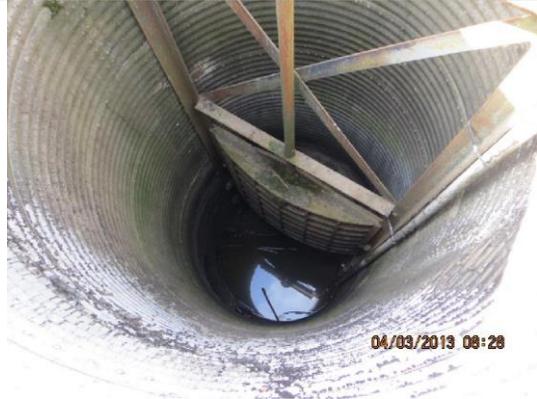
Photo 1 of 3 : UCIP\_FA\_2015\_0189.jpg

**Action/Comments**  
 Inspector Comments: FS\_ID:11526  
 DS\_ID:17828  
 EP\_NO: 1701  
 FS\_HLM: 4.39  
 Repair Type: Non-Urgent  
 Crossing Status: Found  
 UCIP Comments: Animal activity at outlet causing damage to berm and undermining the pipe at the outlet headwall on WS toe.  
 FIELD\_STRUCT\_DESC: 60-inch corrugated metal drain pipe through the levee 20.6 feet below the crown encased in 6-inches of reinforced concrete. Slide gate in 7-foot diameter C.M. pipe riser on waterward slope. Pumping plant with 6-pumps/pipes that discharge into a 4-ft by 18-ft surge box on the LS toe. (Permit No. 1701 - R.D. 2035)  
 FS Date: 04/03/2013

7-foot diameter CMP riser and slide gate on WS slope.

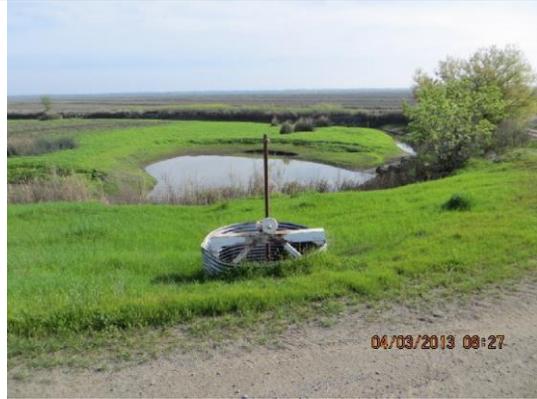
Photo 2 of 3 : UCIP\_FA\_2015\_0190.jpg

7-foot diameter CMP riser and slide gate on WS slope.

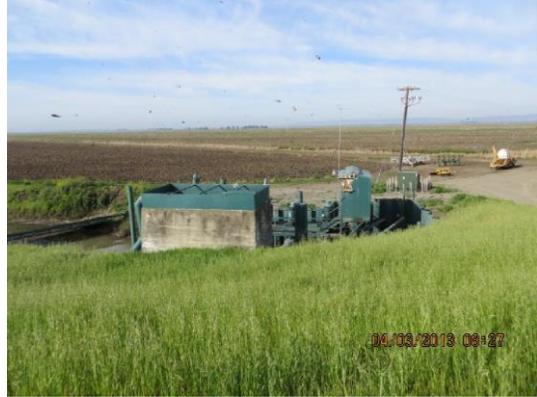
Photo 3 of 3 : UCIP\_FA\_2015\_0191.jpg

Surge box and pumping plant on LS toe.

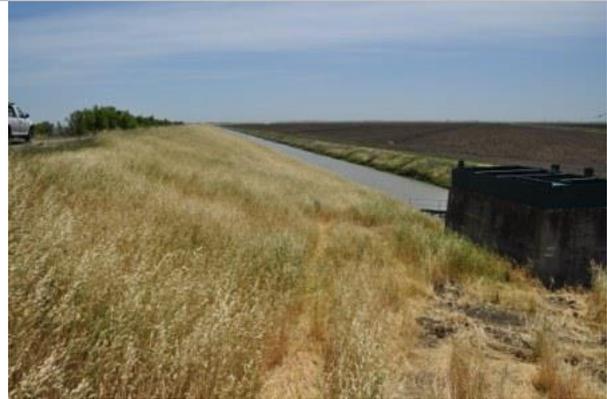
Photo 1 of 2 : FA\_2015\_RD2035\_239\_10\_20151030\_00001.jpg

LM Start	<b>4.43</b>	Rating **	M	Issue No.	<b>10</b>
LM End	<b>6.57</b>	Issue Type +	En	Location *	LS
Category	Earthen Levee			GPS Latitude/Longitude	
				Start	End
Item	Encroachments			38.617921 °	38.589619 °
				-121.645109 °	-121.631277 °
DWR ID	DWR_RD2035_02_s_2013_10				
Action/Comments					
Ditch Inspector Comments: Ditch is at the levee toe.

Drainage ditch at L/S levee toe.

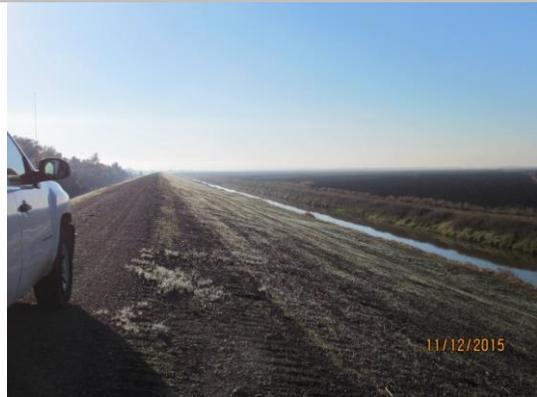
Photo 2 of 2 : FA\_2015\_RD2035\_239\_10\_20151113\_00011.jpg

View of the drainage ditch on the landward side of the levee looking downstream. Fall 2015.

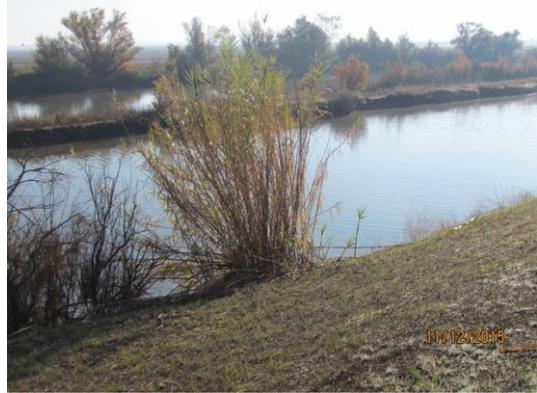
Photo 1 of 1 : FA\_2015\_RD2035\_239\_19\_20151113\_00012.jpg

LM Start	<b>5.81</b>	Rating **	A/W	Issue No.	<b>19</b>
LM End	<b>5.81</b>	Issue Type +	Ma	Location *	WS
Category	Earthen Levee			GPS Latitude/Longitude	
				Start	End
Item	Vegetation			38.600462 °	38.600462 °
				-121.632705 °	-121.632705 °
DWR ID	DWR_RD2035_02_f_2015_19				
Action/Comments					
Remove the wild growth other than native grasses from the levee slopes. Inspector Comments: Recommend getting rid of arundo.

View of the arundo at the toe of the levee. Fall 2015.

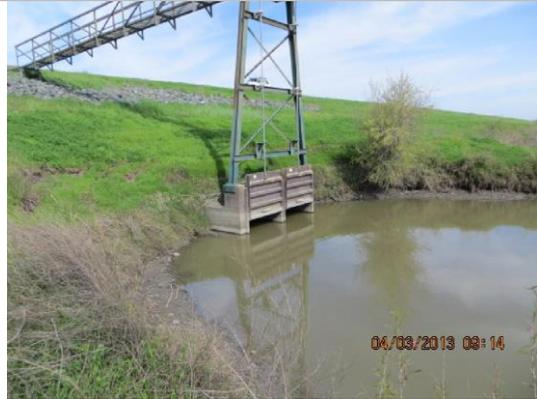
Photo 1 of 3 : UCIP\_FA\_2015\_0468.jpg

LM Start	<b>6.50</b>	Rating **	U	Issue No.	<b>984</b>
LM End	<b>6.50</b>	Issue Type +	En	Location *	WS
Category	Supplemental			GPS Latitude/Longitude	
				Start	End
Item	DWR UCIP Field Study			38.590691 °	38.590691 °
				-121.631284 °	-121.631284 °
DWR ID					
Action/Comments					
Inspector Comments: FS_ID:42938 DS_ID:17868 EP_NO: 16480 FS_HLM: 6.445 Repair Type: Urgent Crossing Status: Found UCIP Comments: Erosion on LS toe at pumping plant. Severe erosion of sheet pile walls at pumping plant. FIELD_STRUCT_DESC: 1 of 2: 60-inch by 48-inch concrete box drainage conduit through the levee 22-feet below the crown. Steel walkway to slidegate handles on WS shoulder. 6X18-foot surge box and pumping plant on LS toe. This pipe replaced the 48-inch at this same location. (Permit No. 16480, 1996) FS Date: 04/03/2013

Slide gates at WS toe.

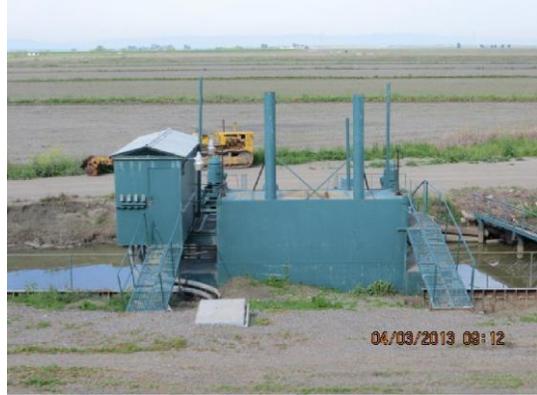
Photo 2 of 3 : UCIP\_FA\_2015\_0469.jpg

Pumping plant on LS toe.

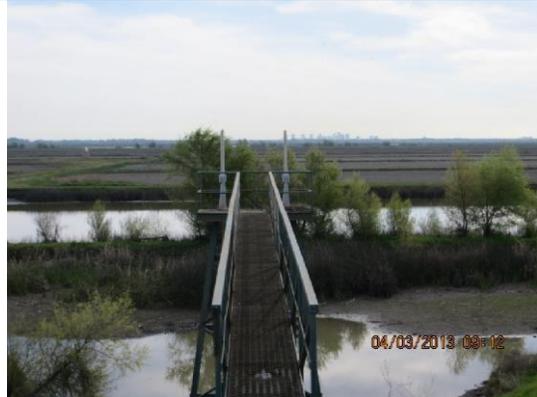
Photo 3 of 3 : UCIP\_FA\_2015\_0470.jpg

Steel walkway to slide gates on WS shoulder.

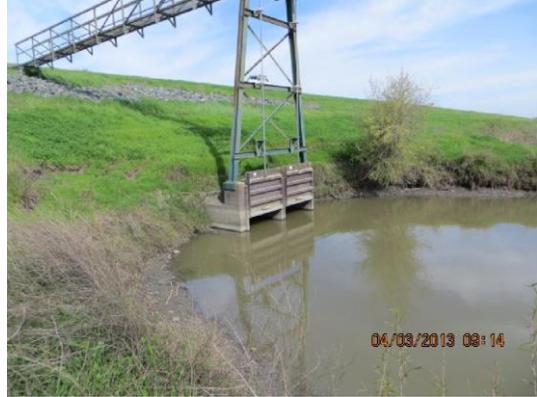
Photo 1 of 3 : UCIP\_FA\_2015\_0465.jpg

LM Start	<b>6.50</b>	Rating **	U	Issue No.	<b>985</b>
LM End	<b>6.50</b>	Issue Type +	En	Location *	WS
Category	Supplemental			GPS Latitude/Longitude	
				Start	End
Item	DWR UCIP Field Study			38.590680 °	38.590680 °
				-121.631283 °	-121.631283 °
DWR ID					
Action/Comments					
Inspector Comments: FS_ID:42937 DS_ID:17891 EP_NO: 16480 FS_HLM: 6.446 Repair Type: Urgent Crossing Status: Found

Slide gates at outlet on WS toe.

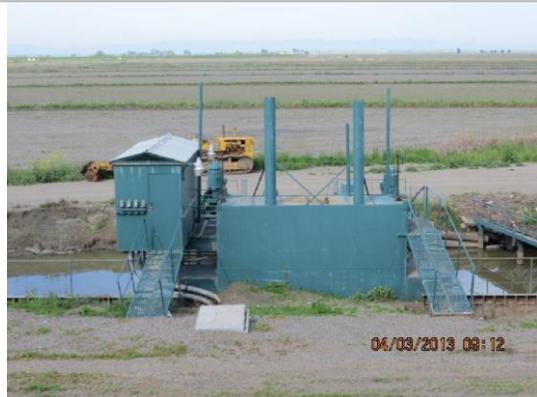
Photo 2 of 3 : UCIP\_FA\_2015\_0466.jpg

Surge box and pumping plant on LS toe.

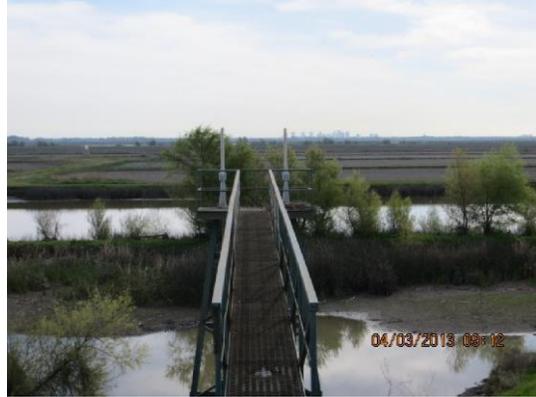
Photo 3 of 3 : UCIP\_FA\_2015\_0467.jpg

Steel walkway to Slide gate handles on WS shoulder.

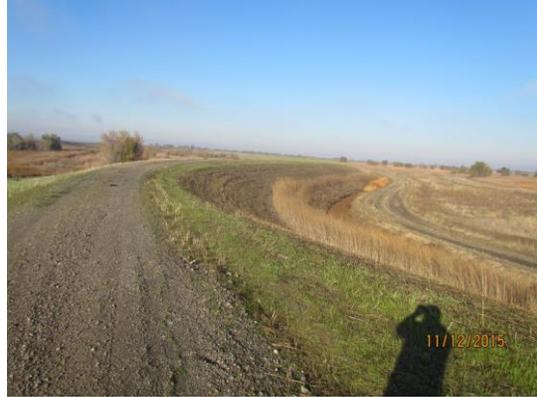
Photo 1 of 1 : FA\_2015\_RD2035\_240\_7\_20151113\_00007.jpg

LM Start	<b>0.00</b>	Rating **	A	Issue No.	<b>7</b>
LM End	<b>2.51</b>	Issue Type +	Ma	Location *	LS
Category	Earthen Levee		GPS Latitude/Longitude		
			Start	End	
Item	Vegetation		38.575385 °	38.590808 °	
			-121.635686 °	-121.665129 °	
DWR ID	DWR_RD2035_03_f_2015_7				
Action/Comments					
Control annual grass and weeds on the levee slopes and easements. Inspector Comments: Levee slope has been burned and dragged.

View of the vegetation on the landward side of the levee looking upstream. Fall 2015.

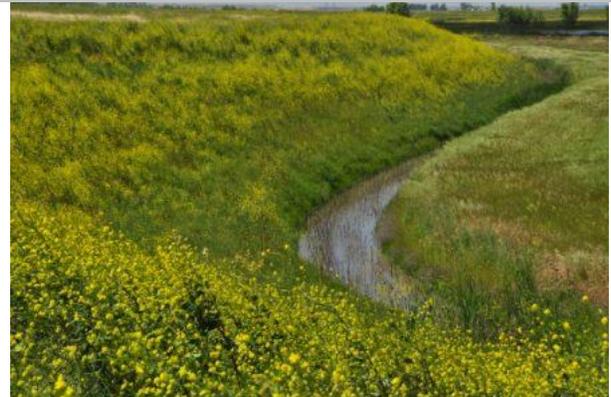
Photo 1 of 1 : FA\_2015\_RD2035\_240\_973\_20151030\_00002.jpg

L/S drainage ditch at levee toe.

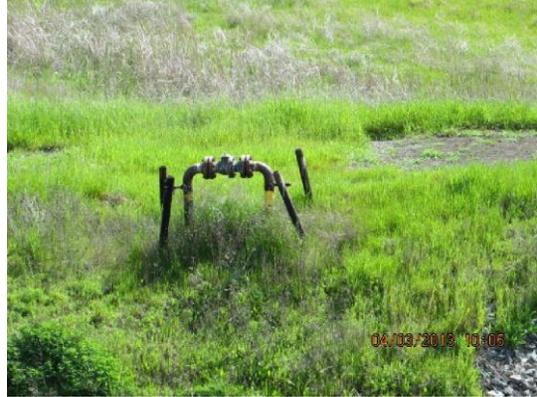
Photo 1 of 2 : UCIP\_FA\_2015\_0487.jpg

Gasline vent off LS toe.

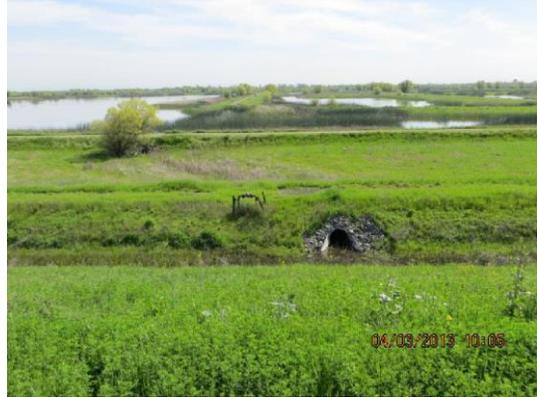
Photo 2 of 2 : UCIP\_FA\_2015\_0488.jpg

Gasline vent off LS toe.

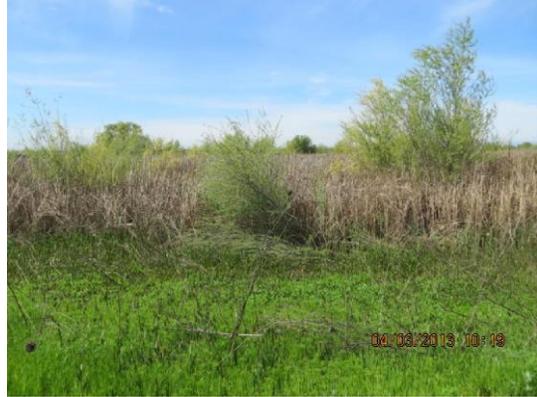
Photo 1 of 3 : UCIP\_FA\_2015\_0489.jpg

Vegetated area blocks access to WS of pipe.

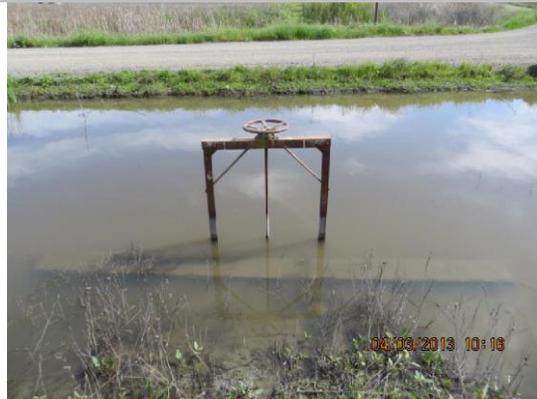
Photo 2 of 3 : UCIP\_FA\_2015\_0490.jpg

Slide gate and headwall in canal at LS toe.

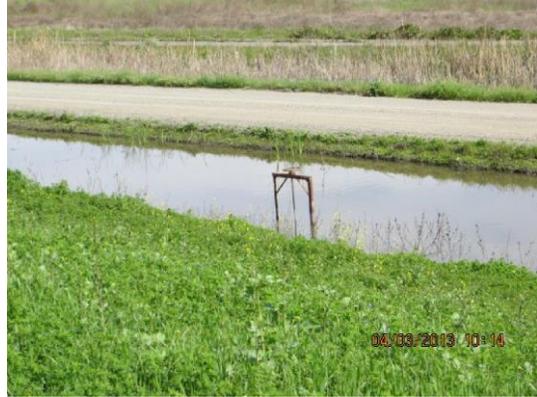
Photo 3 of 3 : UCIP\_FA\_2015\_0491.jpg

Slide gate and headwall in canal at LS toe.

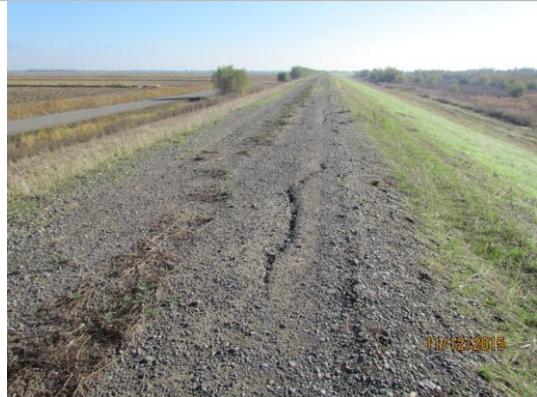
Photo 1 of 1 : FA\_2015\_RD2035\_240\_9\_20151113\_00008.jpg

View of the crack on the crown of the levee looking downstream. Fall 2015.

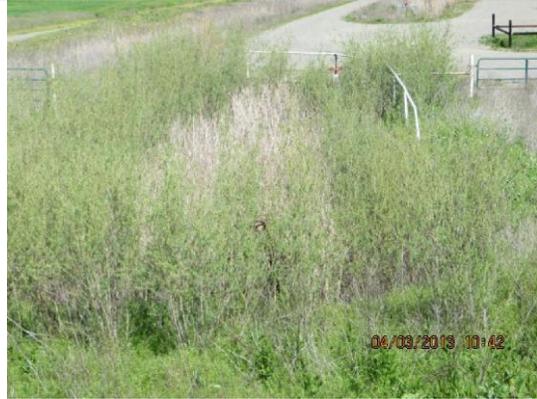
Photo 1 of 2 : UCIP\_FA\_2015\_0500.jpg

Slide gate at LS toe showing excessive vegetation.

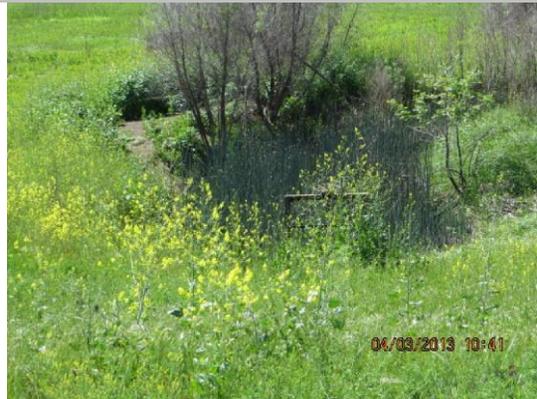
Photo 2 of 2 : UCIP\_FA\_2015\_0501.jpg

Slide gate at WS toe showing excessive vegetation.

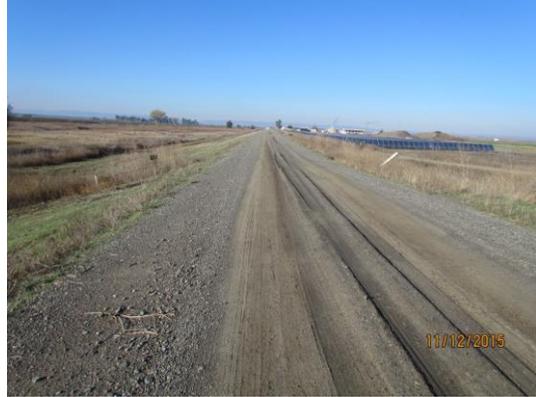
Photo 1 of 1 : FA\_2015\_RD2035\_240\_10\_20151113\_00009.jpg

View of the crown of the levee looking upstream. Fall 2015.

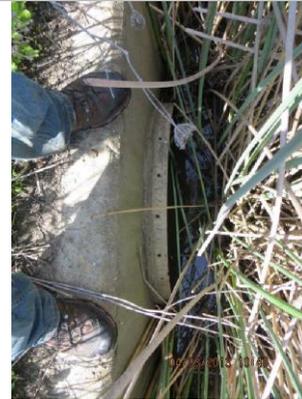
Photo 1 of 3 : UCIP\_FA\_2015\_0502.jpg

Headwall and pipe on LS toe.

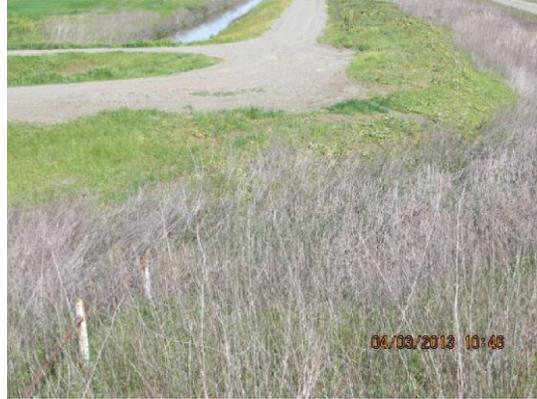
Photo 2 of 3 : UCIP\_FA\_2015\_0503.jpg

Headwall at bottom of fenceline on LS to.e

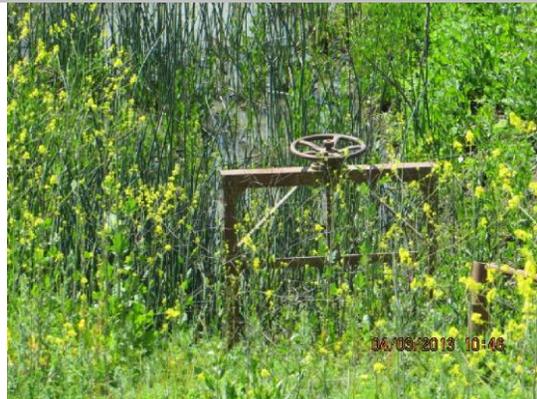
Photo 3 of 3 : UCIP\_FA\_2015\_0504.jpg

Combination flap and slide gate on WS toe. With excessive vegetation
