**Flood Control Project Maintenance  
Levee Inspections**  
**LMA District Cover Sheet**  
**Spring 2009 Levee Inspection Results**

**Reclamation District No. 2035**

**Levee Inspection Report By Mile - Spring 2009**

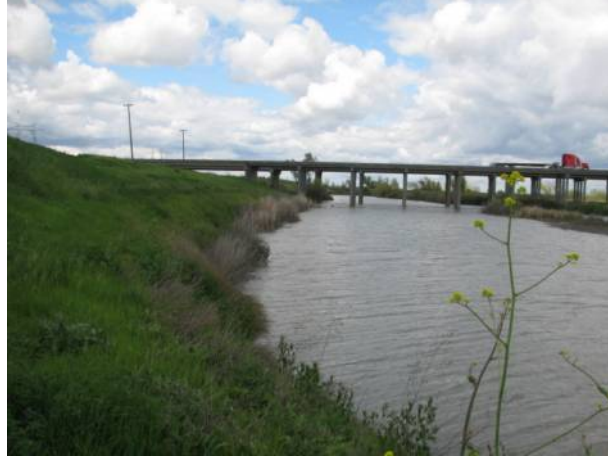
| Levee Mile Report Line | 1 |

| LMR Line | Levee Mile | | Category | Item | Location<br>* | Rating<br>** | Action/Comment | GPS Latitude/Longitude | | Photo | Issue |
|---|---|---|---|---|---|---|--|---|---|---|---|
| 1 | 0.28 | 0.36 | Boat Survey | Boat Survey Erosion | LS | M | Inspector Comments: tension cracks, slumping | 38.673229 °<br>-121.671733 ° | 38.672069 °<br>-121.671516 ° | Y | 976 |

| N 38.67201, W -121.67157. L/M 0.36. Looking up stream, I-5 overpass in the background | |

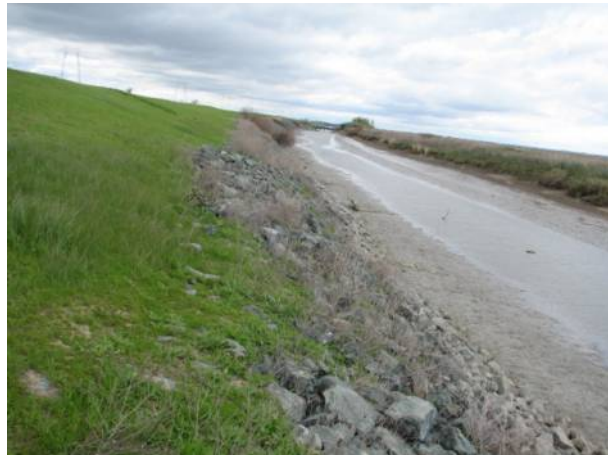
| Levee Mile Report Line | 2 |

| LMR Line | Levee Mile | | Category | Item | Location<br>* | Rating<br>** | Action/Comment | GPS Latitude/Longitude | | Photo | Issue |
|---|---|---|---|---|---|---|--|---|---|---|---|
| 2 | 1.97 | 2.02 | Boat Survey | Boat Survey Erosion | LS | M | Inspector Comments: tension cracks, slumping | 38.648881 °<br>-121.666653 ° | 38.648178 °<br>-121.666385 ° | Y | 977 |

| N 38.64862, W -121.66668. L/M 2.20. Looking up stream | |

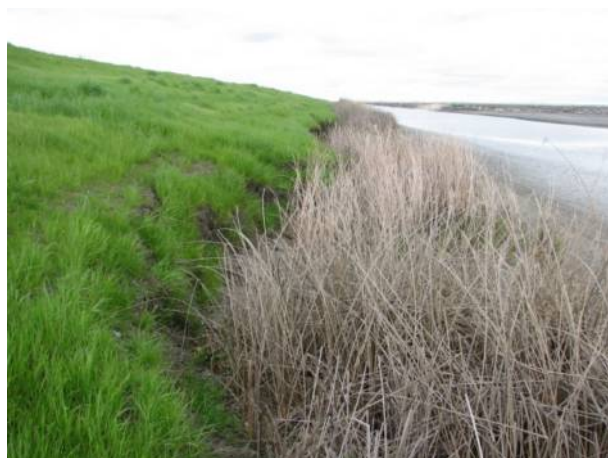
| Levee Mile Report Line | 4 |

| LMR Line | Levee Mile | | Category | Item | Location<br>* | Rating<br>** | Action/Comment | GPS Latitude/Longitude | | Photo | Issue |
|---|---|---|---|---|---|---|--|---|---|---|---|
| 4 | 4.08 | 4.39 | Boat Survey | Boat Survey Erosion | LS | M | Inspector Comments: tension cracks, slumping | 38.622189 °<br>-121.648277 ° | 38.618267 °<br>-121.645371 ° | Y | 978 |

| N 38.61902, W -121.64595. L/M 4.39. Looking up stream. | |

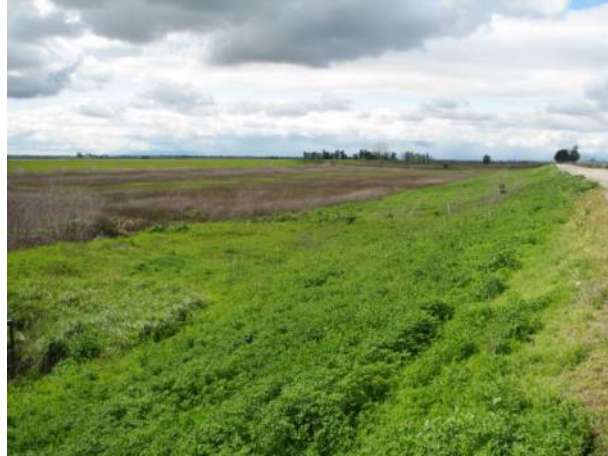
| Levee Mile Report Line | 2 |

| LMR Line | Levee Mile | | Category | Item | Location<br>* | Rating<br>** | Action/Comment | GPS Latitude/Longitude | | Photo | Issue |
|---|---|---|---|---|---|---|---|---|---|---|---|
| 2 | 2.20 | 2.49 | Boat<br>Survey | Boat Survey<br>Erosion | LS | M | Inspector Comments: none | 38.590784 °<br>-121.664910 ° | 38.590890 °<br>-121.659671 ° | Y | 972 |

| N 38.59086, W -121.65882. L/M 2.20 Looking up stream Willow Slough | |
