**Flood Control Project Maintenance  
Levee Inspections**  
**LMA District Cover Sheet**  
**Spring 2010 Levee Inspection Results**

**Reclamation District No. 2035 Conaway**

**Levee Inspection Report By Mile - Spring 2010**

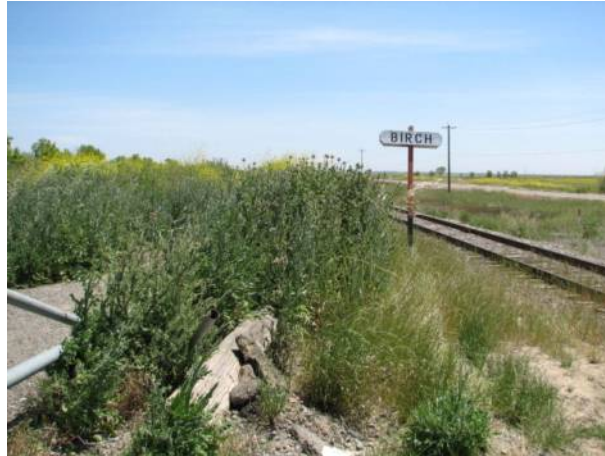
cathom\_s\_20100513\_026.jpg

Levee Mile Report Line	1
Start Levee Mile	0.00
End Levee Mile	2.00
Location	Land Side
Category	Earthen Levee
Item	Vegetation

The land side levee slope L/M 0.00.

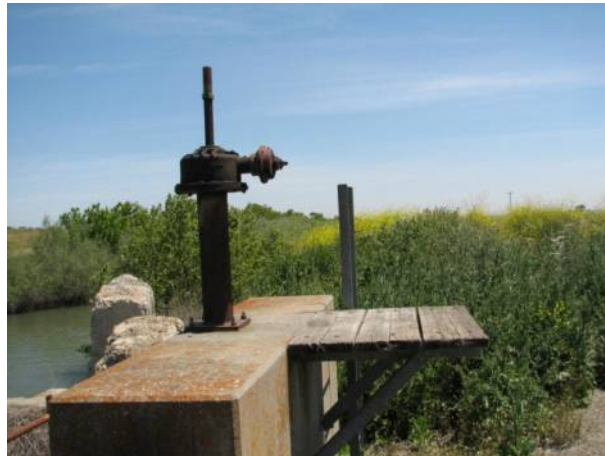
cathom\_s\_20100513\_027.jpg

Levee Mile Report Line	2
Start Levee Mile	0.00
End Levee Mile	2.00
Location	Water Side
Category	Earthen Levee
Item	Vegetation

The water side levee slope L/M 0.00.

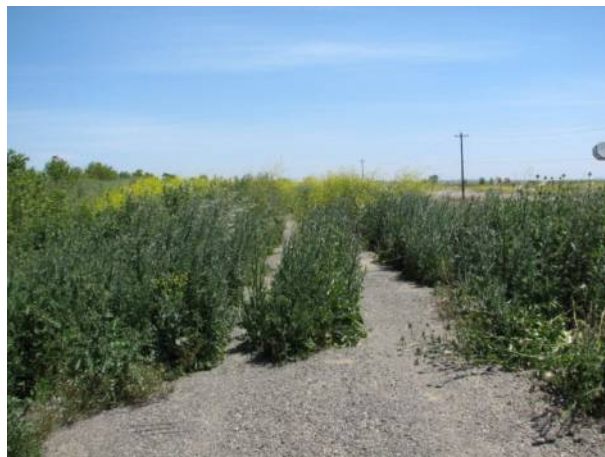
cathom\_s\_20100513\_028.jpg

Levee Mile Report Line	3
Start Levee Mile	0.00
End Levee Mile	2.00
Location	Crown
Category	Earthen Levee
Item	Vegetation

The levee crown L/M 0.00.

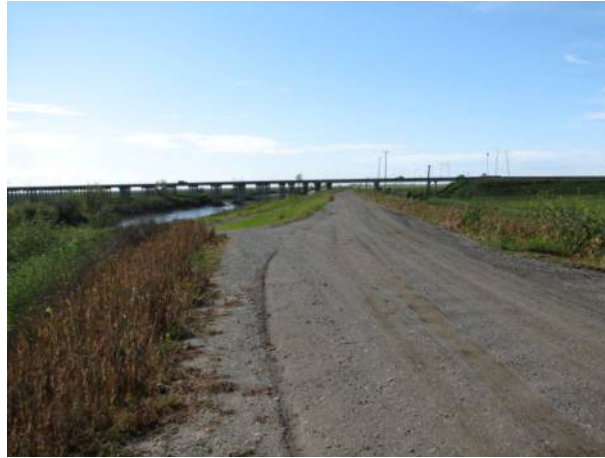
cathom\_s\_20100513\_022.jpg

Levee Mile Report Line	1
Start Levee Mile	0.06
End Levee Mile	7.53
Location	Land Side
Category	Earthen Levee
Item	Vegetation

The water side levee slope L/M 0.06.

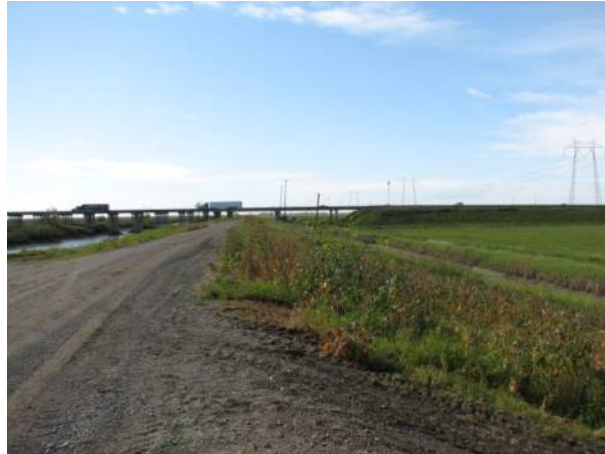
cathom\_s\_20100513\_023.jpg

Levee Mile Report Line	2
Start Levee Mile	0.06
End Levee Mile	7.53
Location	Water Side
Category	Earthen Levee
Item	Vegetation

The land side levee slope L/M 0.06.

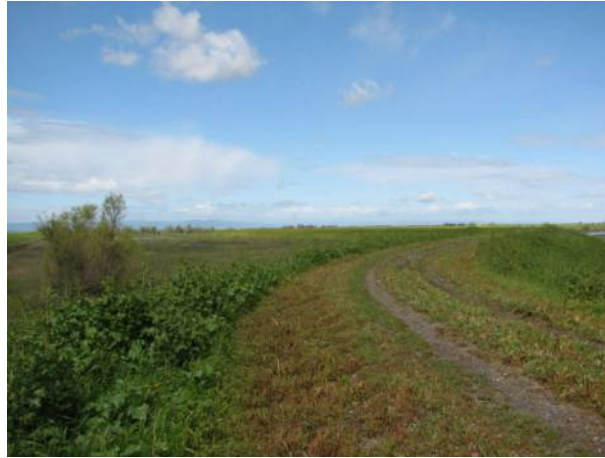
cathom\_s\_20100513\_025.jpg

Levee Mile Report Line	1
Start Levee Mile	0.03
End Levee Mile	2.50
Location	Water Side
Category	Earthen Levee
Item	Vegetation

The water side levee slope L/M 0.03.

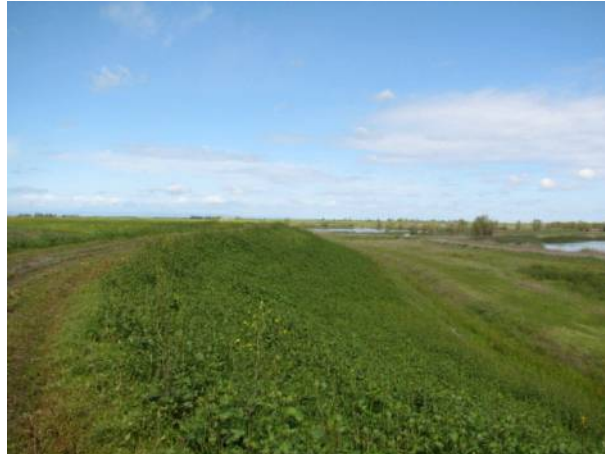
cathom\_s\_20100513\_024.jpg

Levee Mile Report Line	2
Start Levee Mile	0.03
End Levee Mile	2.50
Location	Land Side
Category	Earthen Levee
Item	Vegetation

The land side levee slope L/M 0.03.
