**Flood Control Project Maintenance  
Levee Inspections****LMA District Cover Sheet****Spring 2011 Levee Inspection Results****Reclamation District No. 2035 Conaway**

**Levee Inspection Report By Mile - Spring 2011**

**Reclamation District No. 2035 Conaway**

Waterway						Bank	Unit Miles	Inspection Start/End	Inspector
Unit No. 01 Cache Creek Settling Basin						Right	2.01	05/17/2011 05/17/2011	Clay Thomas

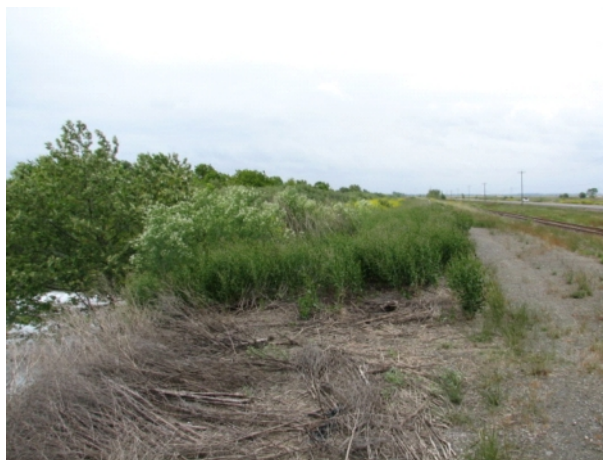
cathom\_s\_20110524\_170.jpg

Levee Mile Report Line	1
Start Levee Mile	0.00
End Levee Mile	2.00
Location	Water Side
Category	Earthen Levee
Item	Vegetation

Levee mile 0.00, this photo is showing the vegetation on the waterside slope.

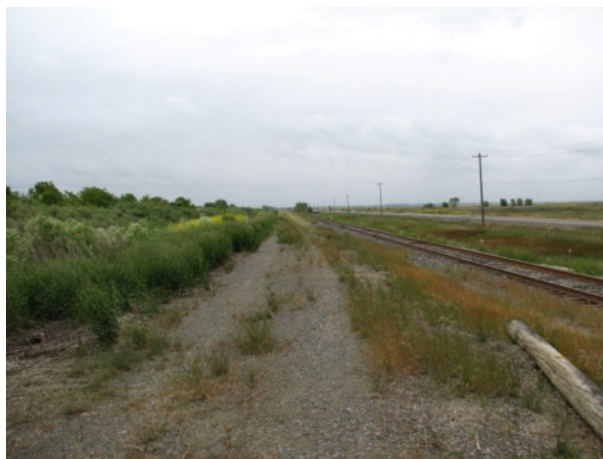
cathom\_s\_20110524\_171.jpg

Levee Mile Report Line	2
Start Levee Mile	0.00
End Levee Mile	2.00
Location	Crown
Category	Earthen Levee
Item	Vegetation

Levee mile 0.00, this photo is showing the vegetation on the levee crown.

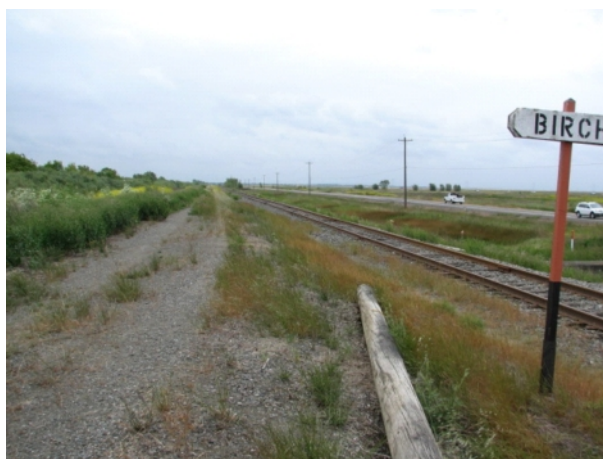
cathom\_s\_20110524\_169.jpg

Levee Mile Report Line	3
Start Levee Mile	0.00
End Levee Mile	2.00
Location	Land Side
Category	Earthen Levee
Item	Vegetation

Levee mile 0.00, this photo is showing the vegetation on the landside slope.

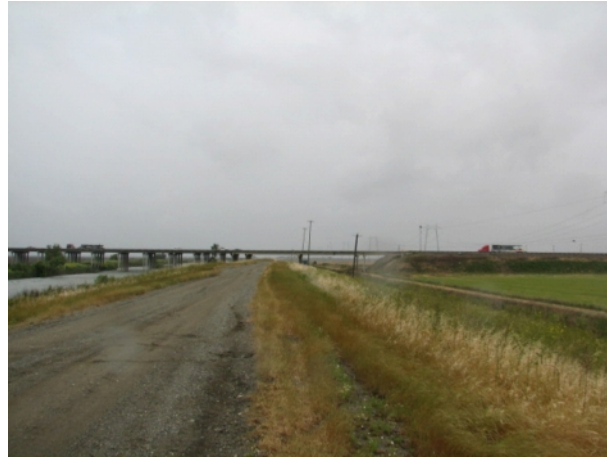
cathom\_s\_20110524\_172.jpg

Levee Mile Report Line	1
Start Levee Mile	0.06
End Levee Mile	7.53
Location	Land Side
Category	Earthen Levee
Item	Vegetation

Levee mile 0.06, this photo shows the vegetation on the landside slope.

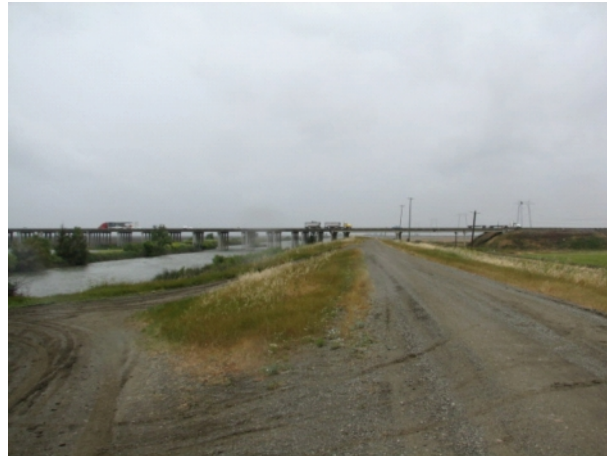
cathom\_s\_20110524\_173.jpg

Levee Mile Report Line	2
Start Levee Mile	0.06
End Levee Mile	7.53
Location	Water Side
Category	Earthen Levee
Item	Vegetation

Levee mile 0.06, this photo shows the vegetation on the waterside slope.

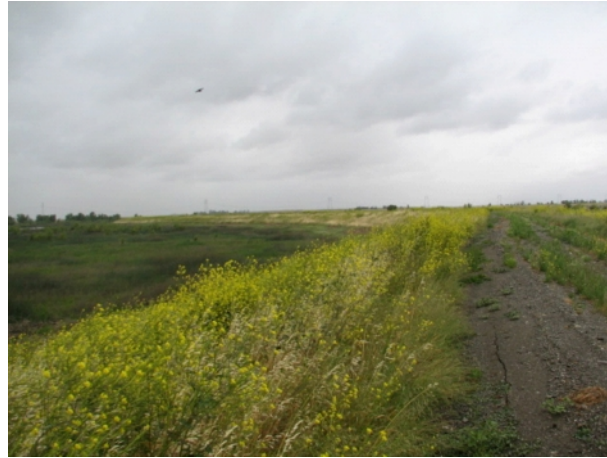
cathom\_s\_20110524\_175.jpg

Levee Mile Report Line	1
Start Levee Mile	0.03
End Levee Mile	2.50
Location	Water Side
Category	Earthen Levee
Item	Vegetation

Levee mile 0.05, this photo shows the vegetation on the waterside slope.

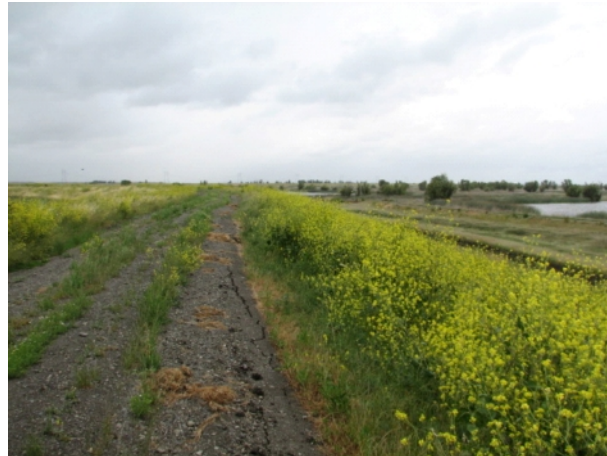
cathom\_s\_20110524\_174.jpg

Levee Mile Report Line	2
Start Levee Mile	0.03
End Levee Mile	2.50
Location	Land Side
Category	Earthen Levee
Item	Vegetation

Levee mile 0.05, this photo shows the vegetation on the landside slope.
