**Flood Control Project Maintenance
Levee Inspections****LMA District Cover Sheet****Spring 2012 Levee Inspection Results****Reclamation District No. 2035 Conaway**

Levee Inspection Report By Mile - Spring 2012

Reclamation District No. 2035 Conaway

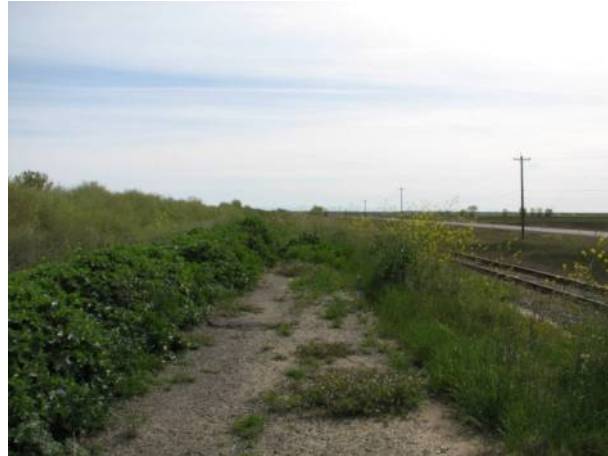
Levee Mile Report Line	4
Start Levee Mile	0.02
End Levee Mile	2.01
Location	Crown
Category	Earthen Levee
Item	Vegetation
This photo was taken at levee mile 0.02 looking downstream at the crown vegetation.	
cathom_s_20120406_423.JPG

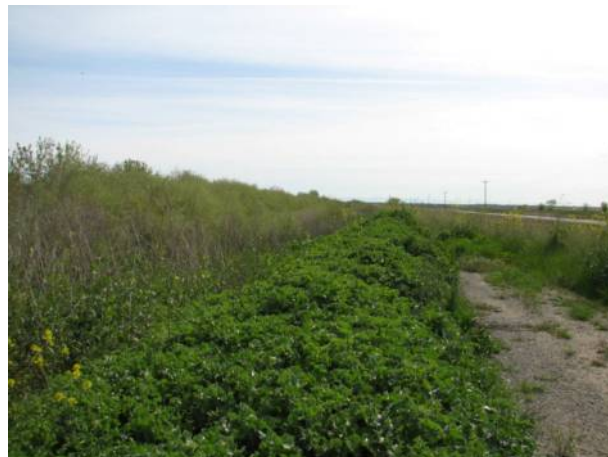
Levee Mile Report Line	5
Start Levee Mile	0.02
End Levee Mile	2.01
Location	Water Side
Category	Earthen Levee
Item	Vegetation
This photo is from levee mile 0.02, waterside vegetation.	
cathom_s_20120406_421.JPG

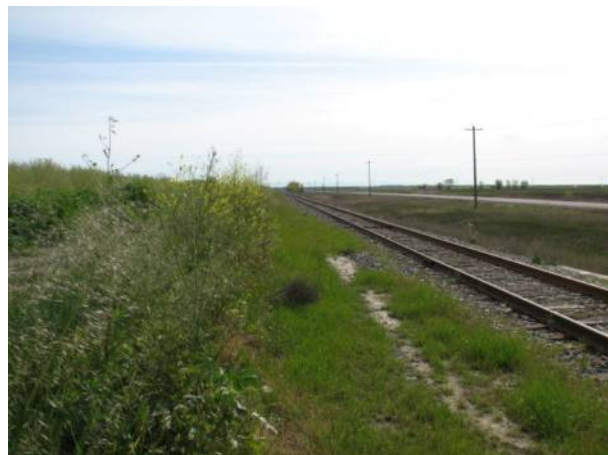
Levee Mile Report Line	6
Start Levee Mile	0.02
End Levee Mile	2.01
Location	Land Side
Category	Earthen Levee
Item	Vegetation
This photo was taken at levee mile 0.02 looking downstream at the landside vegetation.	
cathom_s_20120406_422.JPG

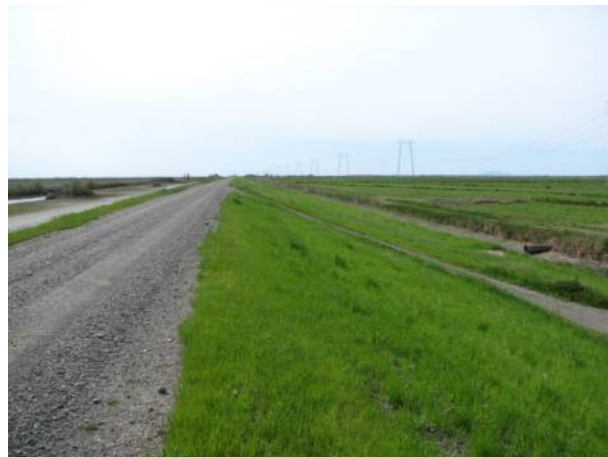
Levee Mile Report Line	2
Start Levee Mile	0.17
End Levee Mile	7.41
Location	Land Side
Category	Earthen Levee
Item	Vegetation
Landward slope looking downstream.	
dpesaven_s_20120504_408.JPG

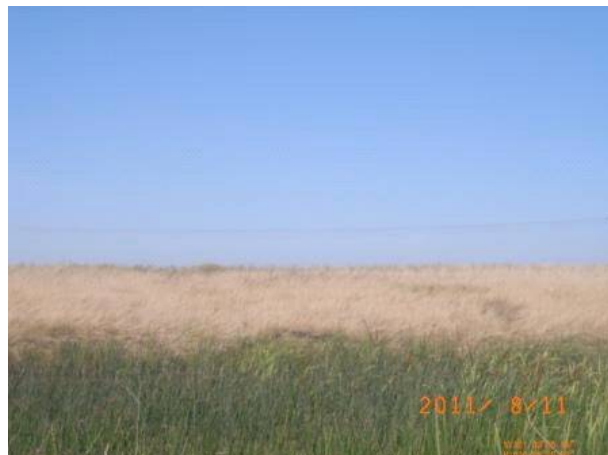
Levee Mile Report Line	3
Start Levee Mile	1.19
End Levee Mile	1.23
Location	Water Side
Category	Supplemental
Item	USACE Erosion Survey
USACE 2011 Photo #1	
cathom_s_20120307_404.jpg

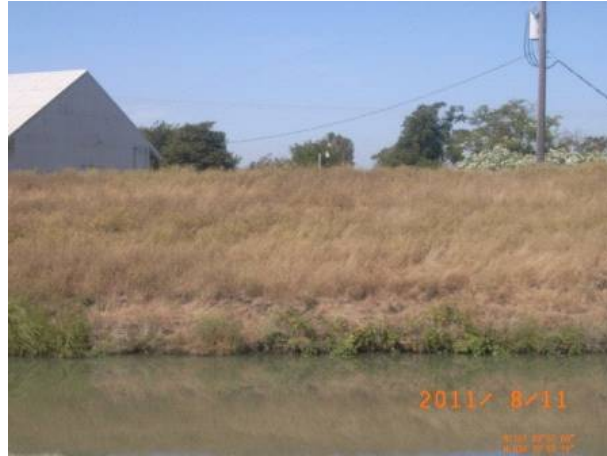
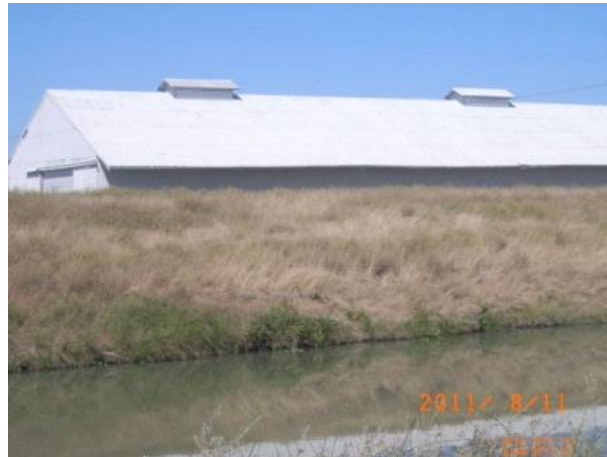
4	1.97	2.01	Supplemental	USACE Erosion Survey	WS Ma	Inspector Comments: 2006 - Wave wash erosion and some saturation slumping occurring. Tension/separation cracks evident in fine grained levee slope materials. 2011: Small sections of slumping lower bank, just downstream of bank rock. [2011 Site ID: YOL_2-0_R]	38.648881 ° -121.666653 °	38.648178 ° -121.666385 °	5 Y
DWR ID: DWR_RD2035_02_s_2012_5									
5	2.23	4.01	Earthen Levee	Encroachments	LS En	AD : Agricultural Ditch	38.645470 ° -121.665573 °	38.623062 ° -121.648925 °	979
DWR ID: DWR_RD2035_02_s_2012_979									
6	4.06	4.37	Supplemental	USACE Erosion Survey	WS Ma	Inspector Comments: 2006 - Wave wash erosion and some saturation slumping occurring. Several small scallops present in lower levee slope/toe due to saturation slumping. Tension/separation cracks evident in fine-grained levee slope materials. 2011: Small pockets of erosion throughout the site. Site formerly called 3.8. [2011 Site ID: YOL_4-2_R]	38.622224 ° -121.648201 °	38.618302 ° -121.645296 °	6 Y

Levee Mile Report Line	4
Start Levee Mile	1.97
End Levee Mile	2.01
Location	Water Side
Category	Supplemental
Item	USACE Erosion Survey

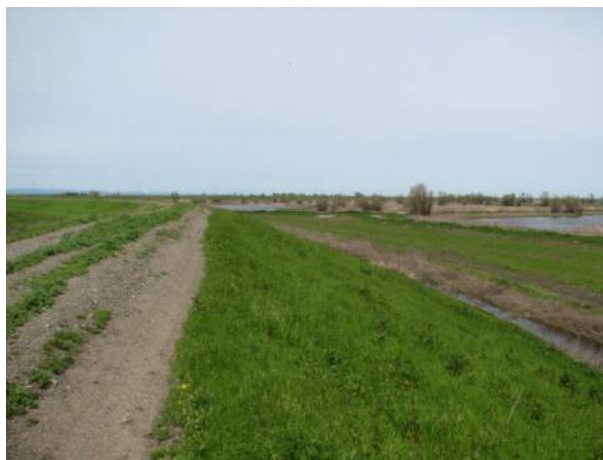
Levee Mile Report Line	1
Start Levee Mile	0.05
End Levee Mile	2.23
Location	Land Side
Category	Earthen Levee
Item	Vegetation

LMR No.	Levee Mile		Category	Item	Location *	Rating **	Action/Comment	GPS Latitude/Longitude		Issue No. Photo
	Start	End						Start	End	
1	0.05	2.23	Earthen Levee	Vegetation	LS	A Ma	V1 : Control annual grass and weeds on the levee slopes and easements.	38.575534 ° -121.636516 °	38.590890 ° -121.660117 °	1 Y
DWR ID: DWR_RD2035_03_s_2012_1										
2	0.05	1.78	Earthen Levee	Vegetation	WS	A Ma	V1 : Control annual grass and weeds on the levee slopes and easements.	38.575535 ° -121.636516 °	38.591170 ° -121.651791 °	2 Y
DWR ID: DWR_RD2035_03_s_2012_2										
3	0.08	2.09	Earthen Levee	Encroachments	LS	M En	AD : Agricultural Ditch	38.575615 ° -121.636680 °	38.590877 ° -121.657538 °	973
DWR ID: DWR_RD2035_03_s_2012_973										
4	1.78	2.15	Earthen Levee	Vegetation	WS	M Ma	V1 : Control annual grass and weeds on the levee slopes and easements.	38.591170 ° -121.651791 °	38.590936 ° -121.658709 °	4
DWR ID: DWR_RD2035_03_s_2012_4

Landward slope looking upstream.

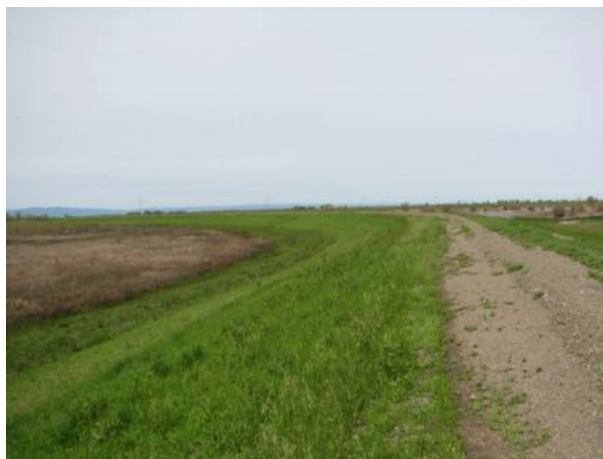
Levee Mile Report Line	2
Start Levee Mile	0.05
End Levee Mile	1.78
Location	Water Side
Category	Earthen Levee
Item	Vegetation

Waterward slope looking upstream.
