**Flood Control Project Maintenance
Levee Inspections****LMA District Cover Sheet****Spring 2013 Levee Inspection Results****Reclamation District No. 2035 Conaway**

Levee Inspection Report By Mile - Spring 2013

Reclamation District No. 2035 Conaway

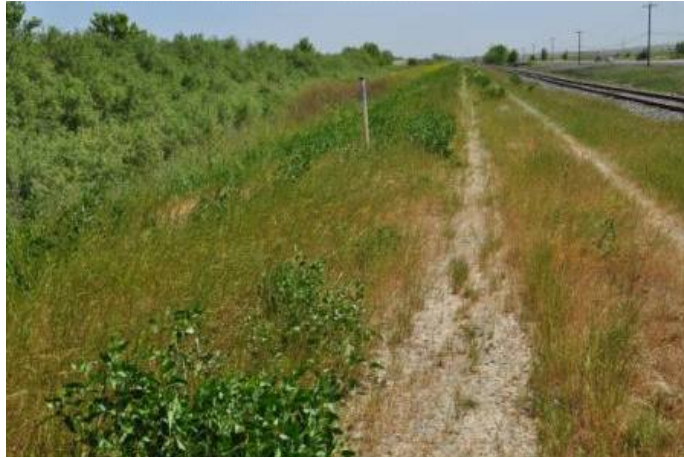
Levee Mile Report Line	4
Start Levee Mile	0.00
End Levee Mile	2.00
Location	Crown
Category	
Item	Vegetation
RD 2035, Unit 1- Vegetation on crown roadway.	
rburnett_s_20130429_286.JPG

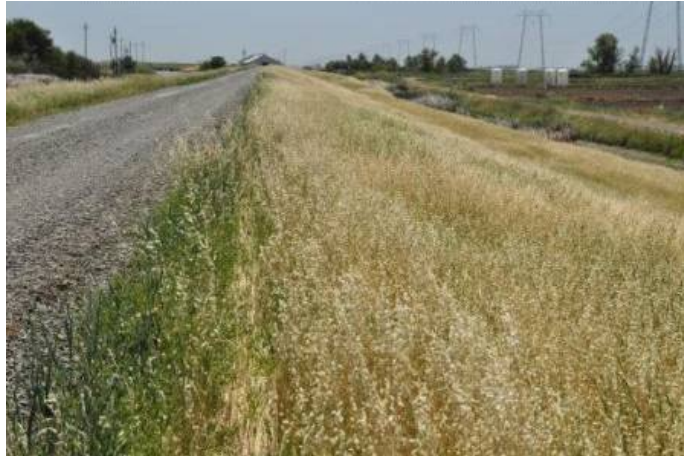
Levee Mile Report Line	1
Start Levee Mile	0.06
End Levee Mile	7.56
Location	Land Side
Category	
Item	Vegetation
L/S slope vegetation.	
rburnett_s_20130429_289.JPG

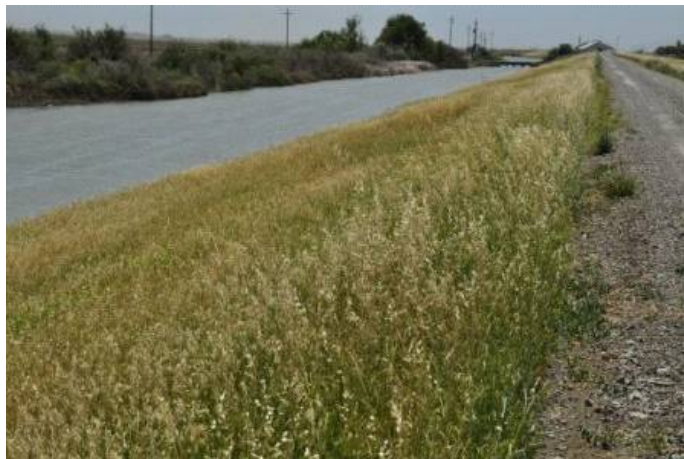
Levee Mile Report Line	2
Start Levee Mile	0.06
End Levee Mile	7.56
Location	Water Side
Category	
Item	Vegetation
W/S slope vegetation.	
rburnett_s_20130429_288.JPG

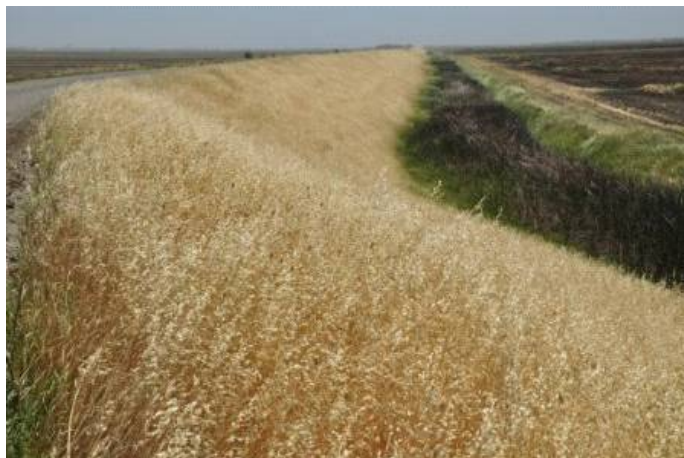
Levee Mile Report Line	6
Start Levee Mile	2.16
End Levee Mile	4.36
Location	Land Side
Category	
Item	Encroachments
Drainage ditch at L/S levee toe.	
rburnett_s_20130429_290.JPG

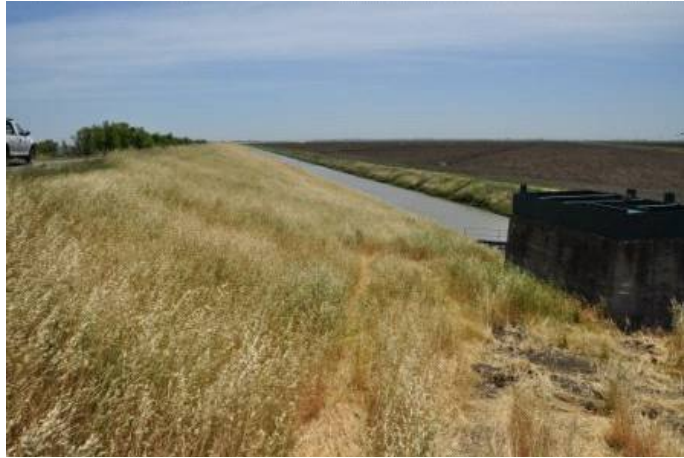
Levee Mile Report Line	10
Start Levee Mile	4.40
End Levee Mile	6.52
Location	Land Side
Category	
Item	Encroachments

LMR No.	Levee Mile		Category	Item	Location *	Rating ** +	Action/Comment	GPS Latitude/Longitude		Issue No.
	Start	End						Start	End	Photo
10	4.40	6.52		Encroachments	LS	M	DT : Ditch En	38.617921 ° -121.645109 °	38.589619 ° -121.631277 °	10 Y
DWR ID: DWR_RD2035_02_s_2013_10

Drainage ditch at L/S levee toe.

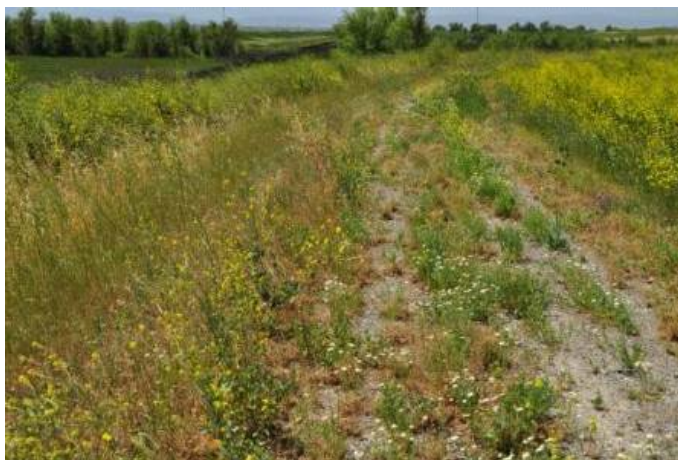
Levee Mile Report Line	1
Start Levee Mile	0.00
End Levee Mile	2.15
Location	Crown
Category	
Item	Vegetation

Typical crown roadway vegetation.

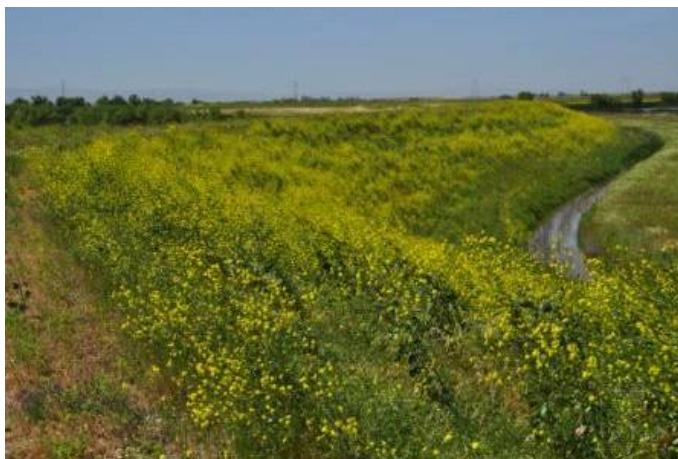
Levee Mile Report Line	2
Start Levee Mile	0.00
End Levee Mile	2.50
Location	Land Side
Category	
Item	Vegetation

Typical L/S slope vegetation.

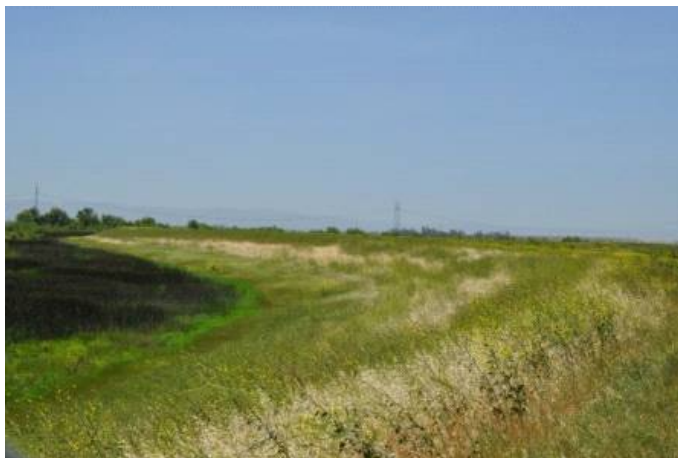
Levee Mile Report Line	3
Start Levee Mile	0.00
End Levee Mile	2.50
Location	Water Side
Category	
Item	Vegetation

Typical L/S vegetation.

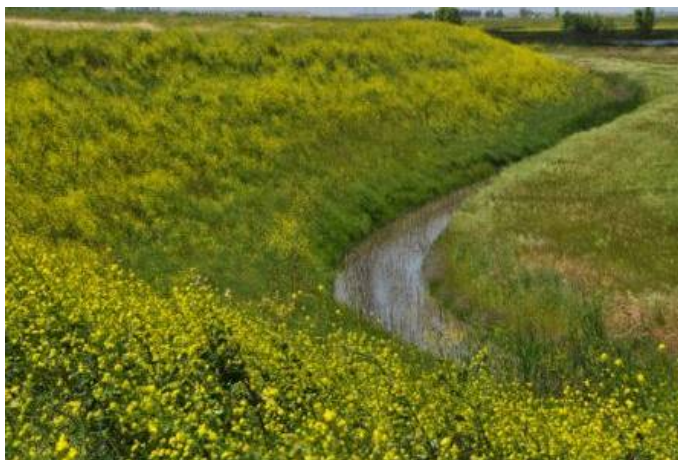
Levee Mile Report Line	4
Start Levee Mile	0.06
End Levee Mile	2.15
Location	Land Side
Category	
Item	Encroachments

L/S drainage ditch at levee toe.

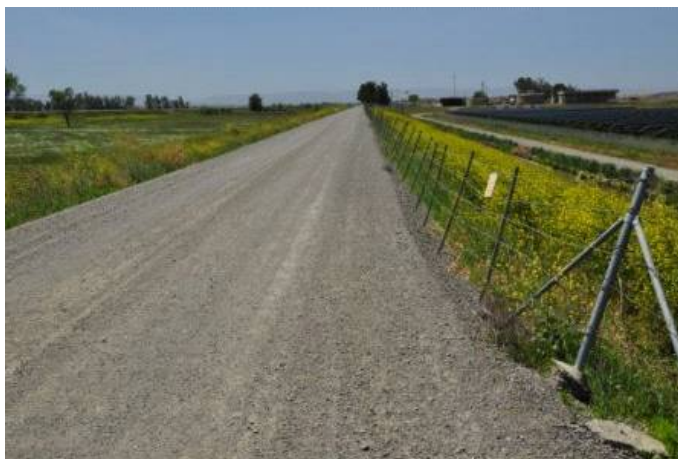
Levee Mile Report Line	5
Start Levee Mile	2.22
End Levee Mile	2.50
Location	Land Side
Category	
Item	Encroachments

Fence along L/S shoulder.
