**Flood Control Project Maintenance
Levee Inspections****LMA District Cover Sheet****Spring 2014 Levee Inspection Results****Reclamation District No. 2035 Conaway**

Levee Inspection Report By Mile - Spring 2014

Waterway	Bank	Unit Miles	Inspection Start/End	Inspector
Unit No. 01 Cache Creek Settling Basin	Right	2.01	04/29/2014 04/29/2014	Matthew Hoffman

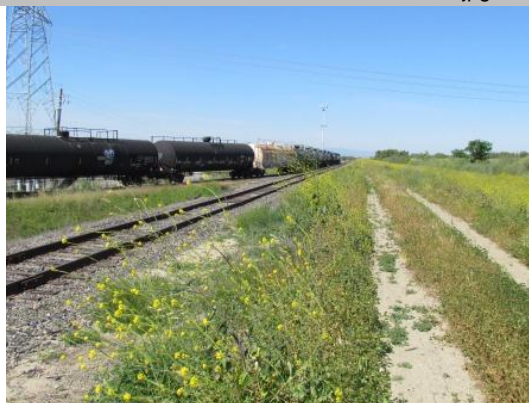
Photo 1 of 1 : mhoffman_s_20140430_491.jpg

LM Start	0.00	Rating **	U	Issue No.	7
LM End	2.01	Issue Type +	Ma	Location *	LS
Category	Earthen Levee			GPS Latitude/Longitude	
				Start	End
Item	Vegetation			38.677367 °	38.677166 °
				-121.709906 °	-121.672758 °
DWR ID	DWR_RD2035_01_s _ 2014_7				
Action/Comments					
Control annual grass and weeds on the levee slopes and easements.

This photo was taken from the crown facing west looking down the landward slope at vegetation requiring annual maintenance. Spring 2014.

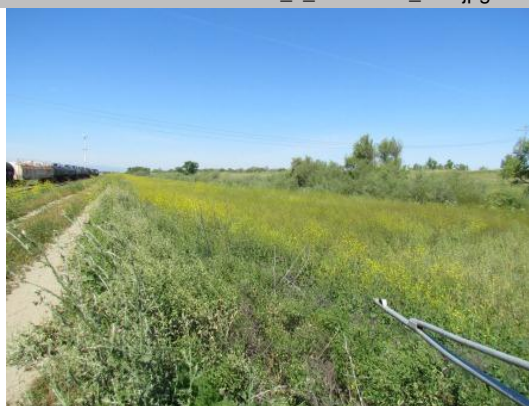
Photo 1 of 1 : mhoffman_s_20140430_492.jpg

LM Start	0.00	Rating **	U	Issue No.	8
LM End	2.01	Issue Type +	Ma	Location *	WS
Category	Earthen Levee			GPS Latitude/Longitude	
				Start	End
Item	Vegetation			38.677367 °	38.677166 °
				-121.709906 °	-121.672758 °
DWR ID	DWR_RD2035_01_s _ 2014_8				
Action/Comments					
Control annual grass and weeds on the levee slopes and easements.

This photo was taken from the crown facing west looking down the waterward slope at vegetation requiring annual maintenance. Spring 2014

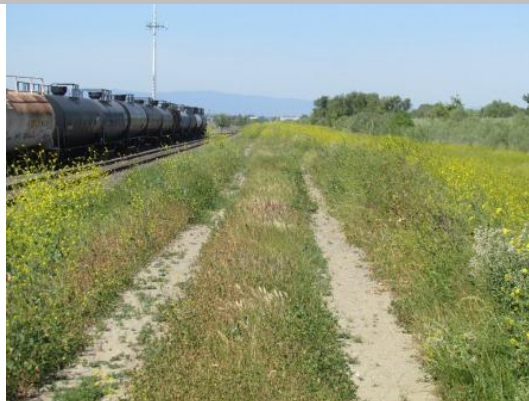
Photo 1 of 1 : mhoffman_s_20140430_493.jpg

LM Start	0.00	Rating **	M	Issue No.	14
LM End	2.01	Issue Type +	Ma	Location *	CR
Category	Earthen Levee			GPS Latitude/Longitude	
				Start	End
Item	Vegetation			38.677367 °	38.677166 °
				-121.709906 °	-121.672758 °
DWR ID	DWR_RD2035_01_s _ 2014_14				
Action/Comments					
Control annual grass and weeds on the levee slopes and easements.

This photo was taken from the crown facing west looking directly down the crown road at vegetation requiring annual maintenance. Spring 2014

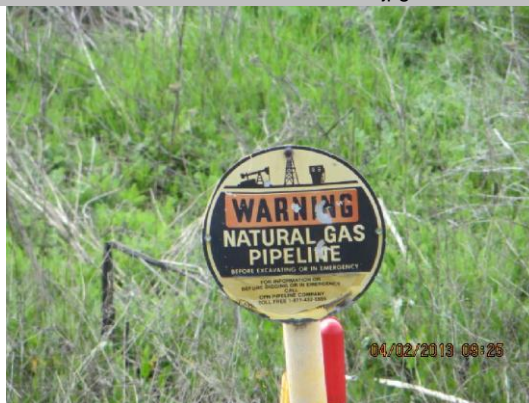
Photo 1 of 1 : UCIP_1409.jpg

LM Start	0.03	Rating **	M	Issue No.	1
LM End	0.03	Issue Type +	En	Location *	WS
Category	Supplemental			GPS Latitude/Longitude	
				Start	End
Item	DWR UCIP Field Study			38.677362 °	38.677362 °
				-121.709327 °	-121.709327 °
DWR ID	DWR_RD2035_01_s_2014_1				
Action/Comments					
Inspector Comments: FS_ID:16063					
EP_NO: N/A					
Repair Type:					
Crossing Status:					
UCIP Comments: No permit identified for this crossing.					
FIELD_STRUCT_DESC: Gas line of an unknown diameter through the levee at an unknown depth. Gas line markers on both sides of levee.					
FS Date: 4/2/2013

Gasline marker on LS toe.

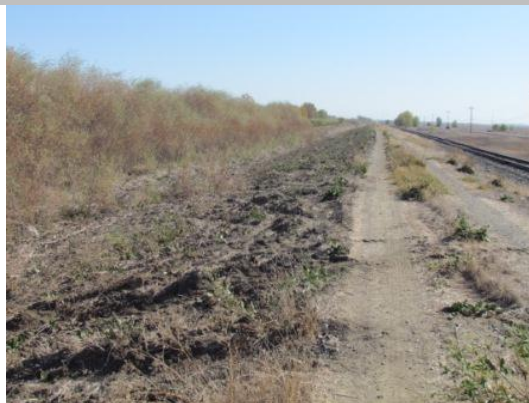
Photo 1 of 1 : mhoffman_s_20140401_265.jpg

LM Start	0.03	Rating **	A/W	Issue No.	11
LM End	2.00	Issue Type +	Ma	Location *	WS
Category	Earthen Levee			GPS Latitude/Longitude	
				Start	End
Item	Encroachments			38.677347 °	38.677175 °
				-121.709285 °	-121.672945 °
DWR ID	DWR_RD2035_01_f_2013_11				
Action/Comments					
Agricultural tilling					
Inspector Comments: Discing on the waterward slope can lead to erosion.

This photo was taken from the levee crown facing east looking at discing on the waterward slope. Fall 2013.

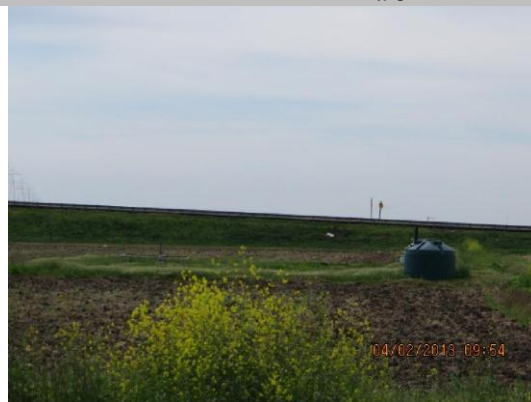
Photo 1 of 1 : UCIP_399.jpg

LM Start	1.85	Rating **	M	Issue No.	2
LM End	1.85	Issue Type +	En	Location *	CR
Category	Supplemental			GPS Latitude/Longitude	
				Start	End
Item	DWR UCIP Field Study			38.677186 °	38.677186 °
				-121.675276 °	-121.675276 °
DWR ID	DWR_RD2035_01_s_2014_2				
Action/Comments					
Inspector Comments: FS_ID:10913					
EP_NO: 13201					
Repair Type:					
Crossing Status:					
UCIP Comments: Pipe needs to be properly marked or abandoned.					
FIELD_STRUCT_DESC: 8-inch diameter casing through the levee 25-feet below the crown. 3-inch gas line through the casing with annular space filled with Bentonite. Possible vent for pipe on LS next to Old River Road.					
FS Date: 4/2/2013

Natural gas well on south side of Old river road.

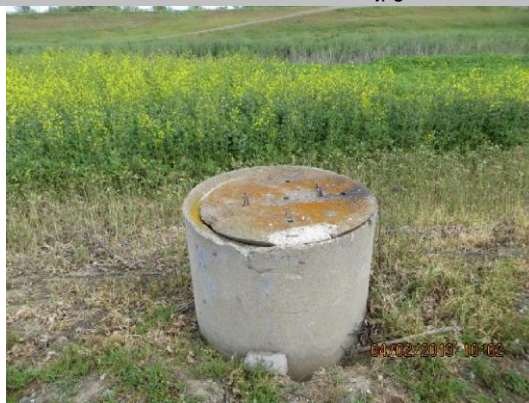
Photo 1 of 1 : UCIP_400.jpg

LM Start	1.91	Rating **	M	Issue No.	6
LM End	1.91	Issue Type +	En	Location *	CR
Category	Supplemental			GPS Latitude/Longitude	
				Start	End
Item	DWR UCIP Field Study			38.677175 °	38.677175 °
				-121.674065 °	-121.674065 °
DWR ID	DWR_RD2035_01_s_2014_6				
Action/Comments					
Inspector Comments: FS_ID:10914					
EP_NO: 2544					
Repair Type:					
Crossing Status:					
UCIP Comments: Pipe appears to be abandoned as there is no pumphouse. Needs to be abandoned properly					
FIELD_STRUCT_DESC: 16-inch drainage pipe through levee 5.0 feet below crown. Pump on piling structure in drainage ditch on landward side. 36-inch concrete standpipe on waterward shoulder. (Permit No. 2544 - City of Woodland)					
FS Date: 4/2/2013

36-inch Concrete stand pipe on WS shoulder.

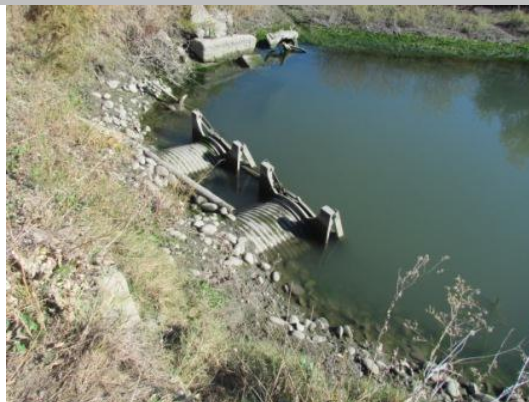
Photo 1 of 1 : mhoffman_s_20140401_266.jpg

LM Start	2.00	Rating **	A/W	Issue No.	13
LM End	2.00	Issue Type +	En	Location *	WS
Category	Earthen Levee			GPS Latitude/Longitude	
				Start	End
Item	Encroachments			38.677177 °	38.677177 °
				-121.672870 °	-121.672870 °
DWR ID	DWR_RD2035_01_f_2013_13				
Action/Comments					
Pipe					
Inspector Comments: Pipes at east end of unit now have flap gates installed but propped open with debris.

This photo was taken from the levee crown facing east at the intersection of unit 2 looking down at flap gates that are propped open with debris. Fall 2013.

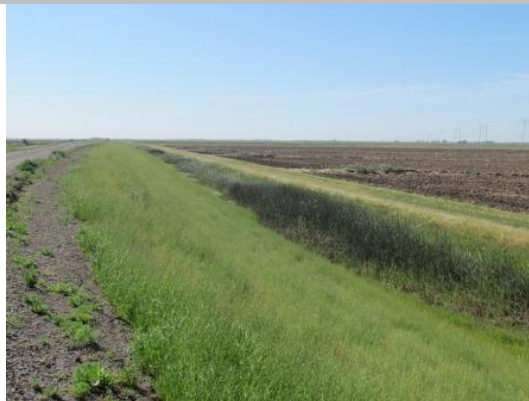
Photo 1 of 1 : mhoffman_s_20140430_494.jpg

LM Start	0.00	Rating **	M	Issue No.	14
LM End	7.57	Issue Type +	Ma	Location *	LS
Category	Earthen Levee			GPS Latitude/Longitude	
				Start	End
Item	Vegetation			38.677166 °	38.575767 °
				-121.672758 °	-121.634701 °
DWR ID	DWR_RD2035_02_s_2014_14				
Action/Comments					
Control annual grass and weeds on the levee slopes and easements.

This photo was taken from the crown facing south looking down the landward levee slope at vegetation requiring maintenance. Spring 2014.

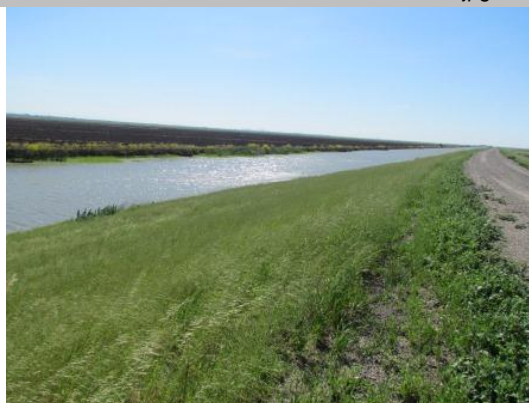
Photo 1 of 1 : mhoffman_s_20140430_495.jpg

LM Start	0.00	Rating **	M	Issue No.	15
LM End	7.57	Issue Type +	Ma	Location *	WS
Category	Earthen Levee			GPS Latitude/Longitude	
				Start	End
Item	Vegetation			38.677166 °	38.575767 °
				-121.672758 °	-121.634701 °
DWR ID	DWR_RD2035_02_s_2014_15				
Action/Comments					
Control annual grass and weeds on the levee slopes and easements.

This photo was taken from the crown facing south looking down the waterward levee slope at vegetation requiring maintenance. Spring 2014.

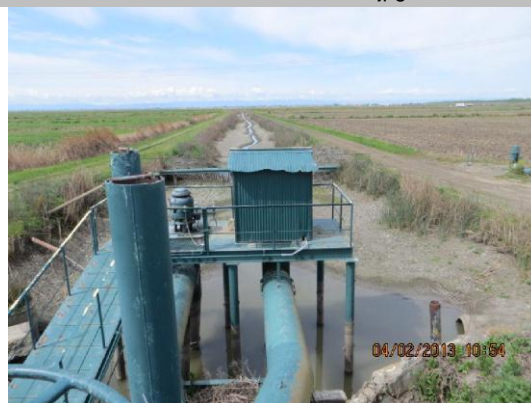
Photo 1 of 1 : UCIP_405.jpg

LM Start	0.37	Rating **	M	Issue No.	1
LM End	0.37	Issue Type +	En	Location *	WS
Category	Supplemental			GPS Latitude/Longitude	
				Start	End
Item	DWR UCIP Field Study			38.671812 °	38.671812 °
				-121.671580 °	-121.671580 °
DWR ID	DWR_RD2035_02_s_2014_1				
Action/Comments					
Inspector Comments: FS_ID:10923					
EP_NO: N/A					
Repair Type:					
Crossing Status:					
UCIP Comments: Flap gate broken in half on WS toe. Some erosion at headwalls on pumping plant.					
FIELD_STRUCT_DESC: 44-inch C.M. pipe through levee 22.0 feet below crown. Pump in drainage ditch at toe of landward slope, slide gate and flap gates in 5X9-foot concrete box. Flap gate on waterward end. 8-inch vent/standpipe at waterward toe. Originally included in O+M (1959).					
FS Date: 4/2/2013

Pump at drainage channel.

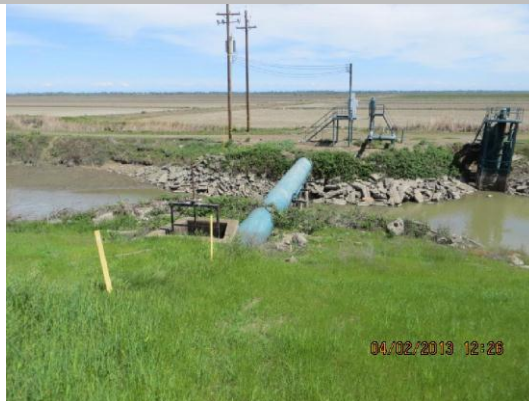
Photo 1 of 1 : UCIP_468.jpg

LM Start	1.70	Rating **	M	Issue No.	2
LM End	1.70	Issue Type +	En	Location *	WS
Category	Supplemental			GPS Latitude/Longitude	
				Start	End
Item	DWR UCIP Field Study			38.652721 °	38.652721 °
				-121.667790 °	-121.667790 °
DWR ID	DWR_RD2035_02_s_2014_2				
Action/Comments					
Inspector Comments: FS_ID:11523 EP_NO: N/A Repair Type: Crossing Status: UCIP Comments: Pipe does not have appropriate cover and is marked as gasoline. Does not appear to be a permitted utility. FIELD_STRUCT_DESC: 4-inch steel pipe 3-inches below the crown with a 2-inch PVC pipe sleeved through it. FS Date: 4/2/2013 7:55:12 AM

Pipe with gasline markers on WS slope.

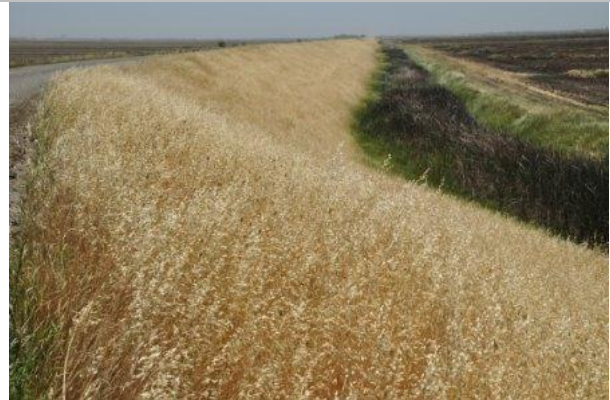
Photo 1 of 1 : mhoffman_s_20140401_271.jpg

LM Start	2.16	Rating **	M	Issue No.	979
LM End	4.36	Issue Type +	En	Location *	LS
Category	Earthen Levee			GPS Latitude/Longitude	
				Start	End
Item	Encroachments			38.646063 °	38.623062 °
				-121.666332 °	-121.648925 °
DWR ID	DWR_RD2035_02_s_2012_979				
Action/Comments					
Ditch

Drainage ditch at L/S levee toe.

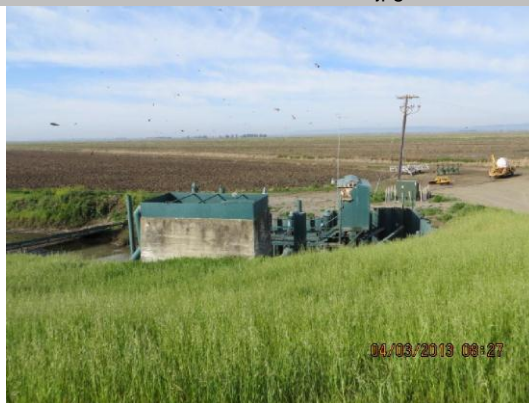
Photo 1 of 1 : UCIP_474.jpg

LM Start	4.39	Rating **	M	Issue No.	11
LM End	4.39	Issue Type +	En	Location *	WS
Category	Supplemental			GPS Latitude/Longitude	
				Start	End
Item	DWR UCIP Field Study			38.618030 °	38.618030 °
				-121.645192 °	-121.645192 °
DWR ID	DWR_RD2035_02_s_2014_11				
Action/Comments					
Inspector Comments: FS_ID:11526					
EP_NO: 1701					
Repair Type:					
Crossing Status:					
UCIP Comments: Animal activity at outlet causing damage to berm and undermining the pipe at the outlet headwall on WS toe.					
FIELD_STRUCT_DESC: 60-inch corrugated metal drain pipe through the levee 20.6 feet below the crown encased in 6-inches of reinforced concrete. Slide gate in 7-foot diameter C.M. pipe riser on waterward slope. Pumping plant with 6-pumps/pipes that discharge into a 4-ft by 18-ft surge box on the LS toe. (Permit No. 1701 - R.D. 2035)					
FS Date: 4/3/2013

Surge box and pumping plant on LS toe.

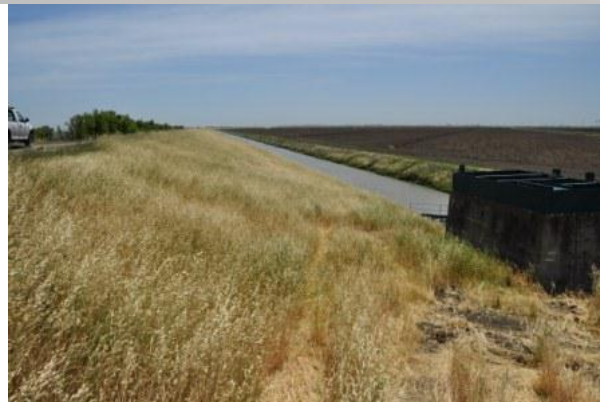
Photo 1 of 1 : mhoffman_s_20140401_270.jpg

LM Start	4.40	Rating **	M	Issue No.	10
LM End	6.52	Issue Type +	En	Location *	LS
Category	Earthen Levee			GPS Latitude/Longitude	
				Start	End
Item	Encroachments			38.617921 °	38.589619 °
				-121.645109 °	-121.631277 °
DWR ID	DWR_RD2035_02_s_2013_10				
Action/Comments					
Ditch

Drainage ditch at L/S levee toe.

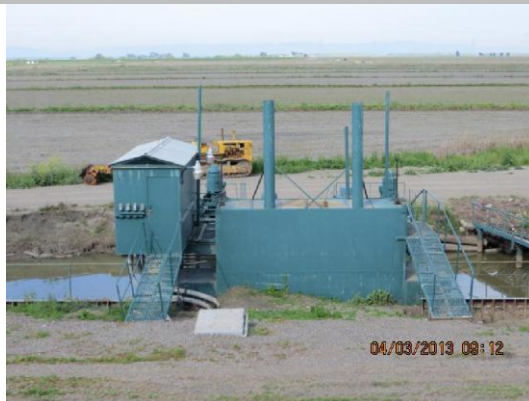
Photo 1 of 1 : UCIP_419.jpg

LM Start	6.45	Rating **	M	Issue No.	12
LM End	6.45	Issue Type +	En	Location *	LS
Category	Supplemental			GPS Latitude/Longitude	
				Start	End
Item	DWR UCIP Field Study			38.590691 °	38.590691 °
				-121.631284 °	-121.631284 °
DWR ID	DWR_RD2035_02_s_2014_12				
Action/Comments					
Inspector Comments: FS_ID:11003					
EP_NO: 16480					
Repair Type:					
Crossing Status:					
UCIP Comments: Erosion on LS toe at pumping plant. Severe erosion of sheet pile walls at pumping plant.					
FIELD_STRUCT_DESC: 1 of 2: 60-inch by 48-inch concrete box drainage conduit through the levee 22-feet below the crown. Steel walkway to slidegate handles on WS shoulder. 6X18-foot surge box and pumping plant on LS toe. This pipe replaced the 48-inch at this same location. (Permit No. 16480, 1996)					
FS Date: 4/3/2013

Pumping plant on LS toe.

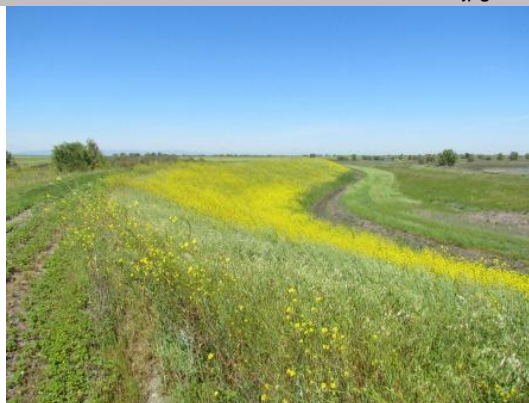
Photo 1 of 1 : mhoffman_s_20140430_496.jpg

LM Start	0.00	Rating **	U	Issue No.	7
LM End	2.51	Issue Type +	Ma	Location *	LS
Category	Earthen Levee			GPS Latitude/Longitude	
				Start	End
Item	Vegetation			38.575378 °	38.590770 °
				-121.635626 °	-121.665222 °
DWR ID	DWR_RD2035_03_s _ 2014_7				
Action/Comments					
Control annual grass and weeds on the levee slopes and easements.

This photo was taken from the crown facing west looking down the landward slope at vegetation requiring maintenance. Spring 2014.

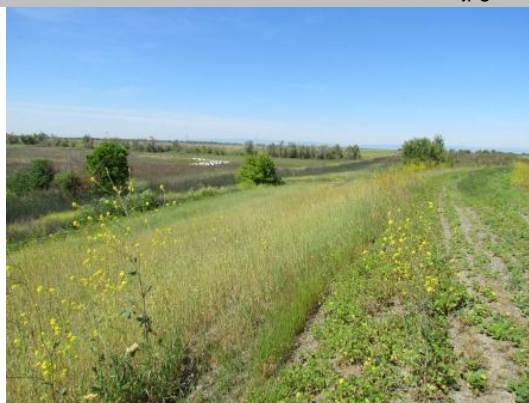
Photo 1 of 1 : mhoffman_s_20140430_497.jpg

LM Start	0.00	Rating **	U	Issue No.	8
LM End	2.51	Issue Type +	Ma	Location *	WS
Category	Earthen Levee			GPS Latitude/Longitude	
				Start	End
Item	Vegetation			38.575378 °	38.590770 °
				-121.635626 °	-121.665222 °
DWR ID	DWR_RD2035_03_s _ 2014_8				
Action/Comments					
Control annual grass and weeds on the levee slopes and easements.

This photo was taken from the crown facing west looking down the waterward slope at vegetation requiring maintenance. Spring 2014.

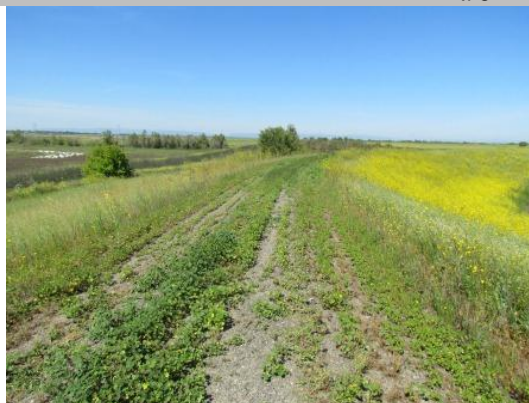
Photo 1 of 1 : mhoffman_s_20140430_498.jpg

LM Start	0.00	Rating **	U	Issue No.	9
LM End	2.51	Issue Type +	Ma	Location *	CR
Category	Earthen Levee			GPS Latitude/Longitude	
				Start	End
Item	Vegetation			38.575378 °	38.590770 °
				-121.635626 °	-121.665222 °
DWR ID	DWR_RD2035_03_s _ 2014_9				
Action/Comments					
Control annual grass and weeds on the levee slopes and easements.

This photo was taken from the crown facing west looking down the crown road at vegetation requiring maintenance. Spring 2014.

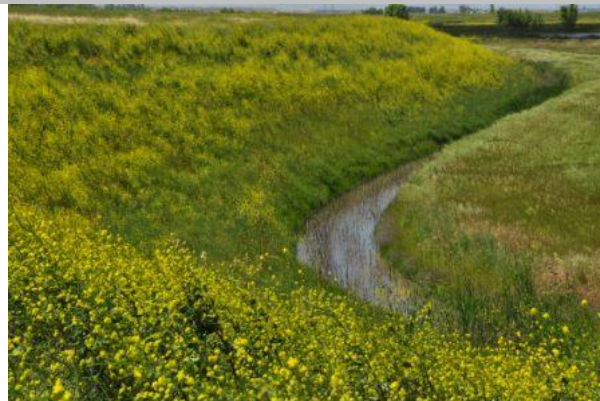
Photo 1 of 1 : mhoffman_s_20140401_277.jpg

LM Start	0.06	Rating **	M	Issue No.	973
LM End	2.15	Issue Type +	En	Location *	LS
Category	Earthen Levee			GPS Latitude/Longitude	
				Start	End
Item	Encroachments			38.575615 °	38.590919 °
				-121.636680 °	-121.658682 °
DWR ID	DWR_RD2035_03_s _ 2012_973				
Action/Comments					
Ditch

L/S drainage ditch at levee toe.

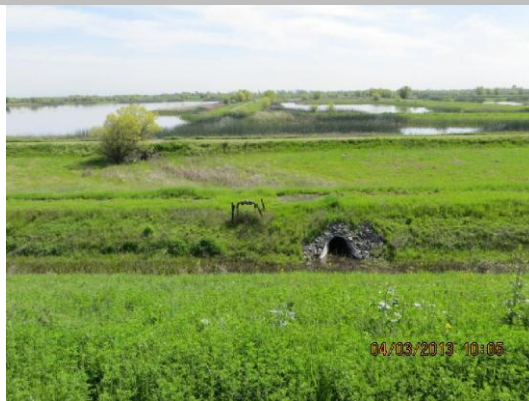
Photo 1 of 1 : UCIP_425.jpg

LM Start	0.80	Rating **	M	Issue No.	1
LM End	0.80	Issue Type +	En	Location *	LS
Category	Supplemental			GPS Latitude/Longitude	
				Start	End
Item	DWR UCIP Field Study			38.581056 °	38.581056 °
				-121.645142 °	-121.645142 °
DWR ID	DWR_RD2035_03_s _ 2014_1				
Action/Comments					
Inspector Comments: FS_ID:11007					
EP_NO: 6123					
Repair Type:					
Crossing Status:					
UCIP Comments: Need to install gasline markers through the levee if pipe is still active.					
FIELD_STRUCT_DESC: 4.5-inch Gas line through levee 2.5 feet below the crown. Pipe at vent visible off LS toe. (Permit No. 6123 - P.G.&E.)					
FS Date: 4/3/2013

Gasline vent off LS toe.

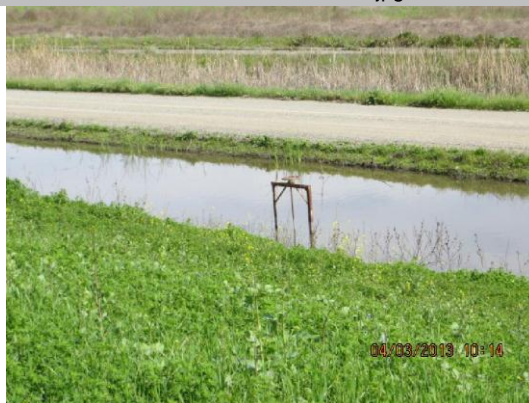
Photo 1 of 1 : UCIP_428.jpg

LM Start	1.38	Rating **	M	Issue No.	2
LM End	1.38	Issue Type +	En	Location *	LS
Category	Supplemental			GPS Latitude/Longitude	
				Start	End
Item	DWR UCIP Field Study			38.589425 °	38.589425 °
				-121.645359 °	-121.645359 °
DWR ID	DWR_RD2035_03_s_2014_2				
Action/Comments					
Inspector Comments: FS_ID:11008					
EP_NO: N/A					
Repair Type:					
Crossing Status:					
UCIP Comments: Need to clear vegetation and debris from WS flapgate.					
FIELD_STRUCT_DESC: 36-inch Corrugated metal pipe through levee 17.5 feet below crown, flap gate on waterward end, slide gate and concrete headwall on landward end. Originally included in O+M manual (1952).					
FS Date: 4/3/2013

Slide gate and headwall in canal at LS toe.

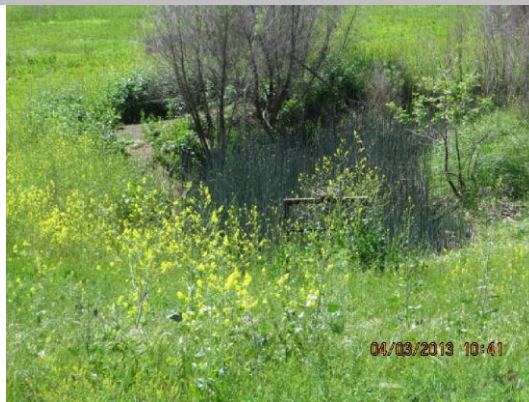
Photo 1 of 1 : UCIP_430.jpg

LM Start	2.16	Rating **	M	Issue No.	4
LM End	2.16	Issue Type +	En	Location *	LS
Category	Supplemental			GPS Latitude/Longitude	
				Start	End
Item	DWR UCIP Field Study			38.590933 °	38.590933 °
				-121.658940 °	-121.658940 °
DWR ID	DWR_RD2035_03_s_2014_4				
Action/Comments					
Inspector Comments: FS_ID:11011					
EP_NO: N/A					
Repair Type:					
Crossing Status:					
UCIP Comments: Debris and vegetation partially blocking inlet and outlet at both toes.					
FIELD_STRUCT_DESC: 48-inch corrugated metal pipe through levee 19.0 feet below crown, slide gate on both ends. Originally included in O+M manual (1952).					
FS Date: 4/3/2013

Slide gate at WS toe showing excessive vegetation.

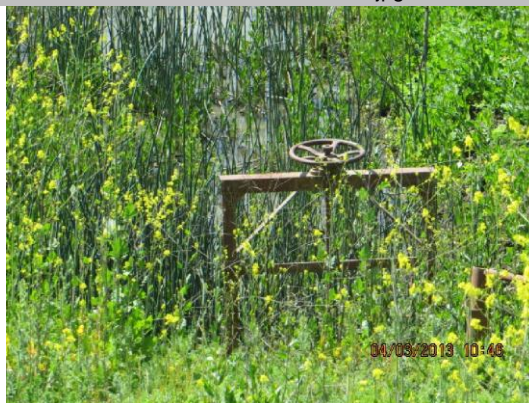
Photo 1 of 1 : UCIP_433.jpg

LM Start	2.18	Rating **	M	Issue No.	6
LM End	2.18	Issue Type +	En	Location *	LS
Category	Supplemental			GPS Latitude/Longitude	
				Start	End
Item	DWR UCIP Field Study			38.590909 °	38.590909 °
				-121.659311 °	-121.659311 °
DWR ID	DWR_RD2035_03_s_2014_6				
Action/Comments					
Inspector Comments: FS_ID:11012					
EP_NO: N/A					
Repair Type:					
Crossing Status:					
UCIP Comments: Debris and vegetation partially blocking both ends of pipe.					
FIELD_STRUCT_DESC: 36-inch pipe through levee 18.0 feet below crown, slide gate on LS toe. Combination flap and slide gate on WS toe. Originally included in O+M manual.					
FS Date: 4/3/2013

Combination flap and slide gate on WS toe. With excessive vegetation

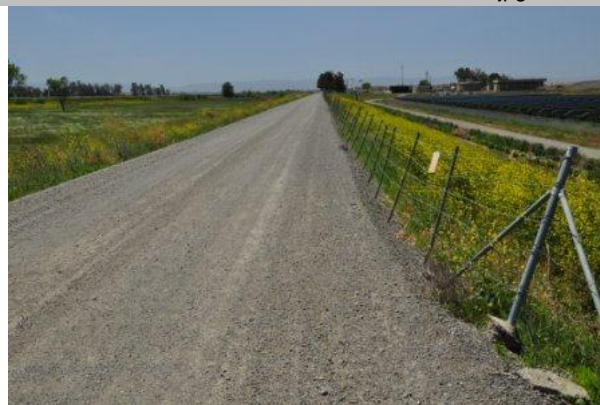
Photo 1 of 1 : mhoffman_s_20140401_276.jpg

LM Start	2.22	Rating **	M	Issue No.	5
LM End	2.50	Issue Type +	En	Location *	LS
Category	Earthen Levee			GPS Latitude/Longitude	
				Start	End
Item	Encroachments			38.590893 °	38.590760 °
				-121.659942 °	-121.665210 °
DWR ID	DWR_RD2035_03_s_2013_5				
Action/Comments					
Fence

Fence along L/S shoulder.
