**Flood Control Project Maintenance  
Levee Inspections****LMA District Cover Sheet****Spring 2015 Levee Inspection Results****Reclamation District No. 2035 Conaway**

## Levee Inspection Report By Mile - Spring 2015

### Reclamation District No. 2035 Conaway

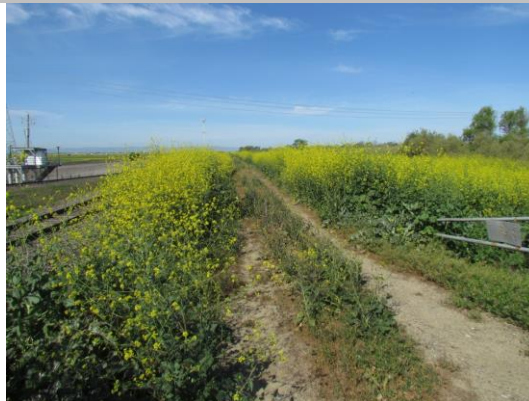
Photo 1 of 1 : SP\_2015\_RD2035\_238\_7\_20150330\_00006.jpg

LM Start	0.00	Rating **	U	Issue No.	7
LM End	2.00	Issue Type +	Ma	Location *	LS
Category	Earthen Levee			GPS Latitude/Longitude	
				Start	End
Item	Vegetation			38.677423 °	38.677178 °
				-121.709905 °	-121.672865 °
DWR ID	DWR_RD2035_01_s _ 2015_7				
Action/Comments					
Control annual grass and weeds on the levee slopes and easements.

View of the vegetation landside of levee facing downstream.

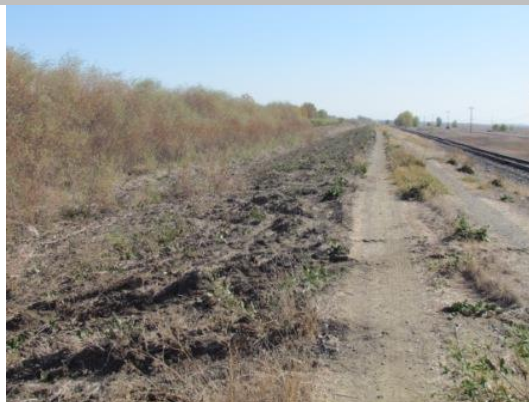
Photo 1 of 1 : SP\_2015\_RD2035\_238\_11\_20150318\_00001.jpg

LM Start	0.03	Rating **	A/W	Issue No.	11
LM End	2.00	Issue Type +	Ma	Location *	WS
Category	Earthen Levee			GPS Latitude/Longitude	
				Start	End
Item	Encroachments			38.677347 °	38.677175 °
				-121.709285 °	-121.672945 °
DWR ID	DWR_RD2035_01_f_2013_11				
Action/Comments					
Agricultural tilling Inspector Comments: Discing on the waterward slope can lead to erosion.

This photo was taken from the levee crown facing east looking at discing on the waterward slope. Fall 2013.

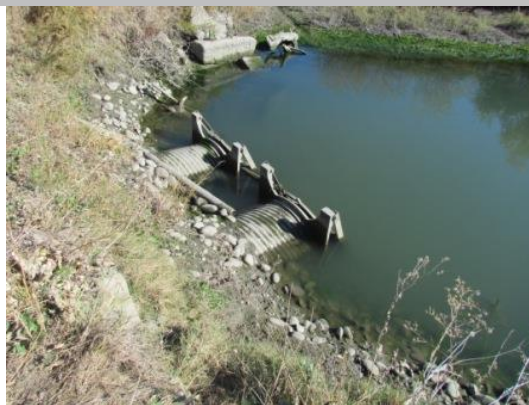
Photo 1 of 1 : SP\_2015\_RD2035\_238\_13\_20150318\_00002.jpg

LM Start	2.00	Rating **	A/W	Issue No.	13
LM End	2.00	Issue Type +	En	Location *	WS
Category	Earthen Levee			GPS Latitude/Longitude	
				Start	End
Item	Encroachments			38.677177 °	38.677177 °
				-121.672870 °	-121.672870 °
DWR ID	DWR_RD2035_01 f _2013_13

Action/Comments					
Pipe Inspector Comments: Pipes at east end of unit now have flap gates installed but propped open with debris.

This photo was taken from the levee crown facing east at the intersection of unit 2 looking down at flap gates that are propped open with debris. Fall 2013.

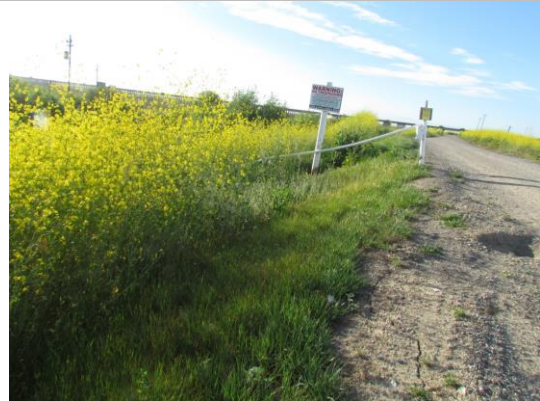
Photo 1 of 1 : SP\_2015\_RD2035\_239\_14\_20150330\_00007.jpg

LM Start	0.05	Rating **	M	Issue No.	14
LM End	1.76	Issue Type +	Ma	Location *	WS
Category	Earthen Levee			GPS Latitude/Longitude	
				Start	End
Item	Vegetation			38.676485 °	38.652040 °
				-121.672577 °	-121.667670 °
DWR ID	DWR_RD2035_02_s _ 2015_14				
Action/Comments					
Control annual grass and weeds on the levee slopes and easements.

View of the vegetation on the waterside of levee looking downstream.

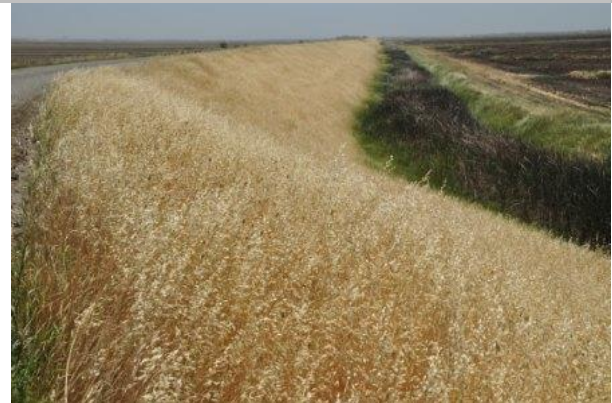
Photo 1 of 1 : SP\_2015\_RD2035\_239\_979\_20150326\_00002.jpg

LM Start	2.18	Rating **	M	Issue No.	979
LM End	4.02	Issue Type +	En	Location *	LS
Category	Earthen Levee			GPS Latitude/Longitude	
				Start	End
Item	Encroachments			38.646063 °	38.623062 °
				-121.666332 °	-121.648925 °
DWR ID	DWR_RD2035_02_s_2012_979				
Action/Comments					
Ditch

Drainage ditch at L/S levee toe.

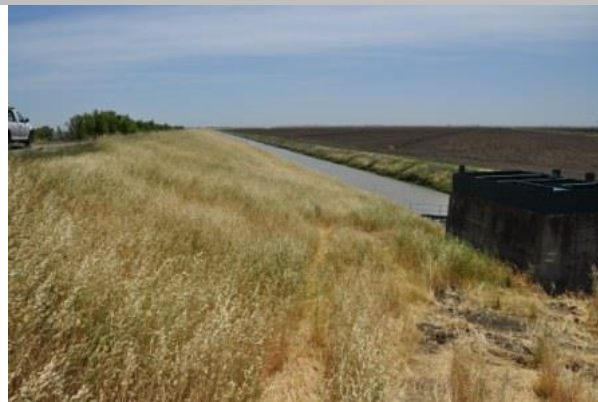
Photo 1 of 1 : SP\_2015\_RD2035\_239\_10\_20150326\_00001.jpg

LM Start	4.43	Rating **	M	Issue No.	10
LM End	6.57	Issue Type +	En	Location *	LS
Category	Earthen Levee			GPS Latitude/Longitude	
				Start	End
Item	Encroachments			38.617921 °	38.589619 °
				-121.645109 °	-121.631277 °
DWR ID	DWR_RD2035_02_s_2013_10				
Action/Comments					
Ditch

Drainage ditch at L/S levee toe.

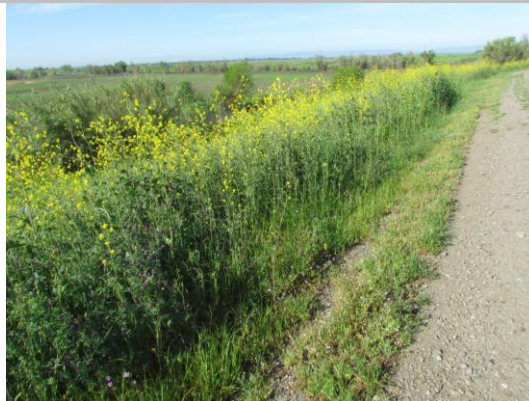
Photo 1 of 1 : SP\_2015\_RD2035\_240\_7\_20150330\_00007.jpg

LM Start	0.00	Rating **	M	Issue No.	7
LM End	2.47	Issue Type +	Ma	Location *	WS
Category	Earthen Levee			GPS Latitude/Longitude	
				Start	End
Item	Vegetation			38.575343 °	38.590817 °
				-121.635635 °	-121.664500 °
DWR ID	DWR_RD2035_03_s _ 2015_7				
Action/Comments					
Control annual grass and weeds on the levee slopes and easements.

View of the vegetation on the waterside of levee facing downstream.

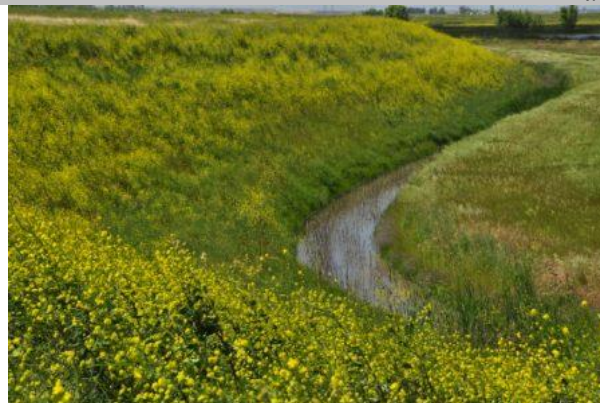
Photo 1 of 1 : SP\_2015\_RD2035\_240\_973\_20150326\_00002.jpg

LM Start	0.06	Rating **	M	Issue No.	973
LM End	2.16	Issue Type +	En	Location *	LS
Category	Earthen Levee			GPS Latitude/Longitude	
				Start	End
Item	Encroachments			38.575615 °	38.590919 °
				-121.636680 °	-121.658682 °
DWR ID	DWR_RD2035_03_s _ 2012_973				
Action/Comments					
Ditch

L/S drainage ditch at levee toe.
