**Flood Control Project Maintenance
Levee Inspections****LMA District Cover Sheet
Spring 2016 Levee Inspection Results****Reclamation District No. 2035 Conaway**

Spring 2016 Levee Inspection Results

Reclamation District No. 2035 Conaway

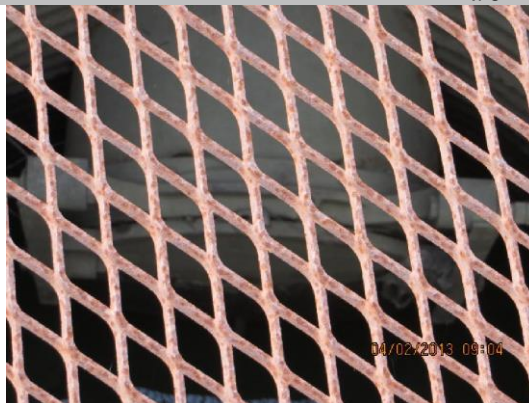
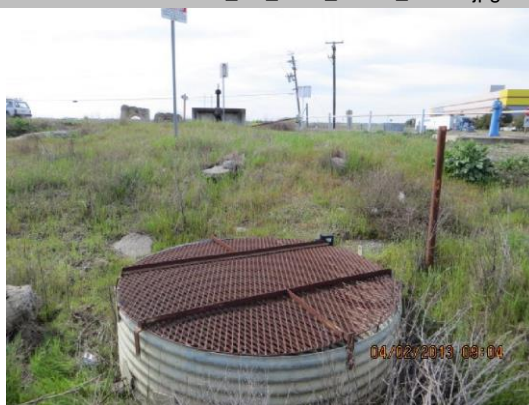
LM Start	0.00	Rating **	M	Issue No.	18
LM End	0.00	Issue Type +	En	Location *	CR
Category	Supplemental			GPS Latitude/Longitude	
				Start	End
Item	DWR UCIP Field Study			38.677393 °	38.677393 °
				-121.709890 °	-121.709890 °
DWR ID					
Comment Code					
Inspector Comment					
FS_ID:41346 DS_ID:17819 EP_NO: 4363 Repair Type: Non-Urgent Crossing Status: Found UCIP Comments: This pipe appears abandoned and if so should be done so properly. FIELD_STRUCT_DESC: 36-inch Corrugated Metal Pipe through levee 7.8 feet below crown. Flap gate in 72-inch CMP riser at WS toe with abandoned pump platform on south side of East Main Street. A 30-inch welded steel pipe is sleeved through the 36-inch C.M. pipe and annular space grouted. (Permit No. 4363 - City of Woodland) FS Date: 4/2/2013 3:09:00 PM

Flap gate and pipe at bottom of 72-inch CMP riser on WS toe.

72-inch CMP riser on WS toe.

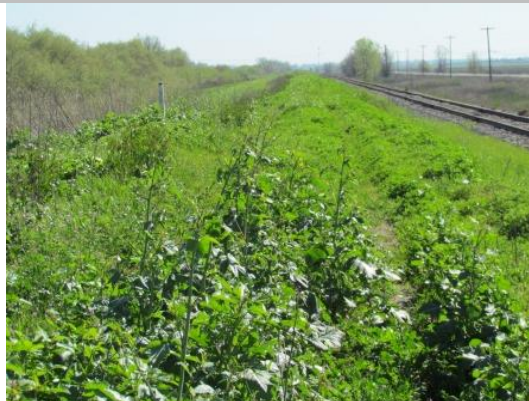
LM Start	0.01	Rating **	U	Issue No.	14
LM End	1.52	Issue Type +	Ma	Location *	CR
Category	Earthen Levee			GPS Latitude/Longitude	
				Start	End
Item	Vegetation			38.677385 °	38.677228 °
				-121.709741 °	-121.681743 °
DWR ID	DWR_RD2035_01_s _ 2016_14				
Comment Code					
V1 : Control annual grass and weeds on the levee slopes and easements.					
Inspector Comment

View of vegetation on crown looking downstream.

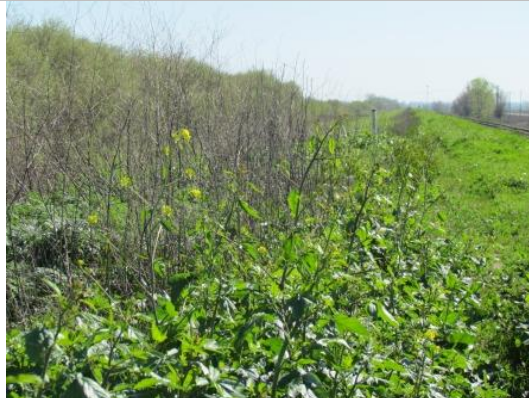
LM Start	0.01	Rating **	M	Issue No.	12
LM End	1.99	Issue Type +	Ma	Location *	WS
Category	Earthen Levee			GPS Latitude/Longitude	
				Start	End
Item	Vegetation			38.677385 °	38.677184 °
				-121.709741 °	-121.673108 °
DWR ID	DWR_RD2035_01_s _ 2016_12				
Comment Code					
V1 : Control annual grass and weeds on the levee slopes and easements.					
Inspector Comment

View of vegetation on waterside looking downstream.

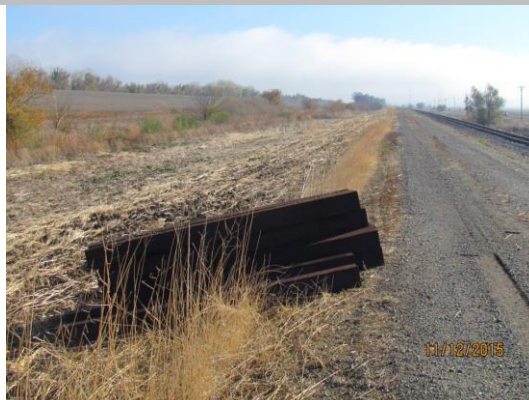
LM Start	0.70	Rating **	M	Issue No.	9
LM End	0.70	Issue Type +	En	Location *	WS
Category	Earthen Levee			GPS Latitude/Longitude	
				Start	End
Item	Encroachments			38.677316 °	38.677316 °
				-121.697009 °	-121.697009 °
DWR ID	DWR_RD2035_01_f_2015_9				
Comment Code					
DE : Debris					
Inspector Comment

View of the wood blocks on the waterward side of the levee looking downstream. Fall 2015.

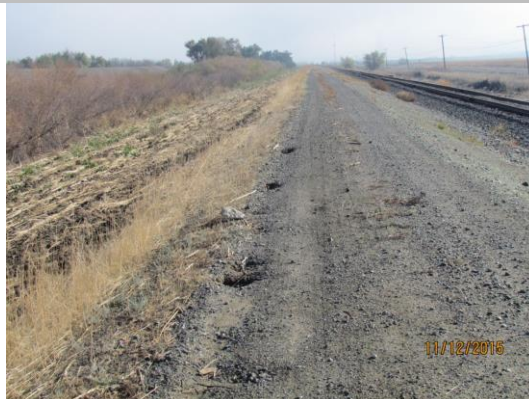
LM Start	1.11	Rating **	M	Issue No.	10
LM End	1.11	Issue Type +	Ma	Location *	CR
Category	Earthen Levee			GPS Latitude/Longitude	
				Start	End
Item	Animal Control			38.677271 °	38.677271 °
				-121.689434 °	-121.689434 °
DWR ID	DWR_RD2035_01_f_2015_10				
Comment Code					
A2 : Repair the levee slope damaged by livestock and prevent large animal access.					
Inspector Comment					
Ruts on crown could be caused by collapsed rodent holes.

View of the ruts that may be caused by collapsed rodent holes on the crown of the levee looking downstream. Fall 2015.

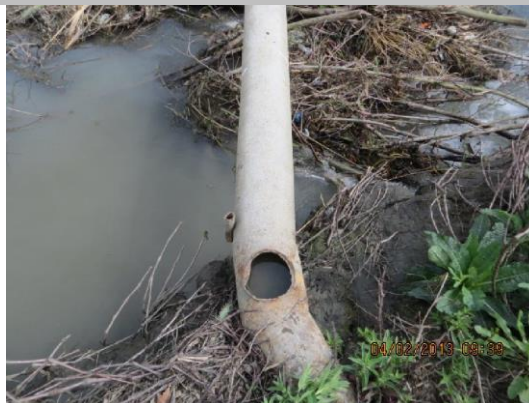
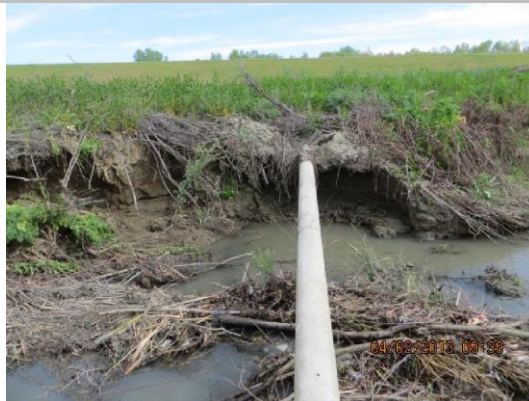
LM Start	1.27	Rating **	M	Issue No.	19
LM End	1.27	Issue Type +	En	Location *	CR
Category	Supplemental			GPS Latitude/Longitude	
				Start	End
Item	DWR UCIP Field Study			38.677249 °	38.677249 °
				-121.686358 °	-121.686358 °
DWR ID					
Comment Code					
Inspector Comment					
FS_ID:42012					
DS_ID:17816					
EP_NO: 12597					
Repair Type: Non-Urgent					
Crossing Status: Found					
UCIP Comments: Pipe appears abandoned and if so should be done so properly.					
FIELD_STRUCT_DESC: 18-inch steel conductor pipe through the levee 3.4 feet below the crown. 10-inch steel pipe sleeved through the 18-inch steel conductor pipe annular space grouted. Siphon breaker on waterward shoulder in steel riser. (Permit No. 12597 - R.D. No. 2035)					
FS Date: 4/2/2013

Exposed pipe at WS toe/stream.

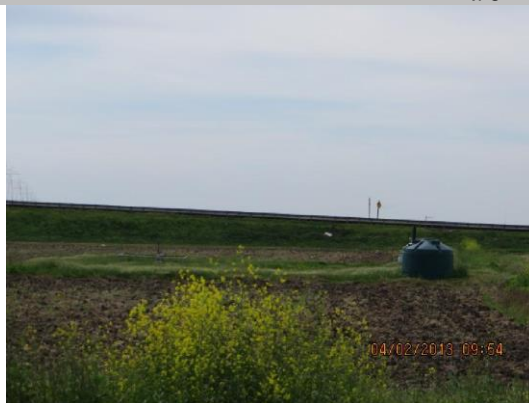
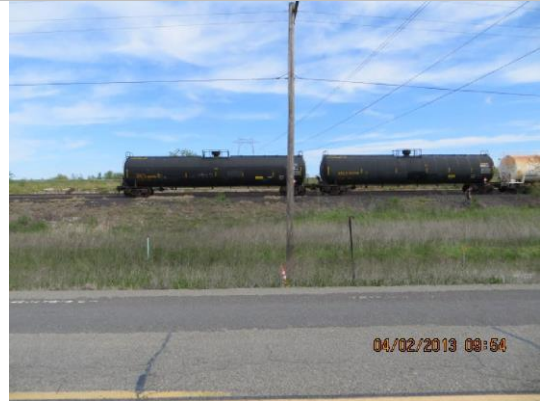
LM Start	1.87	Rating **	M	Issue No.	16
LM End	1.87	Issue Type +	En	Location *	CR
Category	Supplemental			GPS Latitude/Longitude	
				Start	End
Item	DWR UCIP Field Study			38.677186 °	38.677186 °
				-121.675277 °	-121.675277 °
DWR ID					
Comment Code					
Inspector Comment					
FS_ID:10913 DS_ID:17867 EP_NO: 13201 Repair Type: Non-Urgent Crossing Status: Indicator Found UCIP Comments: Pipe needs to be properly marked or abandoned. FIELD_STRUCT_DESC: 8-inch diameter casing through the levee 25- feet below the crown. 3-inch gas line through the casing with annular space filled with Bentonite. Possible vent for pipe on LS next to Old River Road. (Permit No. 13201) FS Date: 4/2/2013

Natural gas well on south side of Old river road.

Vent pipe to right of JP next to Old River Road.

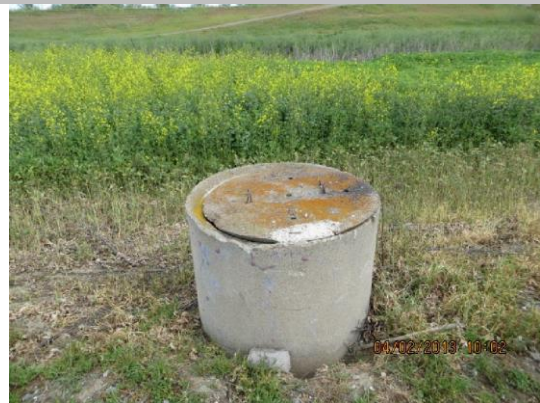
LM Start	1.94	Rating **	M	Issue No.	17
LM End	1.94	Issue Type +	En	Location *	CR
Category	Supplemental			GPS Latitude/Longitude	
				Start	End
Item	DWR UCIP Field Study			38.677175 °	38.677175 °
				-121.674065 °	-121.674065 °
DWR ID					
Comment Code					
Inspector Comment					
FS_ID:10914					
DS_ID:17817					
EP_NO: 2544					
Repair Type: Non-Urgent					
Crossing Status: Found					
UCIP Comments: Pipe appears to be abandoned as there is no pumphouse. Needs to be abandoned properly					
FIELD_STRUCT_DESC: 16-inch drainage pipe through levee 5.0 feet below crown. Pump on piling structure in drainage ditch on landward side. 36-inch concrete standpipe on waterward shoulder. (Permit No. 2544 - City of Woodland)					
FS Date: 4/2/2013

36-inch Concrete stand pipe on WS shoulder.

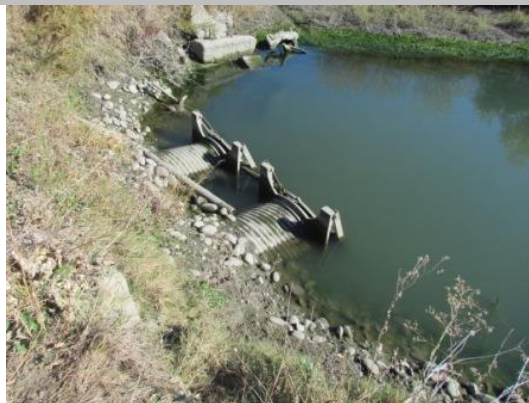
This photo was taken from the levee crown facing east at the intersection of unit 2 looking down at flap gates that are propped open with debris. Fall 2013.

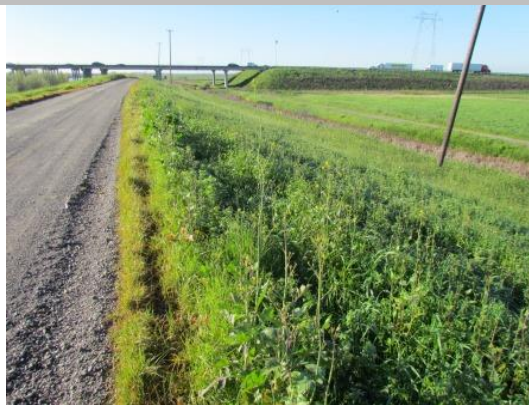
LM Start	0.14	Rating **	M	Issue No.	15
LM End	1.90	Issue Type +	Ma	Location *	LS
Category	Earthen Levee			GPS Latitude/Longitude	
				Start	End
Item	Vegetation			38.675177 °	38.649967 °
				-121.672235 °	-121.667134 °
DWR ID	DWR_RD2035_02_s_2016_15				
Comment Code					
V1 : Control annual grass and weeds on the levee slopes and easements.					
Inspector Comment

View of vegetation on landside looking downstream.

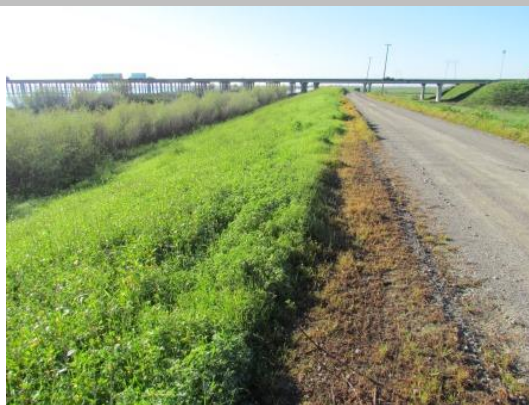
LM Start	0.14	Rating **	M	Issue No.	20
LM End	1.90	Issue Type +	Ma	Location *	WS
Category	Earthen Levee			GPS Latitude/Longitude	
				Start	End
Item	Vegetation			38.675177 °	38.649967 °
				-121.672235 °	-121.667134 °
DWR ID	DWR_RD2035_02_s_2016_20				
Comment Code					
V1 : Control annual grass and weeds on the levee slopes and easements.					
Inspector Comment

View of vegetation on the waterside looking downstream.

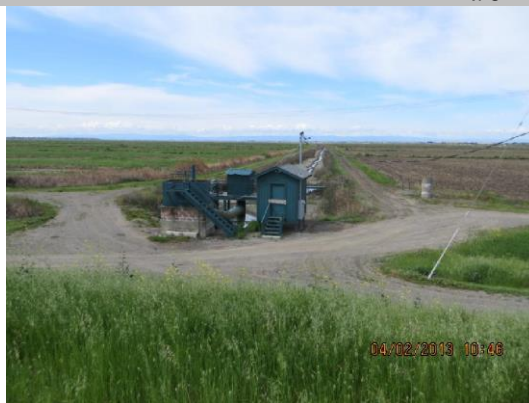
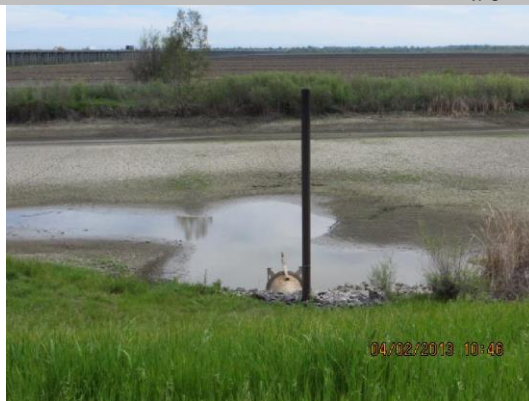
LM Start	0.38	Rating **	U	Issue No.	983
LM End	0.38	Issue Type +	En	Location *	WS
Category	Supplemental			GPS Latitude/Longitude	
				Start	End
Item	DWR UCIP Field Study			38.671813 °	38.671813 °
				-121.671581 °	-121.671581 °
DWR ID					
Comment Code					
Inspector Comment					
FS_ID:43083 DS_ID:17822 EP_NO: N/A Repair Type: Urgent Crossing Status: Found UCIP Comments: Flap gate broken in half on WS toe. Some erosion at headwalls on pumping plant. FIELD_STRUCT_DESC: 44-inch C.M. pipe through levee 22.0 feet below crown. Pump in drainage ditch at toe of landward slope, slide gate and flap gates in 5X9-foot concrete box. Flap gate on waterward end. 8-inch vent/standpipe at waterward toe. Originally included in O+M (1959). FS Date: 4/2/2013

Pumping plant off LS toe.

Pipe and flap gate with vent riser on WS toe.

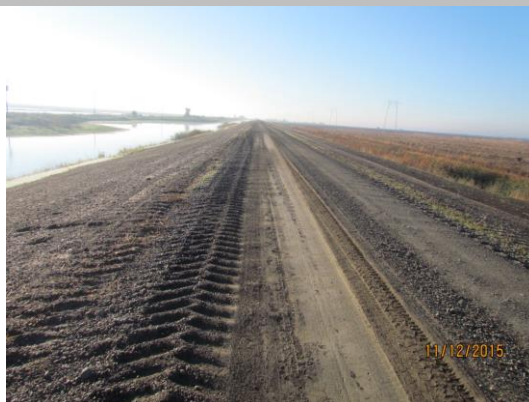
LM Start	0.74	Rating **	M	Issue No.	17
LM End	0.74	Issue Type +	Ma	Location *	CR
Category	Earthen Levee			GPS Latitude/Longitude	
				Start	End
Item	Crown Surface / Depressions / Rutting			38.666603 °	38.666603 °
				-121.670547 °	-121.670547 °
DWR ID	DWR_RD2035_02_f_2015_17				
Comment Code					
C3 : Add appropriate gravel or road base. Grade and compact.					
Inspector Comment

View of the crown of the levee looking downstream. Fall 2015.

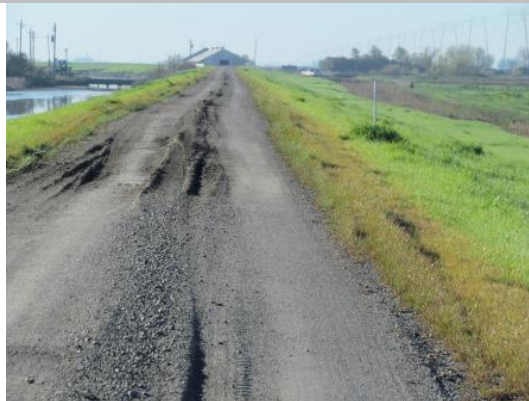
View of ruts/depression in crown looking downstream.

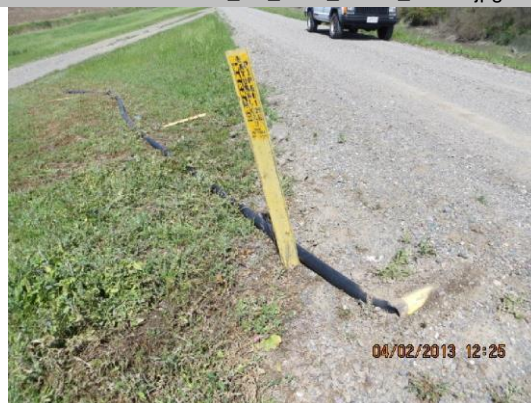
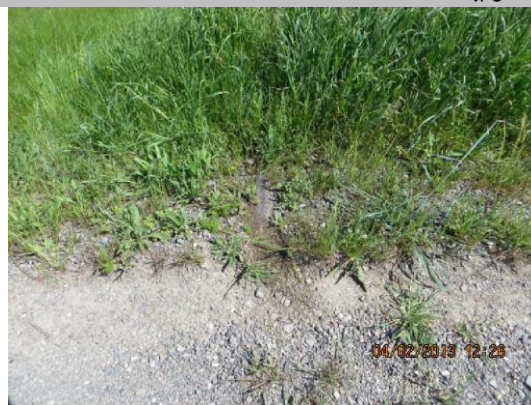
FS_ID:11523
DS_ID:22956
EP_NO: N/A
Repair Type: Urgent
Crossing Status: Found
UCIP Comments: Pipe does not have appropriate cover and is marked as gasline. Does not appear to be a permitted utility.
FIELD_STRUCT_DESC: 4-inch steel pipe 3-inches below the crown with a 2-inch PVC pipe sleeved through it.
FS Date: 4/2/2013 7:55:12 AM

Pipe crossing with gasline marker on LS shoulder.

Pipe on WS shoulder.

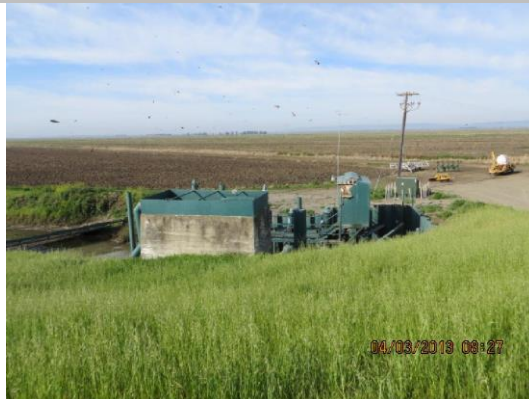
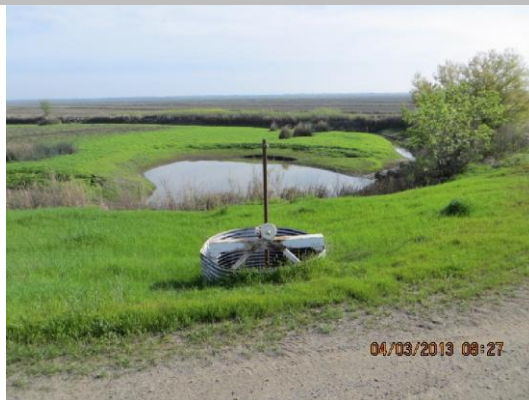
LM Start	4.43	Rating **	M	Issue No.	981
LM End	4.43	Issue Type +	En	Location *	WS
Category	Supplemental			GPS Latitude/Longitude	
				Start	End
Item	DWR UCIP Field Study			38.618030 °	38.618030 °
				-121.645192 °	-121.645192 °
DWR ID					
Comment Code					
Inspector Comment					
FS_ID:11526 DS_ID:17828 EP_NO: 1701 Repair Type: Non-Urgent Crossing Status: Found UCIP Comments: Animal activity at outlet causing damage to berm and undermining the pipe at the outlet headwall on WS toe. FIELD_STRUCT_DESC: 60-inch corrugated metal drain pipe through the levee 20.6 feet below the crown encased in 6-inches of reinforced concrete. Slide gate in 7-foot diameter C.M. pipe riser on waterward slope. Pumping plant with 6-pumps/pipes that discharge into a 4-ft by 18-ft surge box on the LS toe. (Permit No. 1701 - R.D. 2035) FS Date: 4/3/2013

Surge box and pumping plant on LS toe.

7-foot diameter CMP riser and slide gate on WS slope.

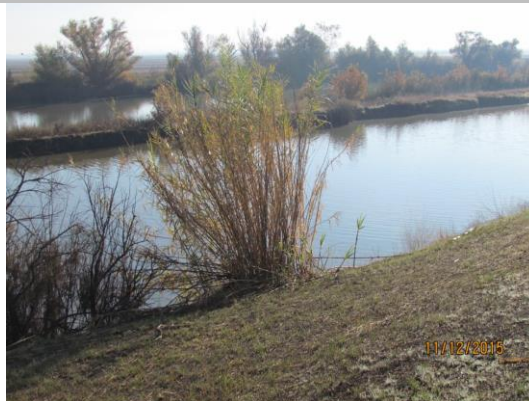
LM Start	5.81	Rating **	A/W	Issue No.	19
LM End	5.81	Issue Type +	Ma	Location *	WS
Category	Earthen Levee			GPS Latitude/Longitude	
				Start	End
Item	Vegetation			38.600462 °	38.600462 °
				-121.632705 °	-121.632705 °
DWR ID	DWR_RD2035_02_f_2015_19				
Comment Code					
V2 : Remove the wild growth other than native grasses from the levee slopes.					
Inspector Comment					
Recommend getting rid of arundo.

View of the arundo at the toe of the levee. Fall 2015.

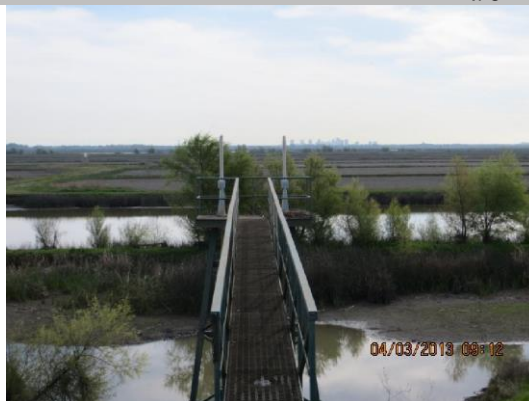
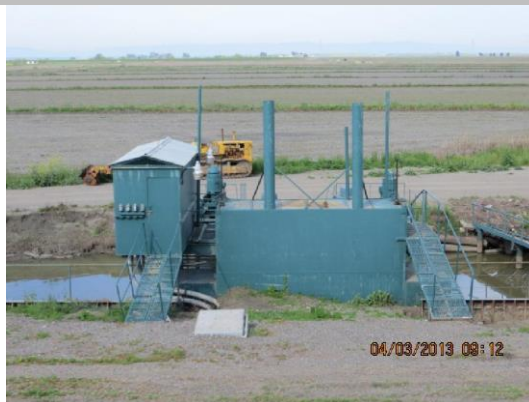
LM Start	6.50	Rating **	U	Issue No.	985
LM End	6.50	Issue Type +	En	Location *	WS
Category	Supplemental			GPS Latitude/Longitude	
				Start	End
Item	DWR UCIP Field Study			38.590691 °	38.590691 °
				-121.631284 °	-121.631284 °
DWR ID					
Comment Code					
Inspector Comment					
FS_ID:42938 DS_ID:17868 EP_NO: 16480 Repair Type: Urgent Crossing Status: Found UCIP Comments: Erosion on LS toe at pumping plant. Severe erosion of sheet pile walls at pumping plant. FIELD_STRUCT_DESC: 1 of 2: 60-inch by 48-inch concrete box drainage conduit through the levee 22-feet below the crown. Steel walkway to slidegate handles on WS shoulder. 6X18-foot surge box and pumping plant on LS toe. This pipe replaced the 48-inch at this same location. (Permit No. 16480, 1996) FS Date: 4/3/2013

Steel walkway to slide gates on WS shoulder.

Pumping plant on LS toe.

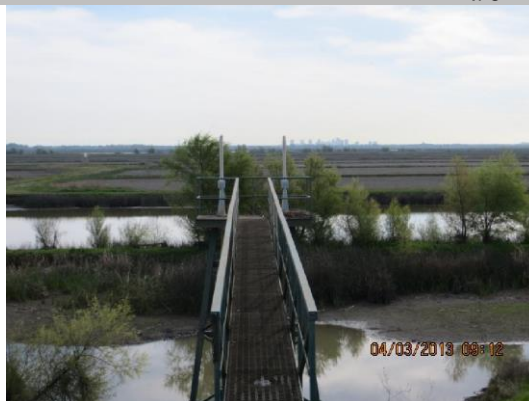
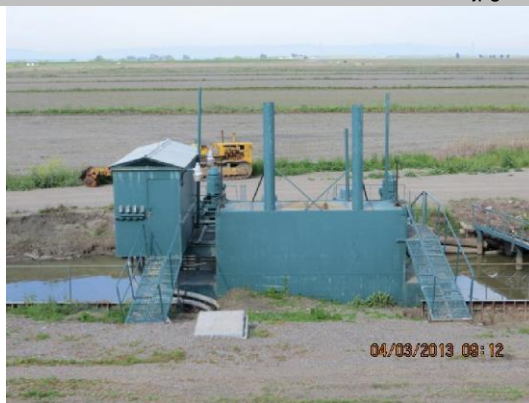
LM Start	6.50	Rating **	U	Issue No.	984
LM End	6.50	Issue Type +	En	Location *	WS
Category	Supplemental			GPS Latitude/Longitude	
				Start	End
Item	DWR UCIP Field Study			38.590680 °	38.590680 °
				-121.631283 °	-121.631283 °
DWR ID					
Comment Code					
Inspector Comment					
FS_ID:42937					
DS_ID:17891					
EP_NO: 16480					
Repair Type: Urgent					
Crossing Status: Found					
UCIP Comments: Severe erosion at pumping plant on LS toe.					
FIELD_STRUCT_DESC: 2 of 2: 60-inch by 48-inch concrete box					
drainage conduit through the levee 22-feet below the crown. Steel					
walkway to slidegate handles on WS shoulder. 6X18-foot surge box					
and pumping plant on LS toe. This pipe replaced the 48-inch at this					
same location. (Permit No. 16480, 1996)					
FS Date: 4/3/2013

Steel walkway to Slide gate handles on WS shoulder.

Surge box and pumping plant on LS toe.

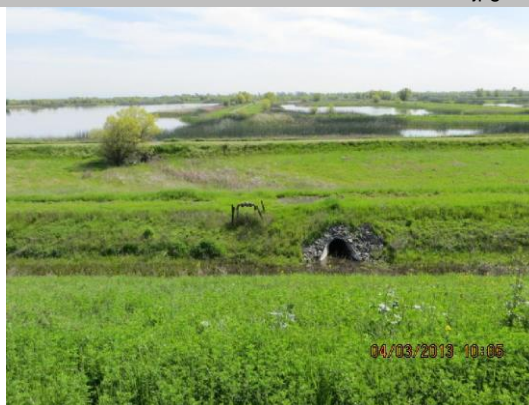
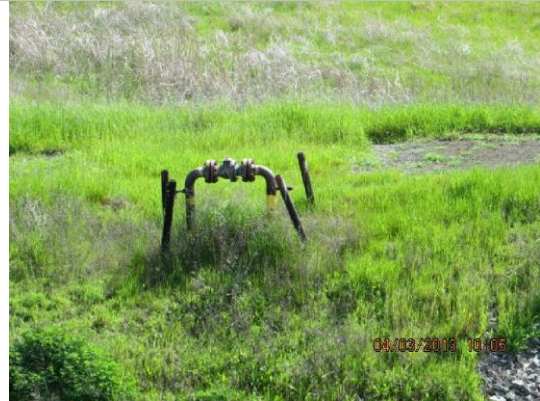
LM Start	0.81	Rating **	U	Issue No.	976
LM End	0.81	Issue Type +	En	Location *	LS
Category	Supplemental			GPS Latitude/Longitude	
				Start	End
Item	DWR UCIP Field Study			38.581057 °	38.581057 °
				-121.645142 °	-121.645142 °
DWR ID					
Comment Code					
Inspector Comment					
FS_ID:41833 DS_ID:17823 EP_NO: 6123 Repair Type: Urgent Crossing Status: Indicator Found UCIP Comments: Need to install gasoline markers through the levee if pipe is still active. FIELD_STRUCT_DESC: 4.5-inch Gas line through levee 2.5 feet below the crown. Pipe at vent visible off LS toe. (Permit No. 6123 - P.G.&E.) FS Date: 4/3/2013

Gasline vent off LS toe.

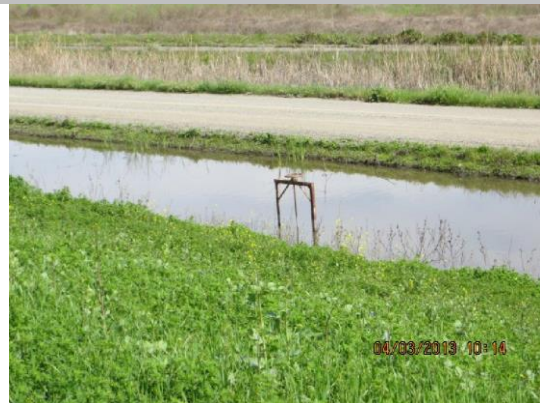
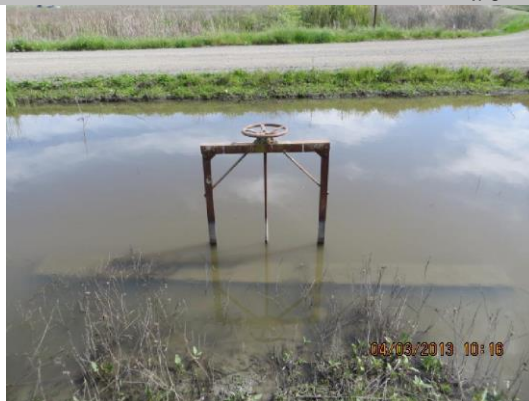
LM Start	1.39	Rating **	M	Issue No.	977
LM End	1.39	Issue Type +	En	Location *	LS
Category	Supplemental			GPS Latitude/Longitude	
				Start	End
Item	DWR UCIP Field Study			38.589425 °	38.589425 °
				-121.645359 °	-121.645359 °
DWR ID					
Comment Code					
Inspector Comment					
FS_ID:41128 DS_ID:17836 EP_NO: N/A Repair Type: Non-Urgent Crossing Status: Found UCIP Comments: Need to clear vegetation and debris from WS at outlet. FIELD_STRUCT_DESC: 36-inch Corrugated metal pipe through levee 17.5 feet below crown, flap gate on waterward end, slide gate and concrete headwall on landward end. Originally included in O+M manual (1952). FS Date: 4/3/2013

Slide gate and headwall in canal at LS toe.

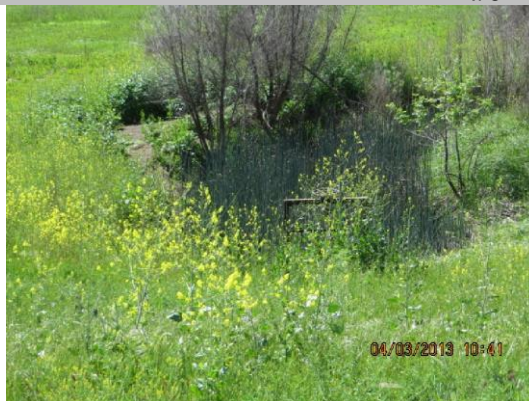
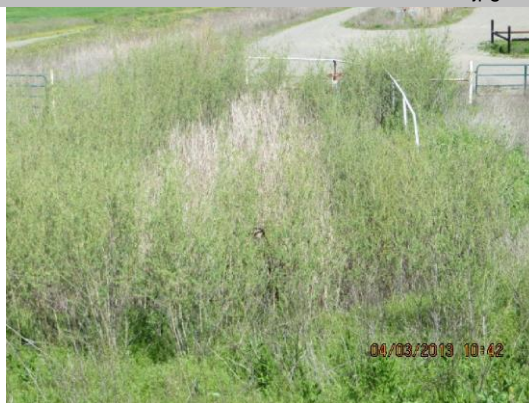
Slide gate at WS toe showing excessive vegetation.

Slide gate at LS toe showing excessive vegetation.

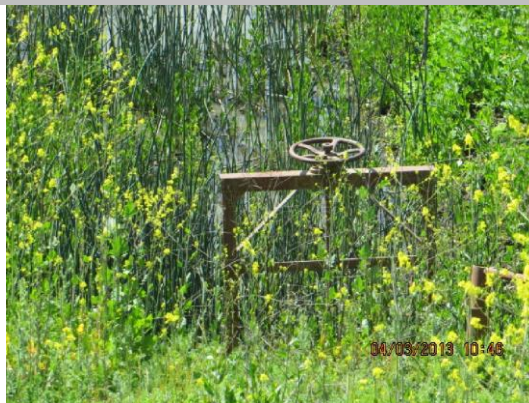
Combination flap and slide gate on WS toe. With excessive vegetation
