**Flood Control Project Maintenance
Levee Inspections**
LMA District Cover Sheet
Spring 2017 Levee Inspection Results

Reclamation District No. 2035 Conaway

Spring 2017 Levee Inspection Results

Waterway			Bank	Unit Miles
Unit No. 01 Cache Creek Settling Basin			Right	2.01
	Spring (March - May)	Summer (June - August)	(September - November) Fall	Winter (December - February)
Unit Maintenance Rating (Fall Only)				
Date of Inspection	4/18/2017 - 4/18/2017			
DWR Inspector	Sterling York			
Accompanied By	Peter Blum

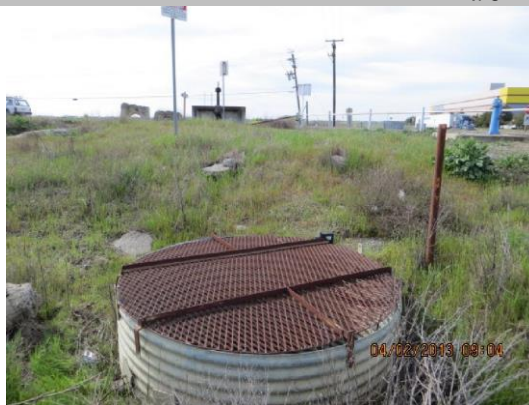
Photo 2 of 3 : UCIP_SP_2017_41346_18101.jpg

72-inch CMP riser on WS toe.

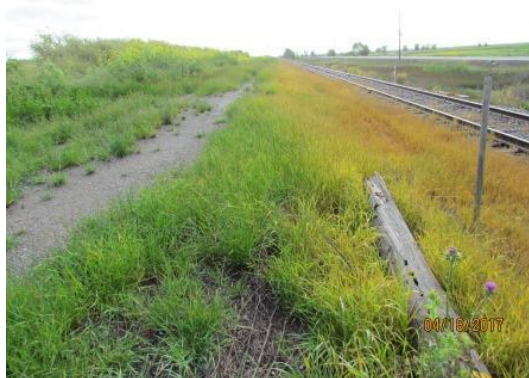
Photo 1 of 1 : SP_2017_RD2035_238_9_20170426_00014.jpg

LM Start	0.01	Rating **	U	Issue No.	13
LM End	2.00	Issue Type +	Ma	Location *	CR
Category	Earthen Levee			GPS Latitude/Longitude	
				Start	End
Item	Vegetation			38.677382 °	38.677191 °
				-121.709750 °	-121.672900 °
DWR ID	DWR_RD2035_01_s_2017_13				
Comment Code					
V1 : Control annual grass and weeds on the levee slopes and easements.					
Inspector Comment					
Annual grasses need to be maintained, Spring 2017.

View looking downstream of annual grasses that need to be maintained, Spring 2017.

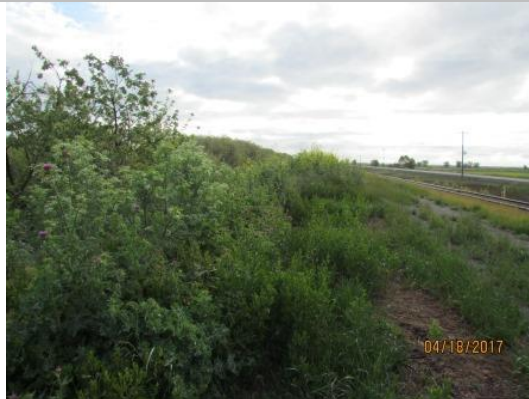
Photo 1 of 1 : SP_2017_RD2035_238_10_20170426_00015.jpg

LM Start	0.01	Rating **	U	Issue No.	10
LM End	2.00	Issue Type +	Ma	Location *	WS
Category	Earthen Levee			GPS Latitude/Longitude	
				Start	End
Item	Vegetation			38.677382 °	38.677191 °
				-121.709746 °	-121.672904 °
DWR ID	DWR_RD2035_01_s_2017_10				
Comment Code					
V2 : Remove the wild growth other than native grasses from the levee slopes.					
Inspector Comment

View looking downstream of vegetation that need to be maintained, Spring 2017.

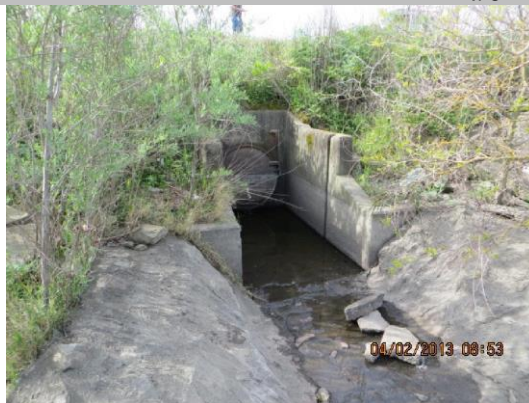
Photo 1 of 3 : UCIP_SP_2017_10827_18109.jpg

FS_ID:10827
DS_ID:17814
EP_NO: 10127
Repair Type: No Action Needed
Crossing Status: Found
UCIP Comments:
FIELD_STRUCT_DESC: 42-inch CM pipe through levee 10.0 feet below crown. Flap gate on waterward end. Grouted spillway on waterward side. Pipe encased in concrete and exposed at LS. (A.B.O. No. 10127 - City of Woodland)
FS Date: 4/2/2013

Flap gate and spillway on WS toe.

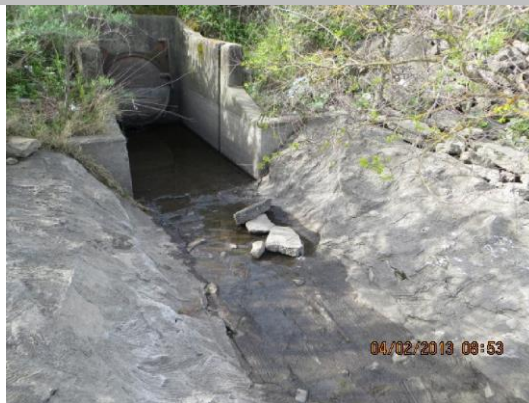
Photo 2 of 3 : UCIP_SP_2017_10827_18108.jpg

Flap gate and spillway on WS toe.

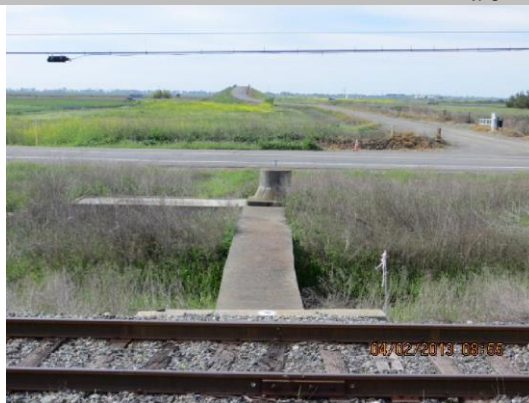
Photo 3 of 3 : UCIP_SP_2017_10827_18107.jpg

LM Start	0.02	Rating **	A/W	Issue No.	15 (cont)	
LM End	0.02	Issue Type +	Ma	Location *	WS	
Category	Supplemental			GPS Latitude/Longitude		
				Start	End	
Item	DWR UCIP LMA Responsibility			38.677377 °	38.677377 °	
				-121.709487 °	-121.709487 °	
DWR ID						
Comment Code						
Inspector Comment						
FS_ID:10827						
DS_ID:17814						
EP_NO: 10127						
Repair Type: No Action Needed						
Crossing Status: Found						
UCIP Comments:						
FIELD_STRUCT_DESC: 42-inch CM pipe through levee 10.0 feet						
below crown. Flap gate on waterward end. Grouted spillway on						
waterward side. Pipe encased in concrete and exposed at LS. (A.B.O.						
No. 10127 - City of Woodland)						
FS Date: 4/2/2013

Concrete encased pipe on LS toe.

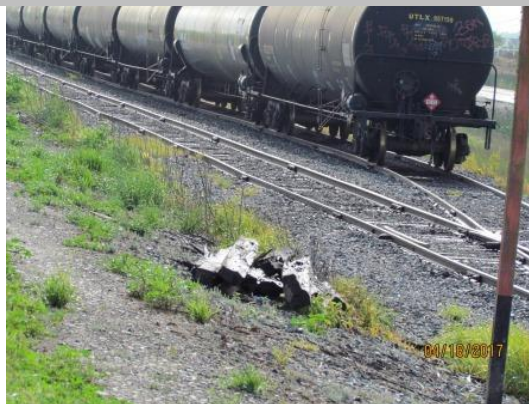
Photo 1 of 1 : SP_2017_RD2035_238_12_20170426_00016.jpg

LM Start	1.77	Rating **	M	Issue No.	12
LM End	1.77	Issue Type +	En	Location *	CR
Category	Earthen Levee			GPS Latitude/Longitude	
				Start	End
Item	Encroachments			38.677212 °	38.677212 °
				-121.677248 °	-121.677248 °
DWR ID	DWR_RD2035_01_s_2017_12				
Comment Code					
MA : Material					
Inspector Comment					
Railroad ties on landside slope need to be removed, Spring 2017.

Landside view of railroad ties on the levee slope, Spring 2017.

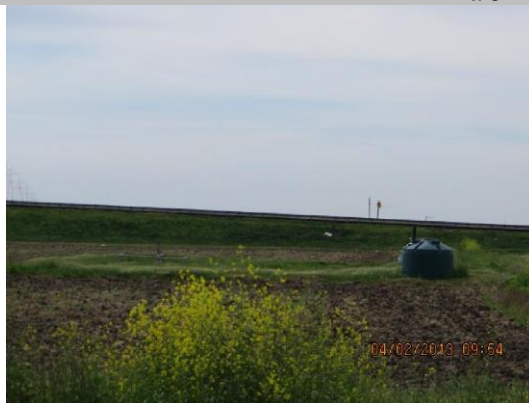
Photo 1 of 2 : UCIP_SP_2017_10913_18188.jpg

FS_ID:10913
DS_ID:17867
EP_NO: 13201
Repair Type: Non-Urgent
Crossing Status: Indicator Found
UCIP Comments: Pipe needs to be properly marked or abandoned.
FIELD_STRUCT_DESC: 8-inch diameter casing through the levee 25-feet below the crown. 3-inch gas line through the casing with annular space filled with Bentonite. Possible vent for pipe on LS next to Old River Road. (Permit No. 13201)
FS Date: 4/2/2013

Natural gas well on south side of Old river road.

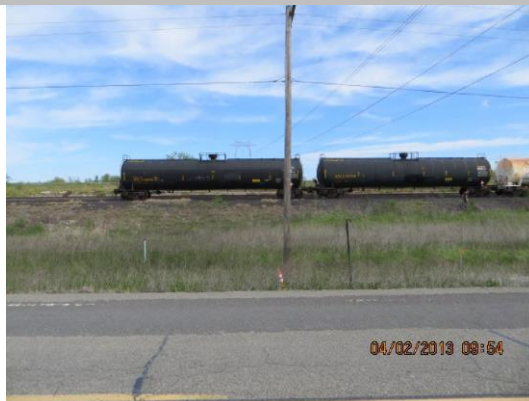
Photo 2 of 2 : UCIP_SP_2017_10913_18187.jpg

Vent pipe to right of JP next to Old River Road.

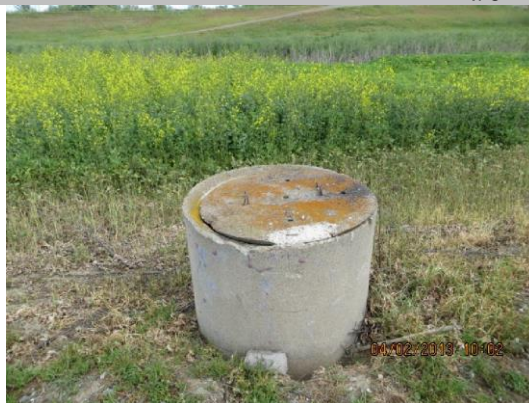
Photo 1 of 1 : UCIP_SP_2017_10914_18189.jpg

LM Start	1.94	Rating **	M	Issue No.	18
LM End	1.94	Issue Type +	En	Location *	CR
Category	Supplemental			GPS Latitude/Longitude	
				Start	End
Item	DWR UCIP Field Study			38.677175 °	38.677175 °
				-121.674065 °	-121.674065 °
DWR ID					
Comment Code					
Inspector Comment					
FS_ID:10914					
DS_ID:17817					
EP_NO: 2544					
Repair Type: Non-Urgent					
Crossing Status: Found					
UCIP Comments: Pipe appears to be abandoned as there is no pumphouse. Needs to be abandoned properly					
FIELD_STRUCT_DESC: 16-inch drainage pipe through levee 5.0 feet below crown. Pump on piling structure in drainage ditch on landward side. 36-inch concrete standpipe on waterward shoulder. (Permit No. 2544 - City of Woodland)					
FS Date: 4/2/2013

36-inch Concrete stand pipe on WS shoulder.

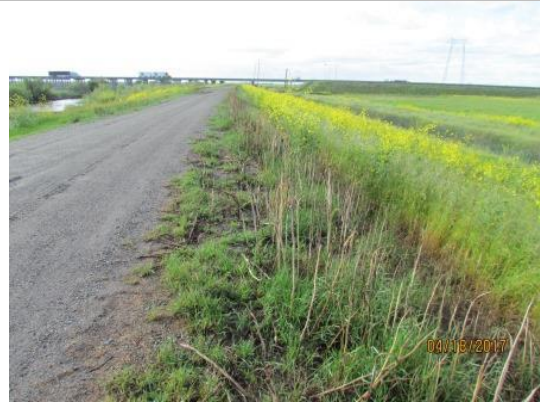
Photo 1 of 1 : SP_2017_RD2035_239_17_20170426_00026.jpg

View looking downstream of annual grasses that need to be maintained, Spring 2017.

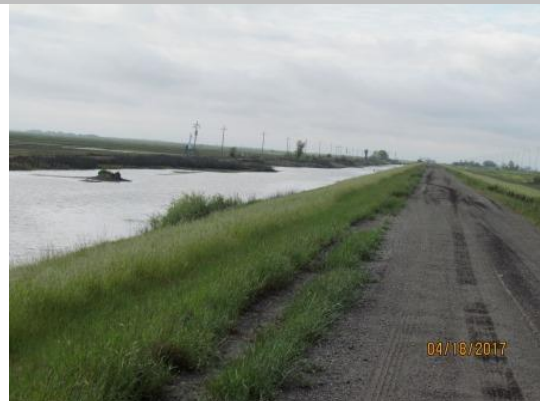
Photo 1 of 1 : SP_2017_RD2035_239_18_20170426_00027.jpg

LM Start	0.04	Rating **	U	Issue No.	18
LM End	7.63	Issue Type +	Ma	Location *	WS
Category	Earthen Levee			GPS Latitude/Longitude	
				Start	End
Item	Vegetation			38.676571 °	38.575374 °
				-121.672576 °	-121.635585 °
DWR ID	DWR_RD2035_02_s_2017_18				
Comment Code					
V1 : Control annual grass and weeds on the levee slopes and easements.					
Inspector Comment					
Annual grasses need to be maintained, Spring 2017.

View looking downstream of annual grasses that need to be maintained, Spring 2017.

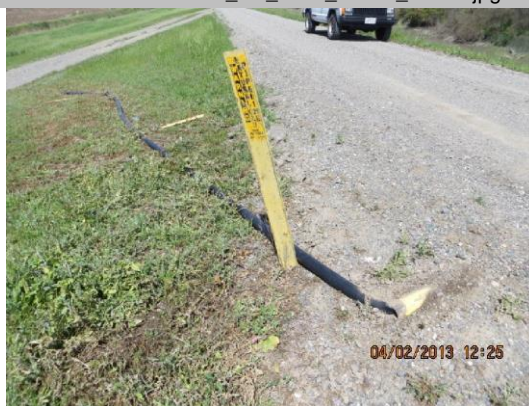
Photo 1 of 3 : UCIP_SP_2017_50090_18922.jpg

FS_ID:50090
DS_ID:22956
EP_NO: N/A
Repair Type: Non-Urgent
Crossing Status: Found
UCIP Comments: 09/14/2016 - Pipe has been removed from the levee and the levee has been repaired. It is unknown if these repairs were done with a permit or if the fill was properly compacted. Gas line markers still on WS shoulder of levee. It is unknown if another gas line exists in this location. (T. Hatch/UCIP)04/02/2013 - Pipe does not have appropriate cover and is marked as gasoline. Does not appear to be a permitted utility. (W. Wylie/UCIP)
FIELD_STRUCT_DESC: *REMOVED* 4-inch steel pipe through the levee, 3-inches below the crown. A 2-inch PVC pipe is sleeved through it. No other appurtenances found. Markers along alignment indicate pipe may be a gas line.
FS Date: 9/14/2016

Pipe crossing with gasoline marker on LS shoulder.

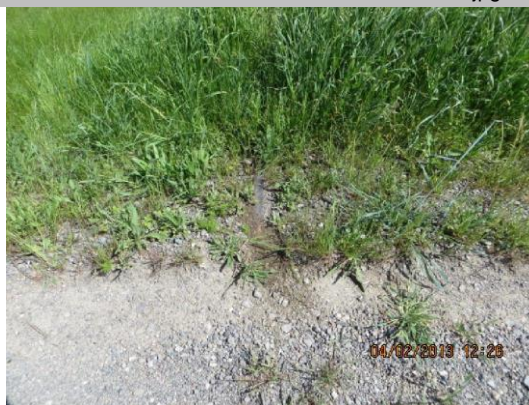
Photo 2 of 3 : UCIP_SP_2017_50090_18921.jpg

Pipe on WS shoulder.

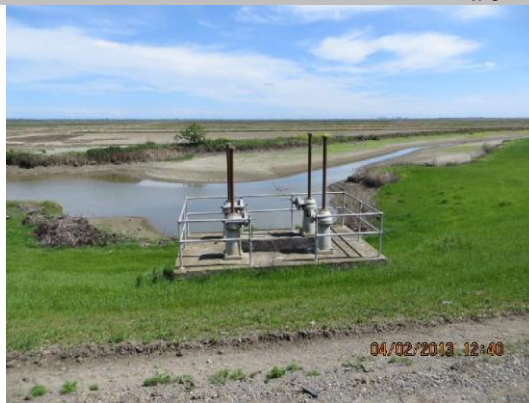
Photo 1 of 3 : UCIP_SP_2017_10933_18226.jpg

LM Start	2.15	Rating **	A/W	Issue No.	982
LM End	2.15	Issue Type +	Ma	Location *	WS
Category	Supplemental			GPS Latitude/Longitude	
				Start	End
Item	DWR UCIP LMA Responsibility			38.646445 °	38.646445 °
				-121.666423 °	-121.666423 °
DWR ID					
Comment Code					
Inspector Comment					
FS_ID:10933 DS_ID:17833 EP_NO: N/A Repair Type: No Action Needed Crossing Status: Found UCIP Comments: FIELD_STRUCT_DESC: 1 of 2: 60-inch pipe through levee 26.0 feet below crown. Concrete well and gate structure on waterward slope. Originally included in O+M manual (1959). FS Date: 4/2/2013

Slide gates in concrete vault on WS slope.

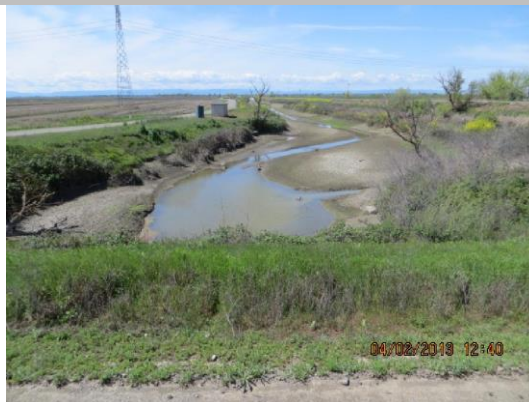
Photo 2 of 3 : UCIP_SP_2017_10933_18225.jpg

LS at intake.

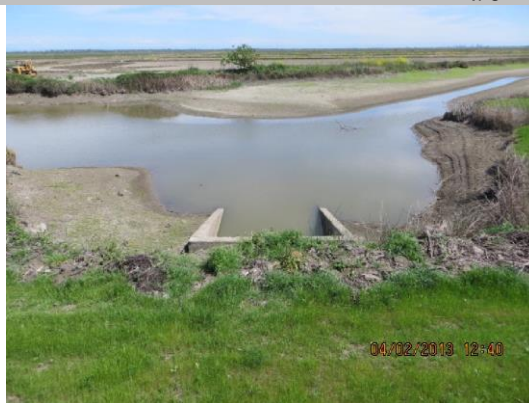
Photo 3 of 3 : UCIP_SP_2017_10933_18224.jpg

LM Start	2.15	Rating **	A/W	Issue No.	982 (cont)
LM End	2.15	Issue Type +	Ma	Location *	WS
Category	Supplemental			GPS Latitude/Longitude	
				Start	End
Item	DWR UCIP LMA Responsibility			38.646445 °	38.646445 °
				-121.666423 °	-121.666423 °
DWR ID					
Comment Code					
Inspector Comment					
FS_ID:10933 DS_ID:17833 EP_NO: N/A Repair Type: No Action Needed Crossing Status: Found UCIP Comments: FIELD_STRUCT_DESC: 1 of 2: 60-inch pipe through levee 26.0 feet below crown. Concrete well and gate structure on waterward slope. Originally included in O+M manual (1959). FS Date: 4/2/2013

Outlet on WS toe.

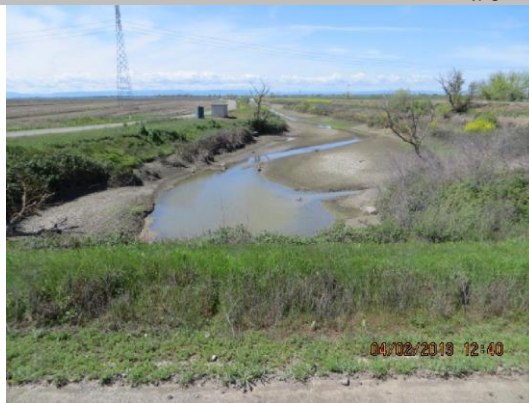
Photo 2 of 3 : UCIP_SP_2017_10934_18229.jpg

LM Start	2.15	Rating **	A/W	Issue No.	983 (cont)	
LM End	2.15	Issue Type +	Ma	Location *	WS	
Category	Supplemental			GPS Latitude/Longitude		
				Start	End	
Item	DWR UCIP LMA Responsibility			38.646425 °	38.646425 °	
				-121.666421 °	-121.666421 °	
DWR ID						
Comment Code						
Inspector Comment						
FS_ID:10934						
DS_ID:17877						
EP_NO: N/A						
Repair Type: No Action Needed						
Crossing Status: Found						
UCIP Comments:						
FIELD_STRUCT_DESC: 2 of 2: 60-inch pipes through levee 26.0 feet below crown. Concrete well and gate structure on waterward slope. Concrete headwalls on both ends. Originally included in O+M manual (1959).						
FS Date: 4/2/2013

Intake at channel on LS toe.

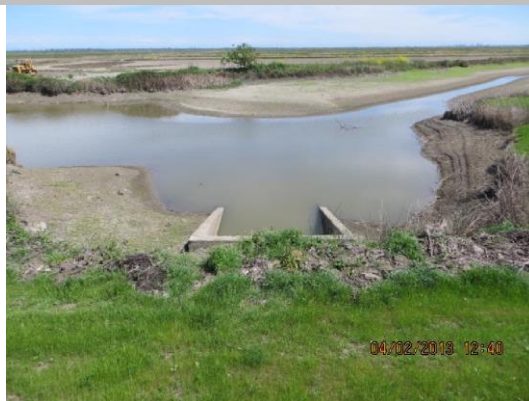
Photo 3 of 3 : UCIP_SP_2017_10934_18228.jpg

Concrete headwall on WS toe.

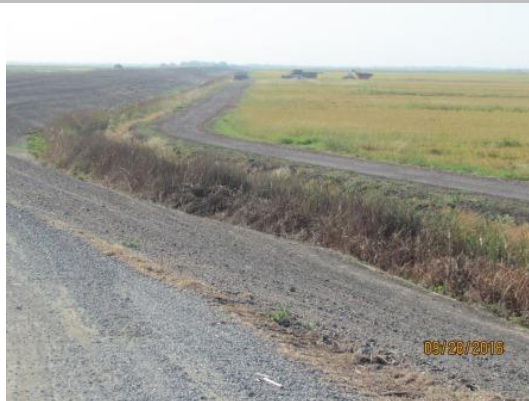
Photo 1 of 1 : SP_2017_RD2035_239_979_20170316_00004.jpg

View of the ditch on the landward side of the levee looking downstream.
Fall 2016.

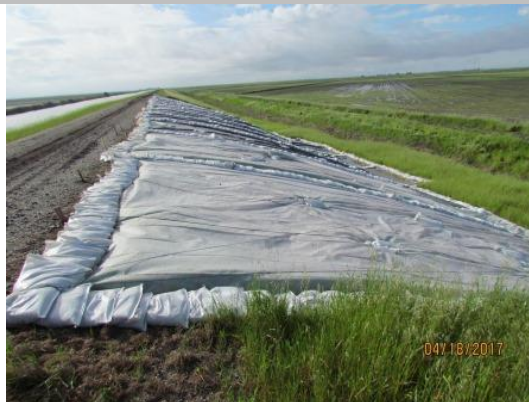
Photo 1 of 1 : SP_2017_RD2035_239_20_20170426_00028.jpg

LM Start	2.69	Rating **	M	Issue No.	20
LM End	2.74	Issue Type +	Ma	Location *	LS
Category	Earthen Levee			GPS Latitude/Longitude	
				Start	End
Item	Slope Stability			38.639811 °	38.639230 °
				-121.661246 °	-121.660819 °
DWR ID	DWR_RD2035_02_s_2017_20				
Comment Code					
S1 : Repair slope instability.					
Inspector Comment					
Slope sloughing that occurred during winter months, Spring 2017.

View looking downstream of a rain coat over landside slope sloughing that occurred during winter months, Spring 2017.

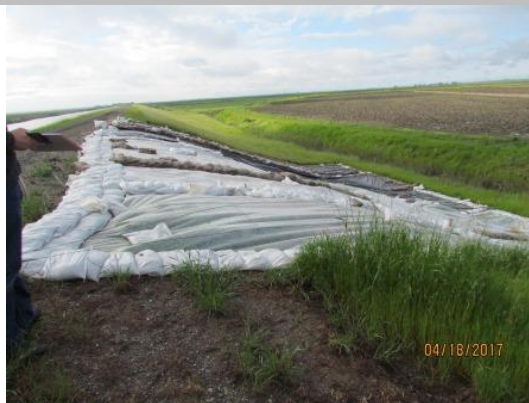
Photo 1 of 1 : SP_2017_RD2035_239_23_20170426_00031.jpg

LM Start	3.27	Rating **	M	Issue No.	23
LM End	3.29	Issue Type +	Ma	Location *	LS
Category	Earthen Levee			GPS Latitude/Longitude	
				Start	End
Item	Slope Stability			38.632475 °	38.632261 °
				-121.655857 °	-121.655695 °
DWR ID	DWR_RD2035_02_s_2017_23				
Comment Code					
S1 : Repair slope instability.					
Inspector Comment					
Slope sloughing that occurred during winter months, Spring 2017.

View looking downstream of a rain coat over landside slope sloughing that occurred during winter months, Spring 2017.

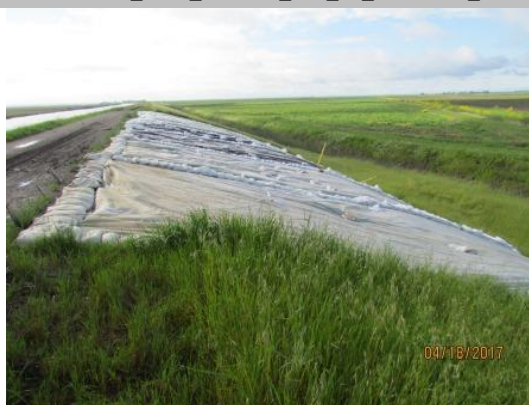
Photo 1 of 1 : SP_2017_RD2035_239_24_20170426_00032.jpg

LM Start	3.39	Rating **	M	Issue No.	24
LM End	3.41	Issue Type +	Ma	Location *	LS
Category	Earthen Levee			GPS Latitude/Longitude	
				Start	End
Item	Slope Stability			38.631082 °	38.630790 °
				-121.654798 °	-121.654588 °
DWR ID	DWR_RD2035_02_s_2017_24				
Comment Code					
S1 : Repair slope instability.					
Inspector Comment					
Slope sloughing that occurred during winter months, Spring 2017.

View looking downstream of a rain coat over landside slope sloughing that occurred during winter months, Spring 2017.

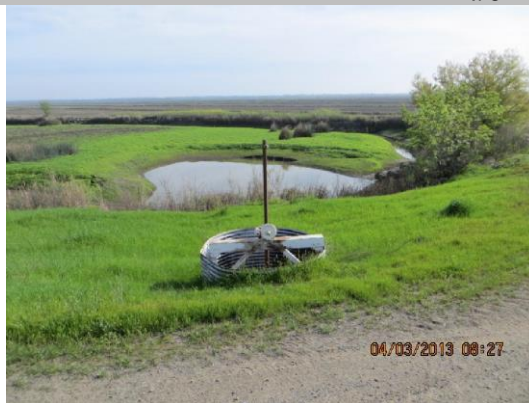
Photo 2 of 3 : UCIP_SP_2017_11526_18934.jpg

7-foot diameter CMP riser and slide gate on WS slope.

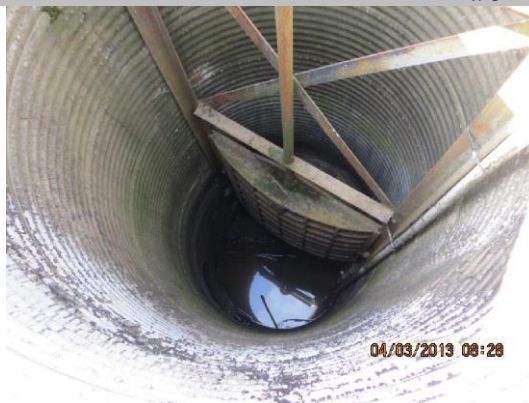
Photo 3 of 3 : UCIP_SP_2017_11526_18933.jpg

7-foot diameter CMP riser and slide gate on WS slope.

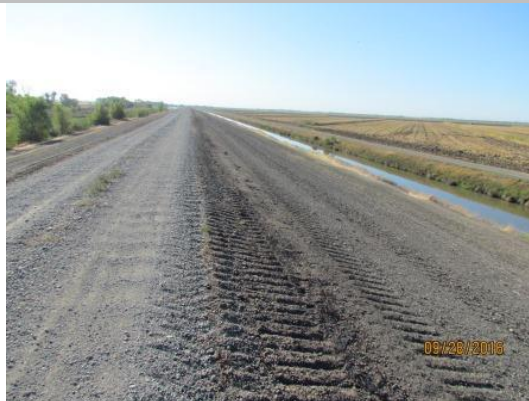
Photo 1 of 1 : SP_2017_RD2035_239_10_20170316_00001.jpg

View of the drainage ditch on the landward side of the levee looking downstream. Fall 2016.

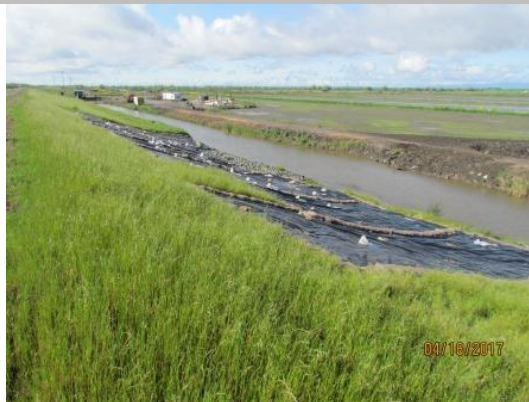
Photo 1 of 1 : SP_2017_RD2035_239_25_20170426_00033.jpg

View looking downstream of a rain coat over landside slope sloughing that occurred during winter months, Spring 2017.

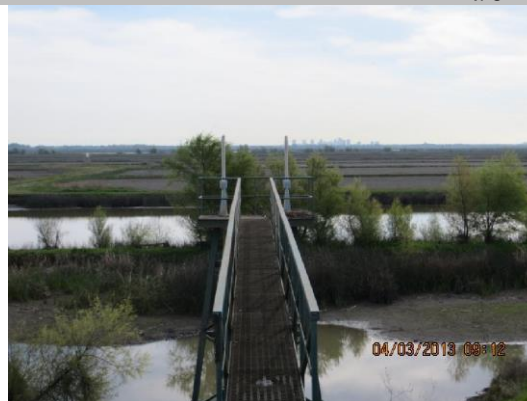
Photo 1 of 3 : UCIP_SP_2017_50089_18327.jpg

Steel walkway to slide gates on WS shoulder.

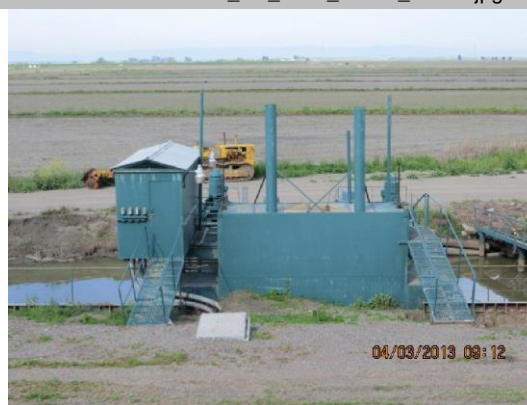
Photo 2 of 3 : UCIP_SP_2017_50089_18326.jpg

Pumping plant on LS toe.

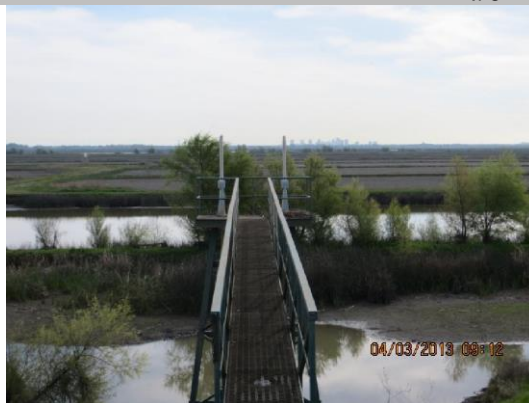
Photo 1 of 3 : UCIP_SP_2017_50088_18321.jpg

Steel walkway to Slide gate handles on WS shoulder.

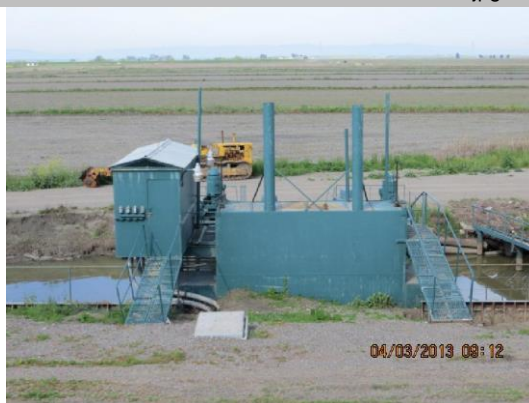
Photo 2 of 3 : UCIP_SP_2017_50088_18320.jpg

Surge box and pumping plant on LS toe.

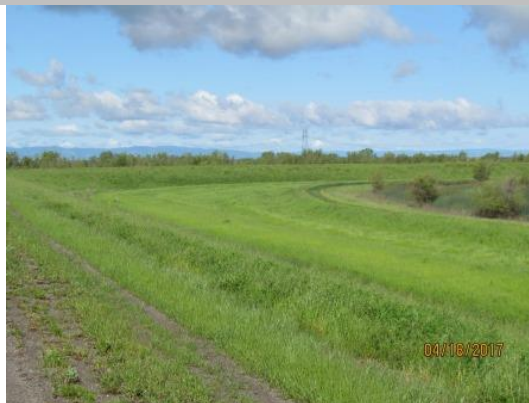
Photo 1 of 1 : SP_2017_RD2035_240_6_20170426_00017.jpg

View looking upstream of annual grasses that need to be maintained, Spring 2017.

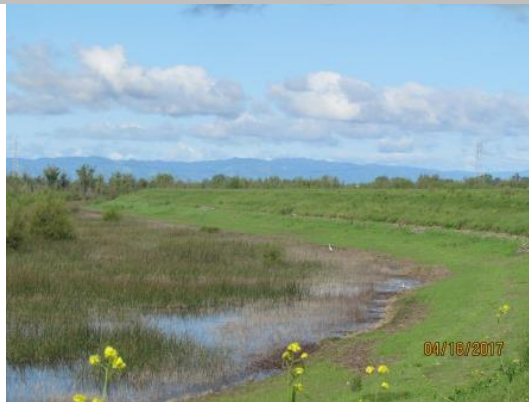
Photo 1 of 1 : SP_2017_RD2035_240_7_20170426_00018.jpg

View looking upstream of annual grasses that need to be maintained, Spring 2017.

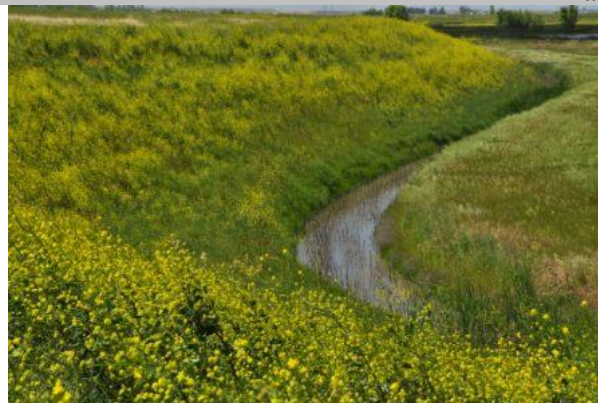
Photo 1 of 2 : SP_2017_RD2035_240_973_20170316_00002.jpg

Landside drainage ditch at levee toe. Spring.

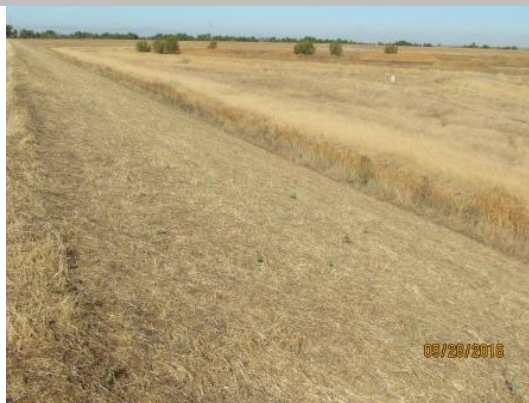
Photo 2 of 2 : SP_2017_RD2035_240_973_20170316_00003.jpg

View of landside ditch at the levee toe looking upstream. Fall 2016.

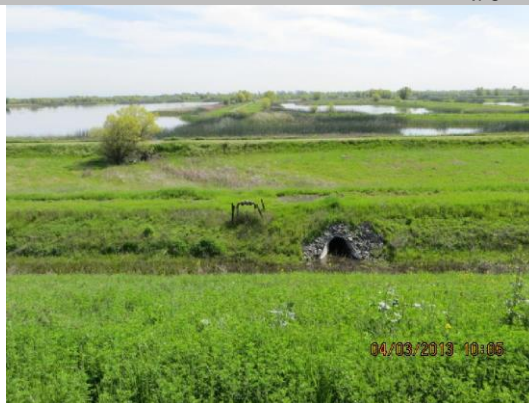
Photo 1 of 3 : UCIP_SP_2017_50078_18345.jpg

Gasline vent off LS toe.

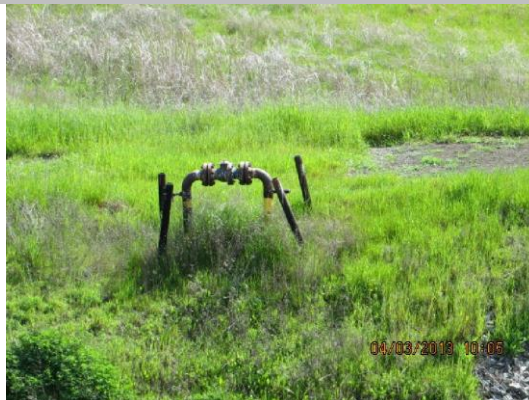
Photo 2 of 3 : UCIP_SP_2017_50078_18344.jpg

Gasline vent off LS toe.

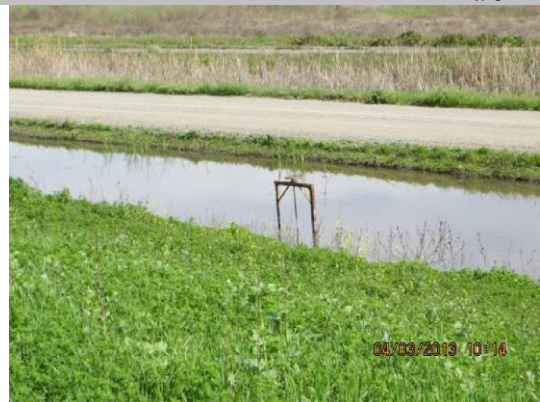
Photo 1 of 3 : UCIP_SP_2017_41128_18348.jpg

Slide gate and headwall in canal at LS toe.

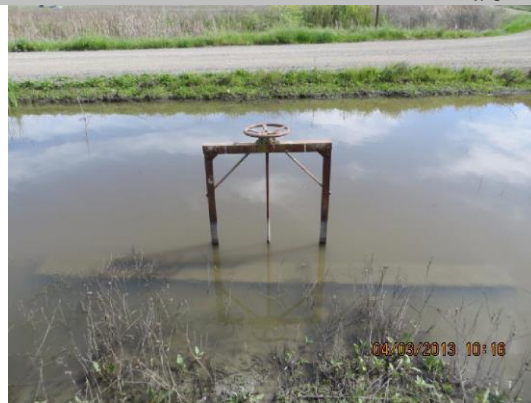
Photo 2 of 3 : UCIP_SP_2017_41128_18347.jpg

Slide gate and headwall in canal at LS toe.

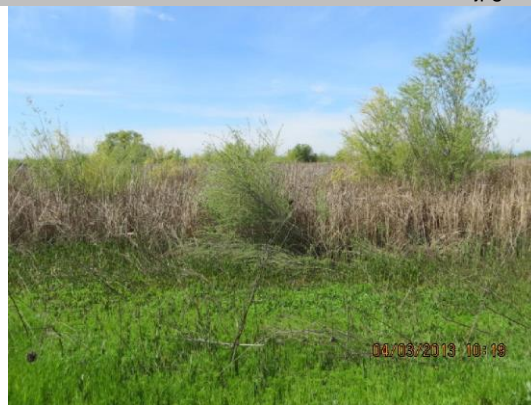
Photo 3 of 3 : UCIP_SP_2017_41128_18346.jpg

Vegetated area blocks access to WS of pipe.

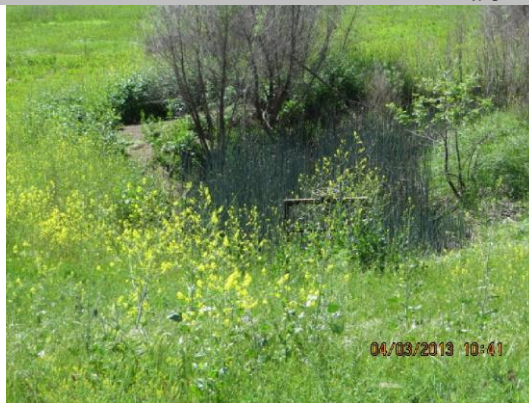
Photo 1 of 2 : UCIP_SP_2017_11011_18354.jpg

Slide gate at WS toe showing excessive vegetation.

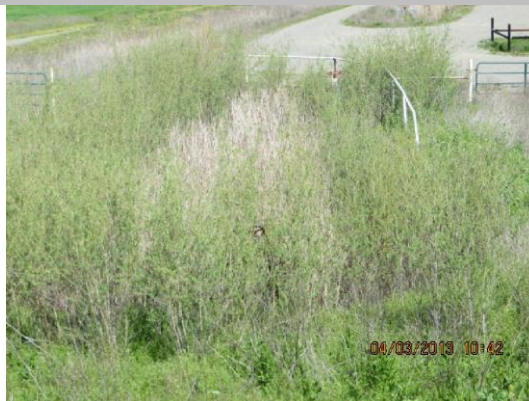
Photo 2 of 2 : UCIP_SP_2017_11011_18353.jpg

Slide gate at LS toe showing excessive vegetation.

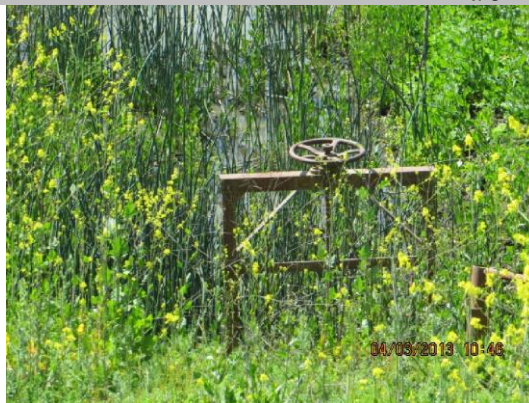
Photo 1 of 3 : UCIP_SP_2017_11012_18357.jpg

Combination flap and slide gate on WS toe. With excessive vegetation

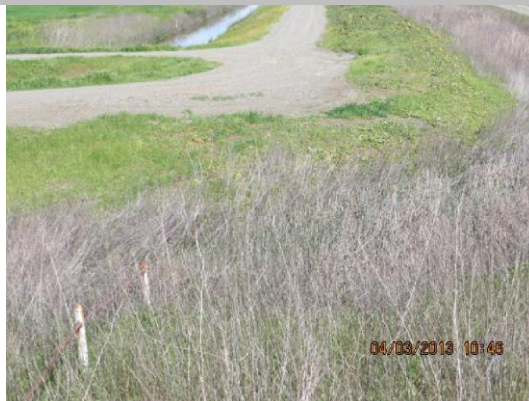
Photo 2 of 3 : UCIP_SP_2017_11012_18356.jpg

Headwall at bottom of fenceline on LS toe

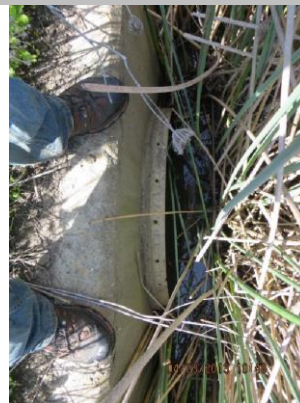
Photo 3 of 3 : UCIP_SP_2017_11012_18355.jpg

Headwall and pipe on LS toe.

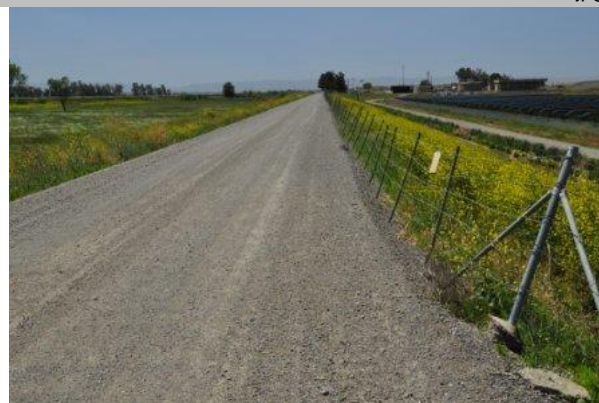
Photo 1 of 1 : SP_2017_RD2035_240_5_20170316_00001.jpg

Fence along the landside shoulder of the crown.
