**Flood Control Project Maintenance
Levee Inspections**
LMA District Cover Sheet
Spring 2018 Levee Inspection Results

Reclamation District No. 2035 Conaway

Spring 2018 Levee Inspection Results

Waterway			Bank	Unit Miles
Unit No. 01 Cache Creek Settling Basin			Right	2.01
	Spring (March - May)	Summer (June - August)	(September - November) Fall	Winter (December - February)
Unit Maintenance Rating (Fall Only)				
Date of Inspection	4/19/2018 - 4/19/2018			
DWR Inspector	Sterling York			
Accompanied By	Peter Blum

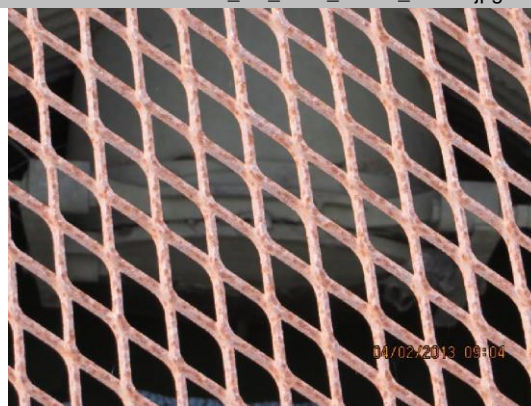
Photo 1 of 3 : UCIP_SP_2018_41346_18102.jpg

Comment Code					
Inspector Comment					
FS_ID:41346 DS_ID:17819 EP_NO: 4363 Repair Type: Non-Urgent Crossing Status: Found UCIP Comments: This pipe appears abandoned and if so should be done so properly. FIELD_STRUCT_DESC: *ABANDONED* 36-inch corrugated metal drainage pipe through the levee, 7.8 feet below the crown. 30-inch welded steel pipe sleeved through the 36-inch corrugated metal pipe (CMP) with annular space grouted. Flap gate in 72-inch corrugated metal pipe (CMP) riser at the waterside (WS) toe with abandoned pump platform on the south side of East Main Street. (Permit No. 4363, 1963 - City of Woodland, City Engineer). [Additional Reference(s): DWR Levee Log, 1990]. FS Date: 4/2/2013 3:09:00 PM

Flap gate and pipe at bottom of 72-inch CMP riser on WS toe.

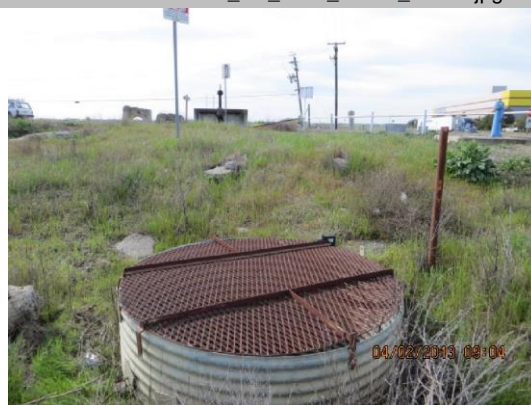
Photo 2 of 3 : UCIP_SP_2018_41346_18101.jpg

72-inch CMP riser on WS toe.

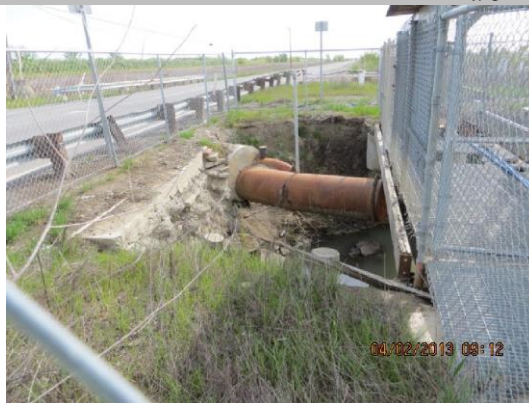
Photo 3 of 3 : UCIP_SP_2018_41346_18100.jpg

Comment Code						
Inspector Comment						
FS_ID:41346 DS_ID:17819 EP_NO: 4363 Repair Type: Non-Urgent Crossing Status: Found UCIP Comments: This pipe appears abandoned and if so should be done so properly. FIELD_STRUCT_DESC: *ABANDONED* 36-inch corrugated metal drainage pipe through the levee, 7.8 feet below the crown. 30-inch welded steel pipe sleeved through the 36-inch corrugated metal pipe (CMP) with annular space grouted. Flap gate in 72-inch corrugated metal pipe (CMP) riser at the waterside (WS) toe with abandoned pump platform on the south side of East Main Street. (Permit No. 4363, 1963 - City of Woodland, City Engineer). [Additional Reference(s): DWR Levee Log, 1990]. FS Date: 4/2/2013 3:09:00 PM

Pipe with 30-inch grouted at 200-feet LS of toe.

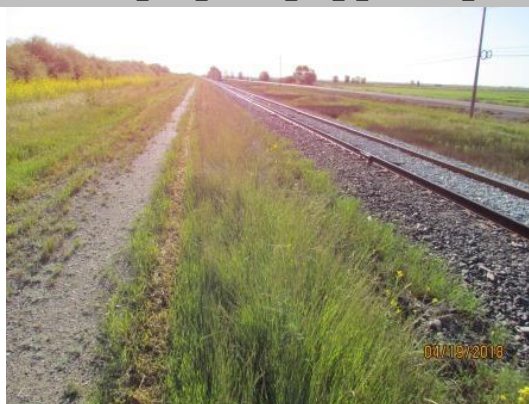
Photo 1 of 1 : SP_2018_RD2035_238_9_20180430_00013.jpg

LM Start	0.02	Rating **	M	Issue No.	9
LM End	2.00	Issue Type +	Ma	Location *	LS
Category	Earthen Levee			GPS Latitude/Longitude	
				Start	End
Item	Vegetation			38.677368 °	38.677186 °
				-121.709565 °	-121.672912 °
DWR ID	DWR_RD2035_01_s_2018_9				
Comment Code					
V1 : Control annual grass and weeds on the levee slopes and easements.					
Inspector Comment					
Annual vegetation needs to be maintained, Spring 2018.

View looking downstream landside of the annual vegetation that needs to be maintained, Spring 2018.

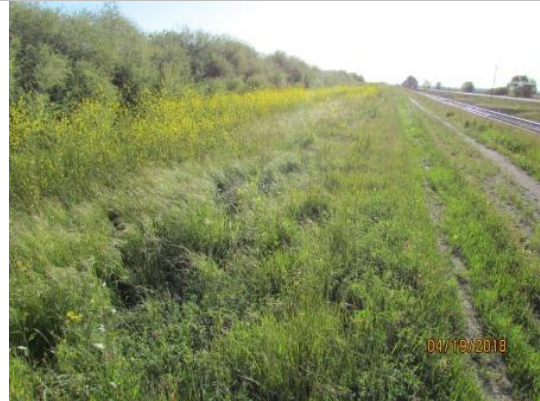
Photo 1 of 1 : SP_2018_RD2035_238_10_20180430_00014.jpg

View looking downstream waterside of the annual vegetation that needs to be maintained, Spring 2018.

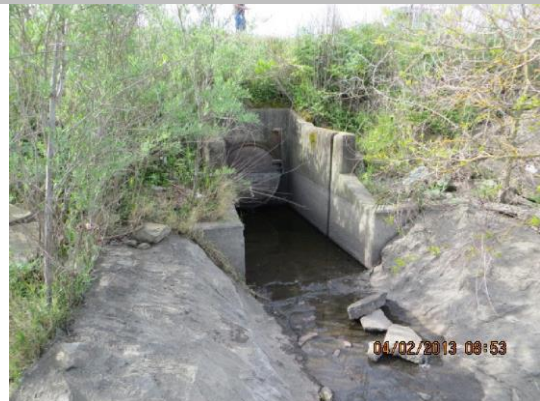
Photo 1 of 3 : UCIP_SP_2018_10827_18109.jpg

Comment Code					
Inspector Comment					
FS_ID:10827 DS_ID:17814 EP_NO: 10127 Repair Type: No Action Needed Crossing Status: Found UCIP Comments: FIELD_STRUCT_DESC: 42-inch concrete encased corrugated metal drainage pipe through the levee, 10 feet below the crown. Flap gate on the waterside (WS) end. Grouted spillway on the WS. Pipe exposed on the landside (LS). (36-inch pipe [HLM 0.02] authorized under Automatic Board Order (ABO) issued as Permit No. 10127, 1974 - City of Woodland, Department of Public Works). [Additional Reference(s): DWR Levee Log, 1990. USACE Sacramento O&M Manual 126, November 1961, (HLM 0.01), listed as 5.5 feet below the crown]. FS Date: 4/2/2013

Flap gate and spillway on WS toe.

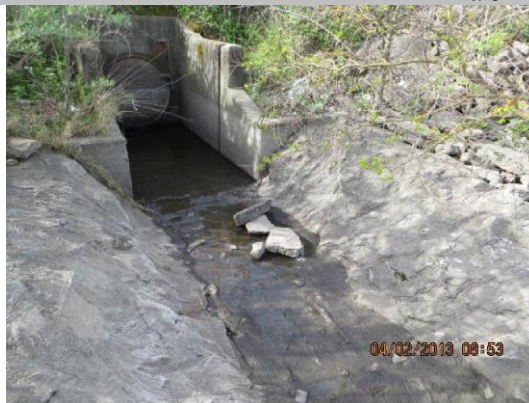
Photo 2 of 3 : UCIP_SP_2018_10827_18108.jpg

Flap gate and spillway on WS toe.

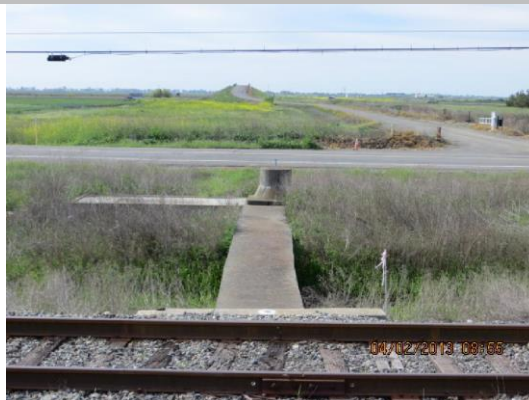
Photo 3 of 3 : UCIP_SP_2018_10827_18107.jpg

Concrete encased pipe on LS toe.

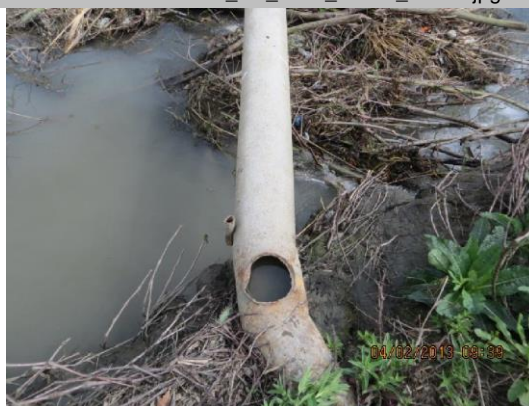
Photo 1 of 3 : UCIP_SP_2018_42012_18115.jpg

LM Start	1.27	Rating **	M	Issue No.	13
LM End	1.27	Issue Type +	En	Location *	
Category	Supplemental			GPS Latitude/Longitude	
				Start	End
Item	DWR UCIP Field Study			38.677249 °	38.677249 °
				-121.686358 °	-121.686358 °
DWR ID					
Comment Code					
Inspector Comment					
FS_ID:42012 DS_ID:17816 EP_NO: 12597 Repair Type: Non-Urgent Crossing Status: Found UCIP Comments: Pipe appears abandoned and if so should be done so properly. FIELD_STRUCT_DESC: *ABANDONED* 18-inch steel conductor pipe for floating silt dredge through the levee, 3.4 feet below the crown. 10-inch steel pipe sleeved through the 18-inch steel conductor pipe with annular space grouted. Siphon breaker on the waterside (WS) shoulder in steel riser. (Permit No. 12597, 1978 - Reclamation District No. 2035). [Additional Reference(s): DWR Levee Log, 1990]. FS Date: 4/2/2013

Exposed pipe at WS toe/stream.

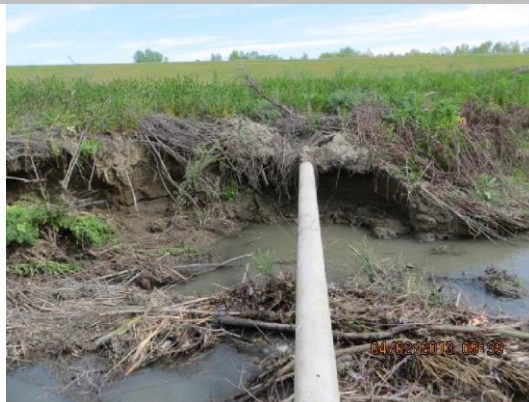
Photo 2 of 3 : UCIP_SP_2018_42012_18114.jpg

Exposed pipe at WS toe/stream.

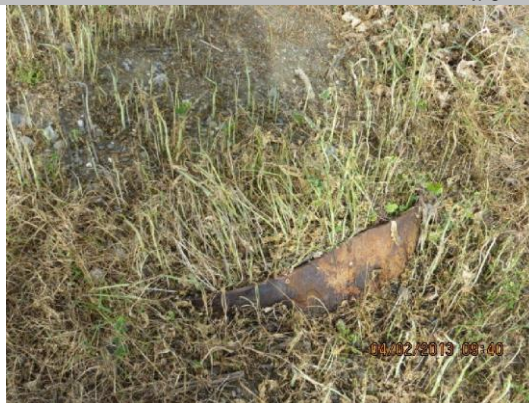
Photo 3 of 3 : UCIP_SP_2018_42012_18113.jpg

Buried steel riser on WS shoulder

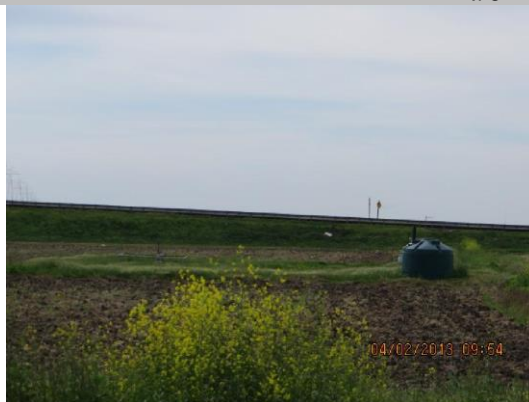
Photo 1 of 2 : UCIP_SP_2018_10913_18188.jpg

LM Start	1.87	Rating **	M	Issue No.	14
LM End	1.87	Issue Type +	En	Location *	
Category	Supplemental			GPS Latitude/Longitude	
				Start	End
Item	DWR UCIP Field Study			38.677186 °	38.677186 °
				-121.675277 °	-121.675277 °
DWR ID					
Comment Code					
Inspector Comment					
FS_ID:10913					
DS_ID:17867					
EP_NO: 13201					
Repair Type: Non-Urgent					
Crossing Status: Indicator Found					
UCIP Comments: Pipe needs to be properly marked or abandoned.					
FIELD_STRUCT_DESC: 8-inch casing of an unknown material through the levee, 25 feet below the crown. 3-inch gas line sleeved through the casing with annular space filled with bentonite. Possible vent for pipe on the landside (LS) next to Old River Road. (Permit No. 13201, 1981 - Pacific Gas and Electric Company [PG&E]).					
FS Date: 4/2/2013

Natural gas well on south side of Old river road.

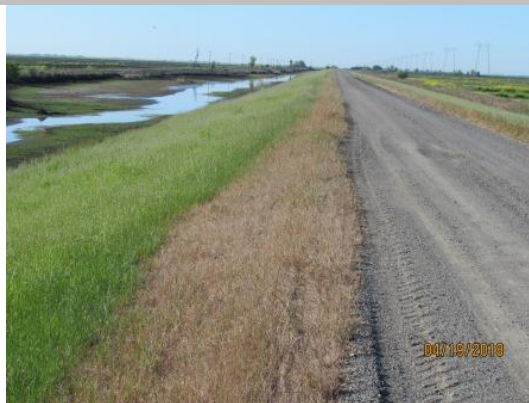
Photo 1 of 1 : SP_2018_RD2035_239_20_20180430_00059.jpg

View looking downstream waterside of the annual vegetation that is maintained, Spring 2018.

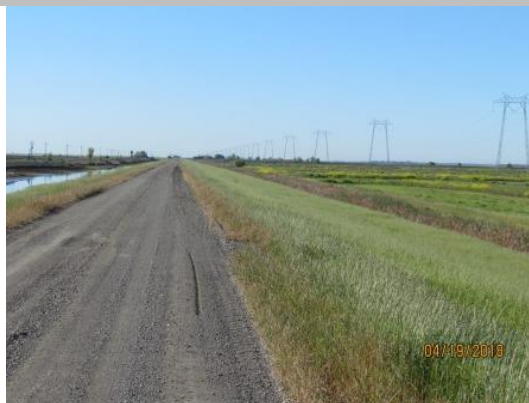
Photo 1 of 1 : SP_2018_RD2035_239_21_20180430_00058.jpg

LM Start	0.02	Rating **	A	Issue No.	21
LM End	3.46	Issue Type +	Ma	Location *	LS
Category	Earthen Levee			GPS Latitude/Longitude	
				Start	End
Item	Vegetation			38.676897 °	38.630112 °
				-121.672717 °	-121.654087 °
DWR ID	DWR_RD2035_02_s_2018_21				
Comment Code					
V1 : Control annual grass and weeds on the levee slopes and easements.					
Inspector Comment

View looking downstream landside of the annual vegetation that is maintained, Spring 2018.

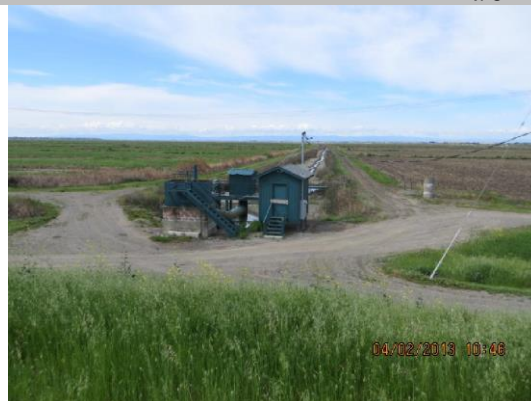
Photo 1 of 3 : UCIP_SP_2018_50171_18202.jpg

FS_ID:50171
DS_ID:17822
EP_NO: N/A
Repair Type: Urgent
Crossing Status: Found
UCIP Comments: 09/14/2016 - Flap gate on the WS was submerged at time of inspection. LS headwall at the pumping plant has exposed rebar. There is still erosion present behind the headwall. However, water was present making it difficult to determine if it is getting worse. As-built drawings were requested from LMA consultant representative. (T. Hatch/UCIP)04/02/2013 - Flap gate broken in half on WS toe. Some erosion at headwalls on pumping plant. (W. Wylie/UCIP) FIELD_STRUCT_DESC: 44-inch corrugated metal drainage pipe through the levee, 22 feet below the crown. Pump on platform in drainage ditch at the landside (LS) toe. Slide gate and flap gates in a 5-foot by 9-foot concrete box. Flap gate on the waterside (WS) toe. 8-inch vent/standpipe at the WS toe. [Additional Reference(s): DWR Levee Log, 1990. USACE Sacramento O&M Manual 121, May 1959, (HLM 0.4) (4-foot by 4-foot concrete culvert listed)].

Pumping plant off LS toe.

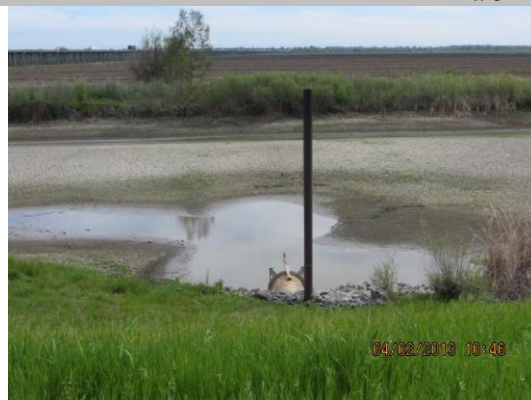
Photo 2 of 3 : UCIP_SP_2018_50171_18201.jpg

Pipe and flap gate with vent riser on WS toe.

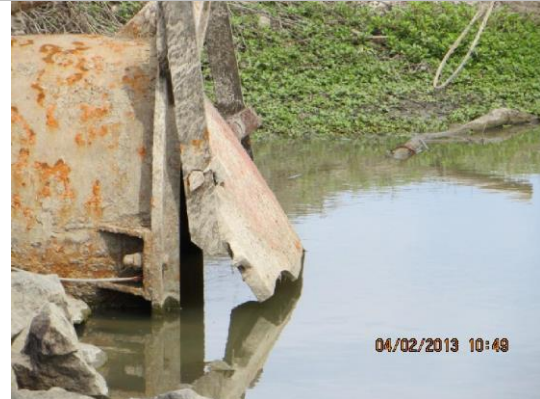
Photo 3 of 3 : UCIP_SP_2018_50171_18200.jpg

Comment Code						
Inspector Comment						
FS_ID:50171 DS_ID:17822 EP_NO: N/A Repair Type: Urgent Crossing Status: Found UCIP Comments: 09/14/2016 - Flap gate on the WS was submerged at time of inspection. LS headwall at the pumping plant has exposed rebar. There is still erosion present behind the headwall. However, water was present making it difficult to determine if it is getting worse. As-built drawings were requested from LMA consultant representative. (T. Hatch/UCIP)04/02/2013 - Flap gate broken in half on WS toe. Some erosion at headwalls on pumping plant. (W. Wylie/UCIP) FIELD_STRUCT_DESC: 44-inch corrugated metal drainage pipe through the levee, 22 feet below the crown. Pump on platform in drainage ditch at the landside (LS) toe. Slide gate and flap gates in a 5-foot by 9-foot concrete box. Flap gate on the waterside (WS) toe. 8-inch vent/standpipe at the WS toe. [Additional Reference(s): DWR Levee Log, 1990. USACE Sacramento O&M Manual 121, May 1959, (HLM 0.4) (4-foot by 4-foot concrete culvert listed)]. FS Date: 9/14/2016

Broken flap gate at WS toe.

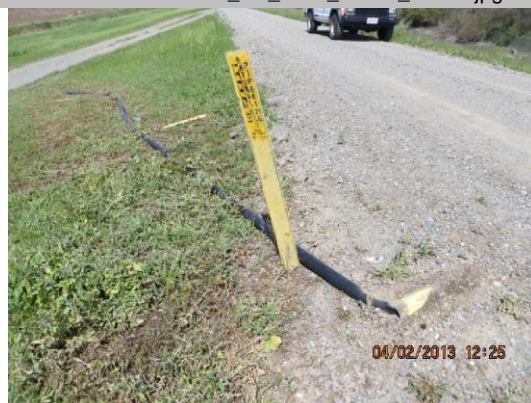
Photo 1 of 3 : UCIP_SP_2018_50090_18922.jpg

FS_ID:50090
DS_ID:22956
EP_NO: N/A
Repair Type: Non-Urgent
Crossing Status: Found
UCIP Comments: 09/14/2016 - Pipe has been removed from the levee and the levee has been repaired. It is unknown if these repairs were done with a permit or if the fill was properly compacted. Gas line markers still on WS shoulder of levee. It is unknown if another gas line exists in this location. (T. Hatch/UCIP)04/02/2013 - Pipe does not have appropriate cover and is marked as gasoline. Does not appear to be a permitted utility. (W. Wylie/UCIP)
FIELD_STRUCT_DESC: *REMOVED* 4-inch steel pipe of an unknown purpose through the levee, 3 inches below the crown. 2-inch polyvinyl chloride (PVC) pipe sleeved through the 4-inch steel pipe. No other appurtenances found. Markers along alignment indicate that the pipe may be a gas line.
FS Date: 9/14/2016

Pipe crossing with gasline marker on LS shoulder.

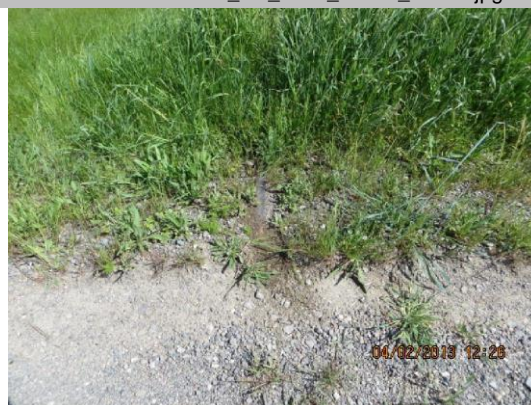
Photo 2 of 3 : UCIP_SP_2018_50090_18921.jpg

Pipe on WS shoulder.

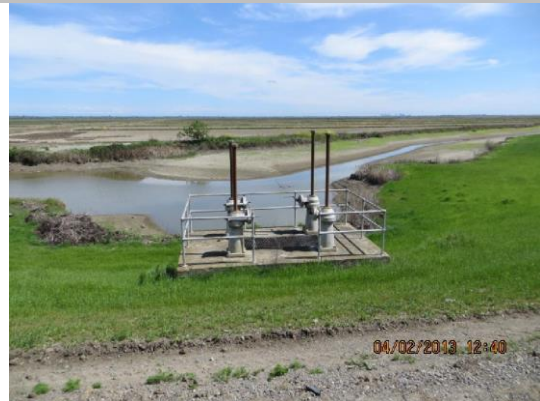
Photo 1 of 3 : UCIP_SP_2018_10933_18226.jpg

LM Start	2.15	Rating **	A/W	Issue No.	982
LM End	2.15	Issue Type +	Ma	Location *	
Category	Supplemental			GPS Latitude/Longitude	
				Start	End
Item	DWR UCIP LMA Responsibility			38.646445 °	38.646445 °
				-121.666423 °	-121.666423 °
DWR ID					
Comment Code					
Inspector Comment					
FS_ID:10933					
DS_ID:17833					
EP_NO: N/A					
Repair Type: No Action Needed					
Crossing Status: Found					
UCIP Comments:					
FIELD_STRUCT_DESC: 1 of 2: 60-inch drainage pipe of an unknown material through the levee, 26 feet below the crown. Concrete well and gate structure on the waterside (WS) slope. [Additional Reference(s): DWR Levee Log, 1990. USACE Sacramento O&M Manual 121, May 1959, (HLM 2.3) (6-foot by 6-foot concrete culvert listed)].					
FS Date: 4/2/2013

Slide gates in concrete vault on WS slope.

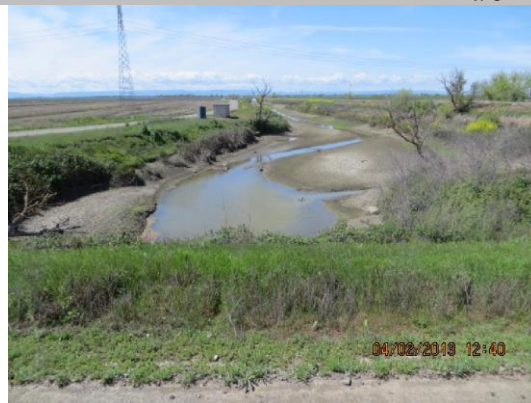
Photo 2 of 3 : UCIP_SP_2018_10933_18225.jpg

LS at intake.

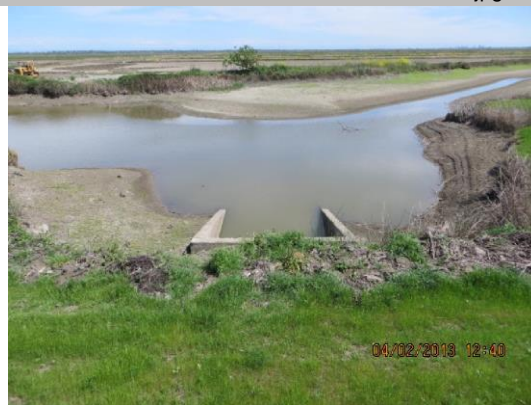
Photo 3 of 3 : UCIP_SP_2018_10933_18224.jpg

Outlet on WS toe.

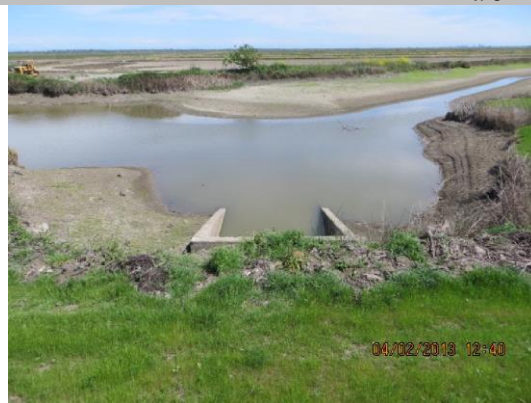
Photo 3 of 3 : UCIP_SP_2018_10934_18228.jpg

Concrete headwall on WS toe.

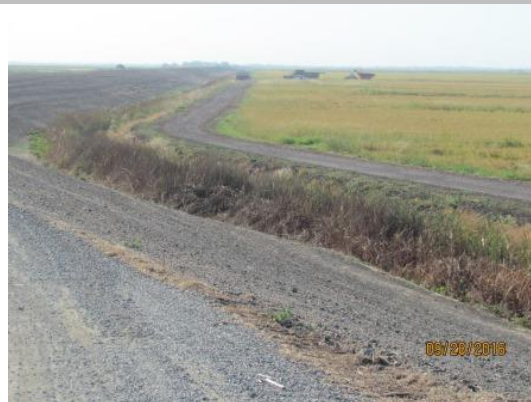
Photo 1 of 1 : SP_2018_RD2035_239_979_20180302_00036.jpg

LM Start	2.18	Rating **	M	Issue No.	979
LM End	4.02	Issue Type +	En	Location *	LS
Category	Earthen Levee			GPS Latitude/Longitude	
				Start	End
Item	Encroachments			38.646063 °	38.623062 °
				-121.666332 °	-121.648925 °
DWR ID	DWR_RD2035_02_s_2012_979				
Comment Code					
DT : Ditch					
Inspector Comment					
Ditch is at the landside toe of the levee.

View of the ditch on the landward side of the levee looking downstream.
Fall 2016 and still exist Fall 2017.

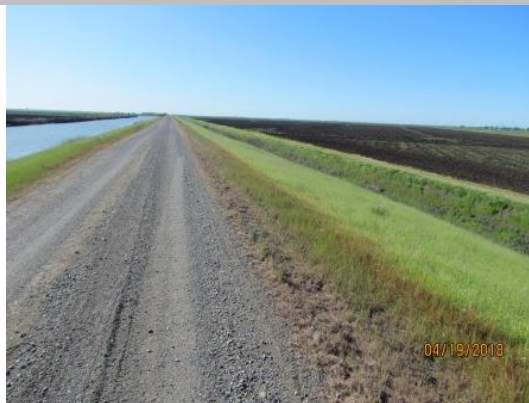
Photo 1 of 1 : SP_2018_RD2035_239_22_20180430_00060.jpg

View looking downstream landside of the annual vegetation that is maintained, Spring 2018.

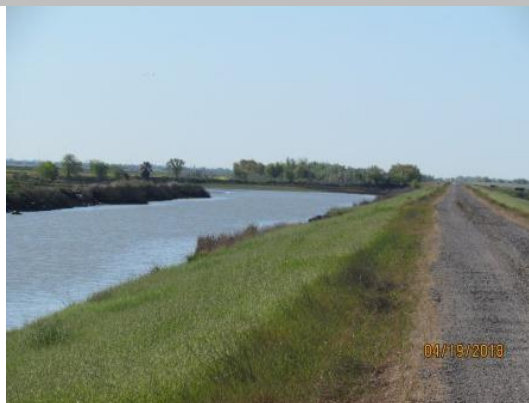
Photo 1 of 1 : SP_2018_RD2035_239_23_20180430_00061.jpg

LM Start	3.46	Rating **	A	Issue No.	23
LM End	7.60	Issue Type +	Ma	Location *	WS
Category	Earthen Levee			GPS Latitude/Longitude	
				Start	End
Item	Vegetation			38.630111 °	38.575489 °
				-121.654087 °	-121.635021 °
DWR ID	DWR_RD2035_02_s_2018_23				
Comment Code					
V1 : Control annual grass and weeds on the levee slopes and easements.					
Inspector Comment					
Annual vegetation is maintained, Spring 2018.

View looking downstream waterside of the annual vegetation that is maintained, Spring 2018.

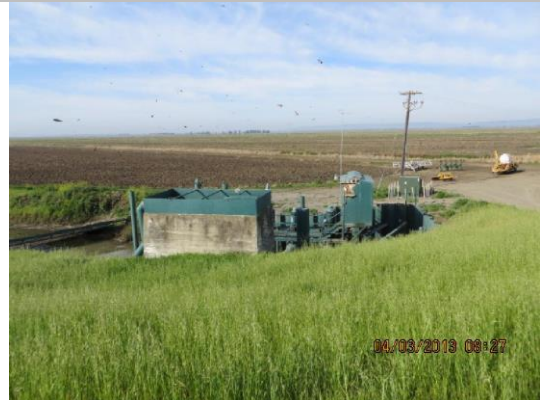
Photo 1 of 3 : UCIP_SP_2018_11526_18935.jpg

Surge box and pumping plant on LS toe.

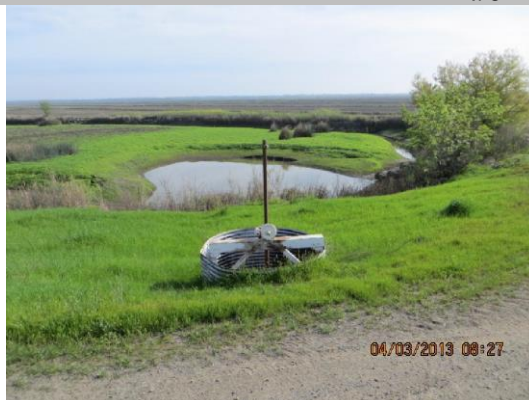
Photo 2 of 3 : UCIP_SP_2018_11526_18934.jpg

7-foot diameter CMP riser and slide gate on WS slope.

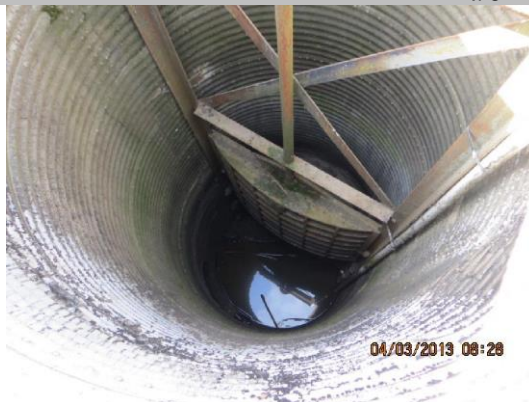
Photo 3 of 3 : UCIP_SP_2018_11526_18933.jpg

7-foot diameter CMP riser and slide gate on WS slope.

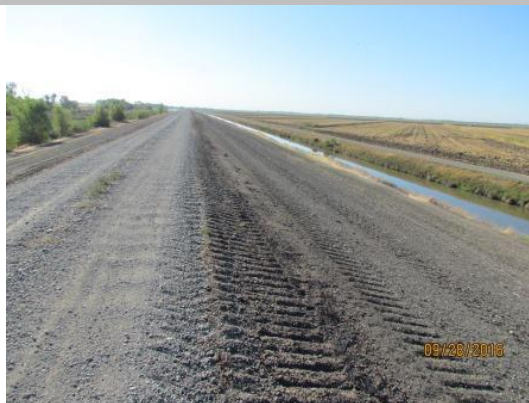
Photo 1 of 1 : SP_2018_RD2035_239_10_20180302_00001.jpg

View of the drainage ditch on the landward side of the levee looking downstream. Fall 2016.

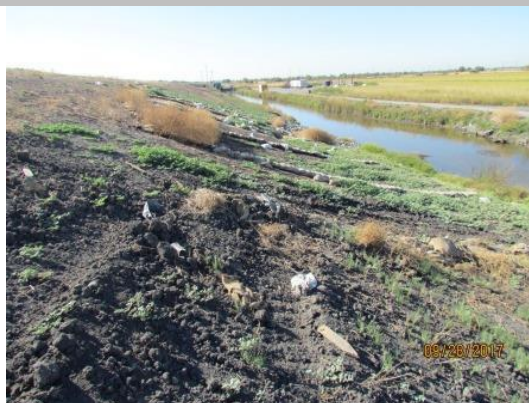
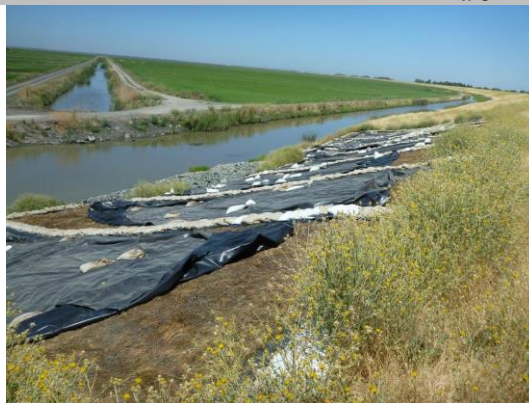
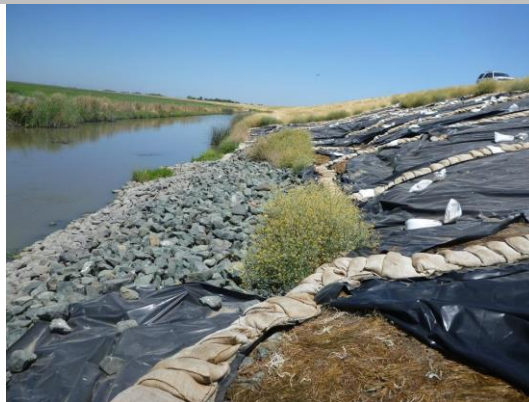
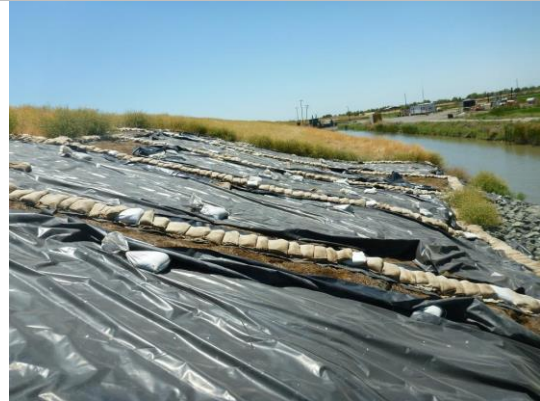
Photo 1 of 4 : SP_2018_RD2035_239_31_20180302_00032.jpg

View looking downstream landside of 2017 Storm Damage, sluffing site. All plastic is remove, sandbags remain, and is NOT scheduled to be repaired in 2017.

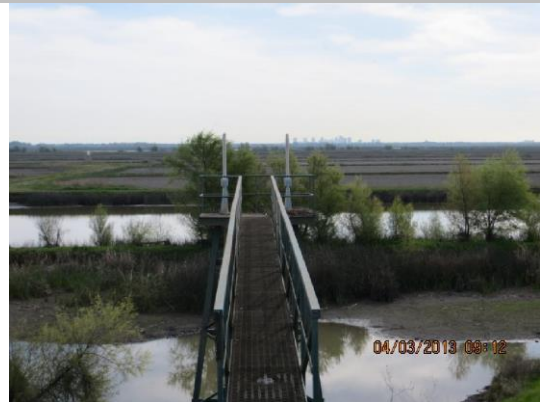
Photo 1 of 3 : UCIP_SP_2018_50089_18327.jpg

Steel walkway to slide gates on WS shoulder.

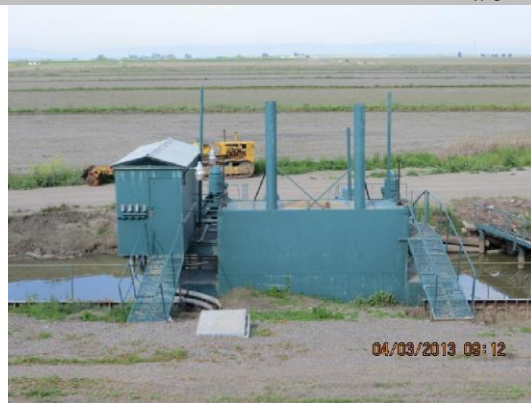
Photo 2 of 3 : UCIP_SP_2018_50089_18326.jpg

Pumping plant on LS toe.

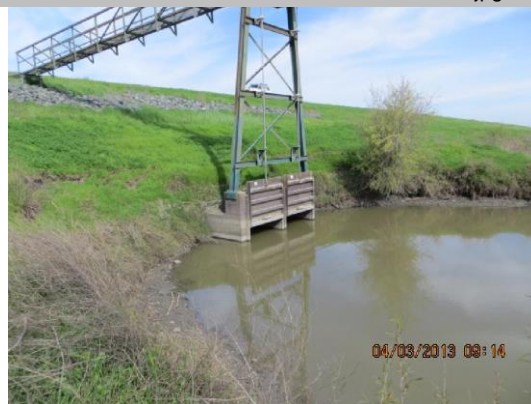
Photo 3 of 3 : UCIP_SP_2018_50089_18325.jpg

Slide gates at WS toe.

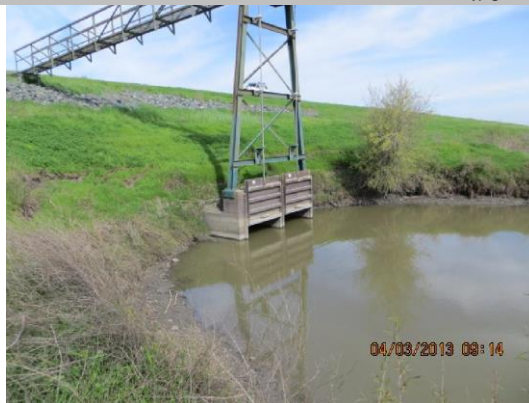
Photo 3 of 3 : UCIP_SP_2018_50088_18319.jpg

Slide gates at outlet on WS toe.

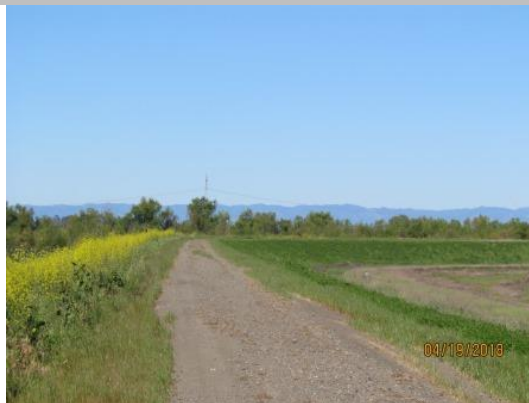
Photo 1 of 1 : SP_2018_RD2035_240_6_20180430_00014.jpg

View looking upstream landside of the annual vegetation that needs to be maintained, Spring 2018.

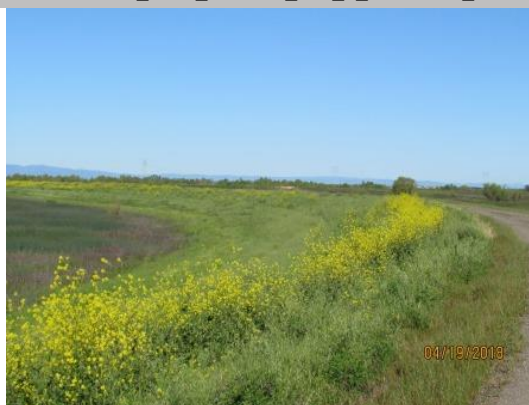
Photo 1 of 1 : SP_2018_RD2035_240_7_20180430_00015.jpg

View looking upstream waterside of the annual vegetation that needs to be maintained, Spring 2018.

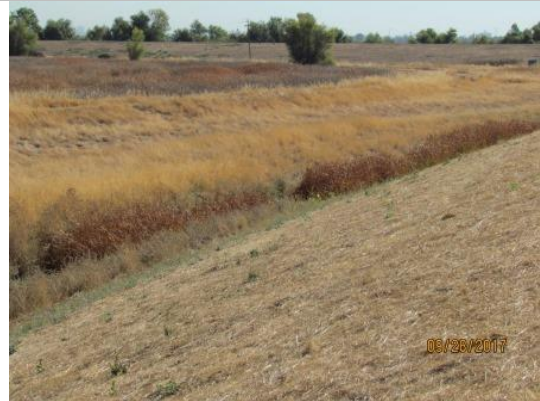
Photo 1 of 1 : SP_2018_RD2035_240_973_20180302_00002.jpg

View looking downstream of the landside ditch at the levee toe, Fall 2017.

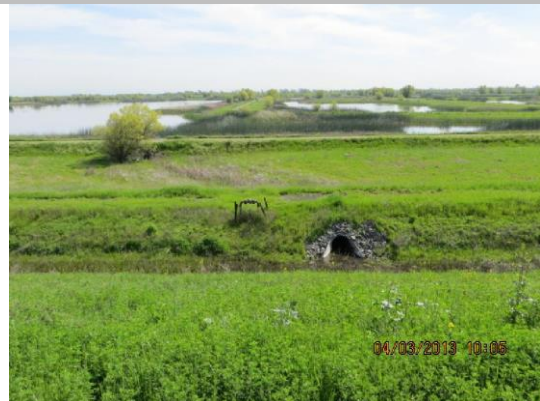
Photo 1 of 3 : UCIP_SP_2018_50078_18345.jpg

Gasline vent off LS toe.

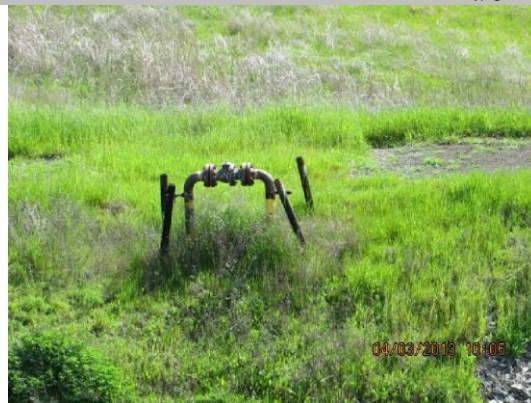
Photo 2 of 3 : UCIP_SP_2018_50078_18344.jpg

Gasline vent off LS toe.

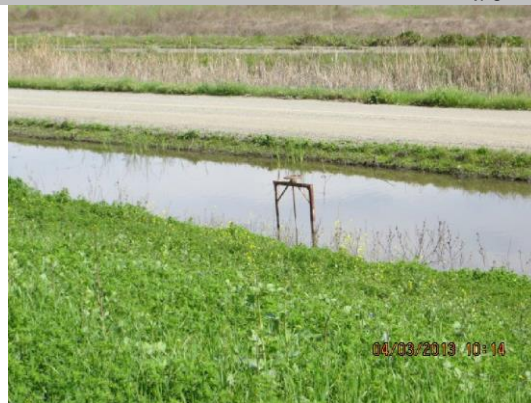
Photo 1 of 3 : UCIP_SP_2018_41128_18348.jpg

Slide gate and headwall in canal at LS toe.

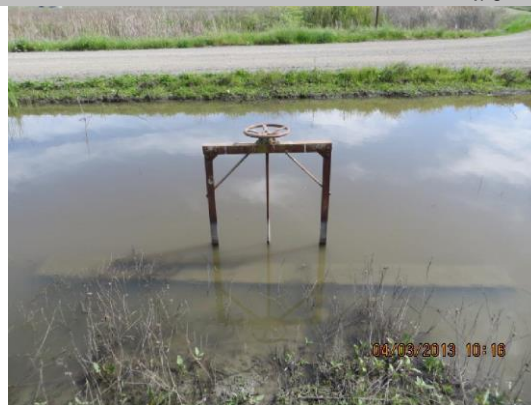
Photo 2 of 3 : UCIP_SP_2018_41128_18347.jpg

Slide gate and headwall in canal at LS toe.

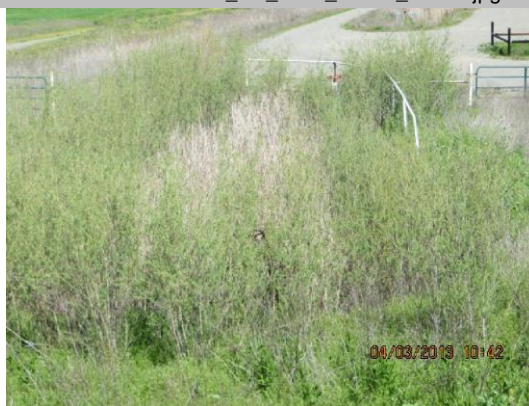
Photo 2 of 2 : UCIP_SP_2018_11011_18353.jpg

Slide gate at LS toe showing excessive vegetation.

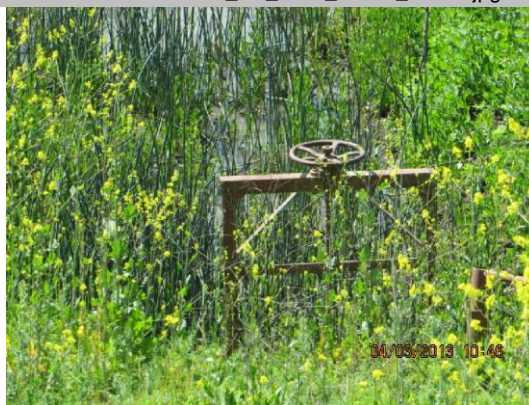
Photo 1 of 3 : UCIP_SP_2018_11012_18357.jpg

Combination flap and slide gate on WS toe. With excessive vegetation

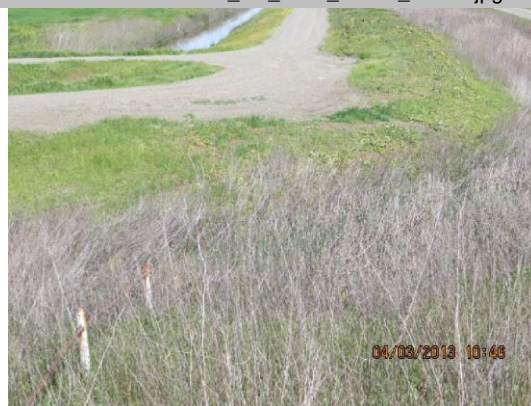
Photo 2 of 3 : UCIP_SP_2018_11012_18356.jpg

Headwall at bottom of fenceline on LS toe

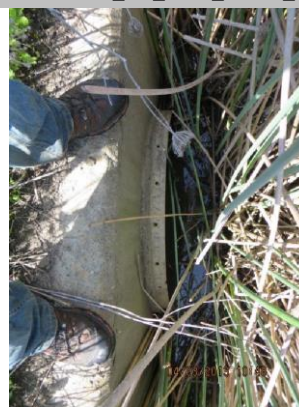
Photo 3 of 3 : UCIP_SP_2018_11012_18355.jpg

Headwall and pipe on LS toe.

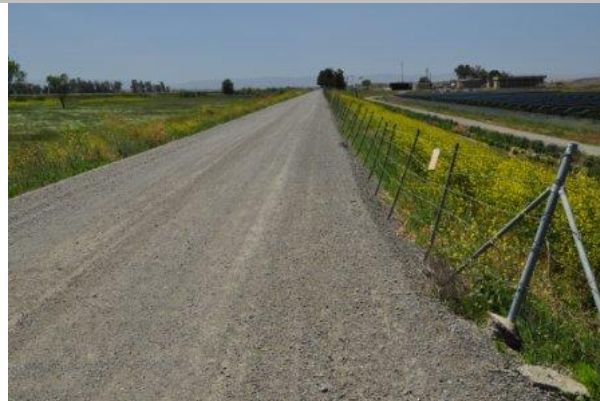
Photo 1 of 1 : SP_2018_RD2035_240_5_20180302_00001.jpg

Fence along the landside shoulder of the crown belongs to the treatment plant and has not changed from previous inspections, Fall 2017.
