**Flood Control Project Maintenance  
Levee Inspections**  
**LMA District Cover Sheet**  
**Spring 2019 Levee Inspection Results**

**Reclamation District No. 2035 Conaway**

**Spring 2019 Levee Inspection Results**

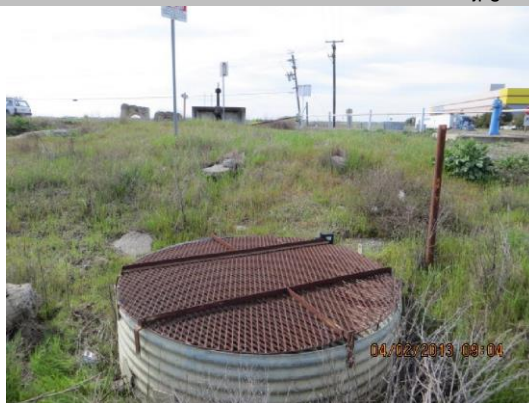
Photo 2 of 3 : UCIP\_SP\_2019\_41346\_18101.jpg

72-inch CMP riser on WS toe.

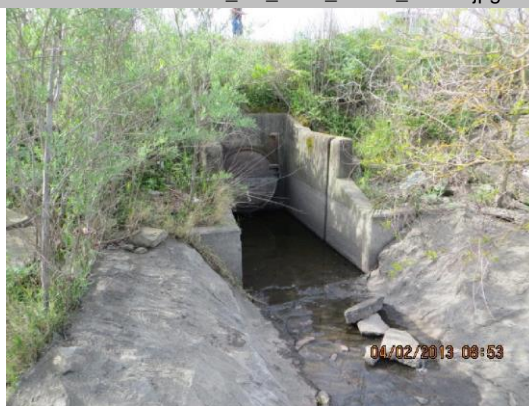
Photo 1 of 3 : UCIP\_SP\_2019\_10827\_18109.jpg

Comment Code					
Inspector Comment					
FS_ID:10827 DS_ID:17814 EP_NO: 10127 Repair Type: No Action Needed Crossing Status: Found UCIP Comments: FIELD_STRUCT_DESC: 42-inch concrete encased corrugated metal drainage pipe through the levee, 10 feet below the crown. Flap gate on the waterside (WS) end. Grouted spillway on the WS. Pipe exposed on the landside (LS). (36-inch pipe [HLM 0.02] authorized under Automatic Board Order (ABO) issued as Permit No. 10127, 1974 - City of Woodland, Department of Public Works). [Additional Reference(s): DWR Levee Log, 1990. USACE Sacramento O&M Manual 126, November 1961, (HLM 0.01), listed as 5.5 feet below the crown]. FS Date: 4/2/2013

Flap gate and spillway on WS toe.

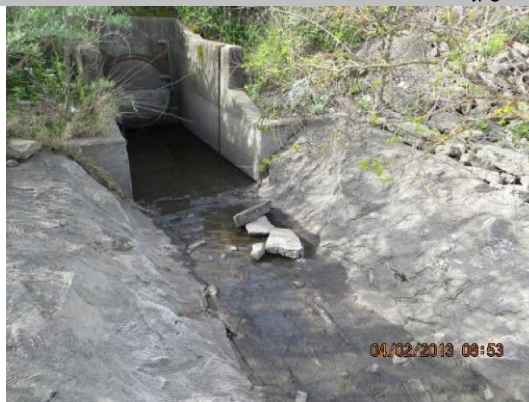
Photo 2 of 3 : UCIP\_SP\_2019\_10827\_18108.jpg

Flap gate and spillway on WS toe.

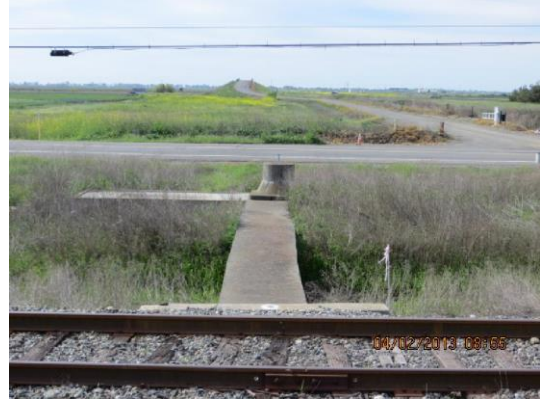
Photo 3 of 3 : UCIP\_SP\_2019\_10827\_18107.jpg

Comment Code						
Inspector Comment						
FS_ID:10827 DS_ID:17814 EP_NO: 10127 Repair Type: No Action Needed Crossing Status: Found UCIP Comments: FIELD_STRUCT_DESC: 42-inch concrete encased corrugated metal drainage pipe through the levee, 10 feet below the crown. Flap gate on the waterside (WS) end. Grouted spillway on the WS. Pipe exposed on the landside (LS). (36-inch pipe [HLM 0.02] authorized under Automatic Board Order (ABO) issued as Permit No. 10127, 1974 - City of Woodland, Department of Public Works). [Additional Reference(s): DWR Levee Log, 1990. USACE Sacramento O&M Manual 126, November 1961, (HLM 0.01), listed as 5.5 feet below the crown]. FS Date: 4/2/2013

Concrete encased pipe on LS toe.

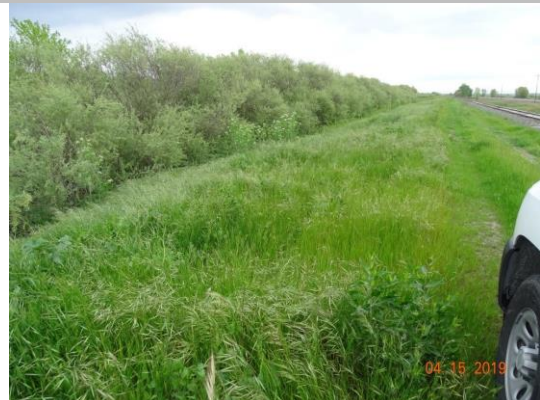
Photo 1 of 1 : SP\_2019\_RD2035\_238\_9\_20190422\_00013.jpg

LM Start	0.03	Rating **	M	Issue No.	9
LM End	2.01	Issue Type +	Ma	Location *	WS
Category	Earthen Levee			GPS Latitude/Longitude	
				Start	End
Item	Vegetation			38.677335 °	38.677183 °
				-121.709358 °	-121.672783 °
DWR ID	DWR_RD2035_01_s_2019_9				
Comment Code					
V1 : Control annual grass and weeds on the levee slopes and easements.					
Inspector Comment

View of vegetation on the waterside slope. Spring 2019.

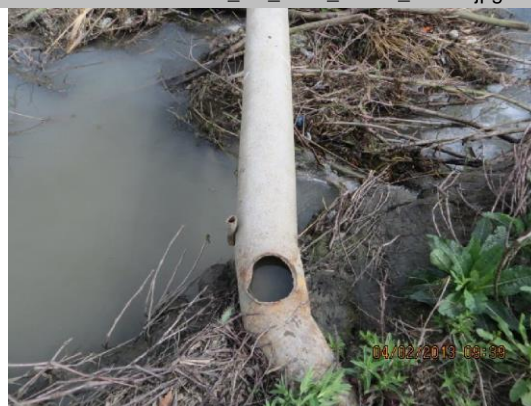
Photo 1 of 3 : UCIP\_SP\_2019\_42012\_18115.jpg

Comment Code					
Inspector Comment					
FS_ID:42012 DS_ID:17816 EP_NO: 12597 Repair Type: Non-Urgent Crossing Status: Found UCIP Comments: 04/02/2013 Pipe appears abandoned and if so should be done so properly. (W. Wylie - DWR UCIP) FIELD_STRUCT_DESC: *ABANDONED* 18-inch steel conductor pipe for floating silt dredge through the levee, 3.4 feet below the crown. 10-inch steel pipe sleeved through the 18-inch steel conductor pipe with annular space grouted. Siphon breaker on the waterside (WS) shoulder in steel riser. (18-inch conductor pipe installed under the railroad fill by boring and 10-inch pipe sleeved through conductor pipe authorized under Permit No. 12597, 1978 - Reclamation District No. 2035). [Additional Reference(s): DWR Levee Log, 1990]. FS Date: 4/2/2013

Exposed pipe at WS toe/stream.

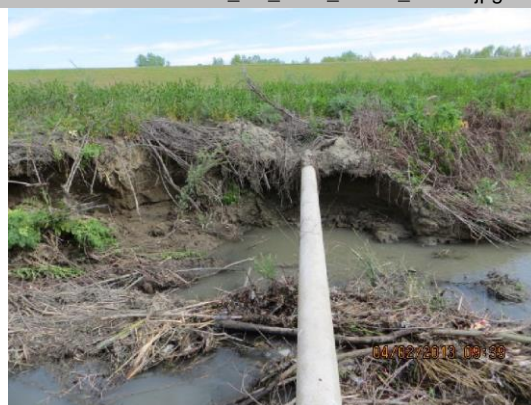
Photo 2 of 3 : UCIP\_SP\_2019\_42012\_18114.jpg

Exposed pipe at WS toe/stream.

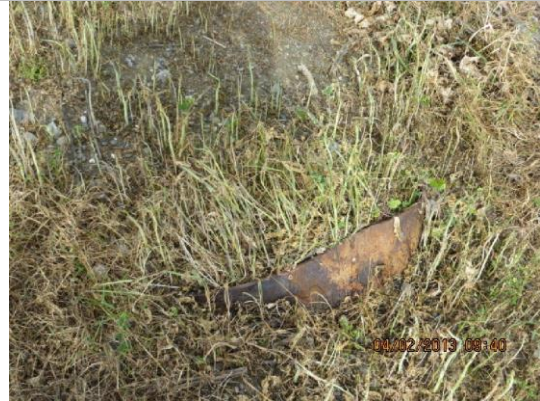
Photo 3 of 3 : UCIP\_SP\_2019\_42012\_18113.jpg

Comment Code						
Inspector Comment						
FS_ID:42012 DS_ID:17816 EP_NO: 12597 Repair Type: Non-Urgent Crossing Status: Found UCIP Comments: 04/02/2013 Pipe appears abandoned and if so should be done so properly. (W. Wylie - DWR UCIP) FIELD_STRUCT_DESC: *ABANDONED* 18-inch steel conductor pipe for floating silt dredge through the levee, 3.4 feet below the crown. 10-inch steel pipe sleeved through the 18-inch steel conductor pipe with annular space grouted. Siphon breaker on the waterside (WS) shoulder in steel riser. (18-inch conductor pipe installed under the railroad fill by boring and 10-inch pipe sleeved through conductor pipe authorized under Permit No. 12597, 1978 - Reclamation District No. 2035). [Additional Reference(s): DWR Levee Log, 1990]. FS Date: 4/2/2013

Buried steel riser on WS shoulder

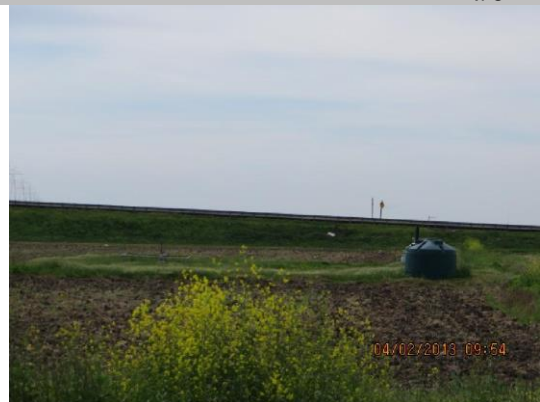
Photo 1 of 2 : UCIP\_SP\_2019\_10913\_18188.jpg

Comment Code					
Inspector Comment					
FS_ID:10913					
DS_ID:17867					
EP_NO: 13201					
Repair Type: Non-Urgent					
Crossing Status: Indicator Found					
UCIP Comments: 04/02/2013 Pipe needs to be properly marked or abandoned. (W. Wylie - DWR UCIP)					
FIELD_STRUCT_DESC: 8-inch casing of an unknown material through the levee, 25 feet below the crown. 3-inch gas line sleeved through the casing with annular space filled with bentonite. Possible vent for pipe on the landside (LS) next to Old River Road. (3-inch gas pipeline within an 8-inch casing authorized under Permit No. 13201, 1981 - Pacific Gas and Electric Company [PG&E]).					
FS Date: 4/2/2013

Natural gas well on south side of Old river road.

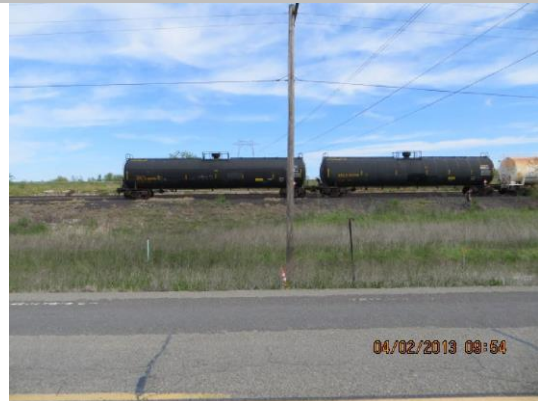
Photo 2 of 2 : UCIP\_SP\_2019\_10913\_18187.jpg

LM Start	1.87	Rating **	M	Issue No.	13 (cont)	
LM End	1.87	Issue Type +	En	Location *		
Category	Supplemental			GPS Latitude/Longitude		
				Start	End	
Item	DWR UCIP Field Study			38.677186 °	38.677186 °	
				-121.675277 °	-121.675277 °	
DWR ID	17867					
Comment Code						
Inspector Comment						
FS_ID:10913 DS_ID:17867 EP_NO: 13201 Repair Type: Non-Urgent Crossing Status: Indicator Found UCIP Comments: 04/02/2013 Pipe needs to be properly marked or abandoned. (W. Wylie - DWR UCIP) FIELD_STRUCT_DESC: 8-inch casing of an unknown material through the levee, 25 feet below the crown. 3-inch gas line sleeved through the casing with annular space filled with bentonite. Possible vent for pipe on the landside (LS) next to Old River Road. (3-inch gas pipeline within an 8-inch casing authorized under Permit No. 13201, 1981 - Pacific Gas and Electric Company [PG&E]). FS Date: 4/2/2013

Vent pipe to right of JP next to Old River Road.

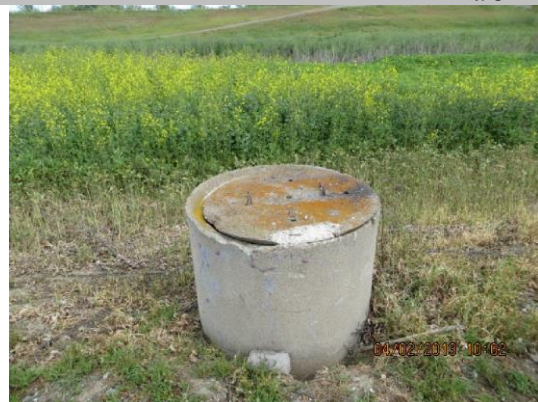
Photo 1 of 1 : UCIP\_SP\_2019\_10914\_18189.jpg

Comment Code						
Inspector Comment						
FS_ID:10914						
DS_ID:17817						
EP_NO: 2544						
Repair Type: Non-Urgent						
Crossing Status: Found						
UCIP Comments: 04/02/2013 Pipe appears to be abandoned as there is no pumphouse. Needs to be abandoned properly (W. Wylie - DWR UCIP)						
FIELD_STRUCT_DESC: 16-inch steel sewage discharge pipe through the levee, 5 feet below the crown. Pump on piling structure in drainage ditch on the landside (LS). 36-inch concrete standpipe on the waterside (WS) shoulder. (16-inch sewage discharge pipe authorized under Permit No. 2544, 1957 - City of Woodland). [Additional Reference(s): DWR Levee Log, 1990].						
FS Date: 4/2/2013

36-inch Concrete stand pipe on WS shoulder.

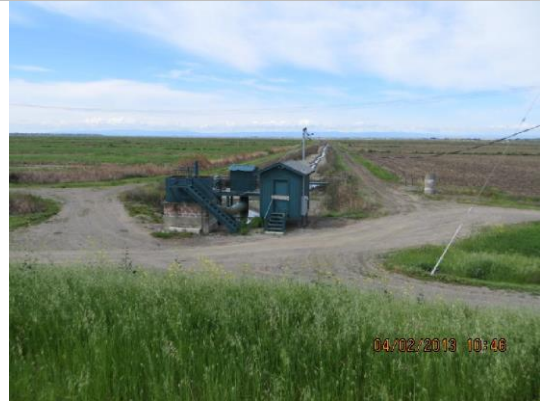
Photo 1 of 3 : UCIP\_SP\_2019\_53429\_18202.jpg

FS\_ID:53429  
DS\_ID:17822  
EP\_NO: N/A  
Repair Type: Urgent  
Crossing Status: Found  
UCIP Comments: 10/30/2018 Same as last inspection. Flap gate on the WS was submerged at the time of the inspection. Erosion is still present behind the headwall. Sink hole/burrow activity was observed along the concrete box located on the LS. Recommend internal inspection of the pipe section through levee to determine the condition of the pipe through the levee. Crossing remains Urgent due to signs of pipe leakage on LS. (O. Magana - DWR UCIP)09/14/2016 - Flap gate on the WS was submerged at time of inspection. LS headwall at the pumping plant has exposed rebar. There is still erosion present behind the headwall. However, water was present making it difficult to determine if it is getting worse. As-built drawings were requested from LMA consultant representative. (T. Hatch/UCIP)04/02/2013 - Flap gate broken in half on WS toe. Some erosion at headwalls on pumping plant. (W. Wylie/UCIP)

Pumping plant off LS toe.

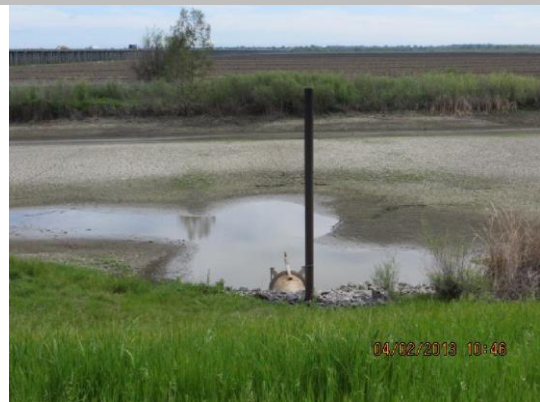
Photo 2 of 3 : UCIP\_SP\_2019\_53429\_18201.jpg

Pipe and flap gate with vent riser on WS toe.

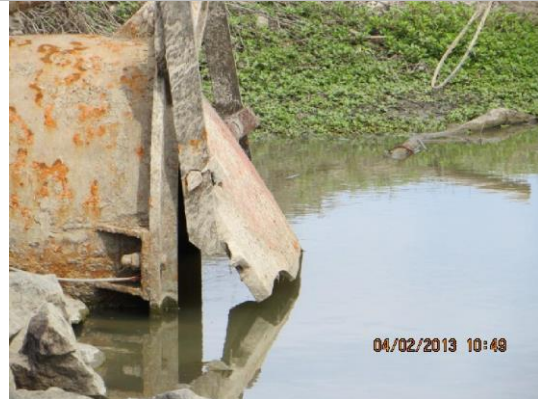
Photo 3 of 3 : UCIP\_SP\_2019\_53429\_18200.jpg

FS\_ID:53429  
DS\_ID:17822  
EP\_NO: N/A  
Repair Type: Urgent  
Crossing Status: Found  
UCIP Comments: 10/30/2018 Same as last inspection. Flap gate on the WS was submerged at the time of the inspection. Erosion is still present behind the headwall. Sink hole/burrow activity was observed along the concrete box located on the LS. Recommend internal inspection of the pipe section through levee to determine the condition of the pipe through the levee. Crossing remains Urgent due to signs of pipe leakage on LS. (O. Magana - DWR UCIP)09/14/2016 - Flap gate on the WS was submerged at time of inspection. LS headwall at the pumping plant has exposed rebar. There is still erosion present behind the headwall. However, water was present making it difficult to determine if it is getting worse. As-built drawings were requested from LMA consultant representative. (T. Hatch/UCIP)04/02/2013 - Flap gate broken in half on WS toe. Some erosion at headwalls on pumping plant. (W. Wylie/UCIP)

Broken flap gate at WS toe.

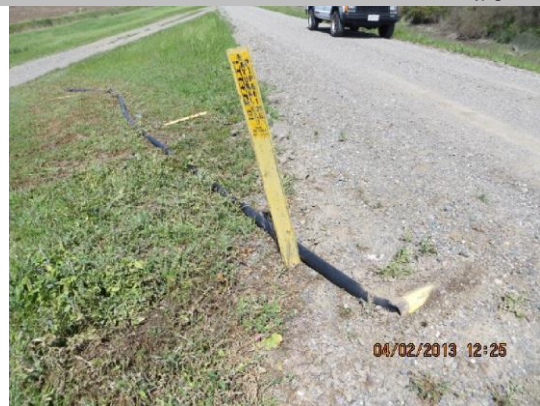
Photo 1 of 3 : UCIP\_SP\_2019\_50090\_18922.jpg

Comment Code					
Inspector Comment					
FS_ID:50090 DS_ID:22956 EP_NO: N/A Repair Type: Non-Urgent Crossing Status: Found UCIP Comments: 09/14/2016 - Pipe has been removed from the levee and the levee has been repaired. It is unknown if these repairs were done with a permit or if the fill was properly compacted. Gas line markers still on WS shoulder of levee. It is unknown if another gas line exists in this location. (T. Hatch/UCIP)04/02/2013 - Pipe does not have appropriate cover and is marked as gasoline. Does not appear to be a permitted utility. (W. Wylie/UCIP) FIELD_STRUCT_DESC: *REMOVED* 4-inch steel pipe of an unknown purpose through the levee, 3 inches below the crown. 2-inch polyvinyl chloride (PVC) pipe sleeved through the 4-inch steel pipe. No other appurtenances found. Markers along alignment indicate that the pipe may be a gas line. FS Date: 9/14/2016

Pipe crossing with gasline marker on LS shoulder.

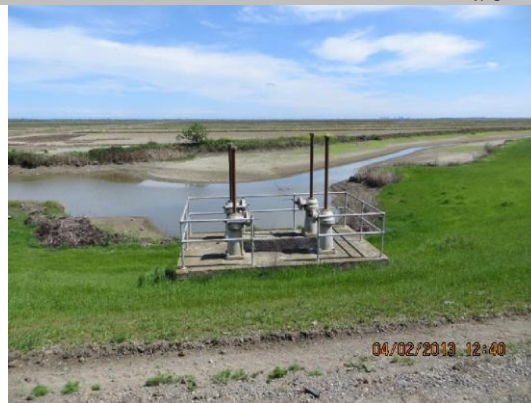
Photo 1 of 3 : UCIP\_SP\_2019\_10933\_18226.jpg

LM Start	2.15	Rating **	A/W	Issue No.	982
LM End	2.15	Issue Type +	Ma	Location *	
Category	Supplemental			GPS Latitude/Longitude	
				Start	End
Item	DWR UCIP LMA Responsibility			38.646445 °	38.646445 °
				-121.666423 °	-121.666423 °
DWR ID	17833				
Comment Code					
Inspector Comment					
FS_ID:10933 DS_ID:17833 EP_NO: N/A Repair Type: No Action Needed Crossing Status: Found UCIP Comments: FIELD_STRUCT_DESC: 1 of 2: 60-inch drainage pipe of an unknown material through the levee, 26 feet below the crown. Concrete well and gate structure on the waterside (WS) slope. [Additional Reference(s): DWR Levee Log, 1990. USACE Sacramento O&M Manual 121, May 1959, (HLM 2.3) (6-foot by 6-foot concrete culvert listed)]. FS Date: 4/2/2013

Slide gates in concrete vault on WS slope.

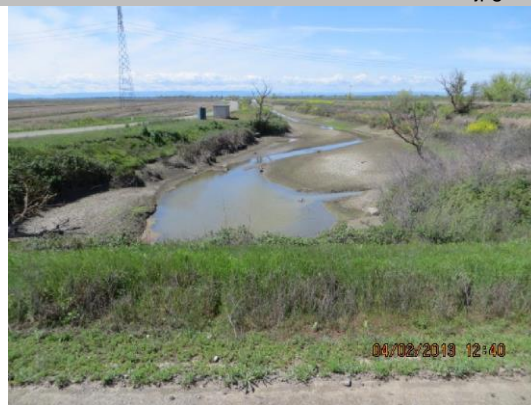
Photo 2 of 3 : UCIP\_SP\_2019\_10933\_18225.jpg

LS at intake.

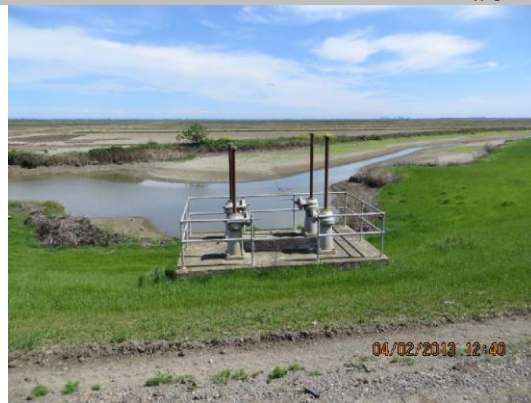
Photo 1 of 3 : UCIP\_SP\_2019\_10934\_18230.jpg

LM Start	2.15	Rating **	A/W	Issue No.	983
LM End	2.15	Issue Type +	Ma	Location *	
Category	Supplemental			GPS Latitude/Longitude	
				Start	End
Item	DWR UCIP LMA Responsibility			38.646425 °	38.646425 °
				-121.666421 °	-121.666421 °
DWR ID	17877				
Comment Code					
Inspector Comment					
FS_ID:10934 DS_ID:17877 EP_NO: N/A Repair Type: No Action Needed Crossing Status: Found UCIP Comments: FIELD_STRUCT_DESC: 2 of 2: 60-inch drainage pipe of an unknown material through the levee, 26 feet below the crown. Concrete well and gate structure on the waterside (WS) slope. Concrete headwalls on both ends. [Additional Reference(s): DWR Levee Log, 1990. USACE Sacramento O&M Manual 121, May 1959, (HLM 2.3) (6-foot by 6-foot concrete culvert listed)]. FS Date: 4/2/2013

Slide gates in concrete vault on WS slope.

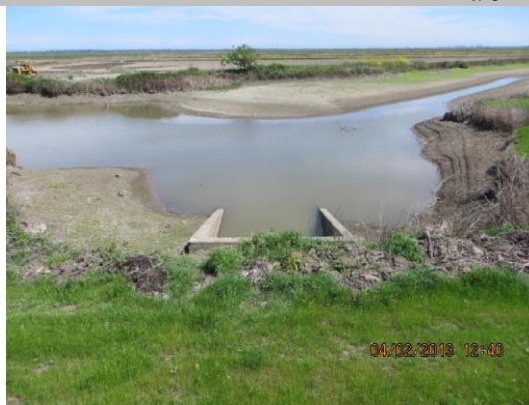
Photo 3 of 3 : UCIP\_SP\_2019\_10934\_18228.jpg

Concrete headwall on WS toe.

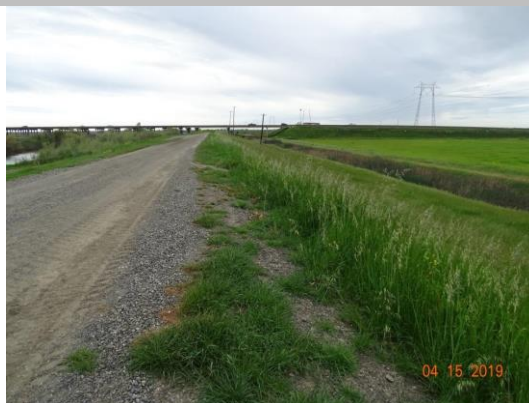
Photo 1 of 1 : SP\_2019\_RD2035\_239\_18\_20190422\_00028.jpg

LM Start	2.20	Rating **	M	Issue No.	18
LM End	6.30	Issue Type +	Ma	Location *	LS
Category	Earthen Levee			GPS Latitude/Longitude	
				Start	End
Item	Vegetation			38.645858 °	38.593535 °
				-121.666110 °	-121.631253 °
DWR ID	DWR_RD2035_02_s_2019_18				
Comment Code					
V1 : Control annual grass and weeds on the levee slopes and easements.					
Inspector Comment

View of vegetation on the landside slope. Spring 2019.

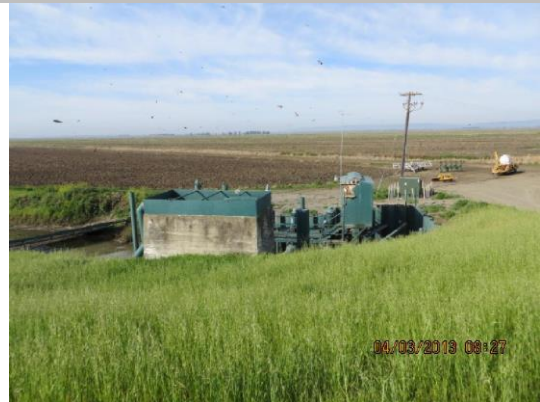
Photo 1 of 3 : UCIP\_SP\_2019\_11526\_18935.jpg

Comment Code						
Inspector Comment						
FS_ID:11526 DS_ID:17828 EP_NO: 1701 Repair Type: Non-Urgent Crossing Status: Found UCIP Comments: 04/03/2013 Animal activity at outlet causing damage to berm and undermining the pipe at the outlet headwall on WS toe. (W. Wylie - DWR UCIP) FIELD_STRUCT_DESC: 60-inch corrugated metal drainage pipe encased in 6 inches of reinforced concrete through the levee, 20.6 feet below the crown. Slide gate in a 7-foot-diameter corrugated metal pipe (CMP) riser on the waterside (WS) slope. Pumping plant with 6 pumps and pipes that discharge into a 4-foot by 18-foot surge box on the landside (LS) toe. (drainage pumping plant, 60-inch pipe, authorized under Permit No. 1701, 1952 - Reclamation District No. 2035). [Additional Reference(s): DWR Levee Log, 1990. USACE Sacramento O&M Manual 121, May 1959, (HLM 4.7)]. FS Date: 4/3/2013

Surge box and pumping plant on LS toe.

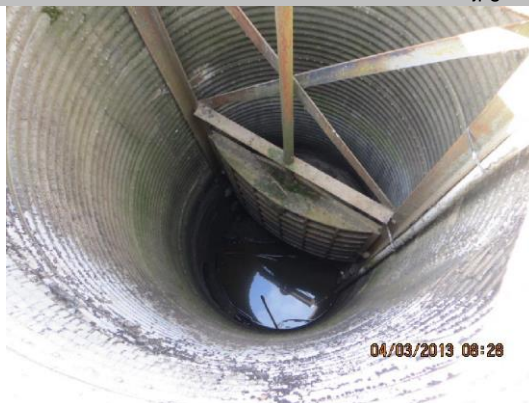
Photo 3 of 3 : UCIP\_SP\_2019\_11526\_18933.jpg

7-foot diameter CMP riser and slide gate on WS slope.

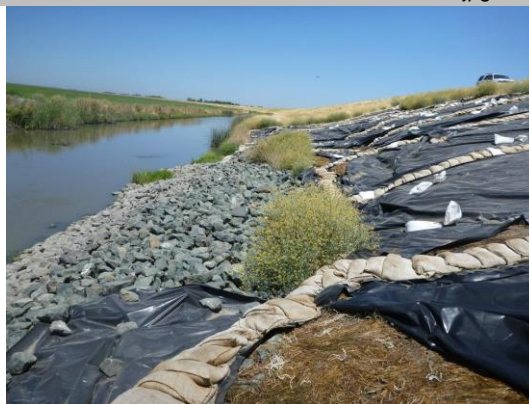
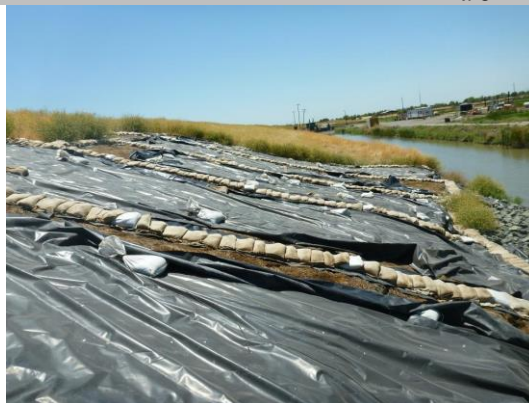
Notes: long longitudinal cracks on the crown. Scheduled for repair in 2020.

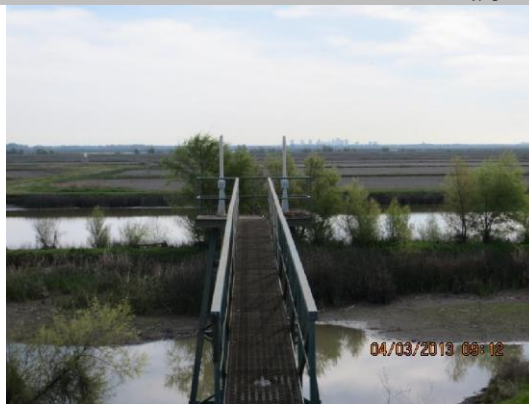
Photo 1 of 3 : UCIP\_SP\_2019\_50089\_18327.jpg

Steel walkway to slide gates on WS shoulder.

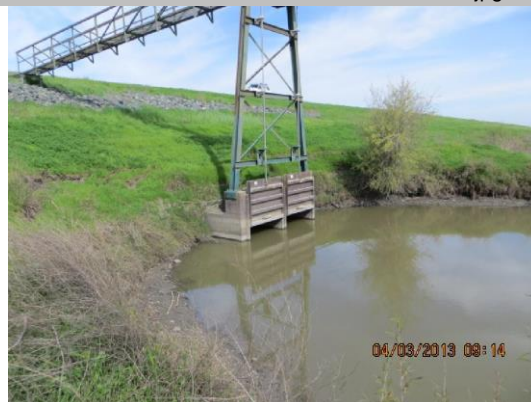
Photo 3 of 3 : UCIP\_SP\_2019\_50089\_18325.jpg

Slide gates at WS toe.

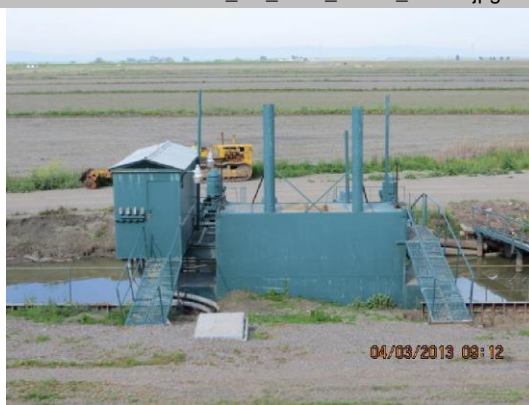
Photo 2 of 3 : UCIP\_SP\_2019\_50088\_18320.jpg

Surge box and pumping plant on LS toe.

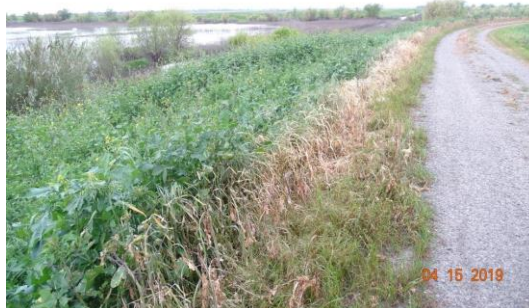
Photo 1 of 1 : SP\_2019\_RD2035\_240\_6\_20190422\_00015.jpg

View of vegetation on the waterside slope. Spring 2019.

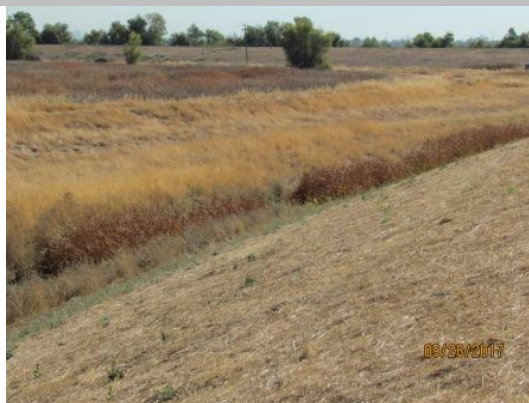
Photo 1 of 1 : SP\_2019\_RD2035\_240\_973\_20190304\_00003.jpg

View looking downstream of the landside ditch at the levee toe, Fall 2017.

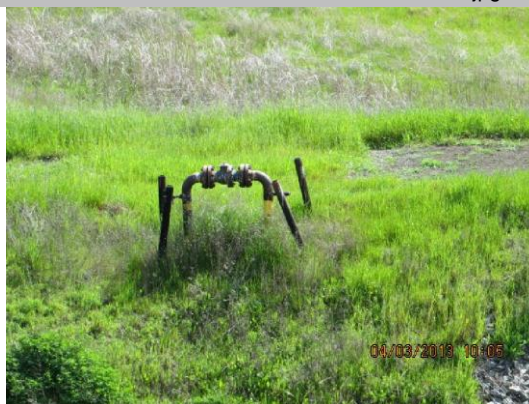
Photo 2 of 3 : UCIP\_SP\_2019\_53430\_18344.jpg

Gasline vent off LS toe.

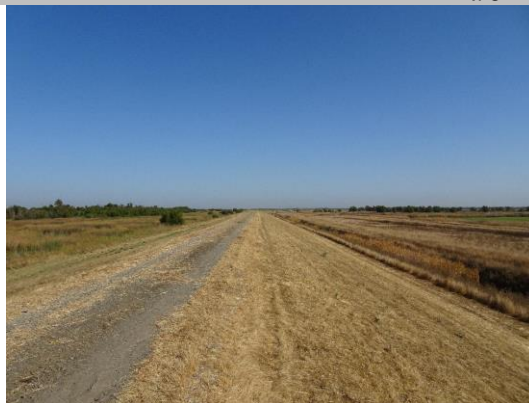
Photo 3 of 3 : UCIP\_SP\_2019\_53430\_75935.jpg

View along the levee crown looking approximately north. The WS of the levee is on the left. The LS is on the right.

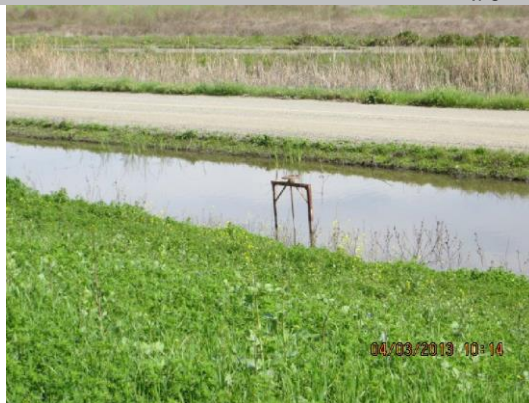
Photo 1 of 3 : UCIP\_SP\_2019\_41128\_18348.jpg

Slide gate and headwall in canal at LS toe.

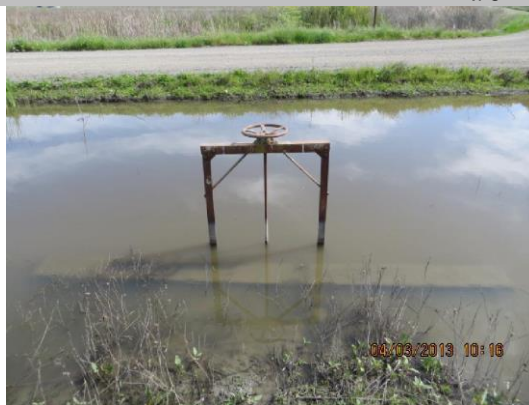
Photo 2 of 3 : UCIP\_SP\_2019\_41128\_18347.jpg

Slide gate and headwall in canal at LS toe.

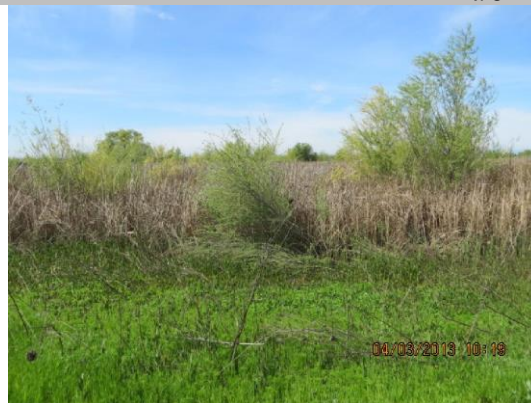
Photo 3 of 3 : UCIP\_SP\_2019\_41128\_18346.jpg

Vegetated area blocks access to WS of pipe.

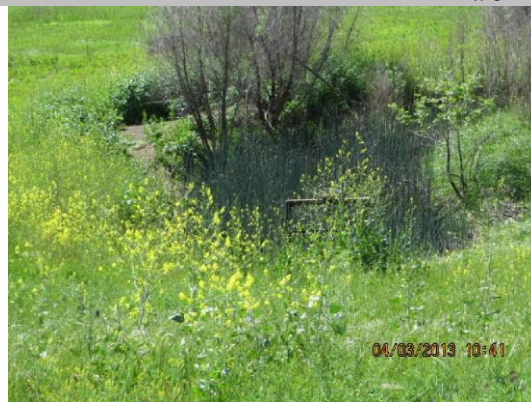
Photo 1 of 2 : UCIP\_SP\_2019\_11011\_18354.jpg

Slide gate at WS toe showing excessive vegetation.

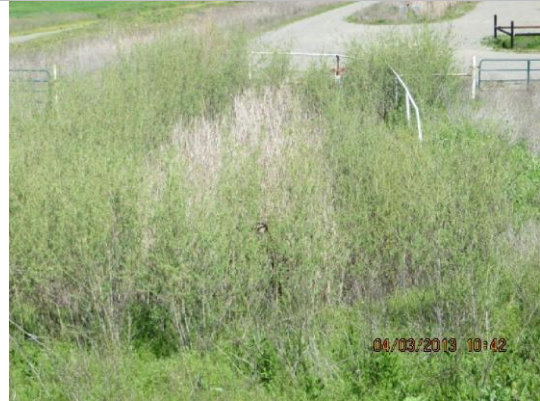
Photo 2 of 2 : UCIP\_SP\_2019\_11011\_18353.jpg

Slide gate at LS toe showing excessive vegetation.

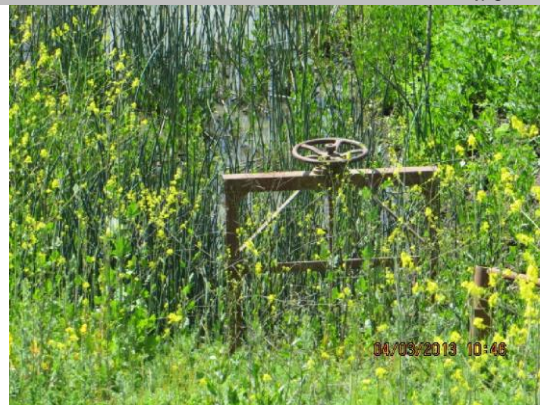
Photo 1 of 3 : UCIP\_SP\_2019\_11012\_18357.jpg

Combination flap and slide gate on WS toe. With excessive vegetation

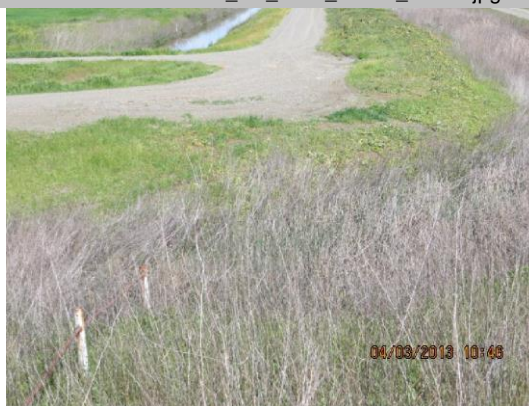
Photo 2 of 3 : UCIP\_SP\_2019\_11012\_18356.jpg

Headwall at bottom of fenceline on LS to.e

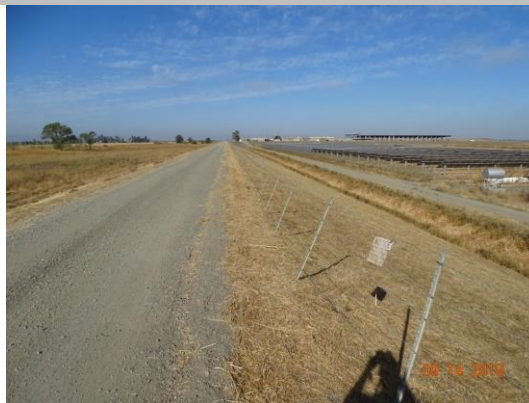
Photo 1 of 2 : SP\_2019\_RD2035\_240\_5\_20190304\_00001.jpg

View of fence on the landside shoulder of the crown. Fall 2018.

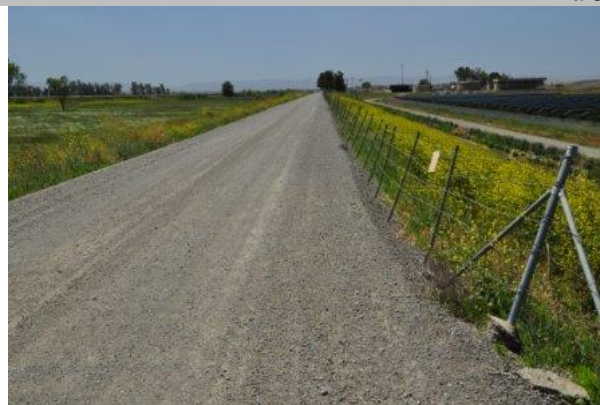
Photo 2 of 2 : SP\_2019\_RD2035\_240\_5\_20190304\_00002.jpg

Fence along the landside shoulder of the crown belongs to the treatment plant and has not changed from previous inspections, Fall 2017.
