**Flood Control Project Maintenance
Levee Inspections**
LMA District Cover Sheet
Spring 2020 Levee Inspection Results

Reclamation District No. 2035 Conaway

Spring 2020 Levee Inspection Results

Waterway			Bank	Unit Miles
Unit No. 01 Cache Creek Settling Basin			Right	2.01
	Spring (March - May)	Summer (June - August)	(September - November) Fall	Winter (December - February)
Unit Maintenance Rating (Fall Only)				
Date of Inspection	4/1/2020 - 4/1/2020			
DWR Inspector	Zach Jojola			
Accompanied By

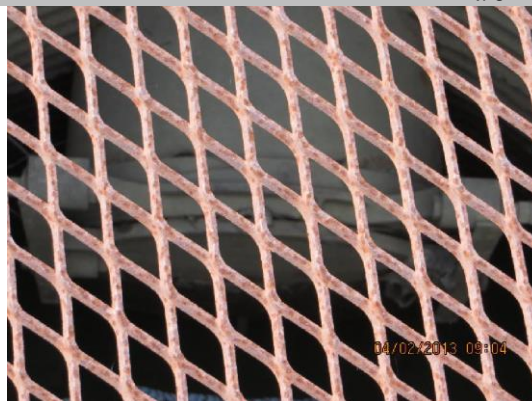
Photo 1 of 3 : UCIP_SP_2020_56045_18102.jpg

DS_ID:17819
FS_ID:56045
EP_NO: 4363
Repair Type: Non-Urgent
Crossing Status: Found
UCIP Comments: 08/16/2019 Pending update... record will be updated in 2020. (O. Magana - DWR UCIP)04/02/2013 This pipe appears abandoned and if so should be done so properly. (W. Wylie - DWR UCIP)
FIELD_STRUCT_DESC: *ABANDONED* 36-inch corrugated metal drainage pipe through the levee, 7.8 feet below the crown. 30-inch welded steel pipe sleeved through the 36-inch corrugated metal pipe (CMP) with annular space grouted. Flap gate in 72-inch corrugated metal pipe (CMP) riser at the waterside (WS) toe with abandoned pump platform on the south side of East Main Street. (30-inch drainage pipe sleeved through 36-inch conductor pipe through the railway embankment authorized under Permit No. 4363, 1963 - City of Woodland, City Engineer). [Additional Reference(s): DWR Levee Log, 1990].
FS Date: 8/16/2019 12:16:00 PM

Flap gate and pipe at bottom of 72-inch CMP riser on WS toe.

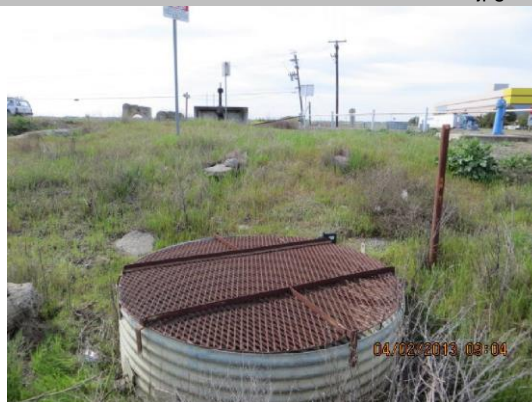
Photo 2 of 3 : UCIP_SP_2020_56045_18101.jpg

72-inch CMP riser on WS toe.

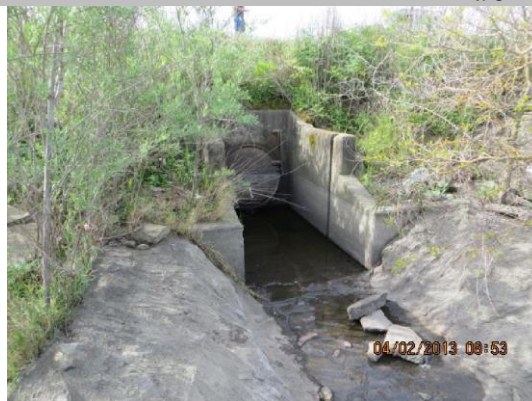
Photo 1 of 3 : UCIP_SP_2020_56049_18109.jpg

DS_ID:17814
 FS_ID:56049
 EP_NO: 10127
 Repair Type: No Action Needed
 Crossing Status: Found
 UCIP Comments: 08/16/2019 Pending update... record will be updated in 2020. (O. Magana - DWR UCIP)
 FIELD_STRUCT_DESC: 42-inch concrete encased corrugated metal drainage pipe through the levee, 10 feet below the crown. Flap gate on the waterside (WS) end. Grouted spillway on the WS. Pipe exposed on the landside (LS). (36-inch pipe [HLM 0.02] authorized under Automatic Board Order (ABO) issued as Permit No. 10127, 1974 - City of Woodland, Department of Public Works). [Additional Reference(s): DWR Levee Log, 1990. USACE Sacramento O&M Manual 126, November 1961, (HLM 0.01), listed as 5.5 feet below the crown].
 FS Date: 8/16/2019 12:20:00 PM

Flap gate and spillway on WS toe.

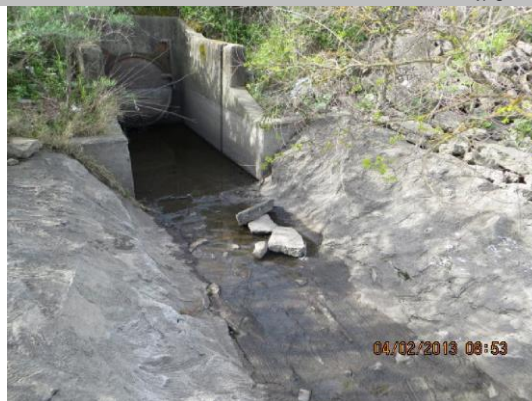
Photo 2 of 3 : UCIP_SP_2020_56049_18108.jpg

Flap gate and spillway on WS toe.

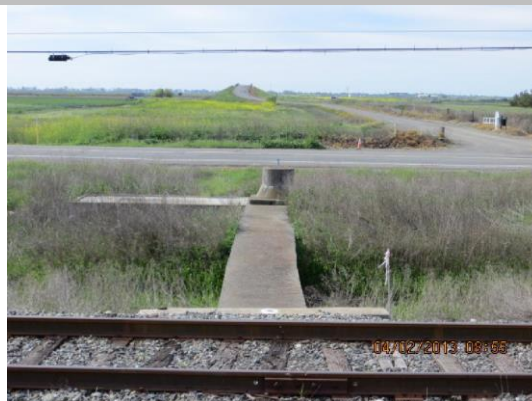
Photo 3 of 3 : UCIP_SP_2020_56049_18107.jpg

Concrete encased pipe on LS toe.

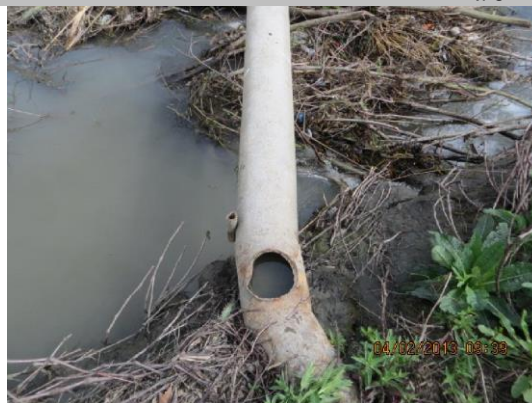
Photo 1 of 3 : UCIP_SP_2020_56056_18115.jpg

Comment Code					
Inspector Comment					
DS_ID:17816 FS_ID:56056 EP_NO: 12597 Repair Type: Non-Urgent Crossing Status: Found UCIP Comments: 08/16/2019 Pending update... record will be updated in 2020. (O. Magana - DWR UCIP)04/02/2013 Pipe appears abandoned and if so should be done so properly. (W. Wylie - DWR UCIP) FIELD_STRUCT_DESC: *ABANDONED* 18-inch steel conductor pipe for floating silt dredge through the levee, 3.4 feet below the crown. 10-inch steel pipe sleeved through the 18-inch steel conductor pipe with annular space grouted. Siphon breaker on the waterside (WS) shoulder in steel riser. (18-inch conductor pipe installed under the railroad fill by boring and 10-inch pipe sleeved through conductor pipe authorized under Permit No. 12597, 1978 - Reclamation District No. 2035). [Additional Reference(s): DWR Levee Log, 1990]. FS Date: 8/16/2019 12:20:00 PM

Exposed pipe at WS toe/stream.

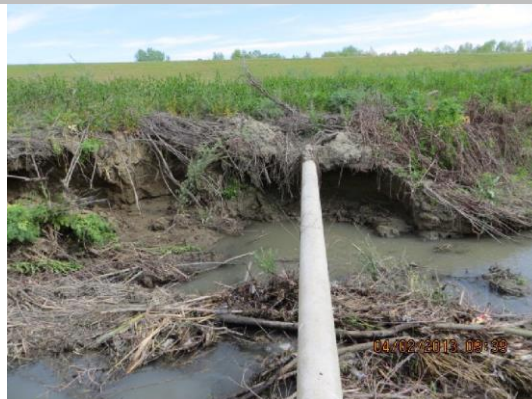
Photo 2 of 3 : UCIP_SP_2020_56056_18114.jpg

Exposed pipe at WS toe/stream.

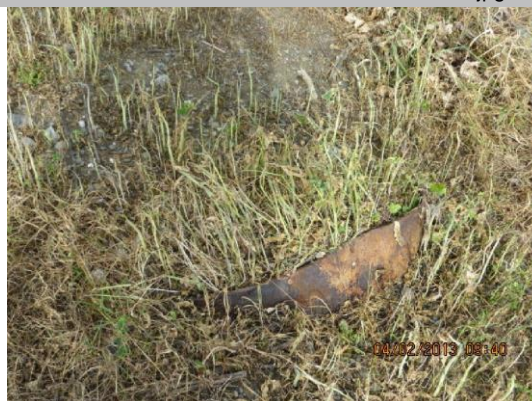
Photo 3 of 3 : UCIP_SP_2020_56056_18113.jpg

Buried steel riser on WS shoulder

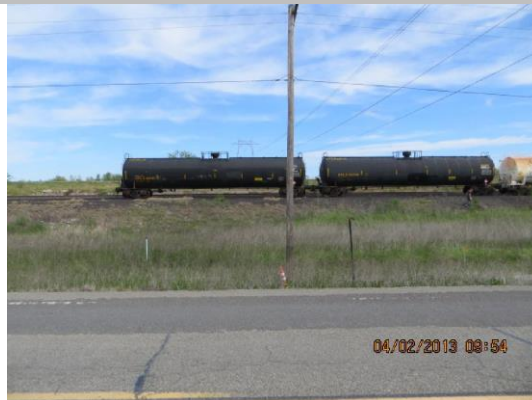
Photo 2 of 2 : UCIP_SP_2020_56059_18187.jpg

Vent pipe to right of JP next to Old River Road.

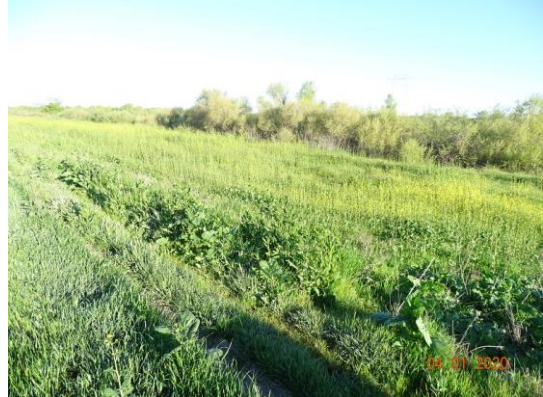
Photo 1 of 1 : SP_2020_RD2035_238_10_20200401_00013.jpg

View of dense vegetation on the waterside slope. Spring 2020.

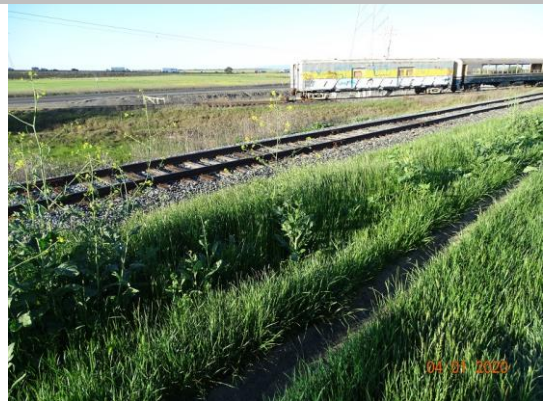
Photo 1 of 1 : SP_2020_RD2035_238_9_20200401_00014.jpg

LM Start	1.93	Rating **	U	Issue No.	9
LM End	2.00	Issue Type +	Ma	Location *	LS
Category	Earthen Levee			GPS Latitude/Longitude	
				Start	End
Item	Vegetation			38.677176 °	38.677172 °
				-121.674258 °	-121.672921 °
DWR ID	DWR_RD2035_01_s _ 2020_9				
Comment Code					
V1 : Control annual grass and weeds on the levee slopes and easements.					
Inspector Comment

View of dense vegetation on the landside slope. Spring 2020.

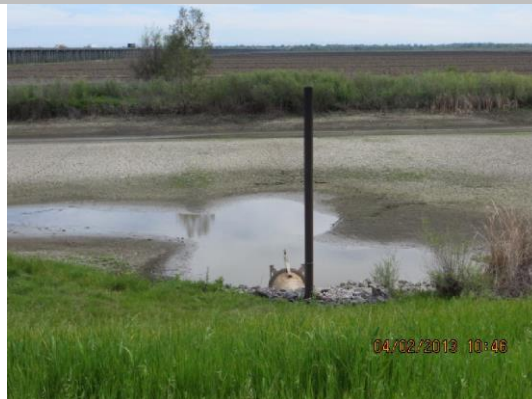
Photo 2 of 3 : UCIP_SP_2020_56053_18201.jpg

Pipe and flap gate with vent riser on WS toe.

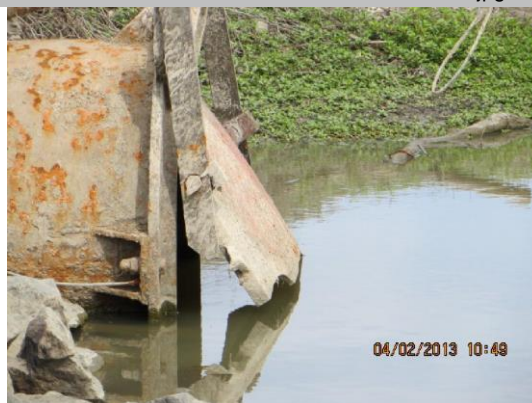
Photo 3 of 3 : UCIP_SP_2020_56053_18200.jpg

Broken flap gate at WS toe.

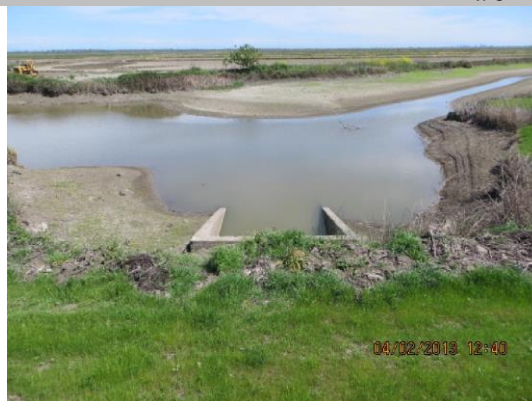
Photo 3 of 3 : UCIP_SP_2020_10933_18224.jpg

Outlet on WS toe.

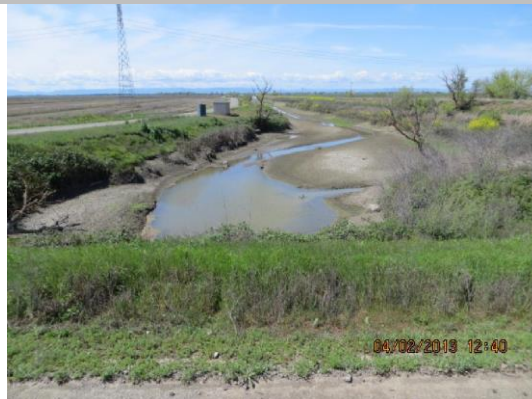
Photo 2 of 3 : UCIP_SP_2020_10934_18229.jpg

Intake at channel on LS toe.

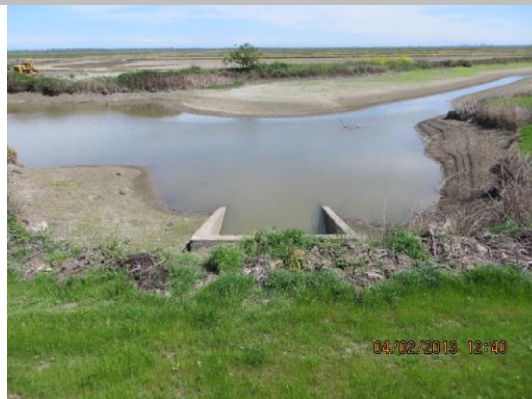
Photo 3 of 3 : UCIP_SP_2020_10934_18228.jpg

Concrete headwall on WS toe.

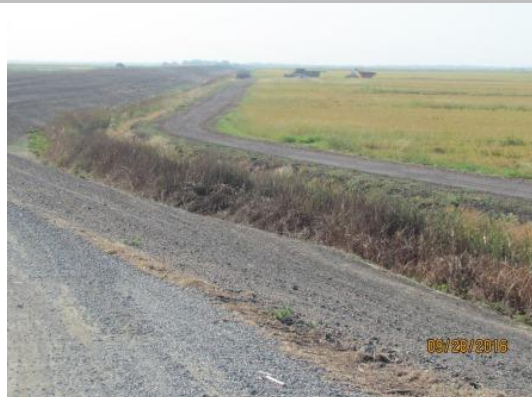
Photo 1 of 1 : SP_2020_RD2035_239_979_20200228_00007.jpg

LM Start	2.18	Rating **	M	Issue No.	979
LM End	4.02	Issue Type +	En	Location *	LS
Category	Earthen Levee			GPS Latitude/Longitude	
				Start	End
Item	Encroachments			38.646063 °	38.623062 °
				-121.666332 °	-121.648925 °
DWR ID	DWR_RD2035_02_s_2012_979				
Comment Code					
DT : Ditch					
Inspector Comment					
A ditch is located at the landside toe of the levee.

View of the ditch on the landward side of the levee looking downstream.
Fall 2016.

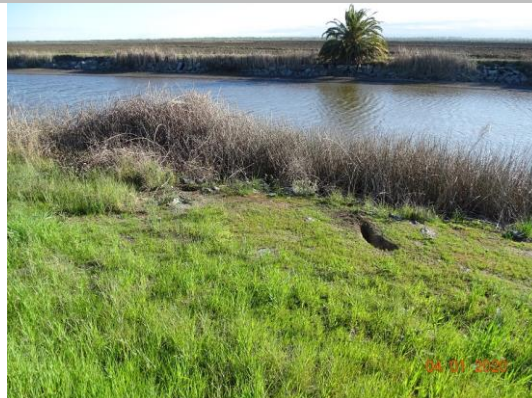
Photo 1 of 1 : SP_2020_RD2035_239_17_20200401_00029.jpg

LM Start	2.61	Rating **	A/W	Issue No.	17
LM End	2.61	Issue Type +	Ma	Location *	WS
Category	Earthen Levee			GPS Latitude/Longitude	
				Start	End
Item	Animal Control			38.640880 °	38.640880 °
				-121.662058 °	-121.662058 °
DWR ID	DWR_RD2035_02_s_2020_17				
Comment Code					
A3 : No rodents visible, but rodent burrows visible; need to backfill and compact or grout burrows.					
Inspector Comment					
Small rodent holes near waterside toe. Recommend monitoring.

View of rodent hole near waterside toe. Spring 2020.

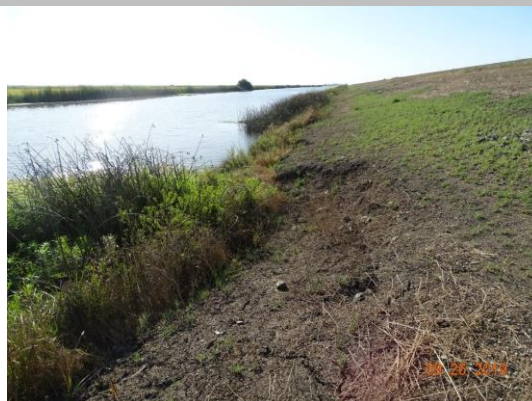
Photo 1 of 1 : SP_2020_RD2035_239_9_20200228_00001.jpg

LM Start	2.91	Rating **	M	Issue No.	9
LM End	2.91	Issue Type +	Ma	Location *	WS
Category	Earthen Levee			GPS Latitude/Longitude	
				Start	End
Item	Erosion / Bank Caving			38.637048 °	38.637048 °
				-121.659227 °	-121.659227 °
DWR ID	DWR_RD2035_02_f_2019_9				
Comment Code					
E2 : Schedule repair of erosion site prior to the next inspection.					
Inspector Comment					
Appears to be a 15' wide section of bank caving near the waterside toe. Recommend repairing.

View of bank caving on the waterside slope. Fall 2019.

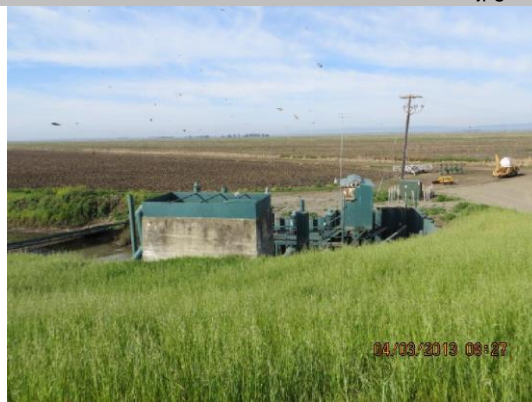
Photo 1 of 3 : UCIP_SP_2020_11526_18935.jpg

Comment Code						
Inspector Comment						
DS_ID:17828 FS_ID:11526 EP_NO: 1701 Repair Type: Non-Urgent Crossing Status: Found UCIP Comments: 04/03/2013 Animal activity at outlet causing damage to berm and undermining the pipe at the outlet headwall on WS toe. (W. Wylie - DWR UCIP) FIELD_STRUCT_DESC: 60-inch corrugated metal drainage pipe encased in 6 inches of reinforced concrete through the levee, 20.6 feet below the crown. Slide gate in a 7-foot-diameter corrugated metal pipe (CMP) riser on the waterside (WS) slope. Pumping plant with 6 pumps and pipes that discharge into a 4-foot by 18-foot surge box on the landside (LS) toe. (drainage pumping plant, 60-inch pipe, authorized under Permit No. 1701, 1952 - Reclamation District No. 2035). [Additional Reference(s): DWR Levee Log, 1990. USACE Sacramento O&M Manual 121, May 1959, (HLM 4.7)]. FS Date: 4/3/2013

Surge box and pumping plant on LS toe.

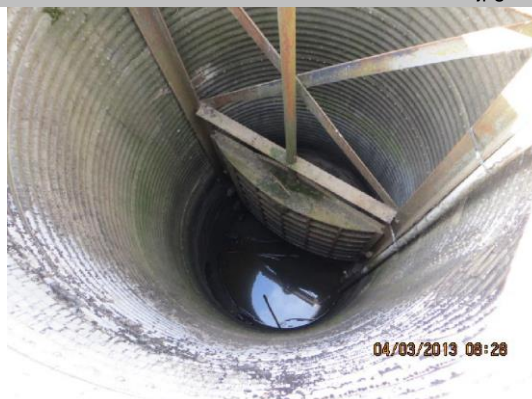
Photo 3 of 3 : UCIP_SP_2020_11526_18933.jpg

7-foot diameter CMP riser and slide gate on WS slope.

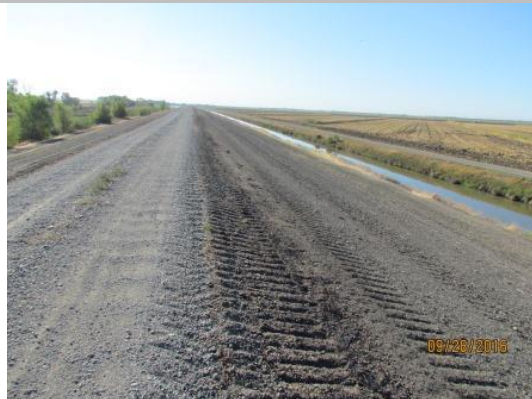
Photo 1 of 1 : SP_2020_RD2035_239_10_20200228_00002.jpg

LM Start	4.43	Rating **	M	Issue No.	10
LM End	6.57	Issue Type +	En	Location *	LS
Category	Earthen Levee			GPS Latitude/Longitude	
				Start	End
Item	Encroachments			38.617921 °	38.589619 °
				-121.645109 °	-121.631277 °
DWR ID	DWR_RD2035_02_s_2013_10				
Comment Code					
DT : Ditch					
Inspector Comment					
A ditch is located at the landside levee toe.

View of the drainage ditch on the landward side of the levee looking downstream. Fall 2016.

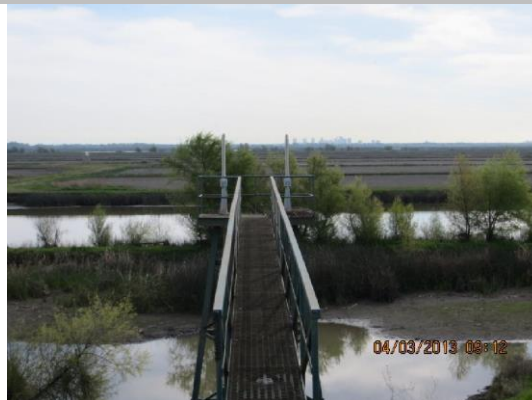
Photo 1 of 3 : UCIP_SP_2020_50089_18327.jpg

Comment Code					
Inspector Comment					
DS_ID:17868					
FS_ID:50089					
EP_NO: 16480					
Repair Type: Non-Urgent					
Crossing Status: Found					
UCIP Comments: 09/14/2016 - Erosion on the LS toe at the sheet pile walls for the pumping plant is still present. It does not appear to be significantly different than during the previous inspection. Erosion should be monitored, but at this time does not appear to result in a potential threat to levee integrity. (T. Hatch/UCIP)04/03/2013 - Erosion on LS toe at pumping plant. Severe erosion of sheet pile walls at pumping plant. (W. Wylie/UCIP)					
FIELD_STRUCT_DESC: 1 of 2: 60-inch by 48-inch reinforced concrete box drainage culvert through the levee, 22 feet below the crown. Steel walkway to the slide gate handles on the waterside (WS) shoulder. 6-foot by 18-foot surge box and pumping plant on the landside (LS) toe. This culvert replaced a 48-inch at the same location. (construct two 60-inch concrete box drainage conduits and remove two 48-inch pipelines, work authorized under Permit No. 16480, 1995 - Conaway Conservancy Group and Reclamation District No. 2035).

Steel walkway to slide gates on WS shoulder.

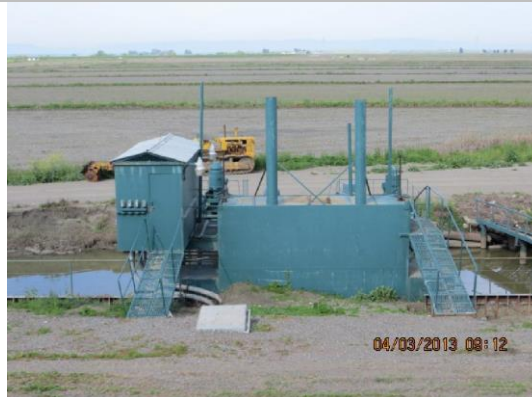
Photo 2 of 3 : UCIP_SP_2020_50089_18326.jpg

Pumping plant on LS toe.

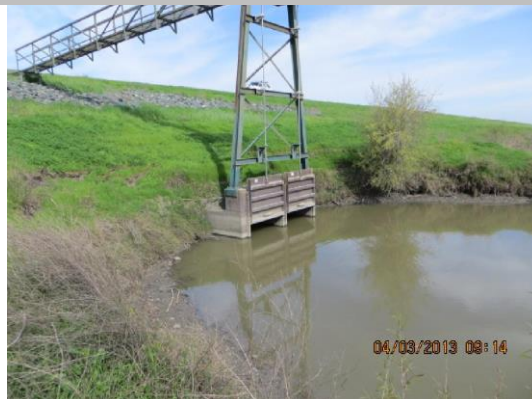
Photo 3 of 3 : UCIP_SP_2020_50089_18325.jpg

Slide gates at WS toe.

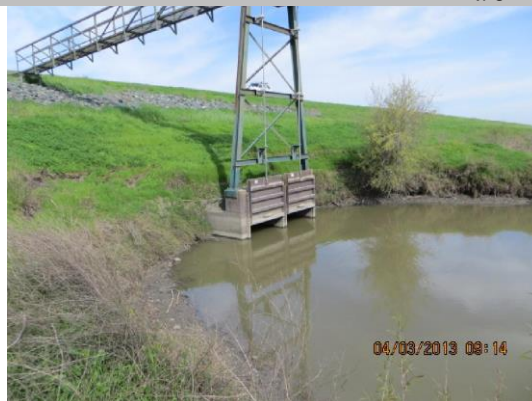
Photo 3 of 3 : UCIP_SP_2020_50088_18319.jpg

Slide gates at outlet on WS toe.

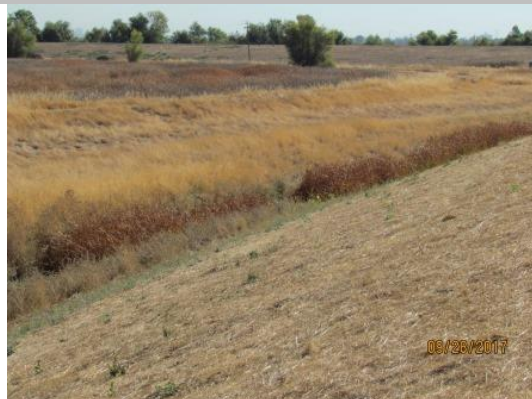
Photo 1 of 1 : SP_2020_RD2035_240_973_20200228_00002.jpg

View looking downstream of the landside ditch at the levee toe. Fall 2017.

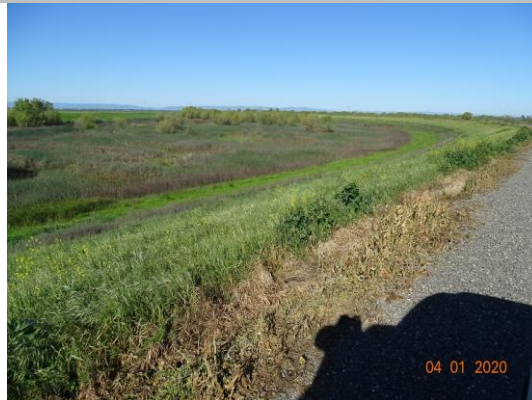
Photo 1 of 1 : SP_2020_RD2035_240_7_20200401_00014.jpg

View of vegetation on the waterside slope. Spring 2020.

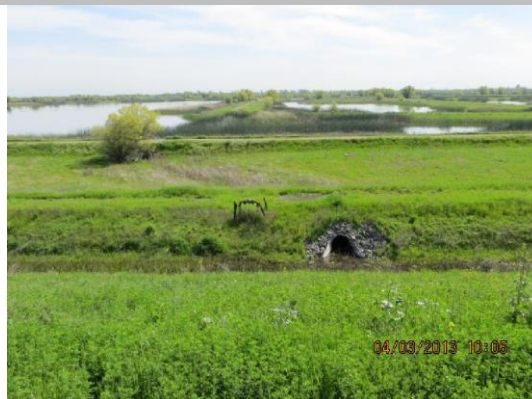
Photo 1 of 3 : UCIP_SP_2020_53430_18345.jpg

Gasline vent off LS toe.

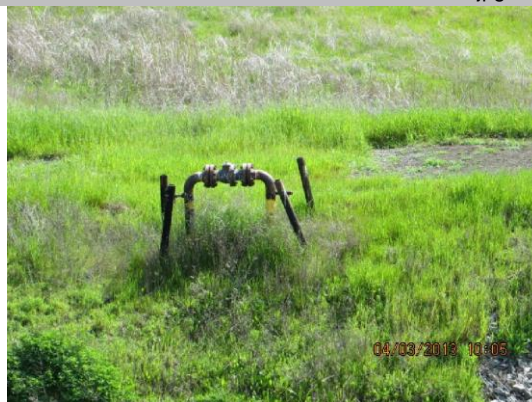
Photo 2 of 3 : UCIP_SP_2020_53430_18344.jpg

Gasline vent off LS toe.

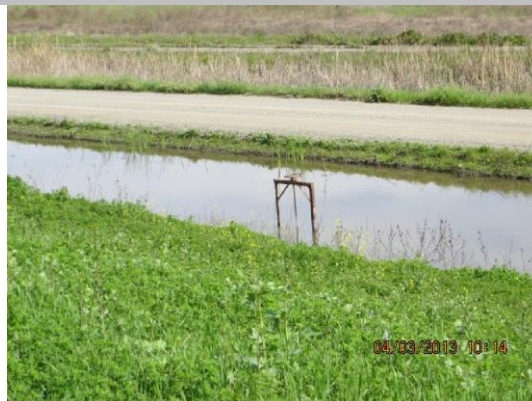
Photo 1 of 3 : UCIP_SP_2020_41128_18348.jpg

Slide gate and headwall in canal at LS toe.

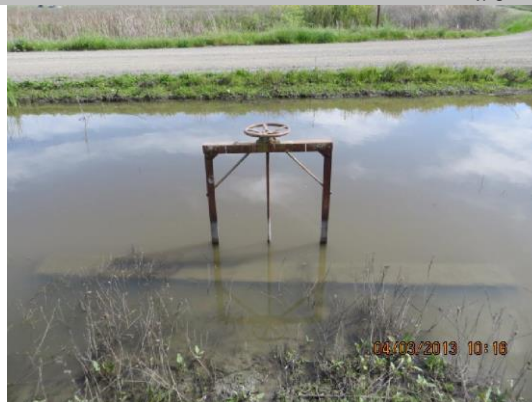
Photo 2 of 3 : UCIP_SP_2020_41128_18347.jpg

Slide gate and headwall in canal at LS toe.

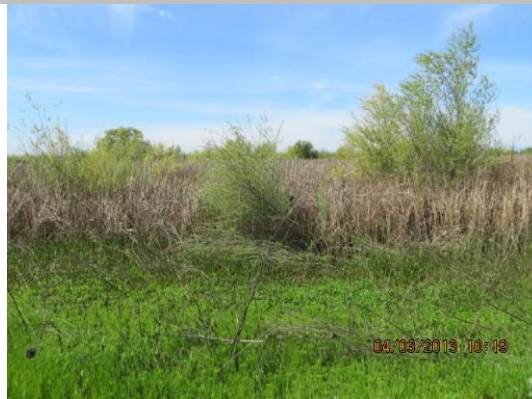
Photo 3 of 3 : UCIP_SP_2020_41128_18346.jpg

Vegetated area blocks access to WS of pipe.

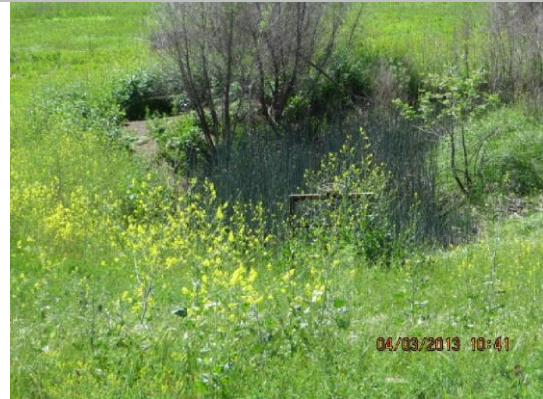
Photo 1 of 2 : UCIP_SP_2020_11011_18354.jpg

Slide gate at WS toe showing excessive vegetation.

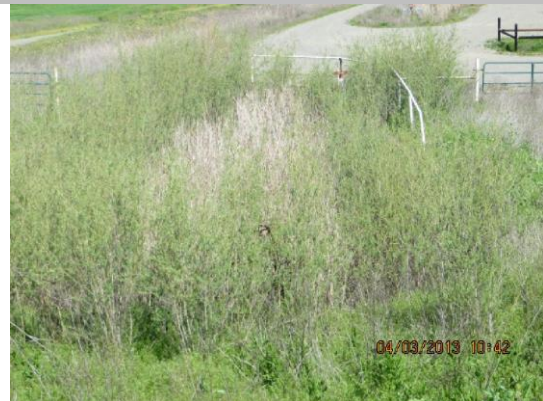
Photo 2 of 2 : UCIP_SP_2020_11011_18353.jpg

Slide gate at LS toe showing excessive vegetation.

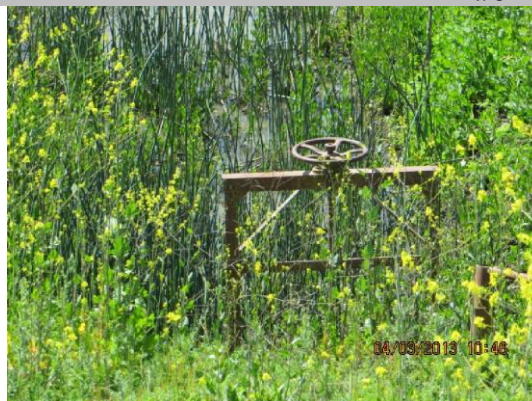
Photo 1 of 3 : UCIP_SP_2020_11012_18357.jpg

Combination flap and slide gate on WS toe. With excessive vegetation

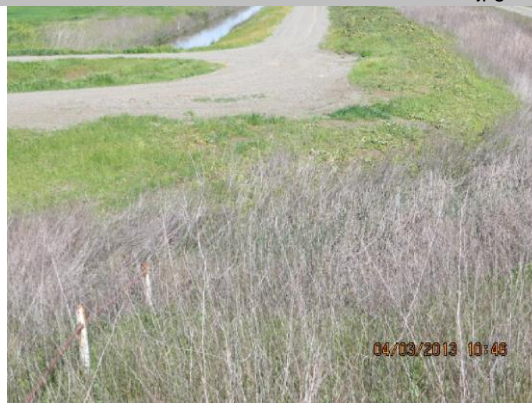
Photo 2 of 3 : UCIP_SP_2020_11012_18356.jpg

Headwall at bottom of fenceline on LS toe

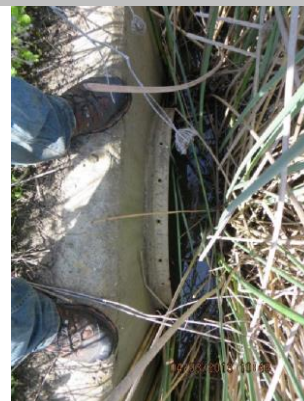
Photo 3 of 3 : UCIP_SP_2020_11012_18355.jpg

Headwall and pipe on LS toe.

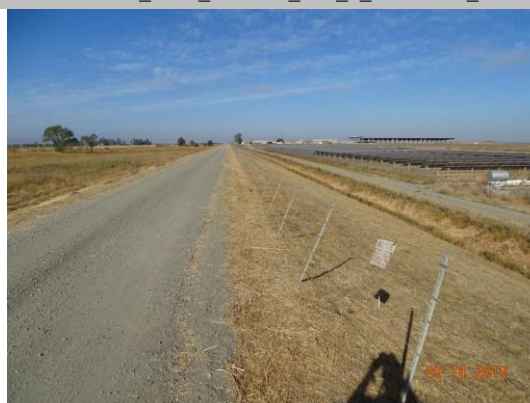
Photo 1 of 1 : SP_2020_RD2035_240_5_20200228_00001.jpg

View of fence on the landside shoulder of the crown. Fall 2018.
