**Flood Control Project Maintenance  
Levee Inspections  
LMA District Cover Sheet**

**Reclamation District No. 2035 Conaway**

**Flood Control Project Maintenance  
Levee Inspections**

**Levee Inspection Report By Mile - Spring 2021**

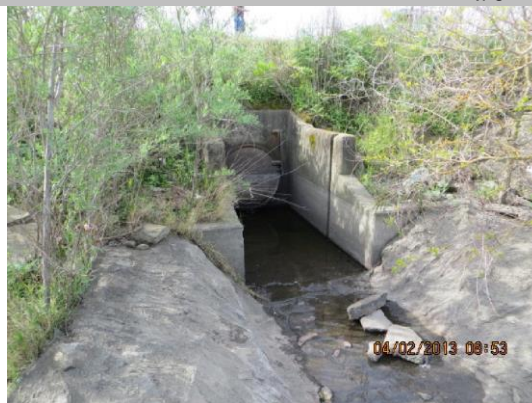
Photo 1 of 3 : UCIP\_SP\_2021\_56049\_18109.jpg

Comment Code						
Inspector Comment						
FS_ID:56049 DS_ID:17814 EP_NO: 10127 Repair Type: No Action Needed Crossing Status: Found UCIP Comments: 08/16/2019 Pending update... record will be updated in 2020. (O. Magana - DWR UCIP) FIELD_STRUCT_DESC: 42-inch concrete encased corrugated metal drainage pipe through the levee, 10 feet below the crown. Flap gate on the waterside (WS) end. Grouted spillway on the WS. Pipe exposed on the landside (LS). (36-inch pipe [HLM 0.02] authorized under Automatic Board Order (ABO) issued as Permit No. 10127, 1974 - City of Woodland, Department of Public Works). [Additional Reference(s): DWR Levee Log, 1990. USACE Sacramento O&M Manual 126, November 1961, (HLM 0.01), listed as 5.5 feet below the crown]. FS Date: 8/16/2019 12:20:00 PM

Flap gate and spillway on WS toe.

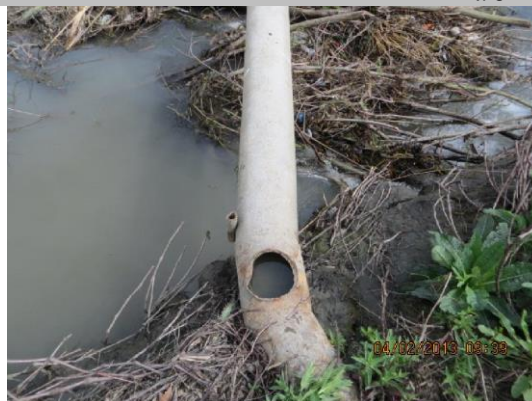
Photo 1 of 3 : UCIP\_SP\_2021\_56056\_18115.jpg

FS\_ID:56056  
DS\_ID:17816  
EP\_NO: 12597  
Repair Type: Non-Urgent  
Crossing Status: Found  
UCIP Comments: 08/16/2019 Pending update... record will be updated in 2020. (O. Magana - DWR UCIP)04/02/2013 Pipe appears abandoned and if so should be done so properly. (W. Wylie - DWR UCIP)  
FIELD\_STRUCT\_DESC: \*ABANDONED\* 18-inch steel conductor pipe for floating silt dredge through the levee, 3.4 feet below the crown. 10-inch steel pipe sleeved through the 18-inch steel conductor pipe with annular space grouted. Siphon breaker on the waterside (WS) shoulder in steel riser. (18-inch conductor pipe installed under the railroad fill by boring and 10-inch pipe sleeved through conductor pipe authorized under Permit No. 12597, 1978 - Reclamation District No. 2035).  
[Additional Reference(s): DWR Levee Log, 1990].  
FS Date: 8/16/2019 12:20:00 PM

Exposed pipe at WS toe/stream.

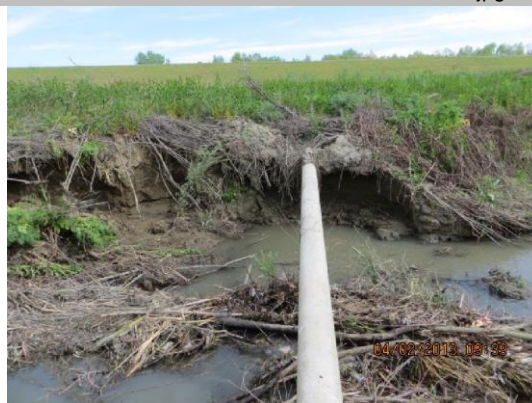
Photo 2 of 3 : UCIP\_SP\_2021\_56056\_18114.jpg

Exposed pipe at WS toe/stream.

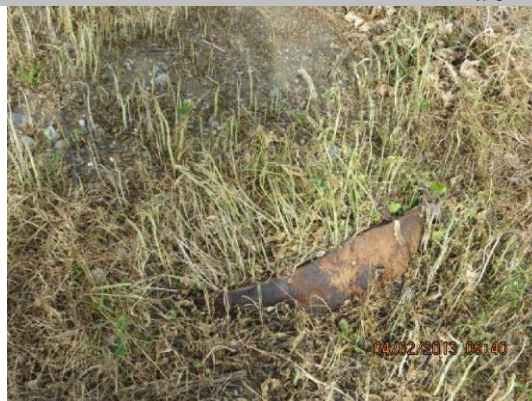
Photo 3 of 3 : UCIP\_SP\_2021\_56056\_18113.jpg

Burried steel riser on WS shoulder

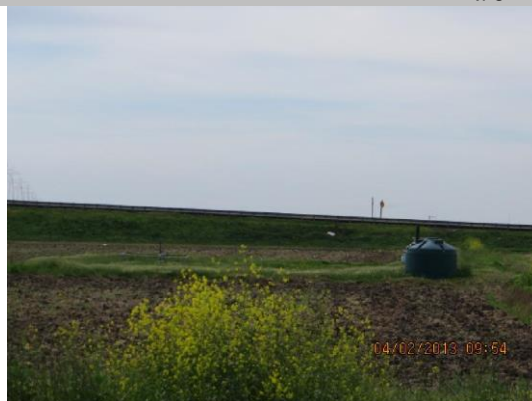
Photo 1 of 2 : UCIP\_SP\_2021\_56059\_18188.jpg

FS\_ID:56059  
 DS\_ID:17867  
 EP\_NO: 13201  
 Repair Type: Non-Urgent  
 Crossing Status: Indicator Found  
 UCIP Comments: 08/16/2019 Pending update... record will be updated in 2020. (O. Magana - DWR UCIP)04/02/2013 Pipe needs to be properly marked or abandoned. (W. Wylie - DWR UCIP)  
 FIELD\_STRUCT\_DESC: 8-inch casing of an unknown material through the levee, 25 feet below the crown. 3-inch gas line sleeved through the casing with annular space filled with bentonite. Possible vent for pipe on the landside (LS) next to Old River Road. (3-inch gas pipeline within an 8-inch casing authorized under Permit No. 13201, 1981 - Pacific Gas and Electric Company [PG&E]).  
 FS Date: 8/16/2019 12:21:00 PM

Natural gas well on south side of Old river road.

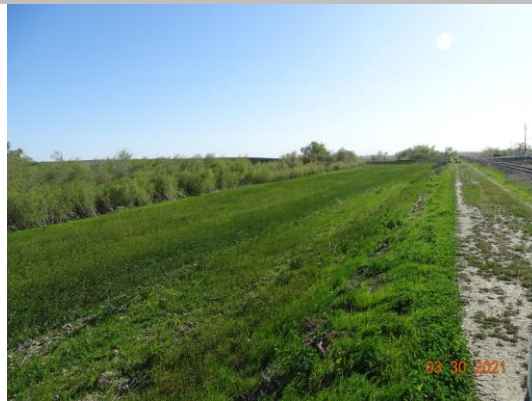
Photo 1 of 1 : SP\_2021\_RD2035\_238\_9\_20210330\_00013.jpg

LM Start	1.90	Rating **	A	Issue No.	9
LM End	1.90	Issue Type +	Ma	Location *	WS
Category	Earthen Levee			GPS Latitude/Longitude	
				Start	End
Item	Vegetation			38.677201 °	38.677201 °
				-121.674701 °	-121.674701 °
DWR ID	DWR_RD2035_01_s_2021_9				
Comment Code					
V1 : Control annual grass and weeds on the levee slopes and easements.					
Inspector Comment					
LMA maintains the vegetation at a high level.

View of maintained waterside slope. Spring 2021.

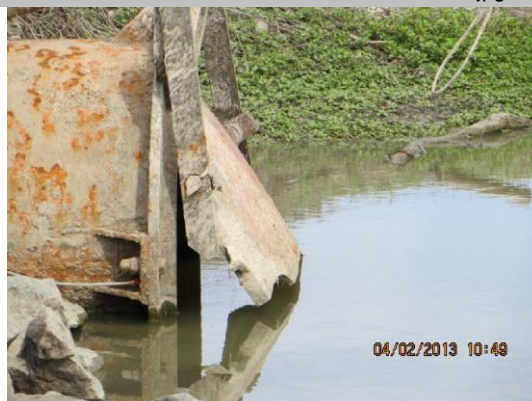
Photo 3 of 3 : UCIP\_SP\_2021\_56053\_18200.jpg

Broken flap gate at WS toe.

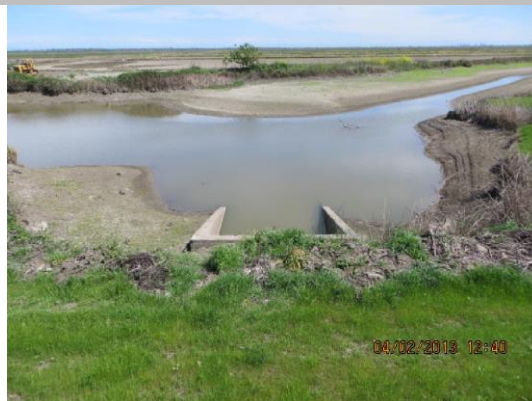
Photo 3 of 3 : UCIP\_SP\_2021\_10934\_18228.jpg

Concrete headwall on WS toe.

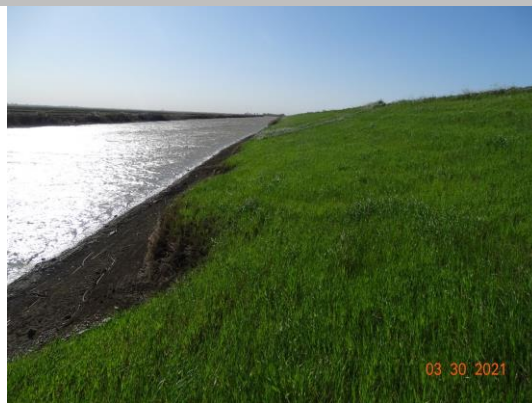
Photo 1 of 1 : SP\_2021\_RD2035\_239\_18\_20210330\_00026.jpg

LM Start	3.42	Rating **	M	Issue No.	18
LM End	3.42	Issue Type +	Ma	Location *	WS
Category	Earthen Levee			GPS Latitude/Longitude	
				Start	End
Item	Erosion / Bank Caving			38.630657 °	38.630657 °
				-121.654502 °	-121.654502 °
DWR ID	DWR_RD2035_02_s_2020_18				
Comment Code					
E2 : Schedule repair of erosion site prior to the next inspection.					
Inspector Comment					
Erosion at the waterside toe.

View of erosion at waterside toe. Spring 2021.

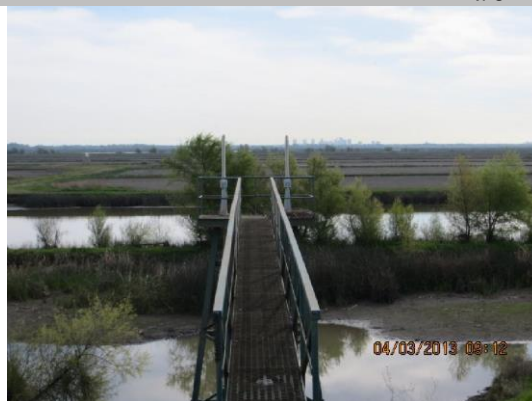
Photo 1 of 3 : UCIP\_SP\_2021\_50089\_18327.jpg

Comment Code						
Inspector Comment						
FS_ID:50089 DS_ID:17868 EP_NO: 16480 Repair Type: Non-Urgent Crossing Status: Found UCIP Comments: 09/14/2016 - Erosion on the LS toe at the sheet pile walls for the pumping plant is still present. It does not appear to be significantly different than during the previous inspection. Erosion should be monitored, but at this time does not appear to result in a potential threat to levee integrity. (T. Hatch/UCIP)04/03/2013 - Erosion on LS toe at pumping plant. Severe erosion of sheet pile walls at pumping plant. (W. Wylie/UCIP) FIELD_STRUCT_DESC: 1 of 2: 60-inch by 48-inch reinforced concrete box drainage culvert through the levee, 22 feet below the crown. Steel walkway to the slide gate handles on the waterside (WS) shoulder. 6-foot by 18-foot surge box and pumping plant on the landside (LS) toe. This culvert replaced a 48-inch at the same location. (construct two 60-inch concrete box drainage conduits and remove two 48-inch pipelines, work authorized under Permit No. 16480, 1995 - Conaway Conservancy Group and Reclamation District No. 2035). FS Date: 9/14/2016

Steel walkway to slide gates on WS shoulder.

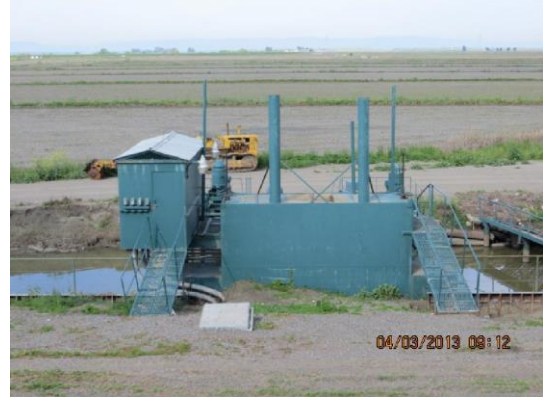
Photo 2 of 3 : UCIP\_SP\_2021\_50089\_18326.jpg

Pumping plant on LS toe.

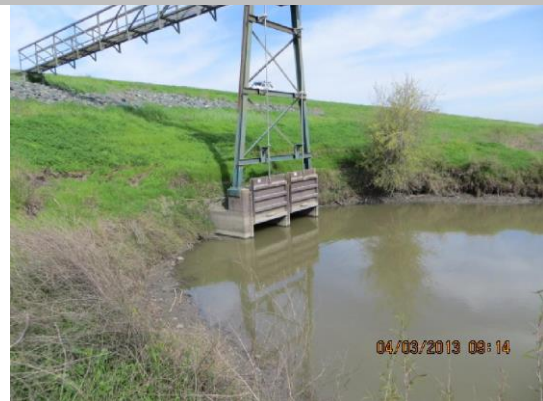
Photo 3 of 3 : UCIP\_SP\_2021\_50089\_18325.jpg

Slide gates at WS toe.

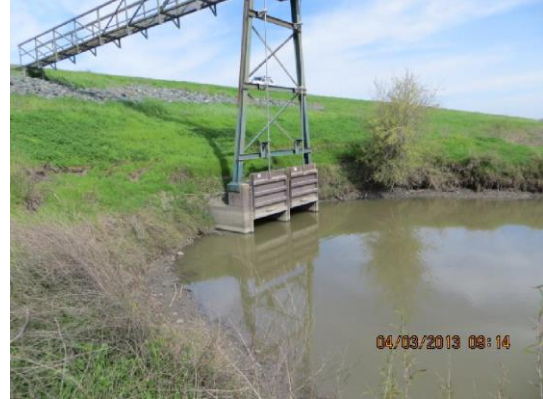
Photo 3 of 3 : UCIP\_SP\_2021\_50088\_18319.jpg

Slide gates at outlet on WS toe.

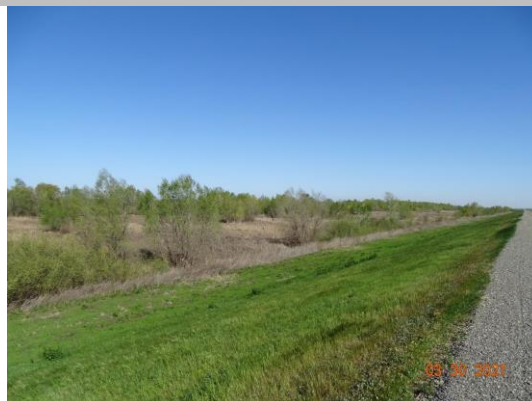
Photo 1 of 1 : SP\_2021\_RD2035\_240\_6\_20210330\_00014.jpg

View of maintained waterside slope. Spring 2021.

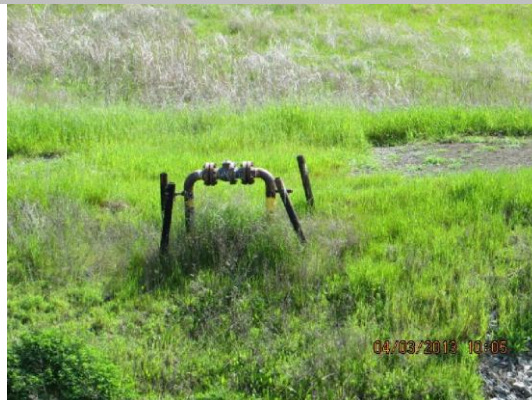
Photo 2 of 3 : UCIP\_SP\_2021\_53430\_18344.jpg

Gasline vent off LS toe.

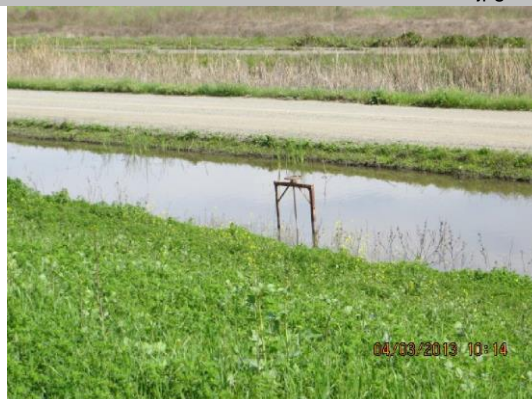
Photo 1 of 3 : UCIP\_SP\_2021\_41128\_18348.jpg

Slide gate and headwall in canal at LS toe.

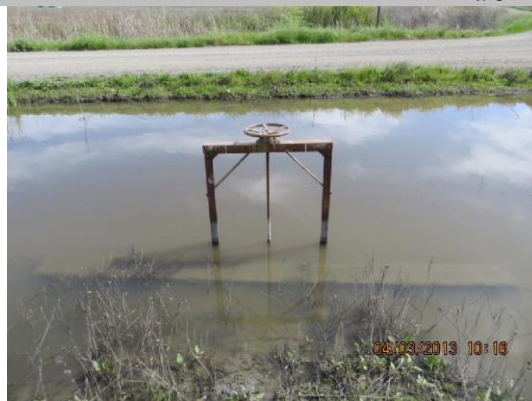
Photo 2 of 3 : UCIP\_SP\_2021\_41128\_18347.jpg

Slide gate and headwall in canal at LS toe.

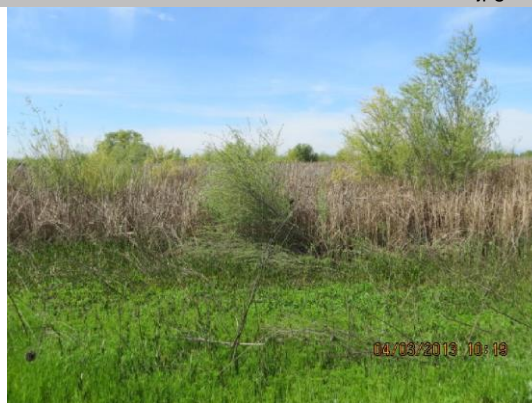
Photo 3 of 3 : UCIP\_SP\_2021\_41128\_18346.jpg

Vegetated area blocks access to WS of pipe.

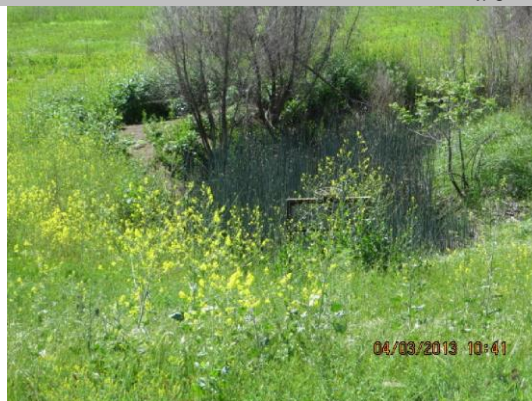
Photo 1 of 2 : UCIP\_SP\_2021\_11011\_18354.jpg

Slide gate at WS toe showing excessive vegetation.

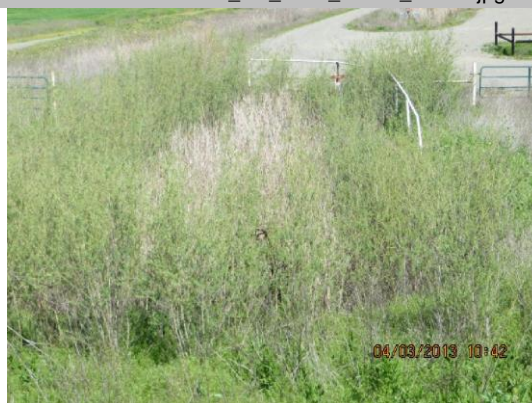
Photo 2 of 2 : UCIP\_SP\_2021\_11011\_18353.jpg

Slide gate at LS toe showing excessive vegetation.

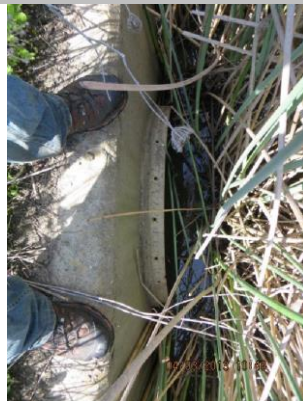
Photo 3 of 3 : UCIP\_SP\_2021\_11012\_18355.jpg

Headwall and pipe on LS toe.

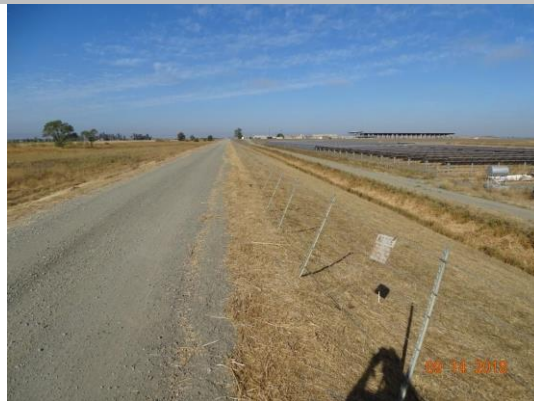
Photo 1 of 1 : SP\_2021\_RD2035\_240\_5\_20210308\_00001.jpg

View of fence on the landside shoulder of the crown. Fall 2018.
