**Flood Control Project Maintenance
Levee Inspections
LMA District Cover Sheet**

Reclamation District No. 2035 Conaway

**Flood Control Project Maintenance
Levee Inspections**

Levee Inspection Report By Mile - Spring 2022

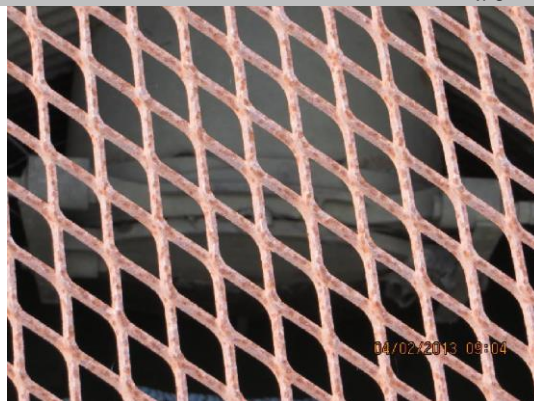
Photo 1 of 3 : UCIP_SP_2022_56045_18102.jpg

FS_ID:56045
DS_ID:17819
EP_NO: 4363
Repair Type: Non-Urgent
Crossing Status: Found
UCIP Comments: 08/16/2019 Pending update... record will be updated in 2020. (O. Magana - DWR UCIP)04/02/2013 This pipe appears abandoned and if so should be done so properly. (W. Wylie - DWR UCIP)
FIELD_STRUCT_DESC: *ABANDONED* 36-inch corrugated metal drainage pipe through the levee, 7.8 feet below the crown. 30-inch welded steel pipe sleeved through the 36-inch corrugated metal pipe (CMP) with annular space grouted. Flap gate in 72-inch corrugated metal pipe (CMP) riser at the waterside (WS) toe with abandoned pump platform on the south side of East Main Street. (30-inch drainage pipe sleeved through 36-inch conductor pipe through the railway embankment authorized under Permit No. 4363, 1963 - City of Woodland, City Engineer). [Additional Reference(s): DWR Levee Log, 1990].
FS Date: 8/16/2019 12:16:00 PM

Flap gate and pipe at bottom of 72-inch CMP riser on WS toe.

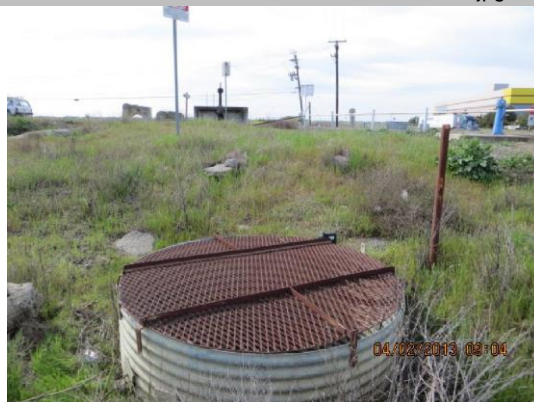
Photo 2 of 3 : UCIP_SP_2022_56045_18101.jpg

72-inch CMP riser on WS toe.

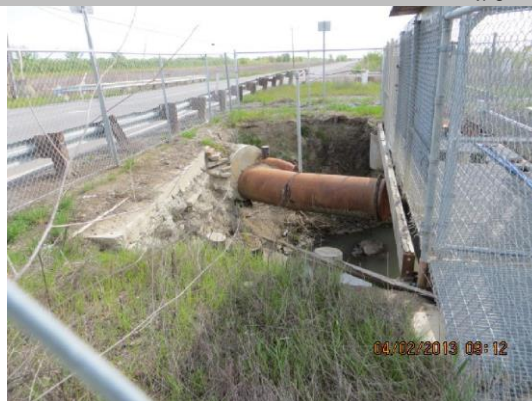
Photo 3 of 3 : UCIP_SP_2022_56045_18100.jpg

Pipe with 30-inch grouted at 200-feet LS of toe.

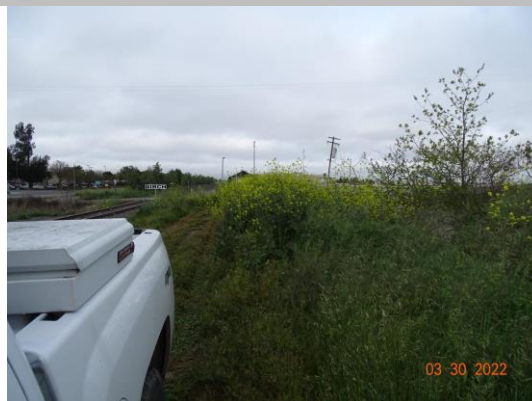
Photo 1 of 1 : SP_2022_RD2035_238_9_20220404_00013.jpg

LM Start	0.01	Rating **	U	Issue No.	9
LM End	0.03	Issue Type +	Ma	Location *	WS
Category	Earthen Levee			GPS Latitude/Longitude	
				Start	End
Item	Vegetation			38.677363 °	38.677362 °
				-121.709661 °	-121.709396 °
DWR ID	DWR_RD2035_01_s_2022_9				
Comment Code					
V1 : Control annual grass and weeds on the levee slopes and easements.					
Inspector Comment					
Tall mustard grass.

View of mustard grass on the waterside slope. Spring 2022.

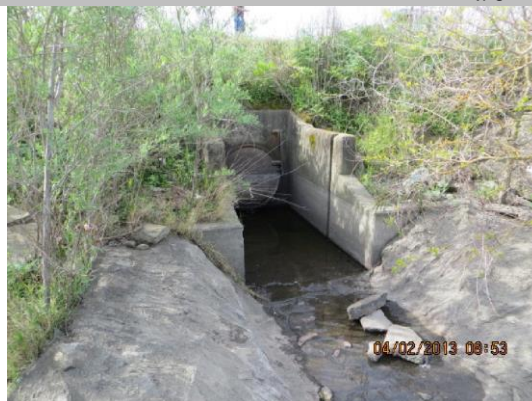
Photo 1 of 3 : UCIP_SP_2022_56049_18109.jpg

Flap gate and spillway on WS toe.

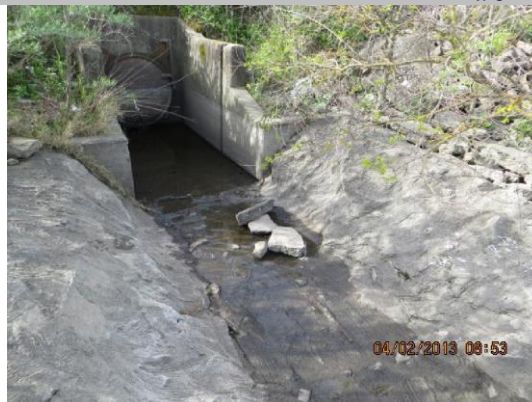
Photo 2 of 3 : UCIP_SP_2022_56049_18108.jpg

Flap gate and spillway on WS toe.

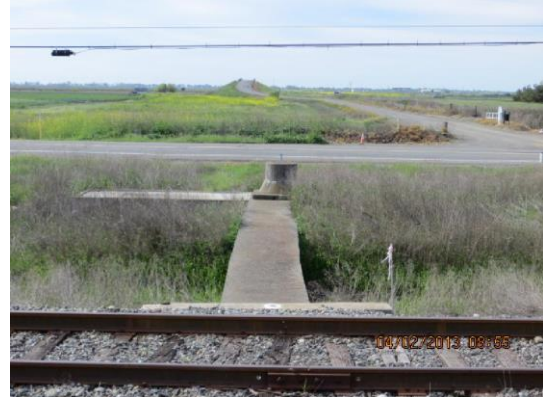
Photo 3 of 3 : UCIP_SP_2022_56049_18107.jpg

Concrete encased pipe on LS toe.

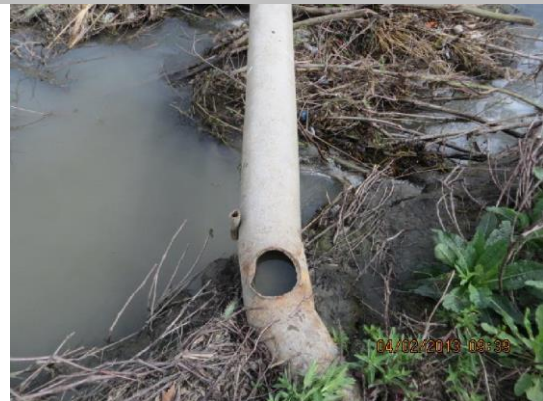
Photo 1 of 3 : UCIP_SP_2022_56056_18115.jpg

FS_ID:56056
DS_ID:17816
EP_NO: 12597
Repair Type: Non-Urgent
Crossing Status: Found
UCIP Comments: 08/16/2019 Pending update... record will be updated in 2020. (O. Magana - DWR UCIP)04/02/2013 Pipe appears abandoned and if so should be done so properly. (W. Wylie - DWR UCIP)
FIELD_STRUCT_DESC: *ABANDONED* 18-inch steel conductor pipe for floating silt dredge through the levee, 3.4 feet below the crown. 10-inch steel pipe sleeved through the 18-inch steel conductor pipe with annular space grouted. Siphon breaker on the waterside (WS) shoulder in steel riser. (18-inch conductor pipe installed under the railroad fill by boring and 10-inch pipe sleeved through conductor pipe authorized under Permit No. 12597, 1978 - Reclamation District No. 2035).
[Additional Reference(s): DWR Levee Log, 1990].
FS Date: 8/16/2019 12:20:00 PM

Exposed pipe at WS toe/stream.

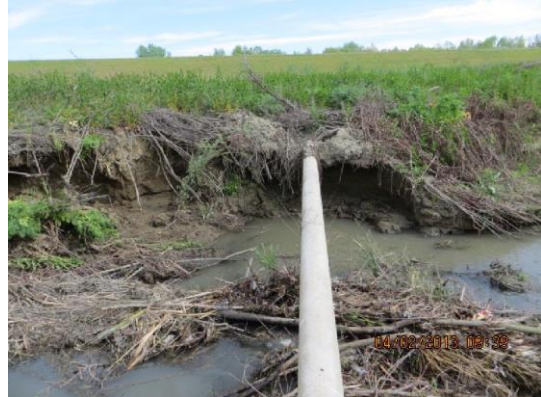
Photo 2 of 3 : UCIP_SP_2022_56056_18114.jpg

Exposed pipe at WS toe/stream.

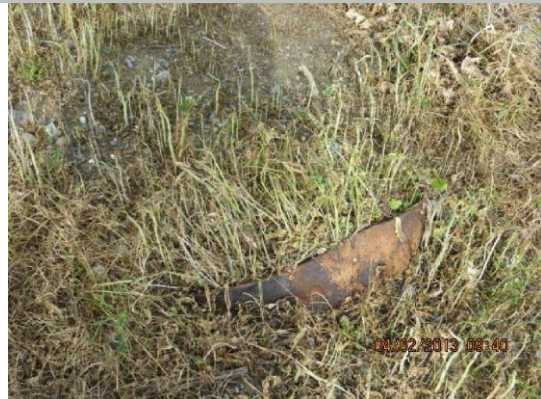
Photo 3 of 3 : UCIP_SP_2022_56056_18113.jpg

Buried steel riser on WS shoulder

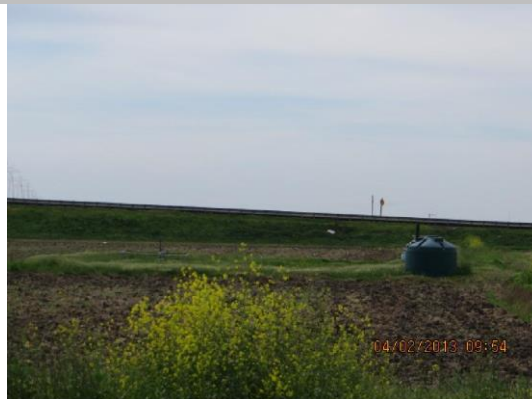
Photo 1 of 2 : UCIP_SP_2022_56059_18188.jpg

Natural gas well on south side of Old river road.

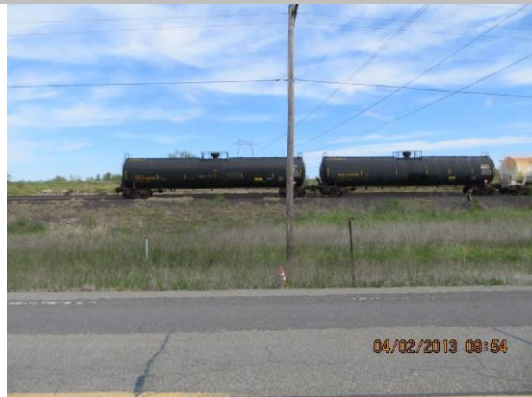
Photo 2 of 2 : UCIP_SP_2022_56059_18187.jpg

Vent pipe to right of JP next to Old River Road.

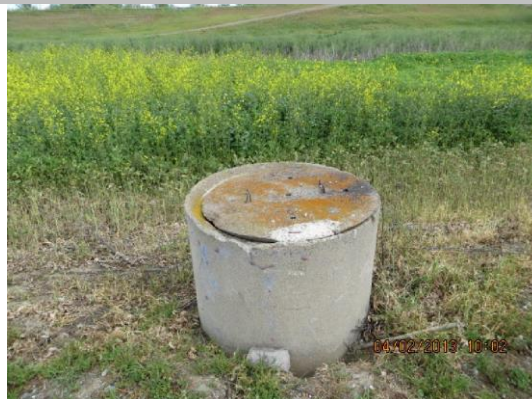
Photo 1 of 1 : UCIP_SP_2022_56060_18189.jpg

36-inch Concrete stand pipe on WS shoulder.

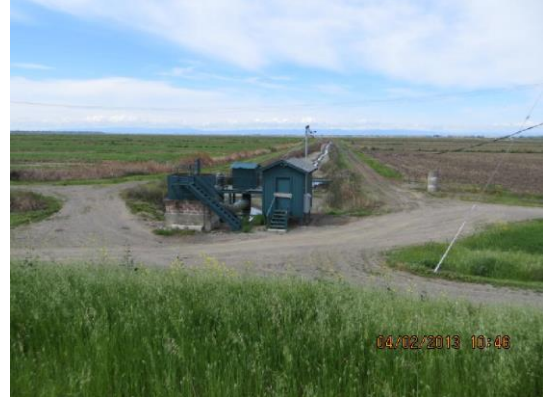
Photo 1 of 3 : UCIP_SP_2022_56053_18202.jpg

Pumping plant off LS toe.

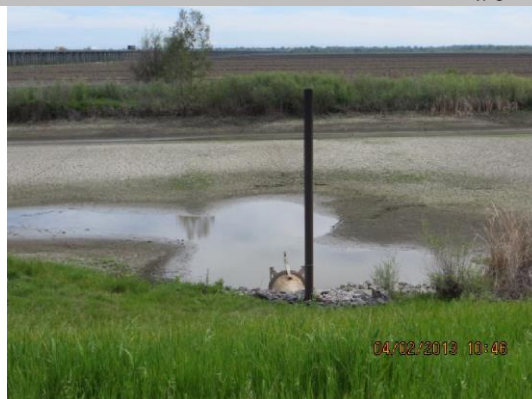
Photo 2 of 3 : UCIP_SP_2022_56053_18201.jpg

Pipe and flap gate with vent riser on WS toe.

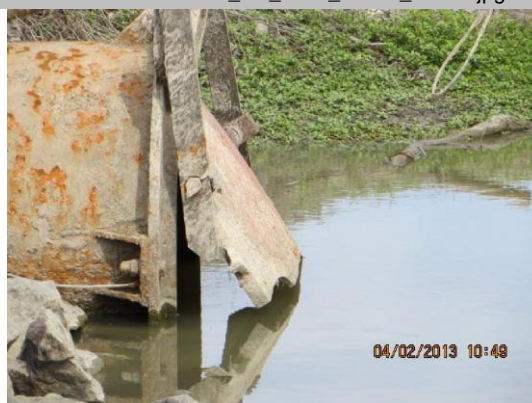
Photo 3 of 3 : UCIP_SP_2022_56053_18200.jpg

Comment Code						
Inspector Comment						
FS_ID:56053 DS_ID:17822 EP_NO: N/A Repair Type: Urgent Crossing Status: Found UCIP Comments: 08/16/2019 Pending update... record will be updated in 2020. (O. Magana - DWR UCIP)10/30/2018 Same as last inspection. Flap gate on the WS was submerged at the time of the inspection. Erosion is still present behind the headwall. Sink hole/burrow activity was observed along the concrete box located on the LS. Recommend internal inspection of the pipe section through levee to determine the condition of the pipe through the levee. Crossing remains Urgent due to signs of pipe leakage on LS. (O. Magana - DWR UCIP)09/14/2016 - Flap gate on the WS was submerged at time of inspection. LS headwall at the pumping plant has exposed rebar. There is still erosion present behind the headwall. However, water was present making it difficult to determine if it is getting worse. As-built drawings were requested from LMA consultant representative. (T. Hatch/UCIP)04/02/2013 - Flap gate broken in half on WS toe. Some erosion at headwalls on pumping plant. (W. Wylie/UCIP) FIELD_STRUCT_DESC: 44-inch corrugated metal drainage pipe through the levee, 22 feet below the crown. Pump on platform in drainage ditch at the landside (LS) toe. Slide gate and flap gates in a 5-foot by 9-foot concrete box. Flap gate on the waterside (WS) toe. 8-inch vent/standpipe at the WS toe. [Additional Reference(s): DWR Levee Log, 1990. USACE Sacramento O&M Manual 121, May 1959, (HLM 0.4) (4-foot by 4-foot concrete culvert listed)]. FS Date: 8/16/2019 12:25:00 PM

Broken flap gate at WS toe.

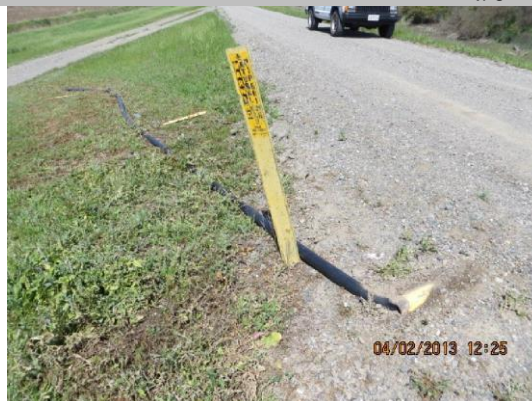
Photo 1 of 3 : UCIP_SP_2022_56057_18922.jpg

Pipe crossing with gasline marker on LS shoulder.

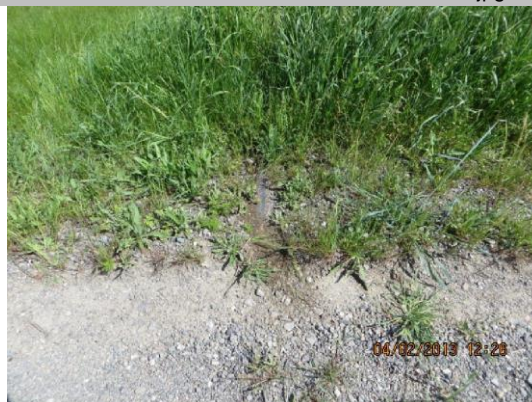
Photo 2 of 3 : UCIP_SP_2022_56057_18921.jpg

Pipe on WS shoulder.

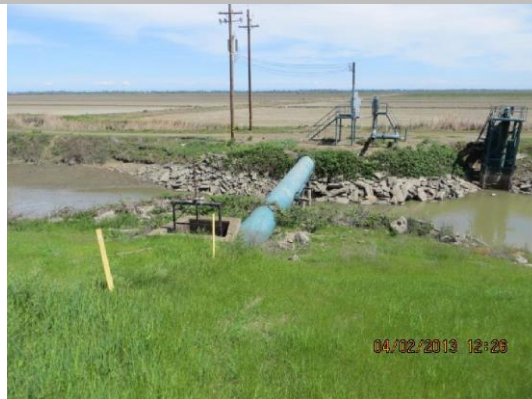
Photo 3 of 3 : UCIP_SP_2022_56057_18920.jpg

Pipe with gasline markers on WS slope.

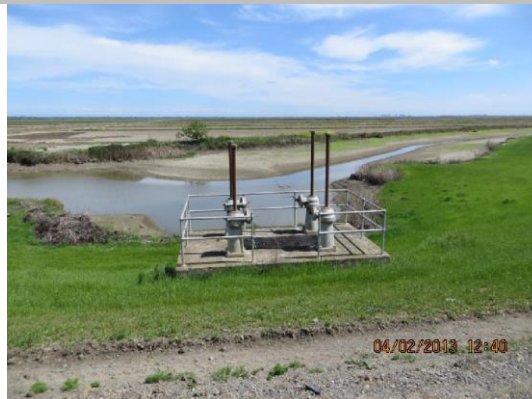
Photo 1 of 3 : UCIP_SP_2022_10933_18226.jpg

Slide gates in concrete vault on WS slope.

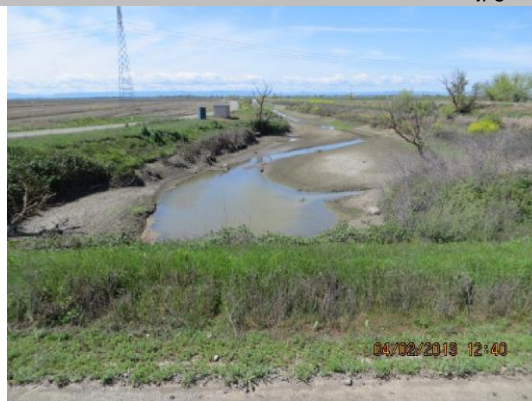
Photo 2 of 3 : UCIP_SP_2022_10933_18225.jpg

LS at intake.

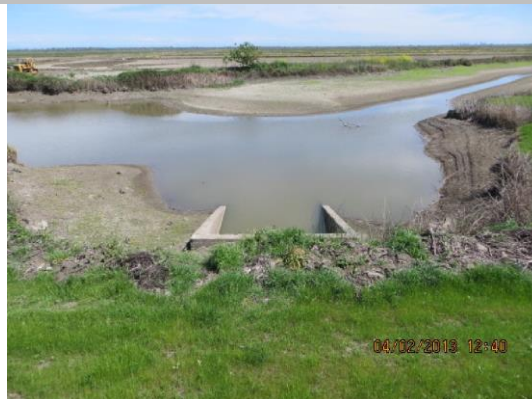
Photo 3 of 3 : UCIP_SP_2022_10933_18224.jpg

Outlet on WS toe.

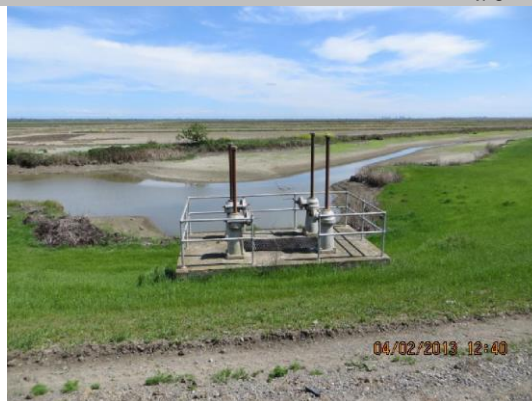
Photo 1 of 3 : UCIP_SP_2022_10934_18230.jpg

Slide gates in concrete vault on WS slope.

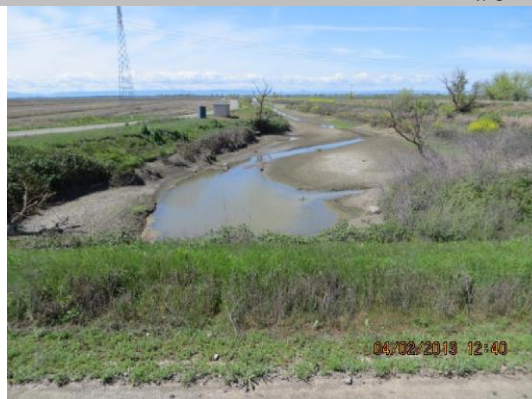
Photo 2 of 3 : UCIP_SP_2022_10934_18229.jpg

Intake at channel on LS toe.

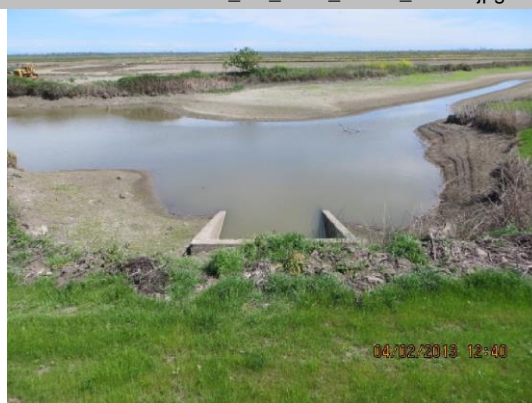
Photo 3 of 3 : UCIP_SP_2022_10934_18228.jpg

Concrete headwall on WS toe.

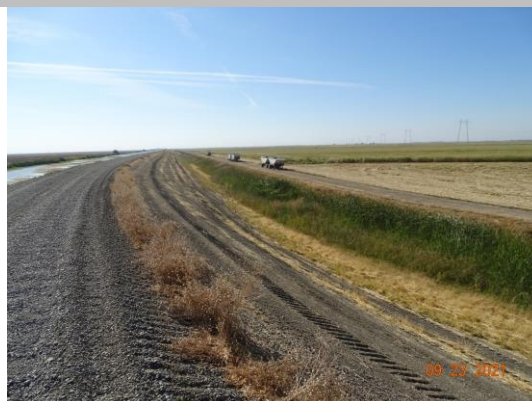
Photo 1 of 1 : SP_2022_RD2035_239_979_20220308_00004.jpg

LM Start	2.18	Rating **	M	Issue No.	979
LM End	4.02	Issue Type +	En	Location *	LS
Category	Earthen Levee			GPS Latitude/Longitude	
				Start	End
Item	Encroachments			38.646063 °	38.623062 °
				-121.666332 °	-121.648925 °
DWR ID	DWR_RD2035_02_s_2012_979				
Comment Code					
DT : Ditch					
Inspector Comment					
A ditch is located at the landside toe of the levee.

View of the ditch at the landside toe. Fall 2021.

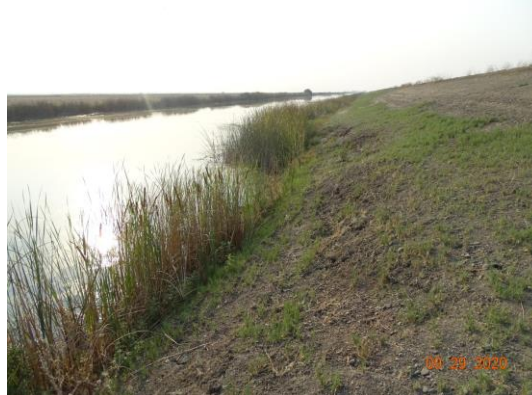
Photo 1 of 1 : SP_2022_RD2035_239_19_20220308_00003.jpg

LM Start	2.79	Rating **	M	Issue No.	19
LM End	2.79	Issue Type +	Ma	Location *	WS
Category	Earthen Levee			GPS Latitude/Longitude	
				Start	End
Item	Erosion / Bank Caving			38.638511 °	38.638511 °
				-121.660277 °	-121.660277 °
DWR ID	DWR_RD2035_02_f_2020_19				
Comment Code					
E2 : Schedule repair of erosion site prior to the next inspection.					
Inspector Comment					
Erosion on the waterside toe.

View of erosion on the waterside slope near the toe. Fall 2020.

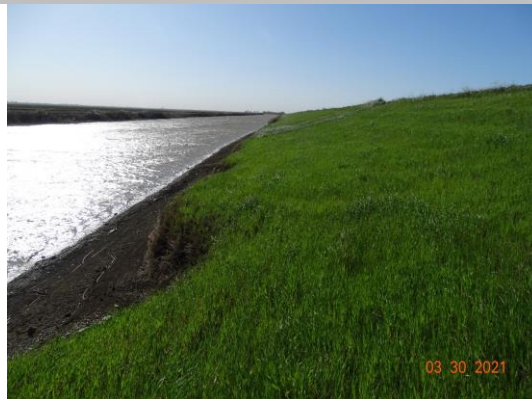
Photo 1 of 1 : SP_2022_RD2035_239_18_20220308_00002.jpg

LM Start	3.42	Rating **	M	Issue No.	18
LM End	3.42	Issue Type +	Ma	Location *	WS
Category	Earthen Levee			GPS Latitude/Longitude	
				Start	End
Item	Erosion / Bank Caving			38.630657 °	38.630657 °
				-121.654502 °	-121.654502 °
DWR ID	DWR_RD2035_02_s_2020_18				
Comment Code					
E2 : Schedule repair of erosion site prior to the next inspection.					
Inspector Comment					
Erosion at the waterside toe.

View of erosion at waterside toe. Spring 2021.

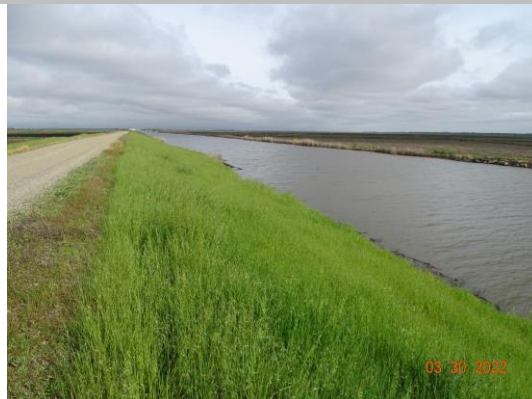
Photo 1 of 1 : SP_2022_RD2035_239_14_20220404_00026.jpg

LM Start	3.70	Rating **	M	Issue No.	14
LM End	3.99	Issue Type +	Ma	Location *	WS
Category	Supplemental			GPS Latitude/Longitude	
				Start	End
Item	2018 USACE Erosion Survey			38.627145 °	38.623533 °
				-121.651820 °	-121.649176 °
DWR ID	DWR_RD2035_02_s_2022_14				
Comment Code					
Inspector Comment					
2018 Site ID: YOL 3.5 R					
Status: Eroding					
2018 Field Notes: Last observed in 2011. Access issues prevented inspection in 2017.					
Site History: 2016 - Erosion observed at levee toe.

View of erosion at the waterside toe. Spring 2022.

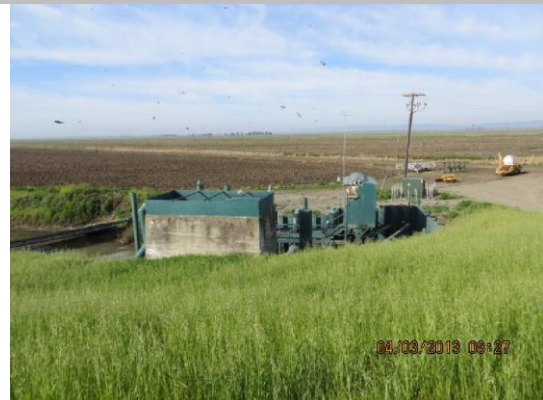
Photo 1 of 3 : UCIP_SP_2022_11526_18935.jpg

Comment Code						
Inspector Comment						
FS_ID:11526 DS_ID:17828 EP_NO: 1701 Repair Type: Non-Urgent Crossing Status: Found UCIP Comments: 04/03/2013 Animal activity at outlet causing damage to berm and undermining the pipe at the outlet headwall on WS toe. (W. Wylie - DWR UCIP) FIELD_STRUCT_DESC: 60-inch corrugated metal drainage pipe encased in 6 inches of reinforced concrete through the levee, 20.6 feet below the crown. Slide gate in a 7-foot-diameter corrugated metal pipe (CMP) riser on the waterside (WS) slope. Pumping plant with 6 pumps and pipes that discharge into a 4-foot by 18-foot surge box on the landside (LS) toe. (drainage pumping plant, 60-inch pipe, authorized under Permit No. 1701, 1952 - Reclamation District No. 2035). [Additional Reference(s): DWR Levee Log, 1990. USACE Sacramento O&M Manual 121, May 1959, (HLM 4.7)]. FS Date: 4/3/2013

Surge box and pumping plant on LS toe.

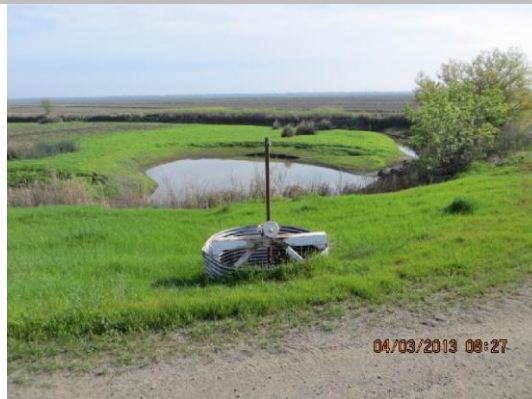
Photo 2 of 3 : UCIP_SP_2022_11526_18934.jpg

7-foot diameter CMP riser and slide gate on WS slope.

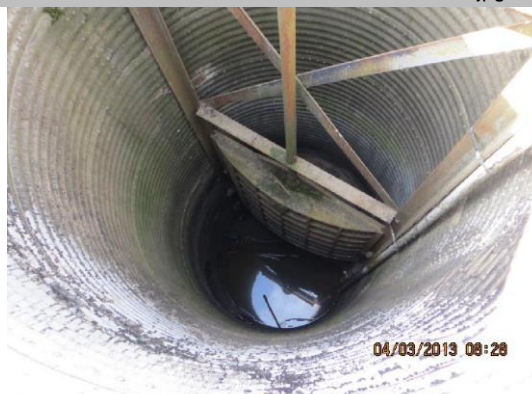
Photo 3 of 3 : UCIP_SP_2022_11526_18933.jpg

7-foot diameter CMP riser and slide gate on WS slope.

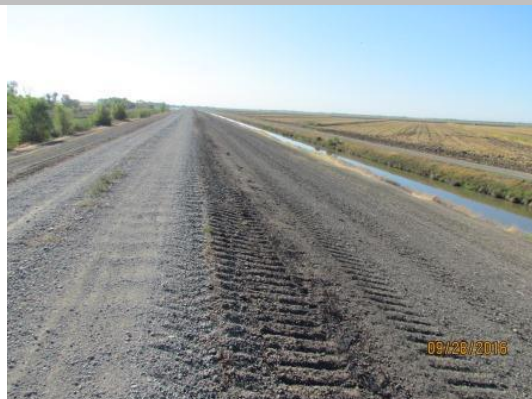
Photo 1 of 1 : SP_2022_RD2035_239_10_20220308_00001.jpg

LM Start	4.43	Rating **	M	Issue No.	10
LM End	6.57	Issue Type +	En	Location *	LS
Category	Earthen Levee			GPS Latitude/Longitude	
				Start	End
Item	Encroachments			38.617921 °	38.589619 °
				-121.645109 °	-121.631277 °
DWR ID	DWR_RD2035_02_s_2013_10				
Comment Code					
DT : Ditch					
Inspector Comment					
A ditch is located at the landside levee toe.

View of the drainage ditch on the landward side of the levee looking downstream. Fall 2016.

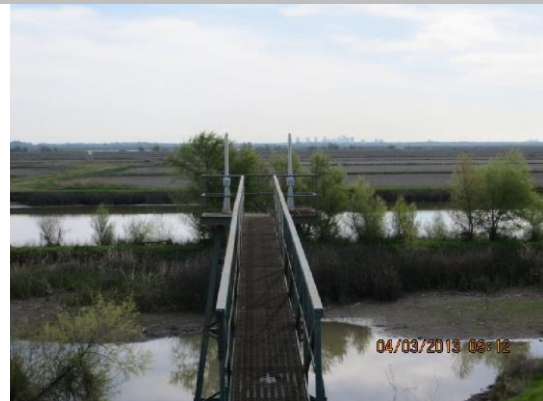
Photo 1 of 3 : UCIP_SP_2022_50089_18327.jpg

Comment Code						
Inspector Comment						
FS_ID:50089 DS_ID:17868 EP_NO: 16480 Repair Type: Non-Urgent Crossing Status: Found UCIP Comments: 09/14/2016 - Erosion on the LS toe at the sheet pile walls for the pumping plant is still present. It does not appear to be significantly different than during the previous inspection. Erosion should be monitored, but at this time does not appear to result in a potential threat to levee integrity. (T. Hatch/UCIP)04/03/2013 - Erosion on LS toe at pumping plant. Severe erosion of sheet pile walls at pumping plant. (W. Wylie/UCIP) FIELD_STRUCT_DESC: 1 of 2: 60-inch by 48-inch reinforced concrete box drainage culvert through the levee, 22 feet below the crown. Steel walkway to the slide gate handles on the waterside (WS) shoulder. 6-foot by 18-foot surge box and pumping plant on the landside (LS) toe. This culvert replaced a 48-inch at the same location. (construct two 60-inch concrete box drainage conduits and remove two 48-inch pipelines, work authorized under Permit No. 16480, 1995 - Conaway Conservancy Group and Reclamation District No. 2035). FS Date: 9/14/2016

Steel walkway to slide gates on WS shoulder.

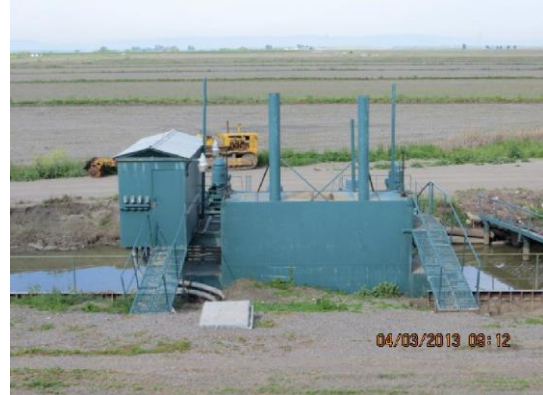
Photo 2 of 3 : UCIP_SP_2022_50089_18326.jpg

Pumping plant on LS toe.

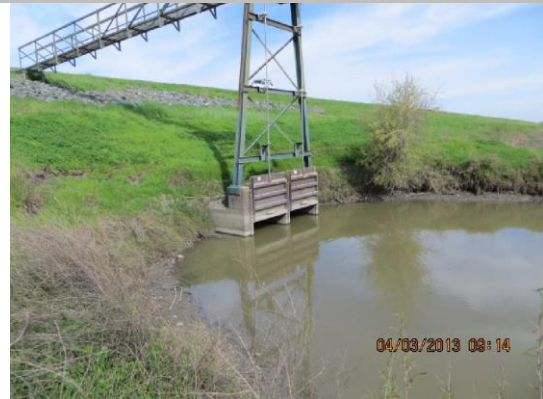
Photo 3 of 3 : UCIP_SP_2022_50089_18325.jpg

Slide gates at WS toe.

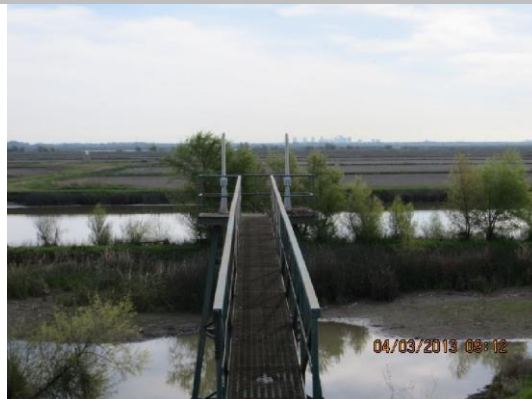
Photo 1 of 3 : UCIP_SP_2022_50088_18321.jpg

FS_ID:50088
DS_ID:17891
EP_NO: 16480
Repair Type: Non-Urgent
Crossing Status: Found
UCIP Comments: 09/14/2016 - Erosion is still present on the LS of the levee off the WS toe. This erosion should continue to be monitored, but does not appear to be a threat to levee integrity at this time. (T. Hatch/UCIP)04/02/2013 - Severe erosion at pumping plant on LS toe. (W. Wylie/UCIP)
FIELD_STRUCT_DESC: 2 of 2: 60-inch by 48-inch reinforced concrete box drainage culvert through the levee, 22 feet below the crown. Steel walkway to the slide gate handles on the waterside (WS) shoulder. 6-foot by 18-foot surge box and pumping plant on the landside (LS) toe. This culvert replaced a 48-inch at the same location. (construct two 60-inch concrete box drainage conduits and remove two 48-inch pipelines, work authorized under Permit No. 16480, 1995 - Conaway Conservancy Group and Reclamation District No. 2035).
FS Date: 9/14/2016

Steel walkway to Slide gate handles on WS shoulder.

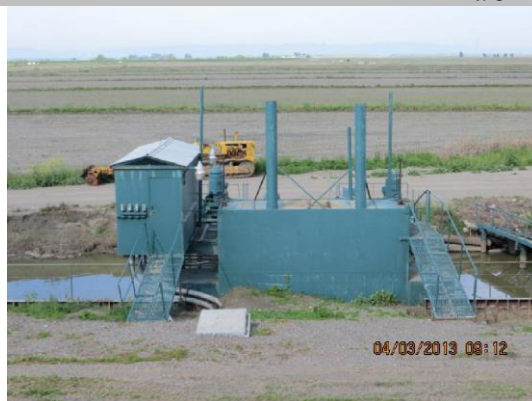
Photo 2 of 3 : UCIP_SP_2022_50088_18320.jpg

Surge box and pumping plant on LS toe.

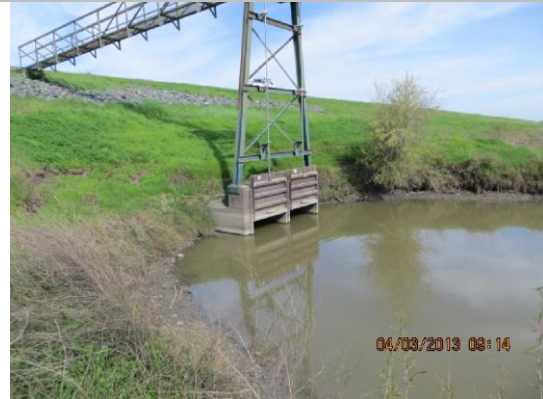
Photo 3 of 3 : UCIP_SP_2022_50088_18319.jpg

Slide gates at outlet on WS toe.

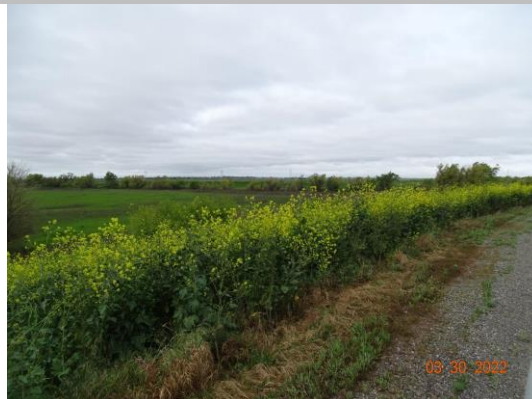
Photo 1 of 1 : SP_2022_RD2035_240_7_20220404_00003.jpg

View of mustard grass on the waterside slope. Spring 2022.

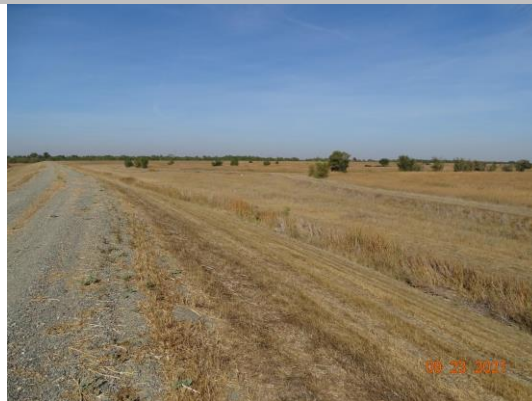
Photo 1 of 1 : SP_2022_RD2035_240_973_20220308_00002.jpg

LM Start	0.06	Rating **	M	Issue No.	973
LM End	2.16	Issue Type +	En	Location *	LS
Category	Earthen Levee			GPS Latitude/Longitude	
				Start	End
Item	Encroachments			38.575615 °	38.590919 °
				-121.636680 °	-121.658682 °
DWR ID	DWR_RD2035_03_s_2012_973				
Comment Code					
DT : Ditch					
Inspector Comment

View of the ditch at the landside toe. Fall 2021.

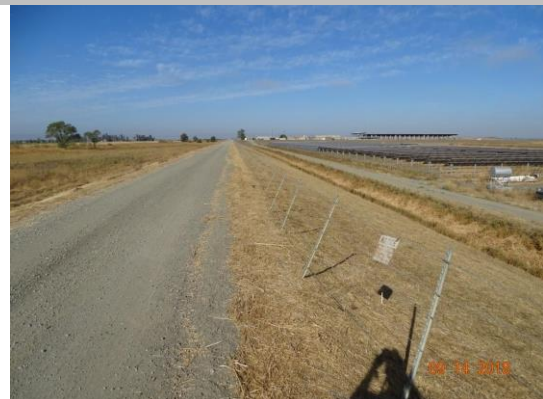
Photo 1 of 1 : SP_2022_RD2035_240_5_20220308_00001.jpg

View of fence on the landside shoulder of the crown. Fall 2018.
