**Flood Control Project Maintenance
Levee Inspections
LMA District Cover Sheet**

Reclamation District No. 2035 Conaway

Levee Inspection Report By Mile - Spring 2023

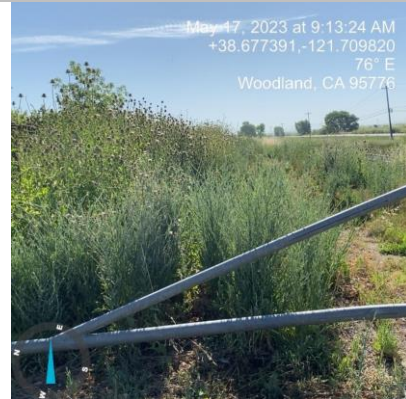
Photo 1 of 1 : SP_2022_RD2035_238_2_20230517_00004.jpg

View of vegetation preventing access on the levee crown (Spring 2023).

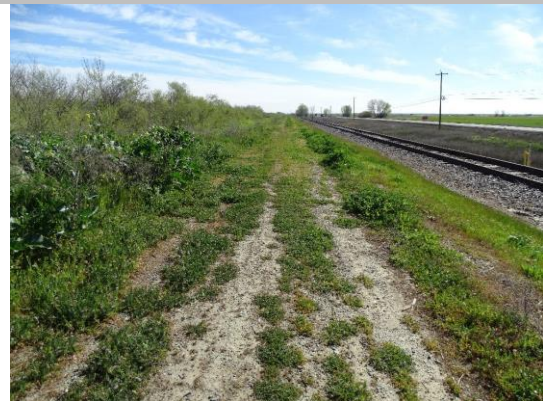
Photo 1 of 3 : UCIP_SP_2022_77644_107275.jpg

Comment Code						
Inspector Comment						
DS_ID:17814 FS_ID:77644 EP_NO: 10127 Repair Type: No Action Needed EVAL Issue: Crossing Status: Found UCIP Comments: 03/09/2022 The record has been update from No Action Needed to Non Urgent. The structure appears to be in good condition. (M. Thao - DWR UCIP)08/16/2019 Pending update... record will be updated in 2020. (O. Magana - DWR UCIP) FIELD_STRUCT_DESC: 42-inch concrete encased corrugated metal drainage pipe through the levee, 10 feet below the crown. Flap gate on the waterside (WS) end. Grouted spillway on the WS. Pipe exposed on the landside (LS). (36-inch pipe [HLM 0.02] authorized under Automatic Board Order (ABO) issued as Permit No. 10127, 1974 - City of Woodland, Department of Public Works). [Additional Reference(s): DWR Levee Log, 1990 (HLM 0.02). USACE Sacramento O&M Manual, Unit 126, November 1961, Revised 29 December 2016, (HLM 0.01), listed as 42-inch CMP 5.5 feet below the crown. USACE As-Built Drawing No. 50-04-3227, January 1960, Sheet 33, STA 775+14, listed as 42-inch concrete pipe encased in concrete conduit]. FS Date: 3/9/2022

Levee crown looking downstream.

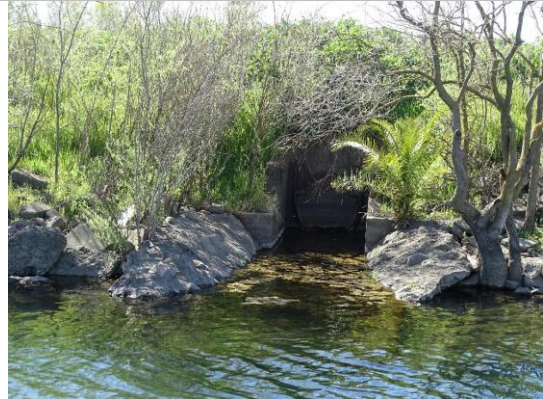
Photo 3 of 3 : UCIP_SP_2022_77644_107277.jpg

WS view: Flap gate and spillway on WS toe (view facing levee from WS).

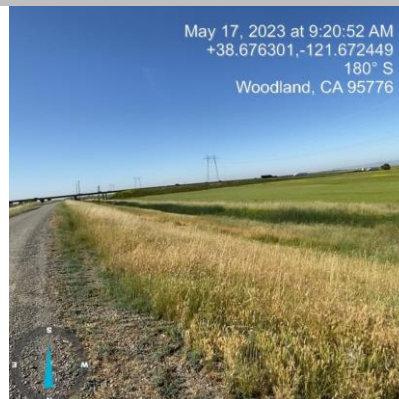
Photo 1 of 1 : SP_2023_RD2035_239_9_20230517_00028.jpg

View of vegetation on the landside slope (Spring 2023).

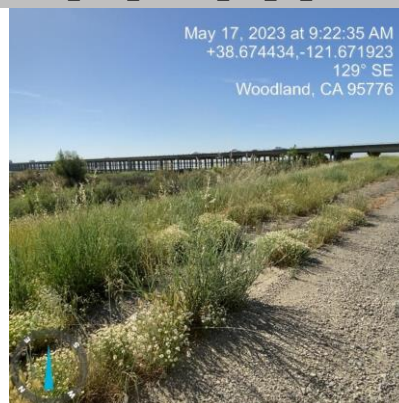
Photo 1 of 1 : SP_2023_RD2035_239_17_20230517_00029.jpg

LM Start	0.06	Rating **	U	Issue No.	17
LM End	7.60	Issue Type +	Ma	Location *	WS
Category	Earthen Levee			GPS Latitude/Longitude	
				Start	End
Item	Vegetation			38.676354°	38.575468°
				-121.672510°	-121.635069°
DWR ID	DWR_RD2035_02_s_2023_17				
Comment Code					
V1 : Control annual grass and weeds on the levee slopes and easements.					
Inspector Comment

View of vegetation on the waterside slope (Spring 2023).

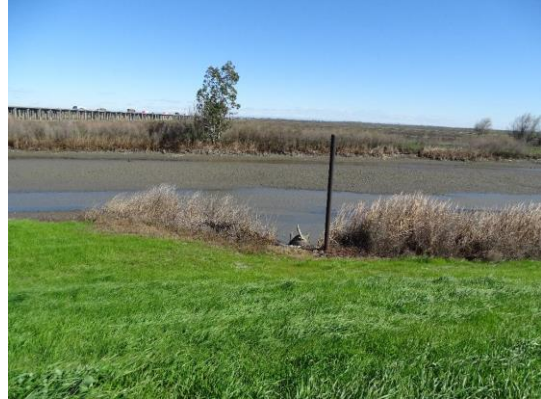
Photo 1 of 2 : UCIP_SP_2023_78134_106894.jpg

Comment Code						
Inspector Comment						
DS_ID:17822 FS_ID:78134 EP_NO: N/A Repair Type: Urgent EVAL Issue: 3a, Flood Risk Crossing Status: Found UCIP Comments: 02/15/2022 The record remains Urgent. Flap gate on WS was partially submerged at the time of inspection, so unable to confirm if the broken flap gate noted in 2013 has been repaired. No permit has been identified authorizing pipe. (Mike T. - DWR UCIP)08/16/2019 Pending update... record will be updated in 2020. (O. Magana - DWR UCIP)10/30/2018 Same as last inspection. Flap gate on the WS was submerged at the time of the inspection. Erosion is still present behind the headwall. Sink hole/burrow activity was observed along the concrete box located on the LS. Recommend internal inspection of the pipe section through levee to determine the condition of the pipe through the levee. Crossing remains Urgent due to signs of pipe leakage on LS. (O. Magana - DWR UCIP)09/14/2016 - Flap gate on the WS was submerged at time of inspection. LS headwall at the pumping plant has exposed rebar. There is still erosion present behind the headwall. However, water was present making it difficult to determine if it is getting worse. As-built drawings were requested from LMA consultant representative. (T. Hatch/UCIP)04/02/2013 - Flap gate broken in half on WS toe. Some erosion at headwalls on pumping plant. (W. Wylie/UCIP) FIELD_STRUCT_DESC: 44-inch corrugated metal drainage pipe through the levee, 22 feet below the crown. Pump on platform in drainage ditch at the landside (LS) toe. Slide gate and flap gates in a 5-foot by 9-foot concrete box. Flap gate on the waterside (WS) toe. 8-inch vent/standpipe at the WS toe. [Additional Reference(s): DWR Levee Log, 1990 (HLM 0.37), listed as 48-inch corrugated metal pipe. USACE Sacramento O&M Manual 121, May 1959, Revised 23 November 2021, (HLM 0.4), listed as 4-foot by 4-foot concrete culvert]. FS Date: 2/15/2022

WS view: Pipe with vent riser on toe.

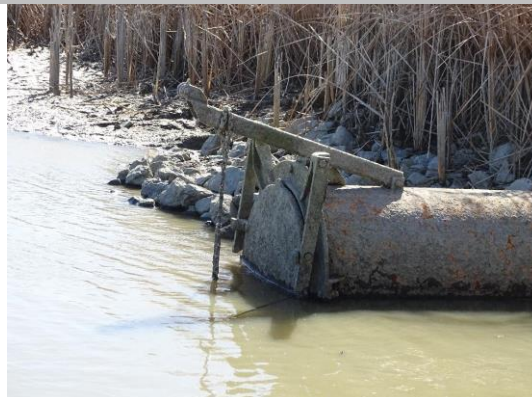
Photo 2 of 2 : UCIP_SP_2023_78134_106895.jpg

WS view: Pipe outlet with flap gate; unable to determine if flap gate has been repaired.

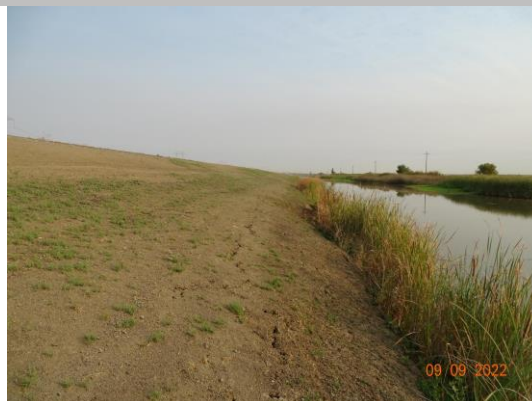
Photo 1 of 1 : SP_2023_RD2035_239_11_20230516_00002.jpg

LM Start	1.20	Rating **	A/W	Issue No.	11
LM End	1.24	Issue Type +	Ma	Location *	WS
Category	Supplemental			GPS Latitude/Longitude	
				Start	End
Item	2018 USACE Erosion Survey			38.660050°	38.659465°
				-121.669028°	-121.668940°
DWR ID	DWR_RD2035_02_f_2018_11				
Comment Code					
Inspector Comment					
2018 Site ID: YOL 1.2 R					
Status: Eroding					
2018 Field Notes: Last observed in 2017.					
Site History: 2011 - Small sections of slumping, likely from wind wave.					
2017 - Small amount of toe erosion.

View of erosion on the waterside slope. Fall 2022.

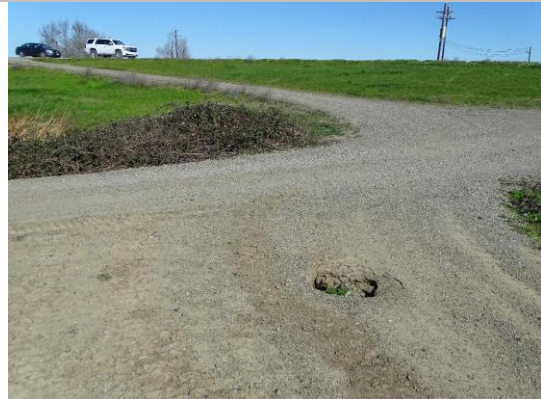
Photo 1 of 2 : UCIP_SP_2023_78230_106907.jpg

DS_ID:17825
FS_ID:78230
EP_NO: N/A
Repair Type: Urgent
EVAL Issue: 1, Pipe Integrity
Crossing Status: Found
UCIP Comments: 02/15/2022 The record has been updated from No Action Needed to Urgent. DWR DMP internal inspection has found pipe integrity issues. LOF of crossing is greater than or equal to 5 and less than 6. Crossing will be monitored until funding becomes available to address the issues. A sinkhole, approximately 1.5-foot in diameter and 0.5-foot deep, was observed approximately 20 feet of the LS toe. The concrete well on the WS well did not have a cover causing a safety hazard. No permit has been identified authorizing the pipe. (M. Thao - DWR UCIP)08/16/2019 Pending update... record will be updated in 2020. (O. Magana - DWR UCIP)
FIELD_STRUCT_DESC: 48-inch corrugated metal irrigation pipe through the levee, 16 feet below the crown. Slide gate in a concrete well on the waterside (WS) slope. Concrete headwall and intake off the landside (LS) toe. Bank revetted with concrete rubble. [Additional Reference(s): DWR Levee Log, 1990 (HLM 1.69). USACE Sacramento O&M Manual 121, May 1959, Revised 23 November 2021, (HLM 1.8), listed as 48-inch pipe].

LS view: Sinkhole located approximately 20 feet off toe.

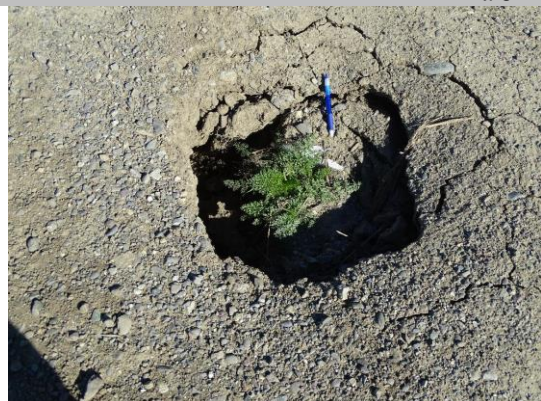
Photo 2 of 2 : UCIP_SP_2023_78230_106908.jpg

LS view: Close-up view of sinkhole, approximately 1.5-foot in diameter and 0.5-foot deep, located approximately 20 off toe.

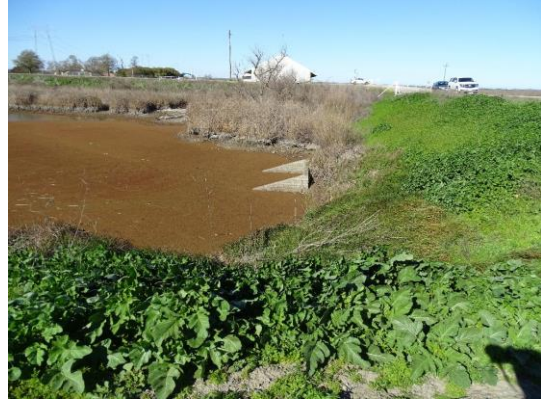
Photo 2 of 3 : UCIP_SP_2023_78206_107032.jpg

LS view: Pipe intake headwall.

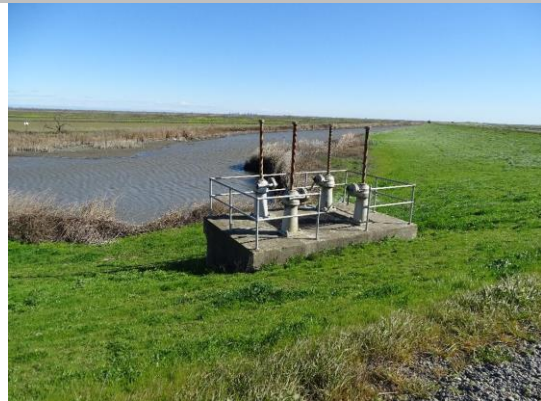
Photo 3 of 3 : UCIP_SP_2023_78206_107031.jpg

WS view: Slide gate operators and concrete vault on WS slope.

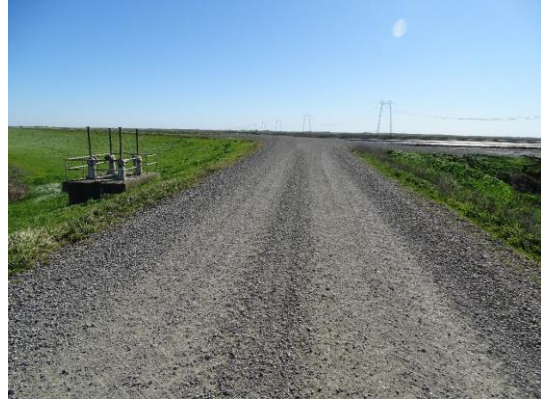
Photo 1 of 3 : UCIP_SP_2023_78205_107033.jpg

Comment Code						
Inspector Comment						
DS_ID:17877						
FS_ID:78205						
EP_NO: N/A						
Repair Type: No Action Needed						
EVAL Issue:						
Crossing Status: Found						
UCIP Comments: 02/15/2022 The record was updated from No Action						
Needed to Non-Urgent due to no permit authorizing the encroachment.						
Overall, the structure was observed to be in good condition with typical						
weather behind the headwall on the LS. (M. Thao - DWR UCIP)						
FIELD_STRUCT_DESC: 2 of 2: 60-inch drainage pipe of an unknown						
material through the levee, 26 feet below the crown. Concrete well and						
gate structure on the waterside (WS) slope. Concrete headwalls on both						
ends. [Additional Reference(s): DWR Levee Log, 1990 (HLM 2.13).						
USACE Sacramento O&M Manual 121, May 1959, Revised 23						
November 2021, (HLM 2.3), listed as 6-foot by 6-foot concrete culvert].						
FS Date: 2/15/2022

Levee crown looking downstream.

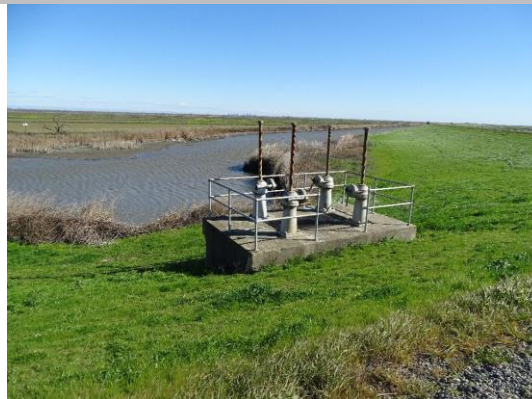
Photo 3 of 3 : UCIP_SP_2023_78205_107034.jpg

WS view: Slide gate operators and concrete vault on WS slope.

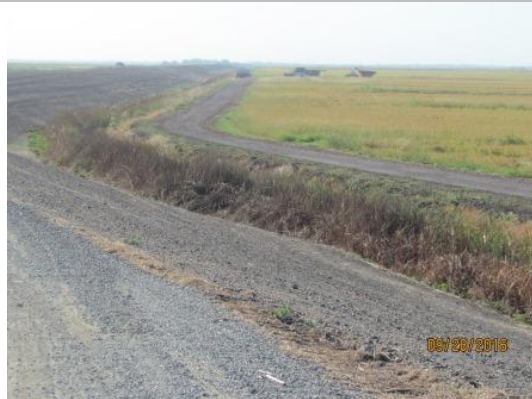
Photo 1 of 1 : SP_2023_RD2035_239_979_20230516_00008.jpg

LM Start	2.18	Rating **	M	Issue No.	979
LM End	4.02	Issue Type +	En	Location *	LS
Category	Earthen Levee			GPS Latitude/Longitude	
				Start	End
Item	Encroachments			38.646063 °	38.623062 °
				-121.666332 °	-121.648925 °
DWR ID	DWR_RD2035_02_s_2012_979				
Comment Code					
DT : Ditch					
Inspector Comment					
A ditch is located at the landside toe of the levee.

View of the ditch on the landward side of the levee looking downstream.
Fall 2016.

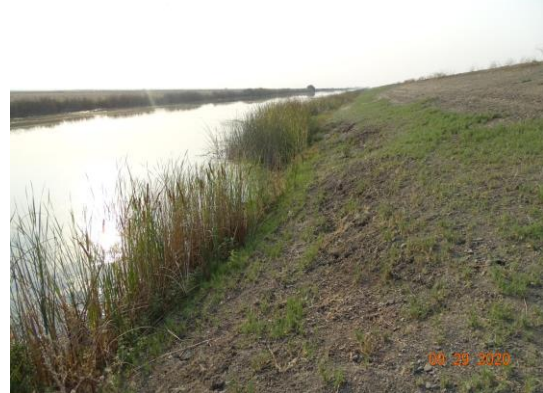
Photo 1 of 1 : SP_2023_RD2035_239_19_20230516_00007.jpg

LM Start	2.79	Rating **	M	Issue No.	19
LM End	2.79	Issue Type +	Ma	Location *	WS
Category	Earthen Levee			GPS Latitude/Longitude	
				Start	End
Item	Erosion / Bank Caving			38.638511°	38.638511°
				-121.660277°	-121.660277°
DWR ID	DWR_RD2035_02_f _ 2020_19				
Comment Code					
E2 : Schedule repair of erosion site prior to the next inspection.					
Inspector Comment					
Erosion on the waterside toe.

View of erosion on the waterside slope near the toe. Fall 2020.

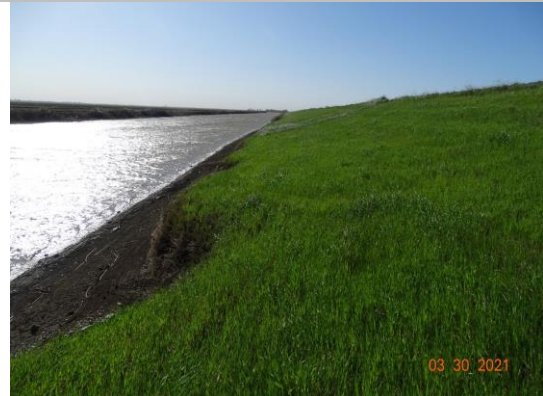
Photo 1 of 1 : SP_2023_RD2035_239_18_20230516_00006.jpg

LM Start	3.42	Rating **	M	Issue No.	18
LM End	3.42	Issue Type +	Ma	Location *	WS
Category	Earthen Levee			GPS Latitude/Longitude	
				Start	End
Item	Erosion / Bank Caving			38.630657°	38.630657°
				-121.654502°	-121.654502°
DWR ID	DWR_RD2035_02_s_2020_18				
Comment Code					
E2 : Schedule repair of erosion site prior to the next inspection.					
Inspector Comment					
Erosion at the waterside toe.

View of erosion at waterside toe. Spring 2021.

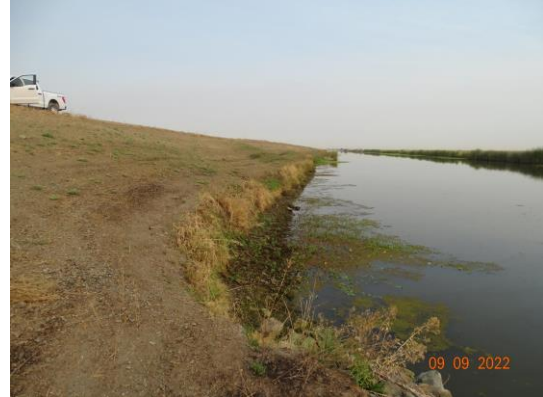
Photo 1 of 1 : SP_2023_RD2035_239_15_20230516_00005.jpg

LM Start	3.70	Rating **	M	Issue No.	15
LM End	3.99	Issue Type +	Ma	Location *	WS
Category	Supplemental			GPS Latitude/Longitude	
				Start	End
Item	2018 USACE Erosion Survey			38.627145°	38.623533°
				-121.651820°	-121.649176°
DWR ID	DWR_RD2035_02_f_2018_15				
Comment Code					
Inspector Comment					
2018 Site ID: YOL 3.5 R					
Status: Eroding					
2018 Field Notes: Last observed in 2011. Access issues prevented inspection in 2017.					
Site History: 2016 - Erosion observed at levee toe.

View of erosion on the waterside slope. Fall 2022.

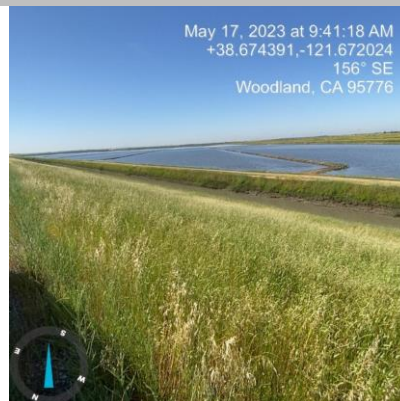
Photo 1 of 1 : SP_2023_RD2035_239_10_20230517_00030.jpg

View of the drainage ditch on the landward side of the levee looking downstream (Spring 2023).

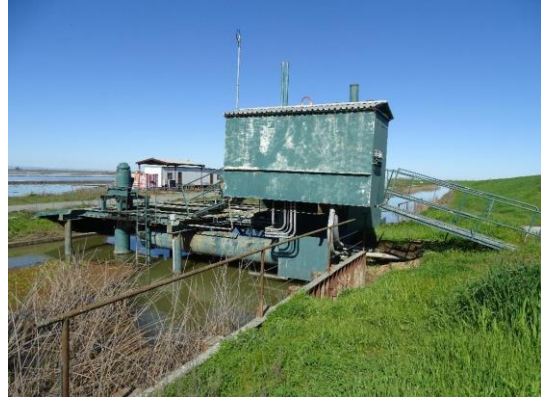
Photo 1 of 3 : UCIP_SP_2023_72221_107058.jpg

Comment Code					
Inspector Comment					
DS_ID:17868 FS_ID:72221 EP_NO: 16480 Repair Type: Non-Urgent EVAL Issue: 6, Levee Damage or Threat for Levee Damage Crossing Status: Found UCIP Comments: 02/17/2022 The record remains Non-Urgent. Erosion is still present on the sheet pile walls of the pumping plant. The erosion does not appear to pose an imminent threat to levee integrity since the erosion is off the LS toe. This pipe replaces DSID 17830. (M. Thao - DWR UCIP)09/14/2016 Erosion on the LS toe at the sheet pile walls for the pumping plant is still present. It does not appear to be significantly different than during the previous inspection. Erosion should be monitored, but at this time does not appear to result in a potential threat to levee integrity. (T. Hatch/UCIP)04/03/2013 Erosion on LS toe at pumping plant. Severe erosion of sheet pile walls at pumping plant. (W. Wylie/UCIP) FIELD_STRUCT_DESC: 1 of 2: 60-inch by 48-inch reinforced concrete box drainage culvert through the levee, 22 feet below the crown. Steel walkway to the slide gate handles on the waterside (WS) shoulder. 6-foot by 18-foot surge box and pumping plant on the landside (LS) toe. This culvert replaced a 48-inch at the same location. (construct two 60-inch concrete box drainage conduits and remove two 48-inch pipelines, work authorized under Permit No. 16480, 1995 - Conaway Conservancy Group and Reclamation District No. 2035). FS Date: 2/17/2022

LS view: Pumping plant off LS toe.

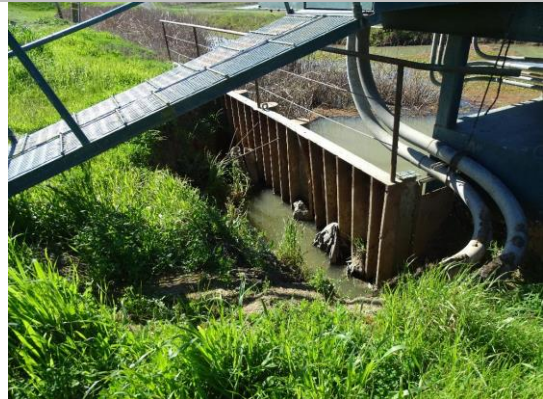
Photo 2 of 3 : UCIP_SP_2023_72220_107065.jpg

LS view: Erosion on the southern side of the pumping plant.

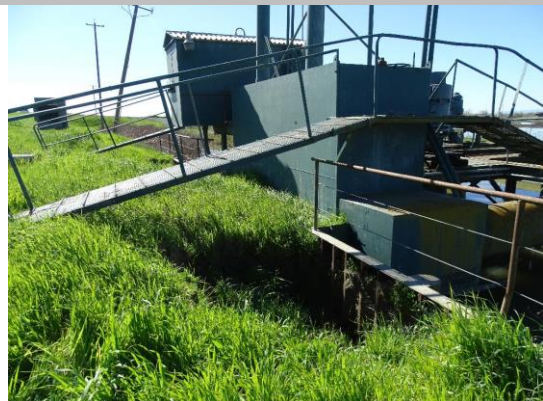
Photo 3 of 3 : UCIP_SP_2023_72220_107067.jpg

LS view: Erosion on the northern side of the pumping plant.

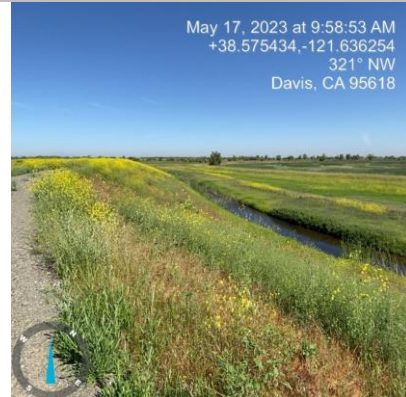
Photo 1 of 1 : SP_2023_RD2035_240_6_20230517_00010.jpg

View of vegetation on the landside slope (Spring 2023).

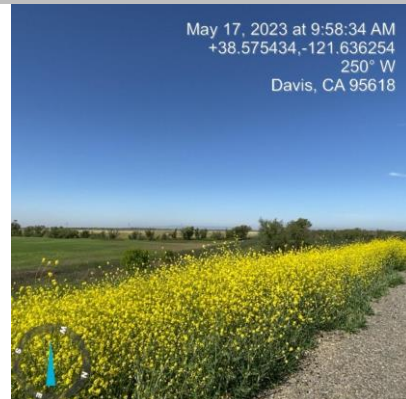
Photo 1 of 1 : SP_2023_RD2035_240_4_20230517_00009.jpg

View of vegetation on waterside slope (Spring 2023).

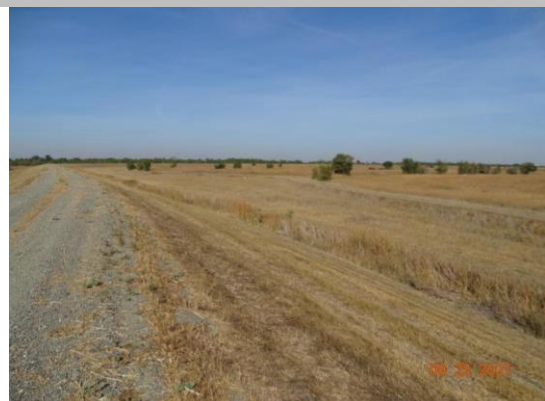
Photo 1 of 1 : SP_2023_RD2035_240_973_20230517_00002.jpg

View of the ditch at the landside toe. Fall 2021.

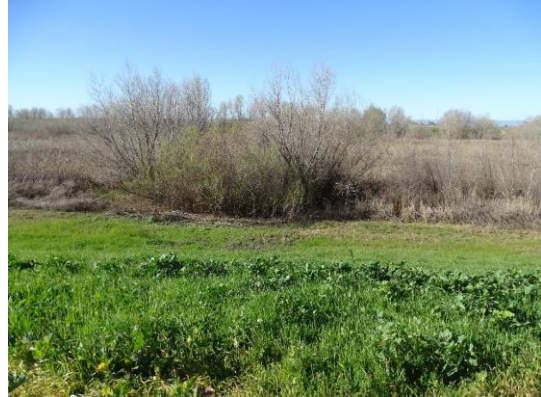
Photo 1 of 2 : UCIP_SP_2023_78554_106711.jpg

Comment Code						
Inspector Comment						
DS_ID:17836 FS_ID:78554 EP_NO: N/A Repair Type: Non-Urgent EVAL Issue: 11, Maintenance Compliance Issue Crossing Status: Found UCIP Comments: 02/17/2022 The record remains Non-Urgent. No permit was found authorizing this encroachment. Inspection of pipe inlet was limited due to water present in the canal. Inspection of pipe outlet was limited due to excessive vegetation. Recommend removing vegetation at the outlet. No permit has been identified authorizing pipe. (M. Thao - DWR UCIP)04/03/2013 Need to clear vegetation and debris from WS at outlet. (W. Wylie - DWR UCIP) FIELD_STRUCT_DESC: 36-inch corrugated metal drainage pipe through the levee, 17.5 feet below the crown. Flap gate on the waterside (WS) end. Slide gate and concrete headwall on the landside (LS) end. [Additional Reference(s): DWR Levee Log, 1990 (HLM 1.38). USACE Sacramento O&M Manual Unit 120, June 1952, Revised 29 December 2016, (Station 327+75), listed as 36-inch pipe]. FS Date: 2/17/2022

WS view: Vegetated area blocks access to pipe outlet.

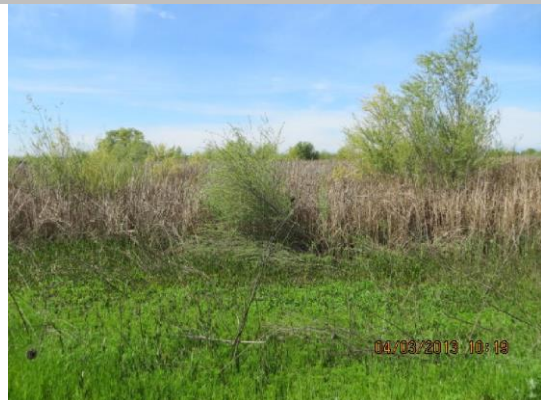
Photo 2 of 2 : UCIP_SP_2023_78554_18346.jpg

Vegetated area blocks access to WS of pipe.

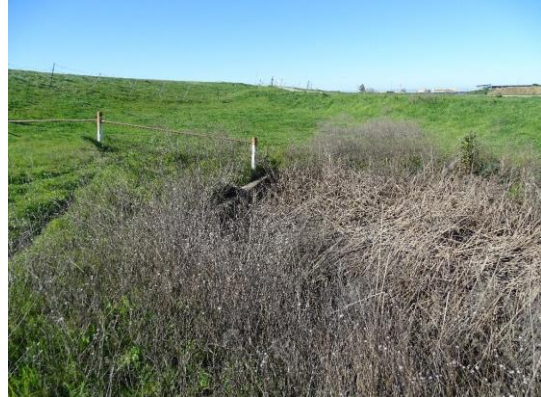
Photo 1 of 2 : UCIP_SP_2023_78556_105492.jpg

DS_ID:17838
FS_ID:78556
EP_NO: N/A
Repair Type: Non-Urgent
EVAL Issue: 11, Maintenance Compliance Issue
Crossing Status: Found
UCIP Comments: 02/15/2022 The record remains Non-Urgent. Inspection of the pipe inlet and outlet were limited due to dense vegetation. Recommend removing vegetation at the pipe inlet and outlet. No permit has been identified authorizing pipe. (M. Thao - DWR UCIP)04/03/2013 Debris and vegetation partially blocking both ends of pipe. (W. Wylie - DWR UCIP)
FIELD_STRUCT_DESC: 36-inch corrugated metal drainage pipe through the levee, 18 feet below the crown. Slide gate on the landside (LS) toe. Combination flap and slide gate on the waterside (WS) toe. [Additional Reference(s): DWR Levee Log, 1990 (HLM 2.18). USACE Sacramento O&M Manual Unit 120, June 1952, Revised 29 December 2016, (Station 289+33), listed as 36-inch pipe].
FS Date: 2/15/2022

LS view: Headwall at toe with excessive vegetation.

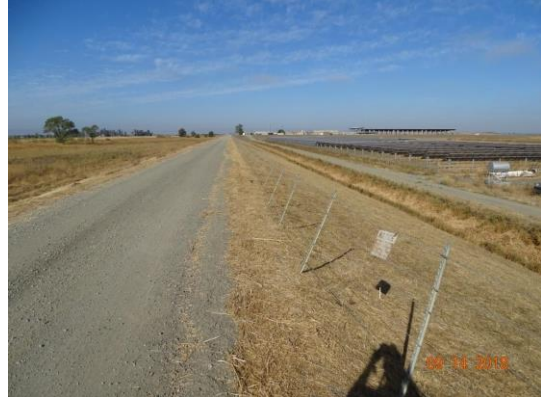
Photo 1 of 1 : SP_2023_RD2035_240_5_20230517_00001.jpg

View of fence on the landside shoulder of the crown. Fall 2018.
