Flood Control Project Maintenance
Levee Inspections
LMA District Cover Sheet

Reclamation District No. 2035 Conaway

**Flood Control Project Maintenance
Levee Inspections**

Levee Inspection Report By Mile - Spring 2024

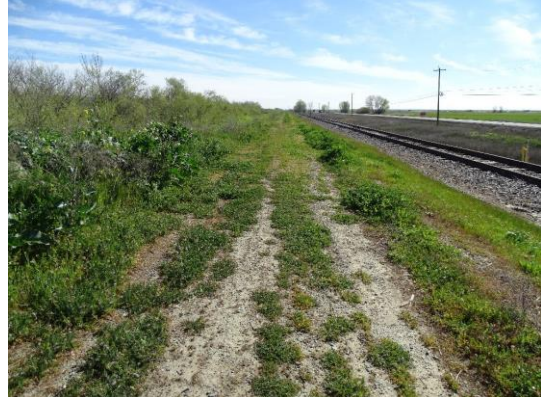
Photo 1 of 3 : UCIP_SP_2024_77644_107275.jpg

Comment Code					
Inspector Comment					
DS_ID:17814 FS_ID:77644 EP_NO: 10127 Repair Type: No Action Needed EVAL Issue: Crossing Status: Found UCIP Comments: 03/09/2022 The record has been update from No Action Needed to Non Urgent. The structure appears to be in good condition. (M. Thao - DWR UCIP)08/16/2019 Pending update... record will be updated in 2020. (O. Magana - DWR UCIP) FIELD_STRUCT_DESC: 42-inch concrete encased corrugated metal drainage pipe through the levee, 10 feet below the crown. Flap gate on the waterside (WS) end. Grouted spillway on the WS. Pipe exposed on the landside (LS). (36-inch pipe [HLM 0.02] authorized under Automatic Board Order (ABO) issued as Permit No. 10127, 1974 - City of Woodland, Department of Public Works). [Additional Reference(s): DWR Levee Log, 1990 (HLM 0.02). USACE Sacramento O&M Manual, Unit 126, November 1961, Revised 29 December 2016, (HLM 0.01), listed as 42-inch CMP 5.5 feet below the crown. USACE As-Built Drawing No. 50-04-3227, January 1960, Sheet 33, STA 775+14, listed as 42-inch concrete pipe encased in concrete conduit]. FS Date: 3/9/2022

Levee crown looking downstream.

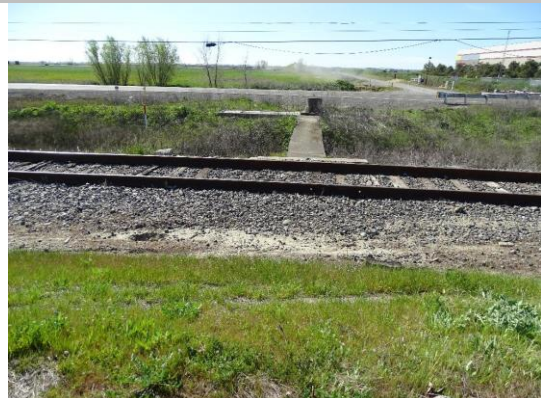
Photo 2 of 3 : UCIP_SP_2024_77644_107276.jpg

LS view: Concrete encased pipe.

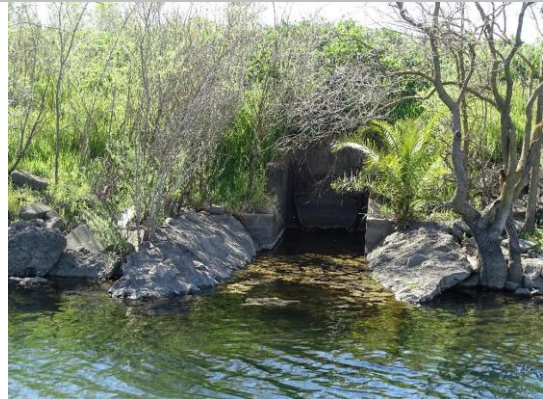
Photo 3 of 3 : UCIP_SP_2024_77644_107277.jpg

WS view: Flap gate and spillway on WS toe (view facing levee from WS).

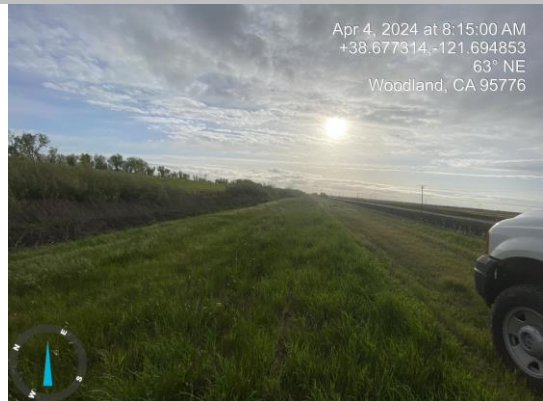
Photo 1 of 1 : SP_2024_RD2035_238_2_20240408_00005.jpg

LM Start	0.81	Rating **	A	Issue No.	2
LM End	0.81	Issue Type +	Ma	Location *	WS
Category	Earthen Levee			GPS Latitude/Longitude	
				Start	End
Item	Vegetation			38.677305°	38.677305°
				-121.694842°	-121.694842°
DWR ID	DWR_RD2035_01_s_2024_2				
Comment Code					
V1 : Control annual grass and weeds on the levee slopes and easements.					
Inspector Comment

View of good vegetation management on the waterside slope (Spring 2024).

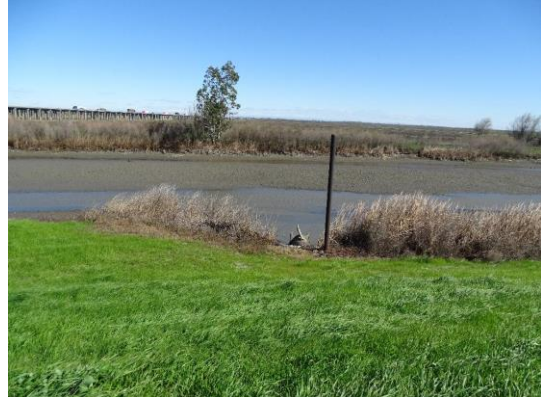
Photo 1 of 2 : UCIP_SP_2024_78134_106894.jpg

Comment Code						
Inspector Comment						
DS_ID:17822 FS_ID:78134 EP_NO: N/A Repair Type: Urgent EVAL Issue: 3a, Flood Risk Crossing Status: Found UCIP Comments: 02/15/2022 The record remains Urgent. Flap gate on WS was partially submerged at the time of inspection, so unable to confirm if the broken flap gate noted in 2013 has been repaired. No permit has been identified authorizing pipe. (Mike T. - DWR UCIP)08/16/2019 Pending update... record will be updated in 2020. (O. Magana - DWR UCIP)10/30/2018 Same as last inspection. Flap gate on the WS was submerged at the time of the inspection. Erosion is still present behind the headwall. Sink hole/burrow activity was observed along the concrete box located on the LS. Recommend internal inspection of the pipe section through levee to determine the condition of the pipe through the levee. Crossing remains Urgent due to signs of pipe leakage on LS. (O. Magana - DWR UCIP)09/14/2016 - Flap gate on the WS was submerged at time of inspection. LS headwall at the pumping plant has exposed rebar. There is still erosion present behind the headwall. However, water was present making it difficult to determine if it is getting worse. As-built drawings were requested from LMA consultant representative. (T. Hatch/UCIP)04/02/2013 - Flap gate broken in half on WS toe. Some erosion at headwalls on pumping plant. (W. Wylie/UCIP) FIELD_STRUCT_DESC: 44-inch corrugated metal drainage pipe through the levee, 22 feet below the crown. Pump on platform in drainage ditch at the landside (LS) toe. Slide gate and flap gates in a 5-foot by 9-foot concrete box. Flap gate on the waterside (WS) toe. 8-inch vent/standpipe at the WS toe. [Additional Reference(s): DWR Levee Log, 1990 (HLM 0.37), listed as 48-inch corrugated metal pipe. USACE Sacramento O&M Manual 121, May 1959, Revised 23 November 2021, (HLM 0.4), listed as 4-foot by 4-foot concrete culvert]. FS Date: 2/15/2022

WS view: Pipe with vent riser on toe.

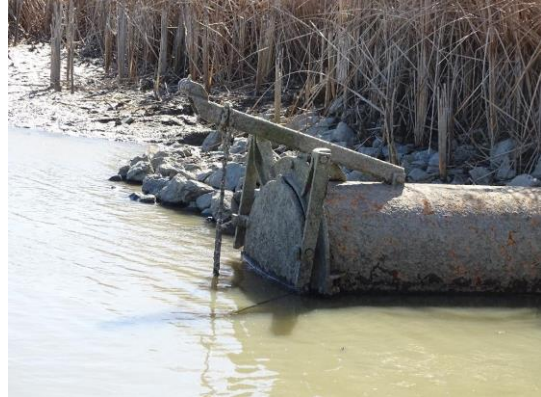
Photo 2 of 2 : UCIP_SP_2024_78134_106895.jpg

WS view: Pipe outlet with flap gate; unable to determine if flap gate has been repaired.

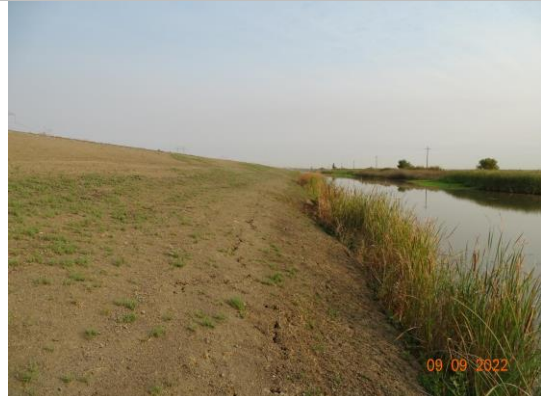
Photo 1 of 1 : SP_2024_RD2035_239_11_20240308_00002.jpg

LM Start	1.20	Rating **	A/W	Issue No.	11
LM End	1.24	Issue Type +	Ma	Location *	WS
Category	Supplemental			GPS Latitude/Longitude	
				Start	End
Item	2018 USACE Erosion Survey			38.660050°	38.659465°
				-121.669028°	-121.668940°
DWR ID	DWR_RD2035_02_f_2018_11				
Comment Code					
Inspector Comment					
2018 Site ID: YOL 1.2 R					
Status: Eroding					
2018 Field Notes: Last observed in 2017.					
Site History: 2011 - Small sections of slumping, likely from wind wave.					
2017 - Small amount of toe erosion.

View of erosion on the waterside slope. Fall 2022.

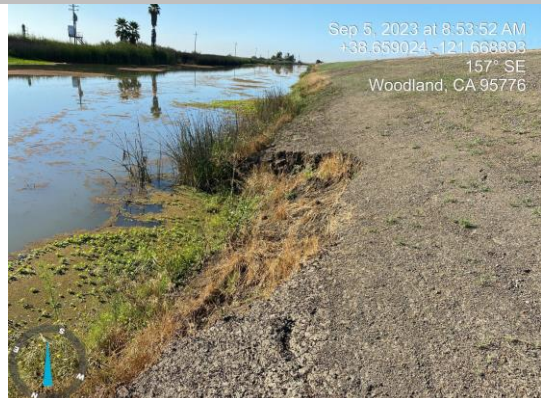
Photo 1 of 1 : SP_2024_RD2035_239_20_20240308_00008.jpg

LM Start	1.24	Rating **	M	Issue No.	20
LM End	1.28	Issue Type +	Ma	Location *	WS
Category	Earthen Levee			GPS Latitude/Longitude	
				Start	End
Item	Erosion / Bank Caving			38.659432°	38.658859°
				-121.669105°	-121.668989°
DWR ID	DWR_RD2035_02_f_2023_20				
Comment Code					
E2 : Schedule repair of erosion site prior to the next inspection.					
Inspector Comment

View of erosion on waterside slope (Fall 2023).

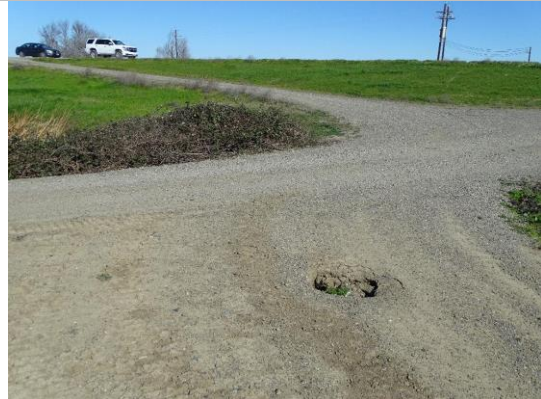
Photo 1 of 2 : UCIP_SP_2024_78230_106907.jpg

Comment Code					
Inspector Comment					
DS_ID:17825 FS_ID:78230 EP_NO: N/A Repair Type: Urgent EVAL Issue: 1, Pipe Integrity Crossing Status: Found UCIP Comments: 02/15/2022 The record has been updated from No Action Needed to Urgent. DWR DMP internal inspection has found pipe integrity issues. LOF of crossing is greater than or equal to 5 and less than 6. Crossing will be monitored until funding becomes available to address the issues. A sinkhole, approximately 1.5-foot in diameter and 0.5-foot deep, was observed approximately 20 feet of the LS toe. The concrete well on the WS well did not have a cover causing a safety hazard. No permit has been identified authorizing the pipe. (M. Thao - DWR UCIP)08/16/2019 Pending update... record will be updated in 2020. (O. Magana - DWR UCIP) FIELD_STRUCT_DESC: 48-inch corrugated metal irrigation pipe through the levee, 16 feet below the crown. Slide gate in a concrete well on the waterside (WS) slope. Concrete headwall and intake off the landside (LS) toe. [Additional Reference(s): DWR Levee Log, 1990 (HLM 1.69). USACE Sacramento O&M Manual 121, May 1959, Revised 23 November 2021, (HLM 1.8), listed as 48-inch pipe]. FS Date: 2/15/2022

LS view: Sinkhole located approximately 20 feet off toe.

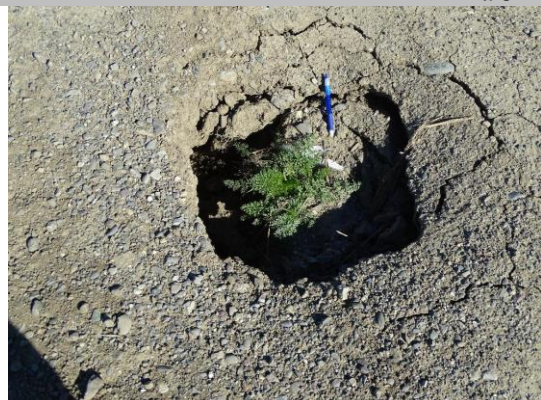
Photo 2 of 2 : UCIP_SP_2024_78230_106908.jpg

LS view: Close-up view of sinkhole, approximately 1.5-foot in diameter and 0.5-foot deep, located approximately 20 off toe.

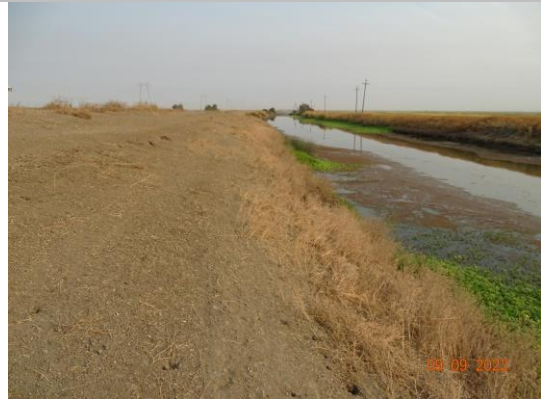
Photo 1 of 1 : SP_2024_RD2035_239_12_20240308_00003.jpg

LM Start	1.98	Rating **	A/W	Issue No.	12
LM End	2.03	Issue Type +	Ma	Location *	WS
Category	Supplemental			GPS Latitude/Longitude	
				Start	End
Item	2018 USACE Erosion Survey			38.648881°	38.648178°
				-121.666653°	-121.666385°
DWR ID	DWR_RD2035_02_s_2024_12				
Comment Code					
Inspector Comment					
2018 Site ID: YOL 2.0 R					
Status: Eroding					
2018 Field Notes: Last observed in 2017.					
Site History: 2006 - Wave wash erosion and some saturation slumping occurring. Tension/separation cracks evident in fine grained levee slope materials. 2011 - Small sections of slumping lower bank, just downstream of bank rock. 2016 - New cracks observed a the midslope. 2017 - Toe continues to erode.

View of erosion on the waterside slope. Fall 2022.

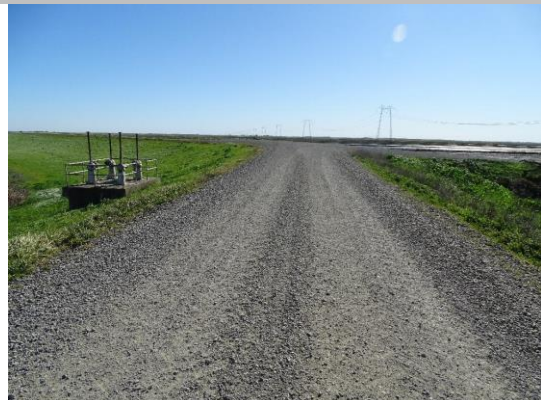
Photo 1 of 3 : UCIP_SP_2024_78206_107030.jpg

Comment Code						
Inspector Comment						
DS_ID:17833 FS_ID:78206 EP_NO: N/A Repair Type: Non-Urgent EVAL Issue: Crossing Status: Found UCIP Comments: 02/15/2022 The record was updated from No Action Needed to Non-Urgent due to no permit authorizing the encroachment. Overall, the structure was observed to be in good condition with typical weather behind the headwall on the LS. (M. Thao - DWR UCIP) FIELD_STRUCT_DESC: 1 of 2: 60-inch drainage pipe of an unknown material through the levee, 26 feet below the crown. Concrete well and gate structure on the waterside (WS) slope. [Additional Reference(s): DWR Levee Log, 1990 (HLM 2.13). USACE Sacramento O&M Manual 121, May 1959, Revised 23 November 2021, (HLM 2.3), listed as 6-foot by 6-foot concrete culvert]. FS Date: 2/15/2022

Levee crown looking downstream.

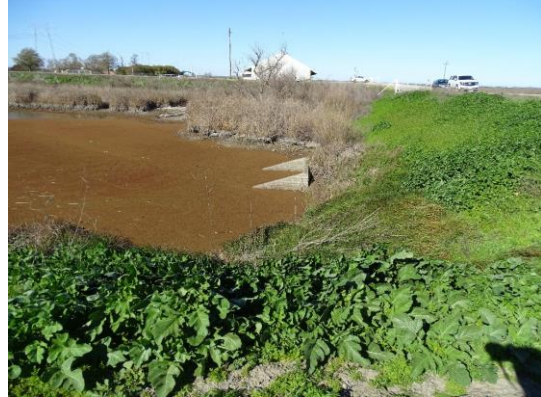
Photo 2 of 3 : UCIP_SP_2024_78206_107032.jpg

LS view: Pipe intake headwall.

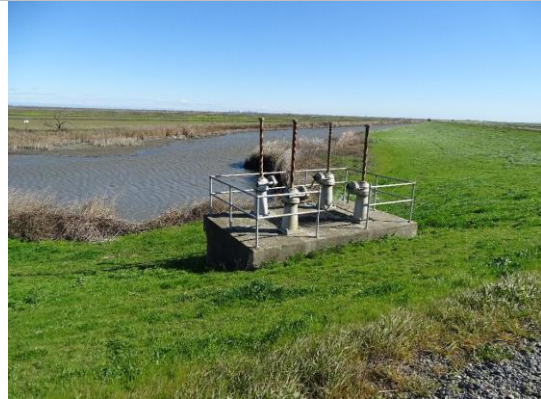
Photo 3 of 3 : UCIP_SP_2024_78206_107031.jpg

WS view: Slide gate operators and concrete vault on WS slope.

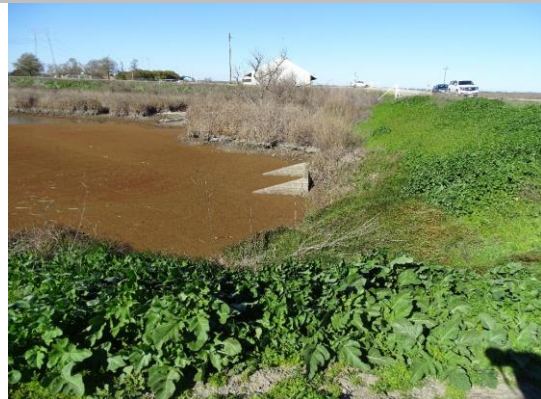
Photo 2 of 3 : UCIP_SP_2024_78205_107035.jpg

Comment Code						
Inspector Comment						
DS_ID:17877						
FS_ID:78205						
EP_NO: N/A						
Repair Type: No Action Needed						
EVAL Issue:						
Crossing Status: Found						
UCIP Comments: 02/15/2022 The record was updated from No Action						
Needed to Non-Urgent due to no permit authorizing the encroachment.						
Overall, the structure was observed to be in good condition with typical						
weather behind the headwall on the LS. (M. Thao - DWR UCIP)						
FIELD_STRUCT_DESC: 2 of 2: 60-inch drainage pipe of an unknown						
material through the levee, 26 feet below the crown. Concrete well and						
gate structure on the waterside (WS) slope. Concrete headwalls on both						
ends. [Additional Reference(s): DWR Levee Log, 1990 (HLM 2.13).						
USACE Sacramento O&M Manual 121, May 1959, Revised 23						
November 2021, (HLM 2.3), listed as 6-foot by 6-foot concrete culvert].						
FS Date: 2/15/2022

LS view: Pipe intake headwall.

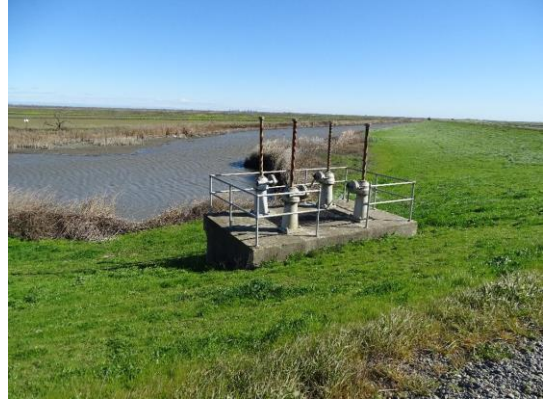
Photo 3 of 3 : UCIP_SP_2024_78205_107034.jpg

WS view: Slide gate operators and concrete vault on WS slope.

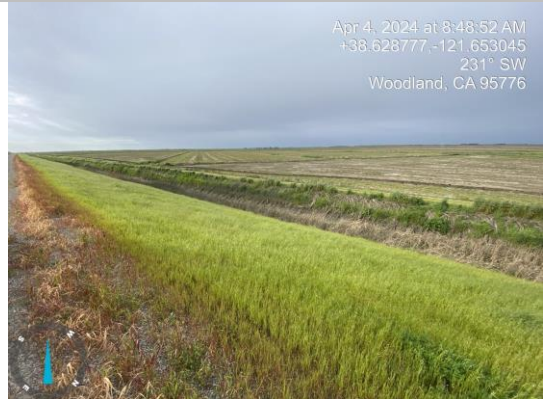
Photo 1 of 1 : SP_2024_RD2035_239_979_20240408_00030.jpg

LM Start	2.18	Rating **	M	Issue No.	979
LM End	4.02	Issue Type +	En	Location *	LS
Category	Earthen Levee			GPS Latitude/Longitude	
				Start	End
Item	Encroachments			38.646063 °	38.623062 °
				-121.666332 °	-121.648925 °
DWR ID	DWR_RD2035_02_s_2012_979				
Comment Code					
DT : Ditch					
Inspector Comment					
A ditch is located at the landside toe of the levee.

View of the ditch on the landward side of the levee looking downstream (Spring 2024).

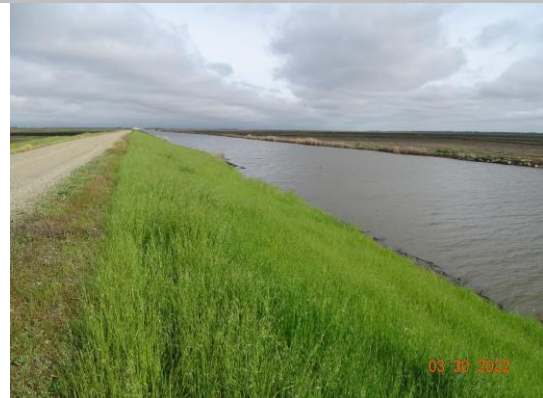
Photo 1 of 1 : SP_2024_RD2035_239_14_20240308_00004.jpg

LM Start	2.78	Rating **	A/W	Issue No.	14
LM End	3.26	Issue Type +	Ma	Location *	WS
Category	Supplemental			GPS Latitude/Longitude	
				Start	End
Item	2018 USACE Erosion Survey			38.638731°	38.632783°
				-121.660247°	-121.655864°
DWR ID	DWR_RD2035_02_f_2018_14				
Comment Code					
Inspector Comment					
2018 Site ID: YOL 2.8 R					
Status: Eroding					
2018 Field Notes: Last observed in 2017.					
Site History: 2011 - Wave wash erosion and several sections of slumping bank along the toe. 2017 - Erosion creeps further into the levee toe.

View of erosion at the waterside toe. Spring 2022.

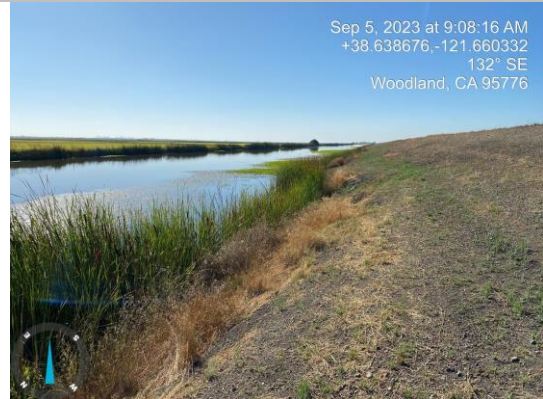
Photo 1 of 1 : SP_2024_RD2035_239_19_20240308_00007.jpg

LM Start	2.79	Rating **	M	Issue No.	19
LM End	2.79	Issue Type +	Ma	Location *	WS
Category	Earthen Levee			GPS Latitude/Longitude	
				Start	End
Item	Erosion / Bank Caving			38.638511°	38.638511°
				-121.660277°	-121.660277°
DWR ID	DWR_RD2035_02_f _ 2020_19				
Comment Code					
E2 : Schedule repair of erosion site prior to the next inspection.					
Inspector Comment

View of erosion on waterside slope (Fall 2023).

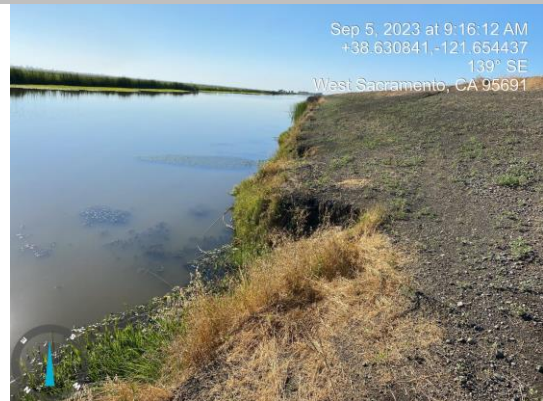
Photo 1 of 1 : SP_2024_RD2035_239_18_20240308_00006.jpg

LM Start	3.42	Rating **	M	Issue No.	18
LM End	3.70	Issue Type +	Ma	Location *	WS
Category	Earthen Levee			GPS Latitude/Longitude	
				Start	End
Item	Erosion / Bank Caving			38.630657°	38.627153°
				-121.654502°	-121.651890°
DWR ID	DWR_RD2035_02_s_2020_18				
Comment Code					
E2 : Schedule repair of erosion site prior to the next inspection.					
Inspector Comment

View of erosion on waterside slope (Fall 2023).

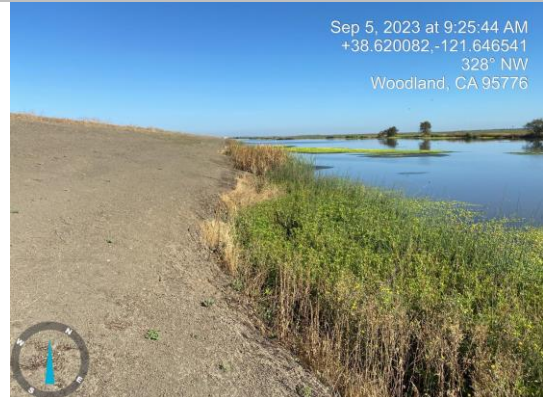
Photo 1 of 1 : SP_2024_RD2035_239_22_20240308_00009.jpg

LM Start	4.09	Rating **	M	Issue No.	22
LM End	4.41	Issue Type +	Ma	Location *	WS
Category	Earthen Levee			GPS Latitude/Longitude	
				Start	End
Item	Erosion / Bank Caving			38.622250°	38.618229°
				-121.648296°	-121.645344°
DWR ID	DWR_RD2035_02_f_2023_22				
Comment Code					
E2 : Schedule repair of erosion site prior to the next inspection.					
Inspector Comment

View of erosion along the waterside slop looking upstream (Fall 2023).

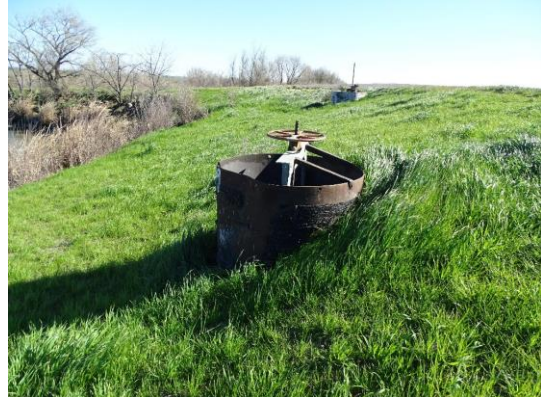
Photo 1 of 1 : UCIP_SP_2024_72251_107044.jpg

Comment Code						
Inspector Comment						
DS_ID:17869 FS_ID:72251 EP_NO: 15563 Repair Type: Non-Urgent EVAL Issue: 4b, Safety Issue Crossing Status: Found UCIP Comments: 02/15/2022 The record was updated from No Action Needed to Non-Urgent. There was no cover on the riser causing a safety hazard. Inspection of the pipe outlet was limited due to the dense vegetation and water present. This pipe replaces DSID 17827. (M. Thao - DWR UCIP) FIELD_STRUCT_DESC: 48-inch corrugated metal dual-purpose pipe through the levee, 16.5 feet below the crown. Slide gate in a 60-inch steel riser on the waterside (WS). Concrete headwalls on both ends. This pipe was installed to replace an existing 48-inch pipe at the same location. (48-inch pipe authorized under Permit No. 15563, 1990 - Reclamation District No. 2035, existing pipe removed). FS Date: 2/15/2022

WS view: Steel riser with no cover and slide gate on the slope.

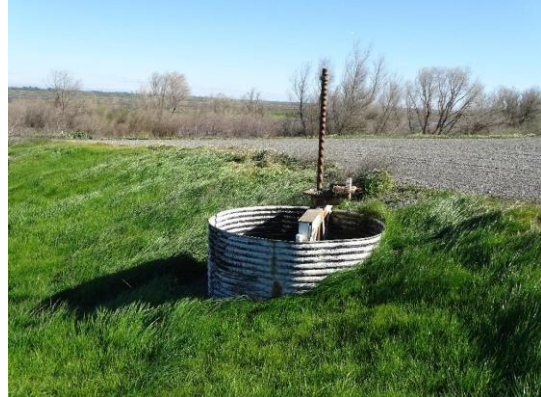
Photo 1 of 2 : UCIP_SP_2024_78211_107049.jpg

Comment Code					
Inspector Comment					
DS_ID:17828 FS_ID:78211 EP_NO: 1701 Repair Type: Urgent EVAL Issue: 2b, Levee Integrity Crossing Status: Found UCIP Comments: 02/15/2022 The record has been updated from Non-Urgent to Urgent. More than 1/2-foot displacement above the pipe alignment on the WS slope was observed. There was no cover on the CMP riser causing a safety hazard. (M. Thao - DWR UCIP)04/03/2013 Animal activity at outlet causing damage to berm and undermining the pipe at the outlet headwall on WS toe. (W. Wylie - DWR UCIP) FIELD_STRUCT_DESC: 60-inch corrugated metal drainage pipe encased in 6 inches of reinforced concrete through the levee, 20.6 feet below the crown. Slide gate in a 7-foot-diameter corrugated metal pipe (CMP) riser on the waterside (WS) slope. Pumping plant with 6 pumps and pipes that discharge into a 4-foot by 18-foot surge box on the landside (LS) toe. (drainage pumping plant, 60-inch pipe, authorized under Permit No. 1701, 1952 - Reclamation District No. 2035). [Additional Reference(s): DWR Levee Log, 1990 (HLM 4.39). USACE Sacramento O&M Manual 121, May 1959, Revised 23 November 2021, (HLM 4.7), listed as 60-inch pipe]. FS Date: 2/15/2022

WS view: CMP riser with no cover and slide gate on the slope.

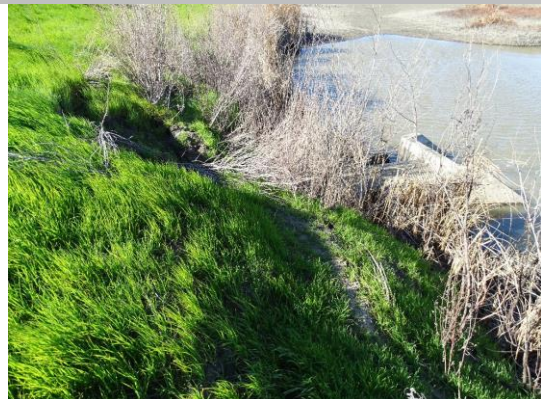
Photo 2 of 2 : UCIP_SP_2024_78211_107051.jpg

WS view: More than 1/2-foot of erosion above pipe alignment.

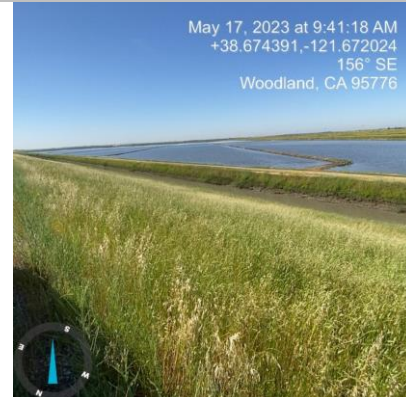
Photo 1 of 1 : SP_2024_RD2035_239_10_20240308_00001.jpg

View of the drainage ditch on the landward side of the levee looking downstream (Spring 2023).

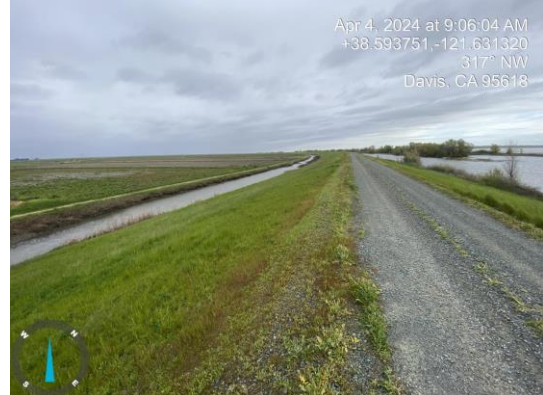
Photo 1 of 1 : SP_2024_RD2035_239_9_20240408_00031.jpg

View of good vegetation management on the landside slope (Spring 2024).

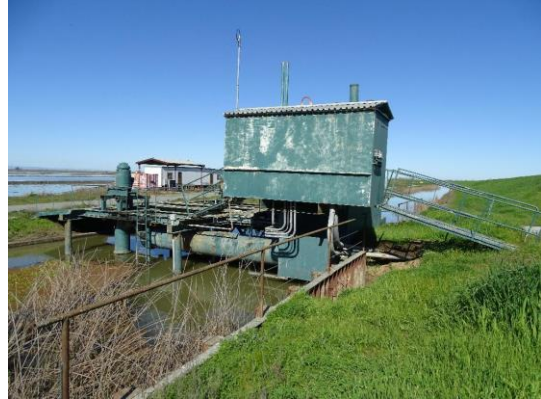
Photo 1 of 3 : UCIP_SP_2024_72221_107058.jpg

Comment Code						
Inspector Comment						
DS_ID:17868 FS_ID:72221 EP_NO: 16480 Repair Type: Non-Urgent EVAL Issue: 6, Levee Damage or Threat for Levee Damage Crossing Status: Found UCIP Comments: 02/17/2022 The record remains Non-Urgent. Erosion is still present on the sheet pile walls of the pumping plant. The erosion does not appear to pose an imminent threat to levee integrity since the erosion is off the LS toe. This pipe replaces DSID 17830. (M. Thao - DWR UCIP)09/14/2016 Erosion on the LS toe at the sheet pile walls for the pumping plant is still present. It does not appear to be significantly different than during the previous inspection. Erosion should be monitored, but at this time does not appear to result in a potential threat to levee integrity. (T. Hatch/UCIP)04/03/2013 Erosion on LS toe at pumping plant. Severe erosion of sheet pile walls at pumping plant. (W. Wylie/UCIP) FIELD_STRUCT_DESC: 1 of 2: 60-inch by 48-inch reinforced concrete box drainage culvert through the levee, 22 feet below the crown. Steel walkway to the slide gate handles on the waterside (WS) shoulder. 6-foot by 18-foot surge box and pumping plant on the landside (LS) toe. This culvert replaced a 48-inch at the same location. (construct two 60-inch concrete box drainage conduits and remove two 48-inch pipelines, work authorized under Permit No. 16480, 1995 - Conaway Conservancy Group and Reclamation District No. 2035). FS Date: 2/17/2022

LS view: Pumping plant off LS toe.

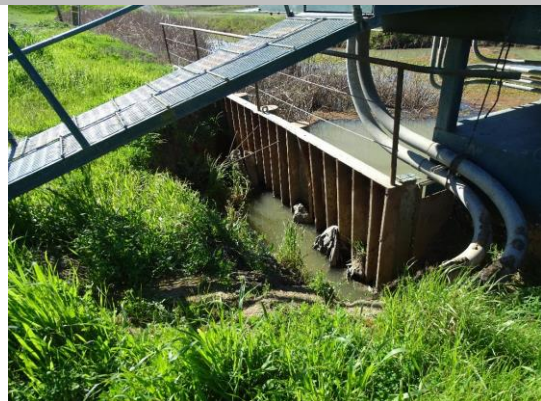
Photo 2 of 3 : UCIP_SP_2024_72221_107057.jpg

LS view: Erosion on the southern side of the pumping plant.

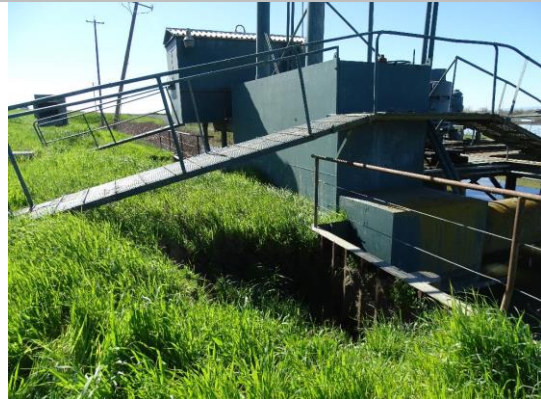
Photo 3 of 3 : UCIP_SP_2024_72221_107059.jpg

LS view: Erosion on the northern side of the pumping plant.

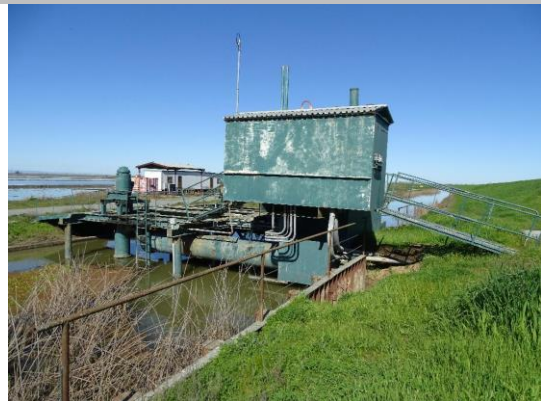
Photo 1 of 3 : UCIP_SP_2024_72220_107066.jpg

DS_ID:17891
FS_ID:72220
EP_NO: 16480
Repair Type: Non-Urgent
EVAL Issue: 6, Levee Damage or Threat for Levee Damage
Crossing Status: Found
UCIP Comments: 02/17/2022 The record remains Non-Urgent. Erosion is still present on the sheet pile walls of the pumping plant. The erosion does not appear to pose an imminent threat to levee integrity since the erosion is off the LS toe. This pipe replaces DSID 17884. (M. Thao - DWR UCIP)09/14/2016 Erosion is still present on the LS of the levee off the WS toe. This erosion should continue to be monitored, but does not appear to be a threat to levee integrity at this time. (T. Hatch/UCIP)04/02/2013 Severe erosion at pumping plant on LS toe. (W. Wylie/UCIP)
FIELD_STRUCT_DESC: 2 of 2: 60-inch by 48-inch reinforced concrete box drainage culvert through the levee, 22 feet below the crown. Steel walkway to the slide gate handles on the waterside (WS) shoulder. 6-foot by 18-foot surge box and pumping plant on the landside (LS) toe. This culvert replaced a 48-inch at the same location. (construct two 60-inch concrete box drainage conduits and remove two 48-inch pipelines, work authorized under Permit No. 16480, 1995 - Conaway Conservancy Group and Reclamation District No. 2035).

LS view: Pumping plant off LS toe.

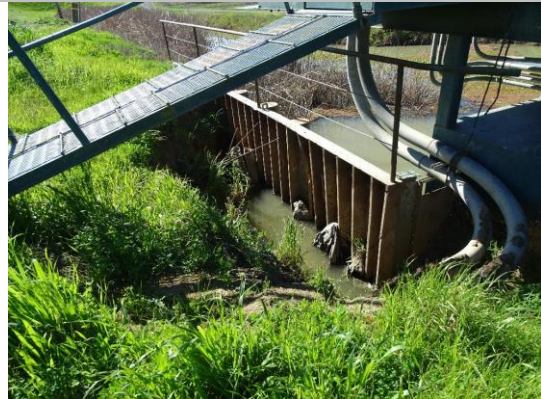
Photo 2 of 3 : UCIP_SP_2024_72220_107065.jpg

LS view: Erosion on the southern side of the pumping plant.

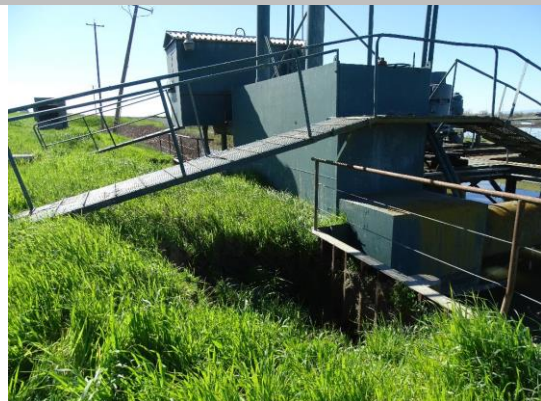
Photo 3 of 3 : UCIP_SP_2024_72220_107067.jpg

LS view: Erosion on the northern side of the pumping plant.

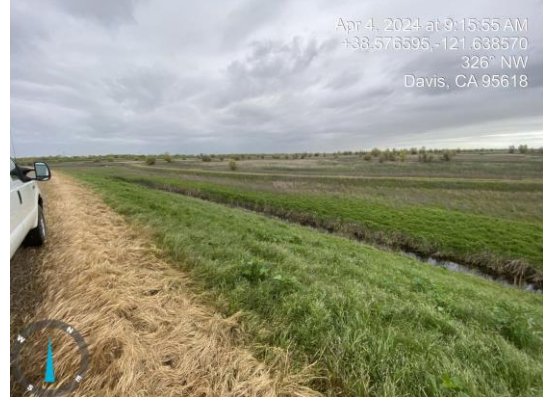
Photo 1 of 1 : SP_2024_RD2035_240_973_20240408_00009.jpg

View of ditch along the landside toe (Spring 2024).

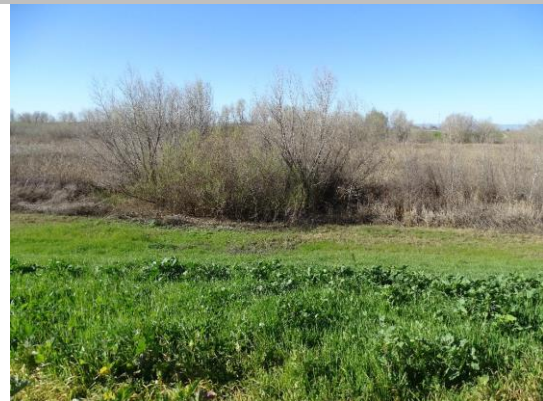
Photo 1 of 2 : UCIP_SP_2024_78554_106711.jpg

Comment Code					
Inspector Comment					
DS_ID:17836 FS_ID:78554 EP_NO: N/A Repair Type: Non-Urgent EVAL Issue: 11, Maintenance Compliance Issue Crossing Status: Found UCIP Comments: 02/17/2022 The record remains Non-Urgent. No permit was found authorizing this encroachment. Inspection of pipe inlet was limited due to water present in the canal. Inspection of pipe outlet was limited due to excessive vegetation. Recommend removing vegetation at the outlet. No permit has been identified authorizing pipe. (M. Thao - DWR UCIP)04/03/2013 Need to clear vegetation and debris from WS at outlet. (W. Wylie - DWR UCIP) FIELD_STRUCT_DESC: 36-inch corrugated metal drainage pipe through the levee, 17.5 feet below the crown. Flap gate on the waterside (WS) end. Slide gate and concrete headwall on the landside (LS) end. [Additional Reference(s): DWR Levee Log, 1990 (HLM 1.38). USACE Sacramento O&M Manual Unit 120, June 1952, Revised 29 December 2016, (Station 327+75), listed as 36-inch pipe]. FS Date: 2/17/2022

WS view: Vegetated area blocks access to pipe outlet.

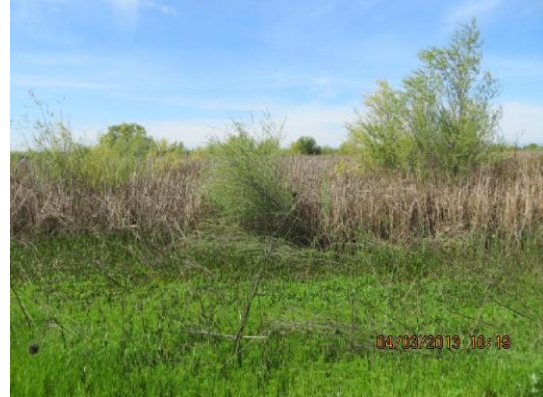
Photo 2 of 2 : UCIP_SP_2024_78554_18346.jpg

Vegetated area blocks access to WS of pipe.

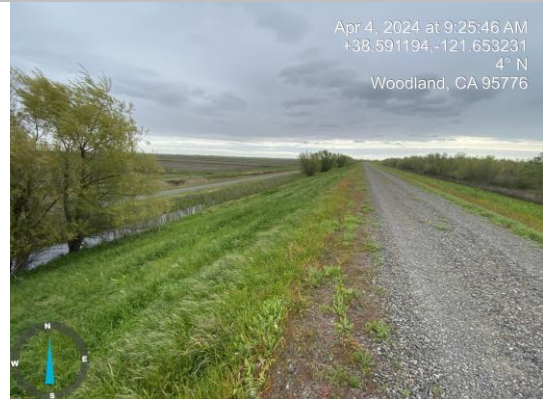
Photo 1 of 1 : SP_2024_RD2035_240_4_20240408_00010.jpg

View of good vegetation management along the landside slope (Spring 2024).

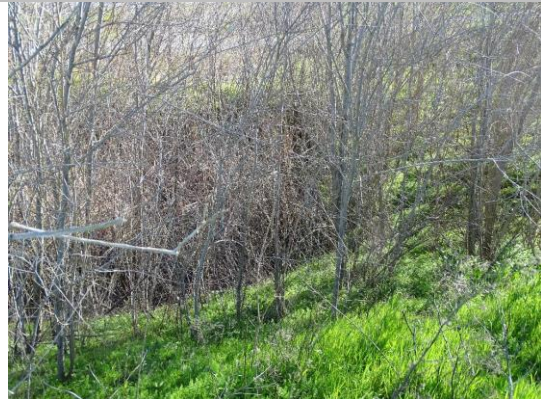
Photo 1 of 2 : UCIP_SP_2024_78555_106679.jpg

Comment Code						
Inspector Comment						
DS_ID:17837 FS_ID:78555 EP_NO: N/A Repair Type: Non-Urgent EVAL Issue: 11, Maintenance Compliance Issue Crossing Status: Found UCIP Comments: 02/15/2022 Record remains Non-Urgent. No permit was found authorizing this encroachment. Inspection of the pipe inlet and outlet were limited due to dense vegetation. Recommend removing vegetation at the inlet and outlet. No permit has been identified authorizing pipe. (M. Thao - DWR UCIP)04/03/2013 Debris and vegetation partially blocking inlet and outlet at both toes. (W. Wylie - DWR UCIP) FIELD_STRUCT_DESC: 48-inch corrugated metal drainage pipe through the levee, 19 feet below the crown. Slide gates on both ends. [Additional Reference(s): DWR Levee Log, 1990 (HLM 2.17). USACE Sacramento O&M Manual Unit 120, June 1952, Revised 29 December 2016, (Station 290+37), listed as 48-inch pipe]. FS Date: 2/15/2022

LS view: Headwall at toe barely visible with excessive vegetation.

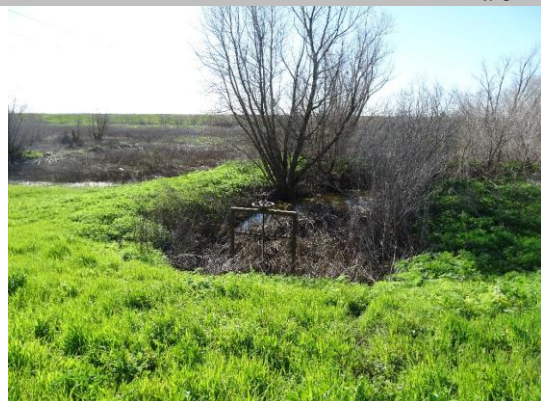
Photo 2 of 2 : UCIP_SP_2024_78555_106680.jpg

WS view: Slide gate on toe with excessive vegetation.

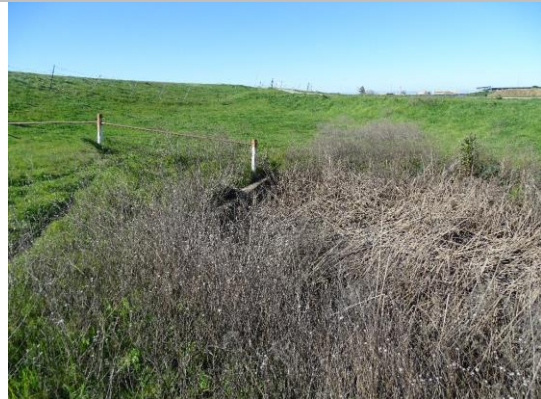
Photo 1 of 2 : UCIP_SP_2024_78556_105492.jpg

DS_ID:17838
 FS_ID:78556
 EP_NO: N/A
 Repair Type: Non-Urgent
 EVAL Issue: 11, Maintenance Compliance Issue
 Crossing Status: Found
 UCIP Comments: 02/15/2022 The record remains Non-Urgent.
 Inspection of the pipe inlet and outlet were limited due to dense vegetation. Recommend removing vegetation at the pipe inlet and outlet. No permit has been identified authorizing pipe. (M. Thao - DWR UCIP)04/03/2013 Debris and vegetation partially blocking both ends of pipe. (W. Wylie - DWR UCIP)
 FIELD_STRUCT_DESC: 36-inch corrugated metal drainage pipe through the levee, 18 feet below the crown. Slide gate on the landside (LS) toe. Combination flap and slide gate on the waterside (WS) toe.
 [Additional Reference(s): DWR Levee Log, 1990 (HLM 2.18). USACE Sacramento O&M Manual Unit 120, June 1952, Revised 29 December 2016, (Station 289+33), listed as 36-inch pipe].
 FS Date: 2/15/2022

LS view: Headwall at toe with excessive vegetation.

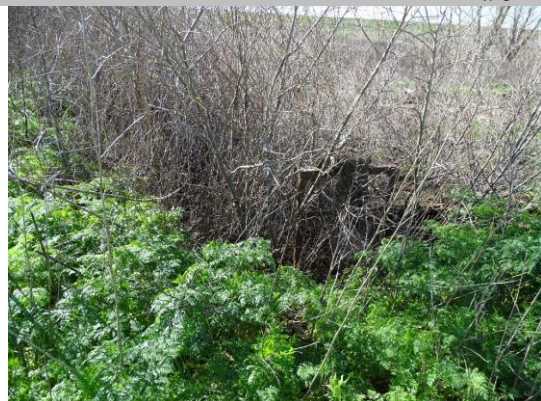
Photo 2 of 2 : UCIP_SP_2024_78556_105493.jpg

WS view: Combination flap and slide gate on toe with excessive vegetation.

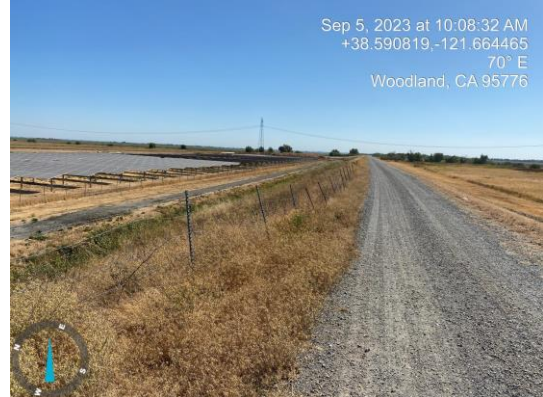
Photo 1 of 1 : SP_2024_RD2035_240_5_20240308_00001.jpg

View of fence on the landside shoulder of the crown (Fall 2023).
