**Flood Control Project Maintenance  
Levee Inspections**

## Maintenance Issue Types Only, Levee Inspection Report By Mile - Spring 2015

### Reclamation District No. 2035 Conaway

Waterway	Bank	Unit Miles	Inspection Start/End	Inspector
Unit No. 01 Cache Creek Settling Basin	Right	2.01	03/30/2015 03/30/2015	Michael Pitta

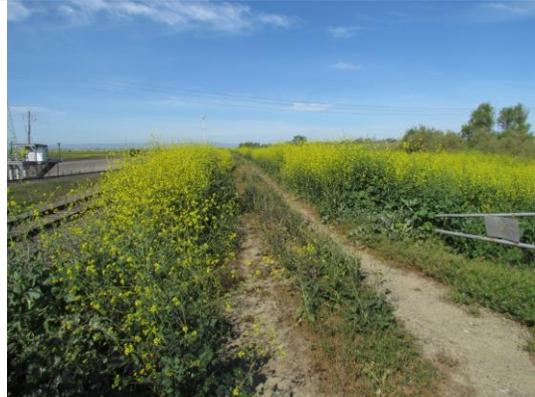
Photo 1 of 1 : SP\_2015\_RD2035\_238\_7\_20150330\_00006.jpg

LM Start	<b>0.00</b>	Rating **	U	Issue No.	<b>7</b>
LM End	<b>2.00</b>	Issue Type +	Ma	Location *	LS
Category	Earthen Levee		GPS Latitude/Longitude		
			Start	End	
Item	Vegetation		38.677423 °	38.677178 °	
			-121.709905 °	-121.672865 °	
DWR ID	DWR_RD2035_01_s_2015_7				
Action/Comments					
Control annual grass and weeds on the levee slopes and easements.

View of the vegetation landside of levee facing downstream.

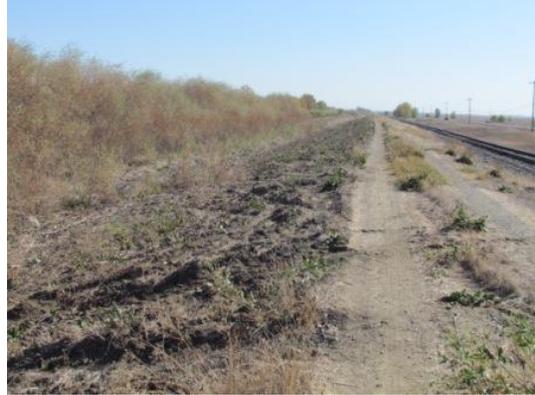
Photo 1 of 1 : SP\_2015\_RD2035\_238\_11\_20150318\_00001.jpg

LM Start	<b>0.03</b>	Rating **	A/W	Issue No.	<b>11</b>
LM End	<b>2.00</b>	Issue Type +	Ma	Location *	WS
Category	Earthen Levee		GPS Latitude/Longitude		
			Start	End	
Item	Encroachments		38.677347 °	38.677175 °	
			-121.709285 °	-121.672945 °	
DWR ID	DWR_RD2035_01_f_2013_11				
Action/Comments					
Agricultural tilling Inspector Comments: Discing on the waterward slope can lead to erosion.

This photo was taken from the levee crown facing east looking at discing on the waterward slope. Fall 2013.

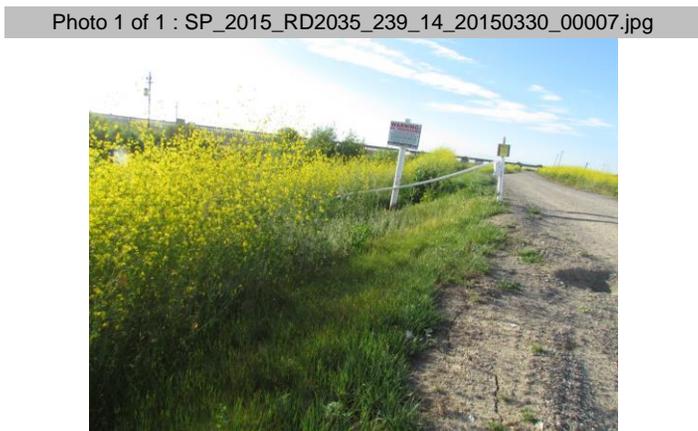
LM Start	<b>0.05</b>	Rating **	M	Issue No.	<b>14</b>
LM End	<b>1.76</b>	Issue Type +	Ma	Location *	WS
Category	Earthen Levee		GPS Latitude/Longitude		
			Start	End	
Item	Vegetation		38.676485 °	38.652040 °	
			-121.672577 °	-121.667670 °	
DWR ID	DWR_RD2035_02_s_2015_14				
Action/Comments					
Control annual grass and weeds on the levee slopes and easements.

View of the vegetation on the waterside of levee looking downstream.

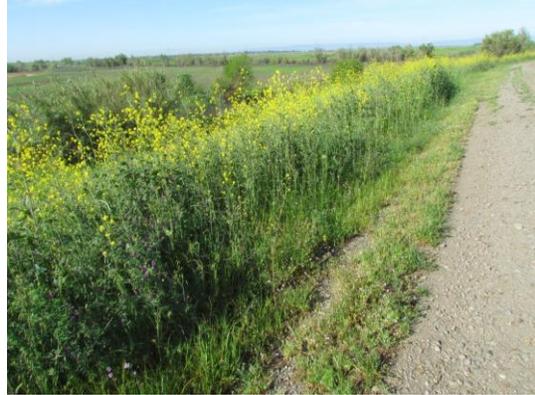
Photo 1 of 1 : SP\_2015\_RD2035\_240\_7\_20150330\_00007.jpg

LM Start	<b>0.00</b>	Rating **	M	Issue No.	<b>7</b>
LM End	<b>2.47</b>	Issue Type +	Ma	Location *	WS
Category	Earthen Levee		GPS Latitude/Longitude		
			Start	End	
Item	Vegetation		38.575343 °	38.590817 °	
			-121.635635 °	-121.664500 °	
DWR ID	DWR_RD2035_03_s_2015_7				
Action/Comments					
Control annual grass and weeds on the levee slopes and easements.

View of the vegetation on the waterside of levee facing downstream.
