**Flood Control Project Maintenance
Levee Inspections**

Maintenance Issue Types Only, Levee Inspection Report By Mile - Spring 2016

Reclamation District No. 2035 Conaway

Waterway	Bank	Unit Miles	Inspection Start/End	Inspector
Unit No. 01 Cache Creek Settling Basin	Right	2.01	03/17/2016 03/17/2016	Sterling York

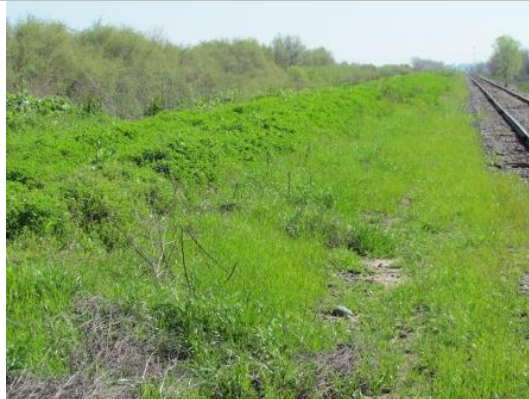
Photo 1 of 1 : SP_2016_RD2035_238_15_20160321_00014.jpg

LM Start	0.01	Rating **	M	Issue No.	15
LM End	1.99	Issue Type +	Ma	Location *	LS
Category	Earthen Levee			GPS Latitude/Longitude	
				Start	End
Item	Vegetation			38.677385 °	38.677184 °
				-121.709742 °	-121.673108 °
DWR ID	DWR_RD2035_01_s _ 2016_15				
Comment Code					
V1 : Control annual grass and weeds on the levee slopes and easements.					
Inspector Comment

View of vegetation on landside looking downstream.

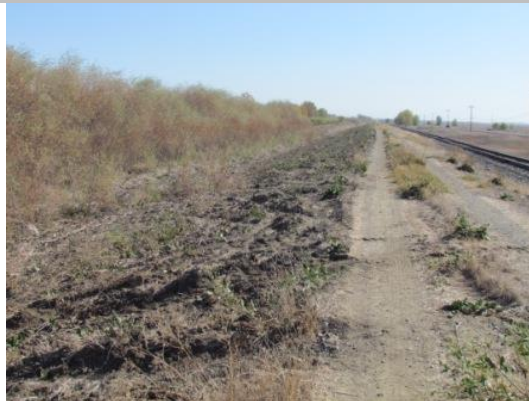
Photo 1 of 1 : SP_2016_RD2035_238_11_20160307_00003.jpg

LM Start	0.03	Rating **	A/W	Issue No.	11
LM End	2.00	Issue Type +	Ma	Location *	WS
Category	Earthen Levee			GPS Latitude/Longitude	
				Start	End
Item	Encroachments			38.677347 °	38.677175 °
				-121.709285 °	-121.672945 °
DWR ID	DWR_RD2035_01_f_2013_11				
Comment Code					
AT : Agricultural tilling					
Inspector Comment					
Discing on the waterward slope can lead to erosion.

This photo was taken from the levee crown facing east looking at discing on the waterward slope. Fall 2013.

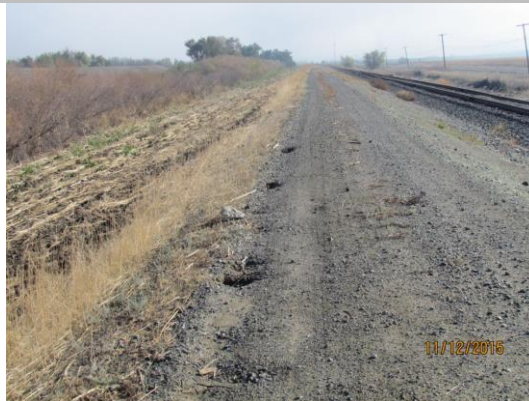
Photo 1 of 1 : SP_2016_RD2035_238_10_20160307_00002.jpg

LM Start	1.11	Rating **	M	Issue No.	10	
LM End	1.11	Issue Type +	Ma	Location *	CR	
Category	Earthen Levee			GPS Latitude/Longitude		
				Start		End
Item	Animal Control			38.677271 °		38.677271 °
				-121.689434 °		-121.689434 °
DWR ID	DWR_RD2035_01_f_2015_10					
Comment Code						
A2 : Repair the levee slope damaged by livestock and prevent large animal access.						
Inspector Comment						
Ruts on crown could be caused by collapsed rodent holes.

View of the ruts that may be caused by collapsed rodent holes on the crown of the levee looking downstream. Fall 2015.

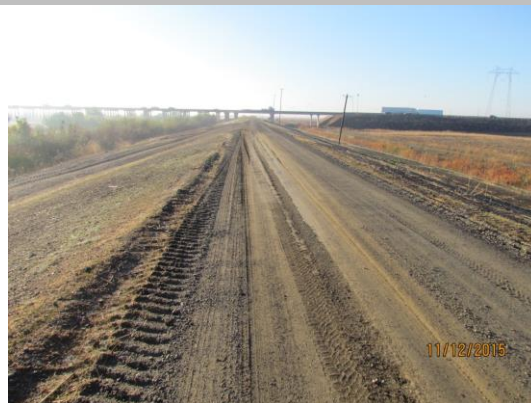
Photo 1 of 1 : SP_2016_RD2035_239_16_20160307_00003.jpg

LM Start	0.10	Rating **	M	Issue No.	16
LM End	0.10	Issue Type +	Ma	Location *	CR
Category	Earthen Levee			GPS Latitude/Longitude	
				Start	End
Item	Crown Surface / Depressions / Rutting			38.675761 °	38.675761 °
				-121.672347 °	-121.672347 °
DWR ID	DWR_RD2035_02_f_2015_16				
Comment Code					
C1 : Add appropriate material and re-grade the levee to bring the crown above the design elevation.					
Inspector Comment

View of the crown of the levee looking downstream. Fall 2015.

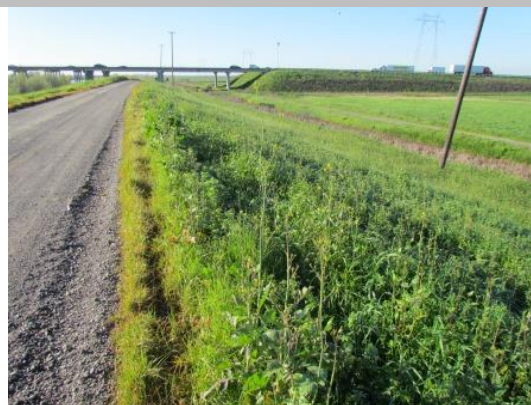
Photo 1 of 1 : SP_2016_RD2035_239_15_20160321_00023.jpg

LM Start	0.14	Rating **	M	Issue No.	15
LM End	1.90	Issue Type +	Ma	Location *	LS
Category	Earthen Levee			GPS Latitude/Longitude	
				Start	End
Item	Vegetation			38.675177 °	38.649967 °
				-121.672235 °	-121.667134 °
DWR ID	DWR_RD2035_02_s_2016_15				
Comment Code					
V1 : Control annual grass and weeds on the levee slopes and easements.					
Inspector Comment

View of vegetation on landside looking downstream.

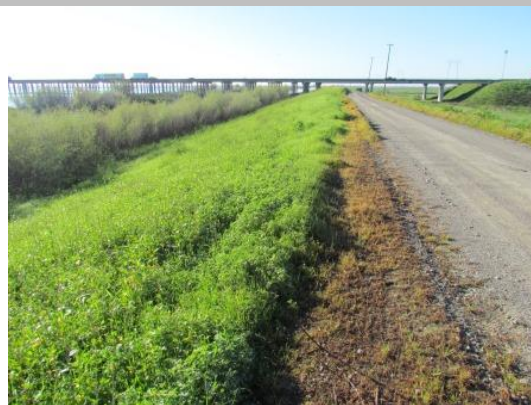
Photo 1 of 1 : SP_2016_RD2035_239_20_20160321_00024.jpg

LM Start	0.14	Rating **	M	Issue No.	20
LM End	1.90	Issue Type +	Ma	Location *	WS
Category	Earthen Levee			GPS Latitude/Longitude	
				Start	End
Item	Vegetation			38.675177 °	38.649967 °
				-121.672235 °	-121.667134 °
DWR ID	DWR_RD2035_02_s_2016_20				
Comment Code					
V1 : Control annual grass and weeds on the levee slopes and easements.					
Inspector Comment

View of vegetation on the waterside looking downstream.

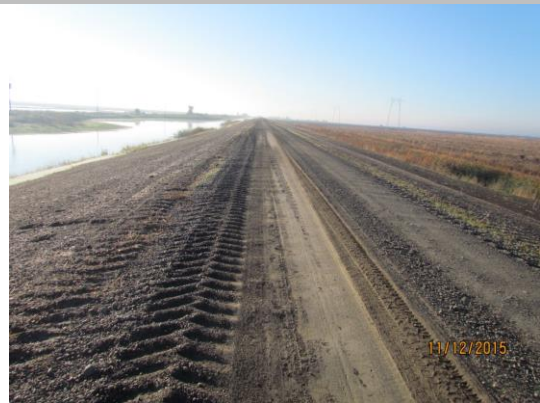
Photo 1 of 1 : SP_2016_RD2035_239_17_20160307_00004.jpg

LM Start	0.74	Rating **	M	Issue No.	17
LM End	0.74	Issue Type +	Ma	Location *	CR
Category	Earthen Levee			GPS Latitude/Longitude	
				Start	End
Item	Crown Surface / Depressions / Rutting			38.666603 °	38.666603 °
				-121.670547 °	-121.670547 °
DWR ID	DWR_RD2035_02_f_2015_17				
Comment Code					
C3 : Add appropriate gravel or road base. Grade and compact.					
Inspector Comment

View of the crown of the levee looking downstream. Fall 2015.

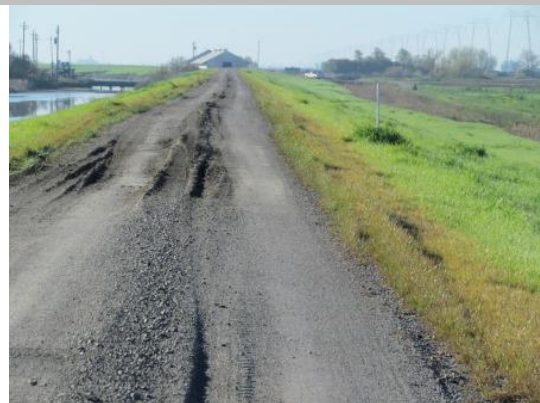
Photo 1 of 1 : SP_2016_RD2035_239_18_20160321_00025.jpg

LM Start	1.15	Rating **	M	Issue No.	18
LM End	1.15	Issue Type +	Ma	Location *	CR
Category	Earthen Levee			GPS Latitude/Longitude	
				Start	End
Item	Crown Surface / Depressions / Rutting			38.660686 °	38.660686 °
				-121.669370 °	-121.669370 °
DWR ID	DWR_RD2035_02_f_2015_18				
Comment Code					
C1 : Add appropriate material and re-grade the levee to bring the crown above the design elevation.					
Inspector Comment

View of ruts/depression in crown looking downstream.

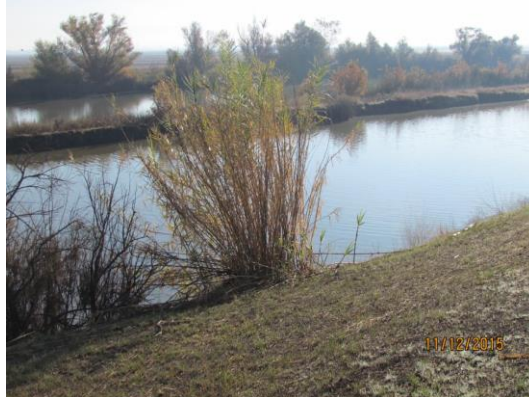
Photo 1 of 1 : SP_2016_RD2035_239_19_20160307_00005.jpg

LM Start	5.81	Rating **	A/W	Issue No.	19
LM End	5.81	Issue Type +	Ma	Location *	WS
Category	Earthen Levee			GPS Latitude/Longitude	
				Start	End
Item	Vegetation			38.600462 °	38.600462 °
				-121.632705 °	-121.632705 °
DWR ID	DWR_RD2035_02_f_2015_19				
Comment Code					
V2 : Remove the wild growth other than native grasses from the levee slopes.					
Inspector Comment					
Recommend getting rid of arundo.

View of the arundo at the toe of the levee. Fall 2015.

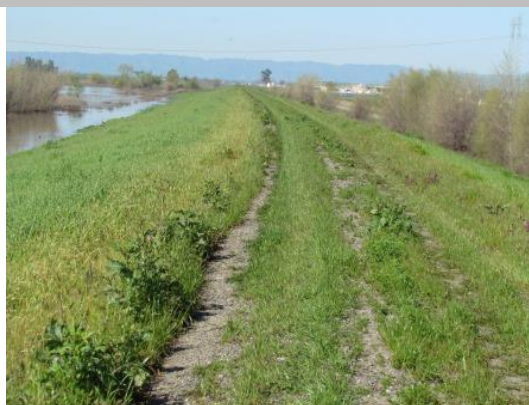
Photo 1 of 1 : SP_2016_RD2035_240_6_20160321_00016.jpg

LM Start	1.63	Rating **	M	Issue No.	6
LM End	2.51	Issue Type +	Ma	Location *	WS
Category	Earthen Levee			GPS Latitude/Longitude	
				Start	End
Item	Vegetation			38.591246 °	38.590805 °
				-121.648896 °	-121.665149 °
DWR ID	DWR_RD2035_03_s_2016_6				
Comment Code					
V1 : Control annual grass and weeds on the levee slopes and easements.					
Inspector Comment

view of vegetation on waterside looking downstream.
