**Flood Control Project Maintenance  
Levee Inspections**

## Maintenance Issue Types Only, Levee Inspection Report By Mile - Spring 2017

### Reclamation District No. 2035 Conaway

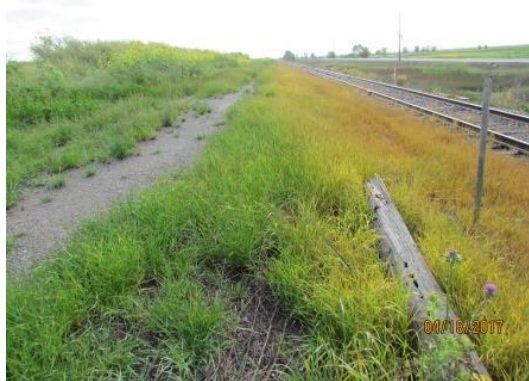
Photo 1 of 1 : SP\_2017\_RD2035\_238\_9\_20170426\_00014.jpg

| Annual grasses need to be maintained, Spring 2017. | | | | | |

View looking downstream of annual grasses that need to be maintained, Spring 2017.

| V1 : Control annual grass and weeds on the levee slopes and easements. | | | | | |

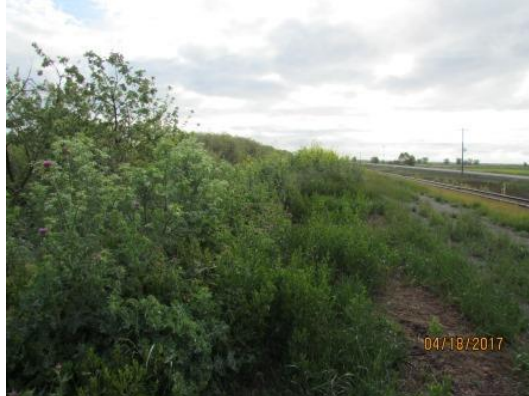
Photo 1 of 1 : SP\_2017\_RD2035\_238\_10\_20170426\_00015.jpg

View looking downstream of vegetation that need to be maintained, Spring 2017.

| V2 : Remove the wild growth other than native grasses from the levee slopes. | | | | | |

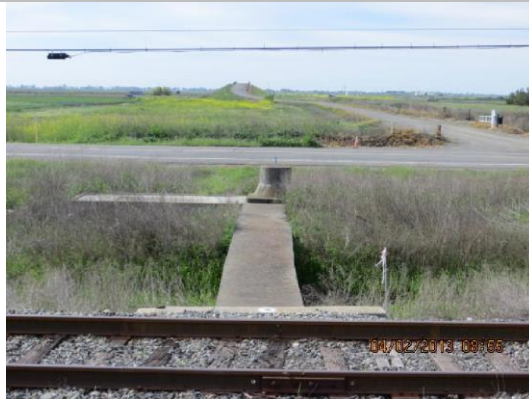
Photo 3 of 3 : UCIP\_SP\_2017\_10827\_18107.jpg

| FS_ID:10827<br>DS_ID:17814<br>EP_NO: 10127<br>Repair Type: No Action Needed<br>Crossing Status: Found<br>UCIP Comments:<br>FIELD_STRUCT_DESC: 42-inch CM pipe through levee 10.0 feet below crown. Flap gate on waterward end. Grouted spillway on waterward side. Pipe encased in concrete and exposed at LS. (A.B.O. No. 10127 - City of Woodland)<br>FS Date: 4/2/2013 | | | | | | |

Concrete encased pipe on LS toe.

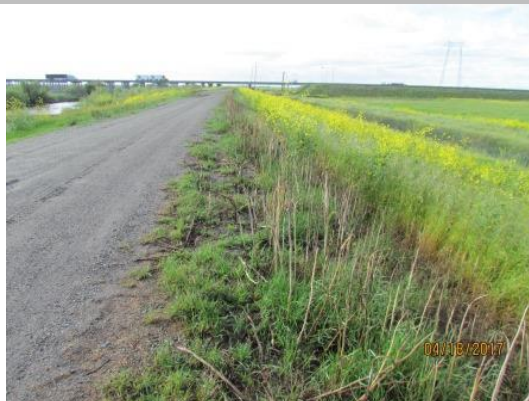
Photo 1 of 1 : SP\_2017\_RD2035\_239\_17\_20170426\_00026.jpg

| Annual grasses need to be maintained, Spring 2017. | | | | | |

View looking downstream of annual grasses that need to be maintained, Spring 2017.

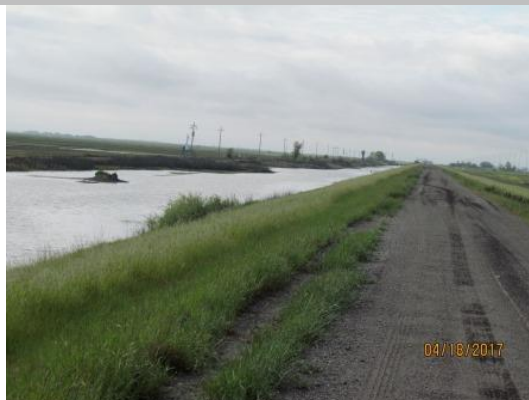
Photo 1 of 1 : SP\_2017\_RD2035\_239\_18\_20170426\_00027.jpg

| Annual grasses need to be maintained, Spring 2017. | | | | | |

View looking downstream of annual grasses that need to be maintained, Spring 2017.

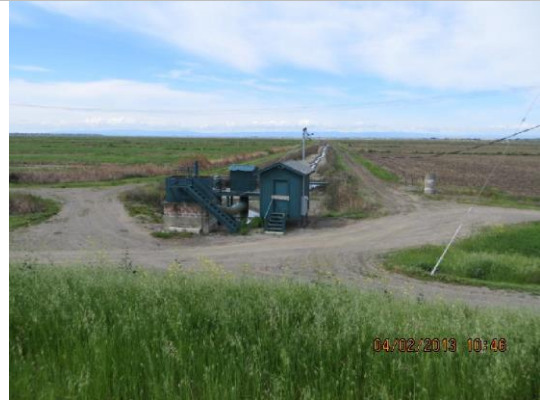
Photo 1 of 3 : UCIP\_SP\_2017\_50171\_18202.jpg

| FS_ID:50171<br>DS_ID:17822<br>EP_NO: N/A<br>Repair Type: Urgent<br>Crossing Status: Found<br>UCIP Comments: 09/14/2016 - Flap gate on the WS was submerged at time of inspection. LS headwall at the pumping plant has exposed rebar. There is still erosion present behind the headwall. However, water was present making it difficult to determine if it is getting worse. As-built drawings were requested from LMA consultant representative. (T. Hatch/UCIP)04/02/2013 - Flap gate broken in half on WS toe. Some erosion at headwalls on pumping plant. (W. Wylie/UCIP)<br>FIELD_STRUCT_DESC: 44-inch corrugated metal drainage pipe through the levee, 22 feet below the crown. There is a pump on a platform in a drainage ditch at the toe of the landside (LS) slope. There is a slide gate and flap gates in 5 foot by 9 foot concrete box. There is a flap gate on waterside (WS) toe. There is an 8-inch vent/standpipe at WS toe. [Additional Reference(s): DWR Levee Logs, 1990. USACE Sacramento O&M Manual 121, May 1959 (LM 0.4)].<br>FS Date: 9/14/2016 | | | | | |

Pumping plant off LS toe.

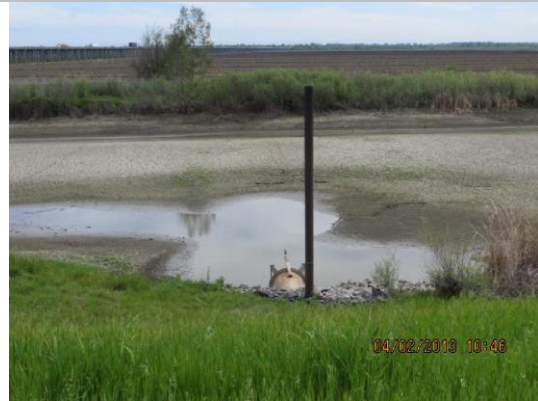
Photo 2 of 3 : UCIP\_SP\_2017\_50171\_18201.jpg

Pipe and flap gate with vent riser on WS toe.

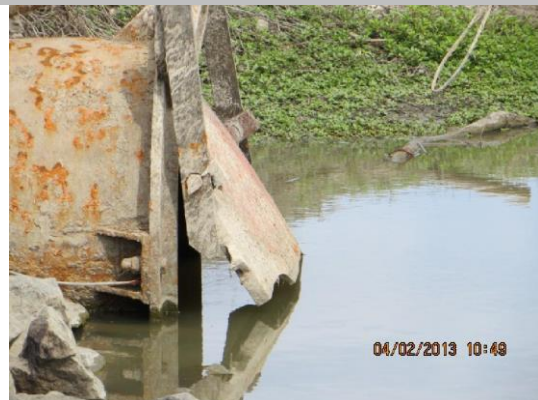
Photo 3 of 3 : UCIP\_SP\_2017\_50171\_18200.jpg

FS\_ID:50171  
DS\_ID:17822  
EP\_NO: N/A  
Repair Type: Urgent  
Crossing Status: Found  
UCIP Comments: 09/14/2016 - Flap gate on the WS was submerged at time of inspection. LS headwall at the pumping plant has exposed rebar. There is still erosion present behind the headwall. However, water was present making it difficult to determine if it is getting worse. As-built drawings were requested from LMA consultant representative. (T. Hatch/UCIP)04/02/2013 - Flap gate broken in half on WS toe. Some erosion at headwalls on pumping plant. (W. Wylie/UCIP) FIELD\_STRUCT\_DESC: 44-inch corrugated metal drainage pipe through the levee, 22 feet below the crown. There is a pump on a platform in a drainage ditch at the toe of the landside (LS) slope. There is a slide gate and flap gates in 5 foot by 9 foot concrete box. There is a flap gate on waterside (WS) toe. There is an 8-inch vent/standpipe at WS toe. [Additional Reference(s): DWR Levee Logs, 1990. USACE Sacramento O&M Manual 121, May 1959 (LM 0.4)].

Broken flap gate at WS toe.

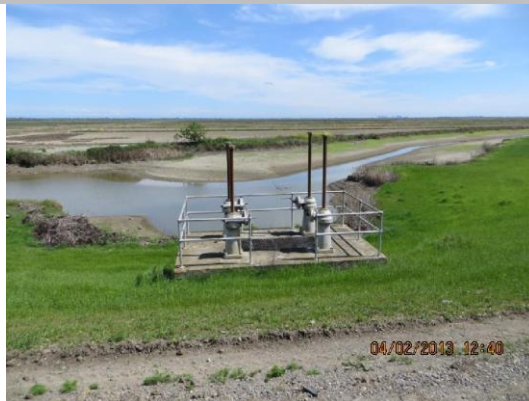
Photo 1 of 3 : UCIP\_SP\_2017\_10933\_18226.jpg

Slide gates in concrete vault on WS slope.

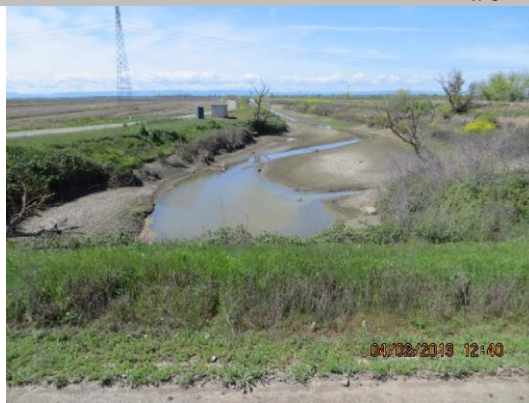
Photo 2 of 3 : UCIP\_SP\_2017\_10933\_18225.jpg

LS at intake.

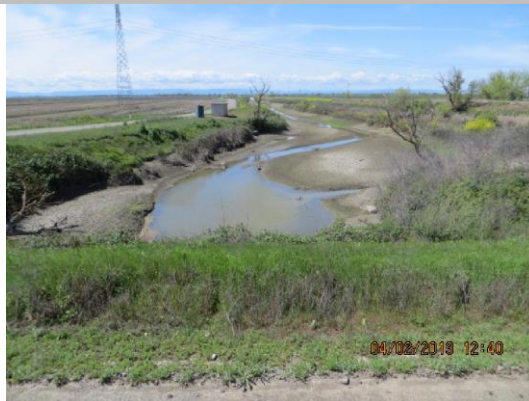
Photo 2 of 3 : UCIP\_SP\_2017\_10934\_18229.jpg

Intake at channel on LS toe.

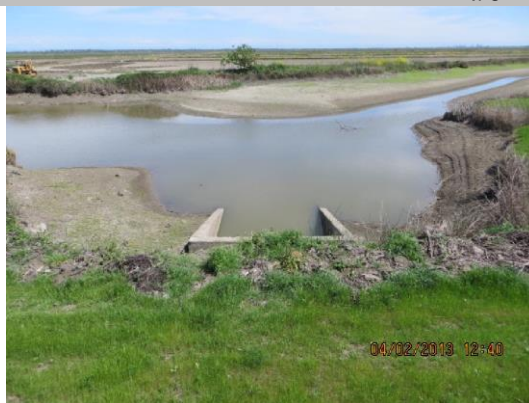
Photo 3 of 3 : UCIP\_SP\_2017\_10934\_18228.jpg

Concrete headwall on WS toe.

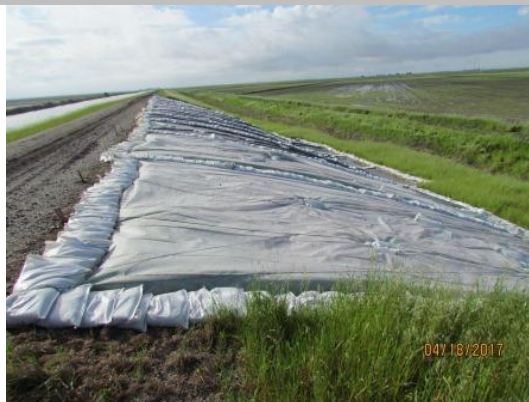
Photo 1 of 1 : SP\_2017\_RD2035\_239\_20\_20170426\_00028.jpg

| Slope sloughing that occurred during winter months, Spring 2017. | | | | | |

View looking downstream of a rain coat over landside slope sloughing that occurred during winter months, Spring 2017.

| S1 : Repair slope instability. | | | | | |

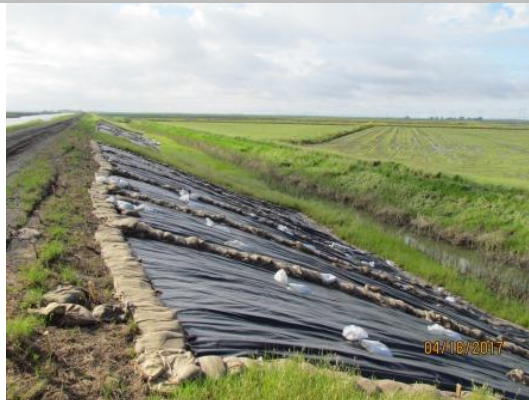
Photo 1 of 1 : SP\_2017\_RD2035\_239\_21\_20170426\_00029.jpg

| Slope sloughing that occurred during winter months, Spring 2017. | | | | | |

View looking downstream of a rain coat over landside slope sloughing that occurred during winter months, Spring 2017.

| S1 : Repair slope instability. | | | | | |

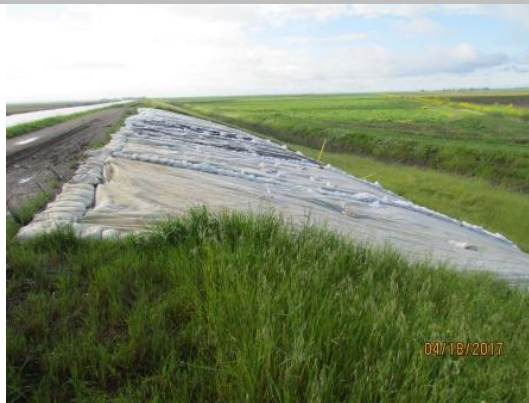
Photo 1 of 1 : SP\_2017\_RD2035\_239\_24\_20170426\_00032.jpg

| Slope sloughing that occurred during winter months, Spring 2017. | | | | | |

View looking downstream of a rain coat over landside slope sloughing that occurred during winter months, Spring 2017.

| S1 : Repair slope instability. | | | | | |

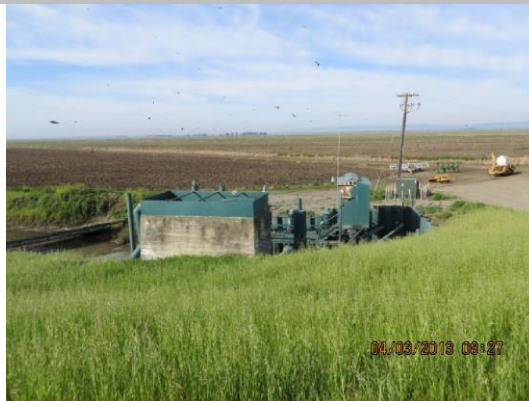
Photo 1 of 3 : UCIP\_SP\_2017\_11526\_18935.jpg

| FS_ID:11526<br>DS_ID:17828<br>EP_NO: 1701<br>Repair Type: Non-Urgent<br>Crossing Status: Found<br>UCIP Comments: Animal activity at outlet causing damage to berm and undermining the pipe at the outlet headwall on WS toe.<br>FIELD_STRUCT_DESC: 60-inch corrugated metal drain pipe through the levee 20.6 feet below the crown encased in 6-inches of reinforced concrete. Slide gate in 7-foot diameter C.M. pipe riser on waterward slope. Pumping plant with 6-pumps/pipes that discharge into a 4-ft by 18-ft surge box on the LS toe. (Permit No. 1701 - R.D. 2035)<br>FS Date: 4/3/2013 | | | | | |

Surge box and pumping plant on LS toe.

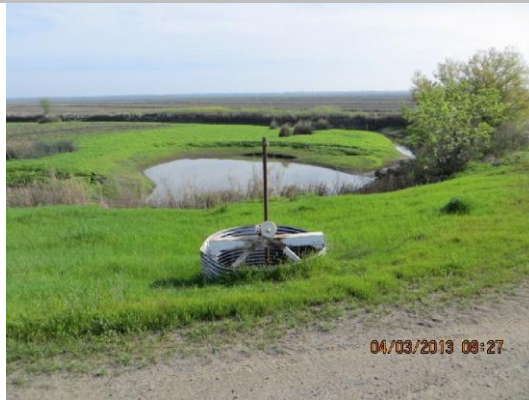
Photo 2 of 3 : UCIP\_SP\_2017\_11526\_18934.jpg

7-foot diameter CMP riser and slide gate on WS slope.

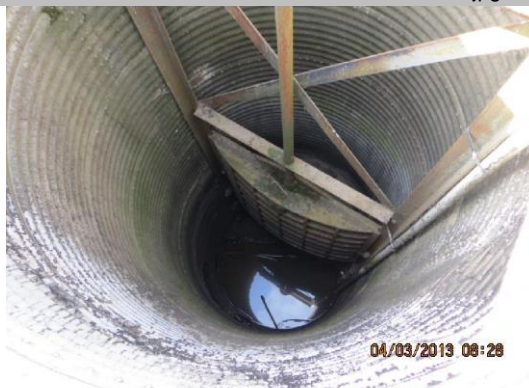
Photo 3 of 3 : UCIP\_SP\_2017\_11526\_18933.jpg

| FS_ID:11526<br>DS_ID:17828<br>EP_NO: 1701<br>Repair Type: Non-Urgent<br>Crossing Status: Found<br>UCIP Comments: Animal activity at outlet causing damage to berm and undermining the pipe at the outlet headwall on WS toe.<br>FIELD_STRUCT_DESC: 60-inch corrugated metal drain pipe through the levee 20.6 feet below the crown encased in 6-inches of reinforced concrete. Slide gate in 7-foot diameter C.M. pipe riser on waterward slope. Pumping plant with 6-pumps/pipes that discharge into a 4-ft by 18-ft surge box on the LS toe. (Permit No. 1701 - R.D. 2035)<br>FS Date: 4/3/2013 | | | | | |

7-foot diameter CMP riser and slide gate on WS slope.

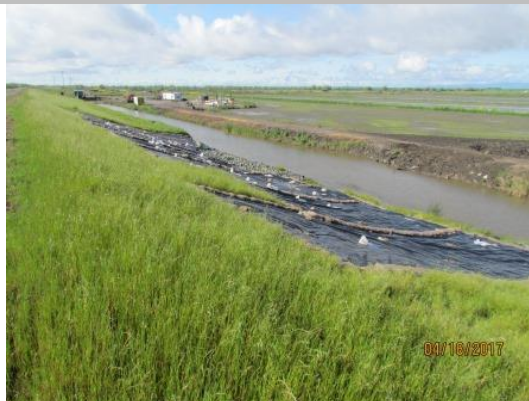
Photo 1 of 1 : SP\_2017\_RD2035\_239\_25\_20170426\_00033.jpg

| Slope sloughing that occurred during winter months, Spring 2017. | | | | | |

View looking downstream of a rain coat over landside slope sloughing that occurred during winter months, Spring 2017.

| S1 : Repair slope instability. | | | | | |

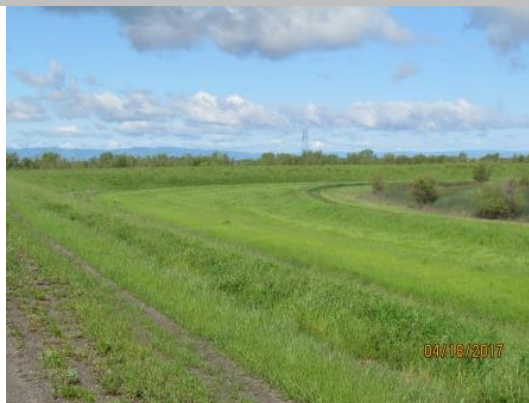
Photo 1 of 1 : SP\_2017\_RD2035\_240\_6\_20170426\_00017.jpg

| Annual grasses need to be maintained, Spring 2017. | | | | | |

View looking upstream of annual grasses that need to be maintained, Spring 2017.

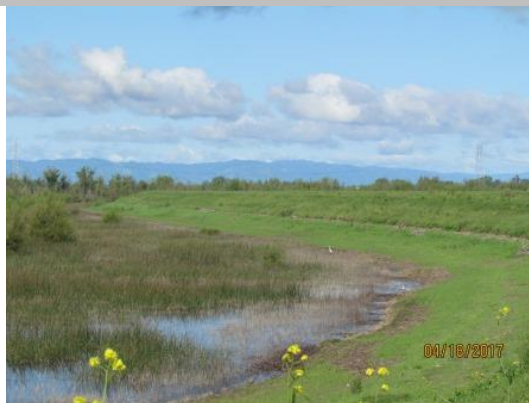
Photo 1 of 1 : SP\_2017\_RD2035\_240\_7\_20170426\_00018.jpg

| Annual grasses need to be maintained, Spring 2017. | | | | | |

View looking upstream of annual grasses that need to be maintained, Spring 2017.

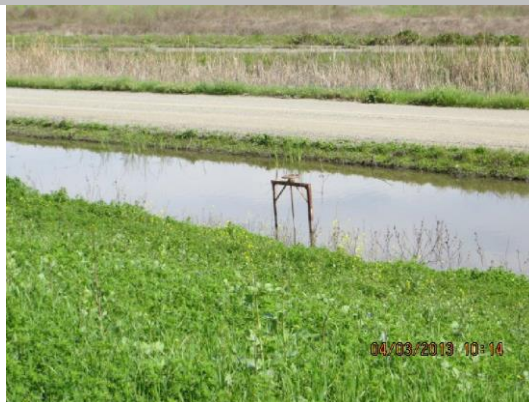
Photo 1 of 3 : UCIP\_SP\_2017\_41128\_18348.jpg

Slide gate and headwall in canal at LS toe.

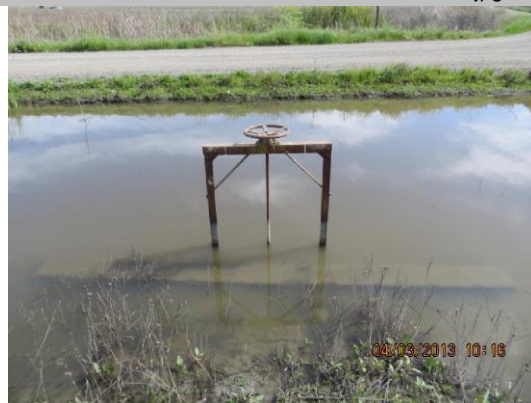
Photo 2 of 3 : UCIP\_SP\_2017\_41128\_18347.jpg

Slide gate and headwall in canal at LS toe.

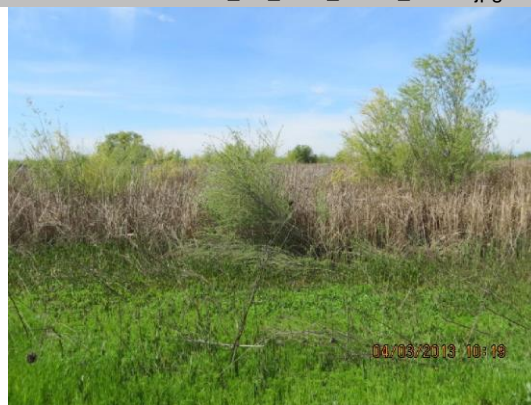
Photo 3 of 3 : UCIP\_SP\_2017\_41128\_18346.jpg

Vegetated area blocks access to WS of pipe.

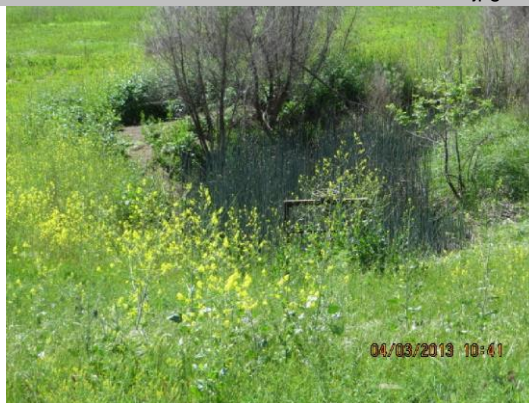
Photo 1 of 2 : UCIP\_SP\_2017\_11011\_18354.jpg

Slide gate at WS toe showing excessive vegetation.

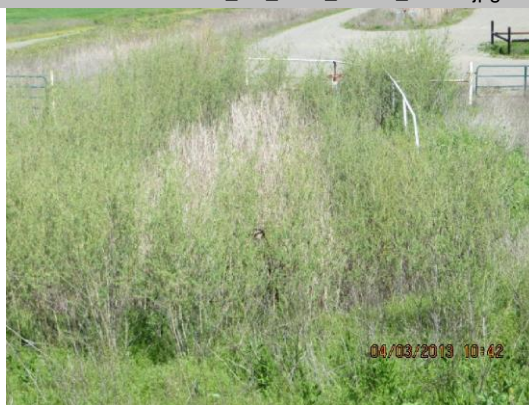
Photo 2 of 2 : UCIP\_SP\_2017\_11011\_18353.jpg

Slide gate at LS toe showing excessive vegetation.

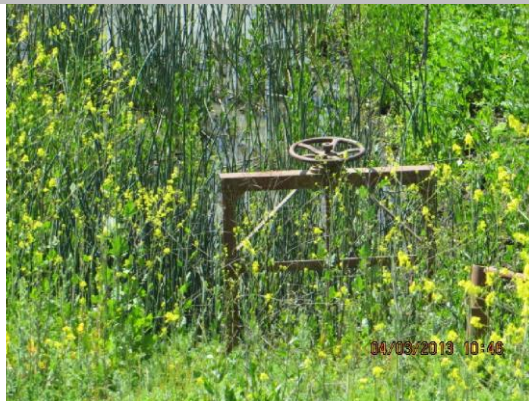
Photo 1 of 3 : UCIP\_SP\_2017\_11012\_18357.jpg

| FS_ID:11012<br>DS_ID:17838<br>EP_NO: N/A<br>Repair Type: Non-Urgent<br>Crossing Status: Found<br>UCIP Comments: Debris and vegetation partially blocking both ends of pipe.<br>FIELD_STRUCT_DESC: 36-inch pipe through levee 18.0 feet below crown, slide gate on LS toe. Combination flap and slide gate on WS toe. Originally included in O+M manual.<br>FS Date: 4/3/2013 | | | | | |

Combination flap and slide gate on WS toe. With excessive vegetation

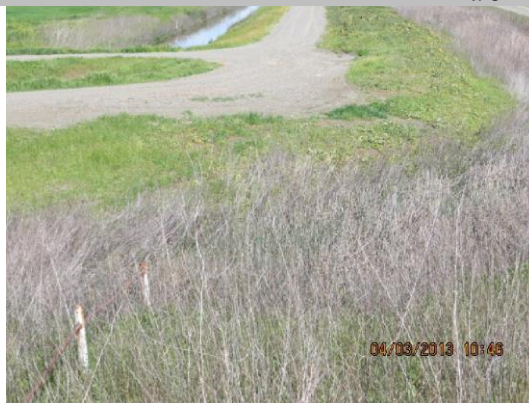
Photo 2 of 3 : UCIP\_SP\_2017\_11012\_18356.jpg

Headwall at bottom of fenceline on LS toe

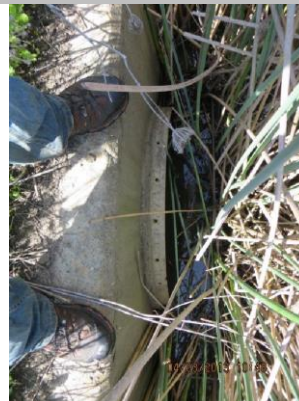
Photo 3 of 3 : UCIP\_SP\_2017\_11012\_18355.jpg

| FS_ID:11012<br>DS_ID:17838<br>EP_NO: N/A<br>Repair Type: Non-Urgent<br>Crossing Status: Found<br>UCIP Comments: Debris and vegetation partially blocking both ends of pipe.<br>FIELD_STRUCT_DESC: 36-inch pipe through levee 18.0 feet below crown, slide gate on LS toe. Combination flap and slide gate on WS toe. Originally included in O+M manual.<br>FS Date: 4/3/2013 | | | | | |

Headwall and pipe on LS toe.
