**Flood Control Project Maintenance
Levee Inspections**

Maintenance Issue Types Only, Levee Inspection Report By Mile - Spring 2018

Reclamation District No. 2035 Conaway

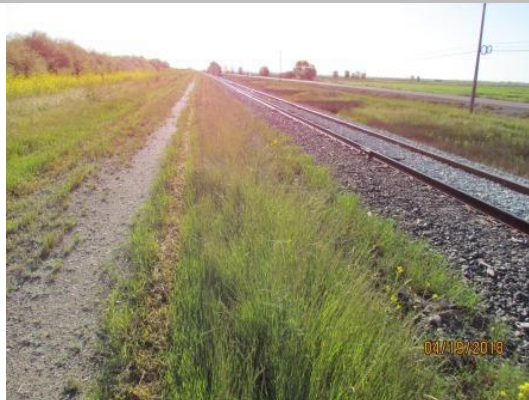
Photo 1 of 1 : SP_2018_RD2035_238_9_20180430_00013.jpg

LM Start	0.02	Rating **	M	Issue No.	9
LM End	2.00	Issue Type +	Ma	Location *	LS
Category	Earthen Levee			GPS Latitude/Longitude	
				Start	End
Item	Vegetation			38.677368 °	38.677186 °
				-121.709565 °	-121.672912 °
DWR ID	DWR_RD2035_01_s_2018_9				
Comment Code					
V1 : Control annual grass and weeds on the levee slopes and easements.					
Inspector Comment					
Annual vegetation needs to be maintained, Spring 2018.

View looking downstream landside of the annual vegetation that needs to be maintained, Spring 2018.

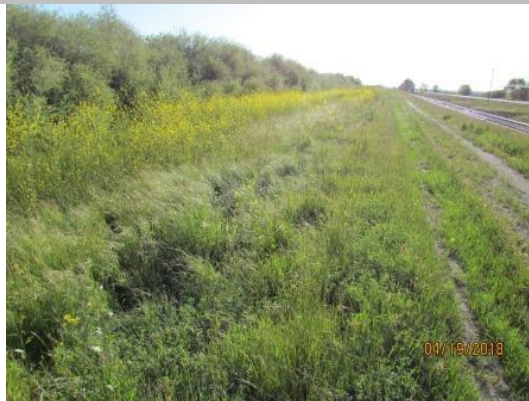
Photo 1 of 1 : SP_2018_RD2035_238_10_20180430_00014.jpg

LM Start	0.02	Rating **	M	Issue No.	10
LM End	2.00	Issue Type +	Ma	Location *	WS
Category	Earthen Levee			GPS Latitude/Longitude	
				Start	End
Item	Vegetation			38.677368 °	38.677186 °
				-121.709565 °	-121.672912 °
DWR ID	DWR_RD2035_01_s_2018_10				
Comment Code					
V1 : Control annual grass and weeds on the levee slopes and easements.					
Inspector Comment					
Annual vegetation needs to be maintained, Spring 2018.

View looking downstream waterside of the annual vegetation that needs to be maintained, Spring 2018.

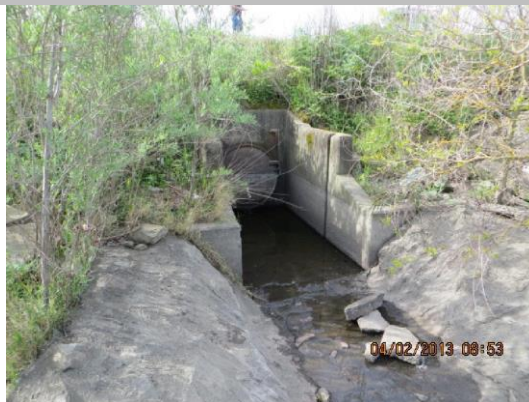
Photo 1 of 3 : UCIP_SP_2018_10827_18109.jpg

Comment Code					
Inspector Comment					
FS_ID:10827 DS_ID:17814 EP_NO: 10127 Repair Type: No Action Needed Crossing Status: Found UCIP Comments: FIELD_STRUCT_DESC: 42-inch concrete encased corrugated metal drainage pipe through the levee, 10 feet below the crown. Flap gate on the waterside (WS) end. Grouted spillway on the WS. Pipe exposed on the landside (LS). (36-inch pipe [HLM 0.02] authorized under Automatic Board Order (ABO) issued as Permit No. 10127, 1974 - City of Woodland, Department of Public Works). [Additional Reference(s): DWR Levee Log, 1990. USACE Sacramento O&M Manual 126, November 1961, (HLM 0.01), listed as 5.5 feet below the crown]. FS Date: 4/2/2013

Flap gate and spillway on WS toe.

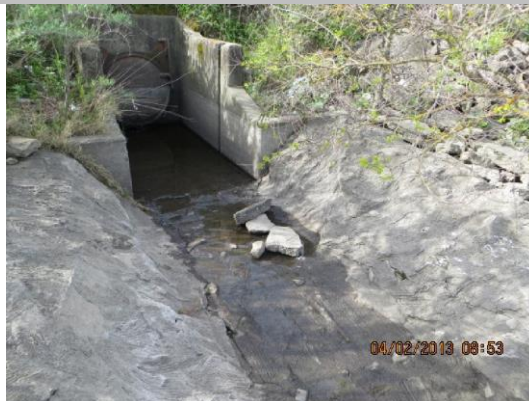
Photo 2 of 3 : UCIP_SP_2018_10827_18108.jpg

Flap gate and spillway on WS toe.

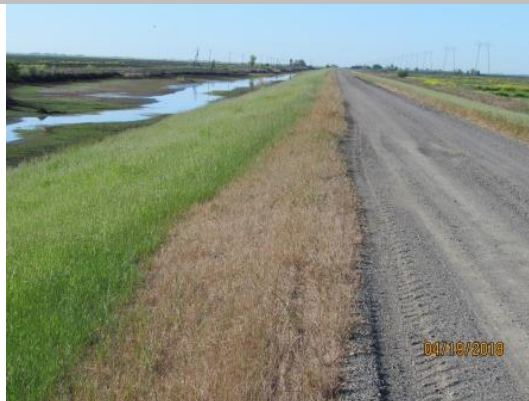
Photo 1 of 1 : SP_2018_RD2035_239_20_20180430_00059.jpg

LM Start	0.02	Rating **	A	Issue No.	20
LM End	3.46	Issue Type +	Ma	Location *	WS
Category	Earthen Levee			GPS Latitude/Longitude	
				Start	End
Item	Vegetation			38.676898 °	38.630112 °
				-121.672717 °	-121.654087 °
DWR ID	DWR_RD2035_02_s_2018_20				
Comment Code					
V1 : Control annual grass and weeds on the levee slopes and easements.					
Inspector Comment

View looking downstream waterside of the annual vegetation that is maintained, Spring 2018.

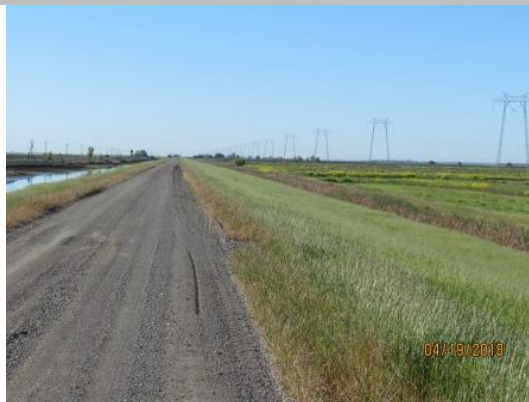
Photo 1 of 1 : SP_2018_RD2035_239_21_20180430_00058.jpg

LM Start	0.02	Rating **	A	Issue No.	21
LM End	3.46	Issue Type +	Ma	Location *	LS
Category	Earthen Levee			GPS Latitude/Longitude	
				Start	End
Item	Vegetation			38.676897 °	38.630112 °
				-121.672717 °	-121.654087 °
DWR ID	DWR_RD2035_02_s_2018_21				
Comment Code					
V1 : Control annual grass and weeds on the levee slopes and easements.					
Inspector Comment

View looking downstream landside of the annual vegetation that is maintained, Spring 2018.

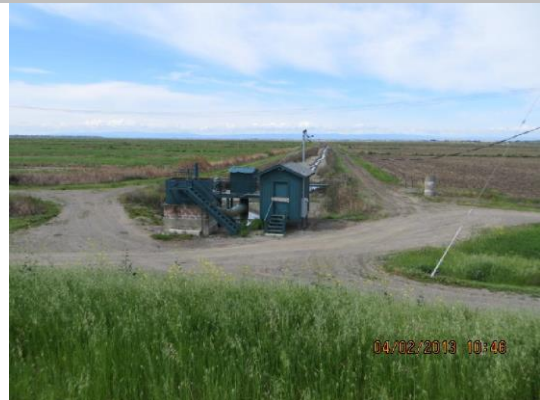
Photo 1 of 3 : UCIP_SP_2018_50171_18202.jpg

Comment Code					
Inspector Comment					
FS_ID:50171					
DS_ID:17822					
EP_NO: N/A					
Repair Type: Urgent					
Crossing Status: Found					
UCIP Comments: 09/14/2016 - Flap gate on the WS was submerged at time of inspection. LS headwall at the pumping plant has exposed rebar. There is still erosion present behind the headwall. However, water was present making it difficult to determine if it is getting worse. As-built drawings were requested from LMA consultant representative. (T. Hatch/UCIP)04/02/2013 - Flap gate broken in half on WS toe. Some erosion at headwalls on pumping plant. (W. Wylie/UCIP) FIELD_STRUCT_DESC: 44-inch corrugated metal drainage pipe through the levee, 22 feet below the crown. Pump on platform in drainage ditch at the landside (LS) toe. Slide gate and flap gates in a 5-foot by 9-foot concrete box. Flap gate on the waterside (WS) toe. 8-inch vent/standpipe at the WS toe. [Additional Reference(s): DWR Levee Log, 1990. USACE Sacramento O&M Manual 121, May 1959, (HLM 0.4) (4-foot by 4-foot concrete culvert listed)].

Pumping plant off LS toe.

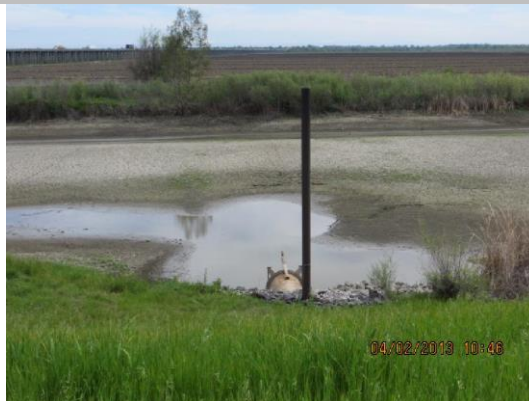
Photo 2 of 3 : UCIP_SP_2018_50171_18201.jpg

FS_ID:50171
DS_ID:17822
EP_NO: N/A
Repair Type: Urgent
Crossing Status: Found
UCIP Comments: 09/14/2016 - Flap gate on the WS was submerged at time of inspection. LS headwall at the pumping plant has exposed rebar. There is still erosion present behind the headwall. However, water was present making it difficult to determine if it is getting worse. As-built drawings were requested from LMA consultant representative. (T. Hatch/UCIP)04/02/2013 - Flap gate broken in half on WS toe. Some erosion at headwalls on pumping plant. (W. Wylie/UCIP) FIELD_STRUCT_DESC: 44-inch corrugated metal drainage pipe through the levee, 22 feet below the crown. Pump on platform in drainage ditch at the landside (LS) toe. Slide gate and flap gates in a 5-foot by 9-foot concrete box. Flap gate on the waterside (WS) toe. 8-inch vent/standpipe at the WS toe. [Additional Reference(s): DWR Levee Log, 1990. USACE Sacramento O&M Manual 121, May 1959, (HLM 0.4) (4-foot by 4-foot concrete culvert listed)].

Pipe and flap gate with vent riser on WS toe.

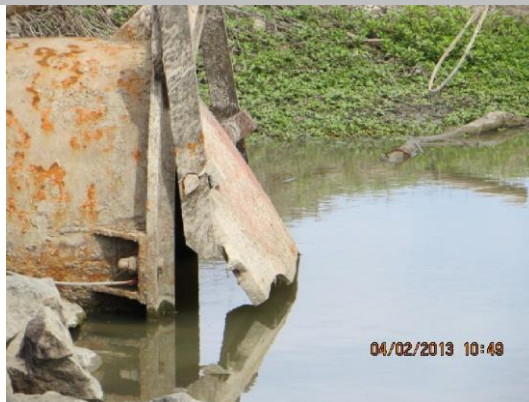
Photo 3 of 3 : UCIP_SP_2018_50171_18200.jpg

Broken flap gate at WS toe.

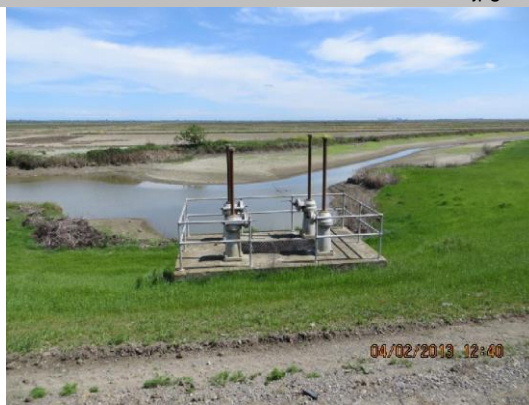
Photo 1 of 3 : UCIP_SP_2018_10933_18226.jpg

LM Start	2.15	Rating **	A/W	Issue No.	982	
LM End	2.15	Issue Type +	Ma	Location *		
Category	Supplemental			GPS Latitude/Longitude		
				Start	End	
Item	DWR UCIP LMA Responsibility			38.646445 °	38.646445 °	
				-121.666423 °	-121.666423 °	
DWR ID						
Comment Code						
Inspector Comment						
FS_ID:10933 DS_ID:17833 EP_NO: N/A Repair Type: No Action Needed Crossing Status: Found UCIP Comments: FIELD_STRUCT_DESC: 1 of 2: 60-inch drainage pipe of an unknown material through the levee, 26 feet below the crown. Concrete well and gate structure on the waterside (WS) slope. [Additional Reference(s): DWR Levee Log, 1990. USACE Sacramento O&M Manual 121, May 1959, (HLM 2.3) (6-foot by 6-foot concrete culvert listed)]. FS Date: 4/2/2013

Slide gates in concrete vault on WS slope.

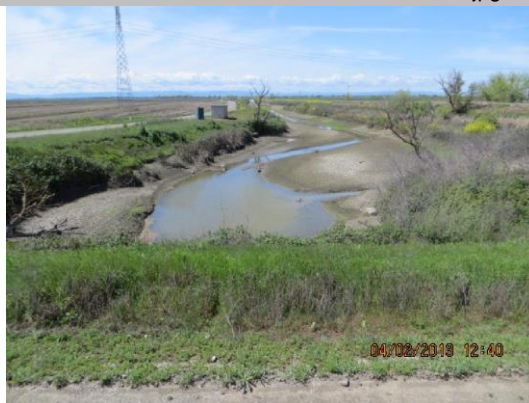
Photo 2 of 3 : UCIP_SP_2018_10933_18225.jpg

LS at intake.

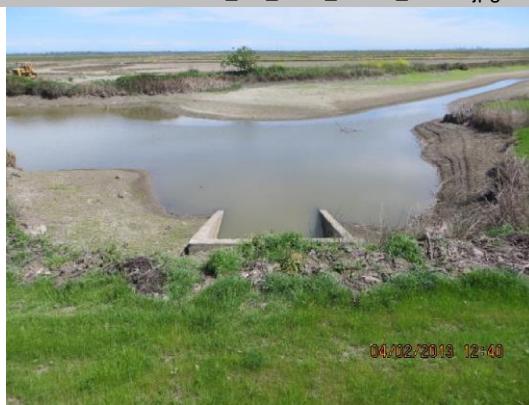
Photo 3 of 3 : UCIP_SP_2018_10933_18224.jpg

Outlet on WS toe.

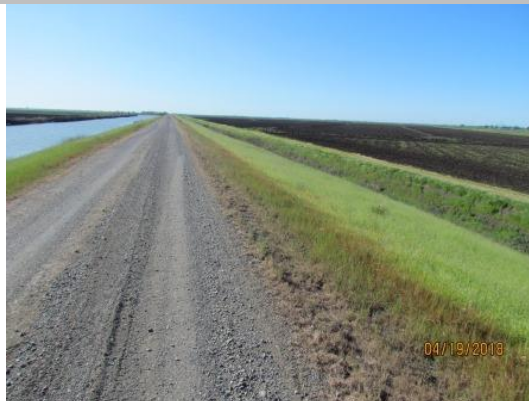
Photo 1 of 1 : SP_2018_RD2035_239_22_20180430_00060.jpg

LM Start	3.46	Rating **	A	Issue No.	22
LM End	7.60	Issue Type +	Ma	Location *	LS
Category	Earthen Levee			GPS Latitude/Longitude	
				Start	End
Item	Vegetation			38.630112 °	38.575489 °
				-121.654087 °	-121.635021 °
DWR ID	DWR_RD2035_02_s_2018_22				
Comment Code					
V1 : Control annual grass and weeds on the levee slopes and easements.					
Inspector Comment					
Annual vegetation is maintained, Spring 2018.

View looking downstream landside of the annual vegetation that is maintained, Spring 2018.

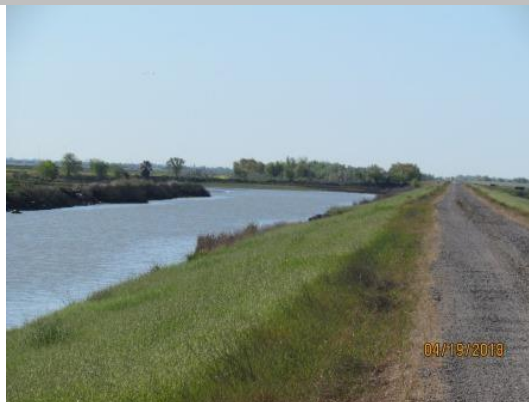
Photo 1 of 1 : SP_2018_RD2035_239_23_20180430_00061.jpg

LM Start	3.46	Rating **	A	Issue No.	23
LM End	7.60	Issue Type +	Ma	Location *	WS
Category	Earthen Levee			GPS Latitude/Longitude	
				Start	End
Item	Vegetation			38.630111 °	38.575489 °
				-121.654087 °	-121.635021 °
DWR ID	DWR_RD2035_02_s_2018_23				
Comment Code					
V1 : Control annual grass and weeds on the levee slopes and easements.					
Inspector Comment					
Annual vegetation is maintained, Spring 2018.

View looking downstream waterside of the annual vegetation that is maintained, Spring 2018.

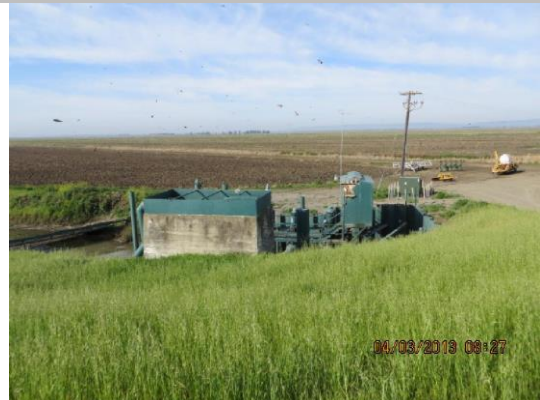
Photo 1 of 3 : UCIP_SP_2018_11526_18935.jpg

Comment Code					
Inspector Comment					
FS_ID:11526 DS_ID:17828 EP_NO: 1701 Repair Type: Non-Urgent Crossing Status: Found UCIP Comments: Animal activity at outlet causing damage to berm and undermining the pipe at the outlet headwall on WS toe. FIELD_STRUCT_DESC: 60-inch corrugated metal drainage pipe encased in 6 inches of reinforced concrete through the levee, 20.6 feet below the crown. Slide gate in a 7-foot-diameter corrugated metal pipe (CMP) riser on the waterside (WS) slope. Pumping plant with 6 pumps and pipes that discharge into a 4-foot by 18-foot surge box on the landside (LS) toe. (Permit No. 1701, 1952 - Reclamation District No. 2035). [Additional Reference(s): DWR Levee Log, 1990. USACE Sacramento O&M Manual 121, May 1959, (HLM 4.7)]. FS Date: 4/3/2013

Surge box and pumping plant on LS toe.

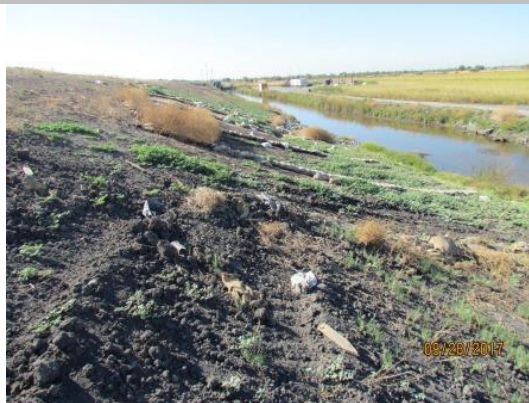
Photo 1 of 4 : SP_2018_RD2035_239_31_20180302_00032.jpg

Notes: long longitudinal cracks on the crown. Scheduled for repair 2019.

View looking downstream landside of 2017 Storm Damage, sluffing site. All plastic is remove, sandbags remain, and is NOT scheduled to be repaired in 2017.

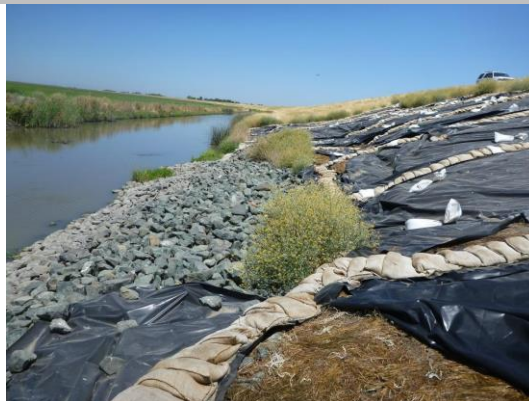
Photo 3 of 4 : LEVAL_SP_2018_195_1603.jpg

LM Start	6.35	Rating **	A/W	Issue No.	31 (cont)	
LM End	6.38	Issue Type +	Ma	Location *		
Category	Supplemental			GPS Latitude/Longitude		
				Start	End	
Item	2017 Storm Damage			38.592840 °	38.592390 °	
				-121.631340 °	-121.631320 °	
DWR ID	DWR_RD2035_02_f_2017_31					
Comment Code						
Inspector Comment						
Levee Evaluation Comments						
Description:						
Site ID No:195						
Site Designation:RD 2035-08						
Repair Type: Erosion						
Rating:Critical						
Field Date:7/13/2017						
Notes: long longitudinal cracks on the crown. Scheduled for repair 2019.

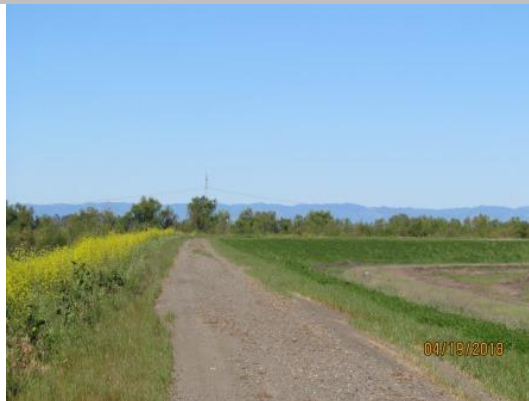
Photo 1 of 1 : SP_2018_RD2035_240_6_20180430_00014.jpg

LM Start	0.00	Rating **	M	Issue No.	6
LM End	2.52	Issue Type +	Ma	Location *	LS
Category	Earthen Levee			GPS Latitude/Longitude	
				Start	End
Item	Vegetation			38.575365 °	38.590787 °
				-121.635652 °	-121.665279 °
DWR ID	DWR_RD2035_03_s_2018_6				
Comment Code					
V1 : Control annual grass and weeds on the levee slopes and easements.					
Inspector Comment					
Annual vegetation needs to be maintained, Spring 2018.

View looking upstream landside of the annual vegetation that needs to be maintained, Spring 2018.

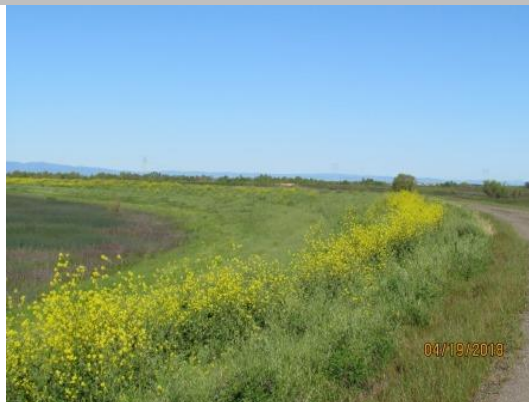
Photo 1 of 1 : SP_2018_RD2035_240_7_20180430_00015.jpg

LM Start	0.00	Rating **	U	Issue No.	7
LM End	2.52	Issue Type +	Ma	Location *	WS
Category	Earthen Levee			GPS Latitude/Longitude	
				Start	End
Item	Vegetation			38.575364 °	38.590787 °
				-121.635652 °	-121.665278 °
DWR ID	DWR_RD2035_03_s_2018_7				
Comment Code					
V1 : Control annual grass and weeds on the levee slopes and easements.					
Inspector Comment					
Annual vegetation needs to be maintained, Spring 2018.

View looking upstream waterside of the annual vegetation that needs to be maintained, Spring 2018.

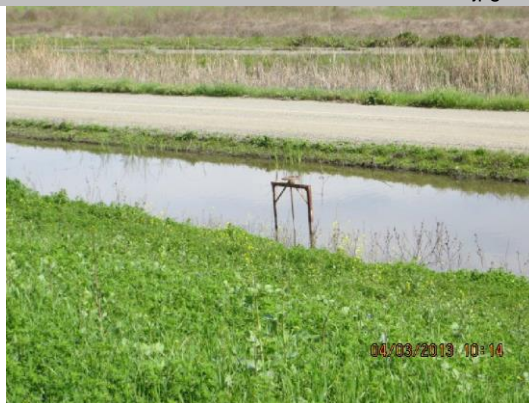
Photo 1 of 3 : UCIP_SP_2018_41128_18348.jpg

LM Start	1.39	Rating **	M	Issue No.	975
LM End	1.39	Issue Type +	Ma	Location *	
Category	Supplemental			GPS Latitude/Longitude	
				Start	End
Item	DWR UCIP LMA Responsibility			38.589425 °	38.589425 °
				-121.645359 °	-121.645359 °
DWR ID					
Comment Code					
Inspector Comment					
FS_ID:41128 DS_ID:17836 EP_NO: N/A Repair Type: Non-Urgent Crossing Status: Found UCIP Comments: Need to clear vegetation and debris from WS at outlet. FIELD_STRUCT_DESC: 36-inch corrugated metal drainage pipe through the levee, 17.5 feet below the crown. Flap gate on the waterside (WS) end. Slide gate and concrete headwall on the landside (LS) end. [Additional Reference(s): DWR Levee Log, 1990. USACE Sacramento O&M Manual 120, June 1952, (Station 327+75)]. FS Date: 4/3/2013

Slide gate and headwall in canal at LS toe.

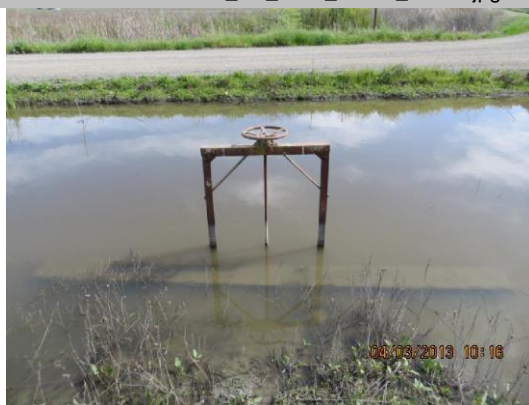
Photo 2 of 3 : UCIP_SP_2018_41128_18347.jpg

Slide gate and headwall in canal at LS toe.

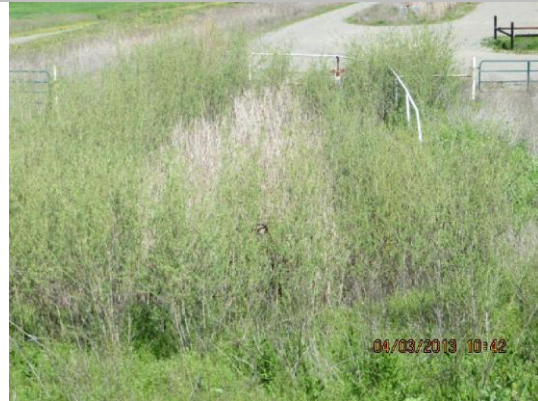
Photo 2 of 2 : UCIP_SP_2018_11011_18353.jpg

LM Start	2.17	Rating **	M	Issue No.	976 (cont)	
LM End	2.17	Issue Type +	Ma	Location *		
Category	Supplemental			GPS Latitude/Longitude		
				Start	End	
Item	DWR UCIP LMA Responsibility			38.590934 °	38.590934 °	
				-121.658940 °	-121.658940 °	
DWR ID						
Comment Code						
Inspector Comment						
FS_ID:11011 DS_ID:17837 EP_NO: N/A Repair Type: Non-Urgent Crossing Status: Found UCIP Comments: Debris and vegetation partially blocking inlet and outlet at both toes. FIELD_STRUCT_DESC: 48-inch corrugated metal drainage pipe through the levee, 19 feet below the crown. Slide gates on both ends. [Additional Reference(s): DWR Levee Log, 1990. USACE Sacramento O&M Manual 120, June 1952, (Station 290+37)]. FS Date: 4/3/2013

Slide gate at LS toe showing excessive vegetation.

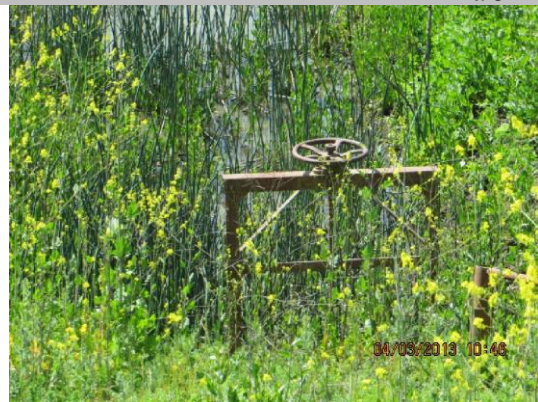
Photo 1 of 3 : UCIP_SP_2018_11012_18357.jpg

LM Start	2.19	Rating **	M	Issue No.	977
LM End	2.19	Issue Type +	Ma	Location *	
Category	Supplemental			GPS Latitude/Longitude	
				Start	End
Item	DWR UCIP LMA Responsibility			38.590909 °	38.590909 °
				-121.659311 °	-121.659311 °
DWR ID					
Comment Code					
Inspector Comment					
FS_ID:11012					
DS_ID:17838					
EP_NO: N/A					
Repair Type: Non-Urgent					
Crossing Status: Found					
UCIP Comments: Debris and vegetation partially blocking both ends of pipe.					
FIELD_STRUCT_DESC: 36-inch corrugated metal drainage pipe through the levee, 18 feet below the crown. Slide gate on the landside (LS) toe. Combination flap and slide gate on the waterside (WS) toe.					
[Additional Reference(s): DWR Levee Log, 1990. USACE Sacramento O&M Manual 120, June 1952, (Station 289+33)].					
FS Date: 4/3/2013

Combination flap and slide gate on WS toe. With excessive vegetation

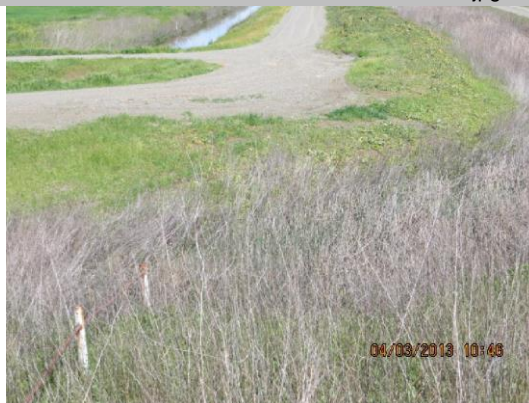
Photo 2 of 3 : UCIP_SP_2018_11012_18356.jpg

Headwall at bottom of fenceline on LS toe

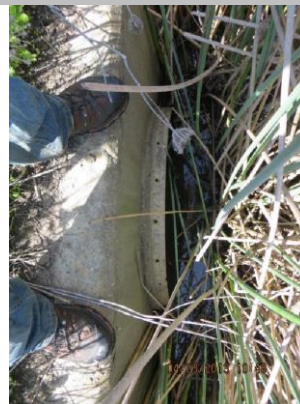
Photo 3 of 3 : UCIP_SP_2018_11012_18355.jpg

Headwall and pipe on LS toe.
