**Flood Control Project Maintenance
Levee Inspections**

Maintenance Issue Types Only, Levee Inspection Report By Mile - Spring 2019

Reclamation District No. 2035 Conaway

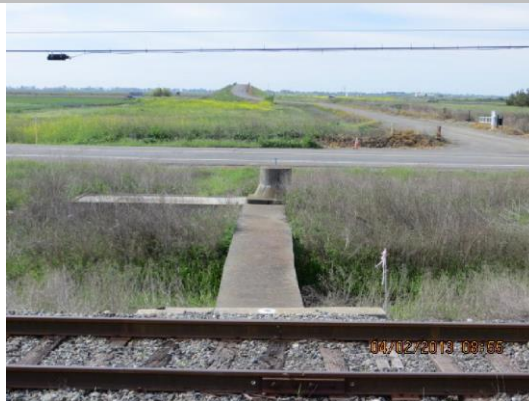
Photo 3 of 3 : UCIP_SP_2019_10827_18107.jpg

Comment Code						
Inspector Comment						
FS_ID:10827 DS_ID:17814 EP_NO: 10127 Repair Type: No Action Needed Crossing Status: Found UCIP Comments: FIELD_STRUCT_DESC: 42-inch concrete encased corrugated metal drainage pipe through the levee, 10 feet below the crown. Flap gate on the waterside (WS) end. Grouted spillway on the WS. Pipe exposed on the landside (LS). (36-inch pipe [HLM 0.02] authorized under Automatic Board Order (ABO) issued as Permit No. 10127, 1974 - City of Woodland, Department of Public Works). [Additional Reference(s): DWR Levee Log, 1990. USACE Sacramento O&M Manual 126, November 1961, (HLM 0.01), listed as 5.5 feet below the crown]. FS Date: 4/2/2013

Concrete encased pipe on LS toe.

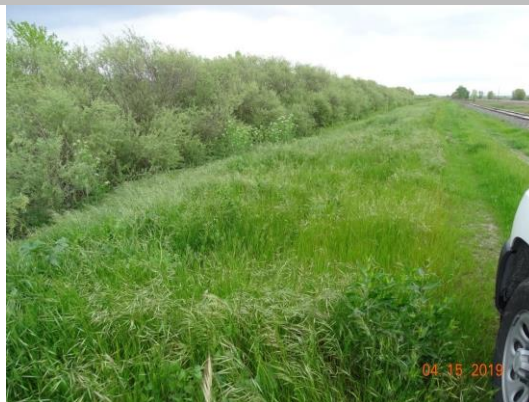
Photo 1 of 1 : SP_2019_RD2035_238_9_20190422_00013.jpg

LM Start	0.03	Rating **	M	Issue No.	9
LM End	2.01	Issue Type +	Ma	Location *	WS
Category	Earthen Levee			GPS Latitude/Longitude	
				Start	End
Item	Vegetation			38.677335 °	38.677183 °
				-121.709358 °	-121.672783 °
DWR ID	DWR_RD2035_01_s_2019_9				
Comment Code					
V1 : Control annual grass and weeds on the levee slopes and easements.					
Inspector Comment

View of vegetation on the waterside slope. Spring 2019.

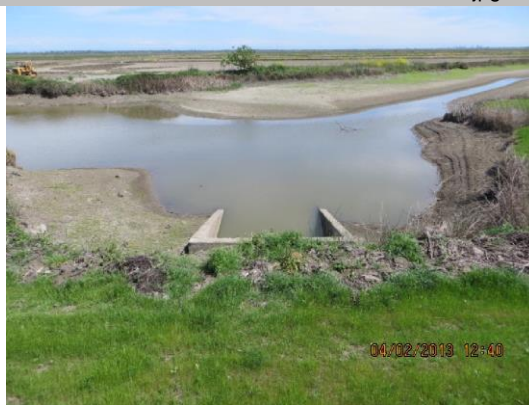
Photo 3 of 3 : UCIP_SP_2019_10933_18224.jpg

Outlet on WS toe.

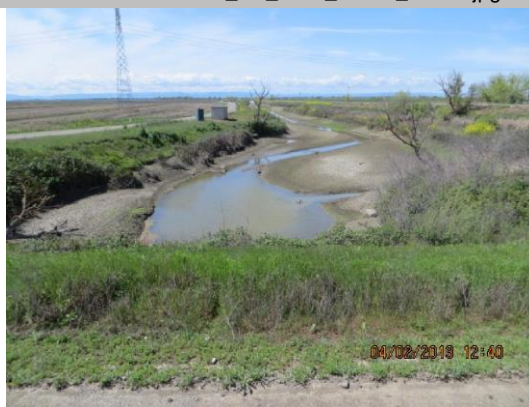
Photo 2 of 3 : UCIP_SP_2019_10934_18229.jpg

Intake at channel on LS toe.

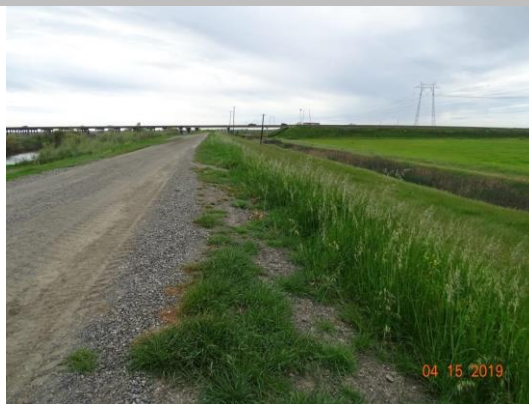
Photo 1 of 1 : SP_2019_RD2035_239_18_20190422_00028.jpg

LM Start	2.20	Rating **	M	Issue No.	18	
LM End	6.30	Issue Type +	Ma	Location *	LS	
Category	Earthen Levee			GPS Latitude/Longitude		
				Start		End
Item	Vegetation			38.645858 °		38.593535 °
				-121.666110 °		-121.631253 °
DWR ID	DWR_RD2035_02_s_2019_18					
Comment Code						
V1 : Control annual grass and weeds on the levee slopes and easements.						
Inspector Comment

View of vegetation on the landside slope. Spring 2019.

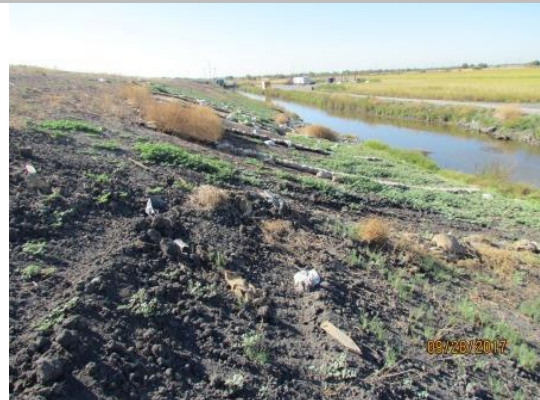
Photo 1 of 4 : SP_2019_RD2035_239_31_20190304_00002.jpg

LM Start	6.35	Rating **	A/W	Issue No.	31
LM End	6.38	Issue Type +	Ma	Location *	LS
Category	Supplemental			GPS Latitude/Longitude	
				Start	End
Item	2017 Storm Damage			38.592840 °	38.592390 °
				-121.631340 °	-121.631320 °
DWR ID	DWR_RD2035_02_f_2017_31				
Comment Code					
Inspector Comment					
Levee Evaluation Comments					
Description:					
Site ID No:195					
Site Designation:RD 2035-08					
Repair Type: Erosion					
Rating:Critical					
Field Date:7/13/2017					
Notes: long longitudinal cracks on the crown. Scheduled for repair in 2020.

View looking downstream landside of 2017 Storm Damage, sluffing site.
All plastic is remove, sandbags remain, and is NOT scheduled to be repaired in 2017.

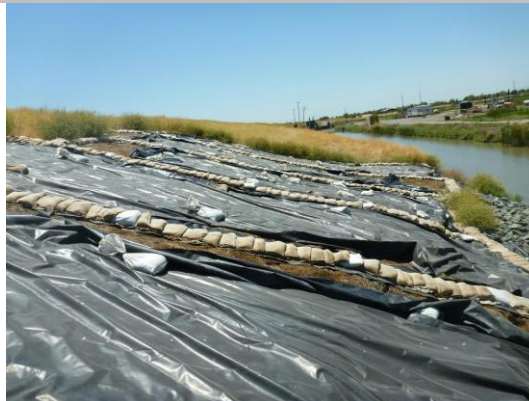
Photo 4 of 4 : LEVAL_SP_2019_195_1592.jpg

LM Start	6.35	Rating **	A/W	Issue No.	31 (cont)
LM End	6.38	Issue Type +	Ma	Location *	LS
Category	Supplemental			GPS Latitude/Longitude	
				Start	End
Item	2017 Storm Damage			38.592840 °	38.592390 °
				-121.631340 °	-121.631320 °
DWR ID	DWR_RD2035_02_f_2017_31				
Comment Code					
Inspector Comment					
Levee Evaluation Comments					
Description:					
Site ID No:195					
Site Designation:RD 2035-08					
Repair Type: Erosion					
Rating:Critical					
Field Date:7/13/2017					
Notes: long longitudinal cracks on the crown. Scheduled for repair in 2020.

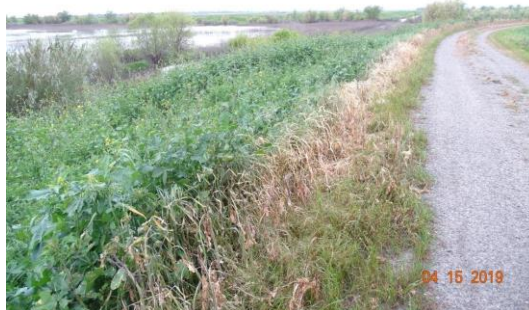
Photo 1 of 1 : SP_2019_RD2035_240_6_20190422_00015.jpg

LM Start	0.00	Rating **	U	Issue No.	6
LM End	0.64	Issue Type +	Ma	Location *	WS
Category	Earthen Levee			GPS Latitude/Longitude	
				Start	End
Item	Vegetation			38.575400 °	38.578663 °
				-121.635697 °	-121.645182 °
DWR ID	DWR_RD2035_03_s_2019_6				
Comment Code					
V1 : Control annual grass and weeds on the levee slopes and easements.					
Inspector Comment

View of vegetation on the waterside slope. Spring 2019.

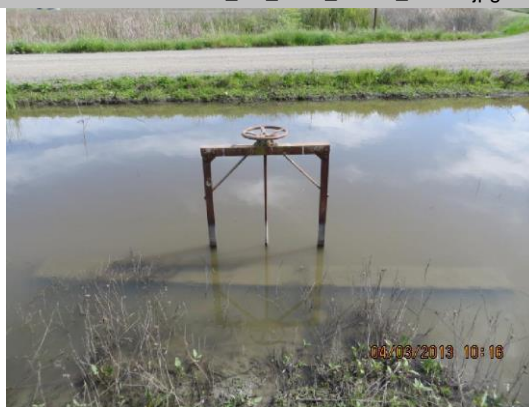
Photo 2 of 3 : UCIP_SP_2019_41128_18347.jpg

Slide gate and headwall in canal at LS toe.
