**Flood Control Project Maintenance  
Levee Inspections**

**Maintenance Issue Types Only, Levee Inspection Report By Mile - Spring 2020**

**Reclamation District No. 2035 Conaway**

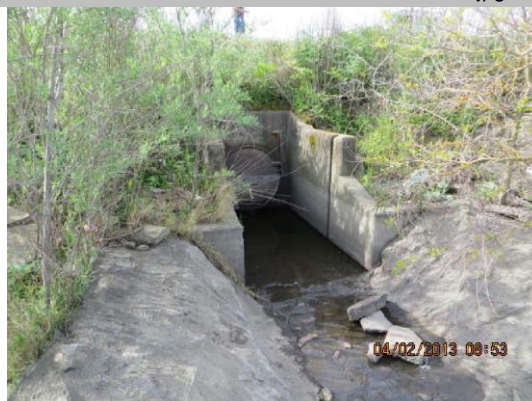
Photo 1 of 3 : UCIP\_SP\_2020\_56049\_18109.jpg

Comment Code						
Inspector Comment						
DS_ID:17814 FS_ID:56049 EP_NO: 10127 Repair Type: No Action Needed Crossing Status: Found UCIP Comments: 08/16/2019 Pending update... record will be updated in 2020. (O. Magana - DWR UCIP) FIELD_STRUCT_DESC: 42-inch concrete encased corrugated metal drainage pipe through the levee, 10 feet below the crown. Flap gate on the waterside (WS) end. Grouted spillway on the WS. Pipe exposed on the landside (LS). (36-inch pipe [HLM 0.02] authorized under Automatic Board Order (ABO) issued as Permit No. 10127, 1974 - City of Woodland, Department of Public Works). [Additional Reference(s): DWR Levee Log, 1990. USACE Sacramento O&M Manual 126, November 1961, (HLM 0.01), listed as 5.5 feet below the crown]. FS Date: 8/16/2019 12:20:00 PM

Flap gate and spillway on WS toe.

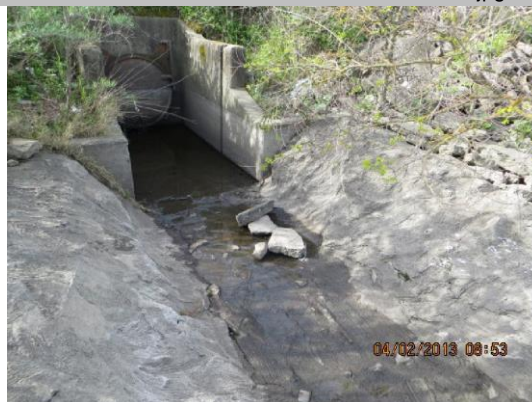
Photo 2 of 3 : UCIP\_SP\_2020\_56049\_18108.jpg

Flap gate and spillway on WS toe.

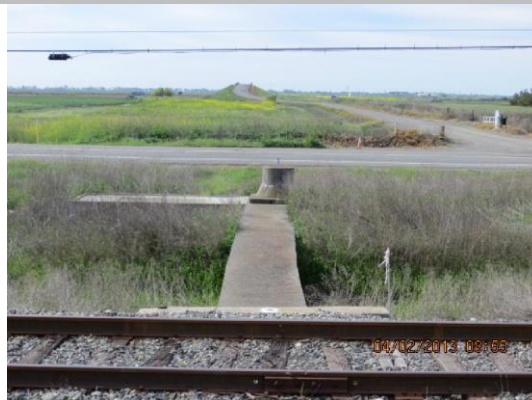
Photo 3 of 3 : UCIP\_SP\_2020\_56049\_18107.jpg

Concrete encased pipe on LS toe.

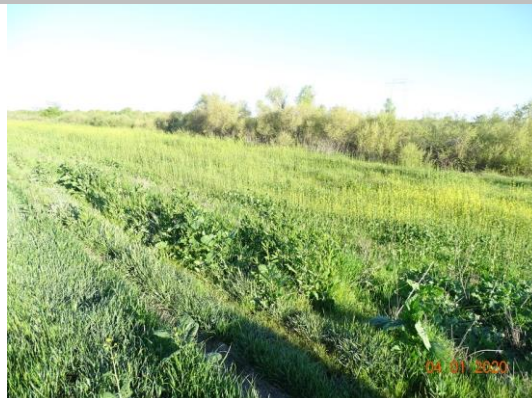
Photo 1 of 1 : SP\_2020\_RD2035\_238\_10\_20200401\_00013.jpg

LM Start	1.93	Rating **	U	Issue No.	10
LM End	2.00	Issue Type +	Ma	Location *	WS
Category	Earthen Levee			GPS Latitude/Longitude	
				Start	End
Item	Vegetation			38.677176 °	38.677172 °
				-121.674258 °	-121.672922 °
DWR ID	DWR_RD2035_01_s_2020_10				
Comment Code					
V1 : Control annual grass and weeds on the levee slopes and easements.					
Inspector Comment

View of dense vegetation on the waterside slope. Spring 2020.

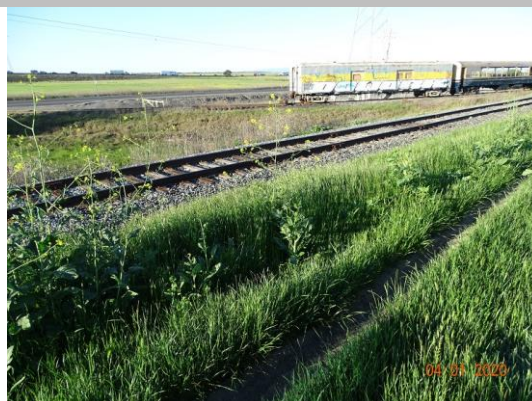
Photo 1 of 1 : SP\_2020\_RD2035\_238\_9\_20200401\_00014.jpg

LM Start	1.93	Rating **	U	Issue No.	9
LM End	2.00	Issue Type +	Ma	Location *	LS
Category	Earthen Levee			GPS Latitude/Longitude	
				Start	End
Item	Vegetation			38.677176 °	38.677172 °
				-121.674258 °	-121.672921 °
DWR ID	DWR_RD2035_01_s_2020_9				
Comment Code					
V1 : Control annual grass and weeds on the levee slopes and easements.					
Inspector Comment

View of dense vegetation on the landside slope. Spring 2020.

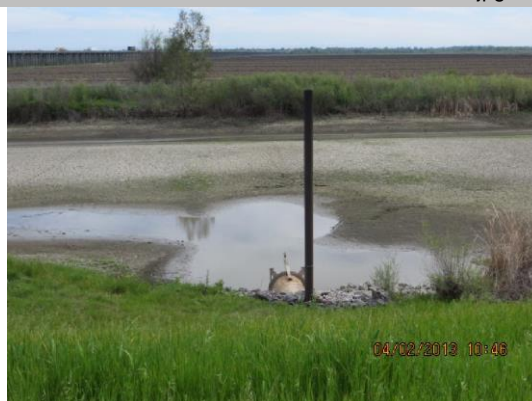
Photo 2 of 3 : UCIP\_SP\_2020\_56053\_18201.jpg

Pipe and flap gate with vent riser on WS toe.

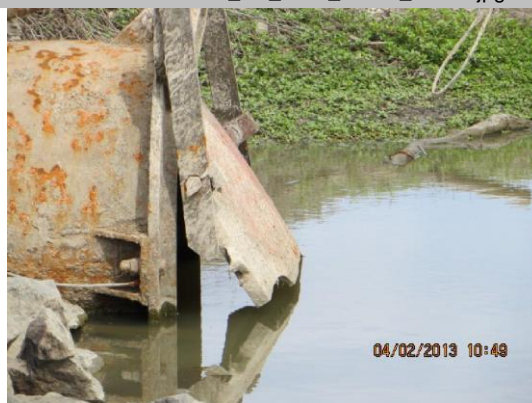
Photo 3 of 3 : UCIP\_SP\_2020\_56053\_18200.jpg

Broken flap gate at WS toe.

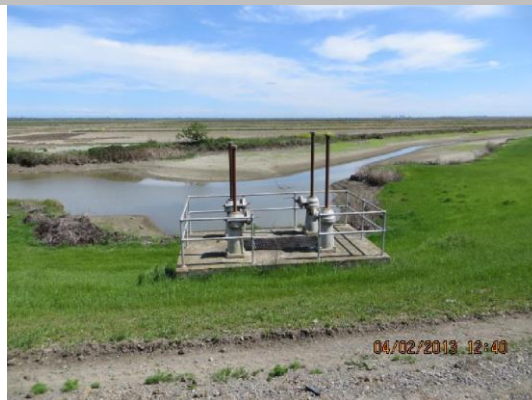
Photo 1 of 3 : UCIP\_SP\_2020\_10933\_18226.jpg

LM Start	2.15	Rating **	A/W	Issue No.	982	
LM End	2.15	Issue Type +	Ma	Location *		
Category	Supplemental			GPS Latitude/Longitude		
				Start	End	
Item	DWR UCIP LMA Responsibility			38.646445 °	38.646445 °	
				-121.666423 °	-121.666423 °	
DWR ID	17833					
Comment Code						
Inspector Comment						
DS_ID:17833						
FS_ID:10933						
EP_NO: N/A						
Repair Type: No Action Needed						
Crossing Status: Found						
UCIP Comments:						
FIELD_STRUCT_DESC: 1 of 2: 60-inch drainage pipe of an unknown material through the levee, 26 feet below the crown. Concrete well and gate structure on the waterside (WS) slope. [Additional Reference(s): DWR Levee Log, 1990. USACE Sacramento O&M Manual 121, May 1959, (HLM 2.3) (6-foot by 6-foot concrete culvert listed)].						
FS Date: 4/2/2013

Slide gates in concrete vault on WS slope.

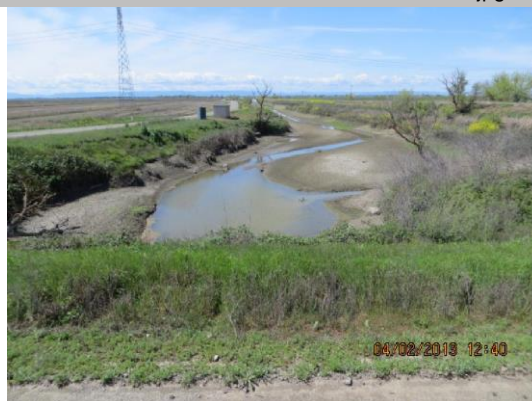
Photo 2 of 3 : UCIP\_SP\_2020\_10933\_18225.jpg

LS at intake.

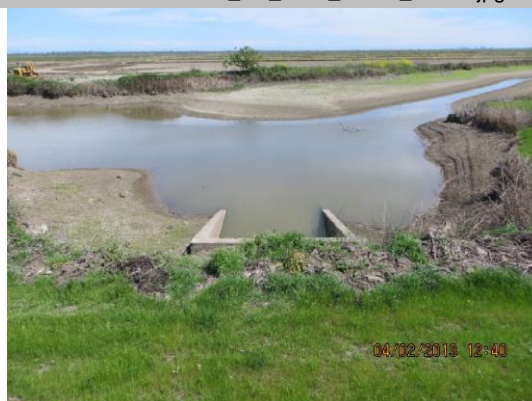
Photo 3 of 3 : UCIP\_SP\_2020\_10933\_18224.jpg

Outlet on WS toe.

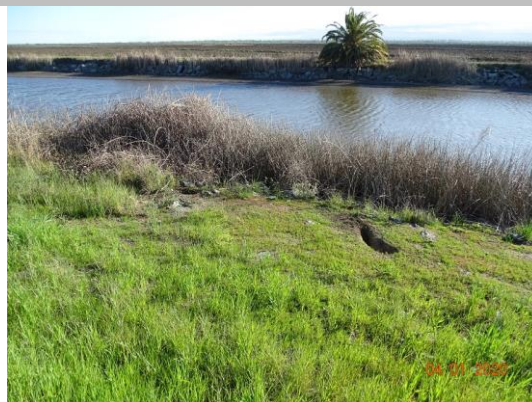
Photo 1 of 1 : SP\_2020\_RD2035\_239\_17\_20200401\_00029.jpg

LM Start	2.61	Rating **	A/W	Issue No.	17
LM End	2.61	Issue Type +	Ma	Location *	WS
Category	Earthen Levee			GPS Latitude/Longitude	
				Start	End
Item	Animal Control			38.640880 °	38.640880 °
				-121.662058 °	-121.662058 °
DWR ID	DWR_RD2035_02_s_2020_17				
Comment Code					
A3 : No rodents visible, but rodent burrows visible; need to backfill and compact or grout burrows.					
Inspector Comment					
Small rodent holes near waterside toe. Recommend monitoring.

View of rodent hole near waterside toe. Spring 2020.

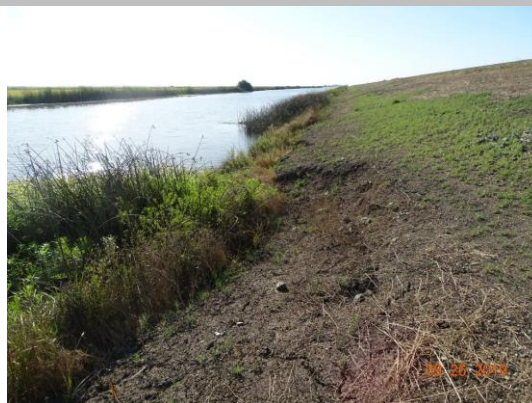
Photo 1 of 1 : SP\_2020\_RD2035\_239\_9\_20200228\_00001.jpg

LM Start	2.91	Rating **	M	Issue No.	9
LM End	2.91	Issue Type +	Ma	Location *	WS
Category	Earthen Levee			GPS Latitude/Longitude	
				Start	End
Item	Erosion / Bank Caving			38.637048 °	38.637048 °
				-121.659227 °	-121.659227 °
DWR ID	DWR_RD2035_02_f_2019_9				
Comment Code					
E2 : Schedule repair of erosion site prior to the next inspection.					
Inspector Comment					
Appears to be a 15' wide section of bank caving near the waterside toe. Recommend repairing.

View of bank caving on the waterside slope. Fall 2019.

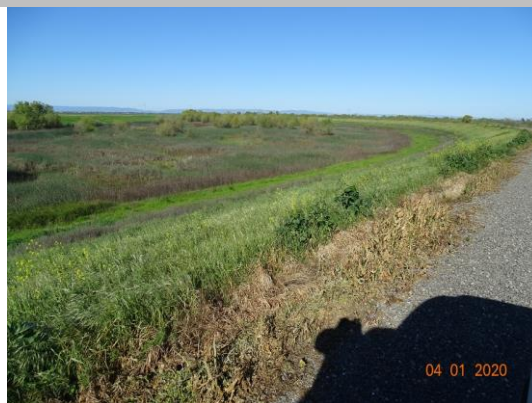
Photo 1 of 1 : SP\_2020\_RD2035\_240\_7\_20200401\_00014.jpg

LM Start	0.06	Rating **	M	Issue No.	7
LM End	0.68	Issue Type +	Ma	Location *	WS
Category	Earthen Levee			GPS Latitude/Longitude	
				Start	End
Item	Vegetation			38.575648 °	38.579261 °
				-121.636700 °	-121.645196 °
DWR ID	DWR_RD2035_03_s_2020_7				
Comment Code					
V1 : Control annual grass and weeds on the levee slopes and easements.					
Inspector Comment

View of vegetation on the waterside slope. Spring 2020.

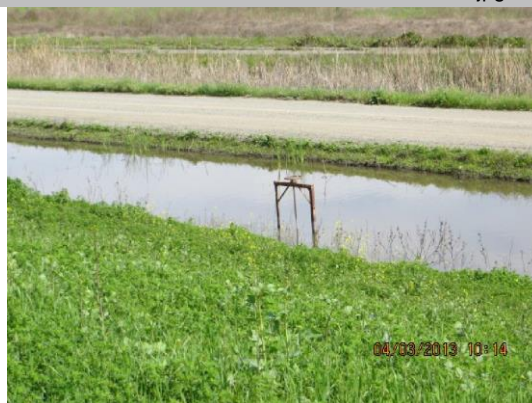
Photo 1 of 3 : UCIP\_SP\_2020\_41128\_18348.jpg

LM Start	1.39	Rating **	M	Issue No.	975
LM End	1.39	Issue Type +	Ma	Location *	
Category	Supplemental			GPS Latitude/Longitude	
				Start	End
Item	DWR UCIP LMA Responsibility			38.589425 °	38.589425 °
				-121.645359 °	-121.645359 °
DWR ID	17836				
Comment Code					
Inspector Comment					
DS_ID:17836 FS_ID:41128 EP_NO: N/A Repair Type: Non-Urgent Crossing Status: Found UCIP Comments: 04/03/2013 Need to clear vegetation and debris from WS at outlet. (W. Wylie - DWR UCIP) FIELD_STRUCT_DESC: 36-inch corrugated metal drainage pipe through the levee, 17.5 feet below the crown. Flap gate on the waterside (WS) end. Slide gate and concrete headwall on the landside (LS) end. [Additional Reference(s): DWR Levee Log, 1990. USACE Sacramento O&M Manual 120, June 1952, (Station 327+75)]. FS Date: 4/3/2013

Slide gate and headwall in canal at LS toe.

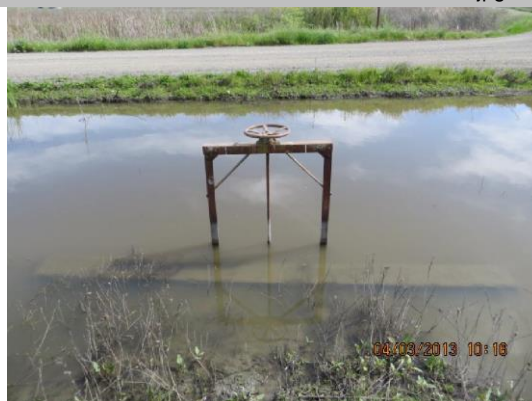
Photo 2 of 3 : UCIP\_SP\_2020\_41128\_18347.jpg

Slide gate and headwall in canal at LS toe.

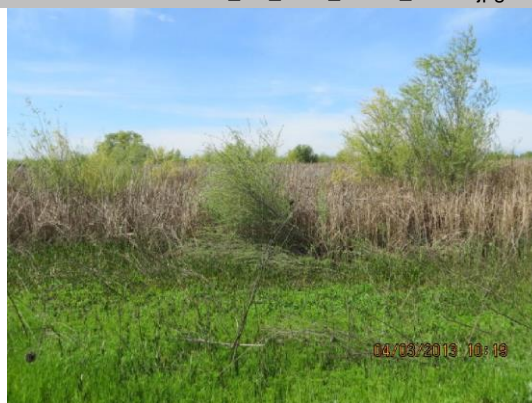
Photo 3 of 3 : UCIP\_SP\_2020\_41128\_18346.jpg

Vegetated area blocks access to WS of pipe.

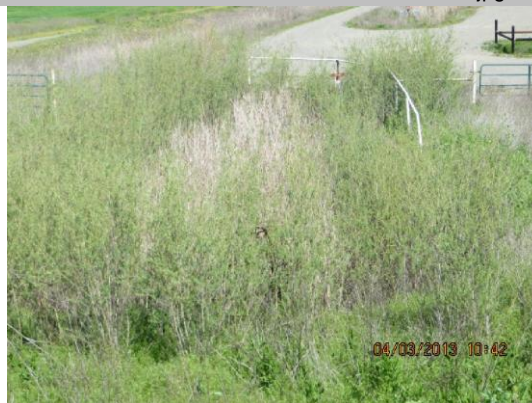
Photo 2 of 2 : UCIP\_SP\_2020\_11011\_18353.jpg

Slide gate at LS toe showing excessive vegetation.

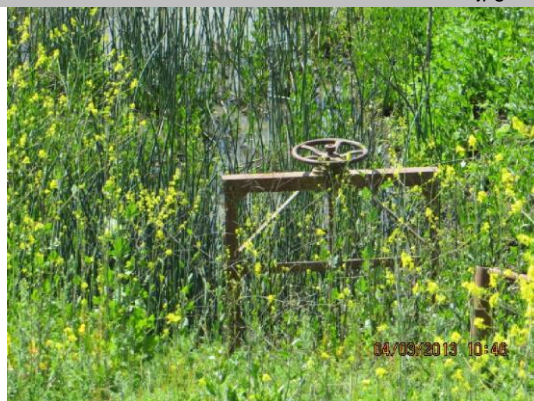
Photo 1 of 3 : UCIP\_SP\_2020\_11012\_18357.jpg

LM Start	2.19	Rating **	M	Issue No.	977
LM End	2.19	Issue Type +	Ma	Location *	
Category	Supplemental			GPS Latitude/Longitude	
				Start	End
Item	DWR UCIP LMA Responsibility			38.590909 °	38.590909 °
				-121.659311 °	-121.659311 °
DWR ID	17838				
Comment Code					
Inspector Comment					
DS_ID:17838 FS_ID:11012 EP_NO: N/A Repair Type: Non-Urgent Crossing Status: Found UCIP Comments: 04/03/2013 Debris and vegetation partially blocking both ends of pipe. (W. Wylie - DWR UCIP) FIELD_STRUCT_DESC: 36-inch corrugated metal drainage pipe through the levee, 18 feet below the crown. Slide gate on the landside (LS) toe. Combination flap and slide gate on the waterside (WS) toe. [Additional Reference(s): DWR Levee Log, 1990. USACE Sacramento O&M Manual 120, June 1952, (Station 289+33)]. FS Date: 4/3/2013

Combination flap and slide gate on WS toe. With excessive vegetation

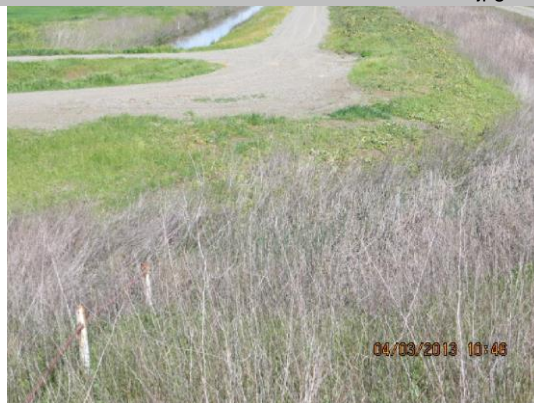
Photo 2 of 3 : UCIP\_SP\_2020\_11012\_18356.jpg

Headwall at bottom of fenceline on LS toe

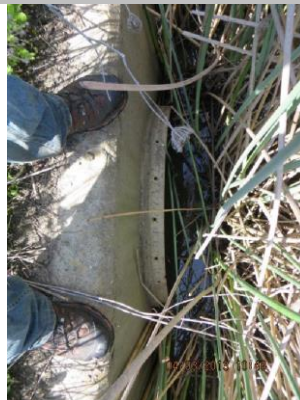
Photo 3 of 3 : UCIP\_SP\_2020\_11012\_18355.jpg

Headwall and pipe on LS toe.
