**Flood Control Project Maintenance
Levee Inspections**

Maintenance Issue Types Only, Levee Inspection Report By Mile - Spring 2021

Reclamation District No. 2035 Conaway

Waterway	Bank	Unit Miles	Inspection Start/End	Inspector
Unit No. 01 Cache Creek Settling Basin	Right	2.01	03/30/2021 03/30/2021	Zach Jojola

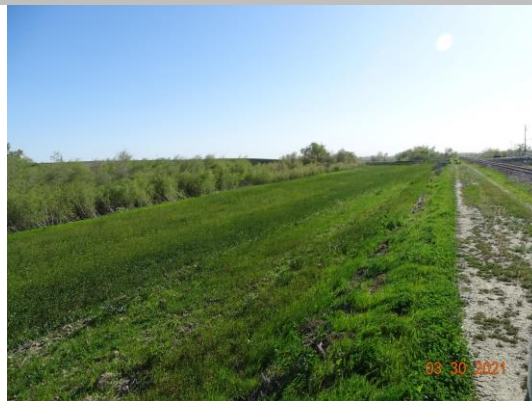
Photo 1 of 1 : SP_2021_RD2035_238_9_20210330_00013.jpg

LM Start	1.90	Rating **	A	Issue No.	9
LM End	1.90	Issue Type +	Ma	Location *	WS
Category	Earthen Levee			GPS Latitude/Longitude	
				Start	End
Item	Vegetation			38.677201 °	38.677201 °
				-121.674701 °	-121.674701 °
DWR ID	DWR_RD2035_01_s_2021_9				
Comment Code					
V1 : Control annual grass and weeds on the levee slopes and easements.					
Inspector Comment					
LMA maintains the vegetation at a high level.

View of maintained waterside slope. Spring 2021.

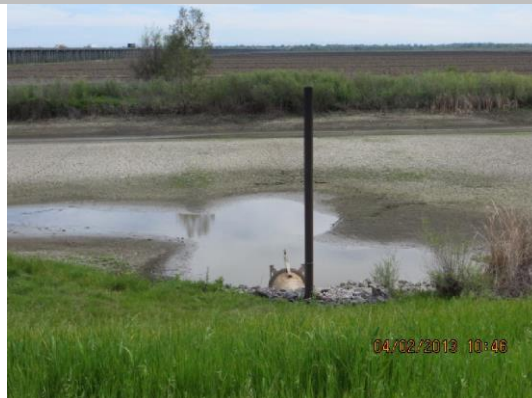
Photo 2 of 3 : UCIP_SP_2021_56053_18201.jpg

Pipe and flap gate with vent riser on WS toe.

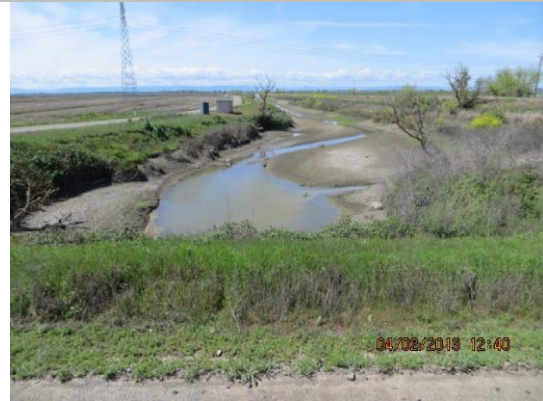
Photo 2 of 3 : UCIP_SP_2021_10933_18225.jpg

LS at intake.

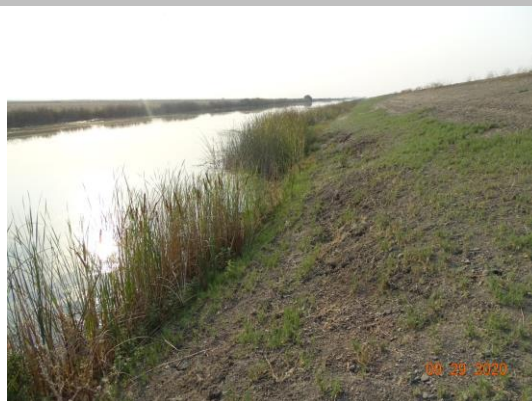
Photo 1 of 1 : SP_2021_RD2035_239_19_20210308_00003.jpg

LM Start	2.79	Rating **	M	Issue No.	19
LM End	2.79	Issue Type +	Ma	Location *	WS
Category	Earthen Levee			GPS Latitude/Longitude	
				Start	End
Item	Erosion / Bank Caving			38.638511 °	38.638511 °
				-121.660277 °	-121.660277 °
DWR ID	DWR_RD2035_02_f_2020_19				
Comment Code					
E2 : Schedule repair of erosion site prior to the next inspection.					
Inspector Comment					
Erosion on the waterside toe.

View of erosion on the waterside slope near the toe. Fall 2020.

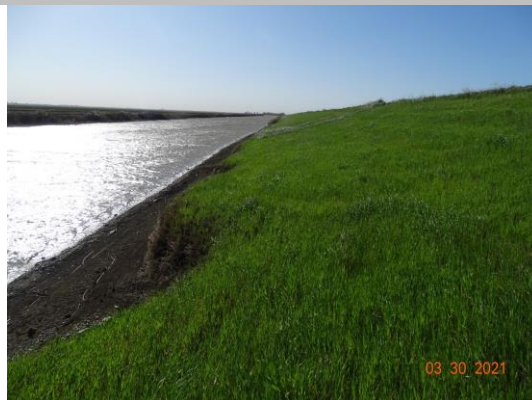
Photo 1 of 1 : SP_2021_RD2035_239_18_20210330_00026.jpg

LM Start	3.42	Rating **	M	Issue No.	18
LM End	3.42	Issue Type +	Ma	Location *	WS
Category	Earthen Levee			GPS Latitude/Longitude	
				Start	End
Item	Erosion / Bank Caving			38.630657 °	38.630657 °
				-121.654502 °	-121.654502 °
DWR ID	DWR_RD2035_02_s_2020_18				
Comment Code					
E2 : Schedule repair of erosion site prior to the next inspection.					
Inspector Comment					
Erosion at the waterside toe.

View of erosion at waterside toe. Spring 2021.

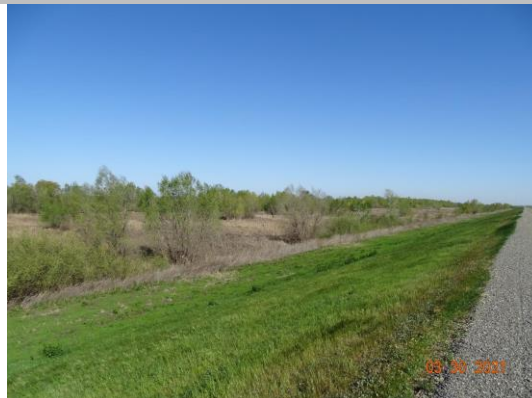
Photo 1 of 1 : SP_2021_RD2035_240_6_20210330_00014.jpg

LM Start	0.72	Rating **	A	Issue No.	6
LM End	0.72	Issue Type +	Ma	Location *	WS
Category	Earthen Levee			GPS Latitude/Longitude	
				Start	End
Item	Vegetation			38.579839 °	38.579839 °
				-121.645175 °	-121.645175 °
DWR ID	DWR_RD2035_03_s_2021_6				
Comment Code					
V1 : Control annual grass and weeds on the levee slopes and easements.					
Inspector Comment					
The LMA maintains the vegetation at a high level.

View of maintained waterside slope. Spring 2021.

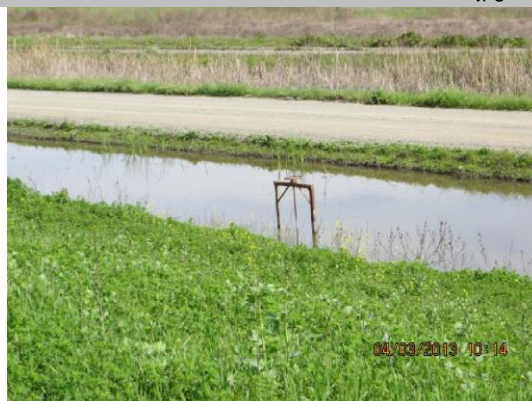
Photo 1 of 3 : UCIP_SP_2021_41128_18348.jpg

LM Start	1.39	Rating **	M	Issue No.	2	
LM End	1.39	Issue Type +	Ma	Location *		
Category	Supplemental			GPS Latitude/Longitude		
				Start		End
Item	DWR UCIP LMA Responsibility			38.589425 °		38.589425 °
				-121.645359 °		-121.645359 °
DWR ID	17836					
Comment Code						
Inspector Comment						
FS_ID:41128 DS_ID:17836 EP_NO: N/A Repair Type: Non-Urgent Crossing Status: Found UCIP Comments: 04/03/2013 Need to clear vegetation and debris from WS at outlet. (W. Wylie - DWR UCIP) FIELD_STRUCT_DESC: 36-inch corrugated metal drainage pipe through the levee, 17.5 feet below the crown. Flap gate on the waterside (WS) end. Slide gate and concrete headwall on the landside (LS) end. [Additional Reference(s): DWR Levee Log, 1990. USACE Sacramento O&M Manual 120, June 1952, (Station 327+75)]. FS Date: 4/3/2013

Slide gate and headwall in canal at LS toe.

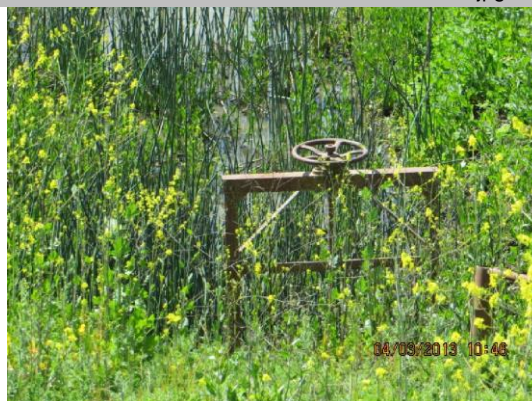
Photo 1 of 3 : UCIP_SP_2021_11012_18357.jpg

LM Start	2.19	Rating **	M	Issue No.	4
LM End	2.19	Issue Type +	Ma	Location *	
Category	Supplemental			GPS Latitude/Longitude	
				Start	End
Item	DWR UCIP LMA Responsibility			38.590909 °	38.590909 °
				-121.659311 °	-121.659311 °
DWR ID	17838				
Comment Code					
Inspector Comment					
FS_ID:11012 DS_ID:17838 EP_NO: N/A Repair Type: Non-Urgent Crossing Status: Found UCIP Comments: 04/03/2013 Debris and vegetation partially blocking both ends of pipe. (W. Wylie - DWR UCIP) FIELD_STRUCT_DESC: 36-inch corrugated metal drainage pipe through the levee, 18 feet below the crown. Slide gate on the landside (LS) toe. Combination flap and slide gate on the waterside (WS) toe. [Additional Reference(s): DWR Levee Log, 1990. USACE Sacramento O&M Manual 120, June 1952, (Station 289+33)]. FS Date: 4/3/2013

Combination flap and slide gate on WS toe. With excessive vegetation

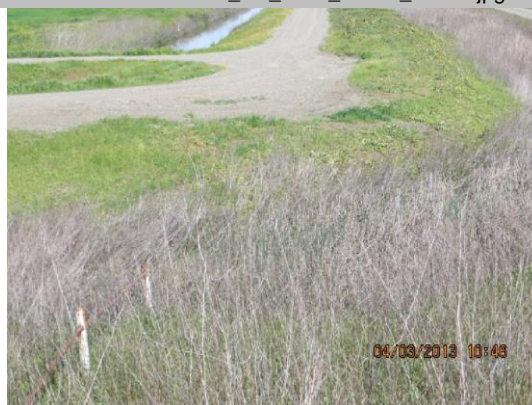
Photo 2 of 3 : UCIP_SP_2021_11012_18356.jpg

Headwall at bottom of fenceline on LS toe
