**Flood Control Project Maintenance
Levee Inspections**

Maintenance Issue Types Only, Levee Inspection Report By Mile - Spring 2022

Reclamation District No. 2035 Conaway

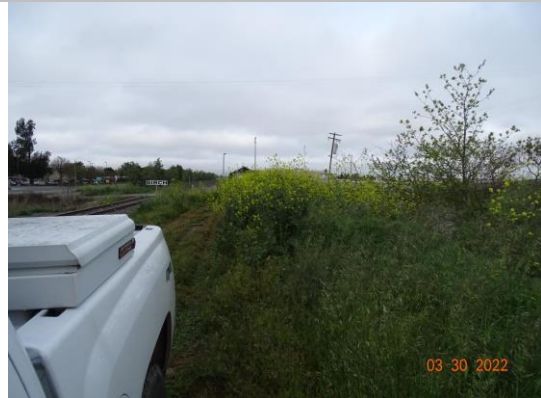
Photo 1 of 1 : SP_2022_RD2035_238_9_20220404_00013.jpg

LM Start	0.01	Rating **	U	Issue No.	9
LM End	0.03	Issue Type +	Ma	Location *	WS
Category	Earthen Levee			GPS Latitude/Longitude	
				Start	End
Item	Vegetation			38.677363 °	38.677362 °
				-121.709661 °	-121.709396 °
DWR ID	DWR_RD2035_01_s_2022_9				
Comment Code					
V1 : Control annual grass and weeds on the levee slopes and easements.					
Inspector Comment					
Tall mustard grass.

View of mustard grass on the waterside slope. Spring 2022.

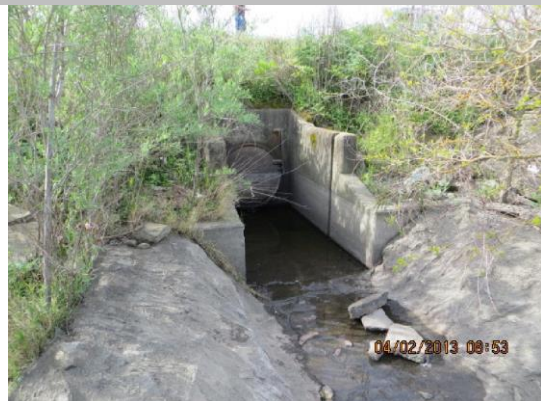
Photo 1 of 3 : UCIP_SP_2022_56049_18109.jpg

Comment Code						
Inspector Comment						
FS_ID:56049 DS_ID:17814 EP_NO: 10127 Repair Type: No Action Needed Crossing Status: Found UCIP Comments: 08/16/2019 Pending update... record will be updated in 2020. (O. Magana - DWR UCIP) FIELD_STRUCT_DESC: 42-inch concrete encased corrugated metal drainage pipe through the levee, 10 feet below the crown. Flap gate on the waterside (WS) end. Grouted spillway on the WS. Pipe exposed on the landside (LS). (36-inch pipe [HLM 0.02] authorized under Automatic Board Order (ABO) issued as Permit No. 10127, 1974 - City of Woodland, Department of Public Works). [Additional Reference(s): DWR Levee Log, 1990. USACE Sacramento O&M Manual 126, November 1961, (HLM 0.01), listed as 5.5 feet below the crown]. FS Date: 8/16/2019 12:20:00 PM

Flap gate and spillway on WS toe.

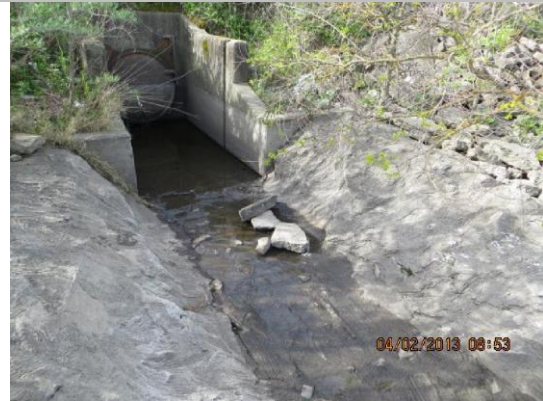
Photo 2 of 3 : UCIP_SP_2022_56049_18108.jpg

Flap gate and spillway on WS toe.

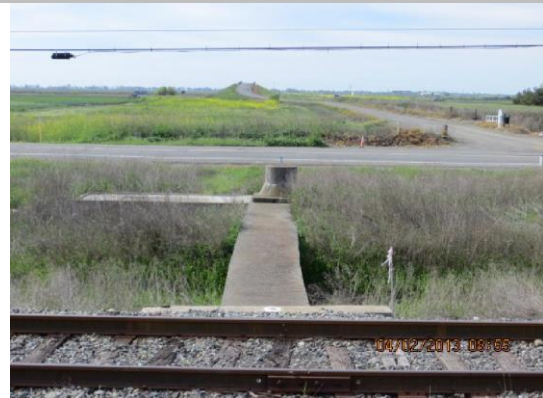
Photo 3 of 3 : UCIP_SP_2022_56049_18107.jpg

Concrete encased pipe on LS toe.

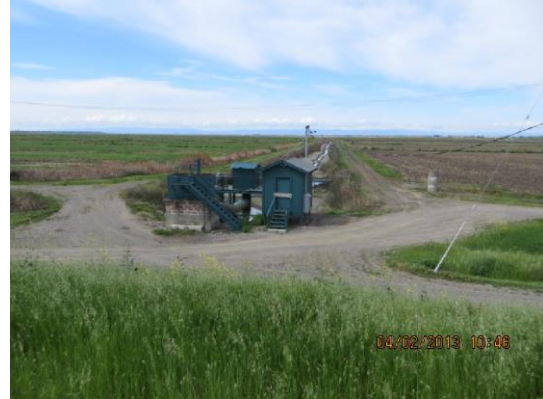
Photo 1 of 3 : UCIP_SP_2022_56053_18202.jpg

Comment Code					
Inspector Comment					
FS_ID:56053 DS_ID:17822 EP_NO: N/A Repair Type: Urgent Crossing Status: Found UCIP Comments: 08/16/2019 Pending update... record will be updated in 2020. (O. Magana - DWR UCIP)10/30/2018 Same as last inspection. Flap gate on the WS was submerged at the time of the inspection. Erosion is still present behind the headwall. Sink hole/burrow activity was observed along the concrete box located on the LS. Recommend internal inspection of the pipe section through levee to determine the condition of the pipe through the levee. Crossing remains Urgent due to signs of pipe leakage on LS. (O. Magana - DWR UCIP)09/14/2016 - Flap gate on the WS was submerged at time of inspection. LS headwall at the pumping plant has exposed rebar. There is still erosion present behind the headwall. However, water was present making it difficult to determine if it is getting worse. As-built drawings were requested from LMA consultant representative. (T. Hatch/UCIP)04/02/2013 - Flap gate broken in half on WS toe. Some erosion at headwalls on pumping plant. (W. Wylie/UCIP) FIELD_STRUCT_DESC: 44-inch corrugated metal drainage pipe through the levee, 22 feet below the crown. Pump on platform in drainage ditch at the landside (LS) toe. Slide gate and flap gates in a 5-foot by 9-foot concrete box. Flap gate on the waterside (WS) toe. 8-inch vent/standpipe at the WS toe. [Additional Reference(s): DWR Levee Log, 1990. USACE Sacramento O&M Manual 121, May 1959, (HLM 0.4) (4-foot by 4-foot concrete culvert listed)]. FS Date: 8/16/2019 12:25:00 PM

Pumping plant off LS toe.

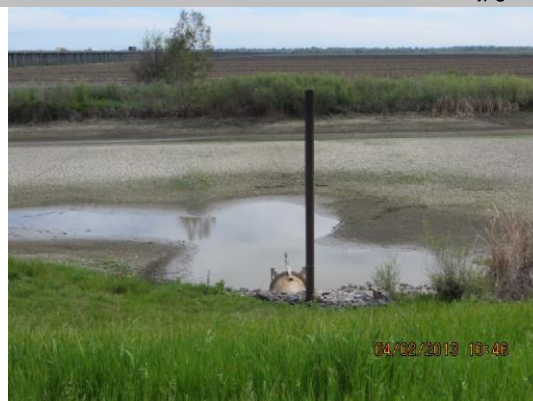
Photo 2 of 3 : UCIP_SP_2022_56053_18201.jpg

Pipe and flap gate with vent riser on WS toe.

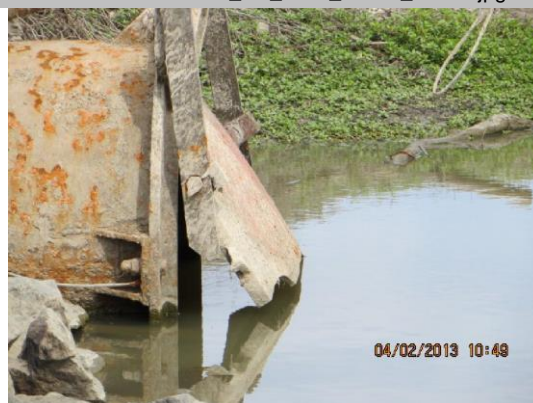
Photo 3 of 3 : UCIP_SP_2022_56053_18200.jpg

Broken flap gate at WS toe.

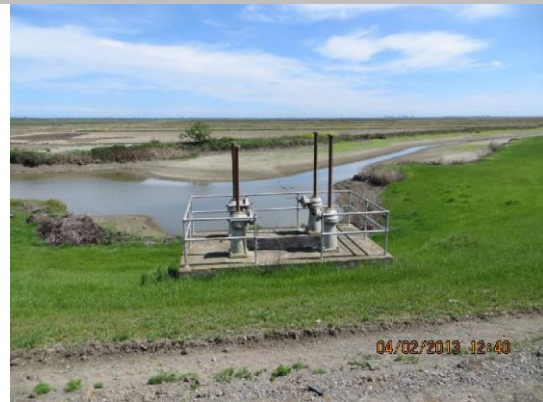
Photo 1 of 3 : UCIP_SP_2022_10933_18226.jpg

LM Start	2.15	Rating **	A/W	Issue No.	3	
LM End	2.15	Issue Type +	Ma	Location *		
Category	Supplemental			GPS Latitude/Longitude		
				Start	End	
Item	DWR UCIP LMA Responsibility			38.646445 °	38.646445 °	
				-121.666423 °	-121.666423 °	
DWR ID	17833					
Comment Code						
Inspector Comment						
FS_ID:10933 DS_ID:17833 EP_NO: N/A Repair Type: No Action Needed Crossing Status: Found UCIP Comments: FIELD_STRUCT_DESC: 1 of 2: 60-inch drainage pipe of an unknown material through the levee, 26 feet below the crown. Concrete well and gate structure on the waterside (WS) slope. [Additional Reference(s): DWR Levee Log, 1990. USACE Sacramento O&M Manual 121, May 1959, (HLM 2.3) (6-foot by 6-foot concrete culvert listed)]. FS Date: 4/2/2013

Slide gates in concrete vault on WS slope.

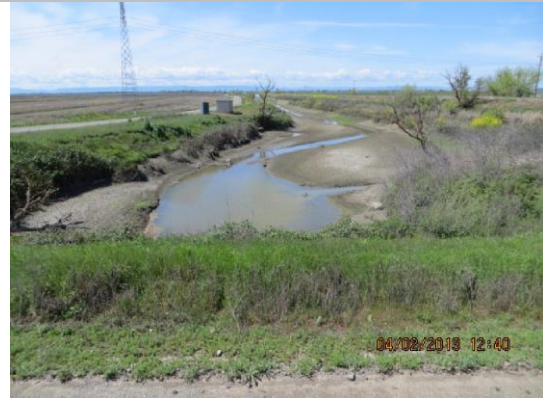
Photo 2 of 3 : UCIP_SP_2022_10933_18225.jpg

LS at intake.

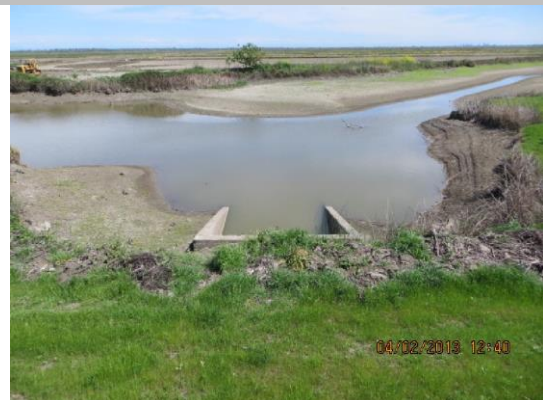
Photo 3 of 3 : UCIP_SP_2022_10933_18224.jpg

Outlet on WS toe.

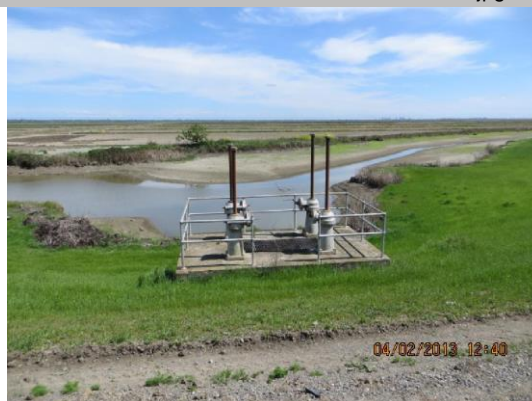
Photo 1 of 3 : UCIP_SP_2022_10934_18230.jpg

LM Start	2.15	Rating **	A/W	Issue No.	4
LM End	2.15	Issue Type +	Ma	Location *	
Category	Supplemental			GPS Latitude/Longitude	
				Start	End
Item	DWR UCIP LMA Responsibility			38.646425 °	38.646425 °
				-121.666421 °	-121.666421 °
DWR ID	17877				
Comment Code					
Inspector Comment					
FS_ID:10934 DS_ID:17877 EP_NO: N/A Repair Type: No Action Needed Crossing Status: Found UCIP Comments: FIELD_STRUCT_DESC: 2 of 2: 60-inch drainage pipe of an unknown material through the levee, 26 feet below the crown. Concrete well and gate structure on the waterside (WS) slope. Concrete headwalls on both ends. [Additional Reference(s): DWR Levee Log, 1990. USACE Sacramento O&M Manual 121, May 1959, (HLM 2.3) (6-foot by 6-foot concrete culvert listed)]. FS Date: 4/2/2013

Slide gates in concrete vault on WS slope.

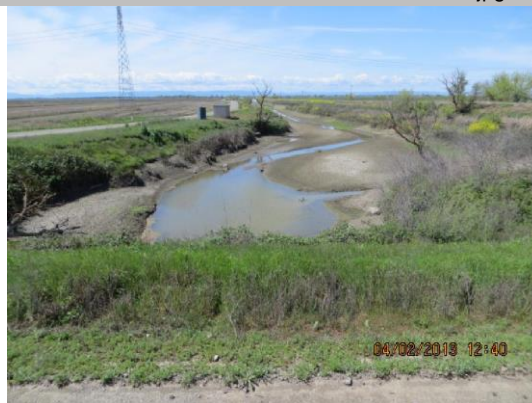
Photo 2 of 3 : UCIP_SP_2022_10934_18229.jpg

Intake at channel on LS toe.

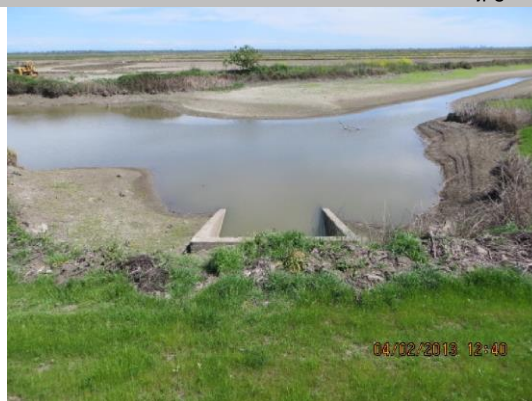
Photo 3 of 3 : UCIP_SP_2022_10934_18228.jpg

Concrete headwall on WS toe.

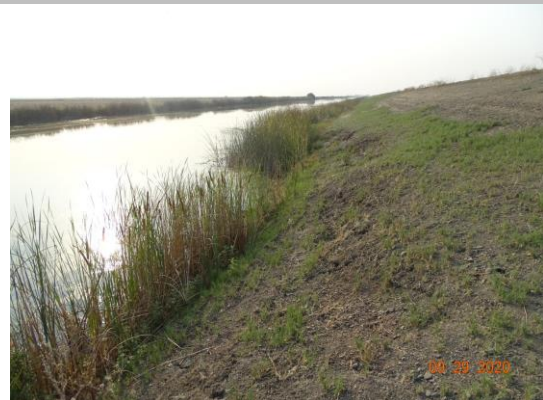
Photo 1 of 1 : SP_2022_RD2035_239_19_20220308_00003.jpg

LM Start	2.79	Rating **	M	Issue No.	19
LM End	2.79	Issue Type +	Ma	Location *	WS
Category	Earthen Levee			GPS Latitude/Longitude	
				Start	End
Item	Erosion / Bank Caving			38.638511 °	38.638511 °
				-121.660277 °	-121.660277 °
DWR ID	DWR_RD2035_02_f_2020_19				
Comment Code					
E2 : Schedule repair of erosion site prior to the next inspection.					
Inspector Comment					
Erosion on the waterside toe.

View of erosion on the waterside slope near the toe. Fall 2020.

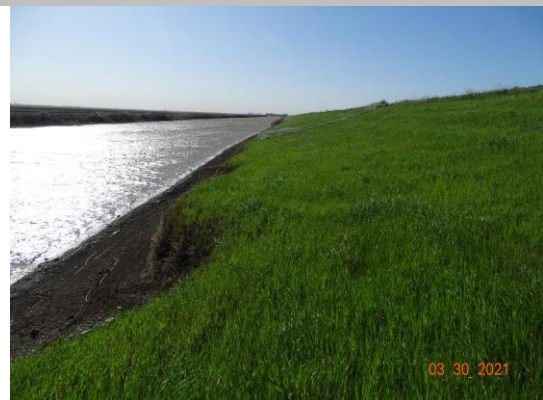
Photo 1 of 1 : SP_2022_RD2035_239_18_20220308_00002.jpg

LM Start	3.42	Rating **	M	Issue No.	18
LM End	3.42	Issue Type +	Ma	Location *	WS
Category	Earthen Levee			GPS Latitude/Longitude	
				Start	End
Item	Erosion / Bank Caving			38.630657 °	38.630657 °
				-121.654502 °	-121.654502 °
DWR ID	DWR_RD2035_02_s_2020_18				
Comment Code					
E2 : Schedule repair of erosion site prior to the next inspection.					
Inspector Comment					
Erosion at the waterside toe.

View of erosion at waterside toe. Spring 2021.

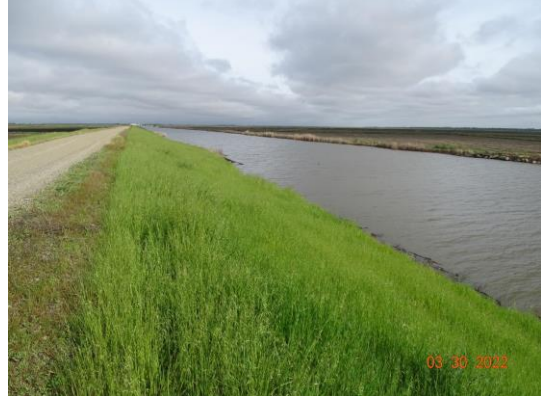
Photo 1 of 1 : SP_2022_RD2035_239_14_20220404_00026.jpg

LM Start	3.70	Rating **	M	Issue No.	14
LM End	3.99	Issue Type +	Ma	Location *	WS
Category	Supplemental			GPS Latitude/Longitude	
				Start	End
Item	2018 USACE Erosion Survey			38.627145 °	38.623533 °
				-121.651820 °	-121.649176 °
DWR ID	DWR_RD2035_02_s_2022_14				
Comment Code					
Inspector Comment					
2018 Site ID: YOL 3.5 R					
Status: Eroding					
2018 Field Notes: Last observed in 2011. Access issues prevented inspection in 2017.					
Site History: 2016 - Erosion observed at levee toe.

View of erosion at the waterside toe. Spring 2022.

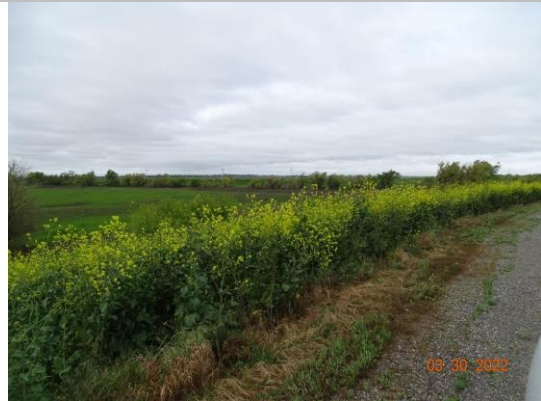
Photo 1 of 1 : SP_2022_RD2035_240_7_20220404_00003.jpg

LM Start	0.02	Rating **	M	Issue No.	7
LM End	0.67	Issue Type +	Ma	Location *	WS
Category	Earthen Levee			GPS Latitude/Longitude	
				Start	End
Item	Vegetation			38.575362 °	38.579011 °
				-121.635982 °	-121.645199 °
DWR ID	DWR_RD2035_03_s_2022_7				
Comment Code					
V1 : Control annual grass and weeds on the levee slopes and easements.					
Inspector Comment

View of mustard grass on the waterside slope. Spring 2022.
