**Flood Control Project Maintenance
Levee Inspections**

Maintenance Issue Types Only, Levee Inspection Report By Mile - Spring 2023

Reclamation District No. 2035 Conaway

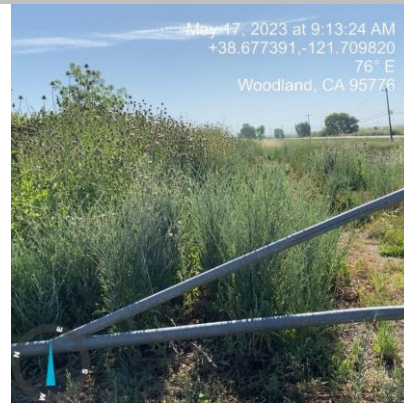
Photo 1 of 1 : SP_2022_RD2035_238_2_20230517_00004.jpg

LM Start	0.00	Rating **	U	Issue No.	2
LM End	2.01	Issue Type +	Ma	Location *	CR
Category	Earthen Levee			GPS Latitude/Longitude	
				Start	End
Item	Vegetation			38.677367°	38.677165°
				-121.709898°	-121.672717°
DWR ID	DWR_RD2035_01_s_2022_2				
Comment Code					
V1 : Control annual grass and weeds on the levee slopes and easements.					
Inspector Comment

View of vegetation preventing access on the levee crown (Spring 2023).

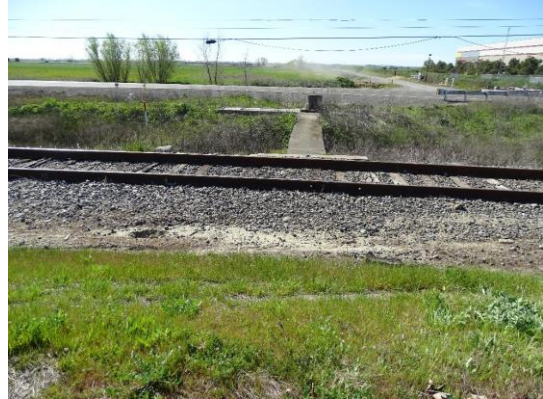
Photo 2 of 3 : UCIP_SP_2022_77644_107276.jpg

LS view: Concrete encased pipe.

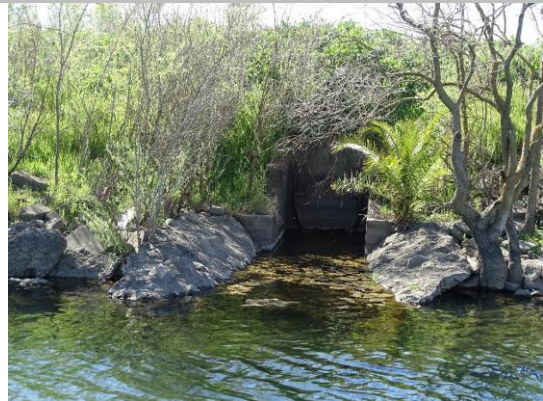
Photo 3 of 3 : UCIP_SP_2022_77644_107277.jpg

WS view: Flap gate and spillway on WS toe (view facing levee from WS).

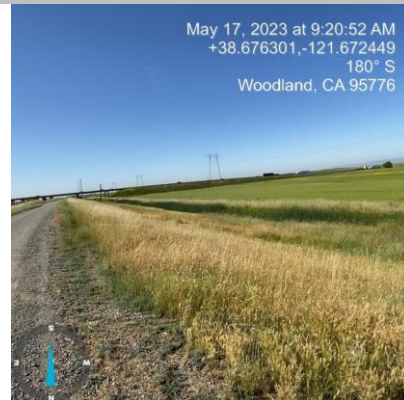
Photo 1 of 1 : SP_2023_RD2035_239_9_20230517_00028.jpg

LM Start	0.06	Rating **	U	Issue No.	9
LM End	7.60	Issue Type +	Ma	Location *	LS
Category	Earthen Levee			GPS Latitude/Longitude	
				Start	End
Item	Vegetation			38.676359°	38.575468°
				-121.672514°	-121.635069°
DWR ID	DWR_RD2035_02_s_2023_9				
Comment Code					
V1 : Control annual grass and weeds on the levee slopes and easements.					
Inspector Comment

View of vegetation on the landside slope (Spring 2023).

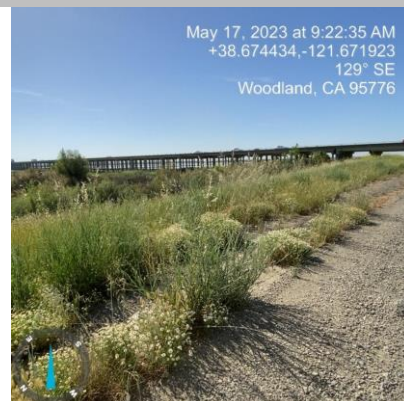
Photo 1 of 1 : SP_2023_RD2035_239_17_20230517_00029.jpg

LM Start	0.06	Rating **	U	Issue No.	17
LM End	7.60	Issue Type +	Ma	Location *	WS
Category	Earthen Levee			GPS Latitude/Longitude	
				Start	End
Item	Vegetation			38.676354°	38.575468°
				-121.672510°	-121.635069°
DWR ID	DWR_RD2035_02_s_2023_17				
Comment Code					
V1 : Control annual grass and weeds on the levee slopes and easements.					
Inspector Comment

View of vegetation on waterside slope (Spring 2023).

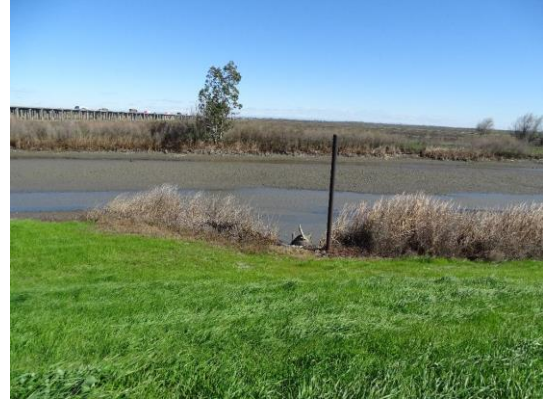
Photo 1 of 2 : UCIP_SP_2023_78134_106894.jpg

Comment Code					
Inspector Comment					
DS_ID:17822 FS_ID:78134 EP_NO: N/A Repair Type: Urgent EVAL Issue: 3a, Flood Risk Crossing Status: Found UCIP Comments: 02/15/2022 The record remains Urgent. Flap gate on WS was partially submerged at the time of inspection, so unable to confirm if the broken flap gate noted in 2013 has been repaired. No permit has been identified authorizing pipe. (Mike T. - DWR UCIP)08/16/2019 Pending update... record will be updated in 2020. (O. Magana - DWR UCIP)10/30/2018 Same as last inspection. Flap gate on the WS was submerged at the time of the inspection. Erosion is still present behind the headwall. Sink hole/burrow activity was observed along the concrete box located on the LS. Recommend internal inspection of the pipe section through levee to determine the condition of the pipe through the levee. Crossing remains Urgent due to signs of pipe leakage on LS. (O. Magana - DWR UCIP)09/14/2016 - Flap gate on the WS was submerged at time of inspection. LS headwall at the pumping plant has exposed rebar. There is still erosion present behind the headwall. However, water was present making it difficult to determine if it is getting worse. As-built drawings were requested from LMA consultant representative. (T. Hatch/UCIP)04/02/2013 - Flap gate broken in half on WS toe. Some erosion at headwalls on pumping plant. (W. Wylie/UCIP) FIELD_STRUCT_DESC: 44-inch corrugated metal drainage pipe through the levee, 22 feet below the crown. Pump on platform in drainage ditch at the landside (LS) toe. Slide gate and flap gates in a 5-foot by 9-foot concrete box. Flap gate on the waterside (WS) toe. 8-inch vent/standpipe at the WS toe. [Additional Reference(s): DWR Levee Log, 1990 (HLM 0.37), listed as 48-inch corrugated metal pipe. USACE Sacramento O&M Manual 121, May 1959, Revised 23 November 2021, (HLM 0.4), listed as 4-foot by 4-foot concrete culvert]. FS Date: 2/15/2022

WS view: Pipe with vent riser on toe.

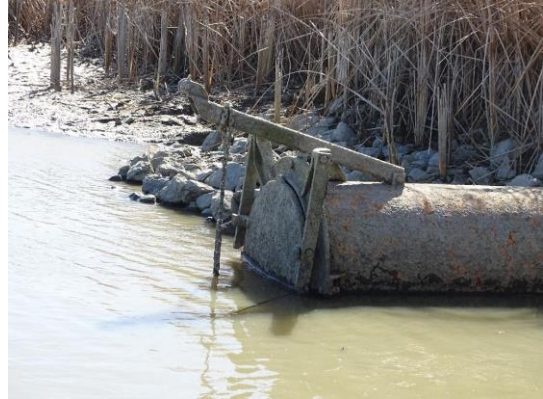
Photo 2 of 2 : UCIP_SP_2023_78134_106895.jpg

WS view: Pipe outlet with flap gate; unable to determine if flap gate has been repaired.

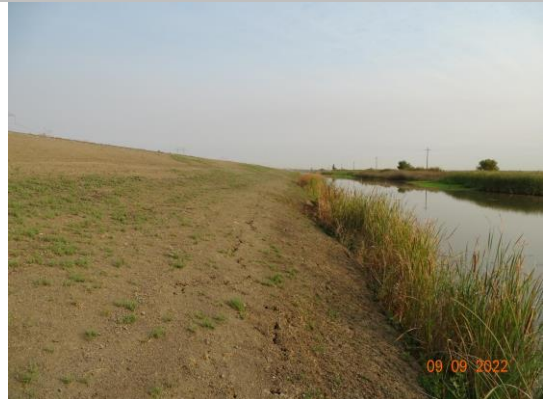
Photo 1 of 1 : SP_2023_RD2035_239_11_20230516_00002.jpg

LM Start	1.20	Rating **	A/W	Issue No.	11
LM End	1.24	Issue Type +	Ma	Location *	WS
Category	Supplemental			GPS Latitude/Longitude	
				Start	End
Item	2018 USACE Erosion Survey			38.660050°	38.659465°
				-121.669028°	-121.668940°
DWR ID	DWR_RD2035_02_f_2018_11				
Comment Code					
Inspector Comment					
2018 Site ID: YOL 1.2 R					
Status: Eroding					
2018 Field Notes: Last observed in 2017.					
Site History: 2011 - Small sections of slumping, likely from wind wave.					
2017 - Small amount of toe erosion.

View of erosion on the waterside slope. Fall 2022.

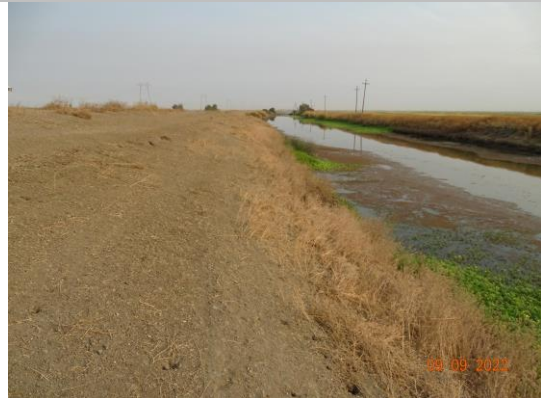
Photo 1 of 1 : SP_2023_RD2035_239_12_20230516_00003.jpg

LM Start	1.98	Rating **	A/W	Issue No.	12
LM End	2.03	Issue Type +	Ma	Location *	WS
Category	Supplemental			GPS Latitude/Longitude	
				Start	End
Item	2018 USACE Erosion Survey			38.648881°	38.648178°
				-121.666653°	-121.666385°
DWR ID	DWR_RD2035_02_f_2020_12				
Comment Code					
Inspector Comment					
2018 Site ID: YOL 2.0 R					
Status: Eroding					
2018 Field Notes: Last observed in 2017.					
Site History: 2006 - Wave wash erosion and some saturation slumping occurring. Tension/separation cracks evident in fine grained levee slope materials. 2011 - Small sections of slumping lower bank, just downstream of bank rock. 2016 - New cracks observed a the midslope. 2017 - Toe continues to erode.

View of erosion on the waterside slope. Fall 2022.

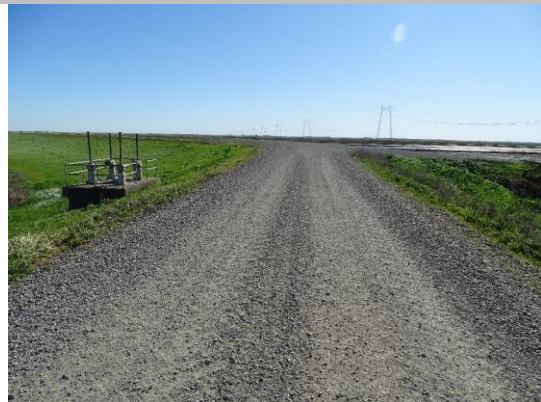
Photo 1 of 3 : UCIP_SP_2023_78206_107030.jpg

Comment Code					
Inspector Comment					
DS_ID:17833 FS_ID:78206 EP_NO: N/A Repair Type: Non-Urgent EVAL Issue: Crossing Status: Found UCIP Comments: 02/15/2022 The record was updated from No Action Needed to Non-Urgent due to no permit authorizing the encroachment. Overall, the structure was observed to be in good condition with typical weather behind the headwall on the LS. (M. Thao - DWR UCIP) FIELD_STRUCT_DESC: 1 of 2: 60-inch drainage pipe of an unknown material through the levee, 26 feet below the crown. Concrete well and gate structure on the waterside (WS) slope. [Additional Reference(s): DWR Levee Log, 1990 (HLM 2.13). USACE Sacramento O&M Manual 121, May 1959, Revised 23 November 2021, (HLM 2.3), listed as 6-foot by 6-foot concrete culvert]. FS Date: 2/15/2022

Levee crown looking downstream.

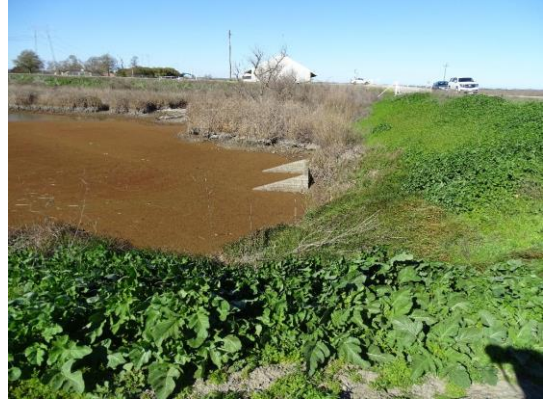
Photo 2 of 3 : UCIP_SP_2023_78206_107032.jpg

LS view: Pipe intake headwall.

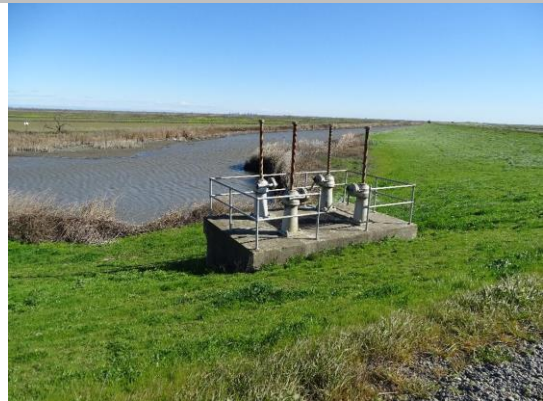
Photo 3 of 3 : UCIP_SP_2023_78206_107031.jpg

WS view: Slide gate operators and concrete vault on WS slope.

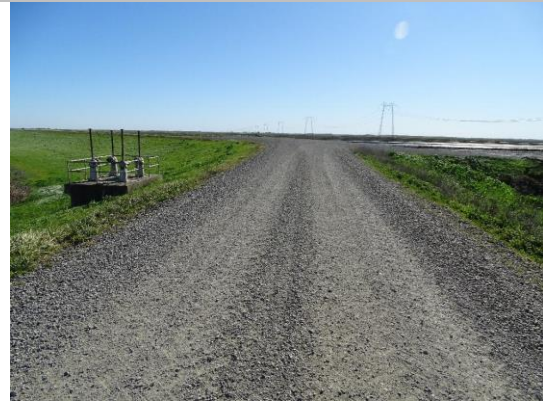
Photo 1 of 3 : UCIP_SP_2023_78205_107033.jpg

Comment Code						
Inspector Comment						
DS_ID:17877						
FS_ID:78205						
EP_NO: N/A						
Repair Type: No Action Needed						
EVAL Issue:						
Crossing Status: Found						
UCIP Comments: 02/15/2022 The record was updated from No Action Needed to Non-Urgent due to no permit authorizing the encroachment. Overall, the structure was observed to be in good condition with typical weather behind the headwall on the LS. (M. Thao - DWR UCIP)						
FIELD_STRUCT_DESC: 2 of 2: 60-inch drainage pipe of an unknown material through the levee, 26 feet below the crown. Concrete well and gate structure on the waterside (WS) slope. Concrete headwalls on both ends. [Additional Reference(s): DWR Levee Log, 1990 (HLM 2.13). USACE Sacramento O&M Manual 121, May 1959, Revised 23 November 2021, (HLM 2.3), listed as 6-foot by 6-foot concrete culvert].						
FS Date: 2/15/2022

Levee crown looking downstream.

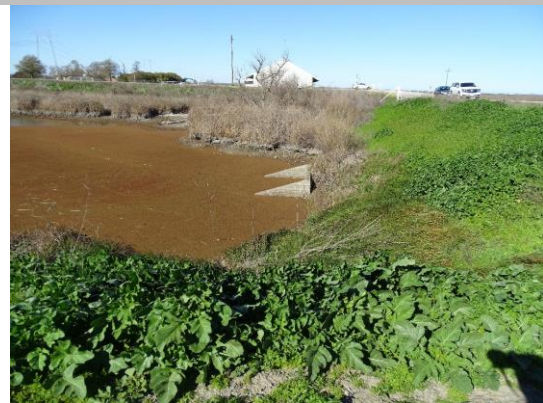
Photo 2 of 3 : UCIP_SP_2023_78205_107035.jpg

LS view: Pipe intake headwall.

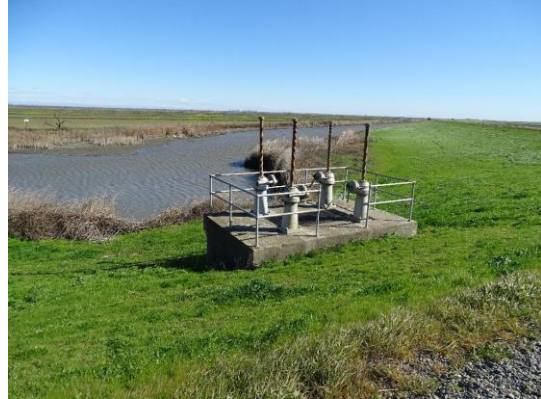
Photo 3 of 3 : UCIP_SP_2023_78205_107034.jpg

WS view: Slide gate operators and concrete vault on WS slope.

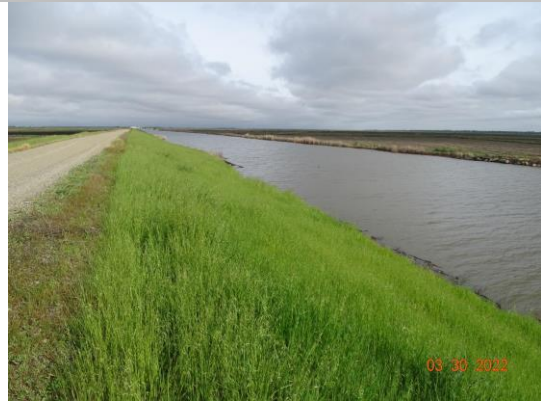
Photo 1 of 1 : SP_2023_RD2035_239_14_20230516_00004.jpg

LM Start	2.78	Rating **	A/W	Issue No.	14
LM End	3.26	Issue Type +	Ma	Location *	WS
Category	Supplemental			GPS Latitude/Longitude	
				Start	End
Item	2018 USACE Erosion Survey			38.638731°	38.632783°
				-121.660247°	-121.655864°
DWR ID	DWR_RD2035_02_f_2018_14				
Comment Code					
Inspector Comment					
2018 Site ID: YOL 2.8 R					
Status: Eroding					
2018 Field Notes: Last observed in 2017.					
Site History: 2011 - Wave wash erosion and several sections of slumping bank along the toe. 2017 - Erosion creeps further into the levee toe.

View of erosion at the waterside toe. Spring 2022.

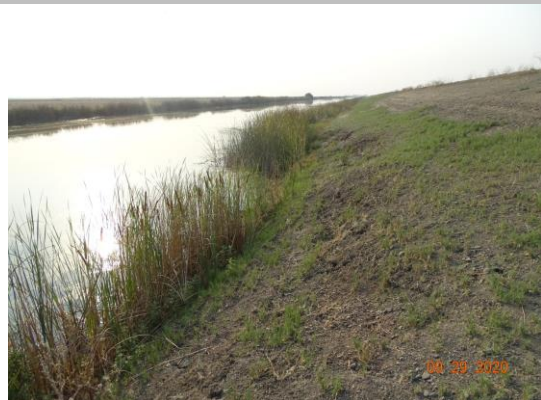
Photo 1 of 1 : SP_2023_RD2035_239_19_20230516_00007.jpg

LM Start	2.79	Rating **	M	Issue No.	19
LM End	2.79	Issue Type +	Ma	Location *	WS
Category	Earthen Levee			GPS Latitude/Longitude	
				Start	End
Item	Erosion / Bank Caving			38.638511°	38.638511°
				-121.660277°	-121.660277°
DWR ID	DWR_RD2035_02_f_2020_19				
Comment Code					
E2 : Schedule repair of erosion site prior to the next inspection.					
Inspector Comment					
Erosion on the waterside toe.

View of erosion on the waterside slope near the toe. Fall 2020.

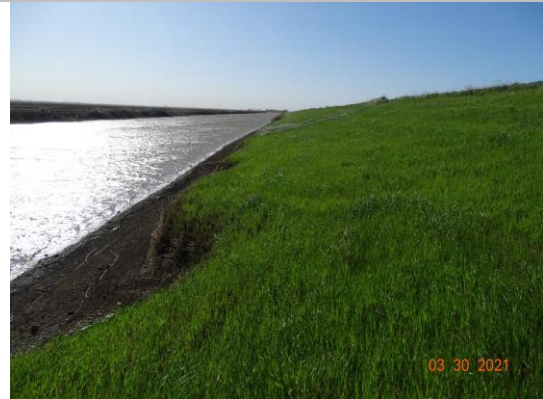
Photo 1 of 1 : SP_2023_RD2035_239_18_20230516_00006.jpg

LM Start	3.42	Rating **	M	Issue No.	18
LM End	3.42	Issue Type +	Ma	Location *	WS
Category	Earthen Levee			GPS Latitude/Longitude	
				Start	End
Item	Erosion / Bank Caving			38.630657°	38.630657°
				-121.654502°	-121.654502°
DWR ID	DWR_RD2035_02_s_2020_18				
Comment Code					
E2 : Schedule repair of erosion site prior to the next inspection.					
Inspector Comment					
Erosion at the waterside toe.

View of erosion at waterside toe. Spring 2021.

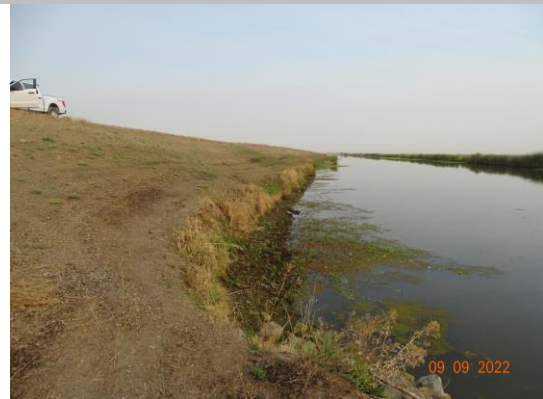
Photo 1 of 1 : SP_2023_RD2035_239_15_20230516_00005.jpg

LM Start	3.70	Rating **	M	Issue No.	15
LM End	3.99	Issue Type +	Ma	Location *	WS
Category	Supplemental			GPS Latitude/Longitude	
				Start	End
Item	2018 USACE Erosion Survey			38.627145°	38.623533°
				-121.651820°	-121.649176°
DWR ID	DWR_RD2035_02_f_2018_15				
Comment Code					
Inspector Comment					
2018 Site ID: YOL 3.5 R					
Status: Eroding					
2018 Field Notes: Last observed in 2011. Access issues prevented inspection in 2017.					
Site History: 2016 - Erosion observed at levee toe.

View of erosion on the waterside slope. Fall 2022.

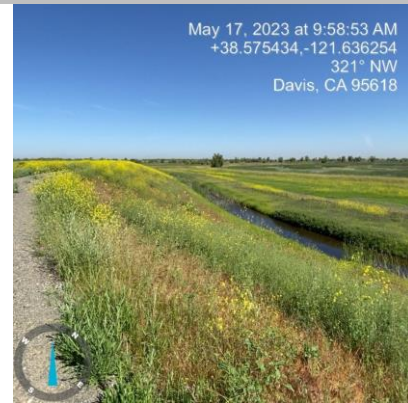
Photo 1 of 1 : SP_2023_RD2035_240_6_20230517_00010.jpg

LM Start	0.03	Rating **	U	Issue No.	6
LM End	2.51	Issue Type +	Ma	Location *	LS
Category	Earthen Levee			GPS Latitude/Longitude	
				Start	End
Item	Vegetation			38.575423°	38.590812°
				-121.636208°	-121.665138°
DWR ID	DWR_RD2035_03_s_2023_6				
Comment Code					
V1 : Control annual grass and weeds on the levee slopes and easements.					
Inspector Comment

View of vegetation on the landside slope (Spring 2023).

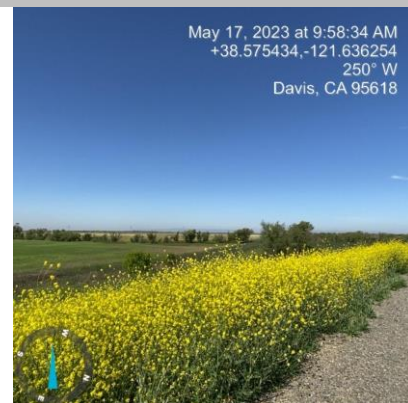
Photo 1 of 1 : SP_2023_RD2035_240_4_20230517_00009.jpg

LM Start	0.03	Rating **	U	Issue No.	4
LM End	2.51	Issue Type +	Ma	Location *	WS
Category	Earthen Levee			GPS Latitude/Longitude	
				Start	End
Item	Vegetation			38.575418°	38.590815°
				-121.636216°	-121.665136°
DWR ID	DWR_RD2035_03_s_2023_4				
Comment Code					
V1 : Control annual grass and weeds on the levee slopes and easements.					
Inspector Comment

View of vegetation on waterside slope (Spring 2023).

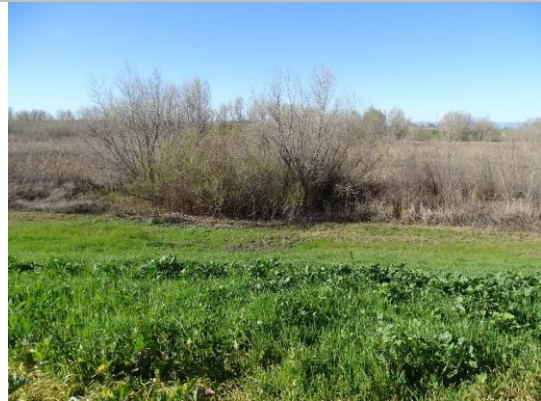
Photo 1 of 2 : UCIP_SP_2023_78554_106711.jpg

Comment Code						
Inspector Comment						
DS_ID:17836 FS_ID:78554 EP_NO: N/A Repair Type: Non-Urgent EVAL Issue: 11, Maintenance Compliance Issue Crossing Status: Found UCIP Comments: 02/17/2022 The record remains Non-Urgent. No permit was found authorizing this encroachment. Inspection of pipe inlet was limited due to water present in the canal. Inspection of pipe outlet was limited due to excessive vegetation. Recommend removing vegetation at the outlet. No permit has been identified authorizing pipe. (M. Thao - DWR UCIP)04/03/2013 Need to clear vegetation and debris from WS at outlet. (W. Wylie - DWR UCIP) FIELD_STRUCT_DESC: 36-inch corrugated metal drainage pipe through the levee, 17.5 feet below the crown. Flap gate on the waterside (WS) end. Slide gate and concrete headwall on the landside (LS) end. [Additional Reference(s): DWR Levee Log, 1990 (HLM 1.38). USACE Sacramento O&M Manual Unit 120, June 1952, Revised 29 December 2016, (Station 327+75), listed as 36-inch pipe]. FS Date: 2/17/2022

WS view: Vegetated area blocks access to pipe outlet.

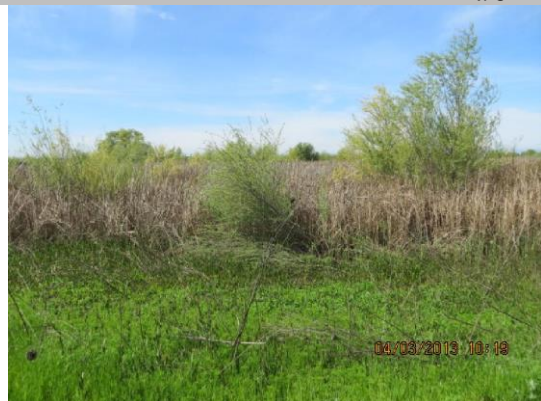
Photo 2 of 2 : UCIP_SP_2023_78554_18346.jpg

Vegetated area blocks access to WS of pipe.

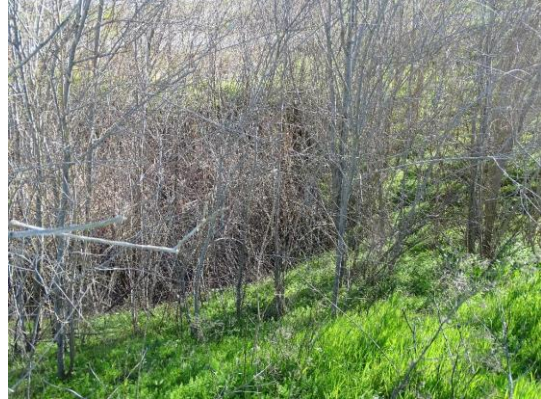
Photo 1 of 2 : UCIP_SP_2023_78555_106679.jpg

Comment Code						
Inspector Comment						
DS_ID:17837						
FS_ID:78555						
EP_NO: N/A						
Repair Type: Non-Urgent						
EVAL Issue: 11, Maintenance Compliance Issue						
Crossing Status: Found						
UCIP Comments: 02/15/2022 Record remains Non-Urgent. No permit was found authorizing this encroachment. Inspection of the pipe inlet and outlet were limited due to dense vegetation. Recommend removing vegetation at the inlet and outlet. No permit has been identified authorizing pipe. (M. Thao - DWR UCIP)04/03/2013 Debris and vegetation partially blocking inlet and outlet at both toes. (W. Wylie - DWR UCIP)						
FIELD_STRUCT_DESC: 48-inch corrugated metal drainage pipe through the levee, 19 feet below the crown. Slide gates on both ends. [Additional Reference(s): DWR Levee Log, 1990 (HLM 2.17). USACE Sacramento O&M Manual Unit 120, June 1952, Revised 29 December 2016, (Station 290+37), listed as 48-inch pipe].

LS view: Headwall at toe barely visible with excessive vegetation.

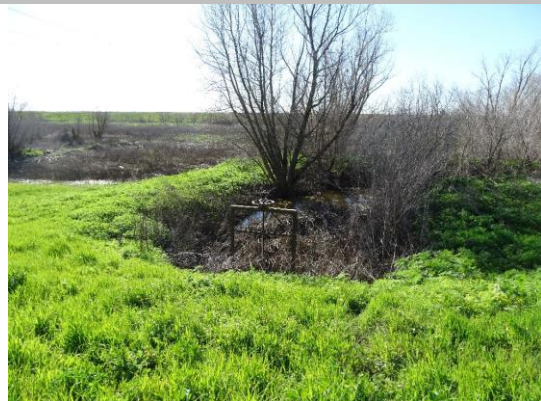
Photo 2 of 2 : UCIP_SP_2023_78555_106680.jpg

WS view: Slide gate on toe with excessive vegetation.

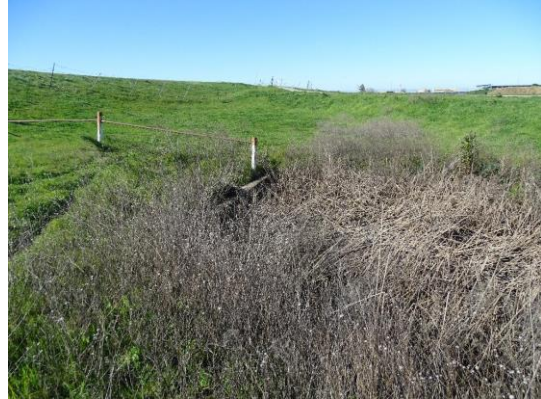
Photo 1 of 2 : UCIP_SP_2023_78556_105492.jpg

Comment Code					
Inspector Comment					
DS_ID:17838 FS_ID:78556 EP_NO: N/A Repair Type: Non-Urgent EVAL Issue: 11, Maintenance Compliance Issue Crossing Status: Found UCIP Comments: 02/15/2022 The record remains Non-Urgent. Inspection of the pipe inlet and outlet were limited due to dense vegetation. Recommend removing vegetation at the pipe inlet and outlet. No permit has been identified authorizing pipe. (M. Thao - DWR UCIP)04/03/2013 Debris and vegetation partially blocking both ends of pipe. (W. Wylie - DWR UCIP) FIELD_STRUCT_DESC: 36-inch corrugated metal drainage pipe through the levee, 18 feet below the crown. Slide gate on the landside (LS) toe. Combination flap and slide gate on the waterside (WS) toe. [Additional Reference(s): DWR Levee Log, 1990 (HLM 2.18). USACE Sacramento O&M Manual Unit 120, June 1952, Revised 29 December 2016, (Station 289+33), listed as 36-inch pipe]. FS Date: 2/15/2022

LS view: Headwall at toe with excessive vegetation.

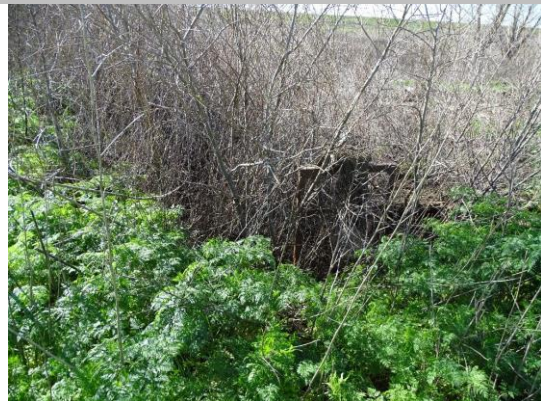
Photo 2 of 2 : UCIP_SP_2023_78556_105493.jpg

WS view: Combination flap and slide gate on toe with excessive vegetation.
