**Flood Control Project Maintenance
Levee Inspections**

Maintenance Issue Types Only, Levee Inspection Report By Mile - Spring 2024

Reclamation District No. 2035 Conaway

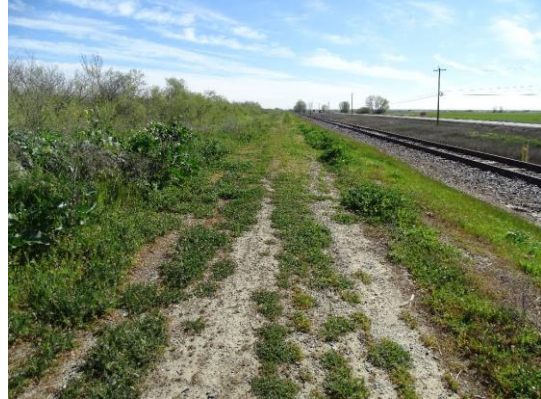
Photo 1 of 3 : UCIP_SP_2024_77644_107275.jpg

Comment Code						
Inspector Comment						
DS_ID:17814 FS_ID:77644 EP_NO: 10127 Repair Type: No Action Needed EVAL Issue: Crossing Status: Found UCIP Comments: 03/09/2022 The record has been update from No Action Needed to Non Urgent. The structure appears to be in good condition. (M. Thao - DWR UCIP)08/16/2019 Pending update... record will be updated in 2020. (O. Magana - DWR UCIP) FIELD_STRUCT_DESC: 42-inch concrete encased corrugated metal drainage pipe through the levee, 10 feet below the crown. Flap gate on the waterside (WS) end. Grouted spillway on the WS. Pipe exposed on the landside (LS). (36-inch pipe [HLM 0.02] authorized under Automatic Board Order (ABO) issued as Permit No. 10127, 1974 - City of Woodland, Department of Public Works). [Additional Reference(s): DWR Levee Log, 1990 (HLM 0.02). USACE Sacramento O&M Manual, Unit 126, November 1961, Revised 29 December 2016, (HLM 0.01), listed as 42-inch CMP 5.5 feet below the crown. USACE As-Built Drawing No. 50-04-3227, January 1960, Sheet 33, STA 775+14, listed as 42-inch concrete pipe encased in concrete conduit]. FS Date: 3/9/2022

Levee crown looking downstream.

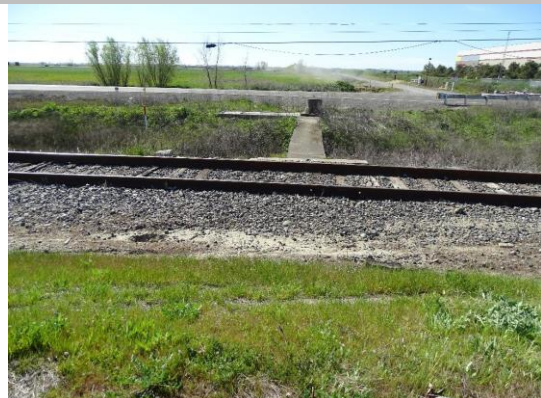
Photo 2 of 3 : UCIP_SP_2024_77644_107276.jpg

LS view: Concrete encased pipe.

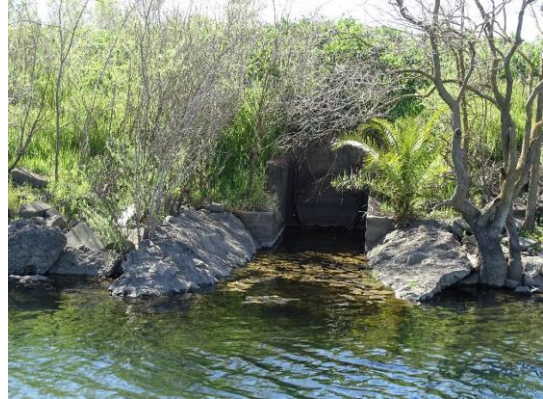
Photo 3 of 3 : UCIP_SP_2024_77644_107277.jpg

WS view: Flap gate and spillway on WS toe (view facing levee from WS).

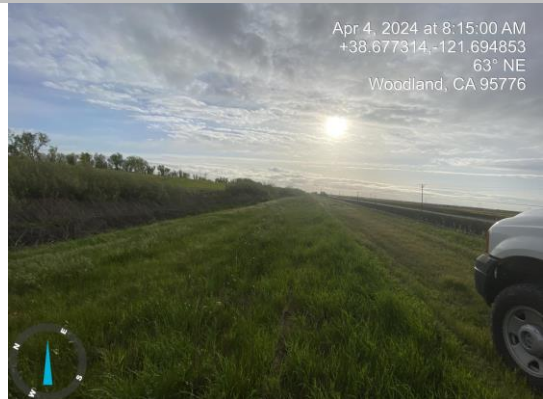
Photo 1 of 1 : SP_2024_RD2035_238_2_20240408_00005.jpg

LM Start	0.81	Rating **	A	Issue No.	2
LM End	0.81	Issue Type +	Ma	Location *	WS
Category	Earthen Levee			GPS Latitude/Longitude	
				Start	End
Item	Vegetation			38.677305°	38.677305°
				-121.694842°	-121.694842°
DWR ID	DWR_RD2035_01_s_2024_2				
Comment Code					
V1 : Control annual grass and weeds on the levee slopes and easements.					
Inspector Comment

View of good vegetation management on the waterside slope (Spring 2024).

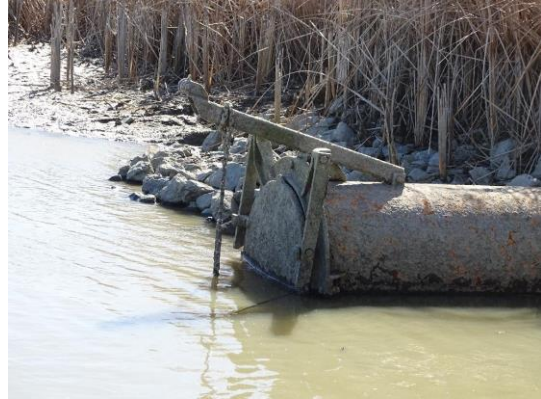
Photo 2 of 2 : UCIP_SP_2024_78134_106895.jpg

Comment Code					
Inspector Comment					
DS_ID:17822 FS_ID:78134 EP_NO: N/A Repair Type: Urgent EVAL Issue: 3a, Flood Risk Crossing Status: Found UCIP Comments: 02/15/2022 The record remains Urgent. Flap gate on WS was partially submerged at the time of inspection, so unable to confirm if the broken flap gate noted in 2013 has been repaired. No permit has been identified authorizing pipe. (Mike T. - DWR UCIP)08/16/2019 Pending update... record will be updated in 2020. (O. Magana - DWR UCIP)10/30/2018 Same as last inspection. Flap gate on the WS was submerged at the time of the inspection. Erosion is still present behind the headwall. Sink hole/burrow activity was observed along the concrete box located on the LS. Recommend internal inspection of the pipe section through levee to determine the condition of the pipe through the levee. Crossing remains Urgent due to signs of pipe leakage on LS. (O. Magana - DWR UCIP)09/14/2016 - Flap gate on the WS was submerged at time of inspection. LS headwall at the pumping plant has exposed rebar. There is still erosion present behind the headwall. However, water was present making it difficult to determine if it is getting worse. As-built drawings were requested from LMA consultant representative. (T. Hatch/UCIP)04/02/2013 - Flap gate broken in half on WS toe. Some erosion at headwalls on pumping plant. (W. Wylie/UCIP) FIELD_STRUCT_DESC: 44-inch corrugated metal drainage pipe through the levee, 22 feet below the crown. Pump on platform in drainage ditch at the landside (LS) toe. Slide gate and flap gates in a 5-foot by 9-foot concrete box. Flap gate on the waterside (WS) toe. 8-inch vent/standpipe at the WS toe. [Additional Reference(s): DWR Levee Log, 1990 (HLM 0.37), listed as 48-inch corrugated metal pipe. USACE Sacramento O&M Manual 121, May 1959, Revised 23 November 2021, (HLM 0.4), listed as 4-foot by 4-foot concrete culvert]. FS Date: 2/15/2022

WS view: Pipe outlet with flap gate; unable to determine if flap gate has been repaired.

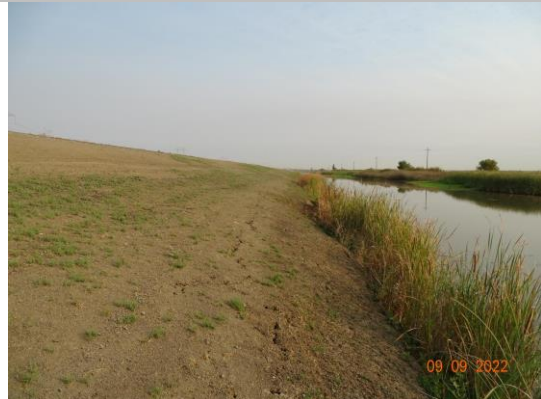
Photo 1 of 1 : SP_2024_RD2035_239_11_20240308_00002.jpg

LM Start	1.20	Rating **	A/W	Issue No.	11
LM End	1.24	Issue Type +	Ma	Location *	WS
Category	Supplemental			GPS Latitude/Longitude	
				Start	End
Item	2018 USACE Erosion Survey			38.660050°	38.659465°
				-121.669028°	-121.668940°
DWR ID	DWR_RD2035_02_f_2018_11				
Comment Code					
Inspector Comment					
2018 Site ID: YOL 1.2 R					
Status: Eroding					
2018 Field Notes: Last observed in 2017.					
Site History: 2011 - Small sections of slumping, likely from wind wave.					
2017 - Small amount of toe erosion.

View of erosion on the waterside slope. Fall 2022.

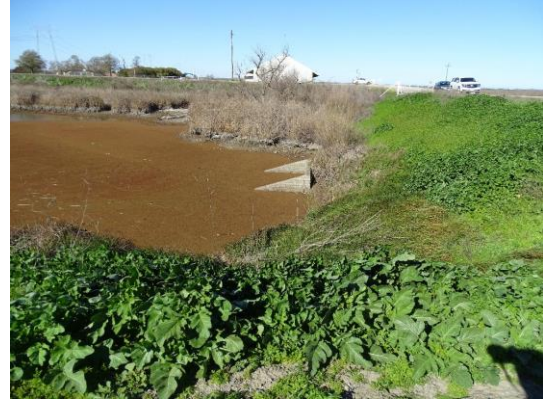
Photo 2 of 3 : UCIP_SP_2024_78206_107032.jpg

Comment Code					
Inspector Comment					
DS_ID:17833 FS_ID:78206 EP_NO: N/A Repair Type: Non-Urgent EVAL Issue: Crossing Status: Found UCIP Comments: 02/15/2022 The record was updated from No Action Needed to Non-Urgent due to no permit authorizing the encroachment. Overall, the structure was observed to be in good condition with typical weather behind the headwall on the LS. (M. Thao - DWR UCIP) FIELD_STRUCT_DESC: 1 of 2: 60-inch drainage pipe of an unknown material through the levee, 26 feet below the crown. Concrete well and gate structure on the waterside (WS) slope. [Additional Reference(s): DWR Levee Log, 1990 (HLM 2.13). USACE Sacramento O&M Manual 121, May 1959, Revised 23 November 2021, (HLM 2.3), listed as 6-foot by 6-foot concrete culvert]. FS Date: 2/15/2022

LS view: Pipe intake headwall.

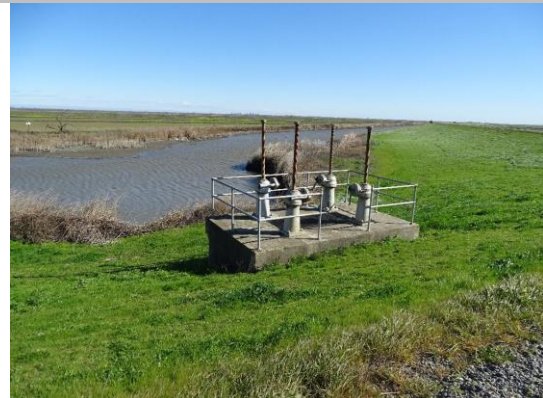
Photo 3 of 3 : UCIP_SP_2024_78206_107031.jpg

WS view: Slide gate operators and concrete vault on WS slope.

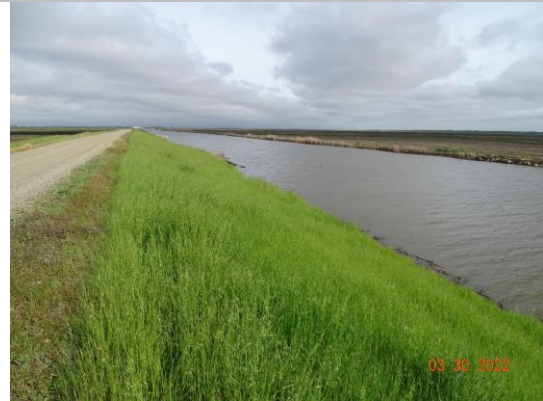
Photo 1 of 1 : SP_2024_RD2035_239_14_20240308_00004.jpg

LM Start	2.78	Rating **	A/W	Issue No.	14
LM End	3.26	Issue Type +	Ma	Location *	WS
Category	Supplemental			GPS Latitude/Longitude	
				Start	End
Item	2018 USACE Erosion Survey			38.638731°	38.632783°
				-121.660247°	-121.655864°
DWR ID	DWR_RD2035_02_f_2018_14				
Comment Code					
Inspector Comment					
2018 Site ID: YOL 2.8 R					
Status: Eroding					
2018 Field Notes: Last observed in 2017.					
Site History: 2011 - Wave wash erosion and several sections of slumping bank along the toe. 2017 - Erosion creeps further into the levee toe.

View of erosion at the waterside toe. Spring 2022.

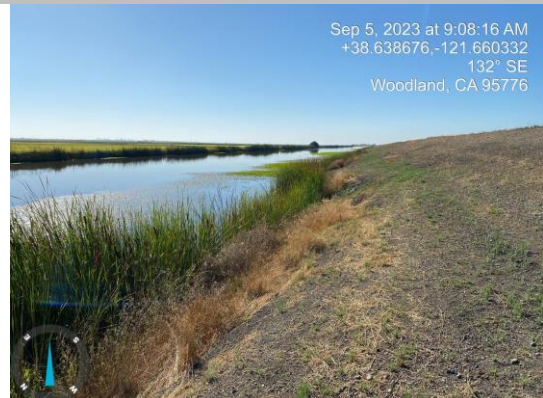
Photo 1 of 1 : SP_2024_RD2035_239_19_20240308_00007.jpg

LM Start	2.79	Rating **	M	Issue No.	19
LM End	2.79	Issue Type +	Ma	Location *	WS
Category	Earthen Levee			GPS Latitude/Longitude	
				Start	End
Item	Erosion / Bank Caving			38.638511°	38.638511°
				-121.660277°	-121.660277°
DWR ID	DWR_RD2035_02_f_2020_19				
Comment Code					
E2 : Schedule repair of erosion site prior to the next inspection.					
Inspector Comment

View of erosion on waterside slope (Fall 2023).

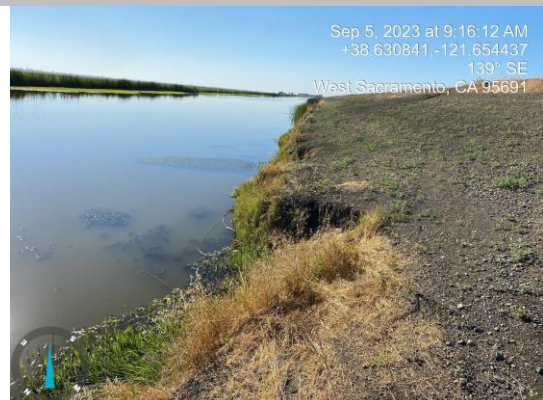
Photo 1 of 1 : SP_2024_RD2035_239_18_20240308_00006.jpg

LM Start	3.42	Rating **	M	Issue No.	18
LM End	3.70	Issue Type +	Ma	Location *	WS
Category	Earthen Levee			GPS Latitude/Longitude	
				Start	End
Item	Erosion / Bank Caving			38.630657°	38.627153°
				-121.654502°	-121.651890°
DWR ID	DWR_RD2035_02_s_2020_18				
Comment Code					
E2 : Schedule repair of erosion site prior to the next inspection.					
Inspector Comment

View of erosion on waterside slope (Fall 2023).

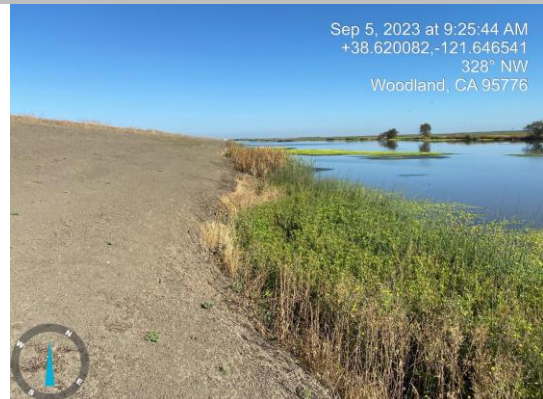
Photo 1 of 1 : SP_2024_RD2035_239_22_20240308_00009.jpg

LM Start	4.09	Rating **	M	Issue No.	22
LM End	4.41	Issue Type +	Ma	Location *	WS
Category	Earthen Levee			GPS Latitude/Longitude	
				Start	End
Item	Erosion / Bank Caving			38.622250°	38.618229°
				-121.648296°	-121.645344°
DWR ID	DWR_RD2035_02_f_2023_22				
Comment Code					
E2 : Schedule repair of erosion site prior to the next inspection.					
Inspector Comment

View of erosion along the waterside slop looking upstream (Fall 2023).

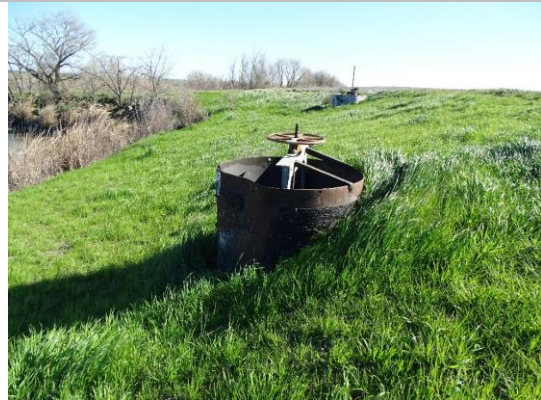
Photo 1 of 1 : UCIP_SP_2024_72251_107044.jpg

Comment Code						
Inspector Comment						
DS_ID:17869 FS_ID:72251 EP_NO: 15563 Repair Type: Non-Urgent EVAL Issue: 4b, Safety Issue Crossing Status: Found UCIP Comments: 02/15/2022 The record was updated from No Action Needed to Non-Urgent. There was no cover on the riser causing a safety hazard. Inspection of the pipe outlet was limited due to the dense vegetation and water present. This pipe replaces DSID 17827. (M. Thao - DWR UCIP) FIELD_STRUCT_DESC: 48-inch corrugated metal dual-purpose pipe through the levee, 16.5 feet below the crown. Slide gate in a 60-inch steel riser on the waterside (WS). Concrete headwalls on both ends. This pipe was installed to replace an existing 48-inch pipe at the same location. (48-inch pipe authorized under Permit No. 15563, 1990 - Reclamation District No. 2035, existing pipe removed). FS Date: 2/15/2022

WS view: Steel riser with no cover and slide gate on the slope.

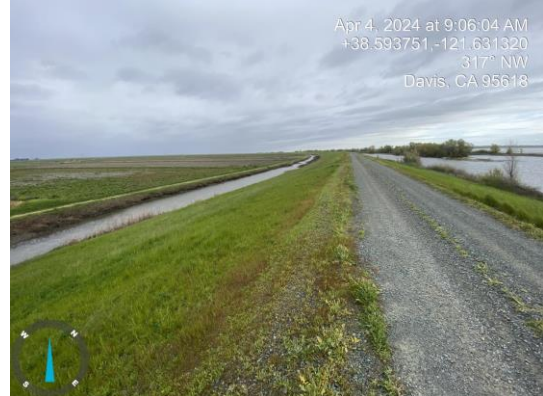
Photo 1 of 1 : SP_2024_RD2035_239_9_20240408_00031.jpg

View of good vegetation management on the landside slope (Spring 2024).

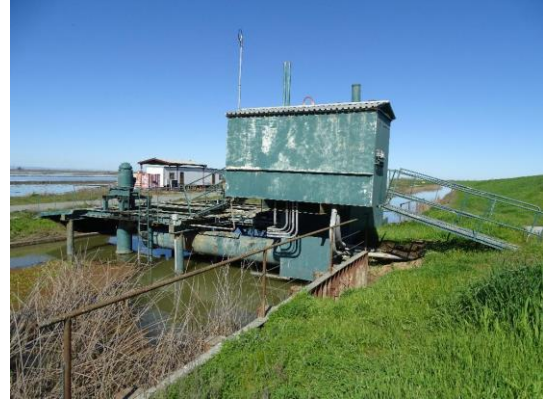
Photo 1 of 3 : UCIP_SP_2024_72221_107058.jpg

Comment Code						
Inspector Comment						
DS_ID:17868 FS_ID:72221 EP_NO: 16480 Repair Type: Non-Urgent EVAL Issue: 6, Levee Damage or Threat for Levee Damage Crossing Status: Found UCIP Comments: 02/17/2022 The record remains Non-Urgent. Erosion is still present on the sheet pile walls of the pumping plant. The erosion does not appear to pose an imminent threat to levee integrity since the erosion is off the LS toe. This pipe replaces DSID 17830. (M. Thao - DWR UCIP)09/14/2016 Erosion on the LS toe at the sheet pile walls for the pumping plant is still present. It does not appear to be significantly different than during the previous inspection. Erosion should be monitored, but at this time does not appear to result in a potential threat to levee integrity. (T. Hatch/UCIP)04/03/2013 Erosion on LS toe at pumping plant. Severe erosion of sheet pile walls at pumping plant. (W. Wylie/UCIP) FIELD_STRUCT_DESC: 1 of 2: 60-inch by 48-inch reinforced concrete box drainage culvert through the levee, 22 feet below the crown. Steel walkway to the slide gate handles on the waterside (WS) shoulder. 6-foot by 18-foot surge box and pumping plant on the landside (LS) toe. This culvert replaced a 48-inch at the same location. (construct two 60-inch concrete box drainage conduits and remove two 48-inch pipelines, work authorized under Permit No. 16480, 1995 - Conaway Conservancy Group and Reclamation District No. 2035). FS Date: 2/17/2022

LS view: Pumping plant off LS toe.

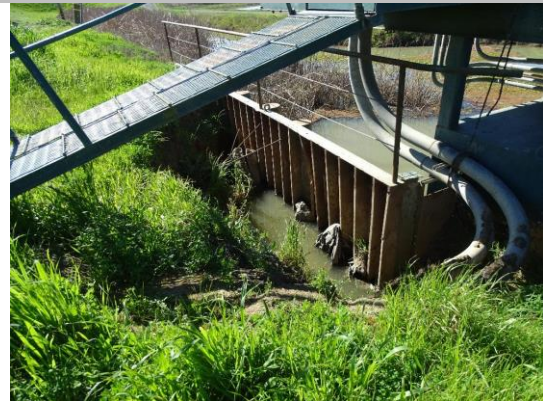
Photo 2 of 3 : UCIP_SP_2024_72221_107057.jpg

LS view: Erosion on the southern side of the pumping plant.

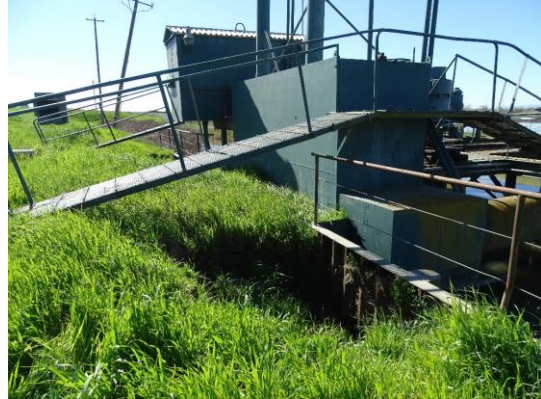
Photo 3 of 3 : UCIP_SP_2024_72221_107059.jpg

LS view: Erosion on the northern side of the pumping plant.

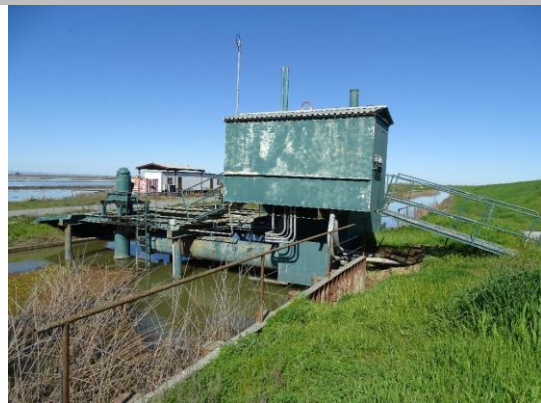
Photo 1 of 3 : UCIP_SP_2024_72220_107066.jpg

DS_ID:17891
 FS_ID:72220
 EP_NO: 16480
 Repair Type: Non-Urgent
 EVAL Issue: 6, Levee Damage or Threat for Levee Damage
 Crossing Status: Found
 UCIP Comments: 02/17/2022 The record remains Non-Urgent. Erosion is still present on the sheet pile walls of the pumping plant. The erosion does not appear to pose an imminent threat to levee integrity since the erosion is off the LS toe. This pipe replaces DSID 17884. (M. Thao - DWR UCIP)09/14/2016 Erosion is still present on the LS of the levee off the WS toe. This erosion should continue to be monitored, but does not appear to be a threat to levee integrity at this time. (T. Hatch/UCIP)04/02/2013 Severe erosion at pumping plant on LS toe. (W. Wylie/UCIP)
 FIELD_STRUCT_DESC: 2 of 2: 60-inch by 48-inch reinforced concrete box drainage culvert through the levee, 22 feet below the crown. Steel walkway to the slide gate handles on the waterside (WS) shoulder. 6-foot by 18-foot surge box and pumping plant on the landside (LS) toe. This culvert replaced a 48-inch at the same location. (construct two 60-inch concrete box drainage conduits and remove two 48-inch pipelines, work authorized under Permit No. 16480, 1995 - Conaway Conservancy Group and Reclamation District No. 2035).

LS view: Pumping plant off LS toe.

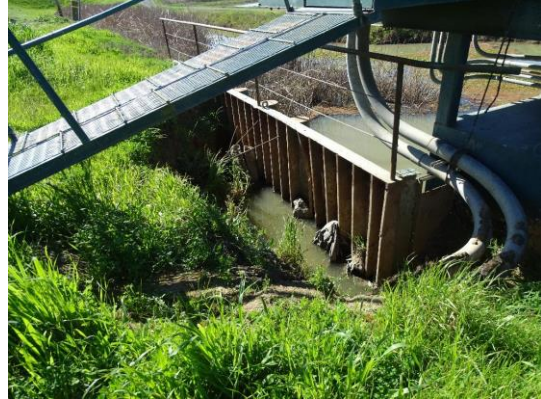
Photo 2 of 3 : UCIP_SP_2024_72220_107065.jpg

LS view: Erosion on the southern side of the pumping plant.

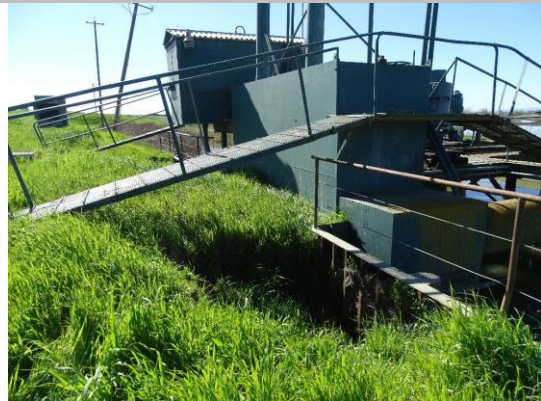
Photo 3 of 3 : UCIP_SP_2024_72220_107067.jpg

LS view: Erosion on the northern side of the pumping plant.

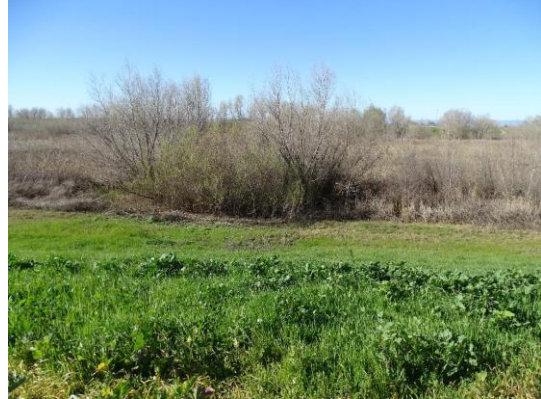
Photo 1 of 2 : UCIP_SP_2024_78554_106711.jpg

Comment Code					
Inspector Comment					
DS_ID:17836 FS_ID:78554 EP_NO: N/A Repair Type: Non-Urgent EVAL Issue: 11, Maintenance Compliance Issue Crossing Status: Found UCIP Comments: 02/17/2022 The record remains Non-Urgent. No permit was found authorizing this encroachment. Inspection of pipe inlet was limited due to water present in the canal. Inspection of pipe outlet was limited due to excessive vegetation. Recommend removing vegetation at the outlet. No permit has been identified authorizing pipe. (M. Thao - DWR UCIP)04/03/2013 Need to clear vegetation and debris from WS at outlet. (W. Wylie - DWR UCIP) FIELD_STRUCT_DESC: 36-inch corrugated metal drainage pipe through the levee, 17.5 feet below the crown. Flap gate on the waterside (WS) end. Slide gate and concrete headwall on the landside (LS) end. [Additional Reference(s): DWR Levee Log, 1990 (HLM 1.38). USACE Sacramento O&M Manual Unit 120, June 1952, Revised 29 December 2016, (Station 327+75), listed as 36-inch pipe]. FS Date: 2/17/2022

WS view: Vegetated area blocks access to pipe outlet.

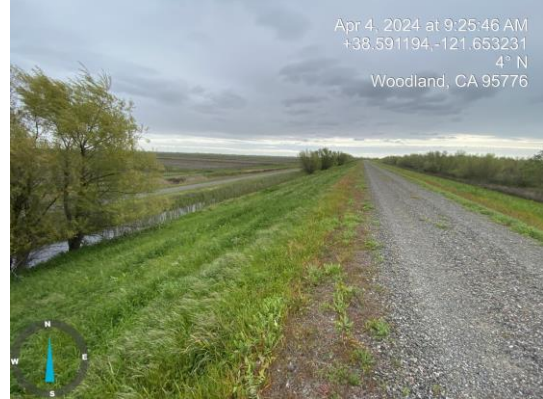
Photo 1 of 1 : SP_2024_RD2035_240_4_20240408_00010.jpg

View of good vegetation management along the landside slope (Spring 2024).

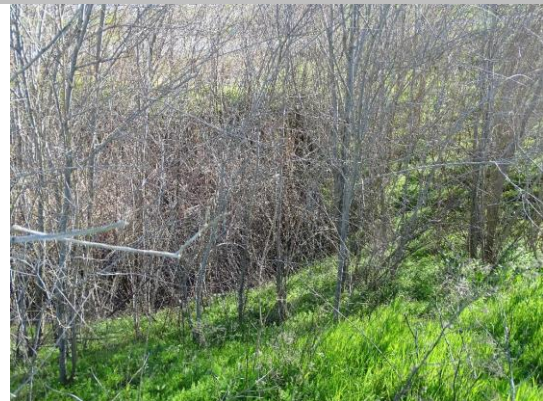
Photo 1 of 2 : UCIP_SP_2024_78555_106679.jpg

Comment Code					
Inspector Comment					
DS_ID:17837 FS_ID:78555 EP_NO: N/A Repair Type: Non-Urgent EVAL Issue: 11, Maintenance Compliance Issue Crossing Status: Found UCIP Comments: 02/15/2022 Record remains Non-Urgent. No permit was found authorizing this encroachment. Inspection of the pipe inlet and outlet were limited due to dense vegetation. Recommend removing vegetation at the inlet and outlet. No permit has been identified authorizing pipe. (M. Thao - DWR UCIP)04/03/2013 Debris and vegetation partially blocking inlet and outlet at both toes. (W. Wylie - DWR UCIP) FIELD_STRUCT_DESC: 48-inch corrugated metal drainage pipe through the levee, 19 feet below the crown. Slide gates on both ends. [Additional Reference(s): DWR Levee Log, 1990 (HLM 2.17). USACE Sacramento O&M Manual Unit 120, June 1952, Revised 29 December 2016, (Station 290+37), listed as 48-inch pipe]. FS Date: 2/15/2022

LS view: Headwall at toe barely visible with excessive vegetation.

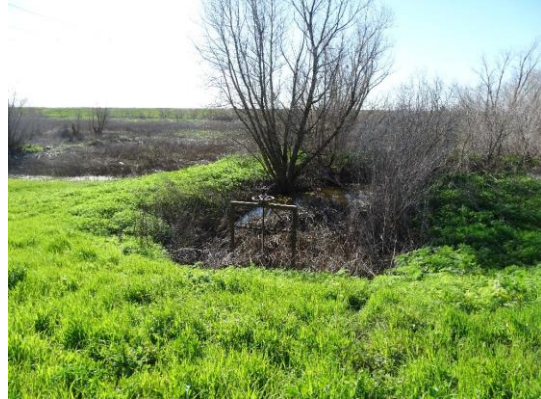
Photo 2 of 2 : UCIP_SP_2024_78555_106680.jpg

WS view: Slide gate on toe with excessive vegetation.

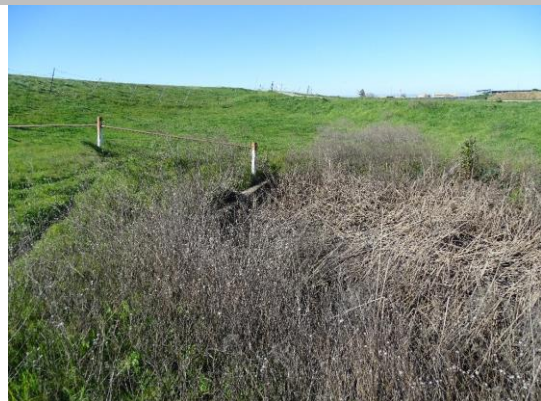
Photo 1 of 2 : UCIP_SP_2024_78556_105492.jpg

DS_ID:17838
FS_ID:78556
EP_NO: N/A
Repair Type: Non-Urgent
EVAL Issue: 11, Maintenance Compliance Issue
Crossing Status: Found
UCIP Comments: 02/15/2022 The record remains Non-Urgent.
Inspection of the pipe inlet and outlet were limited due to dense vegetation. Recommend removing vegetation at the pipe inlet and outlet. No permit has been identified authorizing pipe. (M. Thao - DWR UCIP)04/03/2013 Debris and vegetation partially blocking both ends of pipe. (W. Wylie - DWR UCIP)
FIELD_STRUCT_DESC: 36-inch corrugated metal drainage pipe through the levee, 18 feet below the crown. Slide gate on the landside (LS) toe. Combination flap and slide gate on the waterside (WS) toe.
[Additional Reference(s): DWR Levee Log, 1990 (HLM 2.18). USACE Sacramento O&M Manual Unit 120, June 1952, Revised 29 December 2016, (Station 289+33), listed as 36-inch pipe].
FS Date: 2/15/2022

LS view: Headwall at toe with excessive vegetation.

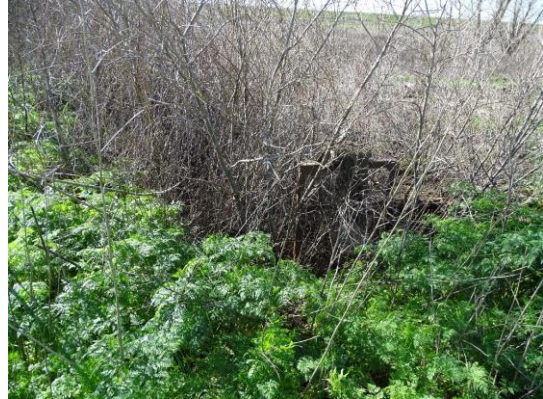
Photo 2 of 2 : UCIP_SP_2024_78556_105493.jpg

WS view: Combination flap and slide gate on toe with excessive vegetation.
