**Flood Control Project Maintenance
Levee Inspections**

Fall 2011 Levee Maintenance Deficiency Summary Report

San Joaquin River Basin

Reclamation District No. 2058 Pescadaro

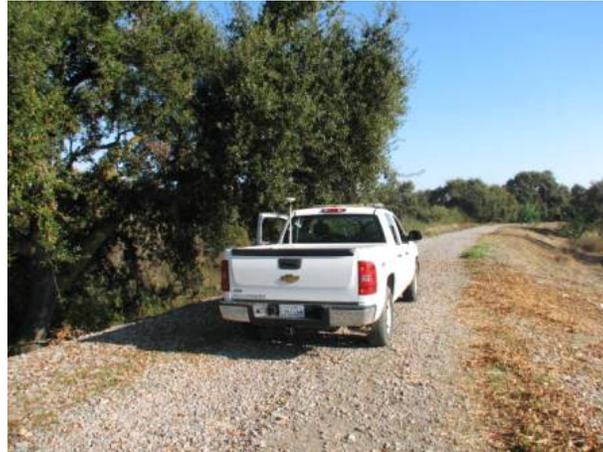
Levee Mile Report Line	2
Start Levee Mile	0.20
End Levee Mile	0.20
Location	Crown
Category	Earthen Levee
Item	Trim / Thin Trees
11/08/2011 Tree over roadway needs to be trimmed up to allow 12' clearance.	
jeto_f_20111118_572.jpg

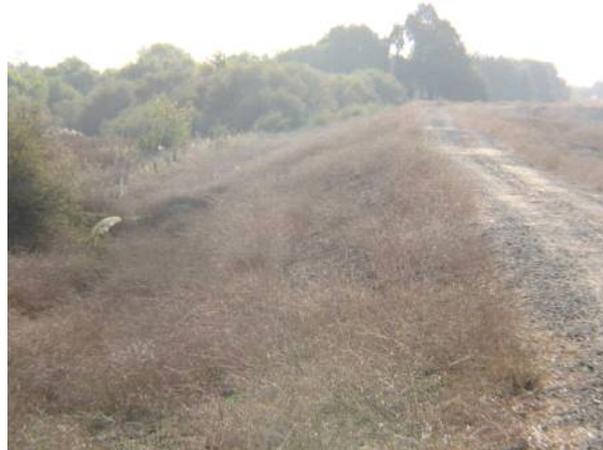
Levee Mile Report Line	3
Start Levee Mile	0.22
End Levee Mile	0.28
Location	Water Side
Category	Earthen Levee
Item	Vegetation
11/08/2011 LMA is in the process of herding goats through the area. Job has not been completed yet.	
jeto_f_20111118_573.jpg

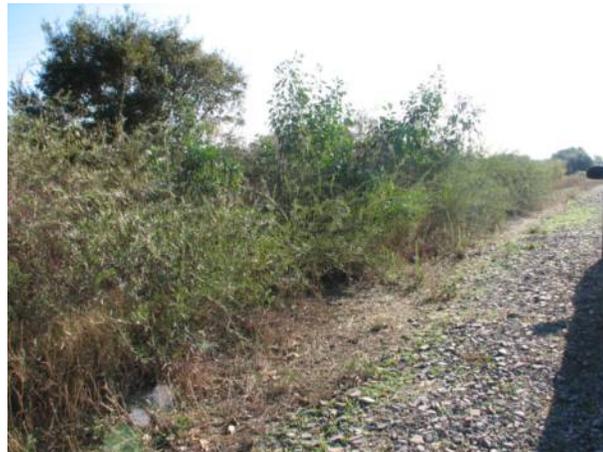
Levee Mile Report Line	8
Start Levee Mile	0.42
End Levee Mile	0.42
Location	Water Side
Category	Earthen Levee
Item	Vegetation
11/08/2011 Thick brush in this area needs to be taken back to 20' from hinge point.	
jeto_f_20111118_574.jpg

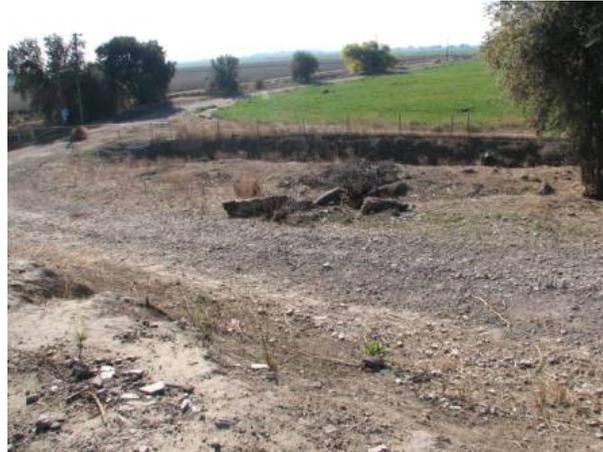
Levee Mile Report Line	9
Start Levee Mile	0.70
End Levee Mile	0.70
Location	Land Side
Category	Earthen Levee
Item	Encroachments
11/08/2011 Old pipe debris needs to be removed.	
jeto_f_20111118_575.jpg

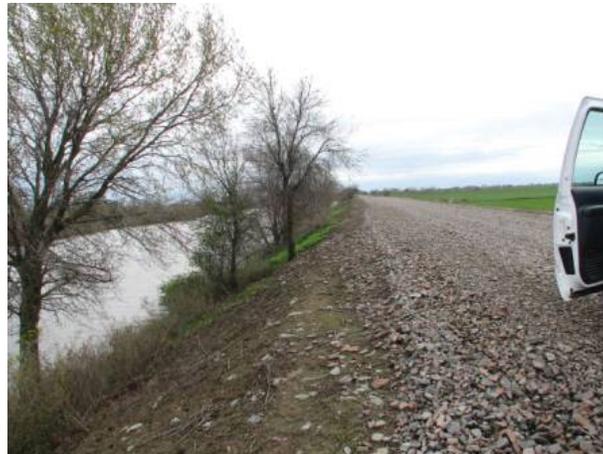
Levee Mile Report Line	13
Start Levee Mile	1.22
End Levee Mile	1.22
Location	Water Side
Category	Earthen Levee
Item	Vegetation
03/23/11 the issue has been corrected by the enactment of a goat grazing program, coord. w/ FWS.	
jeto_f_20110923_145.jpg

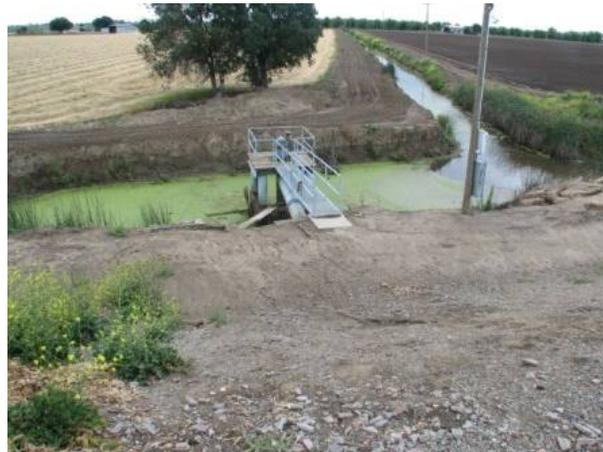
Levee Mile Report Line	14
Start Levee Mile	1.24
End Levee Mile	1.24
Location	Crown
Category	Earthen Levee
Item	Encroachments
Drainage discharge to Paradise Cut.	
jeto_f_20110923_147.jpg

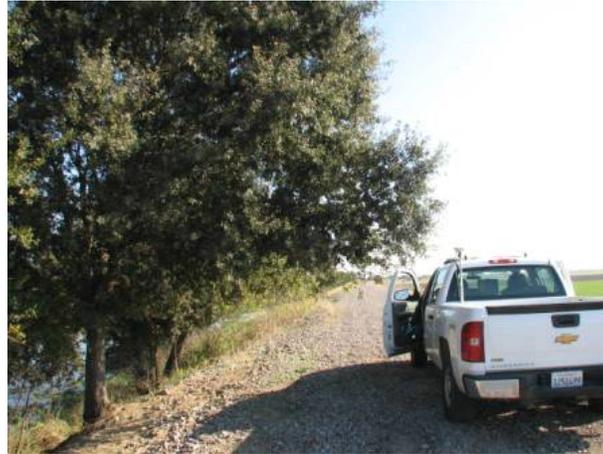
Levee Mile Report Line	15
Start Levee Mile	1.33
End Levee Mile	1.33
Location	Crown
Category	Earthen Levee
Item	Trim / Thin Trees

11/08/2011 Tree needs to be trimmed to allow 12' clearance over the roadway.

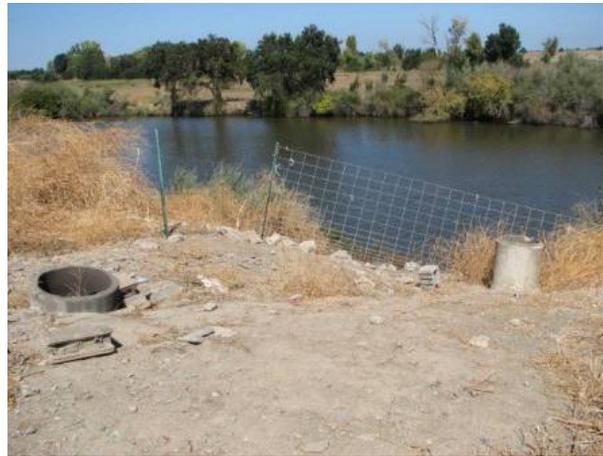
Levee Mile Report Line	20
Start Levee Mile	2.15
End Levee Mile	2.15
Location	Water Side
Category	Supplemental
Item	DWR Erosion Survey

Downstream view of site. Note the fenced area

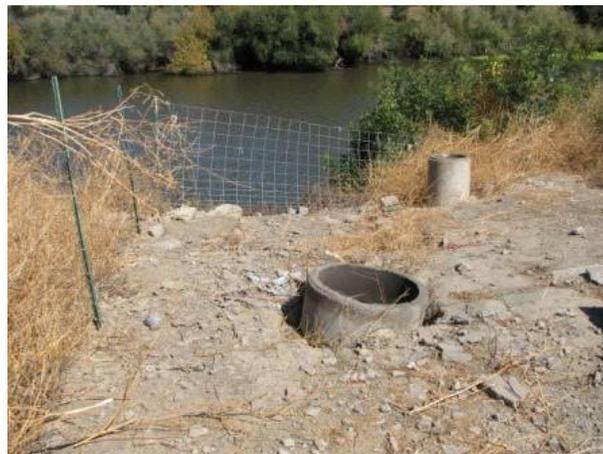
Levee Mile Report Line	20
Start Levee Mile	2.15
End Levee Mile	2.15
Location	Water Side
Category	Supplemental
Item	DWR Erosion Survey

Direct view of siphon breaker.

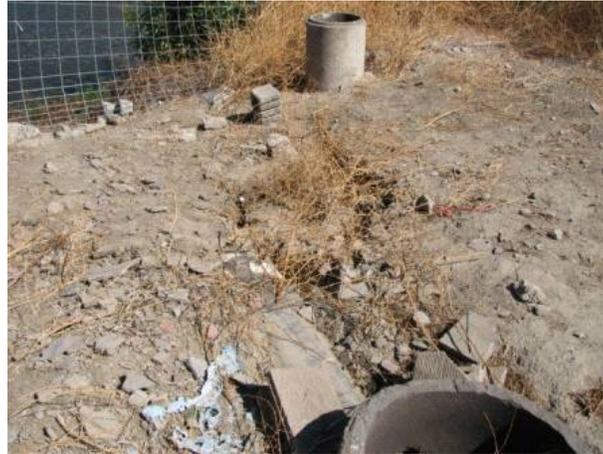
Levee Mile Report Line	20
Start Levee Mile	2.15
End Levee Mile	2.15
Location	Water Side
Category	Supplemental
Item	DWR Erosion Survey

Direct view of siphon breaker.

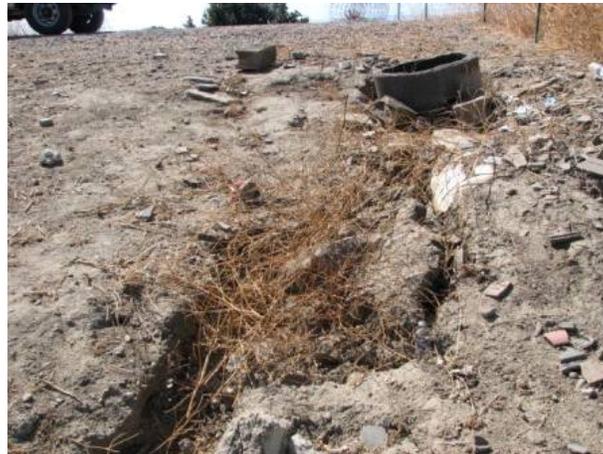
Levee Mile Report Line	20
Start Levee Mile	2.15
End Levee Mile	2.15
Location	Water Side
Category	Supplemental
Item	DWR Erosion Survey

Notches created by water leaking/overflowing from the siphon breaker.

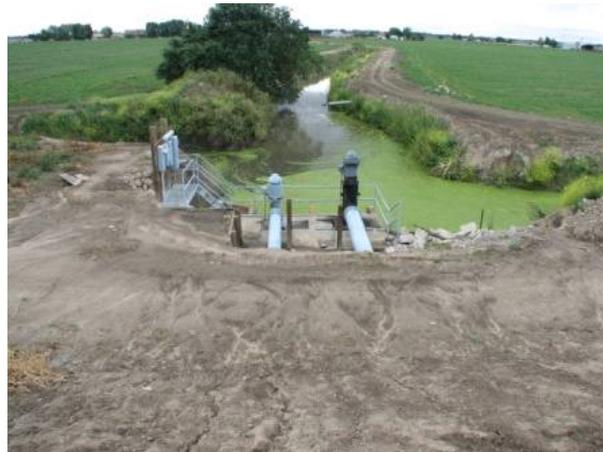
Levee Mile Report Line	21
Start Levee Mile	2.15
End Levee Mile	2.15
Location	Crown
Category	Earthen Levee
Item	Encroachments

Drainage discharge to Paradise Cut.

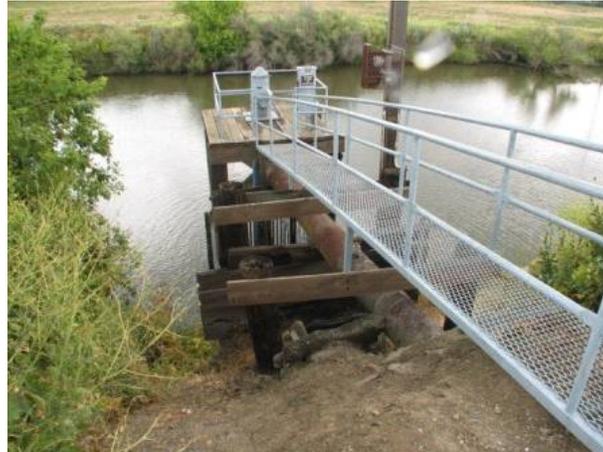
Levee Mile Report Line	24
Start Levee Mile	2.89
End Levee Mile	2.89
Location	Water Side
Category	Earthen Levee
Item	Encroachments

Irrigation intake from Paradise Cut.

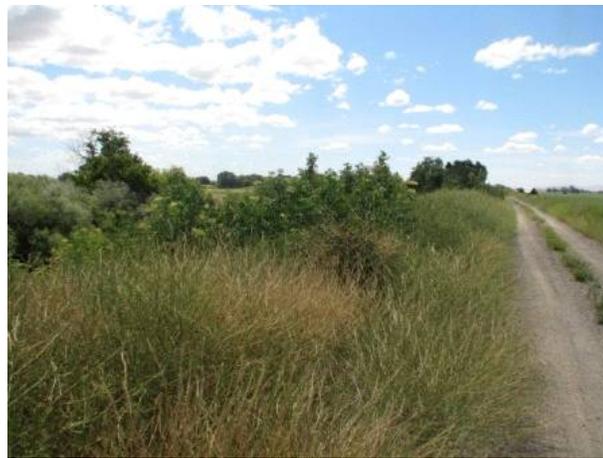
Levee Mile Report Line	30
Start Levee Mile	3.77
End Levee Mile	3.77
Location	Water Side
Category	Earthen Levee
Item	Vegetation

30	3.77	3.77	Earthen Levee	Vegetation	WS	U	Elderberries are blocking visibility and flood fight capability. Inspector Comments: Removal of this type of vegetation is currently prohibited by FWS.	37.791745 ° -121.363553 °	37.791745 ° -121.363553 °	939 Y
31	3.79	5.49	Earthen Levee	Vegetation	LS	M	Remove the wild growth other than native grasses from the levee slopes. Inspector Comments: Landside vegetation as not been addressed yet. Goats have been working up to this point,	37.791512 ° -121.363325 °	37.781497 ° -121.340385 °	19 Y
32	3.96	3.96	Earthen Levee	Trim / Thin Trees	LS	C	Trim trees to at least five feet above ground level. Inspector Comments: Condition of trees has not changed.	37.789398 ° -121.361713 °	37.789398 ° -121.361713 °	975
33	4.01	4.01	Earthen Levee	Vegetation	LS	M	Elderberries are blocking visibility and flood fight capability. Inspector Comments: Elderberry on landside hinge point.	37.789128 ° -121.361042 °	37.789128 ° -121.361042 °	26 Y

Tall brush on top 20' of waterside slope obstructs access and visibility.

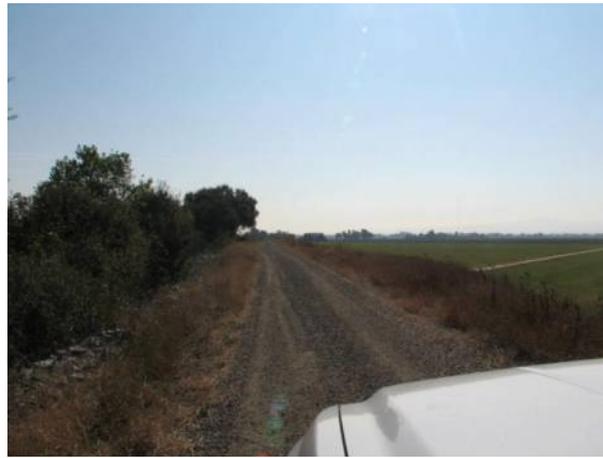
Levee Mile Report Line	31
Start Levee Mile	3.79
End Levee Mile	5.49
Location	Land Side
Category	Earthen Levee
Item	Vegetation

11/08/2011 Landside vegetation shown is ahead of the goat herd.

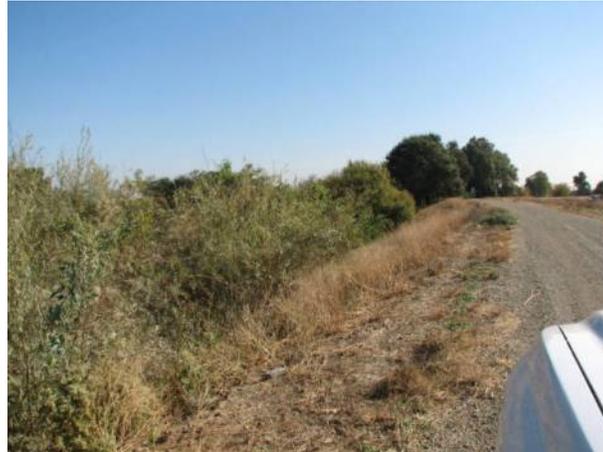
Levee Mile Report Line	33
Start Levee Mile	4.01
End Levee Mile	4.01
Location	Land Side
Category	Earthen Levee
Item	Vegetation
11/08/2011 thick stand of elderberry bushes in this area.	
jeto_f_20111118_579.jpg

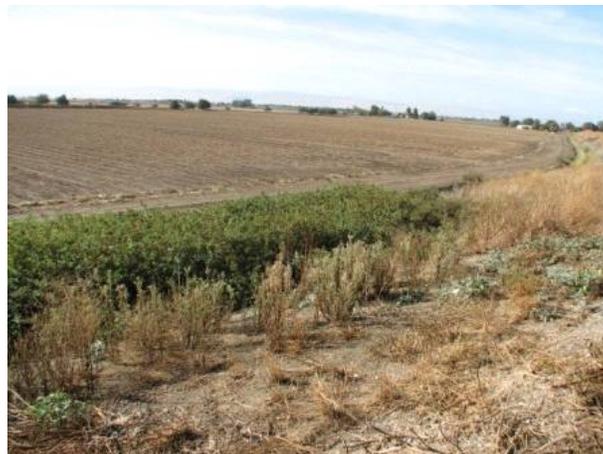
Levee Mile Report Line	36
Start Levee Mile	4.46
End Levee Mile	4.46
Location	Land Side
Category	Earthen Levee
Item	Vegetation
Wild rose on levee toe and slope obstructs access and visibility.	
jeto_f_20110923_152.jpg

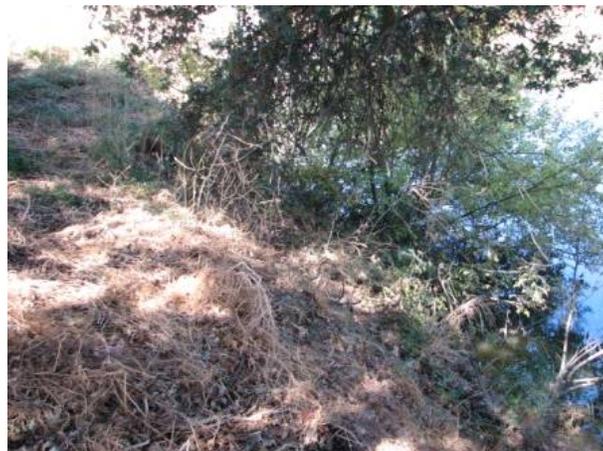
LMIR No.	Levee Mile		Category	Item	Location	Rating	Action/Comment	GPS Latitude/Longitude		Issue No. Photo
	Start	End						Start	End	
37	4.49	4.53	Supplemental	DWR Erosion Survey	WS	M	Inspector Comments: 09/02/2011: This site was not visited due to the time limit.09/22/2010: No significant changes observed. Minor pocket erosions are lined at the lower bank. Upper slope and bench were recently sprayed for vegetation control. Two large Oak and Willow trees are on midslope and bench. The remaining bench was re-measured and found to be approximately 10 feet. There was no indication of active erosion on site during the site visit.08/05/2010: Recommended for annual assessment and monitoring of site during flood events, per CLRO.07/23/2009: No major change observed since last visit; site is a 200-ft. long near-vertical berm erosion; recommend annual assessment and monitoring of erosion site, per CLRO CES Evaluation 2008 Report; Site # is the same site previously reported as RM4.0,LM4.51; previously rated "U".09/10/2008: Two large trees (2-3' DBH) with partial roots exposed.2007: Visited site 03/13/2007. [2011 Site ID:RD2058U01RM3.97]	37.789810 ° -121.352490 °	37.789810 ° -121.352490 °	2 Y

Levee Mile Report Line	37
Start Levee Mile	4.49
End Levee Mile	4.53
Location	Water Side
Category	Supplemental
Item	DWR Erosion Survey
Downstream view. Seasonal vegetation covering one of several pocket erosions lined along the bank.	
SJR2011_RD2058U01RM3.97_1.jpg

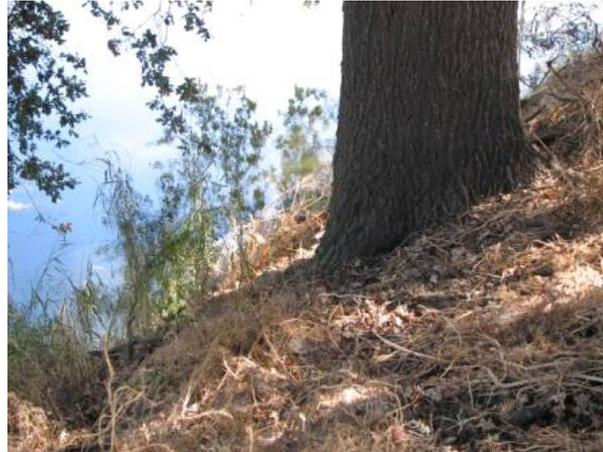
Levee Mile Report Line	37
Start Levee Mile	4.49
End Levee Mile	4.53
Location	Water Side
Category	Supplemental
Item	DWR Erosion Survey
Upstream view of the base of 1 of 2 large Oake trees on site. No signs of scouring on the base.	
SJR2011_RD2058U01RM3.97_2.jpg

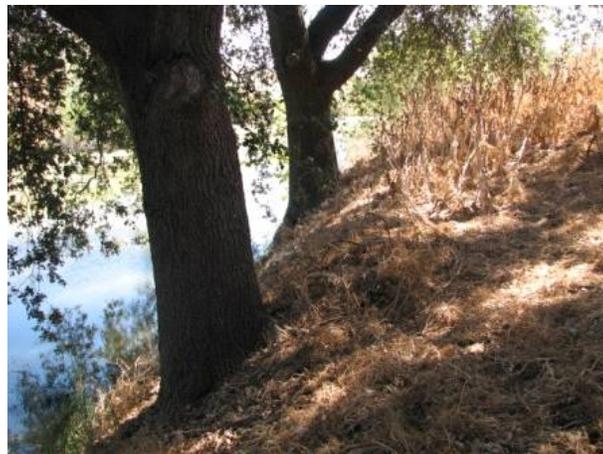
Levee Mile Report Line	37
Start Levee Mile	4.49
End Levee Mile	4.53
Location	Water Side
Category	Supplemental
Item	DWR Erosion Survey
Upstream view of both Oak trees located on the bench.	
SJR2011_RD2058U01RM3.97_3.jpg

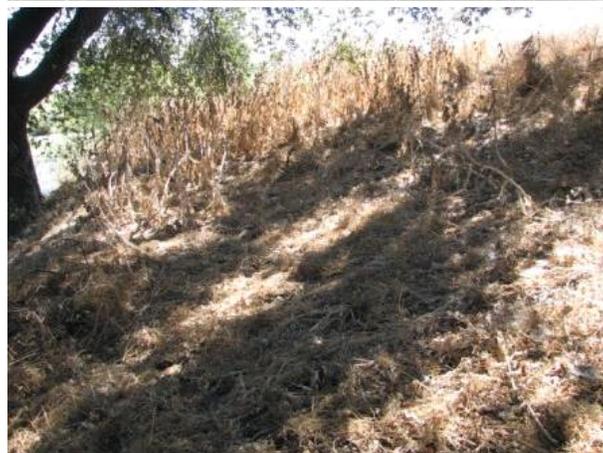
Levee Mile Report Line	37
Start Levee Mile	4.49
End Levee Mile	4.53
Location	Water Side
Category	Supplemental
Item	DWR Erosion Survey
Upstream view of the waterside slope. Vegetation on the slope was recently sprayed.	
SJR2011_RD2058U01RM3.97_4.jpg

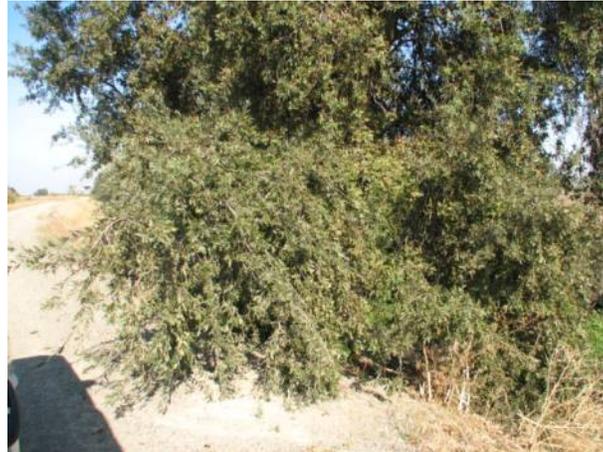
Levee Mile Report Line	38
Start Levee Mile	4.81
End Levee Mile	4.81
Location	Water Side
Category	Earthen Levee
Item	Trim / Thin Trees
11/08/2011 Tree needs to be trimmed up 5'.	
jeto_f_20111118_582.jpg

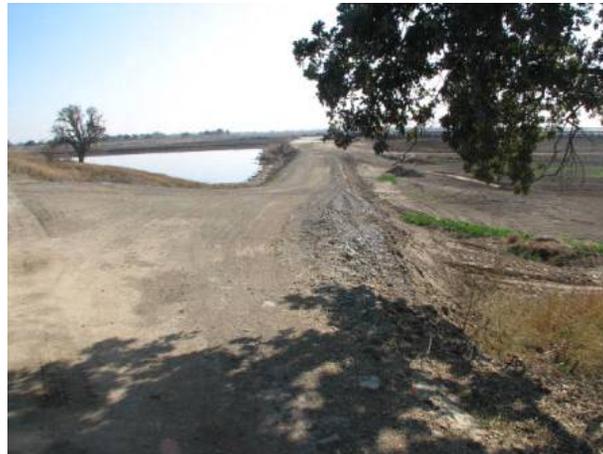
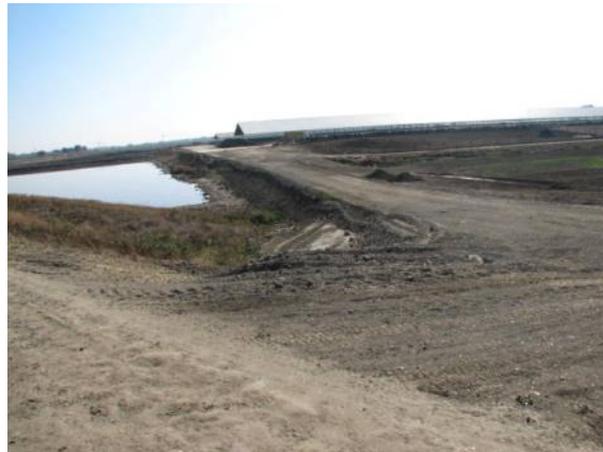
Levee Mile Report Line	40
Start Levee Mile	5.16
End Levee Mile	5.16
Location	Land Side
Category	Earthen Levee
Item	Encroachments
11/08/2011 New ramp has been constructed by Dairy farmer connecting his barns to the levee.	
jeto_f_20111118_583.jpg

Levee Mile Report Line	40
Start Levee Mile	5.16
End Levee Mile	5.16
Location	Land Side
Category	Earthen Levee
Item	Encroachments
11/08/2011 New ramp has been constructed by Dairy farmer connecting his barns to the levee.	
jeto_f_20111118_584.jpg

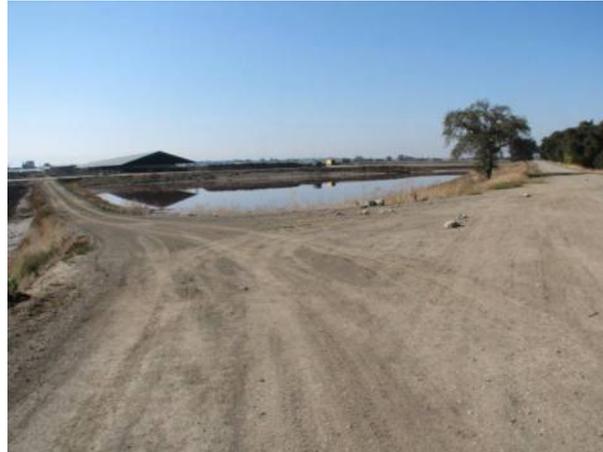
Levee Mile Report Line	41
Start Levee Mile	5.37
End Levee Mile	5.37
Location	Land Side
Category	Earthen Levee
Item	Encroachments
11/08/2011 Photo shows existing middle ramp to the levee which has been raised.	
jeto_f_20111118_585.jpg

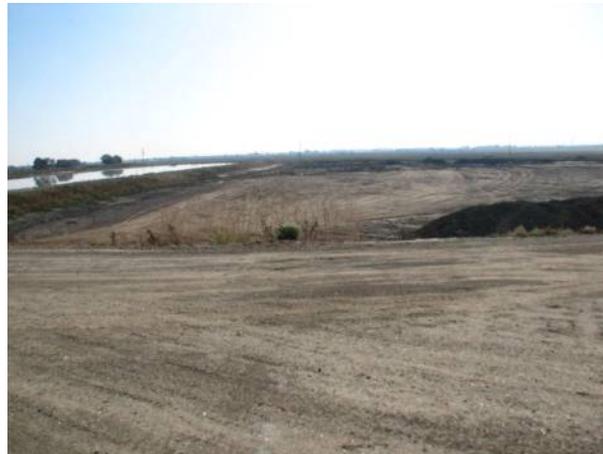
Levee Mile Report Line	41
Start Levee Mile	5.37
End Levee Mile	5.37
Location	Land Side
Category	Earthen Levee
Item	Encroachments
11/08/2011 Photo shows view from the levee looking to the left of the middle ramp.	
jeto_f_20111118_586.jpg

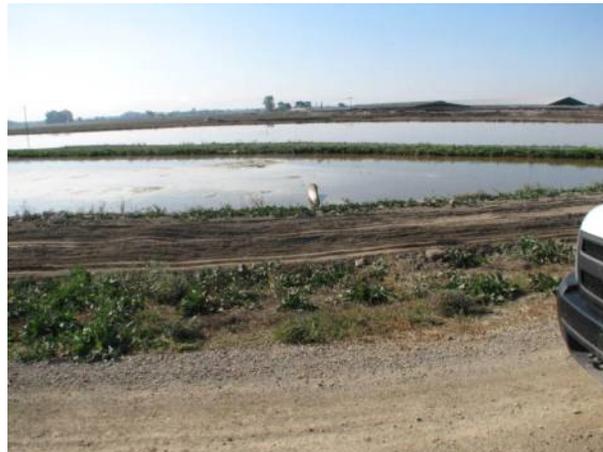
Levee Mile Report Line	42
Start Levee Mile	5.49
End Levee Mile	5.49
Location	Land Side
Category	Earthen Levee
Item	Encroachments
11/08/2011 This appears to be an open pipe which may be penetrating the levee, no exit pipe could be found on the waterside.	
jeto_f_20111118_588.jpg

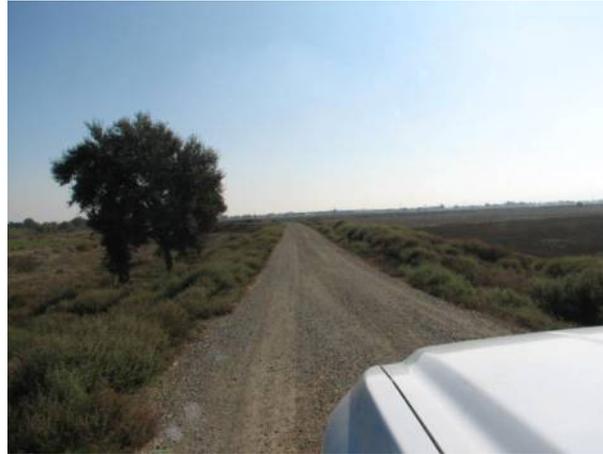
43	5.62	5.99	Earthen Levee	Vegetation	LS	M	Remove the wild growth other than native grasses from the levee slopes. Inspector Comments: Landside vegetation blocks visibility of the landside slope and toe.	37.779795 ° -121.339923 °	37.775818 ° -121.336092 °	31 Y
44	6.42	6.42	Earthen Levee	Animal Control	LS	C	No rodents visible, but rodent burrows visible; need to backfill and compact or grout burrows. Inspector Comments: Numerous burrows remain on levee.	37.772047 ° -121.330188 °	37.772047 ° -121.330188 °	985 Y
45	6.57	6.57	Earthen Levee	Encroachments	LS	PO	Agricultural Ditch Inspector Comments: Ditch has been created to discourage trespassing, needs to be backfilled.	37.770188 ° -121.329665 °	37.770188 ° -121.329665 °	33 Y

Levee Mile Report Line	43
Start Levee Mile	5.62
End Levee Mile	5.99
Location	Land Side
Category	Earthen Levee
Item	Vegetation
11/08/2011 Landside vegetation prevents visibility of the landside toe and slope.	
jeto_f_20111118_589.jpg

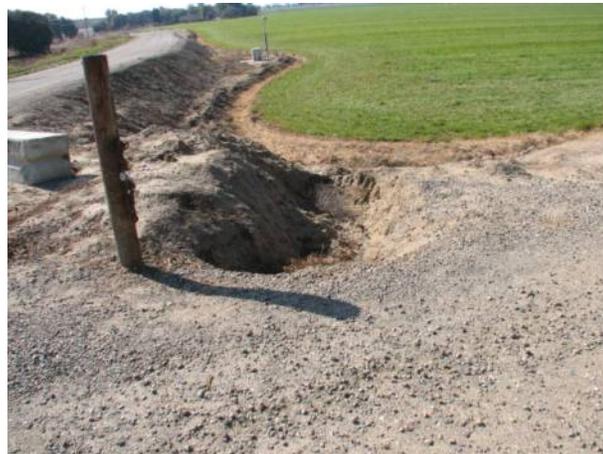
Levee Mile Report Line	45
Start Levee Mile	6.57
End Levee Mile	6.57
Location	Land Side
Category	Earthen Levee
Item	Encroachments
11/08/2011 Gulley was cut into the levee to prevent illegal entry, needs to be backfilled and recompacted.	
jeto_f_20111118_590.jpg
