**Flood Control Project Maintenance  
Levee Inspections**

**Fall 2014 Levee Maintenance Deficiency Summary Report  
Overall LMA & Unit Ratings, including DWR Erosion Survey**

**Reclamation District No. 2058 Pescadero**

Waterway	Bank	Unit Miles
Unit No. 01 Paradise Cut	Left	6.58

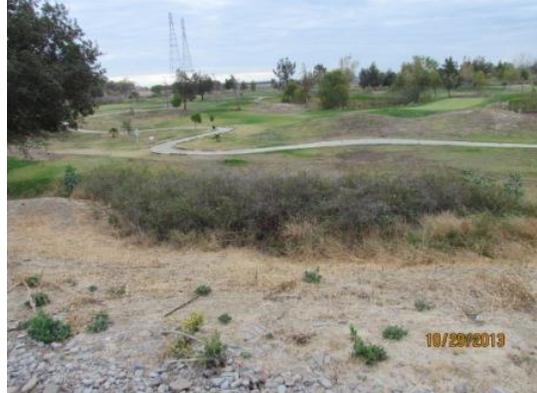
Photo 1 of 1 : FA\_2014\_RD2058\_111\_4\_20141001\_00004.jpg

LM Start	<b>0.23</b>	Rating **	A/W	Issue No.	<b>4</b>
LM End	<b>0.23</b>	Issue Type +	Ob	Location *	LS
Category	Earthen Levee		GPS Latitude/Longitude		
			Start	End	
Item	Vegetation		37.804351 °	37.804351 °	
			-121.418433 °	-121.418433 °	
DWR ID	DWR_RD2058_01_f_2013_4				
Action/Comments					
Environmental Requirements. Inspector Comments: Wild rose on the levee. This area is riparian rabbit habitat.

View of the wild rose habitat for the brush rabbit.

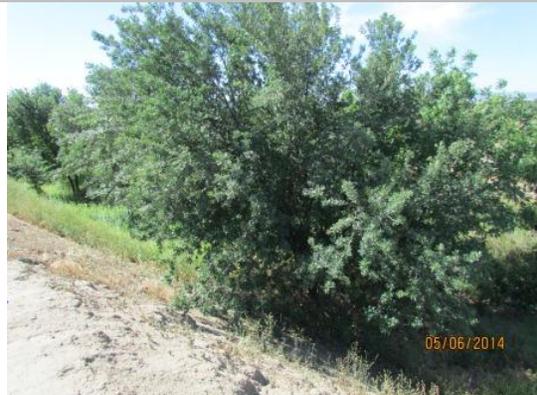
Photo 1 of 1 : FA\_2014\_RD2058\_111\_301\_20141001\_00019.jpg

LM Start	<b>0.50</b>	Rating **	M	Issue No.	<b>301</b>
LM End	<b>0.50</b>	Issue Type +	Ma	Location *	LS
Category	Earthen Levee		GPS Latitude/Longitude		
			Start	End	
Item	Trim / Thin Trees		37.802932 °	37.802932 °	
			-121.414652 °	-121.414652 °	
DWR ID	DWR_RD2058_01_s_2014_301				
Action/Comments					
Trim trees to at least five feet above ground level.

View of the trees at the landside levee toe obstructing visibility and access.

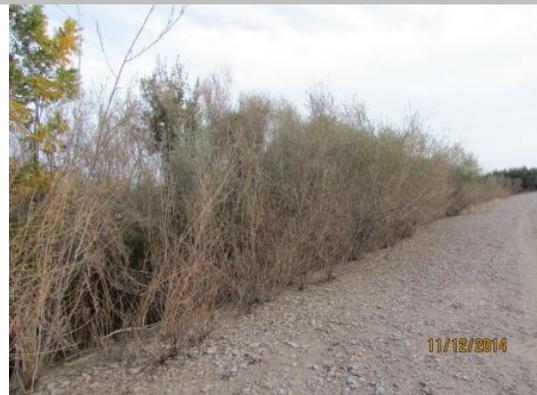
Photo 1 of 1 : FA\_2014\_RD2058\_111\_961\_20141119\_00025.jpg

LM Start	<b>1.72</b>	Rating **	<b>M</b>	Issue No.	<b>961</b>
LM End	<b>1.78</b>	Issue Type +	<b>Ma</b>	Location *	<b>WS</b>
Category	Earthen Levee		GPS Latitude/Longitude		
			Start	End	
Item	Vegetation		37.804333 °	37.804615 °	
			-121.393657 °	-121.392588 °	
DWR ID	DWR_RD2058_01_s_2012_961				
Action/Comments					
Remove the wild growth other than native grasses from the levee slopes.

View if the overgrown vegetation on the waterside slope to be removed.

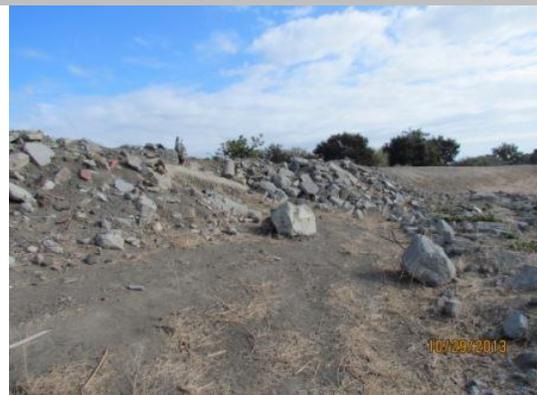
Photo 1 of 1 : FA\_2014\_RD2058\_111\_11\_20141001\_00005.jpg

LM Start	<b>1.84</b>	Rating **	<b>U</b>	Issue No.	<b>11</b>
LM End	<b>1.84</b>	Issue Type +	<b>En</b>	Location *	<b>LS</b>
Category	Earthen Levee		GPS Latitude/Longitude		
			Start	End	
Item	Encroachments		37.804785 °	37.804785 °	
			-121.391524 °	-121.391524 °	
DWR ID	DWR_RD2058_01_f_2013_11				
Action/Comments					
Material Inspector Comments: Pile of concrete contains rebar on landside slope obstructing visibility and access.

View of the concrete with rebar placed on the landside slope.

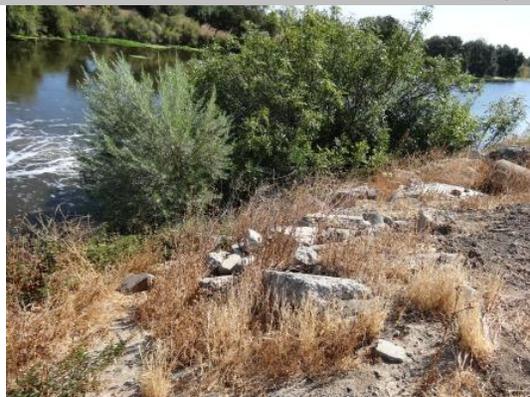
Photo 1 of 1 : SJR2014\_RD2058U01RM1.78\_1.jpg

LM Start	<b>2.15</b>	Rating **	M	Issue No.	<b>1</b>
LM End	<b>2.15</b>	Issue Type +	Ma	Location *	WS
Category	Supplemental			GPS Latitude/Longitude	
				Start	End
Item	DWR Erosion Survey			37.803769 °	37.803769 °
				-121.386341 °	-121.386341 °
DWR ID

**Action/Comments**  
 Inspector Comments: 08/26/2014: No significant change observed.  
 08/28/2013: No significant change observed.  
 07/31/2012: Site was visited on 07/26/2012. No significant change observed. A new vertical pipe was installed and concrete blocks left on the site. Dense vegetation is visible at the site. No signs of new leaks or spill from the siphon breaker.  
 09/02/2011: Site was not visited due to the time limit.  
 09/22/2010: No significant change observed. Vegetation downstream, upstream and on the lower slope of the site have been recently sprayed. These areas were also fenced off during the site visit, making it difficult for us to examine the condition of the lower slope. Possible leak or spill from the siphon breaker is creating notches along the slope and developing into a headward erosion. If the problem continues, it will erode the slope and fully expose the pipe to outside elements.

07/23/2009: A possible leak or spill from a siphon breaker is eroding the slope and developing into a headward erosion; a portion of the buried pipe is exposed; the lower slope seems to be lined with chunks of concrete debris or other rock material. [2014 Site ID:RD2058U01RM1.78]

Direct view of the site.

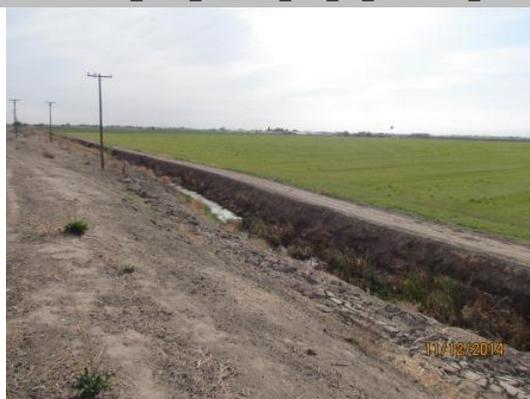
Photo 1 of 1 : FA\_2014\_RD2058\_111\_12\_20141119\_00026.jpg

LM Start	<b>2.26</b>	Rating **	M	Issue No.	<b>12</b>
LM End	<b>2.33</b>	Issue Type +	En	Location *	LS
Category	Earthen Levee			GPS Latitude/Longitude	
				Start	End
Item	Encroachments			37.803375 °	37.803136 °
				-121.384196 °	-121.383078 °
DWR ID	DWR_RD2058_01_f_2013_12

**Action/Comments**  
 Ditch

View of the ditch at the landside levee toe.

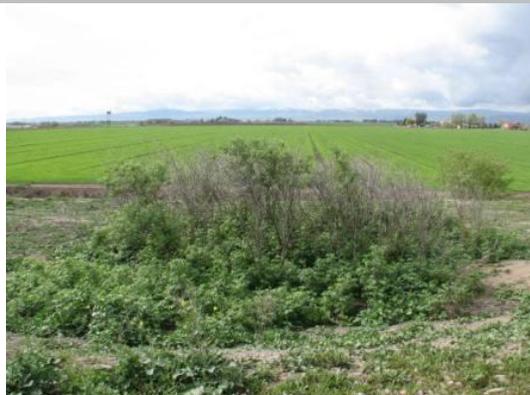
Photo 1 of 1 : FA\_2014\_RD2058\_111\_16\_20141001\_00007.jpg

LM Start	<b>2.42</b>	Rating **	A/W	Issue No.	<b>16</b>
LM End	<b>2.42</b>	Issue Type +	Ma	Location *	LS
Category	Earthen Levee		GPS Latitude/Longitude		
			Start	End	
Item	Vegetation		37.802782 °	37.802782 °	
			-121.381413 °	-121.381413 °	
DWR ID	DWR_RD2058_01_s_2012_16				
Action/Comments					
Elderberries are blocking visibility and flood fight capability. Inspector Comments: Elderberry growing on landside toe.

03/28/2012 Large elderberry bush on landside slope.

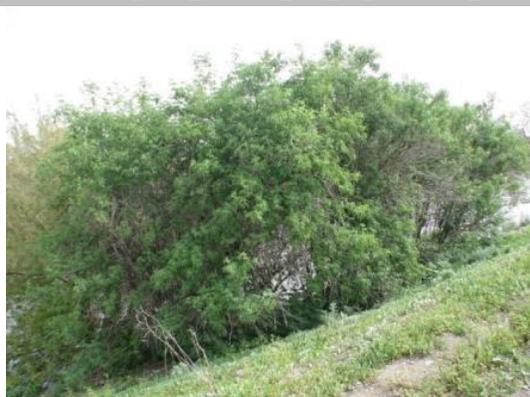
Photo 1 of 1 : FA\_2014\_RD2058\_111\_63\_20141001\_00018.jpg

LM Start	<b>2.64</b>	Rating **	A/W	Issue No.	<b>63</b>
LM End	<b>2.64</b>	Issue Type +	Ma	Location *	WS
Category	Earthen Levee		GPS Latitude/Longitude		
			Start	End	
Item	Vegetation		37.801962 °	37.801962 °	
			-121.377684 °	-121.377684 °	
DWR ID	DWR_RD2058_01_s_2012_63				
Action/Comments					
Elderberries are blocking visibility and flood fight capability. Inspector Comments: Elderberry on waterside slope.

03/28/2012 Large elderberry bush located on waterward slope.

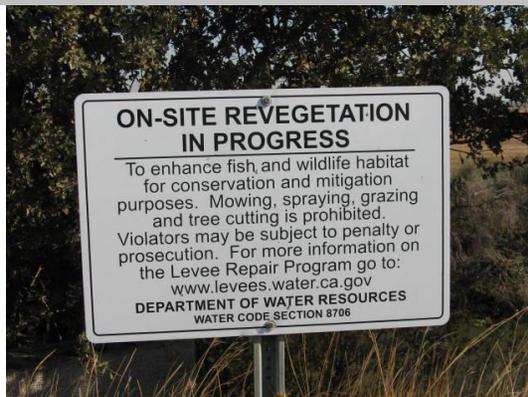
Photo 1 of 1 : FA\_2014\_RD2058\_111\_20\_20141001\_00008.jpg

LM Start	<b>3.85</b>	Rating **	A/W	Issue No.	<b>20</b>
LM End	<b>3.85</b>	Issue Type +	Ma	Location *	WS
Category	Earthen Levee		GPS Latitude/Longitude		
			Start	End	
Item	Vegetation		37.790807 °	37.790807 °	
			-121.362905 °	-121.362905 °	
DWR ID	DWR_RD2058_01_s_2012_20				
Action/Comments					
Environmental Requirements. Inspector Comments: Revegetation site.

11/08/2011 Revegetation site, cannot trim or cut vegetation in this area.

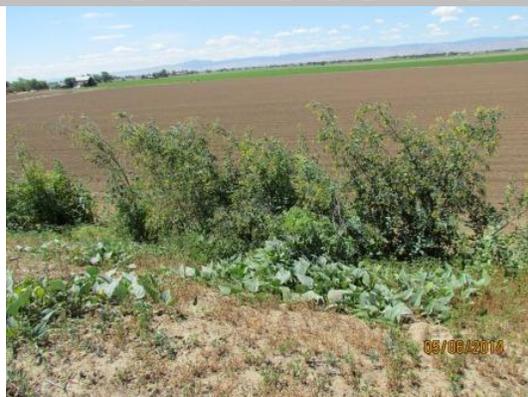
Photo 1 of 1 : FA\_2014\_RD2058\_111\_22\_20141001\_00009.jpg

LM Start	<b>3.96</b>	Rating **	M	Issue No.	<b>22</b>
LM End	<b>3.96</b>	Issue Type +	Ma	Location *	LS
Category	Earthen Levee		GPS Latitude/Longitude		
			Start	End	
Item	Vegetation		37.789434 °	37.789434 °	
			-121.361721 °	-121.361721 °	
DWR ID	DWR_RD2058_01_s_2014_22				
Action/Comments					
Remove the wild growth other than native grasses from the levee slopes.

View of the tall vegetation on the landside levee slope and toe.

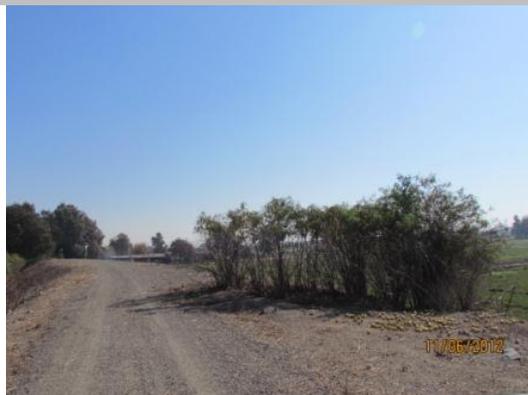
Photo 1 of 1 : FA\_2014\_RD2058\_111\_26\_20141001\_00011.jpg

LM Start	<b>4.01</b>	Rating **	M	Issue No.	<b>26</b>
LM End	<b>4.01</b>	Issue Type +	Ma	Location *	LS
Category	Earthen Levee		GPS Latitude/Longitude		
			Start	End	
Item	Vegetation		37.789128 °	37.789128 °	
			-121.361042 °	-121.361042 °	
DWR ID	DWR_RD2058_01_s_2012_26				
Action/Comments					
Elderberries are blocking visibility and flood fight capability. Inspector Comments: Elderberry on landside hinge point.

Elderberry bushes on landside slope.

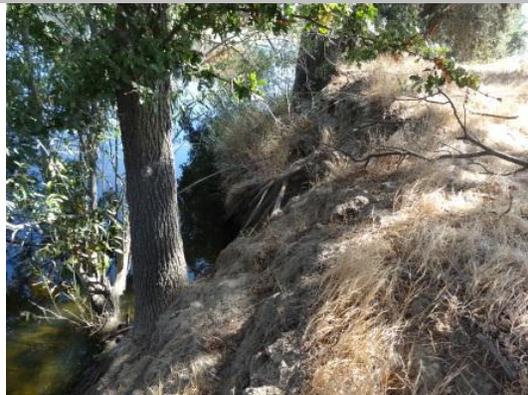
Photo 1 of 1 : SJR2014\_RD2058U01RM3.97\_1.jpg

LM Start	<b>4.49</b>	Rating **	M	Issue No.	<b>2</b>
LM End	<b>4.53</b>	Issue Type +	Ma	Location *	WS
Category	Supplemental		GPS Latitude/Longitude		
			Start	End	
Item	DWR Erosion Survey		37.789810 °	37.789810 °	
			-121.352490 °	-121.352490 °	
DWR ID

Direct view of the erosion near a tree.

**Action/Comments**  
 Inspector Comments: 08/26/2014: No significant change observed.  
 08/28/2013: No significant change observed.  
 07/26/2012: The site has been visited, and no significant change has been observed.  
 09/02/2011: This site was not visited due to the time limit.  
 09/22/2010: No significant change observed. Minor pocket erosions are lined at the lower bank. Two large Oak and Willow trees are on mid-slope and bench. The remaining bench was re-measured and found to be approximately 10 feet. There was no indication of active erosion on site during the site visit.  
 08/05/2010: Recommended for annual assessment and monitoring of the site during flood events, per CLRO.  
 07/23/2009: No major change observed since last visit; site is a 200-ft. long near-vertical berm erosion; recommend annual assessment and monitoring of the erosion site, per CLRO CES Evaluation 2008 Report; Site # is the same site previously reported as RM4.0,LM4.51; previously rated "U".

09/10/2008: Two large trees (2-3' DBH) with partial roots exposed.  
 2007: Visited site 03/13/2007. [2014 Site ID:RD2058U01RM3.97]

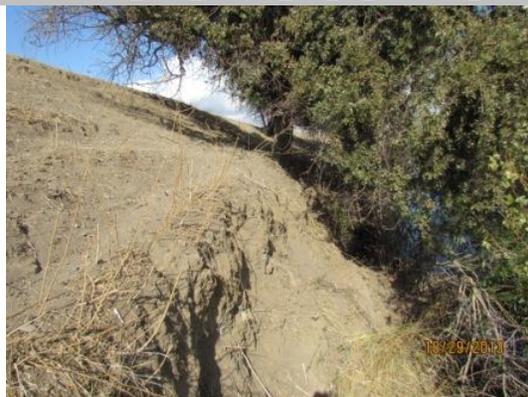
Photo 1 of 1 : FA\_2014\_RD2058\_111\_15\_20141001\_00006.jpg

LM Start	<b>4.82</b>	Rating **	U	Issue No.	<b>15</b>
LM End	<b>4.82</b>	Issue Type +	Ma	Location *	WS
Category	Earthen Levee		GPS Latitude/Longitude		
			Start	End	
Item	Erosion / Bank Caving		37.785862 °	37.785862 °	
			-121.350303 °	-121.350303 °	
DWR ID	DWR_RD2058_01_f_2013_15

View of the erosion at the waterside levee toe.

**Action/Comments**  
 Note and monitor erosion site.  
 Inspector Comments: The erosion has about a 3 foot vertical cut at the waterside levee toe.

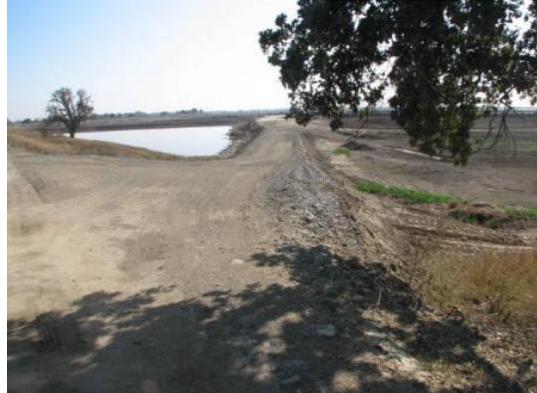
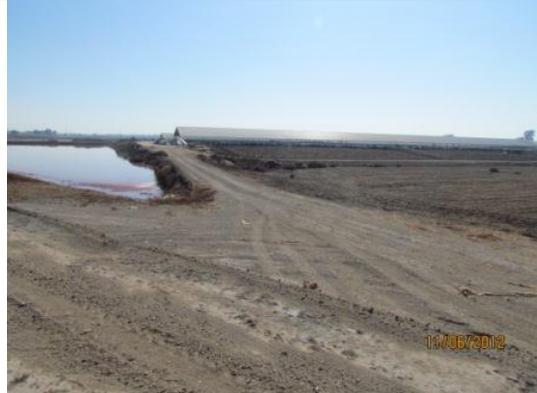
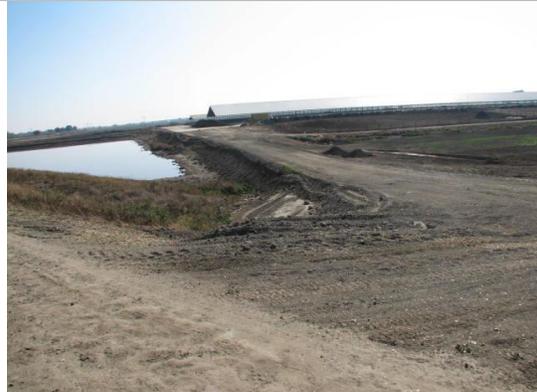
LM Start	<b>5.16</b>	Rating **	<b>U</b>	Issue No.	<b>29</b>
LM End	<b>5.16</b>	Issue Type +	<b>En</b>	Location *	<b>LS</b>
Category	Earthen Levee		GPS Latitude/Longitude		
			Start	End	
Item	Encroachments		37.783102 °	37.783102 °	
			-121.345682 °	-121.345682 °	
DWR ID	DWR_RD2058_01_s_2012_29				
Action/Comments					
Ramp Inspector Comments: New ramp construction connecting dairy to levee. Construction of ramp results in a new pond on the landside of the levee. 2/21/2012, owner has said that he will contact the CVFPB to resolve this issue.

11/08/2011 New ramp has been constructed by Dairy farmer connecting his barns to the levee.

Completed new ramp constructed by Dairy farmer connecting his barns to the levee.

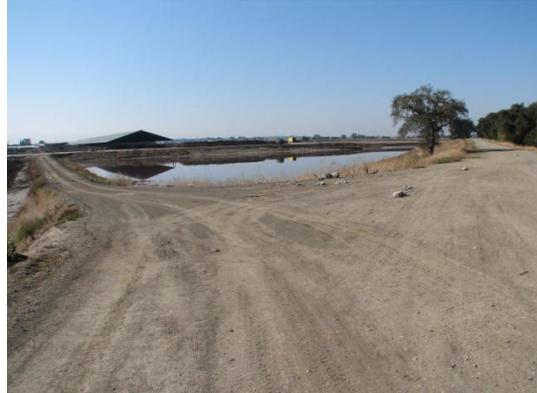
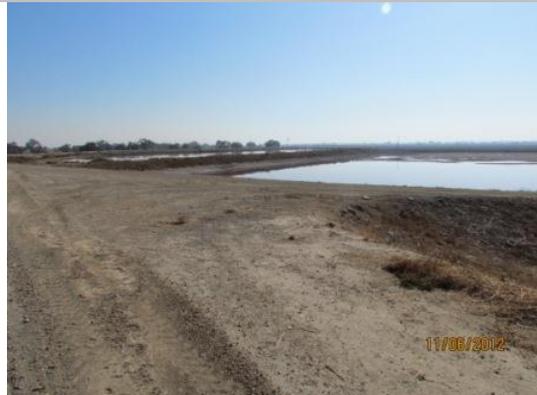
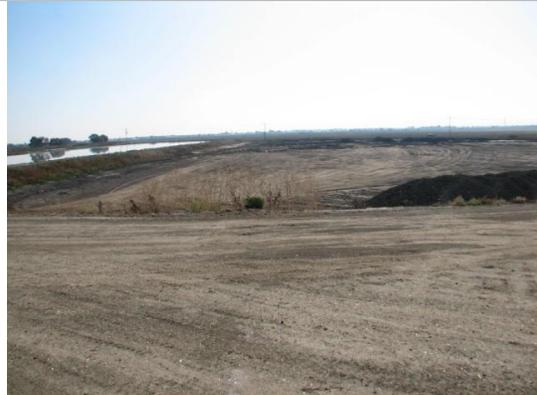
LM Start	<b>5.37</b>	Rating **	U	Issue No.	<b>30</b>
LM End	<b>5.37</b>	Issue Type +	En	Location *	LS
Category	Earthen Levee		GPS Latitude/Longitude		
			Start	End	
Item	Encroachments		37.782268 °	37.782268 °	
			-121.342257 °	-121.342257 °	
DWR ID	DWR_RD2058_01_s_2012_30				
Action/Comments					
Ramp Inspector Comments: Ramp constructed to dairy. Raised ramps, see issue 29 are creating new holding ponds for dairy at levee toe.

11/08/2011 Photo shows existing middle ramp to the levee which has been raised.

Completed new ramp constructed by Dairy farmer connecting his barns to the levee.

11/08/2011 Photo shows view from the levee looking to the left of the middle ramp.
