**Flood Control Project Maintenance
Levee Inspections**

Fall 2015 Levee Maintenance Deficiency Summary Report

Reclamation District No. 2058 Pescadero

Waterway		Bank	Unit Miles
Unit No. 01 Paradise Cut		Left	6.58

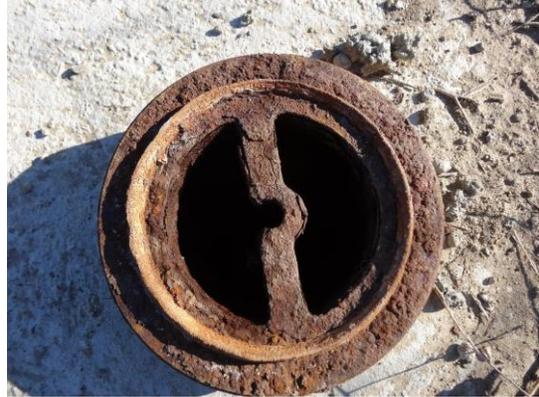
Photo 1 of 3 : UCIP_FA_2015_2637.jpg

LM Start	Rating **	M	Issue No.	975
LM End	Issue Type +	En	Location *	N/A
Category	Supplemental	GPS Latitude/Longitude		
		Start	End	
Item	DWR UCIP Field Study	37.803886 °	37.803886 °	
		-121.386271 °	-121.386271 °	
DWR ID				
Action/Comments				
Inspector Comments: FS_ID:46770 DS_ID:22706 EP_NO: N/A FS_HLM: 2.142 Repair Type: Non-Urgent Crossing Status: Found UCIP Comments: Leaky and damaged siphon breaker on waterside shoulder. Update: leaky siphon breaker at LM 2.14 repaired per Spring 2015 Inspection Report. Need to confirm repair was done at this location. FIELD_STRUCT_DESC: 16-inch steel stormdrain pipe 8.0-feet below the crown. Siphon Breaker on waterward shoulder. Pump on concrete sump on landside. Originally included in the 1964 O&M manual, SJR 10, March 1964. FS Date: 05/13/2015

WS view: Upper part of the siphon breaker missing.

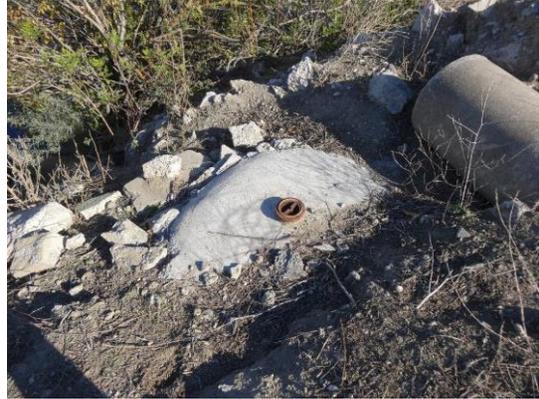
Photo 2 of 3 : UCIP_FA_2015_2638.jpg

WS view: siphon breaker on concrete pad on levee slope.

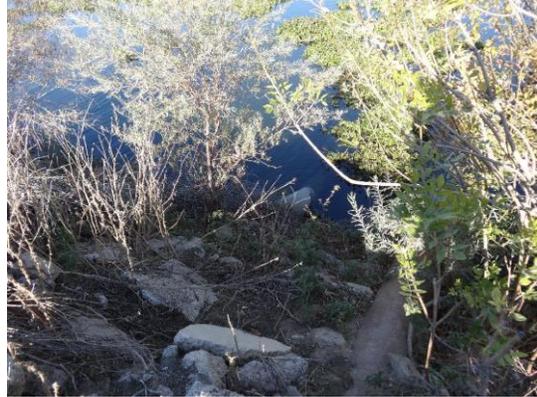
Photo 3 of 3 : UCIP_FA_2015_2639.jpg

LM Start	Rating **	M	Issue No.	975 (cont)	
LM End	Issue Type +	En	Location *	N/A	
Category	Supplemental		GPS Latitude/Longitude		
			Start	End	
Item	DWR UCIP Field Study		37.803886 °	37.803886 °	
			-121.386271 °	-121.386271 °	
DWR ID					
Action/Comments					
Inspector Comments: FS_ID:46770 DS_ID:22706 EP_NO: N/A FS_HLM: 2.142 Repair Type: Non-Urgent Crossing Status: Found

WS view: exposed steel pipe (right) on channel bank.

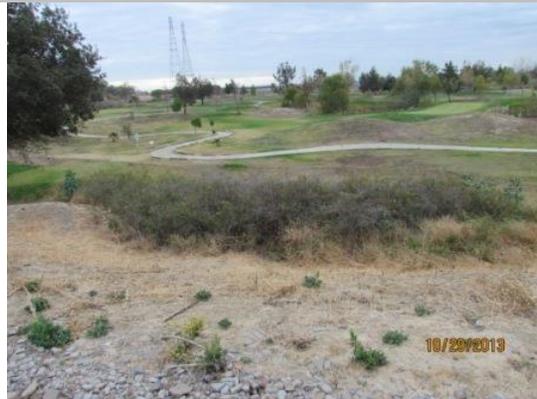
Photo 1 of 1 : FA_2015_RD2058_111_4_20150910_00003.jpg

LM Start	0.23	Rating **	A/W	Issue No.	4
LM End	0.23	Issue Type +	Ob	Location *	LS
Category	Earthen Levee		GPS Latitude/Longitude		
			Start	End	
Item	Vegetation		37.804351 °	37.804351 °	
			-121.418433 °	-121.418433 °	
DWR ID	DWR_RD2058_01_f_2013_4				
Action/Comments					
Environmental Requirements. Inspector Comments: Wild rose on the levee. This area is riparian rabbit habitat.

View of the wild rose habitat for the brush rabbit.

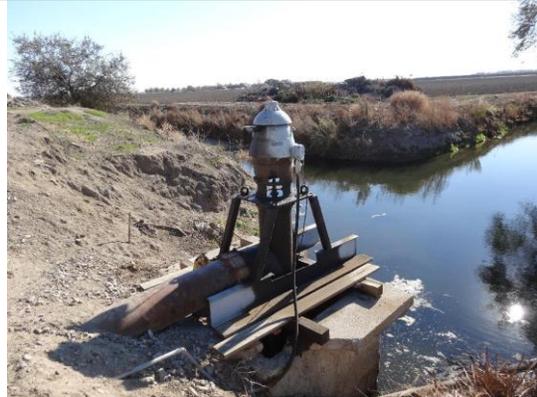
Photo 1 of 3 : UCIP_FA_2015_2635.jpg

LM Start	0.72	Rating **	M	Issue No.	976
LM End	0.72	Issue Type +	En	Location *	LS
Category	Supplemental			GPS Latitude/Longitude	
				Start	End
Item	DWR UCIP Field Study			37.801792 °	37.801792 °
				-121.410921 °	-121.410921 °
DWR ID					
Action/Comments					
Inspector Comments: FS_ID:45843 DS_ID:22700 EP_NO: 5055 FS_HLM: 0.728 Repair Type: Non-Urgent Crossing Status: Found UCIP Comments: Excessive oil leakage. FIELD_STRUCT_DESC: 16-inch steel stormdrain pipe through levee 3.8 feet below crown. Pump on concrete sump on landside. Siphon breaker under protective cover on the waterward slope (Permit No. 5055, 1666). FS Date: 05/12/2015

LS view: exposed pipe and vertical pump on concrete sump on drain ditch.

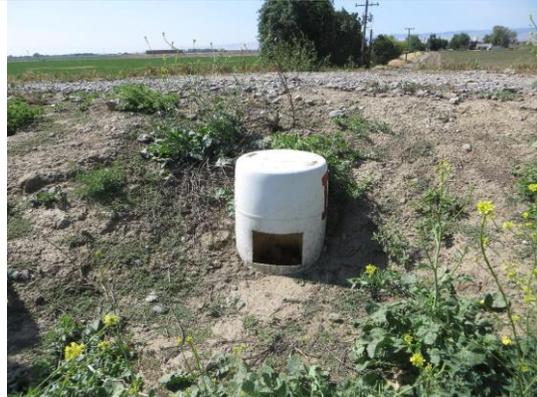
Photo 2 of 3 : UCIP_FA_2015_6316.jpg

WS view: siphon breaker in protective casing.

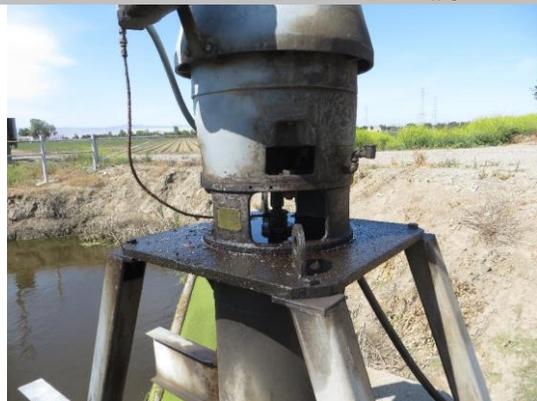
Photo 3 of 3 : UCIP_FA_2015_6317.jpg

Action/Comments
 Inspector Comments: FS_ID:45843
 DS_ID:22700
 EP_NO: 5055
 FS_HLM: 0.728
 Repair Type: Non-Urgent
 Crossing Status: Found
 UCIP Comments: Excessive oil leakage.
 FIELD_STRUCT_DESC: 16-inch steel stormdrain pipe through levee 3.8 feet below crown. Pump on concrete sump on landside. Siphon breaker under protective cover on the waterward slope (Permit No. 5055, 1666).
 FS Date: 05/12/2015

LS view: closeup of pump showing excessive oil leakage.

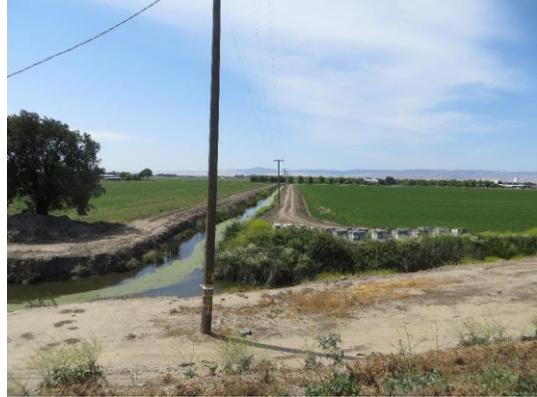
Photo 1 of 1 : UCIP_FA_2015_5861.jpg

LM Start	1.21	Rating **	M	Issue No.	977
LM End	1.21	Issue Type +	En	Location *	LS
Category	Supplemental			GPS Latitude/Longitude	
				Start	End
Item	DWR UCIP Field Study			37.802249 °	37.802249 °
				-121.402183 °	-121.402183 °
DWR ID					
Action/Comments					
Inspector Comments: FS_ID:45847 DS_ID:22693 EP_NO: 10426 FS_HLM: 1.225 Repair Type: Non-Urgent Crossing Status: Indicator Found

View of LS. Alignment of Crossing to right of canal at dirt access road.

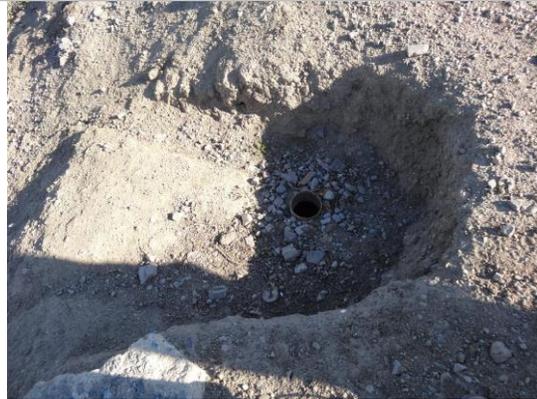
Photo 1 of 1 : UCIP_FA_2015_2636.jpg

LM Start	1.22	Rating **	U	Issue No.	978
LM End	1.22	Issue Type +	En	Location *	LS
Category	Supplemental			GPS Latitude/Longitude	
				Start	End
Item	DWR UCIP Field Study			37.802301 °	37.802301 °
				-121.401977 °	-121.401977 °
DWR ID					
Action/Comments					
Inspector Comments: FS_ID:45850 DS_ID:22694 EP_NO: 11546 FS_HLM: 1.237 Repair Type: Urgent Crossing Status: Found UCIP Comments: Erosion on west side of pipe at W/S toe. FIELD_STRUCT_DESC: 18-inch steel stormdrain pipe through the levee 2-feet below the crown. Pump in ditch on the landward side. Siphon breaker on waterside shoulder. Electrical service pole at the landward toe. Permit No. 11546, 1976. FS Date: 05/13/2015

WS view: siphon breaker hole. Siphon breaker removed for repair.

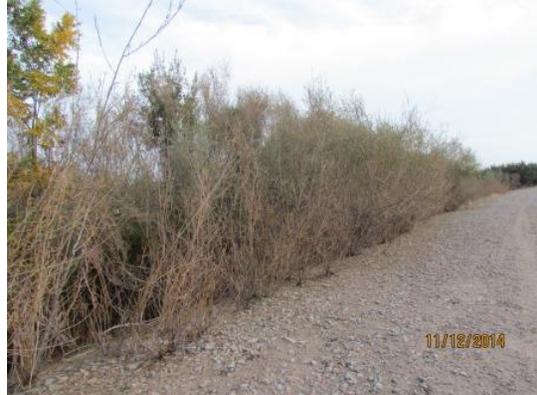
Photo 1 of 1 : FA_2015_RD2058_111_961_20150910_00020.jpg

View if the overgrown vegetation on the waterside slope to be removed.

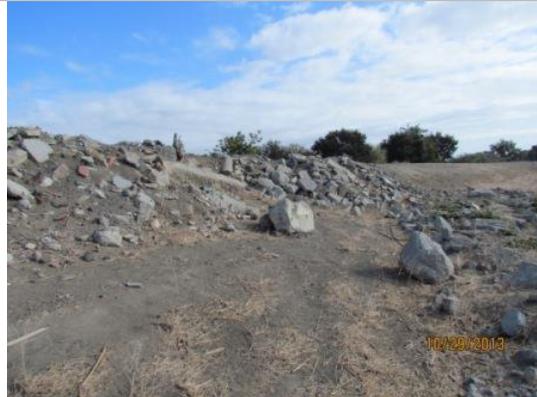
Photo 1 of 1 : FA_2015_RD2058_111_11_20150910_00004.jpg

LM Start	1.82	Rating **	U	Issue No.	11
LM End	1.82	Issue Type +	En	Location *	LS
Category	Earthen Levee		GPS Latitude/Longitude		
			Start	End	
Item	Encroachments		37.804785 °	37.804785 °	
			-121.391524 °	-121.391524 °	
DWR ID	DWR_RD2058_01_f_2013_11				
Action/Comments					
Material Inspector Comments: Pile of concrete contains rebar on landside slope obstructing visibility and access.

View of the concrete with rebar placed on the landside slope.

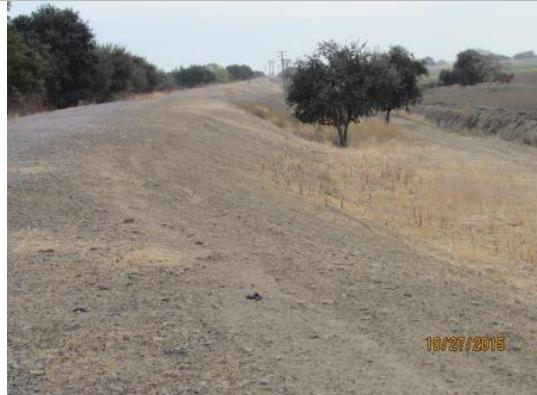
Photo 1 of 1 : FA_2015_RD2058_111_14_20151112_00025.jpg

LM Start	1.85	Rating **	A	Issue No.	14
LM End	1.85	Issue Type +	Ma	Location *	LS
Category	Earthen Levee		GPS Latitude/Longitude		
			Start	End	
Item	Vegetation		37.804801 °	37.804801 °	
			-121.390950 °	-121.390950 °	
DWR ID	DWR_RD2058_01_f_2015_14				
Action/Comments					
Control annual grass and weeds on the levee slopes and easements.

View of the acceptable vegetation control on the landside levee slope.

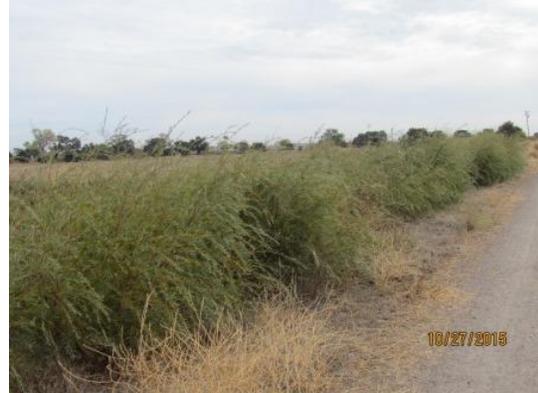
Photo 1 of 1 : FA_2015_RD2058_111_17_20151112_00026.jpg

View of the willows on the waterside levee slope.

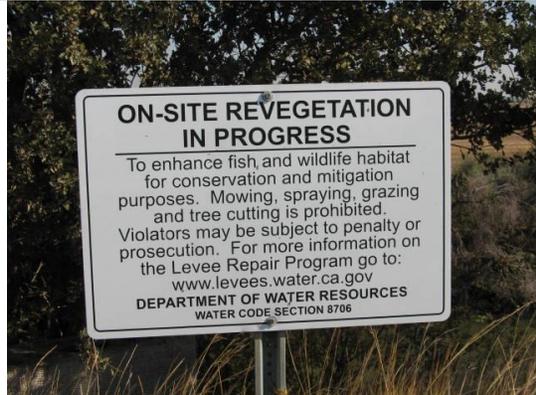
Photo 1 of 1 : FA_2015_RD2058_111_20_20150910_00008.jpg

11/08/2011 Revegetation site, cannot trim or cut vegetation in this area.

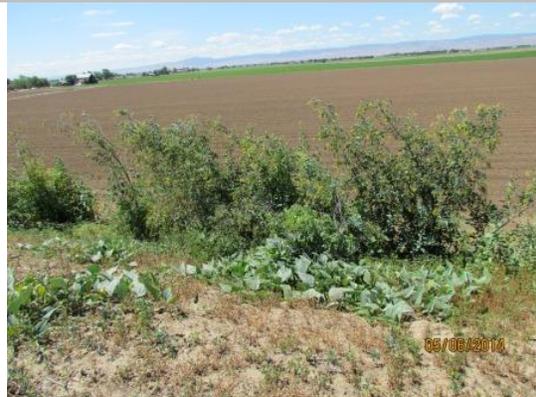
Photo 1 of 1 : FA_2015_RD2058_111_22_20150910_00009.jpg

LM Start	3.91	Rating **	A/W	Issue No.	22
LM End	3.91	Issue Type +	Ma	Location *	LS
Category	Earthen Levee		GPS Latitude/Longitude		
			Start	End	
Item	Vegetation		37.789434 °	37.789434 °	
			-121.361721 °	-121.361721 °	
DWR ID	DWR_RD2058_01_s_2014_22				
Action/Comments					
Remove the wild growth other than native grasses from the levee slopes. Inspector Comments: LMA removed vegetation in Fall 2015.

View of the tall vegetation on the landside levee slope and toe.

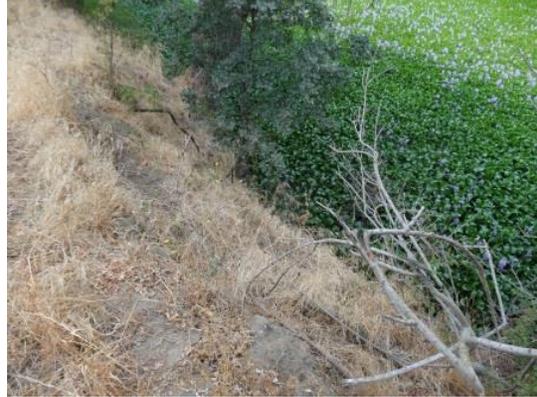
Photo 1 of 3 : SJR2015_RD2058U01RM3.97_13.jpg

Inspector Comments: 08/04/2015: No significant change observed.
 08/26/2014: No significant change observed.
 08/28/2013: No significant change observed.
 07/26/2012: The site has been visited, and no significant change has been observed.
 09/02/2011: This site was not visited due to the time limit.
 09/22/2010: No significant change observed. Minor pocket erosions are lined at the lower bank. Two large Oak and Willow trees are on mid-slope and bench. The remaining bench was re-measured and found to be approximately 10 feet. There was no indication of active erosion on site during the site visit.
 08/05/2010: Recommended for annual assessment and monitoring of the site during flood events, per CLRO.
 07/23/2009: No major change observed since last visit; site is a 200-ft. long near-vertical berm erosion; recommend annual assessment and monitoring of the erosion site, per CLRO CES Evaluation 2008 Report; Site # is the same site previously reported as RM4.0,LM4.51; previously rated "U".

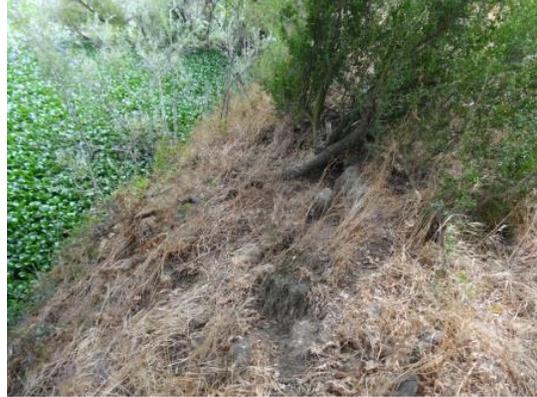
Photo 2 of 3 : SJR2015_RD2058U01RM3.97_2.jpg

Direct view of the erosion near a tree.

Inspector Comments: 08/04/2015: No significant change observed.
 08/26/2014: No significant change observed.
 08/28/2013: No significant change observed.
 07/26/2012: The site has been visited, and no significant change has been observed.
 09/02/2011: This site was not visited due to the time limit.
 09/22/2010: No significant change observed. Minor pocket erosions are lined at the lower bank. Two large Oak and Willow trees are on mid-slope and bench. The remaining bench was re-measured and found to be approximately 10 feet. There was no indication of active erosion on site during the site visit.
 08/05/2010: Recommended for annual assessment and monitoring of the site during flood events, per CLRO.
 07/23/2009: No major change observed since last visit; site is a 200-ft. long near-vertical berm erosion; recommend annual assessment and monitoring of the erosion site, per CLRO CES Evaluation 2008 Report; Site # is the same site previously reported as RM4.0,LM4.51; previously rated "U".

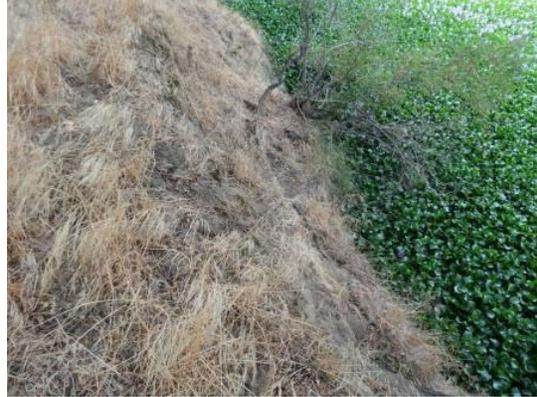
Photo 3 of 3 : SJR2015_RD2058U01RM3.97_5.jpg

LM Start	4.43	Rating **	M	Issue No.	1 (cont)
LM End	4.47	Issue Type +	Ma	Location *	WS
Category	Supplemental		GPS Latitude/Longitude		
			Start	End	
Item	DWR Erosion Survey		37.789810 °	37.789810 °	
			-121.352490 °	-121.352490 °	
DWR ID					
Action/Comments					
Inspector Comments: 08/04/2015: No significant change observed. 08/26/2014: No significant change observed. 08/28/2013: No significant change observed. 07/26/2012: The site has been visited, and no significant change has been observed. 09/02/2011: This site was not visited due to the time limit. 09/22/2010: No significant change observed. Minor pocket erosions are lined at the lower bank. Two large Oak and Willow trees are on mid-slope and bench. The remaining bench was re-measured and found to be approximately 10 feet. There was no indication of active erosion on site during the site visit. 08/05/2010: Recommended for annual assessment and monitoring of the site during flood events, per CLRO. 07/23/2009: No major change observed since last visit; site is a 200-ft. long near-vertical berm erosion; recommend annual assessment and monitoring of the erosion site, per CLRO CES Evaluation 2008 Report; Site # is the same site previously reported as RM4.0,LM4.51; previously rated "U". 09/10/2008: Two large trees (2-3' DBH) with partial roots exposed. 2007: Visited site 03/13/2007. [2015 Site ID:RD2058U01RM3.97]

Direct view of a pocket erosion site.

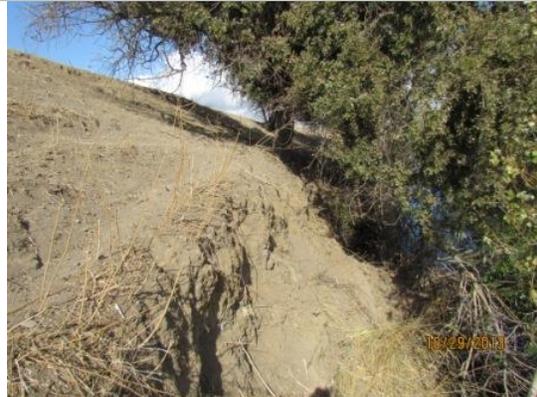
Photo 1 of 1 : FA_2015_RD2058_111_15_20150910_00006.jpg

LM Start	4.77	Rating **	U	Issue No.	15
LM End	4.77	Issue Type +	Ma	Location *	WS
Category	Earthen Levee		GPS Latitude/Longitude		
			Start	End	
Item	Erosion / Bank Caving		37.785862 °	37.785862 °	
			-121.350303 °	-121.350303 °	
DWR ID	DWR_RD2058_01_f_2013_15				
Action/Comments					
Note and monitor erosion site. Inspector Comments: The erosion has about a 3 foot vertical cut at the waterside levee toe.

View of the erosion at the waterside levee toe.

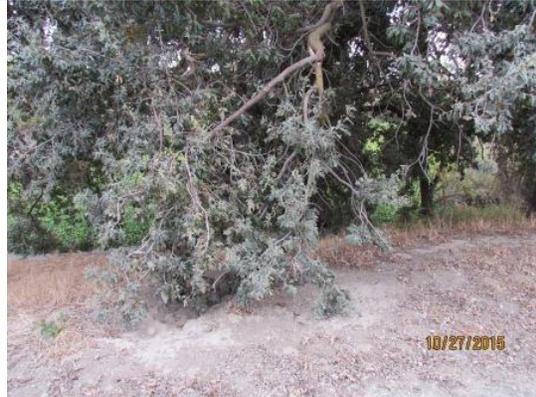
Photo 1 of 1 : FA_2015_RD2058_111_18_20151112_00027.jpg

View of the branch touching the waterside levee slope.

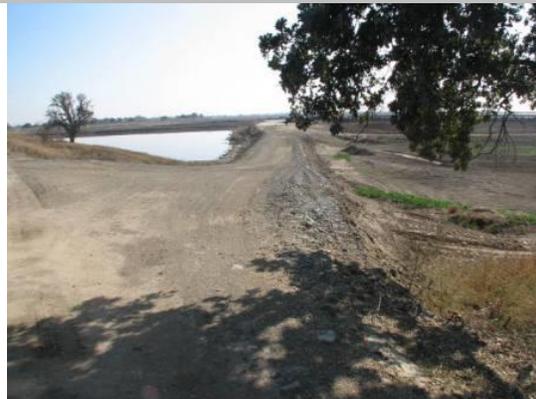
Photo 1 of 3 : FA_2015_RD2058_111_29_20150910_00011.jpg

LM Start	5.10	Rating **	U	Issue No.	29
LM End	5.10	Issue Type +	En	Location *	LS
Category	Earthen Levee		GPS Latitude/Longitude		
			Start	End	
Item	Encroachments		37.783102 °	37.783102 °	
			-121.345682 °	-121.345682 °	
DWR ID	DWR_RD2058_01_s_2012_29				
Action/Comments					
Ramp Inspector Comments: New ramp construction connecting dairy to levee. Construction of ramp results in a new pond on the landside of the levee. 2/21/2012, owner has said that he will contact the CVFPB to resolve this issue.

11/08/2011 New ramp has been constructed by Dairy farmer connecting his barns to the levee.

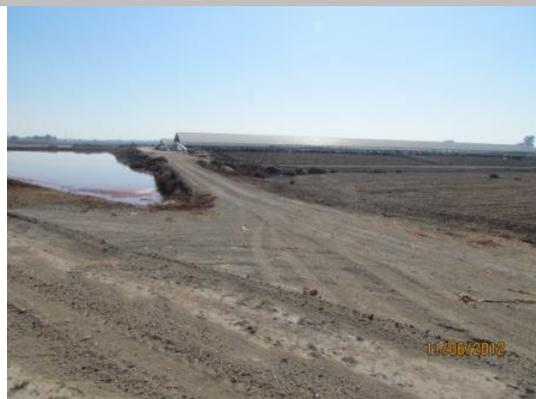
Photo 2 of 3 : FA_2015_RD2058_111_29_20150910_00012.jpg

Completed new ramp constructed by Dairy farmer connecting his barns to the levee.

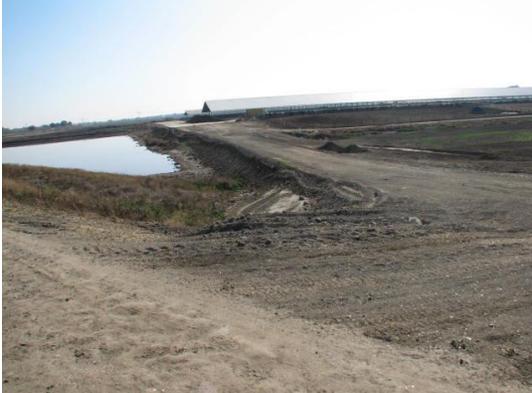
Photo 3 of 3 : FA_2015_RD2058_111_29_20150910_00013.jpg

11/08/2011 New ramp has been constructed by Dairy farmer connecting his barns to the levee.

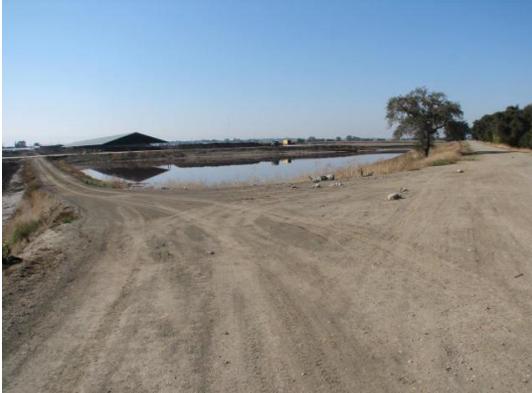
Photo 1 of 3 : FA_2015_RD2058_111_30_20150910_00014.jpg

LM Start	5.29	Rating **	U	Issue No.	30
LM End	5.29	Issue Type +	En	Location *	LS
Category	Earthen Levee		GPS Latitude/Longitude		
			Start	End	
Item	Encroachments		37.782268 °	37.782268 °	
			-121.342257 °	-121.342257 °	
DWR ID	DWR_RD2058_01_s_2012_30				
Action/Comments					
Ramp Inspector Comments: Ramp constructed to dairy. Raised ramps, see issue 29 are creating new holding ponds for dairy at levee toe.

11/08/2011 Photo shows existing middle ramp to the levee which has been raised.

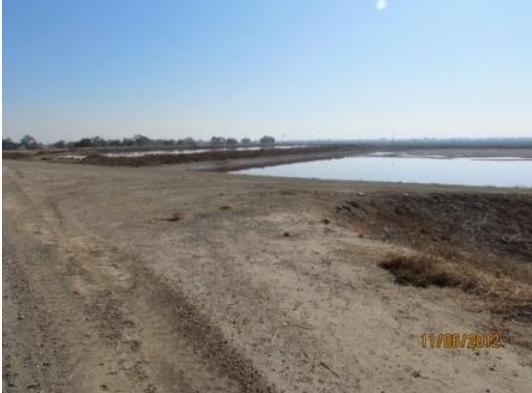
Photo 2 of 3 : FA_2015_RD2058_111_30_20150910_00015.jpg

Completed new ramp constructed by Dairy farmer connecting his barns to the levee.

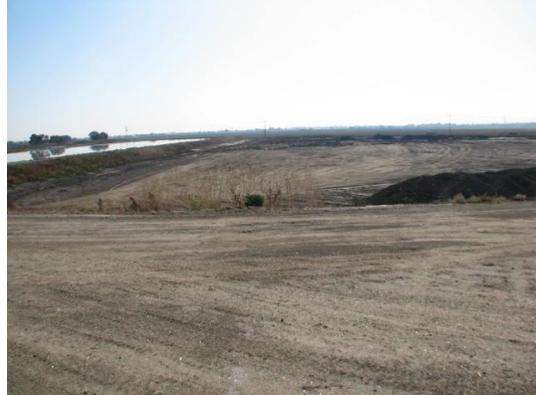
Photo 3 of 3 : FA_2015_RD2058_111_30_20150910_00016.jpg

11/08/2011 Photo shows view from the levee looking to the left of the middle ramp.

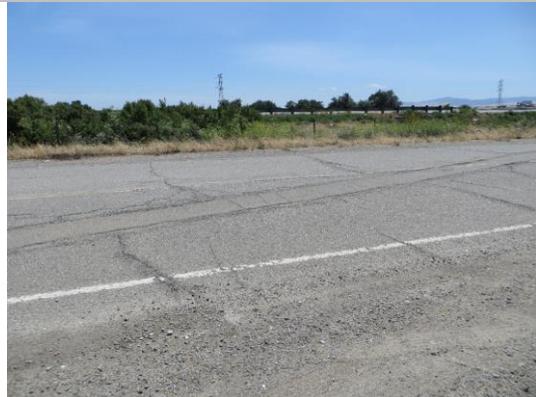
Photo 1 of 3 : UCIP_FA_2015_5855.jpg

LM Start	6.46	Rating **	M	Issue No.	979
LM End	6.46	Issue Type +	En	Location *	LS
Category	Supplemental		GPS Latitude/Longitude		
			Start	End	
Item	DWR UCIP Field Study		37.770158 °	37.770158 °	
			-121.329430 °	-121.329430 °	
DWR ID					
Action/Comments					
Inspector Comments: FS_ID:45769 DS_ID:25078 EP_NO: 13262 FS_HLM: 6.583 Repair Type: Non-Urgent Crossing Status: Indicator Found UCIP Comments: Owner needs to install sign at crossing. FIELD_STRUCT_DESC: 3 of 3: 4-inch communication conduit encased in concrete through levee 3.0 feet below crown. Sign on both banks of levee. Manhole on both sides of Manthey Rd at utility crossing. (Permit No. 13262, 1981) FS Date: 05/13/2015

Cuts in pavement visible appr. 450 ft from WS toe.

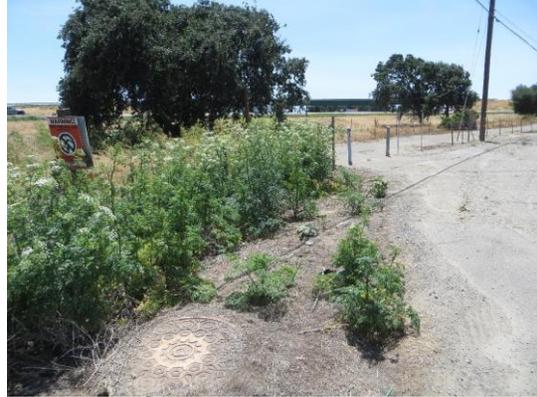
Photo 2 of 3 : UCIP_FA_2015_5856.jpg

Comm sign and Pac Bell manhole appr. 600 ft from LS toe.

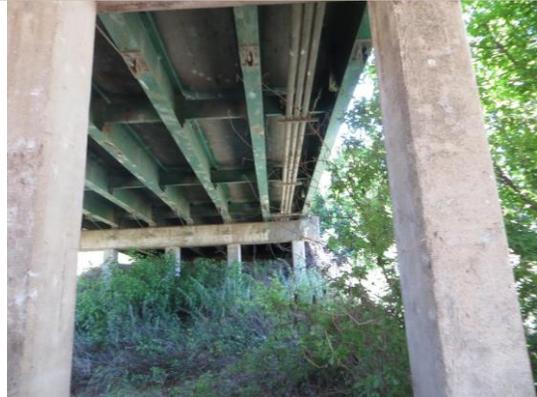
Photo 3 of 3 : UCIP_FA_2015_5857.jpg

Pipes visible under Manthey Rd Bridge at Paradise Cut.

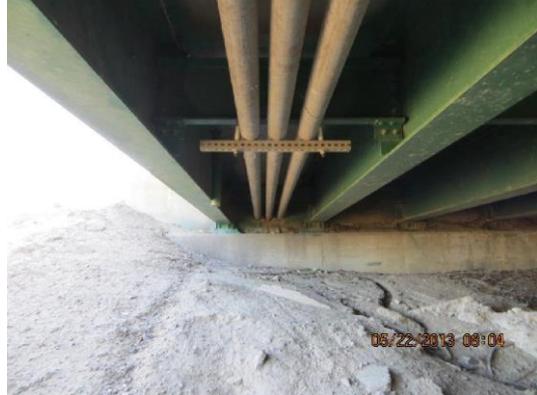
Photo 1 of 3 : UCIP_FA_2015_6020.jpg

LM Start	6.46	Rating **	M	Issue No.	980
LM End	6.46	Issue Type +	En	Location *	LS
Category	Supplemental			GPS Latitude/Longitude	
				Start	End
Item	DWR UCIP Field Study			37.770158 °	37.770158 °
				-121.329430 °	-121.329430 °
DWR ID					
Action/Comments					
Inspector Comments: FS_ID:45871 DS_ID:22701 EP_NO: 13262 FS_HLM: 6.583 Repair Type: Non-Urgent Crossing Status: Indicator Found

Pipes visible under Manthey Rd Bridge at Paradise Cut.

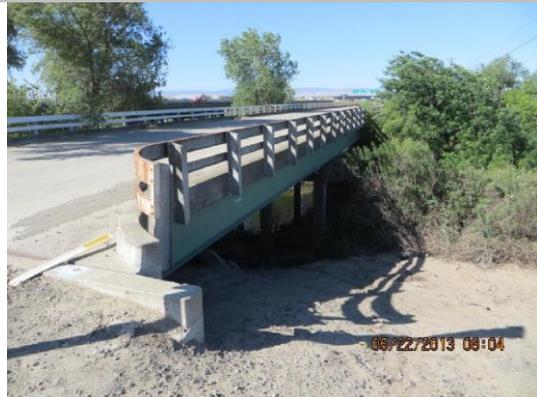
Photo 2 of 3 : UCIP_FA_2015_6021.jpg

Pipes visible under Manthey Rd Bridge at Paradise Cut.

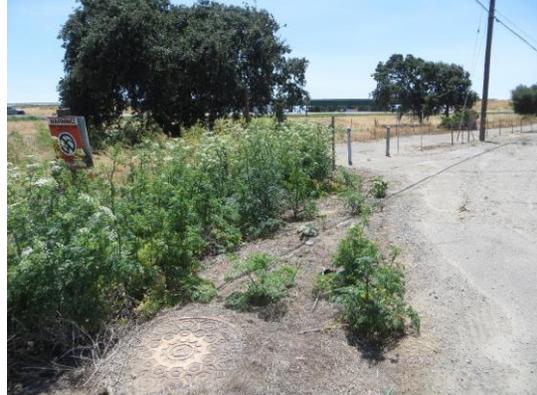
Photo 3 of 3 : UCIP_FA_2015_6320.jpg

Comm sign and Pac Bell manhole appr. 600 ft from LS toe.

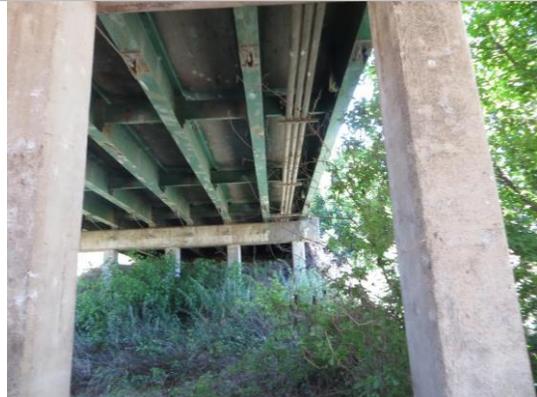
Photo 1 of 3 : UCIP_FA_2015_5852.jpg

LM Start	6.46	Rating **	M	Issue No.	981
LM End	6.46	Issue Type +	En	Location *	LS
Category	Supplemental			GPS Latitude/Longitude	
				Start	End
Item	DWR UCIP Field Study			37.770159 °	37.770159 °
				-121.329426 °	-121.329426 °
DWR ID					
Action/Comments					
Inspector Comments: FS_ID:45768 DS_ID:25077 EP_NO: 13262 FS_HLM: 6.583 Repair Type: Non-Urgent Crossing Status: Indicator Found UCIP Comments: Owner needs to install signs at crossing. FIELD_STRUCT_DESC: 2 of 3: 4-inch communication conduit encased in concrete through levee 3.0 feet below crown. Sign on both banks of levee. Manhole on both sides of Manthey Rd at utility crossing. (Permit No. 13262, 1981) FS Date: 05/13/2015

Pipes visible under Manthey Rd Bridge at Paradise Cut

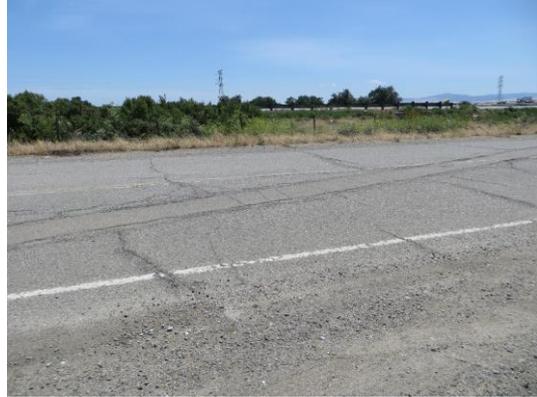
Photo 2 of 3 : UCIP_FA_2015_5853.jpg

Cuts in pavement visible appr. 450 ft from WS toe.

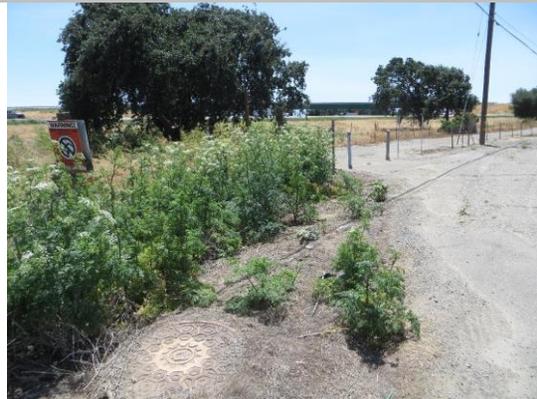
Photo 3 of 3 : UCIP_FA_2015_5854.jpg

Comm sign and Pac Bell manhole appr. 600 ft from LS toe.
