**Flood Control Project Maintenance  
Levee Inspections**  
**LMA District Cover Sheet**  
**Spring 2009 Levee Inspection Results**

**Reclamation District No. 2058**

**Levee Inspection Report By Mile - Spring 2009**

Waterway		Bank	Unit Miles	Inspection Start/End	Inspector
Unit No. 01 Paradise Cut		Left	6.70	04/20/2009 04/20/2009	Richard Willoughby

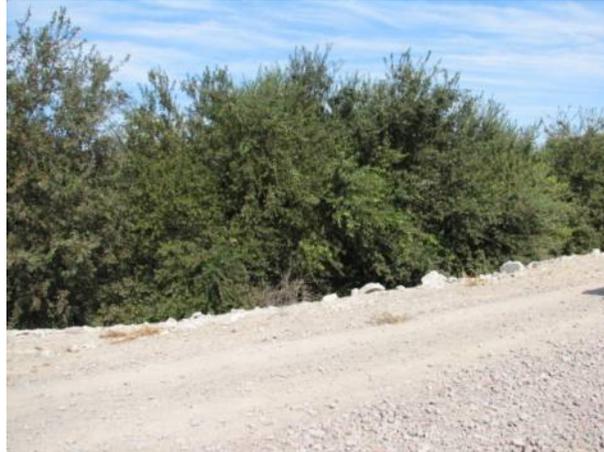
Levee Mile Report Line	5
Start Levee Mile	0.82
End Levee Mile	0.93
Location	Water Side
Category	Earthen Levee
Item	Trim / Thin Trees
RD 2058: Significant density of trees along the WS of this levee.

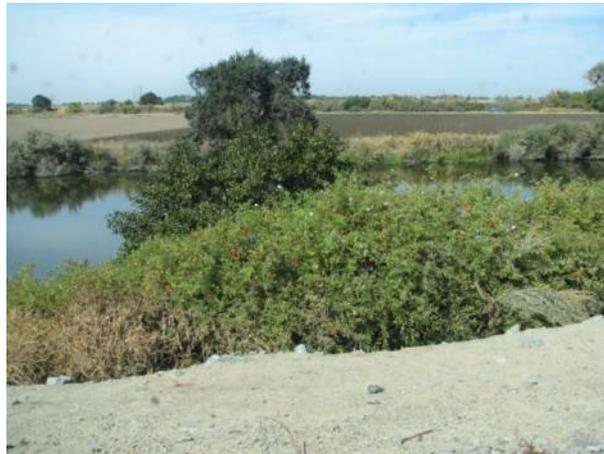
Levee Mile Report Line	9
Start Levee Mile	1.30
End Levee Mile	1.30
Location	Water Side
Category	Earthen Levee
Item	Vegetation
RD 2058: Elderberries present on WS but cannot be removed due to environmental constraints.

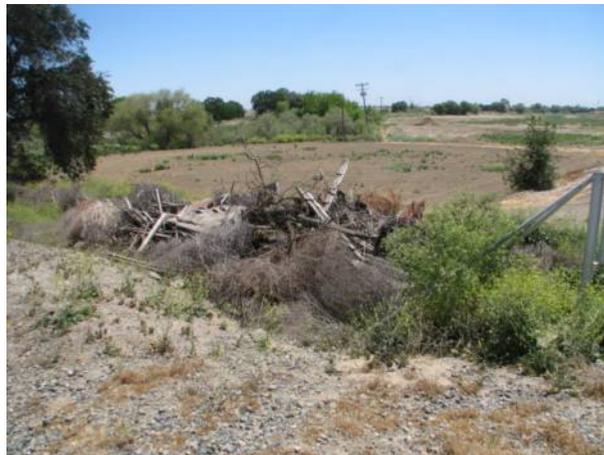
Levee Mile Report Line	26
Start Levee Mile	6.01
End Levee Mile	6.01
Location	Water Side
Category	Earthen Levee
Item	Encroachments
Garbage on waterward slope at LM 6.01
