**Flood Control Project Maintenance
Levee Inspections**
LMA District Cover Sheet
Spring 2012 Levee Inspection Results

Reclamation District No. 2058 Pescadero

Spring 2012 Levee Inspection Results

Waterway	Bank	Unit Miles
Unit No. 01 Paradise Cut	Left	6.71

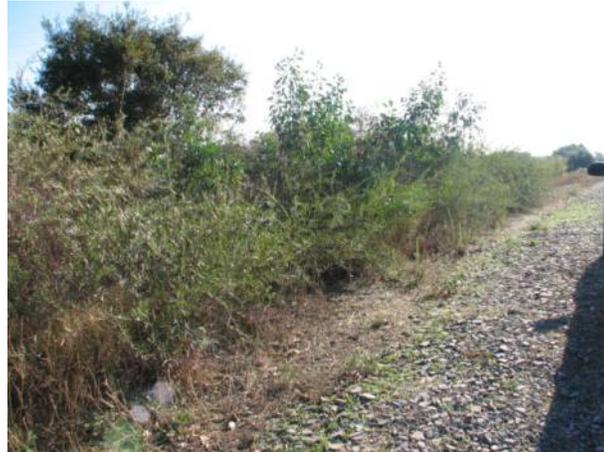
DWR ID: DWR_RD2058_01_s_2012_6		
6	0.42	0.42	Earthen Levee	Vegetation	WS	M Ma	V2 : Remove the wild growth other than native grasses from the levee slopes. Inspector Comments: Thick vegetation at this point, needs to be removed.	37.803813 ° -121.415578 °	37.803813 ° -121.415578 °	8 Y
								DWR ID: DWR_RD2058_01_s_2012_8		
7	0.70	0.70	Earthen Levee	Encroachments	LS	C Ma	PI : Pipe	37.801887 ° -121.411328 °	37.801887 ° -121.411328 °	13
								DWR ID: DWR_RD2058_01_s_2012_13		
8	0.97	1.05	Earthen Levee	Trim / Thin Trees	WS	C Ma	T1 : Trim trees to at least five feet above ground level.	37.801378 ° -121.406636 °	37.801442 ° -121.405179 °	957
								DWR ID: DWR_RD2058_01_s_2012_957		
9	1.12	1.17	Earthen Levee	Trim / Thin Trees	WS	C Ma	T1 : Trim trees to at least five feet above ground level.	37.801687 ° -121.404178 °	37.801900 ° -121.403308 °	5
								DWR ID: DWR_RD2058_01_s_2012_5		
10	1.24	1.24	Earthen Levee	Encroachments	CRA/W	PI : Pipe Ma		37.802314 ° -121.401984 °	37.802314 ° -121.401984 °	22 Y

Levee Mile Report Line	6
Start Levee Mile	0.42
End Levee Mile	0.42
Location	Water Side
Category	Earthen Levee
Item	Vegetation
11/08/2011 Thick brush in this area needs to be taken back to 20' from hinge point.	
jeto_s_20120309_216.jpg

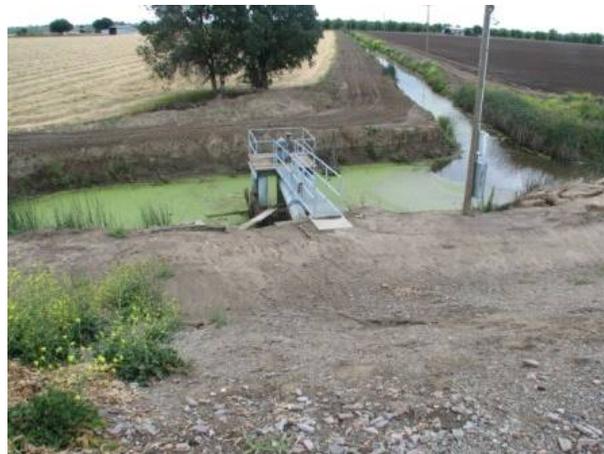
Levee Mile Report Line	10
Start Levee Mile	1.24
End Levee Mile	1.24
Location	Crown
Category	Earthen Levee
Item	Encroachments
Drainage discharge to Paradise Cut.	
jeto_s_20120309_221.jpg

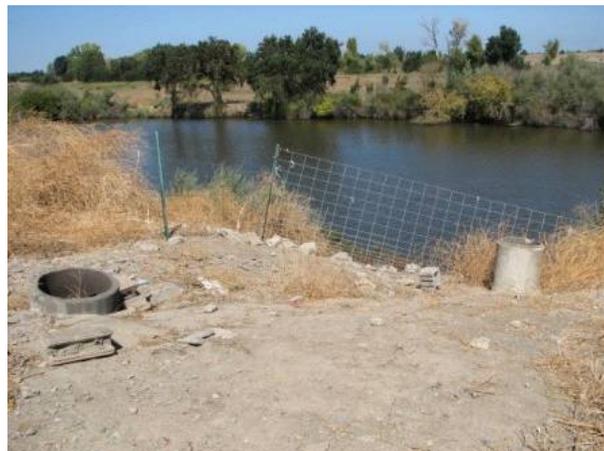
LMR No.	Levee Mile		Category	Item	Location	Rating	Action/Comment	GPS Latitude/Longitude		Issue No. Photo
	Start	End						Start	End	
13	2.15	2.15	Supplemental	DWR Erosion Survey	WS	M Ma	Inspector Comments: 09/02/2011: Site was not visited due to the time limit.09/22/2010: No significant changes observed. Vegetation downstream, upstream and on the lower slope of the site have managed. These areas were also fenced off during the site visit, making it difficult for us to examine the condition of the lower slope. Possible leak or spill from the siphon breaker is creating notches along the slope and developing into a headward erosion. If the problem continues, it will erode the slope and fully expose the pipe to outside elements.07/23/2009: A possible leak or spill from a siphon breaker is eroding the slope and developing into a headward erosion; a portion of the buried pipe is exposed; the lower slope seems to be lined with chunks of concrete debris or other rock material. [2011 Site ID:RD2058U01RM1.78]	37.803769 ° -121.386341 °	37.803769 ° -121.386341 °	1 Y

Levee Mile Report Line	13
Start Levee Mile	2.15
End Levee Mile	2.15
Location	Water Side
Category	Supplemental
Item	DWR Erosion Survey
Downstream view of site. Note the fenced area	
jeto_s_20120309_206.jpg

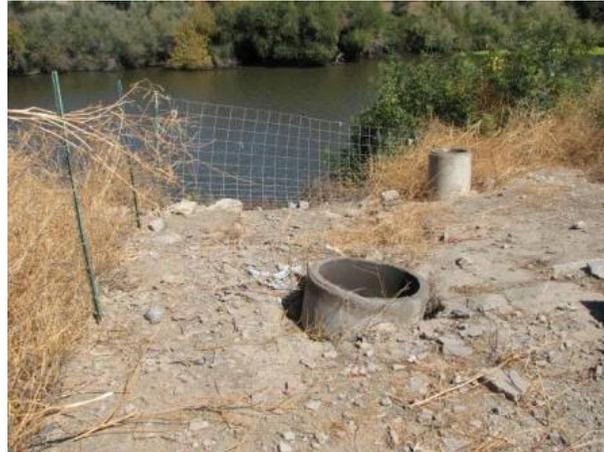
Levee Mile Report Line	13
Start Levee Mile	2.15
End Levee Mile	2.15
Location	Water Side
Category	Supplemental
Item	DWR Erosion Survey

Direct view of siphon breaker.

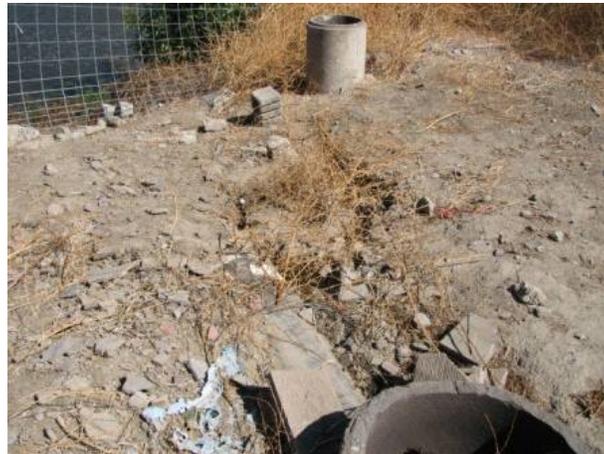
Levee Mile Report Line	13
Start Levee Mile	2.15
End Levee Mile	2.15
Location	Water Side
Category	Supplemental
Item	DWR Erosion Survey

Direct view of siphon breaker.

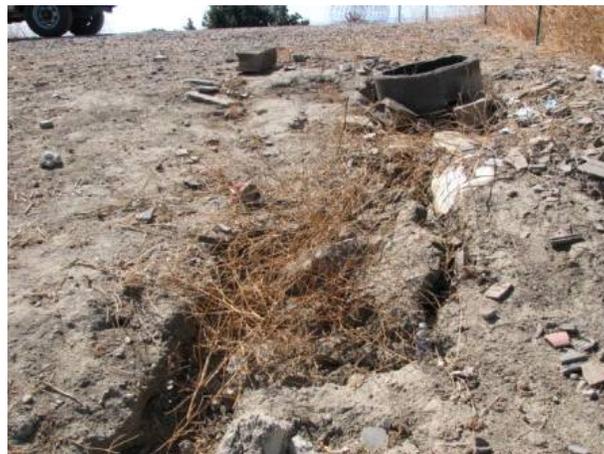
Levee Mile Report Line	13
Start Levee Mile	2.15
End Levee Mile	2.15
Location	Water Side
Category	Supplemental
Item	DWR Erosion Survey

Notches created by water leaking/overflowing from the siphon breaker.

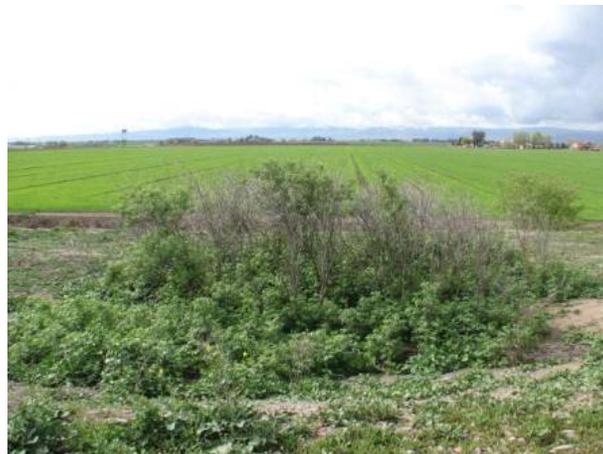
Levee Mile Report Line	15
Start Levee Mile	2.42
End Levee Mile	2.42
Location	Land Side
Category	Earthen Levee
Item	Vegetation
03/28/2012 Large elderberry bush on landside slope.	
jeto_s_20120329_721.jpg

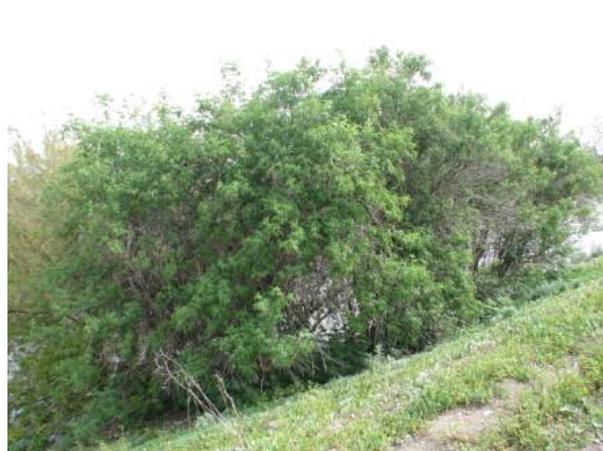
Levee Mile Report Line	16
Start Levee Mile	2.64
End Levee Mile	2.64
Location	Water Side
Category	Earthen Levee
Item	Vegetation
03/28/2012 Large elderberry bush located on waterward slope.	
jeto_s_20120329_722.jpg

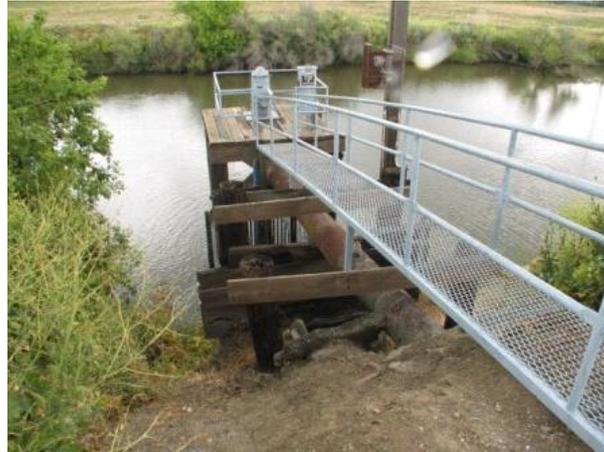
Levee Mile Report Line	20
Start Levee Mile	2.89
End Levee Mile	2.89
Location	Water Side
Category	Earthen Levee
Item	Encroachments

Irrigation intake from Paradise Cut.

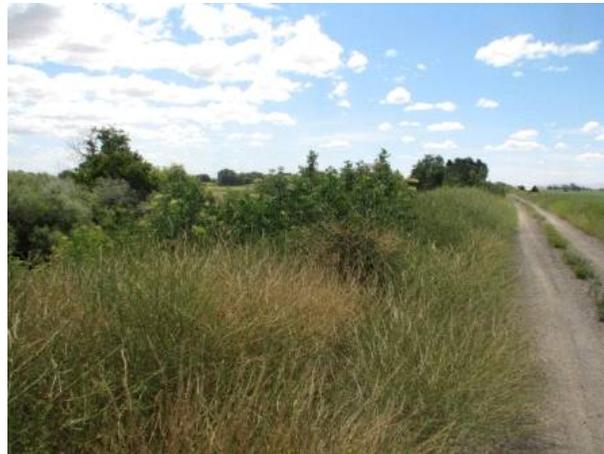
Levee Mile Report Line	25
Start Levee Mile	3.77
End Levee Mile	3.77
Location	Water Side
Category	Earthen Levee
Item	Vegetation

Tall brush on top 20' of waterside slope obstructs access and visibility.

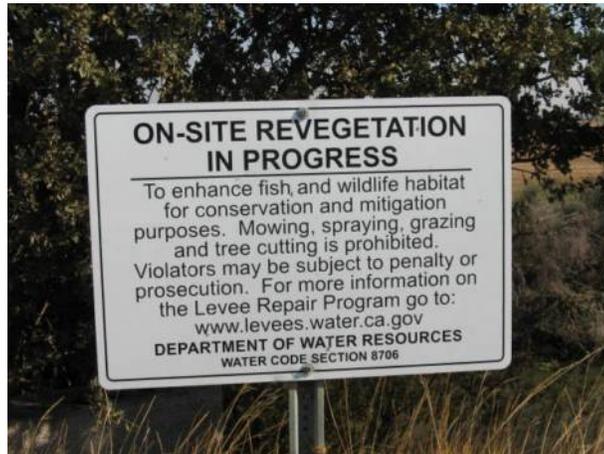
Levee Mile Report Line	27
Start Levee Mile	3.85
End Levee Mile	3.85
Location	Water Side
Category	Earthen Levee
Item	Vegetation

DWR ID: DWR_RD2058_01_s_2012_19										
27	3.85	3.85	Earthen Levee	Vegetation	WSA/W	Ob	V8 : Environmental Requirements. Inspector Comments: Revegetation site.	37.790807 ° -121.362905 °	37.790807 ° -121.362905 °	20 Y
DWR ID: DWR_RD2058_01_s_2012_20										
28	4.01	4.01	Earthen Levee	Vegetation	LS	M Ma	V4 : Elderberries are blocking visibility and flood fight capability. Inspector Comments: Elderberry on landside hinge point.	37.789128 ° -121.361042 °	37.789128 ° -121.361042 °	26 Y
DWR ID: DWR_RD2058_01_s_2012_26										
29	4.01	5.99	Earthen Levee	Vegetation	WS	C Ma	V2 : Remove the wild growth other than native grasses from the levee slopes. Inspector Comments: Waterside vegetation growth needs to be removed on top 20'.	37.789115 ° -121.361033 °	37.775817 ° -121.336097 °	28
DWR ID: DWR_RD2058_01_s_2012_28										
30	4.01	4.01	Earthen Levee	Vegetation	WSA/W	Ma	V4 : Elderberries are blocking visibility and flood fight capability.	37.789096 ° -121.360966 °	37.789096 ° -121.360966 °	69

11/08/2011 Revegetation site, cannot trim or cut vegetation in this area.

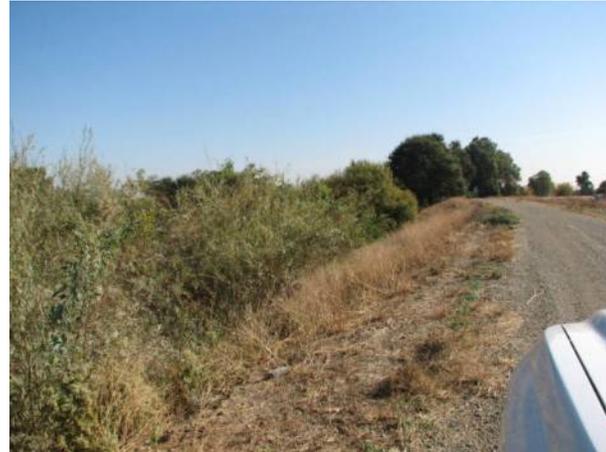
Levee Mile Report Line	28
Start Levee Mile	4.01
End Levee Mile	4.01
Location	Land Side
Category	Earthen Levee
Item	Vegetation
11/08/2011 thick stand of elderberry bushes in this area.	
jeto_s_20120309_224.jpg

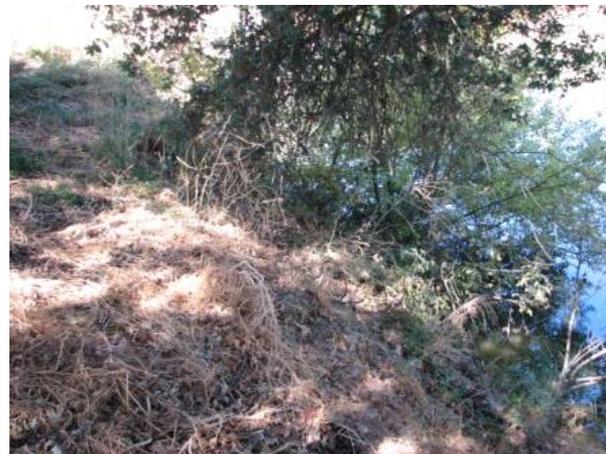
LMIR No.	Levee Mile		Category	Item	Location	Rating	Action/Comment	GPS Latitude/Longitude		Issue No. Photo
	Start	End						Start	End	
34	4.49	4.53	Supplemental	DWR Erosion Survey	WS	M Ma	Inspector Comments: 09/02/2011: This site was not visited due to the time limit.09/22/2010: No significant changes observed. Minor pocket erosions are lined at the lower bank. Two large Oak and Willow trees are on midslope and bench. The remaining bench was re-measured and found to be approximately 10 feet. There was no indication of active erosion on site during the site visit.08/05/2010: Recommended for annual assessment and monitoring of site during flood events, per CLRO.07/23/2009: No major change observed since last visit; site is a 200-ft. long near-vertical berm erosion; recommend annual assessment and monitoring of erosion site, per CLRO CES Evaluation 2008 Report; Site # is the same site previously reported as RM4.0,LM4.51; previously rated "U".09/10/2008: Two large trees (2-3' DBH) with partial roots exposed.2007: Visited site 03/13/2007. [2011 Site ID:RD2058U01RM3.97]	37.789810 ° -121.352490 °	37.789810 ° -121.352490 °	2 Y

Levee Mile Report Line	34
Start Levee Mile	4.49
End Levee Mile	4.53
Location	Water Side
Category	Supplemental
Item	DWR Erosion Survey
Downstream view. Seasonal vegetation covering one of several pocket erosions lined along the bank.	
jeto_s_20120309_210.jpg

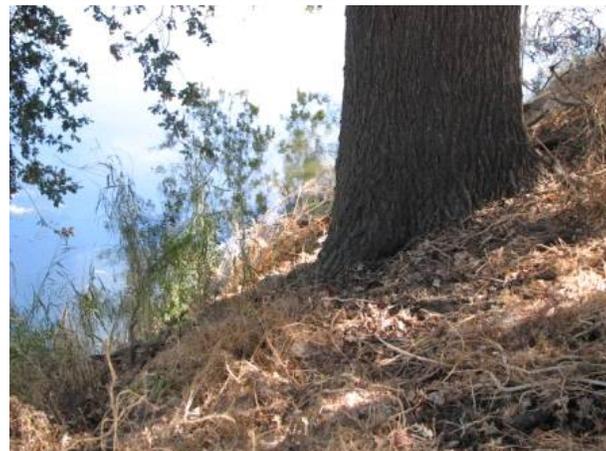
Levee Mile Report Line	34
Start Levee Mile	4.49
End Levee Mile	4.53
Location	Water Side
Category	Supplemental
Item	DWR Erosion Survey
Upstream view of the base of 1 of 2 large Oake trees on site. No signs of scouring on the base.	
jeto_s_20120309_211.jpg

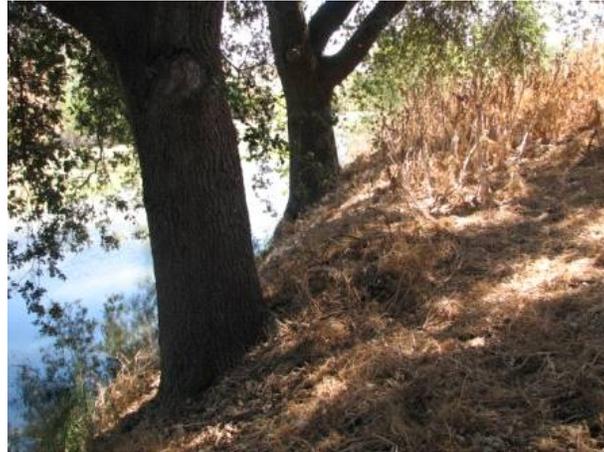
Levee Mile Report Line	34
Start Levee Mile	4.49
End Levee Mile	4.53
Location	Water Side
Category	Supplemental
Item	DWR Erosion Survey
Upstream view of both Oak trees located on the bench.	
jeto_s_20120309_212.jpg

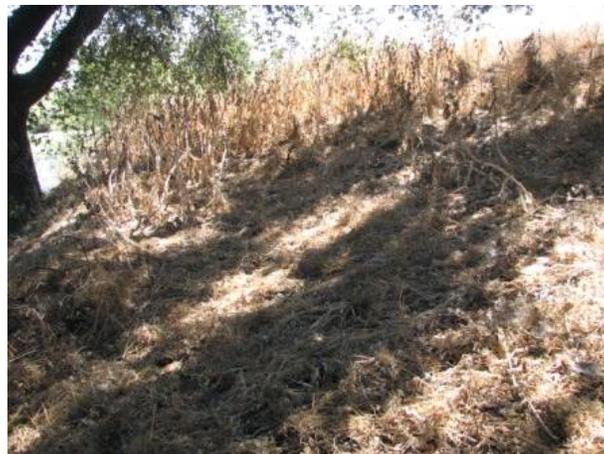
Levee Mile Report Line	34
Start Levee Mile	4.49
End Levee Mile	4.53
Location	Water Side
Category	Supplemental
Item	DWR Erosion Survey
Upstream view of the waterside slope. Vegetation on the slope was recently sprayed.	
jeto_s_20120309_213.jpg

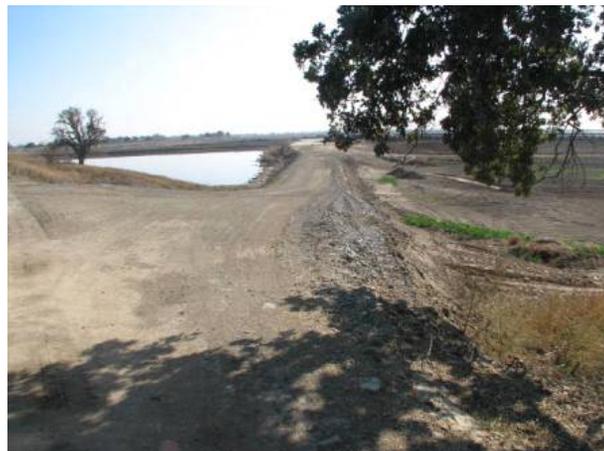
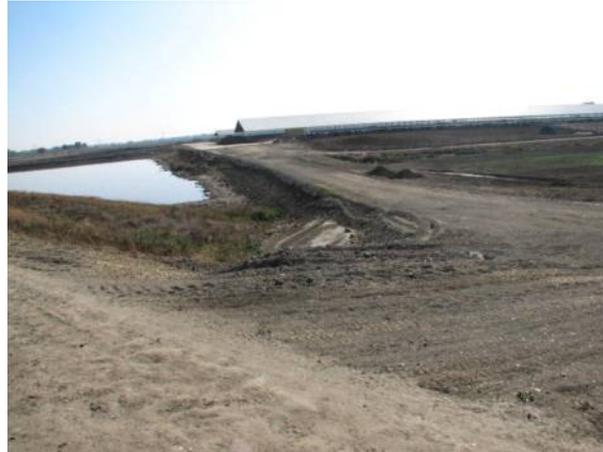
DWR ID: DWR_RD2058_01_s_2012_2										
35	4.81	4.81	Earthen Levee	Trim / Thin Trees	WS	C Ma	T1 : Trim trees to at least five feet above ground level.	37.786005 ° -121.350508 °	37.786005 ° -121.350508 °	941
DWR ID: DWR_RD2058_01_s_2012_941										
36	4.87	4.87	Earthen Levee	Trim / Thin Trees	WS	C Ma	T1 : Trim trees to at least five feet above ground level.	37.785190 ° -121.350078 °	37.785190 ° -121.350078 °	11
DWR ID: DWR_RD2058_01_s_2012_11										
37	5.16	5.16	Earthen Levee	Encroachments	LS	U En	RA : Ramp Inspector Comments: New Ramp construction Connecting Dairy to levee. Construction of ramp results in a new pond on the landside of the levee. 2/21/2012, owner has said that he will contact the CVFPB to resolve this issue.	37.783102 ° -121.345682 °	37.783102 ° -121.345682 °	29 Y
DWR ID: DWR_RD2058_01_s_2012_29										
38	5.37	5.37	Earthen Levee	Encroachments	LS	U En	RA : Ramp Inspector Comments: Ramp constructed to dairy. Raised ramps, see issue 29 are creating new holding ponds for dairy at levee toe.	37.782268 ° -121.342257 °	37.782268 ° -121.342257 °	30 Y

Levee Mile Report Line	37
Start Levee Mile	5.16
End Levee Mile	5.16
Location	Land Side
Category	Earthen Levee
Item	Encroachments
11/08/2011 New ramp has been constructed by Dairy farmer connecting his barns to the levee.	
jeto_s_20120309_225.jpg

Levee Mile Report Line	37
Start Levee Mile	5.16
End Levee Mile	5.16
Location	Land Side
Category	Earthen Levee
Item	Encroachments
11/08/2011 New ramp has been constructed by Dairy farmer connecting his barns to the levee.	
jeto_s_20120309_226.jpg

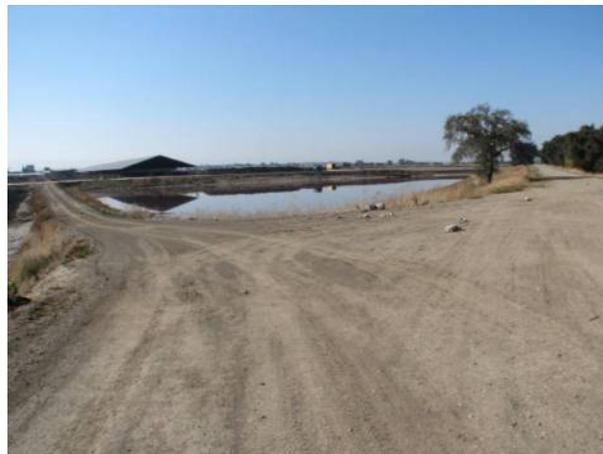
Levee Mile Report Line	38
Start Levee Mile	5.37
End Levee Mile	5.37
Location	Land Side
Category	Earthen Levee
Item	Encroachments
11/08/2011 Photo shows existing middle ramp to the levee which has been raised.	
jeto_s_20120309_227.jpg

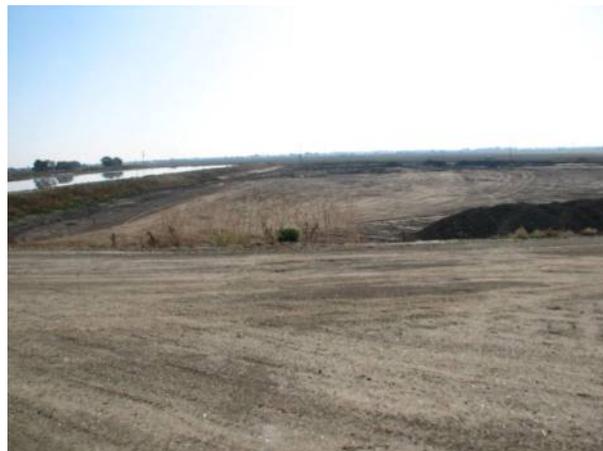
Levee Mile Report Line	38
Start Levee Mile	5.37
End Levee Mile	5.37
Location	Land Side
Category	Earthen Levee
Item	Encroachments
11/08/2011 Photo shows view from the levee looking to the left of the middle ramp.	
jeto_s_20120309_228.jpg
