**Flood Control Project Maintenance
Levee Inspections**

Maintenance Issue Types Only, Levee Inspection Report By Mile - Spring 2015

Reclamation District No. 2058 Pescadero

Waterway	Bank	Unit Miles	Inspection Start/End	Inspector
Unit No. 01 Paradise Cut	Left	6.58	05/12/2015 05/12/2015	Maksim Khashchuk

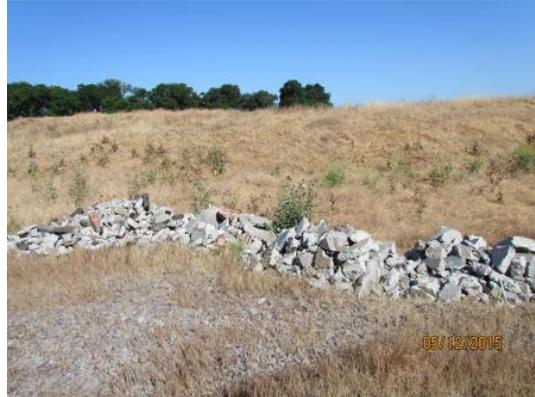
Photo 1 of 1 : SP_2015_RD2058_111_562_20150518_00832.jpg

LM Start	0.14	Rating **	M	Issue No.	562
LM End	0.14	Issue Type +	Ma	Location *	WS
Category	Earthen Levee		GPS Latitude/Longitude		
			Start	End	
Item	Encroachments		37.803271 °	37.803271 °	
			-121.419533 °	-121.419533 °	
DWR ID	DWR_RD2058_01_s_2015_562				
Action/Comments					
Debris Inspector Comments: Debris contains asphalt.

View of the concrete and asphalt debris on the waterside levee slope.

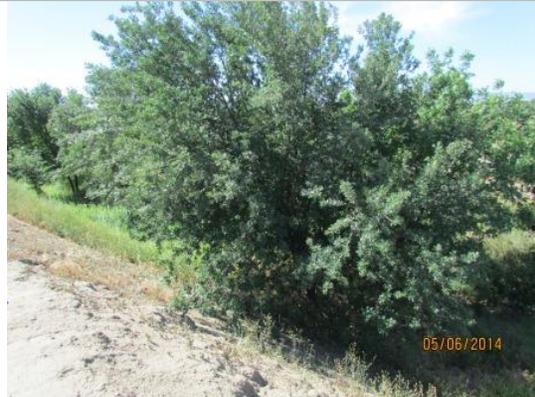
Photo 1 of 1 : SP_2015_RD2058_111_301_20150317_00018.jpg

View of the trees at the landside levee toe obstructing visibility and access.

LM Start	0.50	Rating **	M	Issue No.	301
LM End	0.50	Issue Type +	Ma	Location *	LS
Category	Earthen Levee		GPS Latitude/Longitude		
			Start	End	
Item	Trim / Thin Trees		37.802932 °	37.802932 °	
			-121.414652 °	-121.414652 °	
DWR ID	DWR_RD2058_01_s_2014_301				
Action/Comments					
Trim trees to at least five feet above ground level.

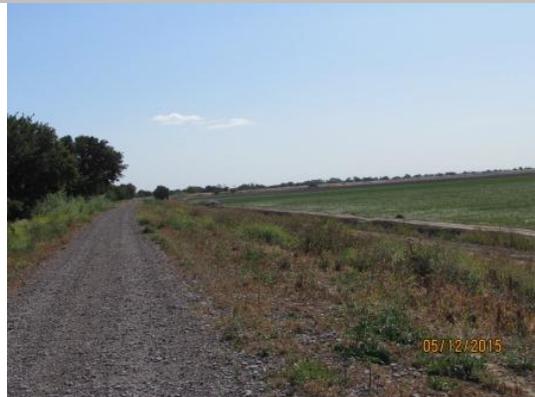
Photo 1 of 1 : SP_2015_RD2058_111_563_20150518_00833.jpg

View of the vegetation on the landside levee slope.

LM Start	1.25	Rating **	M	Issue No.	563
LM End	1.25	Issue Type +	Ma	Location *	LS
Category	Earthen Levee		GPS Latitude/Longitude		
			Start	End	
Item	Vegetation		37.802399 °	37.802399 °	
			-121.401558 °	-121.401558 °	
DWR ID	DWR_RD2058_01_s_2015_563				
Action/Comments					
Control annual grass and weeds on the levee slopes and easements.

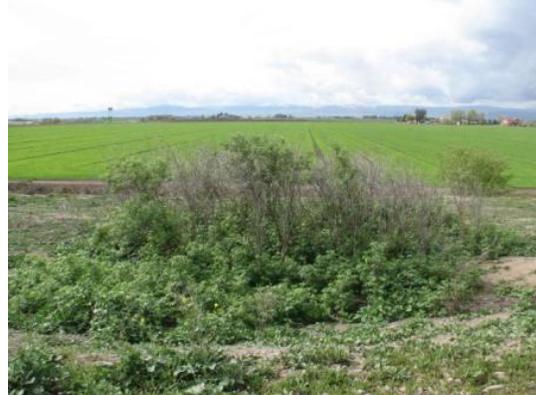
Photo 1 of 1 : SP_2015_RD2058_111_16_20150317_00007.jpg

LM Start	2.39	Rating **	A/W	Issue No.	16
LM End	2.39	Issue Type +	Ma	Location *	LS
Category	Earthen Levee		GPS Latitude/Longitude		
			Start	End	
Item	Vegetation		37.802782 °	37.802782 °	
			-121.381413 °	-121.381413 °	
DWR ID	DWR_RD2058_01_s_2012_16				
Action/Comments					
Elderberries are blocking visibility and flood fight capability. Inspector Comments: Elderberry growing on landside toe.

03/28/2012 Large elderberry bush on landside slope.

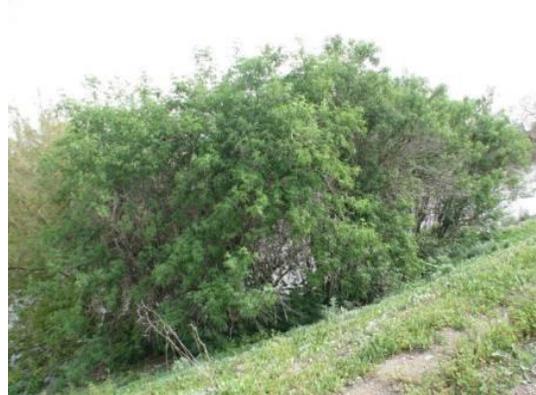
Photo 1 of 1 : SP_2015_RD2058_111_63_20150317_00017.jpg

LM Start	2.61	Rating **	A/W	Issue No.	63
LM End	2.61	Issue Type +	Ma	Location *	WS
Category	Earthen Levee		GPS Latitude/Longitude		
			Start	End	
Item	Vegetation		37.801962 °	37.801962 °	
			-121.377684 °	-121.377684 °	
DWR ID	DWR_RD2058_01_s_2012_63				
Action/Comments					
Elderberries are blocking visibility and flood fight capability. Inspector Comments: Elderberry on waterside slope.

03/28/2012 Large elderberry bush located on waterward slope.

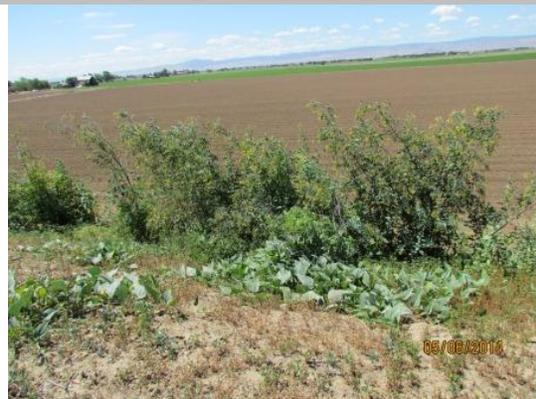
Photo 1 of 1 : SP_2015_RD2058_111_22_20150317_00009.jpg

View of the tall vegetation on the landside levee slope and toe.

LM Start	3.91	Rating **	M	Issue No.	22
LM End	3.91	Issue Type +	Ma	Location *	LS
Category	Earthen Levee		GPS Latitude/Longitude		
			Start	End	
Item	Vegetation		37.789434 °	37.789434 °	
			-121.361721 °	-121.361721 °	
DWR ID	DWR_RD2058_01_s_2014_22				
Action/Comments					
Remove the wild growth other than native grasses from the levee slopes.

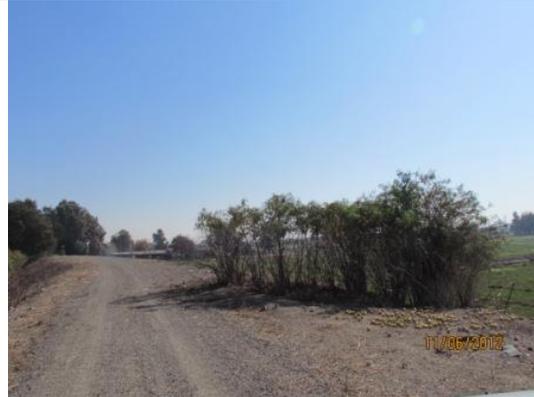
Photo 1 of 1 : SP_2015_RD2058_111_26_20150317_00010.jpg

LM Start	3.96	Rating **	M	Issue No.	26
LM End	3.96	Issue Type +	Ma	Location *	LS
Category	Earthen Levee		GPS Latitude/Longitude		
			Start	End	
Item	Vegetation		37.789128 °	37.789128 °	
			-121.361042 °	-121.361042 °	
DWR ID	DWR_RD2058_01_s_2012_26				
Action/Comments					
Elderberries are blocking visibility and flood fight capability. Inspector Comments: Elderberry on landside hinge point.

Elderberry bushes on landside slope.

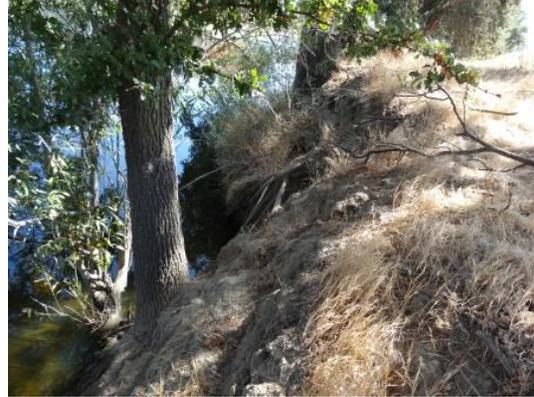
Photo 1 of 1 : SP_2015_RD2058_111_2_20150317_00002.jpg

LM Start	4.45	Rating **	M	Issue No.	2
LM End	4.45	Issue Type +	Ma	Location *	WS
Category	Supplemental			GPS Latitude/Longitude	
				Start	End
Item	DWR Erosion Survey			37.789810 °	37.789810 °
				-121.352490 °	-121.352490 °
DWR ID	DWR_RD2058_01_s_2015_2				
Action/Comments					
Inspector Comments: 08/26/2014: No significant change observed. 08/28/2013: No significant change observed. 07/26/2012: The site has been visited, and no significant change has been observed. 09/02/2011: This site was not visited due to the time limit. 09/22/2010: No significant change observed. Minor pocket erosions are lined at the lower bank. Two large Oak and Willow trees are on mid-slope and bench. The remaining bench was re-measured and found to be approximately 10 feet. There was no indication of active erosion on site during the site visit. 08/05/2010: Recommended for annual assessment and monitoring of the site during flood events, per CLRO. 07/23/2009: No major change observed since last visit; site is a 200-ft. long near-vertical berm erosion; recommend annual assessment and monitoring of the erosion site, per CLRO CES Evaluation 2008 Report; Site # is the same site previously reported as RM4.0,LM4.51; previously rated "U". 09/10/2008: Two large trees (2-3' DBH) with partial roots exposed. 2007: Visited site 03/13/2007. [2014 Site ID:RD2058U01RM3.97]

Direct view of the erosion near a tree.

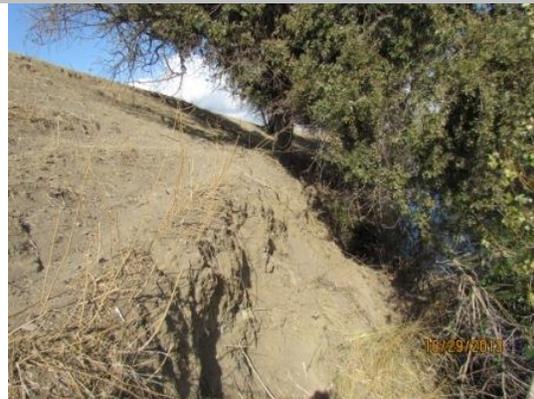
Photo 1 of 1 : SP_2015_RD2058_111_15_20150317_00006.jpg

LM Start	4.77	Rating **	U	Issue No.	15
LM End	4.77	Issue Type +	Ma	Location *	WS
Category	Earthen Levee			GPS Latitude/Longitude	
				Start	End
Item	Erosion / Bank Caving			37.785862 °	37.785862 °
				-121.350303 °	-121.350303 °
DWR ID	DWR_RD2058_01_f_2013_15				
Action/Comments					
Note and monitor erosion site. Inspector Comments: The erosion has about a 3 foot vertical cut at the waterside levee toe.

View of the erosion at the waterside levee toe.

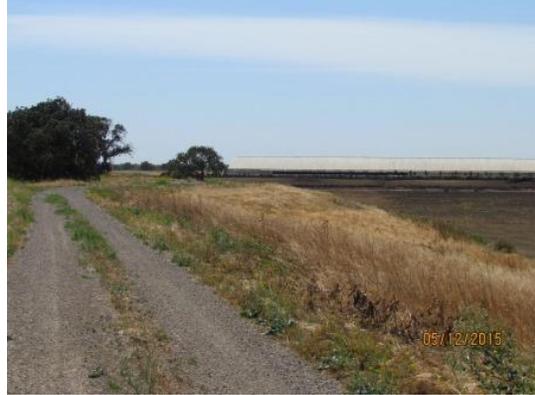
Photo 1 of 1 : SP_2015_RD2058_111_564_20150518_00834.jpg

View of the vegetation on the landside levee slope.

LM Start	4.91	Rating **	M	Issue No.	564
LM End	4.91	Issue Type +	Ma	Location *	LS
Category	Earthen Levee		GPS Latitude/Longitude		
			Start	End	
Item	Vegetation		37.784378 °	37.784378 °	
			-121.348562 °	-121.348562 °	
DWR ID	DWR_RD2058_01_s_2015_564				
Action/Comments					
Control annual grass and weeds on the levee slopes and easements.
