**Flood Control Project Maintenance  
Levee Inspections**

**Fall 2011 Levee Maintenance Deficiency Summary Report**

**Reclamation District No. 2060 Hastings**

**Levee Inspection Report By Mile - Fall 2011**

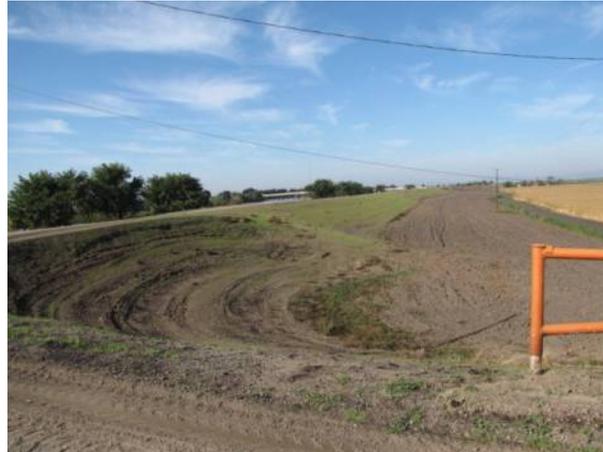
Levee Mile Report Line	1
Start Levee Mile	0.00
End Levee Mile	0.00
Location	Land Side
Category	Earthen Levee
Item	Vegetation
Standing on landside Unit 1 RD 2060 looking downstream L/M 0.00. Photo taken 10-13-2011.	
phillips_f_20111013_011.jpg

LMIR No.	Levee Mile		Category	Item	Location *	Rating **	Action/Comment	GPS Latitude/Longitude		Issue No. Photo
	Start	End						Start	End	
1	0.00	0.00	Earthen Levee	Vegetation	LS	A	Remove the wild growth other than native grasses from the levee slopes. Inspector Comments: RD 2060 has done a great job maintaining the levees.	38.247554 ° -121.696222 °	38.247554 ° -121.696220 °	2 Y
2	0.01	0.03	Earthen Levee	Trim / Thin Trees	WS	C	Trim trees to at least five feet above ground level.	38.247368 ° -121.696743 °	38.247328 ° -121.697022 °	1
3	0.03	0.03	Earthen Levee	Vegetation	WS	A	Remove the wild growth other than native grasses from the levee slopes.	38.247278 ° -121.697098 °	38.247278 ° -121.697098 °	3 Y
4	0.56	0.57	Earthen Levee	Erosion / Bank Caving	WS	M	Note and monitor erosion site. Inspector Comments: District has placed some more rock in this area, they will place more later. 3-08,2011 viewed the erosion site, this site is still active. District say that they will make repairs end of April or May 2011.	38.248630 ° -121.706403 °	38.248617 ° -121.706667 °	14

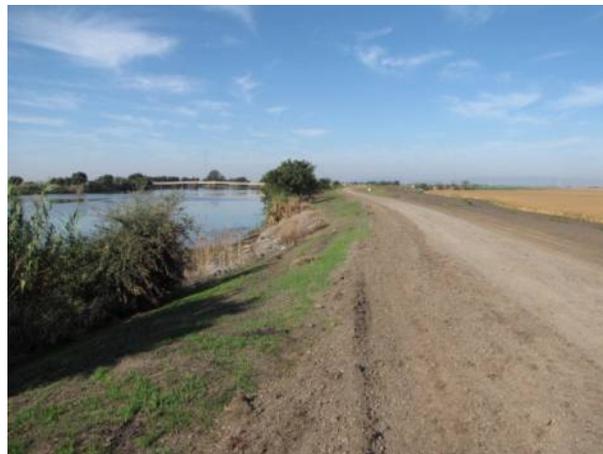
Levee Mile Report Line	3
Start Levee Mile	0.03
End Levee Mile	0.03
Location	Water Side
Category	Earthen Levee
Item	Vegetation
Standing on waterside Unit 1 RD 2060 L/M 0.03 looking downstream. Photo taken 10-13-2011.	
phillips_f_20111013_012.jpg

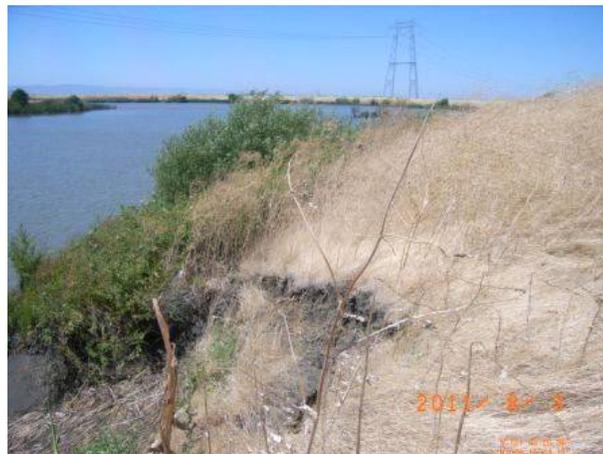
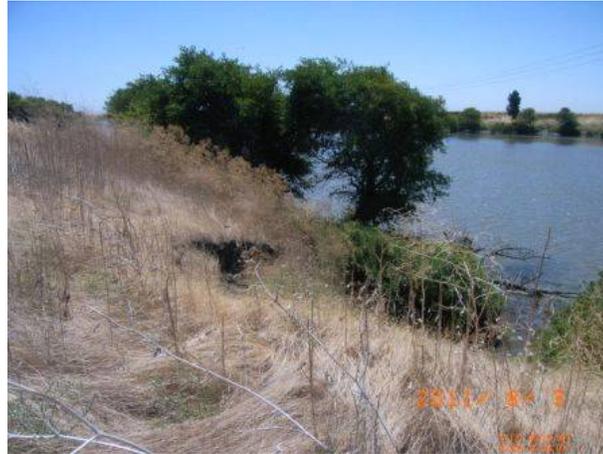
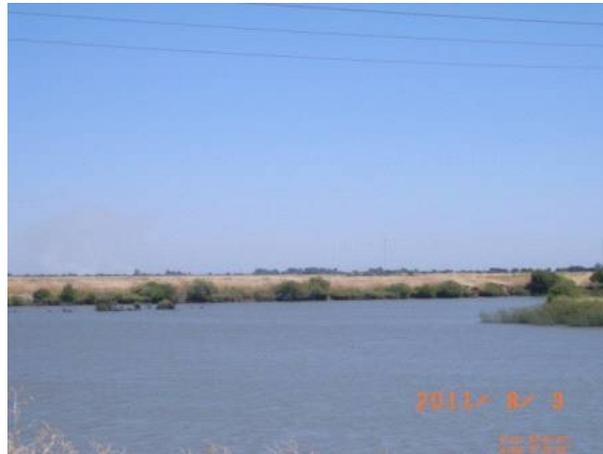
5	1.70	1.70	Supplemental	USACE Erosion Survey	WS	M	Inspector Comments: 2011: Multiple erosion pockets. Deep cracks throughout site could lead to further bank failure. [2011 Site ID: LDS_1-9_L]	38.256535 ° -121.724753 °	38.257517 ° -121.724823 °	4 Y
6	2.34	2.34	Supplemental	USACE Erosion Survey	WS	M	Inspector Comments: 2011: Two erosion pockets from rotational failures. Very soft soil. [2011 Site ID: LDS_2-4_L]	38.257224 ° -121.731953 °	38.257319 ° -121.732423 °	5 Y
7	5.07	5.07	Earthen Levee	Repair Gates	CR	M		38.263157 ° -121.771543 °	38.263157 ° -121.771543 °	6

Levee Mile Report Line	5
Start Levee Mile	1.70
End Levee Mile	1.70
Location	Water Side
Category	Supplemental
Item	USACE Erosion Survey
USACE 2011 Photo #1	
USACE2011_LDS_1-9_L_1.jpg

Levee Mile Report Line	5
Start Levee Mile	1.70
End Levee Mile	1.70
Location	Water Side
Category	Supplemental
Item	USACE Erosion Survey
USACE 2011 Photo #2	
USACE2011_LDS_1-9_L_2.jpg

Levee Mile Report Line	5
Start Levee Mile	1.70
End Levee Mile	1.70
Location	Water Side
Category	Supplemental
Item	USACE Erosion Survey
USACE 2011 Photo #3	
USACE2011_LDS_1-9_L_3.jpg

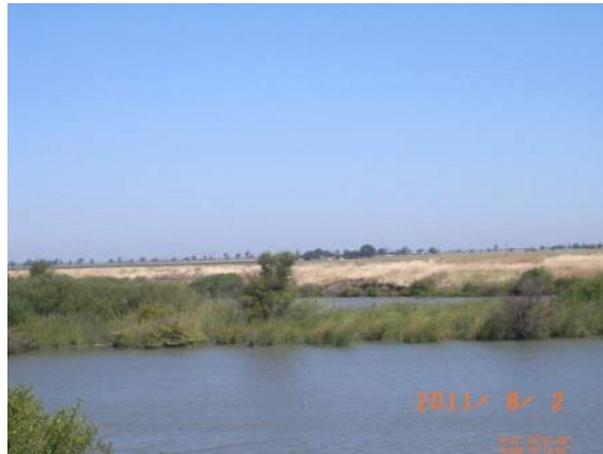
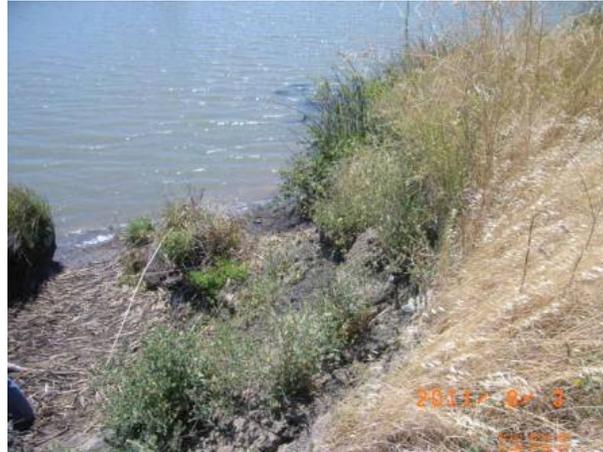
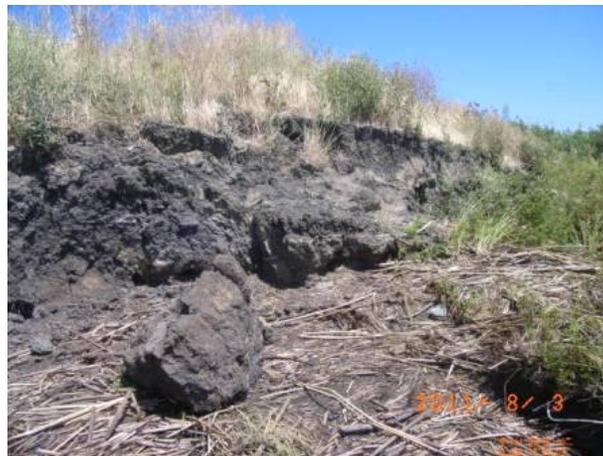
Levee Mile Report Line	6
Start Levee Mile	2.34
End Levee Mile	2.34
Location	Water Side
Category	Supplemental
Item	USACE Erosion Survey
USACE 2011 Photo #1	
USACE2011_LDS_2-4_L_1.jpg

Levee Mile Report Line	6
Start Levee Mile	2.34
End Levee Mile	2.34
Location	Water Side
Category	Supplemental
Item	USACE Erosion Survey
USACE 2011 Photo #2	
USACE2011_LDS_2-4_L_2.jpg

Levee Mile Report Line	6
Start Levee Mile	2.34
End Levee Mile	2.34
Location	Water Side
Category	Supplemental
Item	USACE Erosion Survey
USACE 2011 Photo #3	
USACE2011_LDS_2-4_L_3.jpg

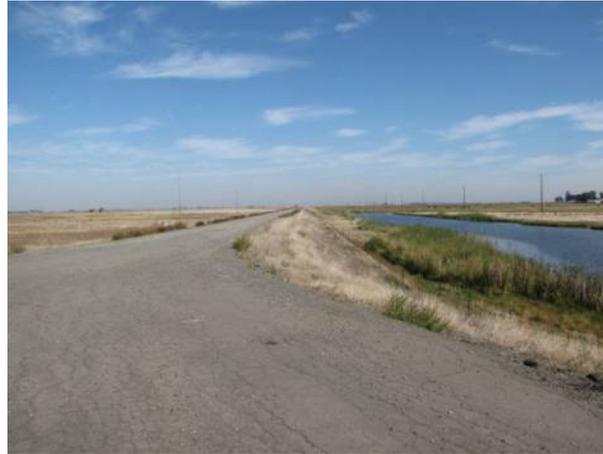
Levee Mile Report Line	1
Start Levee Mile	0.00
End Levee Mile	0.00
Location	Land Side
Category	Earthen Levee
Item	Vegetation
Standing on waterward shoulder of RD 2060 looking downstream from L/M 0.00. This photo was taken 10-13-2011.	
phillips_f_20111013_013.jpg

LMIR No.	Levee Mile		Category	Item	Location	Rating	Action/Comment	GPS Latitude/Longitude		Issue No. Photo
	Start	End						Start	End	
1	0.00	0.00	Earthen Levee	Vegetation	LS	A	Remove the wild growth other than native grasses from the levee slopes. Inspector Comments: Unit 2 is well maintained, no problems.	38.276269 ° -121.795888 °	38.276269 ° -121.795888 °	1 Y
2	0.00	0.00	Earthen Levee	Vegetation	WS	A	Remove the wild growth other than native grasses from the levee slopes.	38.276269 ° -121.795888 °	38.276269 ° -121.795888 °	2 Y

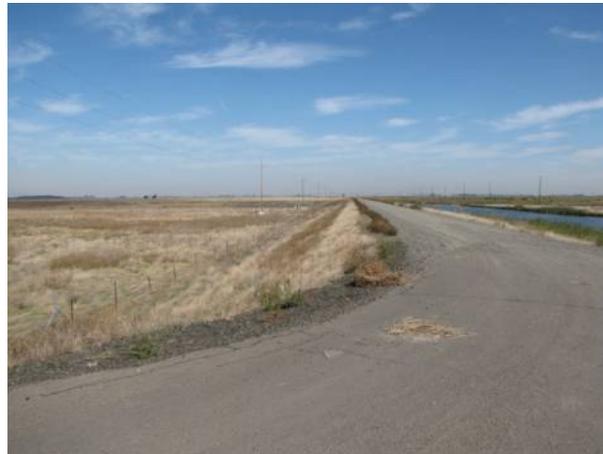
Levee Mile Report Line	2
Start Levee Mile	0.00
End Levee Mile	0.00
Location	Water Side
Category	Earthen Levee
Item	Vegetation
Standing on landward side of Unit 2 looking downstream from L/M 0.00 RD 2060. Photo taken 10-13-2011.	
phillips_f_20111013_014.jpg

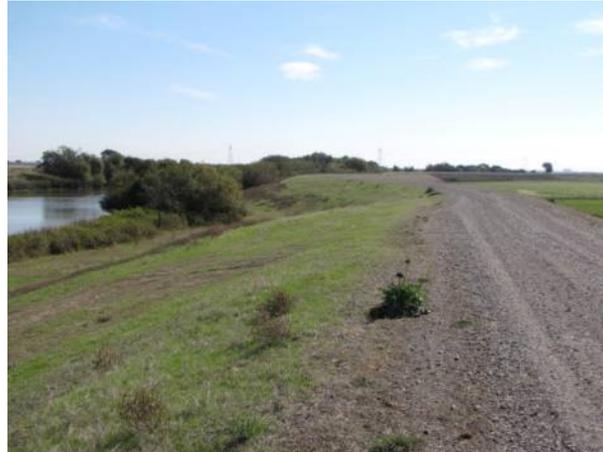
Levee Mile Report Line	1
Start Levee Mile	0.00
End Levee Mile	0.00
Location	Water Side
Category	Earthen Levee
Item	Vegetation
Standing on the waterward shoulder L/M 0.00 looking downstream RD 2060 Unit 3. Photo taken 10-13-2011.	
phillips_f_20111013_015.jpg

LMIR No.	Levee Mile		Category	Item	Location	Rating	Action/Comment	GPS Latitude/Longitude		Issue No. Photo
	Start	End						Start	End	
1	0.00	0.00	Earthen Levee	Vegetation	WS	A	Remove the wild growth other than native grasses from the levee slopes. Inspector Comments: Both landward and waterward levee slopes looks good.	38.295814 ° -121.746896 °	38.295814 ° -121.746896 °	1 Y
2	0.00	0.00	Earthen Levee	Vegetation	LS	A	Remove the wild growth other than native grasses from the levee slopes.	38.295814 ° -121.746896 °	38.295814 ° -121.746896 °	2 Y
3	0.04	0.56	Earthen Levee	Vegetation	CR	C	Remove the wild growth other than native grasses from the levee slopes.	38.296485 ° -121.748137 °	38.291878 ° -121.741010 °	3 Y
4	1.54	1.63	Supplemental	USACE Erosion Survey	WS	M	Inspector Comments: Site added in 1997 and removed in 2003. 2005 - Put back in the inventory. 2006 - Stone repair at the middle of the site. 2011: Some rock has been placed at toe in the past year. [2011 Site ID: CHS_23-6_R]	38.288192 ° -121.724806 °	38.286418 ° -121.723168 °	4 Y

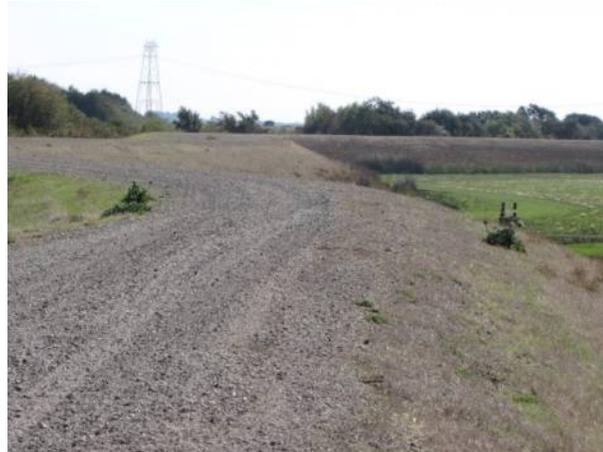
Levee Mile Report Line	2
Start Levee Mile	0.00
End Levee Mile	0.00
Location	Land Side
Category	Earthen Levee
Item	Vegetation
Standing on the landward shoulder looking downstream from L/M 0.00 Unit 3 RD 2060. Photo taken 10-13-2011.	
phillips_f_20111013_016.jpg

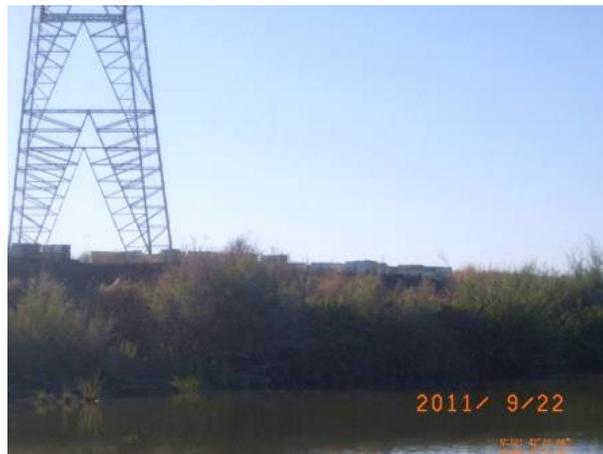
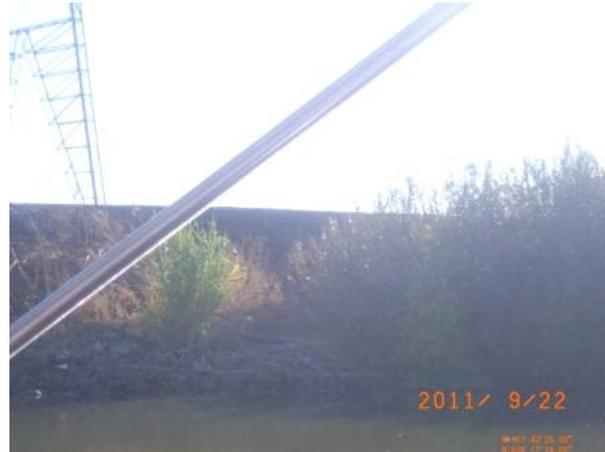
Levee Mile Report Line	4
Start Levee Mile	1.54
End Levee Mile	1.63
Location	Water Side
Category	Supplemental
Item	USACE Erosion Survey
USACE 2011 Photo #1	
USACE2011_CHS_23-6_R_1.jpg

Levee Mile Report Line	4
Start Levee Mile	1.54
End Levee Mile	1.63
Location	Water Side
Category	Supplemental
Item	USACE Erosion Survey
USACE 2011 Photo #2	
USACE2011_CHS_23-6_R_2.jpg

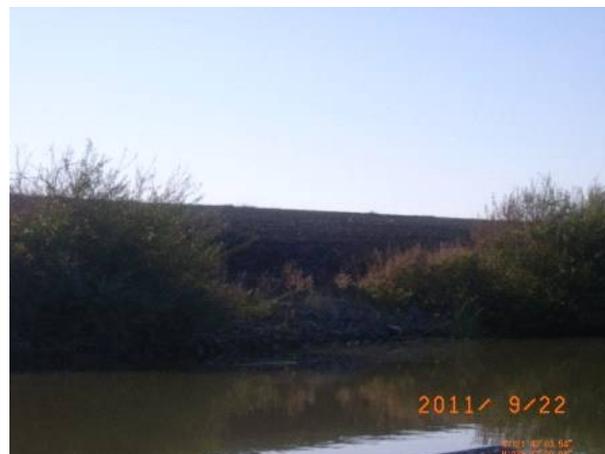
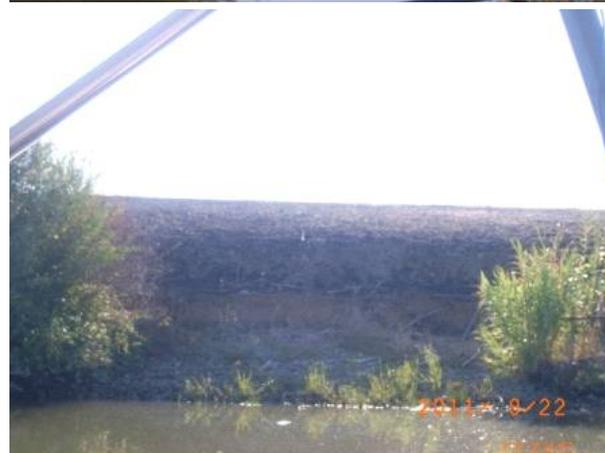
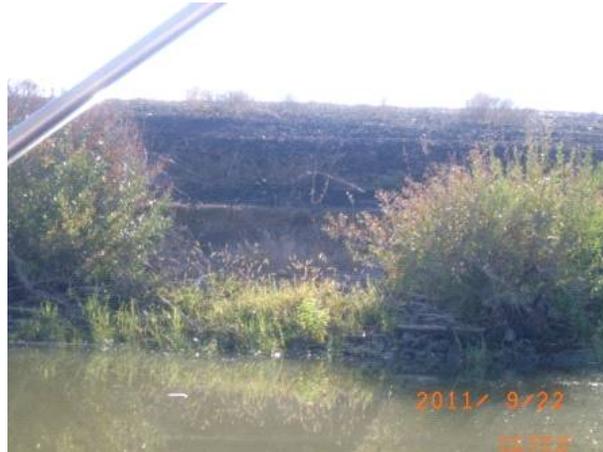
5	1.95	1.95	Supplemental	USACE Erosion Survey	WS	M	Inspector Comments: 2010 - Small maintenance site. 2011: No observed change. [2011 Site ID: CHS_23-0_R]	38.283302 ° -121.717814 °	38.284105 ° -121.718471 °	5 Y
6	2.10	2.20	Supplemental	USACE Erosion Survey	WS	M	Inspector Comments: 2007 - Geotechnical failure of midside slope and wave wash/scalloping in toe area. Stone revetment upstream and downstream of site. Similar sites are present all along the right bank downstream of this site, most could be repaired with some maintenance. 2010 - Minor new erosion. 2011: No observed change. [2011 Site ID: CHS_22-8_R]	38.282100 ° -121.716817 °	38.281510 ° -121.716319 °	8 Y
7	2.28	2.48	Supplemental	USACE Erosion Survey	WS	M	Inspector Comments: 2008 - Small scour pockets and mid-slope wave wash. 2010 - More vegetation growth, could be fixed through maintenance. 2011: site extended downstream. new erosion. [2011 Site ID: CHS_22-6_R]	38.280377 ° -121.714633 °	38.278306 ° -121.712722 °	10 Y

Levee Mile Report Line	5
Start Levee Mile	1.95
End Levee Mile	1.95
Location	Water Side
Category	Supplemental
Item	USACE Erosion Survey
USACE 2011 Photo #1	
USACE2011_CHS_23-0_R_1.jpg

Levee Mile Report Line	5
Start Levee Mile	1.95
End Levee Mile	1.95
Location	Water Side
Category	Supplemental
Item	USACE Erosion Survey
USACE 2011 Photo #2	
USACE2011_CHS_23-0_R_2.jpg

Levee Mile Report Line	5
Start Levee Mile	1.95
End Levee Mile	1.95
Location	Water Side
Category	Supplemental
Item	USACE Erosion Survey
USACE 2011 Photo #3	
USACE2011_CHS_23-0_R_3.jpg

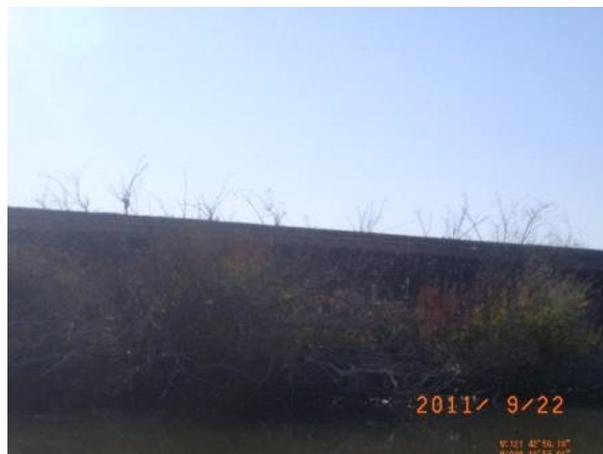
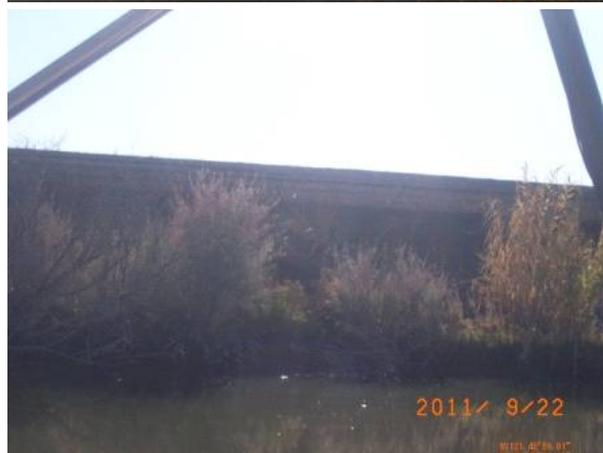
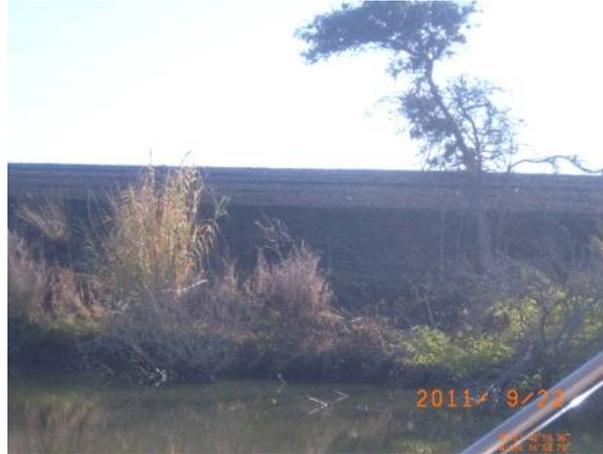
Levee Mile Report Line	6
Start Levee Mile	2.10
End Levee Mile	2.20
Location	Water Side
Category	Supplemental
Item	USACE Erosion Survey
USACE 2011 Photo #1	
USACE2011_CHS_22-8_R_1.jpg

Levee Mile Report Line	6
Start Levee Mile	2.10
End Levee Mile	2.20
Location	Water Side
Category	Supplemental
Item	USACE Erosion Survey
USACE 2011 Photo #2	
USACE2011_CHS_22-8_R_2.jpg

Levee Mile Report Line	6
Start Levee Mile	2.10
End Levee Mile	2.20
Location	Water Side
Category	Supplemental
Item	USACE Erosion Survey
USACE 2011 Photo #3	
USACE2011_CHS_22-8_R_3.jpg

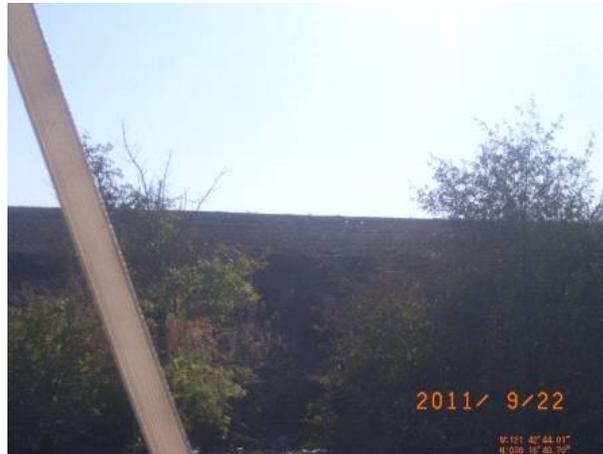
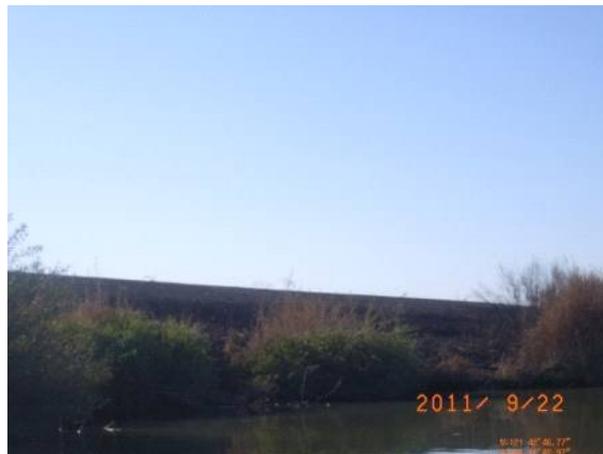
Levee Mile Report Line	7
Start Levee Mile	2.28
End Levee Mile	2.48
Location	Water Side
Category	Supplemental
Item	USACE Erosion Survey
USACE 2011 Photo #1	
USACE2011_CHS_22-6_R_1.jpg

Levee Mile Report Line	7
Start Levee Mile	2.28
End Levee Mile	2.48
Location	Water Side
Category	Supplemental
Item	USACE Erosion Survey
USACE 2011 Photo #2	
USACE2011_CHS_22-6_R_2.jpg

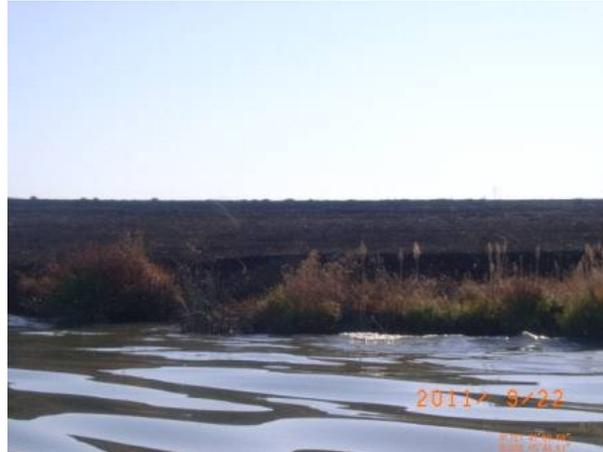
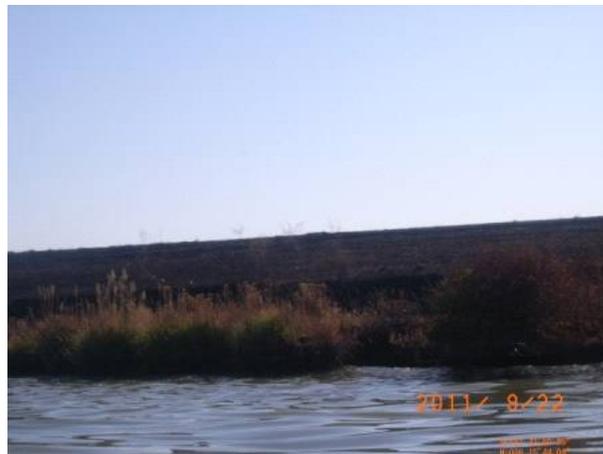
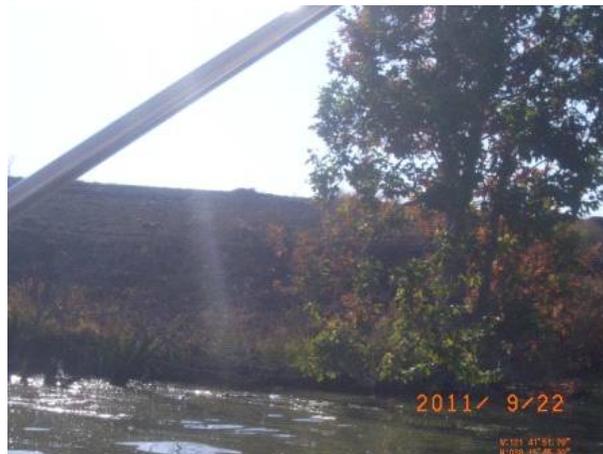
8	3.67	3.88	Supplemental	USACE Erosion Survey	WS	M	Inspector Comments: 2011: Several large pockets of erosion from rotational failure. Toe is slumping. [2011 Site ID: CHS_21-1_R]	38.264585 ° -121.698868 °	38.261616 ° -121.697423 °	11 Y
9	3.76	3.76	Earthen Levee	Encroachments	WS	C	Debris	38.264713 ° -121.699262 °	38.264713 ° -121.699262 °	6 Y

Levee Mile Report Line	8
Start Levee Mile	3.67
End Levee Mile	3.88
Location	Water Side
Category	Supplemental
Item	USACE Erosion Survey
USACE 2011 Photo #1	
USACE2011_CHS_21-1_R_1.jpg

Levee Mile Report Line	8
Start Levee Mile	3.67
End Levee Mile	3.88
Location	Water Side
Category	Supplemental
Item	USACE Erosion Survey
USACE 2011 Photo #2	
USACE2011_CHS_21-1_R_2.jpg

Levee Mile Report Line	8
Start Levee Mile	3.67
End Levee Mile	3.88
Location	Water Side
Category	Supplemental
Item	USACE Erosion Survey
USACE 2011 Photo #3	
USACE2011_CHS_21-1_R_3.jpg
