**Flood Control Project Maintenance
Levee Inspections**

Fall 2012 Levee Maintenance Deficiency Summary Report

Reclamation District No. 2060 Hastings

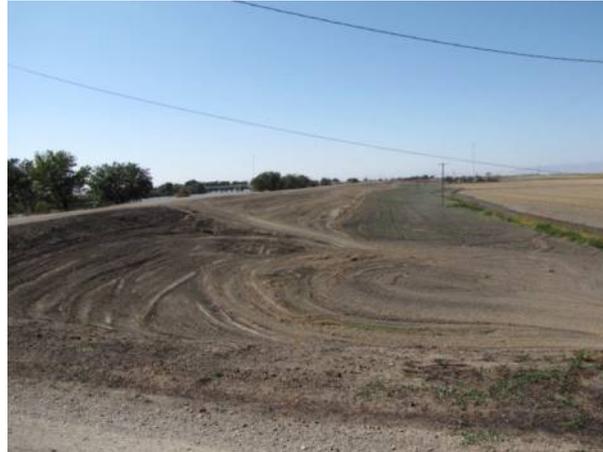
Levee Mile Report Line	4
Start Levee Mile	0.00
End Levee Mile	0.00
Location	Land Side
Category	Earthen Levee
Item	Vegetation
RD2060 Unit 1 looking downstream from levee mile 0.00. Photo taken 11-04-2012.	
phillips_f_20121120_398.jpg

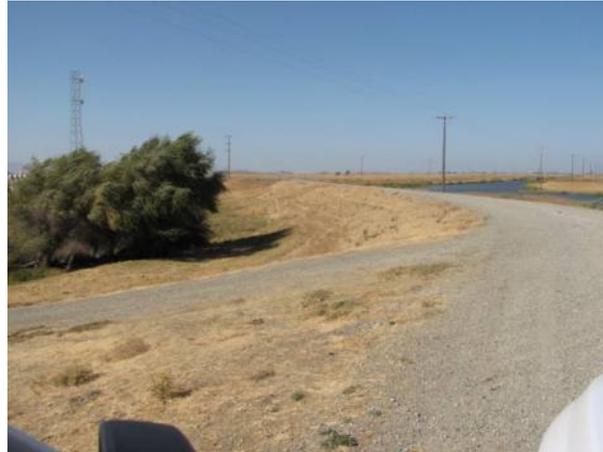
Levee Mile Report Line	1
Start Levee Mile	0.00
End Levee Mile	0.00
Location	Land Side
Category	Earthen Levee
Item	Vegetation
RD 2060 Unit 2 looking downstream from landside. Photo taken 10-04-2012.	
phillips_f_20121120_396.jpg

LMIR No.	Levee Mile		Category	Item	* Location	+ Rating	Action/Comment	GPS Latitude/Longitude		Issue No. Photo
	Start	End						Start	End	
1	0.00	0.00	Earthen Levee	Vegetation	LS	A	V1 : Control annual grass and weeds on the levee slopes and easements.	38.274777 °	38.274777 °	1
					Ma			-121.794835 °	-121.794835 °	Y

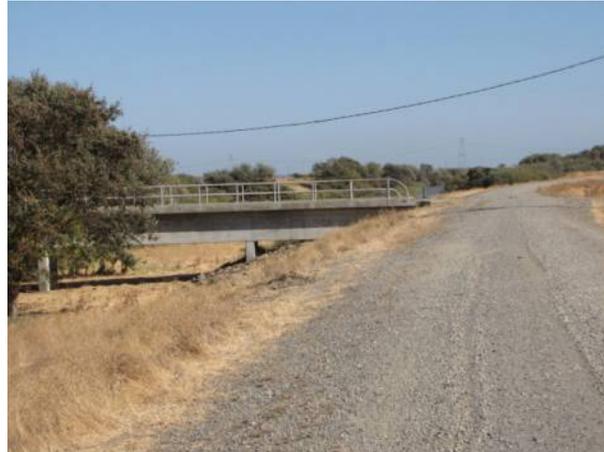
Levee Mile Report Line	1
Start Levee Mile	0.00
End Levee Mile	0.00
Location	Land Side
Category	Earthen Levee
Item	Vegetation
RD 2060 Unit 3 looking downstream from levee mile 0.00 landside. Photo taken 10-04-2012.	
phillips_f_20121120_397.jpg

LMIR No.	Levee Mile		Category	Item	Location	Rating	Action/Comment	GPS Latitude/Longitude		Issue No. Photo
	Start	End						Start	End	
1	0.00	0.00	Earthen Levee	Vegetation	LS	A	V2 : Remove the wild growth other than native grasses from the levee slopes.	38.296604 ° -121.748591 °	38.296604 ° -121.748591 °	1 Y
DWR ID: DWR_RD2060_03_f_2012_1										
2	1.55	1.70	Supplemental Survey	USACE Erosion	WS	M	Inspector Comments: Site added in 1997 and removed in 2003. 2005 - Put back in the inventory. 2006 - Stone repair at the middle of the site. 2011 - Some rock place at toe in the past year. 2012: No observed change. [2012 Site ID: CHS_23-6_R]	38.288192 ° -121.724806 °	38.286418 ° -121.723168 °	4 Y
DWR ID:										
3	2.02	2.08	Supplemental Survey	USACE Erosion	WS	M	Inspector Comments: 2010 - Small maintenance site. 2012: No observed change. [2012 Site ID: CHS_23-0_R]	38.284105 ° -121.718471 °	38.283302 ° -121.717814 °	5 Y

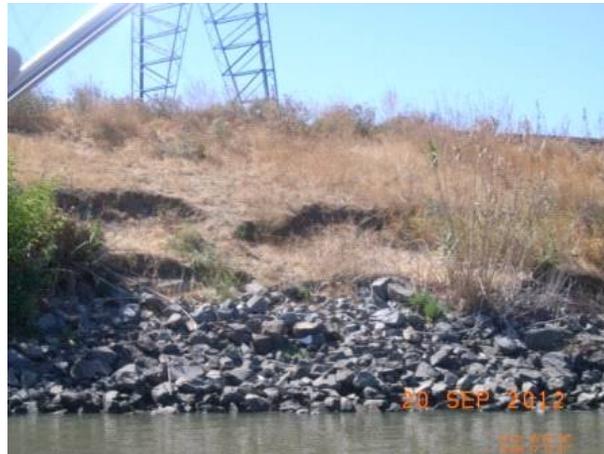
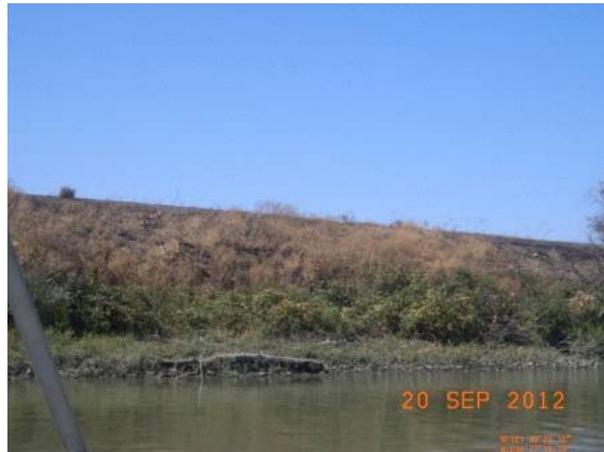
Levee Mile Report Line	2
Start Levee Mile	1.55
End Levee Mile	1.70
Location	Water Side
Category	Supplemental
Item	USACE Erosion Survey
USACE 2012 Photo #1	
USACE2012_CHS_23-6_R_1.jpg

Levee Mile Report Line	2
Start Levee Mile	1.55
End Levee Mile	1.70
Location	Water Side
Category	Supplemental
Item	USACE Erosion Survey
USACE 2012 Photo #2	
USACE2012_CHS_23-6_R_2.jpg

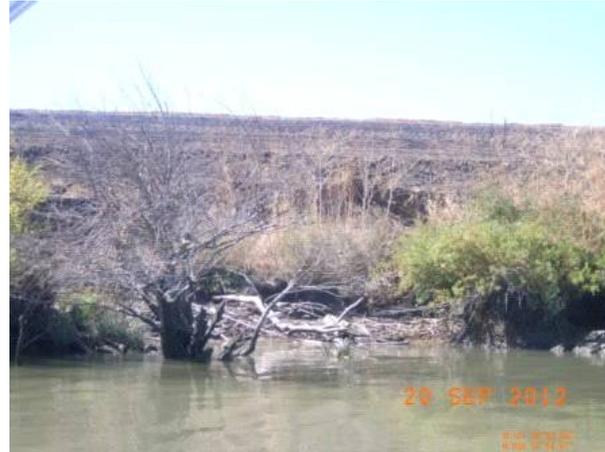
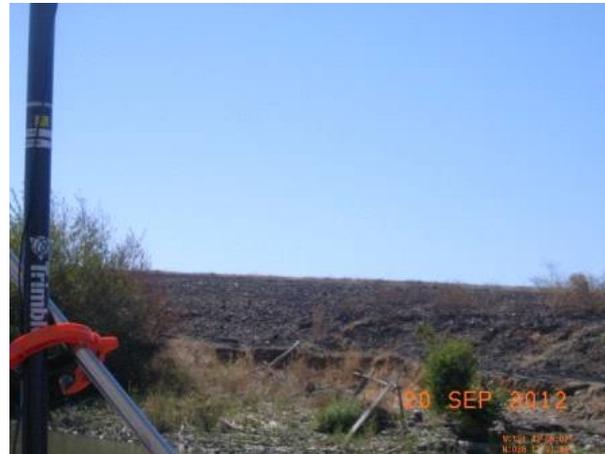
Levee Mile Report Line	3
Start Levee Mile	2.02
End Levee Mile	2.08
Location	Water Side
Category	Supplemental
Item	USACE Erosion Survey
USACE 2012 Photo #1	
USACE2012_CHS_23-0_R_1.jpg

Levee Mile Report Line	3
Start Levee Mile	2.02
End Levee Mile	2.08
Location	Water Side
Category	Supplemental
Item	USACE Erosion Survey
USACE 2012 Photo #2	
USACE2012_CHS_23-0_R_2.jpg

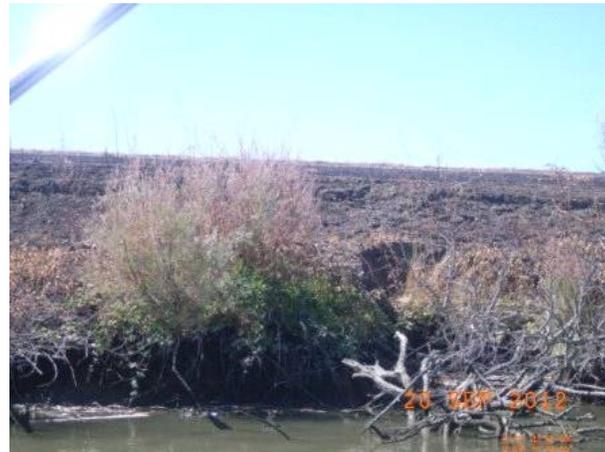
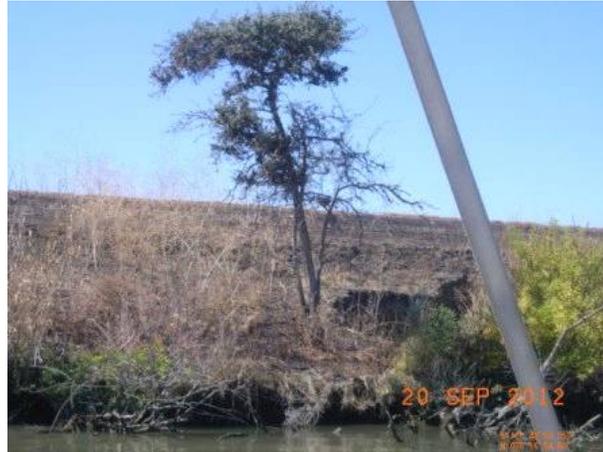
DWR ID:										
4	2.18	2.23	Supplemental Survey	USACE Erosion	WS	M	Inspector Comments: 2007 - Geotechnical failure of midside slope and wave wash/scalloping in toe area. Stone revetment upstream and downstream of site. Similar sites are present all along the right bank downstream of this site, most could be repaired with some maintenance. 2010 - Minor new erosion. 2012: No observed change. [2012 Site ID: CHS_22-8_R]	38.282100 ° -121.716817 °	38.281510 ° -121.716319 °	6 Y
DWR ID:										
5	2.38	2.54	Supplemental Survey	USACE Erosion	WS	M	Inspector Comments: 2008 - Small scour pockets and mid-slope wave wash. 2010 - More vegetation growth, could be fixed through maintenance. 2011 - Site extended downstream and new erosion. 2012: No observed change. [2012 Site ID: CHS_22-6_R]	38.280377 ° -121.714633 °	38.278306 ° -121.712722 °	8 Y
DWR ID:										
6	2.79	3.25	Earthen Levee	Vegetation	WSA/W	Ob	V8 : Environmental Requirements.	38.280919 ° -121.715756 °	38.275177 ° -121.709777 °	3 Y

Levee Mile Report Line	4
Start Levee Mile	2.18
End Levee Mile	2.23
Location	Water Side
Category	Supplemental
Item	USACE Erosion Survey
USACE 2012 Photo #1	
USACE2012_CHS_22-8_R_1.jpg

Levee Mile Report Line	4
Start Levee Mile	2.18
End Levee Mile	2.23
Location	Water Side
Category	Supplemental
Item	USACE Erosion Survey
USACE 2012 Photo #2	
USACE2012_CHS_22-8_R_2.jpg

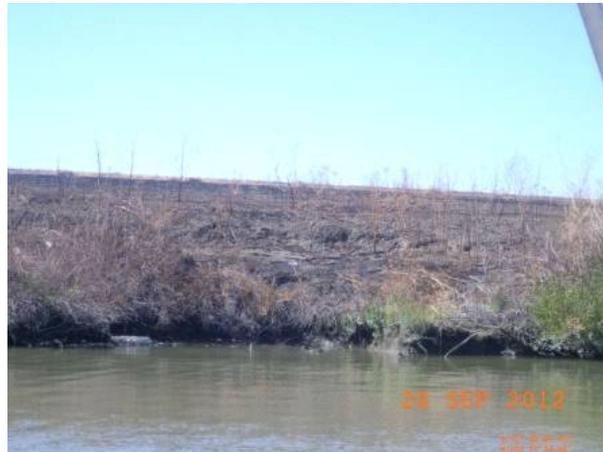
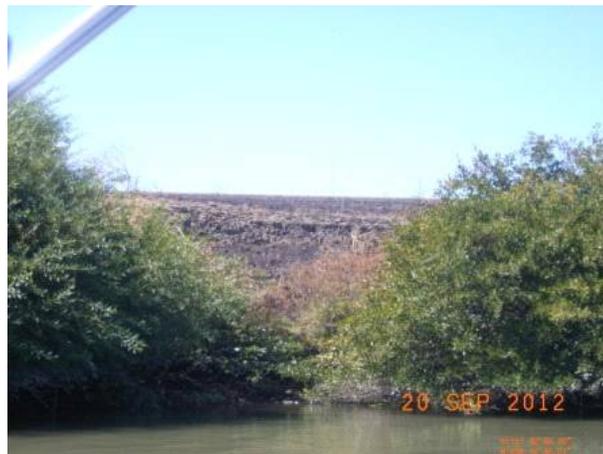
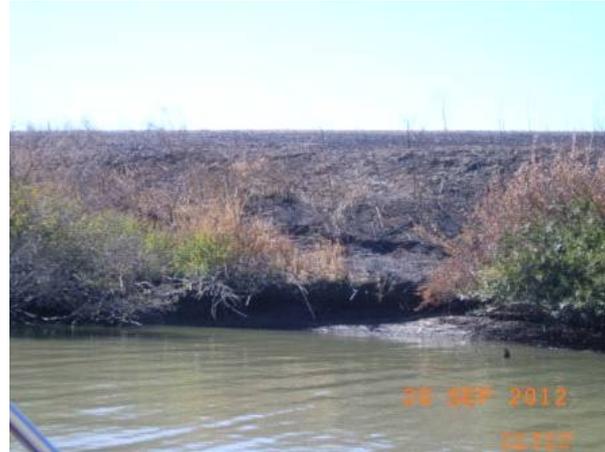
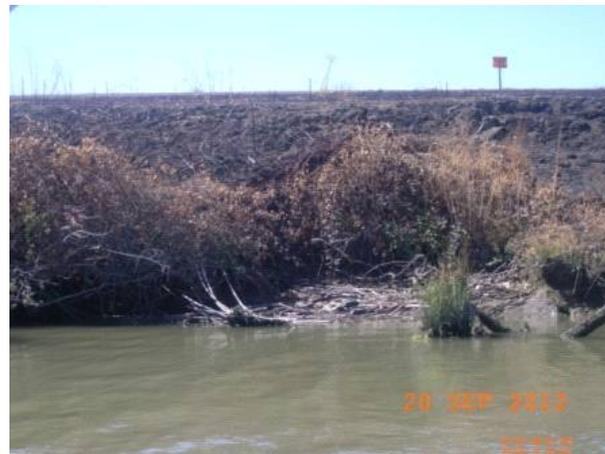
Levee Mile Report Line	5
Start Levee Mile	2.38
End Levee Mile	2.54
Location	Water Side
Category	Supplemental
Item	USACE Erosion Survey
USACE 2012 Photo #1	
USACE2012_CHS_22-6_R_1.jpg

Levee Mile Report Line	5
Start Levee Mile	2.38
End Levee Mile	2.54
Location	Water Side
Category	Supplemental
Item	USACE Erosion Survey
USACE 2012 Photo #2	
USACE2012_CHS_22-6_R_2.jpg

Levee Mile Report Line	5
Start Levee Mile	2.38
End Levee Mile	2.54
Location	Water Side
Category	Supplemental
Item	USACE Erosion Survey
USACE 2012 Photo #3	
USACE2012_CHS_22-6_R_3.jpg

Levee Mile Report Line	5
Start Levee Mile	2.38
End Levee Mile	2.54
Location	Water Side
Category	Supplemental
Item	USACE Erosion Survey
USACE 2012 Photo #4	
USACE2012_CHS_22-6_R_4.jpg

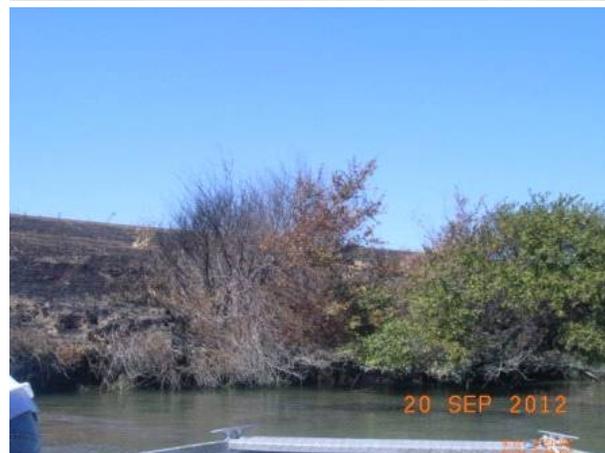
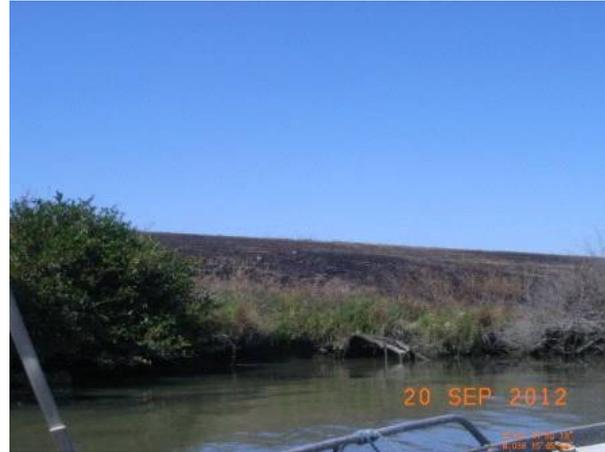
DWR ID: DWR_RD2060_03_s_2012_3										
7	3.28	3.48	Earthen Levee	Vegetation	WSA/W	Ob	V8 : Environmental Requirements. Inspector Comments: There was a fire this spring that burned this veg. site, during this inspection new growth has sprouted up. 2012	38.270863 ° -121.706800 °	38.270324 ° -121.705904 °	12 Y
DWR ID: DWR_RD2060_03_s_2012_12										
8	3.78	4.00	Supplemental Survey	USACE Erosion	WS	M	Inspector Comments: 2011 - Several pockets of erosion from rotational failure and slumping toe. 2012: No observed change. [2012 Site ID: CHS_21-1_R]	38.264585 ° -121.698868 °	38.261616 ° -121.697423 °	10 Y
DWR ID:

Levee Mile Report Line	8
Start Levee Mile	3.78
End Levee Mile	4.00
Location	Water Side
Category	Supplemental
Item	USACE Erosion Survey
USACE 2012 Photo #1	
USACE2012_CHS_21-1_R_1.jpg

Levee Mile Report Line	8
Start Levee Mile	3.78
End Levee Mile	4.00
Location	Water Side
Category	Supplemental
Item	USACE Erosion Survey
USACE 2012 Photo #2	
USACE2012_CHS_21-1_R_2.jpg
