**Flood Control Project Maintenance
Levee Inspections**

Fall 2014 Levee Maintenance Deficiency Summary Report

Reclamation District No. 2060 Hastings

Levee Inspection Report By Mile - Fall 2014

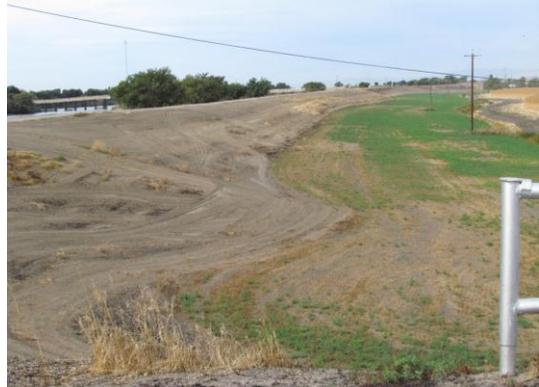
Photo 1 of 1 : FA_2014_RD2060_241_3_20141027_00002.jpg

LM Start	0.00	Rating **	A	Issue No.	3
LM End	6.94	Issue Type +	Ma	Location *	LS
Category	Earthen Levee		GPS Latitude/Longitude		
			Start	End	
Item	Vegetation		38.247325 °	38.274841 °	
			-121.696303 °	-121.794855 °	
DWR ID	DWR_RD2060_01_f_2014_3				
Action/Comments					
Control annual grass and weeds on the levee slopes and easements.

Looking downstream landside levee slope was cleaned and dragged by District. Levee mile 0.00 Unit 1

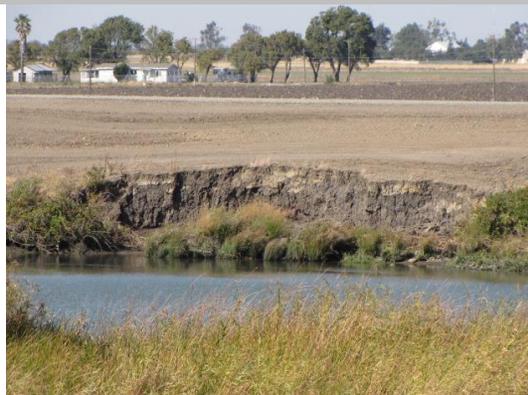
Photo 1 of 1 : FA_2014_RD2060_241_17_20141027_00001.jpg

LM Start	2.40	Rating **	U	Issue No.	17
LM End	2.40	Issue Type +	Ma	Location *	WS
Category	Earthen Levee			GPS Latitude/Longitude	
				Start	End
Item	Erosion / Bank Caving			38.259254 °	38.259254 °
				-121.727257 °	-121.727257 °
DWR ID	DWR_RD2060_01_s_2013_17				
Action/Comments					
Schedule repair of erosion site prior to the next inspection. Inspector Comments: District is aware of the problem, they are scheduling the area to be repaired 2014. During my inspection 10-23-2014 no new repairs has been done at this location. No new photo taken of site.

From RD 536 Looking across channel at RD 2060 Unit 1 erosion site levee mile 2.40 scour hole up to 20' deep and more than 50 feet across. Photo taken 10-08-2013. This erosion site is still active, District has it scheduled for repairs 2014.

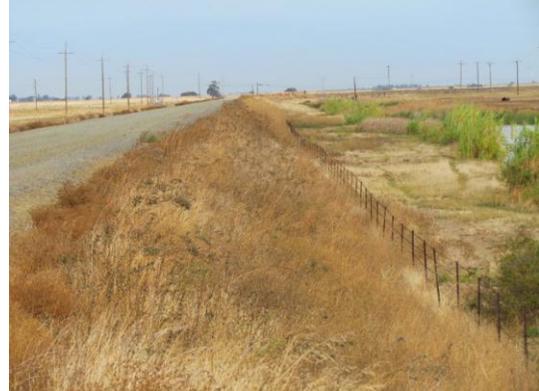
Photo 1 of 1 : FA_2014_RD2060_242_10_20141027_00005.jpg

LM Start	0.00	Rating **	M	Issue No.	10
LM End	3.70	Issue Type +	Ma	Location *	LS
Category	Earthen Levee		GPS Latitude/Longitude		
			Start	End	
Item	Vegetation		38.274841 °	38.296651 °	
			-121.794855 °	-121.748801 °	
DWR ID	DWR_RD2060_02_f_2014_10				
Action/Comments					
Control annual grass and weeds on the levee slopes and easements. Inspector Comments: Looking downstream from landside slope.

Looking downstream from landside of levee slope.

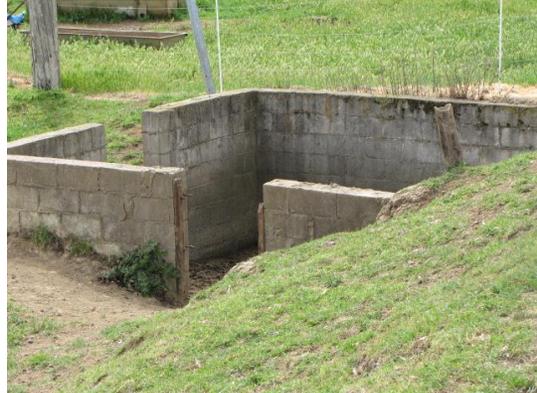
Photo 1 of 1 : FA_2014_RD2060_242_4_20141008_00001.jpg

LM Start	2.10	Rating **	M	Issue No.	4
LM End	2.10	Issue Type +	En	Location *	LS
Category	Earthen Levee			GPS Latitude/Longitude	
				Start	End
Item	Encroachments			38.290085 °	38.290085 °
				-121.775486 °	-121.775486 °
DWR ID	DWR_RD2060_02_s_2013_4				
Action/Comments					
Wall Inspector Comments: Abandoned concrete structure at this location this was once used as a pump site.

This old block structure not in use was placed within the levee section. Photo taken 3-28-2013. No new photo of site during Spring Inspection 03-04-2014.

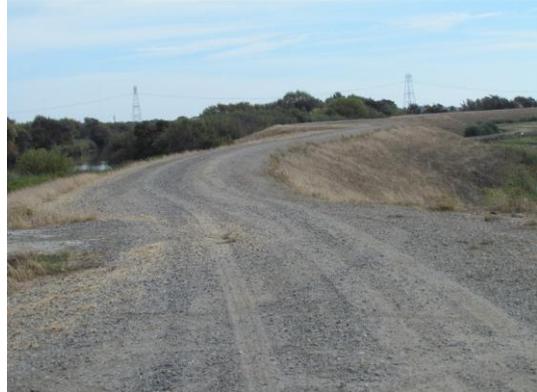
Photo 1 of 1 : FA_2014_RD2060_243_15_20141201_00014.jpg

LM Start	0.00	Rating **	A	Issue No.	15
LM End	0.00	Issue Type +	Ma	Location *	LS
Category	Earthen Levee		GPS Latitude/Longitude		
			Start	End	
Item	Vegetation		38.296651 °	38.296651 °	
			-121.748800 °	-121.748800 °	
DWR ID	DWR_RD2060_03_f_2014_15				
Action/Comments					
Control annual grass and weeds on the levee slopes and easements. Inspector Comments: The District has mowed both levee slopes landward and waterward, starting from levee mile 0.00 heading downstream.

Looking downstream from levee mile 0.00 landside levee slope, grasses has been mowed both landside and waterside.

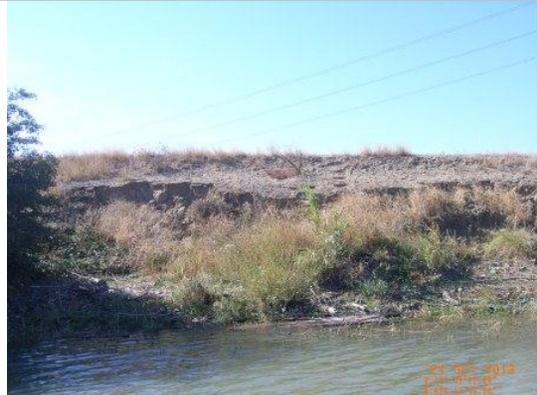
Photo 1 of 1 : FA_2014_RD2060_243_10_20141008_00008.jpg

LM Start	1.51	Rating **	M	Issue No.	10
LM End	1.60	Issue Type +	Ma	Location *	WS
Category	Supplemental			GPS Latitude/Longitude	
				Start	End
Item	USACE Erosion Survey			38.288598 °	38.286051 °
				-121.725184 °	-121.722818 °
DWR ID	DWR_RD2060_03_f_2014_10				
Action/Comments					
Inspector Comments: Site added in 1997 and removed in 2003. 2005 - Put back in the inventory. 2006 - Stone repair at the middle of the site. 2011 - Some rock place at toe in the past year. 2013: Site extended both upstream and downstream to include new erosion pockets. [2013 Site ID: CHS_23-6_R]

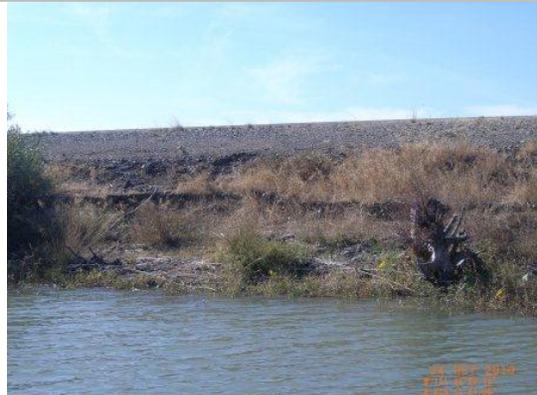
Photo 1 of 1 : FA_2014_RD2060_243_9_20141008_00007.jpg

LM Start	1.96	Rating **	M	Issue No.	9
LM End	2.08	Issue Type +	Ma	Location *	WS
Category	Supplemental			GPS Latitude/Longitude	
				Start	End
Item	USACE Erosion Survey			38.284105 °	38.283302 °
				-121.718471 °	-121.717814 °
DWR ID	DWR_RD2060_03_f_2014_9				
Action/Comments					
Inspector Comments: 2010 - Small maintenance site. 2013: No observed changes. [2013 Site ID: CHS_23-0_R]

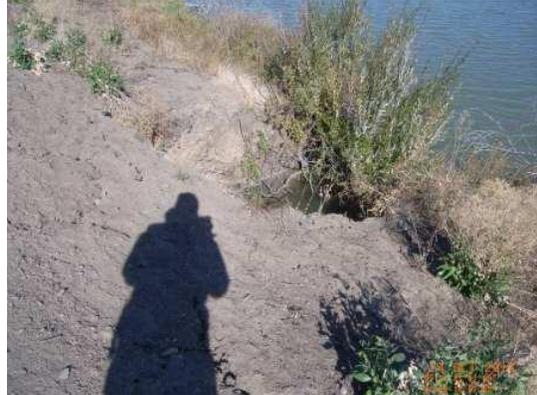
Photo 1 of 1 : FA_2014_RD2060_243_8_20141008_00006.jpg

LM Start	2.11	Rating **	M	Issue No.	8
LM End	2.17	Issue Type +	Ma	Location *	WS
Category	Supplemental			GPS Latitude/Longitude	
				Start	End
Item	USACE Erosion Survey			38.282847 °	38.282245 °
				-121.717549 °	-121.717058 °
DWR ID	DWR_RD2060_03_f_2014_8				
Action/Comments					
Inspector Comments: 2013: Pockets of erosion behind willows. [2013 Site ID: CHS_22-9_R]

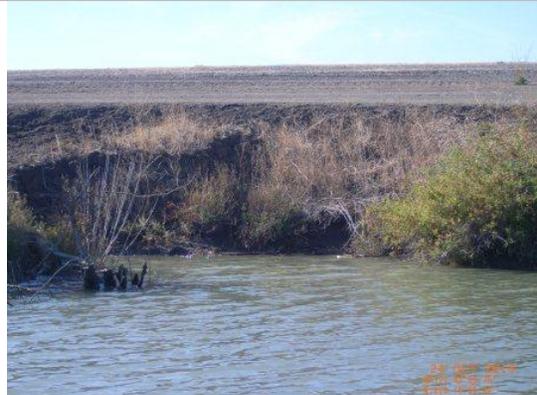
Photo 1 of 1 : FA_2014_RD2060_243_6_20141008_00004.jpg

LM Start	2.18	Rating **	M	Issue No.	6
LM End	2.24	Issue Type +	Ma	Location *	WS
Category	Supplemental			GPS Latitude/Longitude	
				Start	End
Item	USACE Erosion Survey			38.282069 °	38.281482 °
				-121.716891 °	-121.716356 °
DWR ID	DWR_RD2060_03_f_2014_6				
Action/Comments					
Inspector Comments: 2007 - Geotechnical failure of midside slope and wave wash/scalloping in toe area. Stone revetment upstream and downstream of site. Similar sites are present all along the right bank downstream of this site, most could be repaired with some maintenance. 2010 - Minor new erosion. 2013: No observed changes. [2013 Site ID: CHS_22-8_R]

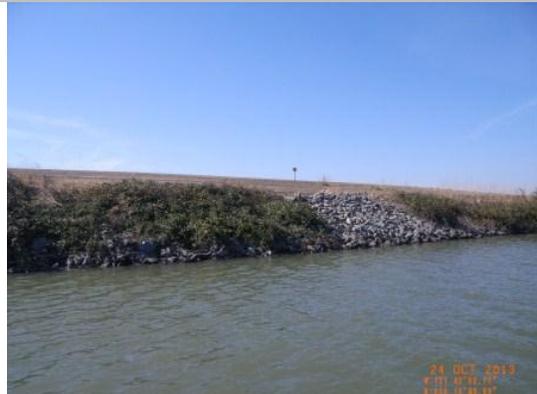
Photo 1 of 1 : FA_2014_RD2060_243_5_20141008_00003.jpg

LM Start	2.34	Rating **	M	Issue No.	5
LM End	2.53	Issue Type +	Ma	Location *	WS
Category	Supplemental			GPS Latitude/Longitude	
				Start	End
Item	USACE Erosion Survey			38.280356 °	38.278214 °
				-121.714697 °	-121.712857 °
DWR ID	DWR_RD2060_03_f_2014_5				
Action/Comments					
Inspector Comments: 2008 - Small scour pockets and mid-slope wave wash. 2010 - More vegetation growth, could be fixed through maintenance. 2011 - Site extended downstream and new erosion. 2013: No observed changes. [2013 Site ID: CHS_22-6_R]

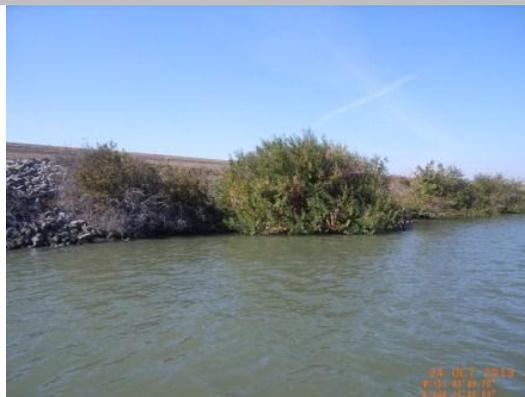
Photo 1 of 1 : FA_2014_RD2060_243_4_20141008_00002.jpg

LM Start	2.54	Rating **	M	Issue No.	4
LM End	2.58	Issue Type +	Ma	Location *	WS
Category	Supplemental		GPS Latitude/Longitude		
			Start	End	
Item	USACE Erosion Survey		38.278109 °	38.277754 °	
			-121.712671 °	-121.712144 °	
DWR ID	DWR_RD2060_03_f_2014_4				
Action/Comments					
Inspector Comments: 2013: Erosion pockets into the levee toe. [2013 Site ID: CHS_22-5_R]

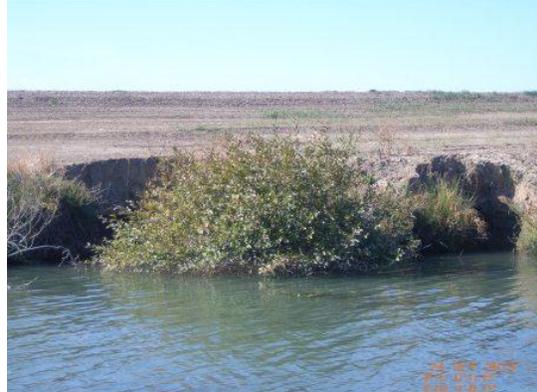
Photo 1 of 1 : FA_2014_RD2060_243_1_20141008_00001.jpg

LM Start	3.67	Rating **	M	Issue No.	1
LM End	4.08	Issue Type +	Ma	Location *	WS
Category	Supplemental		GPS Latitude/Longitude		
			Start	End	
Item	USACE Erosion Survey		38.264585 °	38.260593 °	
			-121.698868 °	-121.696403 °	
DWR ID	DWR_RD2060_03_f_2014_1				
Action/Comments					
Inspector Comments: 2011 - Several pockets of erosion from rotational failure and slumping toe. 2013: Site extended downstream to include new erosion pockets. [2013 Site ID: CHS_21-1_R]
