**Flood Control Project Maintenance
Levee Inspections
LMA District Cover Sheet
Spring 2010 Levee Inspection Results**

Reclamation District No. 2060 Hastings

Spring 2010 Levee Inspection Results

Levee Inspection Report By Mile - Spring 2010

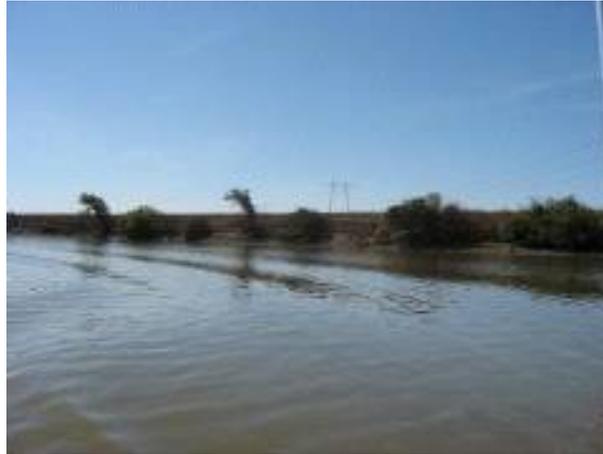
Levee Mile Report Line	4
Start Levee Mile	1.56
End Levee Mile	1.71
Location	Water Side
Category	Supplemental
Item	USACE Erosion Survey
2009: no berm, 2:1 slope, slumping, clays and silts, 0.27 ft/s [2009 SiteID:CHS_23-6_R]	
USACE2009_CHS_23-6_R_2009_09_18-D4P29_small.JPG

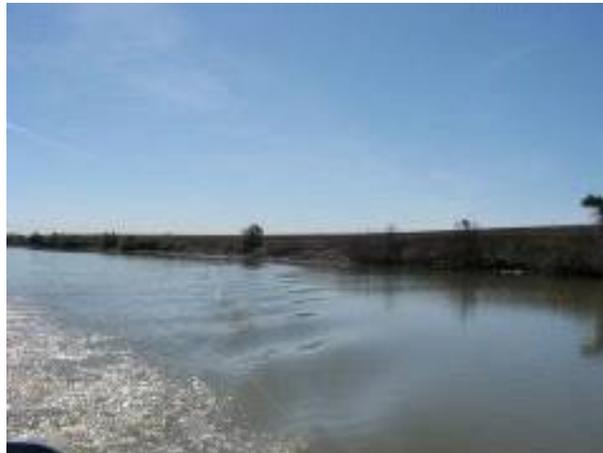
6	1.59	5.02	Earthen Levee	Vegetation	LS	M	Control annual grass and weeds on the levee slopes and easements.	38.287575 ° -121.724582 °	38.247473 ° -121.696282 °	4
7	2.19	2.24	Supplemental	USACE Erosion Survey	WS	M	Inspector Comments: 2009: no berm, 2.5:1 slope, slumping, clays and sands, 1 ft/s [2009 SiteID:CHS_22-8_R]	38.282111 ° -121.716694 °	38.281489 ° -121.716222 °	11 Y
8	3.76	3.76	Earthen Levee	Encroachments	WS	M	Debris	38.264713 ° -121.699262 °	38.264713 ° -121.699262 °	6

Levee Mile Report Line	7
Start Levee Mile	2.19
End Levee Mile	2.24
Location	Water Side
Category	Supplemental
Item	USACE Erosion Survey
2009: no berm, 2.5:1 slope, slumping, clays and sands, 1 ft/s [2009 SiteID:CHS_22-8_R]	
USACE2009_CHS_22-8_R_2009_09_18-D4P28_small.JPG
