**Flood Control Project Maintenance
Levee Inspections**
LMA District Cover Sheet
Spring 2015 Levee Inspection Results

Reclamation District No. 2060 Hastings

Levee Inspection Report By Mile - Spring 2015

Waterway	Bank	Unit Miles	Inspection Start/End	Inspector
Unit No. 01 Lindsey Slough	Left	6.97	04/22/2015 04/22/2015	Herman Phillips

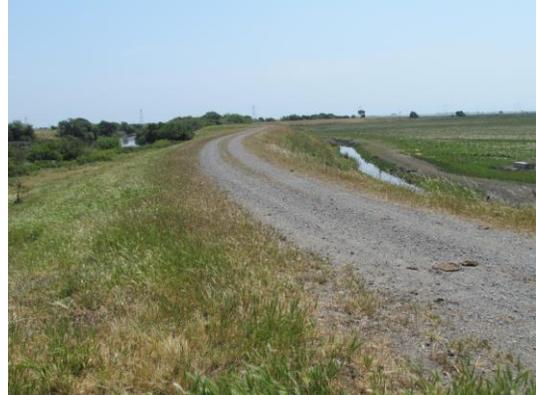
Photo 1 of 1 : SP_2015_RD2060_243_14_20150603_00011.jpg

LM Start	0.08	Rating **	M	Issue No.	14
LM End	0.08	Issue Type +	Ma	Location *	WS
Category	Earthen Levee			GPS Latitude/Longitude	
				Start	End
Item	Vegetation			38.296283 °	38.296283 °
				-121.747450 °	-121.747448 °
DWR ID	DWR_RD2060_03_s_2015_14				
Action/Comments					
Control annual grass and weeds on the levee slopes and easements.

View of the vegetation on the levee slopes.

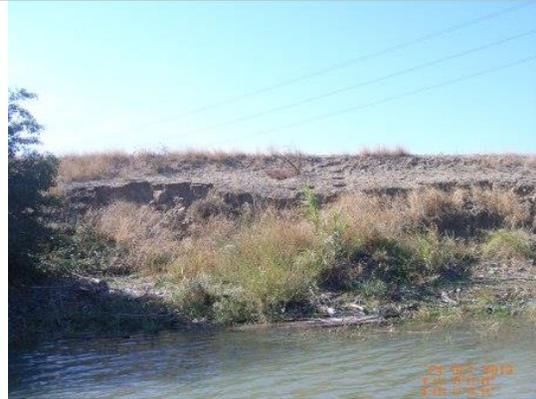
Photo 1 of 1 : SP_2015_RD2060_243_10_20150312_00007.jpg

LM Start	1.52	Rating **	M	Issue No.	10
LM End	1.74	Issue Type +	Ma	Location *	WS
Category	Supplemental			GPS Latitude/Longitude	
				Start	End
Item	USACE Erosion Survey			38.288598 °	38.286051 °
				-121.725184 °	-121.722818 °
DWR ID	DWR_RD2060_03_f_ 2014_10				
Action/Comments					
Inspector Comments: Site added in 2003. 2005 - Put back in the inventory. 2006 - Stone repair at the middle of the site. 2011 - Some rock place at toe in the past year. 2013: Site extended both upstream and downstream to include new erosion pockets. [2013 Site ID: CHS_23-6_R]

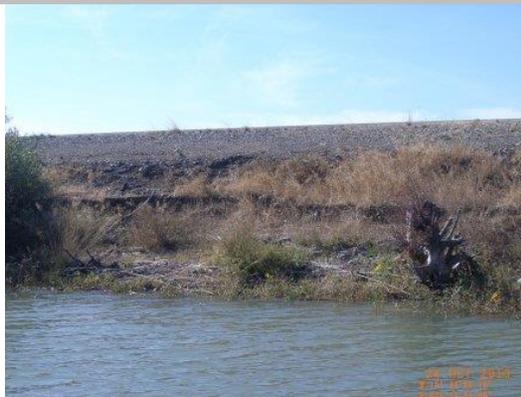
Photo 1 of 1 : SP_2015_RD2060_243_9_20150312_00006.jpg

LM Start	2.02	Rating **	M	Issue No.	9
LM End	2.08	Issue Type +	Ma	Location *	WS
Category	Supplemental			GPS Latitude/Longitude	
				Start	End
Item	USACE Erosion Survey			38.284105 °	38.283302 °
				-121.718471 °	-121.717814 °
DWR ID	DWR_RD2060_03_f_2014_9				
Action/Comments					
Inspector Comments: 2010 - Small maintenance site. 2013: No observed changes. [2013 Site ID: CHS_23-0_R]

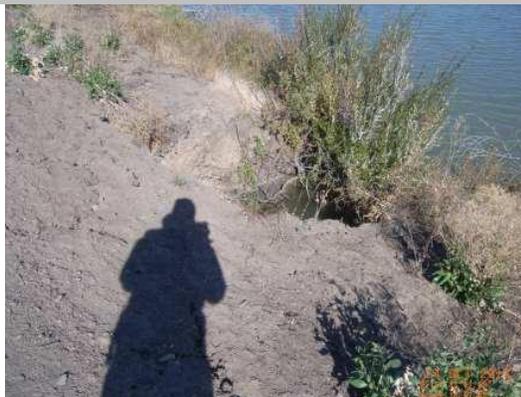
Photo 1 of 1 : SP_2015_RD2060_243_8_20150312_00005.jpg

LM Start	2.12	Rating **	M	Issue No.	8
LM End	2.17	Issue Type +	Ma	Location *	WS
Category	Supplemental			GPS Latitude/Longitude	
				Start	End
Item	USACE Erosion Survey			38.282847 °	38.282245 °
				-121.717549 °	-121.717058 °
DWR ID	DWR_RD2060_03_f_2014_8				
Action/Comments					
Inspector Comments: 2013: Pockets of erosion behind willows. [2013 Site ID: CHS_22-9_R]

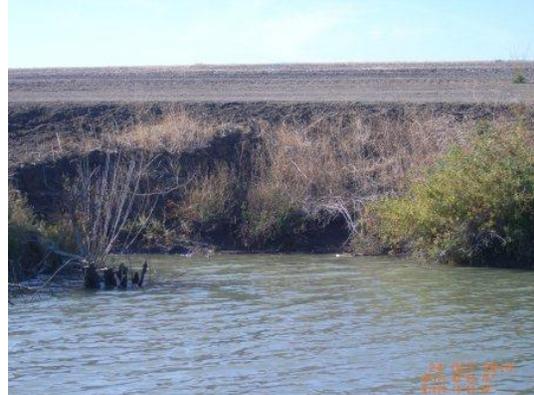
Photo 1 of 1 : SP_2015_RD2060_243_6_20150312_00004.jpg

LM Start	2.18	Rating **	M	Issue No.	6
LM End	2.23	Issue Type +	Ma	Location *	WS
Category	Supplemental			GPS Latitude/Longitude	
				Start	End
Item	USACE Erosion Survey			38.282069 °	38.281482 °
				-121.716891 °	-121.716356 °
DWR ID	DWR_RD2060_03_f_2014_6				
Action/Comments					
Inspector Comments: 2007 - Geotechnical failure of midside slope and wave wash/scalloping in toe area. Stone revetment upstream and downstream of site. Similar sites are present all along the right bank downstream of this site, most could be repaired with some maintenance. 2010 - Minor new erosion. 2013: No observed changes. [2013 Site ID: CHS_22-8_R]

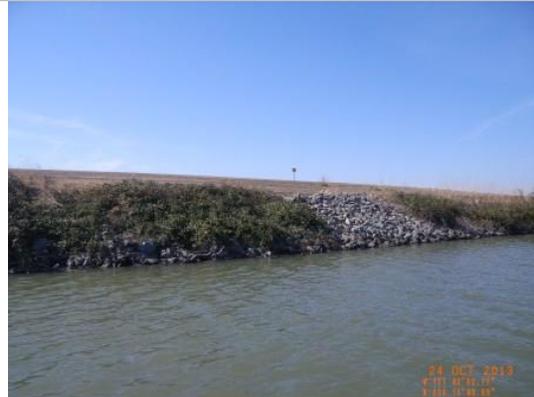
Photo 1 of 1 : SP_2015_RD2060_243_5_20150312_00003.jpg

LM Start	2.35	Rating **	M	Issue No.	5
LM End	2.53	Issue Type +	Ma	Location *	WS
Category	Supplemental			GPS Latitude/Longitude	
				Start	End
Item	USACE Erosion Survey			38.280356 °	38.278214 °
				-121.714697 °	-121.712857 °
DWR ID	DWR_RD2060_03_f_2014_5				
Action/Comments					
Inspector Comments: 2008 - Small scour pockets and mid-slope wave wash. 2010 - More vegetation growth, could be fixed through maintenance. 2011 - Site extended downstream and new erosion. 2013: No observed changes. [2013 Site ID: CHS_22-6_R]

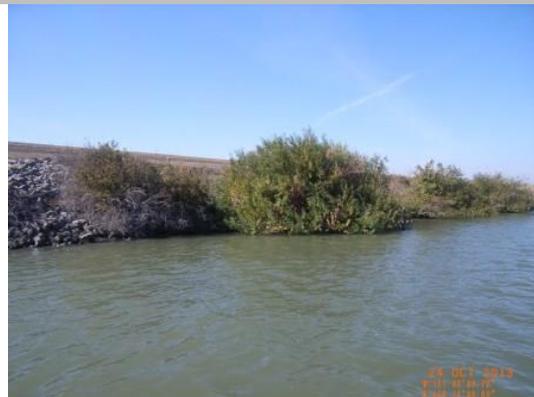
Photo 1 of 1 : SP_2015_RD2060_243_4_20150312_00002.jpg

LM Start	2.55	Rating **	M	Issue No.	4
LM End	2.58	Issue Type +	Ma	Location *	WS
Category	Supplemental			GPS Latitude/Longitude	
				Start	End
Item	USACE Erosion Survey			38.278109 °	38.277754 °
				-121.712671 °	-121.712144 °
DWR ID	DWR_RD2060_03_f_2014_4				
Action/Comments					
Inspector Comments: 2013: Erosion pockets into the levee toe. [2013 Site ID: CHS_22-5_R]

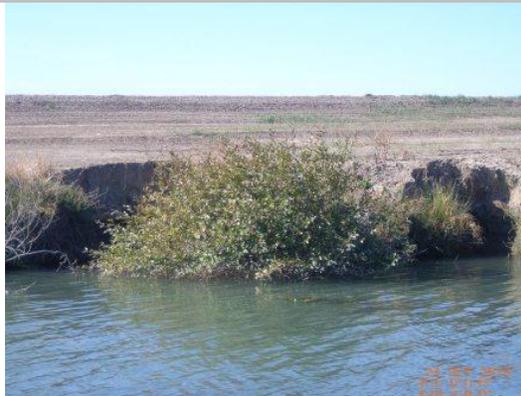
Photo 1 of 1 : SP_2015_RD2060_243_1_20150312_00001.jpg

LM Start	3.78	Rating **	M	Issue No.	1
LM End	4.09	Issue Type +	Ma	Location *	WS
Category	Supplemental			GPS Latitude/Longitude	
				Start	End
Item	USACE Erosion Survey			38.264585 °	38.260593 °
				-121.698868 °	-121.696403 °
DWR ID	DWR_RD2060_03_f_2014_1				
Action/Comments					
Inspector Comments: 2011 - Several pockets of erosion from rotational failure and slumping toe. 2013: Site extended downstream to include new erosion pockets. [2013 Site ID: CHS_21-1_R]
