**Flood Control Project Maintenance  
Levee Inspections**  
**LMA District Cover Sheet**  
**Spring 2016 Levee Inspection Results**

**Reclamation District No. 2060 Hastings**

**Levee Inspection Report By Mile - Spring 2016**

Waterway	Bank	Unit Miles	Inspection Start/End	Inspector
Unit No. 01 Lindsey Slough	Left	6.97	03/22/2016 03/22/2016	Herman Phillips

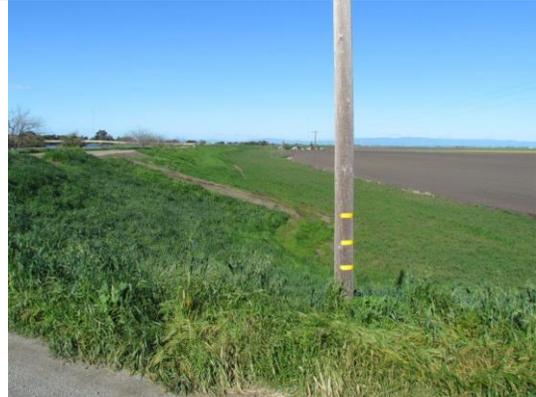
Photo 1 of 1 : SP\_2016\_RD2060\_241\_10\_20160328\_00006.jpg

LM Start	<b>0.05</b>	Rating **	M	Issue No.	<b>10</b>
LM End	<b>2.03</b>	Issue Type +	Ma	Location *	LS
Category	Earthen Levee		GPS Latitude/Longitude		
			Start	End	
Item	Vegetation		38.247232 °	38.258917 °	
			-121.697075 °	-121.725188 °	
DWR ID	DWR_RD2060_01_s_2016_10				
Comment Code					
V1 : Control annual grass and weeds on the levee slopes and easements.					
Inspector Comment

Looking downstream from levee mile 0.00 Unit 1 RD 2060. Weeds present on the landside slope.

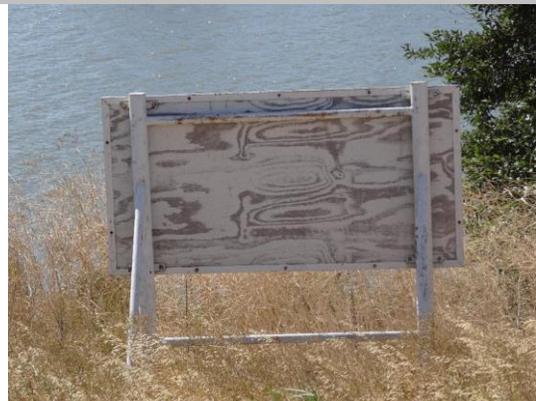
Photo 1 of 2 : UCIP\_SP\_2016\_41908\_30541.jpg

LM Start	<b>3.65</b>	Rating **	M	Issue No.	<b>19</b>
LM End	<b>3.65</b>	Issue Type +	En	Location *	WS
Category	Supplemental			GPS Latitude/Longitude	
				Start	End
Item	DWR UCIP Field Study			38.261314 °	38.261314 °
				-121.749191 °	-121.749191 °
DWR ID					
Comment Code					
Inspector Comment					
FS_ID:41908 DS_ID:22050 EP_NO: 10119 Repair Type: Non-Urgent Crossing Status: Indicator Found UCIP Comments: Need to contact owner and verify status of crossing. FIELD_STRUCT_DESC: 8-5/8-inch gas pipeline crosses Lindsey Slough to R.D. 536. Gasline marker on LS and sign board on WS. (Permit no. 10119) FS Date: 8/15/2013

WS view: gasoline sign board on levee slope.

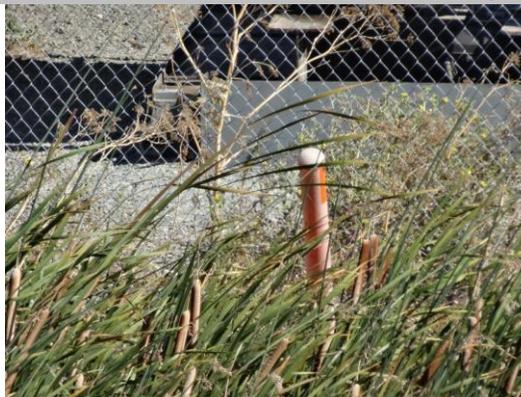
Photo 2 of 2 : UCIP\_SP\_2016\_41878\_30548.jpg

LM Start	<b>3.76</b>	Rating **	M	Issue No.	<b>18 (cont)</b>
LM End	<b>3.76</b>	Issue Type +	En	Location *	WS
Category	Supplemental			GPS Latitude/Longitude	
				Start	End
Item	DWR UCIP Field Study			38.261211 °	38.261211 °
				-121.751117 °	-121.751117 °
DWR ID					
Comment Code					
Inspector Comment					
FS_ID:41878 DS_ID:22045 EP_NO: 12784 Repair Type: Non-Urgent Crossing Status: Indicator Found UCIP Comments: Need to contact owner to determine status and install signs if appropriate. FIELD_STRUCT_DESC: 8.625-inch diameter natural gas pipeline across the channel and both levees of Lindsey Slough. 4 feet below the crown. Gasline marker found off LS (Permit No. 12784). FS Date: 8/15/2013

LS view: closer view of gasline indicator found on LS.

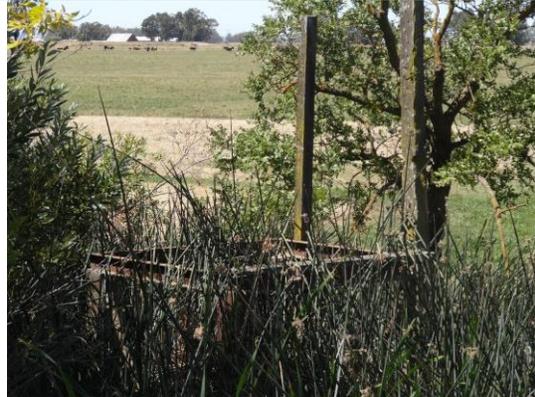
Photo 1 of 2 : UCIP\_SP\_2016\_46769\_31088.jpg

LM Start	<b>0.00</b>	Rating **	M	Issue No.	<b>13</b>
LM End	<b>0.00</b>	Issue Type +	En	Location *	LS
Category	Supplemental			GPS Latitude/Longitude	
				Start	End
Item	DWR UCIP Field Study			38.289474 °	38.289474 °
				-121.775914 °	-121.775914 °
DWR ID					
Comment Code					
Inspector Comment					
FS_ID:46769 DS_ID:22059 EP_NO: N/A Repair Type: Non-Urgent Crossing Status: Indicator Found UCIP Comments: - Abandoned pump structure in stream needs proper abandonment- Not accessible due to wired fence FIELD_STRUCT_DESC: *ABANDONED* pump structure in stream and a concrete distribution on landside. Not accessible due to wired fence. FS Date: 8/15/2013

WS view: abandoned pump support in stream/channel. Not accessible due to vegetation.

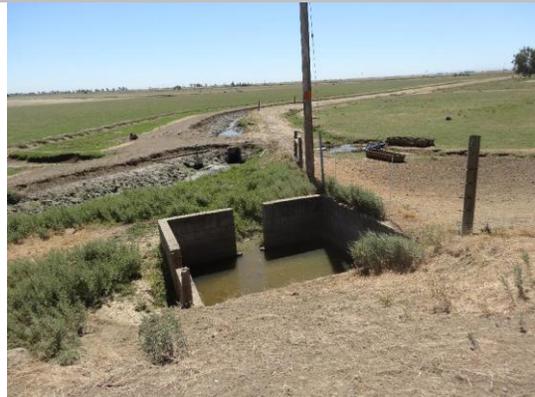
Photo 2 of 2 : UCIP\_SP\_2016\_46769\_31087.jpg

LM Start	<b>0.00</b>	Rating **	M	Issue No.	<b>13 (cont)</b>
LM End	<b>0.00</b>	Issue Type +	En	Location *	LS

LS view: abandoned concrete distribution box. Not accessible due to wire fence.

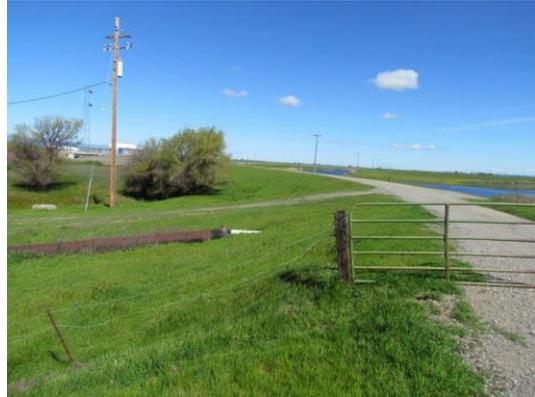
Photo 1 of 1 : SP\_2016\_RD2060\_242\_10\_20160328\_00011.jpg

LM Start	<b>0.00</b>	Rating **	A	Issue No.	<b>10</b>
LM End	<b>3.54</b>	Issue Type +	Ma	Location *	LS
Category	Earthen Levee		GPS Latitude/Longitude		
			Start	End	
Item	Vegetation		38.275135 °	38.296370 °	
			-121.795035 °	-121.750610 °	
DWR ID	DWR_RD2060_02_s_2016_10				
Comment Code					
V1 : Control annual grass and weeds on the levee slopes and easements.					
Inspector Comment					
No unwanted vegetation on the levee slopes.

Looking downstream from levee mile 0.00 Unit 2 RD 2060 landside slope.

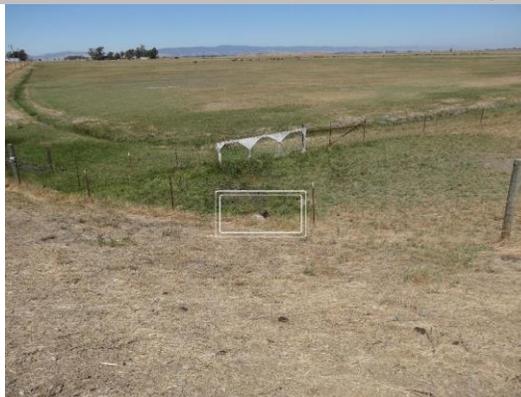
Photo 1 of 2 : UCIP\_SP\_2016\_18386\_30873.jpg

LM Start	<b>1.74</b>	Rating **	M	Issue No.	<b>11</b>
LM End	<b>1.74</b>	Issue Type +	En	Location *	WS
Category	Supplemental			GPS Latitude/Longitude	
				Start	End
Item	DWR UCIP Field Study			38.285219 °	38.285219 °
				-121.777085 °	-121.777085 °
DWR ID					
Comment Code					
Inspector Comment					
FS_ID:18386 DS_ID:22056 EP_NO: 10148 Repair Type: Non-Urgent Crossing Status: Found UCIP Comments: U-type concrete headwall on LS. Not accessible due to fence. Vegetation is partially blocking inlet & outlet pipe. FIELD_STRUCT_DESC: 24-inch CM drainpipe through levee, 16.0 feet below crown, flap gate on waterward end. U-type concrete headwall on LS. Not accessible due to fence. Vegetation is partially blocking inlet & outlet pipe. FS Date: 8/15/2013

WS view: overview of CMP from levee.

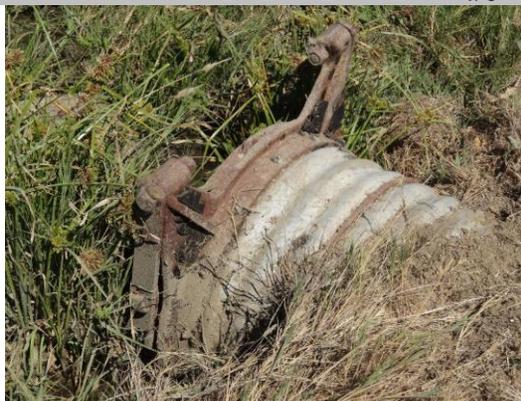
Photo 2 of 2 : UCIP\_SP\_2016\_18386\_30872.jpg

LM Start	<b>1.74</b>	Rating **	M	Issue No.	<b>11 (cont)</b>
LM End	<b>1.74</b>	Issue Type +	En	Location *	WS

WS view: CM pipe with flap gate. Not accessible. Vegetation is partially blocking outlet pipe.

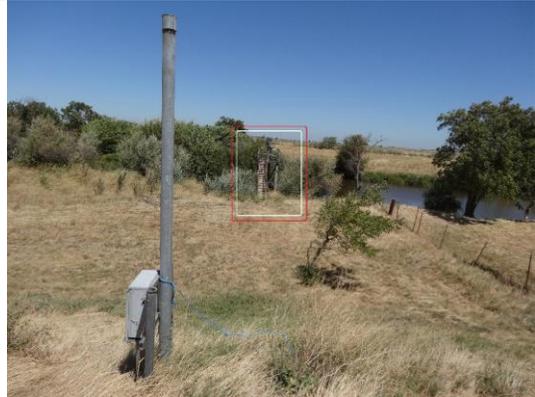
Photo 1 of 2 : UCIP\_SP\_2016\_41668\_31161.jpg

LM Start	<b>2.15</b>	Rating **	M	Issue No.	<b>12</b>
LM End	<b>2.15</b>	Issue Type +	En	Location *	LS
Category	Supplemental			GPS Latitude/Longitude	
				Start	End
Item	DWR UCIP Field Study			38.290440 °	38.290440 °
				-121.774808 °	-121.774808 °
DWR ID					
Comment Code					
Inspector Comment					
FS_ID:41668 DS_ID:22060 EP_NO: 5927 Repair Type: Non-Urgent Crossing Status: Found UCIP Comments: verify pipe has been abandoned properly. - abandoned pump and pipe.- electrical box on WS shoulder. FIELD_STRUCT_DESC: *Abandoned* 18-inch steel pipe through levee 4.0 feet below crown, siphon breaker on landward slope. Pump on piling on bank, distribution box at landward toe. (Permit No. 5927 - Cache Slough Pheasant Club). FS Date: 8/15/2013

WS view: electrical box on pole and pump structure in background.

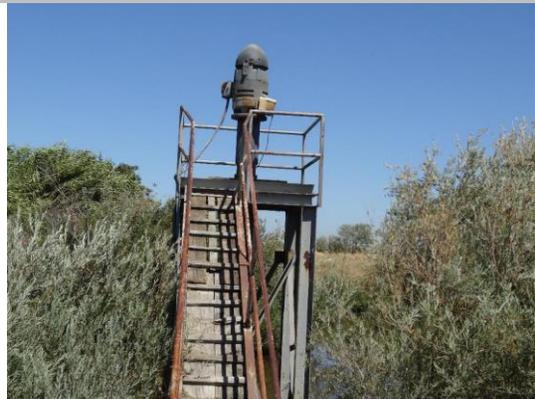
Photo 2 of 2 : UCIP\_SP\_2016\_41668\_31160.jpg

LM Start	<b>2.15</b>	Rating **	M	Issue No.	<b>12 (cont)</b>
LM End	<b>2.15</b>	Issue Type +	En	Location *	LS

WS view: pump on pile structure with stairs on bank.

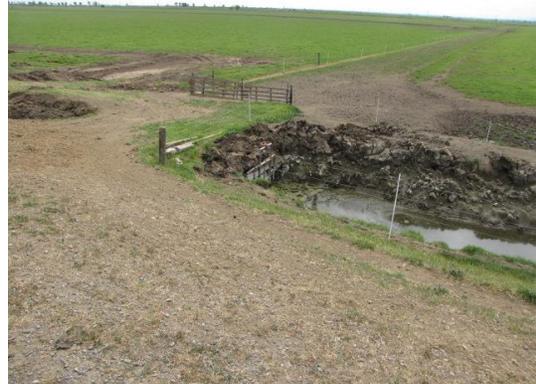
Photo 1 of 1 : SP\_2016\_RD2060\_242\_6\_20160223\_00002.jpg

LM Start	<b>2.22</b>	Rating **	M	Issue No.	<b>6</b>
LM End	<b>2.22</b>	Issue Type +	En	Location *	LS
Category	Earthen Levee		GPS Latitude/Longitude		
			Start	End	
Item	Encroachments		38.290475 °	38.290475 °	
			-121.773390 °	-121.773390 °	
DWR ID	DWR_RD2060_02_s_2013_6				
Comment Code					
DT : Ditch					
Inspector Comment					
This ditch used for irrigation is not a new issue.

This ditch encroaches within the 10-foot easement. Photo taken 3-28-2013. No new photo was taken of this ditch during the Spring Inspection of 2014.

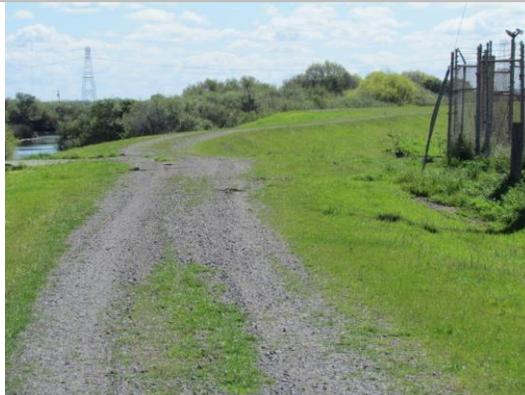
Photo 1 of 1 : SP\_2016\_RD2060\_243\_13\_20160328\_00016.jpg

LM Start	<b>0.61</b>	Rating **	A	Issue No.	<b>13</b>
LM End	<b>1.44</b>	Issue Type +	Ma	Location *	LS
Category	Earthen Levee		GPS Latitude/Longitude		
			Start	End	
Item	Vegetation		38.292018 °	38.289470 °	
			-121.740227 °	-121.726227 °	
DWR ID	DWR_RD2060_03_s_2016_13				
Comment Code					
V1 : Control annual grass and weeds on the levee slopes and easements.					
Inspector Comment					
No unwanted weeds present on the levee section 0.61-1.41.

Looking downstream from levee mile 0.61 -1.44 Unit 3 RD 2060.

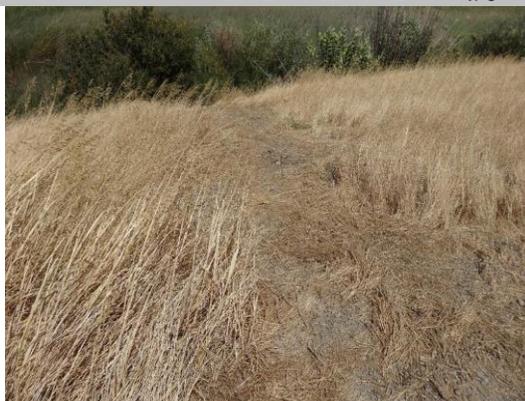
Photo 1 of 2 : UCIP\_SP\_2016\_18727\_31317.jpg

LM Start	<b>0.90</b>	Rating **	M	Issue No.	<b>17</b>
LM End	<b>0.90</b>	Issue Type +	En	Location *	LS
Category	Supplemental		GPS Latitude/Longitude		
			Start	End	
Item	DWR UCIP Field Study		38.290684 °	38.290684 °	
			-121.735668 °	-121.735668 °	
DWR ID					
Comment Code					
Inspector Comment					
FS_ID:18727 DS_ID:22067 EP_NO: N/A Repair Type: Non-Urgent Crossing Status: Found UCIP Comments: Seem abandoned. Not found- pump on LS. Needs more exploration. FIELD_STRUCT_DESC: 6-inch steel pipe through the levee, 2.8 feet below the crown. O&M Manual SAC 107, April 1959. FS Date: 8/15/2013

Waterside view: levee slope.

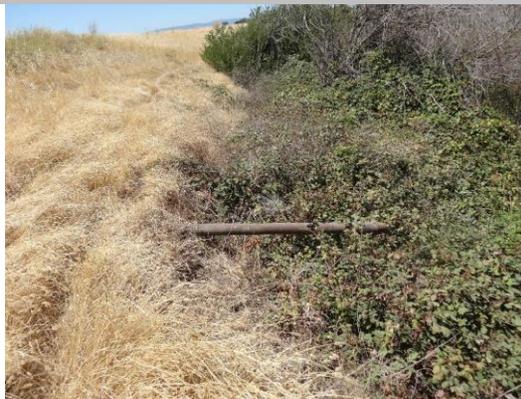
Photo 2 of 2 : UCIP\_SP\_2016\_18727\_31316.jpg

LM Start	<b>0.90</b>	Rating **	M	Issue No.	<b>17 (cont)</b>
LM End	<b>0.90</b>	Issue Type +	En	Location *	LS
Category	Supplemental			GPS Latitude/Longitude	
				Start	End
Item	DWR UCIP Field Study			38.290684 °	38.290684 °
				-121.735668 °	-121.735668 °
DWR ID					
Comment Code					
Inspector Comment					
FS_ID:18727 DS_ID:22067 EP_NO: N/A Repair Type: Non-Urgent Crossing Status: Found UCIP Comments: Seem abandoned. Not found- pump on LS. Needs more exploration. FIELD_STRUCT_DESC: 6-inch steel pipe through the levee, 2.8 feet below the crown. O&M Manual SAC 107, April 1959. FS Date: 8/15/2013

Waterside view: levee slope and a steel pipe.

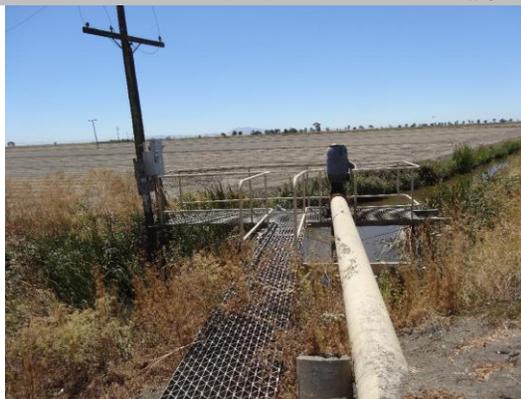
Photo 1 of 2 : UCIP\_SP\_2016\_18726\_31314.jpg

LM Start	<b>0.90</b>	Rating **	M	Issue No.	<b>16</b>
LM End	<b>0.90</b>	Issue Type +	En	Location *	LS
Category	Supplemental			GPS Latitude/Longitude	
				Start	End
Item	DWR UCIP Field Study			38.290684 °	38.290684 °
				-121.735639 °	-121.735639 °
DWR ID					
Comment Code					
Inspector Comment					
FS_ID:18726 DS_ID:22063 EP_NO: 6342 Repair Type: Non-Urgent Crossing Status: Found UCIP Comments: Leaky siphon breaker may need to be repaired.  Dense vegetation on WS. Not found- gate valve on LS. FIELD_STRUCT_DESC: 16-inch steel pipe through levee 8.0 feet below crown, vertical pump in drain ditch on land-side. Siphon breaker on waterside. (App. No. 6342-A - Hastings Farms) FS Date: 8/15/2013

Landside view: pump, service pole, steel support structure, walkway, and pipe.

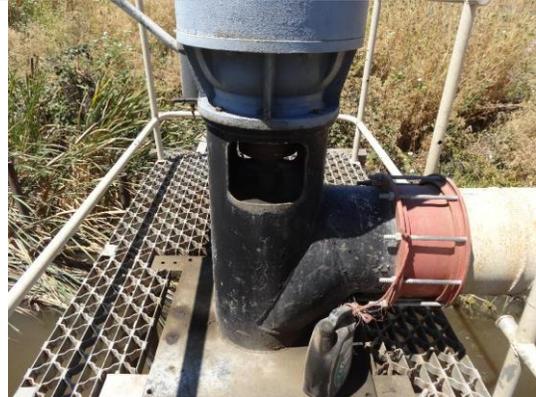
Photo 2 of 2 : UCIP\_SP\_2016\_18726\_31313.jpg

LM Start	<b>0.90</b>	Rating **	M	Issue No.	<b>16 (cont)</b>
LM End	<b>0.90</b>	Issue Type +	En	Location *	LS
Category	Supplemental			GPS Latitude/Longitude	
				Start	End
Item	DWR UCIP Field Study			38.290684 °	38.290684 °
				-121.735639 °	-121.735639 °
DWR ID					
Comment Code					
Inspector Comment					
FS_ID:18726 DS_ID:22063 EP_NO: 6342 Repair Type: Non-Urgent Crossing Status: Found UCIP Comments: Leaky siphon breaker may need to be repaired.  Dense vegetation on WS.Not found- gate valve on LS. FIELD_STRUCT_DESC: 16-inch steel pipe through levee 8.0 feet below crown, vertical pump in drain ditch on land-side. Siphon breaker on waterside. (App. No. 6342-A - Hastings Farms) FS Date: 8/15/2013

Landside view: pipe and pump on steel structure in drain ditch.

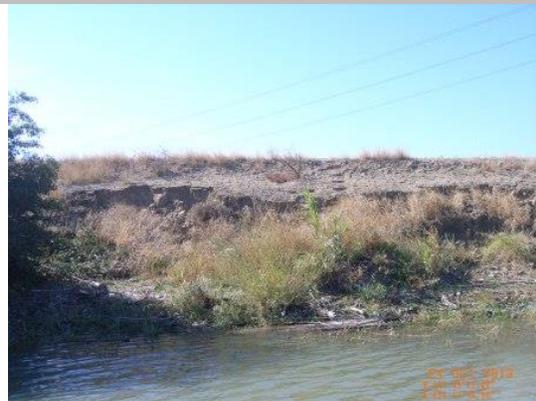
Photo 1 of 1 : SP\_2016\_RD2060\_243\_8\_20160223\_00007.jpg

LM Start	<b>1.52</b>	Rating **	M	Issue No.	<b>8</b>
LM End	<b>1.74</b>	Issue Type +	Ma	Location *	WS
Category	Supplemental			GPS Latitude/Longitude	
				Start	End
Item	2015 USACE Erosion Survey, DRAFT			38.288598 °	38.286051 °
				-121.725184 °	-121.722818 °
DWR ID	DWR_RD2060_03_s_2016_8				
Comment Code					
Inspector Comment					
Site added in 1997 and removed in 2003. 2005 - Put back in the inventory. 2006 - Stone repair at the middle of the site. 2011 - Some rock place at toe in the past year. 2013 - Site extended both upstream and downstream to include new erosion pockets. 2015: No observed changes. [2015 Site ID: CHS_23-6_R]

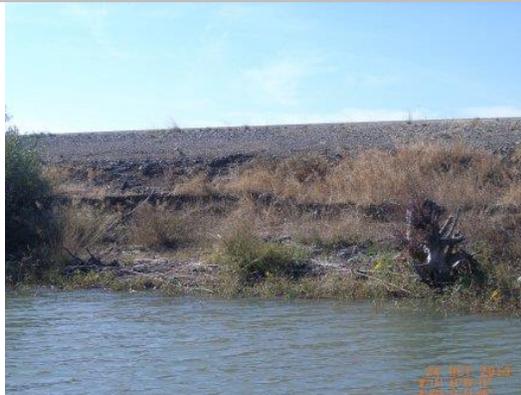
Photo 1 of 1 : SP\_2016\_RD2060\_243\_1\_20160223\_00001.jpg

LM Start	<b>2.02</b>	Rating **	M	Issue No.	<b>1</b>
LM End	<b>2.08</b>	Issue Type +	Ma	Location *	WS
Category	Supplemental			GPS Latitude/Longitude	
				Start	End
Item	2015 USACE Erosion Survey, DRAFT			38.284105°	38.283302°
				-121.718471°	-121.717814°
DWR ID	DWR_RD2060_03_s_2016_1				
Comment Code					
Inspector Comment					
2010 - Small maintenance site. 2015: No observed changes. [2015 Site ID: CHS_23-0_R]

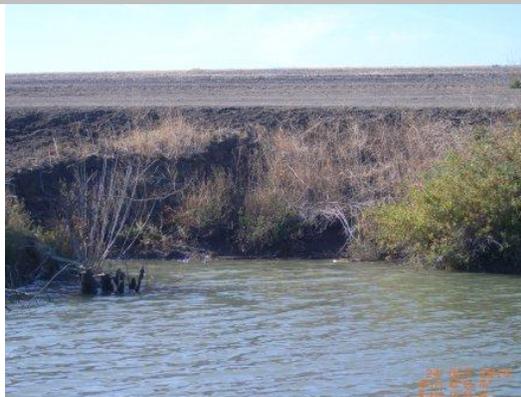
Photo 1 of 1 : SP\_2016\_RD2060\_243\_7\_20160223\_00006.jpg

LM Start	<b>2.18</b>	Rating **	M	Issue No.	<b>7</b>
LM End	<b>2.23</b>	Issue Type +	Ma	Location *	WS
Category	Supplemental			GPS Latitude/Longitude	
				Start	End
Item	2015 USACE Erosion Survey, DRAFT			38.282100°	38.281510°
				-121.716817°	-121.716319°
DWR ID	DWR_RD2060_03_s_2016_7				
Comment Code					
Inspector Comment					
2007 - Geotechnical failure of midside slope and wave wash/scalloping in toe area. Stone revetment upstream and downstream of site. Similar sites are present all along the right bank downstream of this site, most could be repaired with some maintenance. 2010 - Minor new erosion. 2015: No observed changes. [2015 Site ID: CHS_22-8_R]

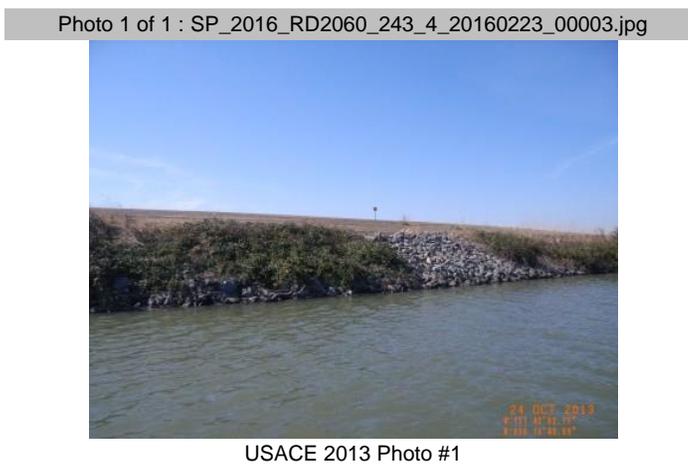
LM Start	<b>2.35</b>	Rating **	M	Issue No.	<b>4</b>
LM End	<b>2.53</b>	Issue Type +	Ma	Location *	WS
Category	Supplemental			GPS Latitude/Longitude	
				Start	End
Item	2015 USACE Erosion Survey, DRAFT			38.280377 °	38.278306 °
				-121.714633 °	-121.712722 °
DWR ID	DWR_RD2060_03_s_2016_4				
Comment Code					
Inspector Comment					
2008 - Small scour pockets and mid-slope wave wash. 2010 - More vegetation growth, could be fixed through maintenance. 2011 - Site extended downstream and new erosion. 2015: No observed changes. [2015 Site ID: CHS_22-6_R]

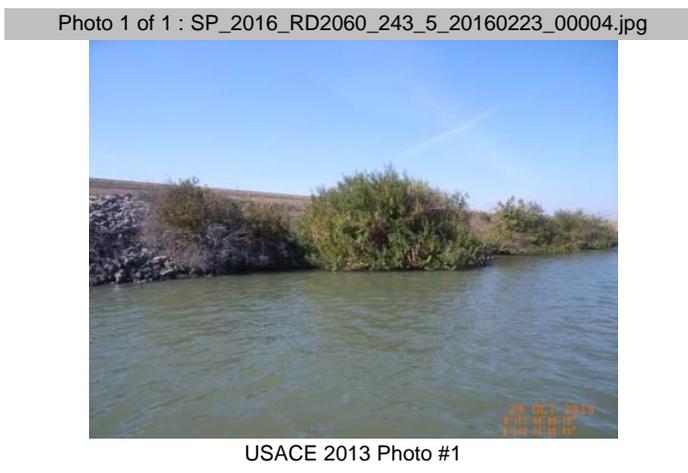
LM Start	<b>2.55</b>	Rating **	M	Issue No.	<b>5</b>
LM End	<b>2.58</b>	Issue Type +	Ma	Location *	WS
Category	Supplemental			GPS Latitude/Longitude	
				Start	End
Item	2015 USACE Erosion Survey, DRAFT			38.278145 °	38.277774 °
				-121.712609 °	-121.712137 °
DWR ID	DWR_RD2060_03_s_2016_5				
Comment Code					
Inspector Comment					
2013 - Erosion pockets into the levee toe. 2015: Erosion pockets have increased in size. [2015 Site ID: CHS_22-5_R]

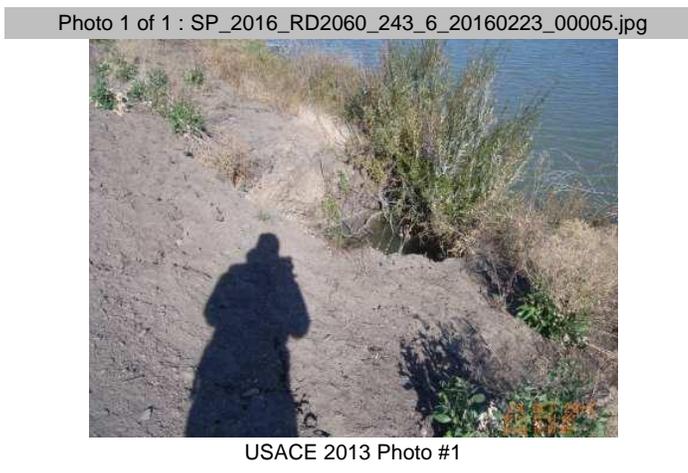
LM Start	<b>2.79</b>	Rating **	M	Issue No.	<b>6</b>
LM End	<b>2.79</b>	Issue Type +	Ma	Location *	LS
Category	Earthen Levee			GPS Latitude/Longitude	
				Start	End
Item	Slope Stability			38.275302 °	38.275302 °
				-121.710130 °	-121.710127 °
DWR ID	DWR_RD2060_03_s_2016_6				
Comment Code					
S1 : Repair slope instability.					
Inspector Comment

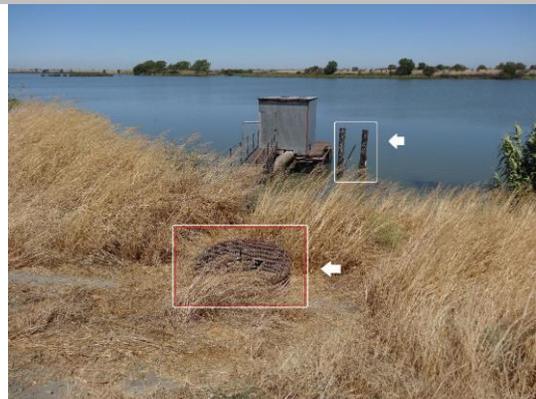
Photo 1 of 2 : UCIP\_SP\_2016\_18723\_31303.jpg

LM Start	<b>3.24</b>	Rating **	M	Issue No.	<b>15</b>
LM End	<b>3.24</b>	Issue Type +	En	Location *	WS
Category	Supplemental			GPS Latitude/Longitude	
				Start	End
Item	DWR UCIP Field Study			38.270151 °	38.270151 °
				-121.705782 °	-121.705782 °
DWR ID					
Comment Code					
Inspector Comment					
FS_ID:18723 DS_ID:22064 EP_NO: N/A Repair Type: Non-Urgent Crossing Status: Indicator Found UCIP Comments: Only a CMP riser was found on WS. FIELD_STRUCT_DESC: Only a CMP riser was found WS. All other features not found as described: 36-inch steel pipe through levee 15.0 feet below crown, slide gate in CM riser on waterward slope. (Asbestos bonded pipe.) Pump in pump house on pile structure in stream. Service pole and anchor on landward slope. Only a CMP riser was found WS. FS Date: 8/15/2013

WS view: slide gate in CMP riser (bottom- marked) and may be abandoned pile for pump support (marked- right).

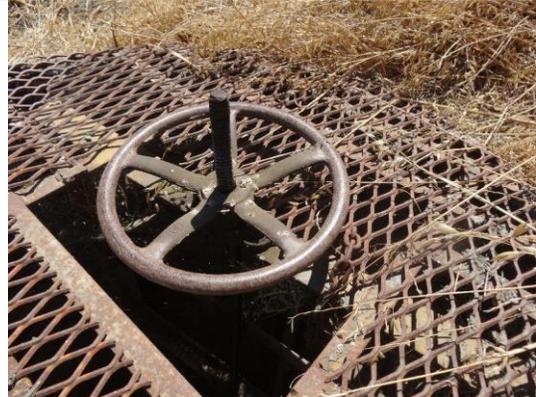
Photo 2 of 2 : UCIP\_SP\_2016\_18723\_31302.jpg

LM Start	<b>3.24</b>	Rating **	M	Issue No.	<b>15 (cont)</b>
LM End	<b>3.24</b>	Issue Type +	En	Location *	WS
Category	Supplemental			GPS Latitude/Longitude	
				Start	End
Item	DWR UCIP Field Study			38.270151 °	38.270151 °
				-121.705782 °	-121.705782 °
DWR ID					
Comment Code					
Inspector Comment					
FS_ID:18723 DS_ID:22064 EP_NO: N/A Repair Type: Non-Urgent Crossing Status: Indicator Found UCIP Comments: Only a CMP riser was found on WS. FIELD_STRUCT_DESC: Only a CMP riser was found WS. All other features not found as described: 36-inch steel pipe through levee 15.0 feet below crown, slide gate in CM riser on waterward slope. (Asbestos bonded pipe.) Pump in pump house on pile structure in stream. Service pole and anchor on landward slope. Only a CMP riser was found WS. FS Date: 8/15/2013

WS view: closer view of slide gate in CMP riser.

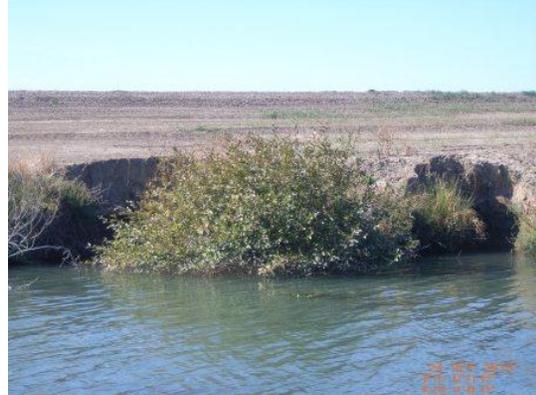
Photo 1 of 1 : SP\_2016\_RD2060\_243\_2\_20160223\_00002.jpg

LM Start	<b>3.78</b>	Rating **	M	Issue No.	<b>2</b>
LM End	<b>4.09</b>	Issue Type +	Ma	Location *	WS
Category	Supplemental			GPS Latitude/Longitude	
				Start	End
Item	2015 USACE Erosion Survey, DRAFT			38.264585 °	38.260593 °
				-121.698868 °	-121.696403 °
DWR ID	DWR_RD2060_03_s_2016_2				
Comment Code					
Inspector Comment					
2011 - Several pockets of erosion from rotational failure and slumping toe. 2013 - Site extended downstream to include new erosion pockets. 2015: No observed changes. [2015 Site ID: CHS_21-1_R]
