**Flood Control Project Maintenance
Levee Inspections**

Maintenance Issue Types Only, Levee Inspection Report By Mile - Spring 2015

Reclamation District No. 2060 Hastings

Waterway	Bank	Unit Miles	Inspection Start/End	Inspector
Unit No. 01 Lindsey Slough	Left	6.97	04/22/2015 04/22/2015	Herman Phillips

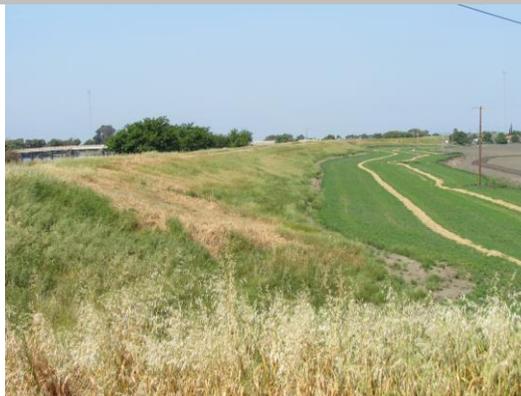
Photo 1 of 1 : SP_2015_RD2060_241_3_20150603_00002.jpg

LM Start	0.05	Rating **	A	Issue No.	3
LM End	6.97	Issue Type +	Ma	Location *	LS
Category	Earthen Levee		GPS Latitude/Longitude		
			Start	End	
Item	Vegetation		38.247298 °	38.274875 °	
			-121.697150 °	-121.794847 °	
DWR ID	DWR_RD2060_01_s_2015_3				
Action/Comments					
Control annual grass and weeds on the levee slopes and easements.

RD 2060 looking downstream landside levee slope.

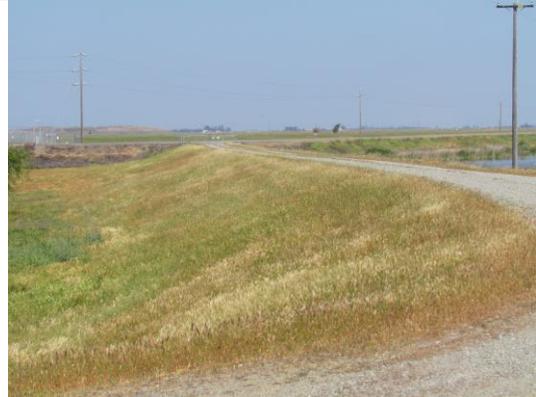
Photo 1 of 1 : SP_2015_RD2060_242_10_20150603_00006.jpg

LM Start	0.00	Rating **	A	Issue No.	10
LM End	3.64	Issue Type +	Ma	Location *	LS
Category	Earthen Levee		GPS Latitude/Longitude		
			Start	End	
Item	Vegetation		38.274841 °	38.296651 °	
			-121.794855 °	-121.748801 °	
DWR ID	DWR_RD2060_02_f_2014_10				
Action/Comments					
Control annual grass and weeds on the levee slopes and easements. Inspector Comments: Looking downstream from landside slope.

Looking downstream from landside levee slope.

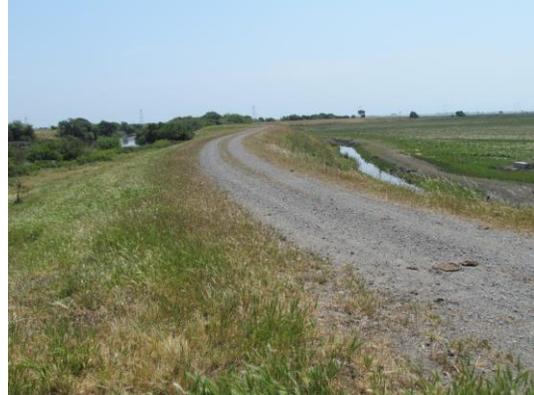
Photo 1 of 1 : SP_2015_RD2060_243_14_20150603_00011.jpg

LM Start	0.08	Rating **	M	Issue No.	14
LM End	0.08	Issue Type +	Ma	Location *	WS
Category	Earthen Levee		GPS Latitude/Longitude		
			Start	End	
Item	Vegetation		38.296283 °	38.296283 °	
			-121.747450 °	-121.747448 °	
DWR ID	DWR_RD2060_03_s_2015_14				
Action/Comments					
Control annual grass and weeds on the levee slopes and easements.

View of the vegetation on the levee slopes.

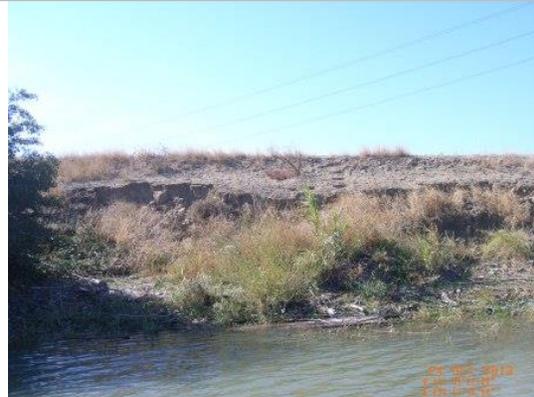
Photo 1 of 1 : SP_2015_RD2060_243_10_20150312_00007.jpg

LM Start	1.52	Rating **	M	Issue No.	10
LM End	1.74	Issue Type +	Ma	Location *	WS
Category	Supplemental		GPS Latitude/Longitude		
			Start	End	
Item	USACE Erosion Survey		38.288598 °	38.286051 °	
			-121.725184 °	-121.722818 °	
DWR ID	DWR_RD2060_03_f_2014_10				
Action/Comments					
Inspector Comments: Site added in 1997 and removed in 2003. 2005 - Put back in the inventory. 2006 - Stone repair at the middle of the site. 2011 - Some rock place at toe in the past year. 2013: Site extended both upstream and downstream to include new erosion pockets. [2013 Site ID: CHS_23-6_R]

USACE 2013 Photo #1

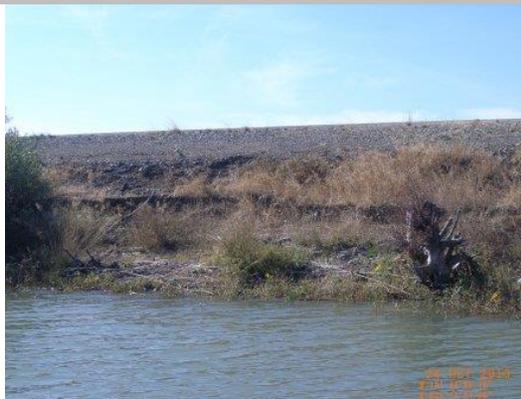
Photo 1 of 1 : SP_2015_RD2060_243_9_20150312_00006.jpg

LM Start	2.02	Rating **	M	Issue No.	9
LM End	2.08	Issue Type +	Ma	Location *	WS
Category	Supplemental		GPS Latitude/Longitude		
			Start	End	
Item	USACE Erosion Survey		38.284105 °	38.283302 °	
			-121.718471 °	-121.717814 °	
DWR ID	DWR_RD2060_03_f_2014_9				
Action/Comments					
Inspector Comments: 2010 - Small maintenance site. 2013: No observed changes. [2013 Site ID: CHS_23-0_R]

USACE 2013 Photo #1

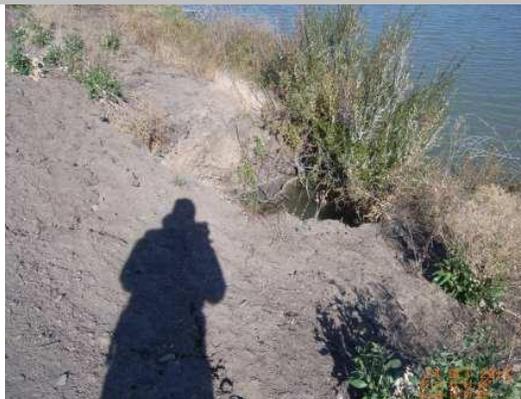
Photo 1 of 1 : SP_2015_RD2060_243_8_20150312_00005.jpg

LM Start	2.12	Rating **	M	Issue No.	8
LM End	2.17	Issue Type +	Ma	Location *	WS
Category	Supplemental		GPS Latitude/Longitude		
			Start	End	
Item	USACE Erosion Survey		38.282847 °	38.282245 °	
			-121.717549 °	-121.717058 °	
DWR ID	DWR_RD2060_03_f_2014_8				
Action/Comments					
Inspector Comments: 2013: Pockets of erosion behind willows. [2013 Site ID: CHS_22-9_R]

USACE 2013 Photo #1

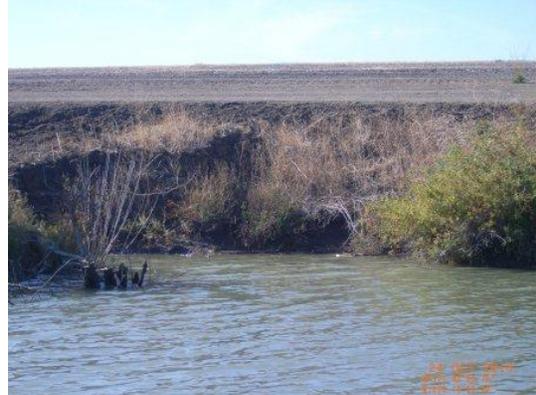
Photo 1 of 1 : SP_2015_RD2060_243_6_20150312_00004.jpg

LM Start	2.18	Rating **	M	Issue No.	6
LM End	2.23	Issue Type +	Ma	Location *	WS
Category	Supplemental			GPS Latitude/Longitude	
				Start	End
Item	USACE Erosion Survey			38.282069 °	38.281482 °
				-121.716891 °	-121.716356 °
DWR ID	DWR_RD2060_03_f_2014_6				
Action/Comments					
Inspector Comments: 2007 - Geotechnical failure of midside slope and wave wash/scalloping in toe area. Stone revetment upstream and downstream of site. Similar sites are present all along the right bank downstream of this site, most could be repaired with some maintenance. 2010 - Minor new erosion. 2013: No observed changes. [2013 Site ID: CHS_22-8_R]

USACE 2013 Photo #1

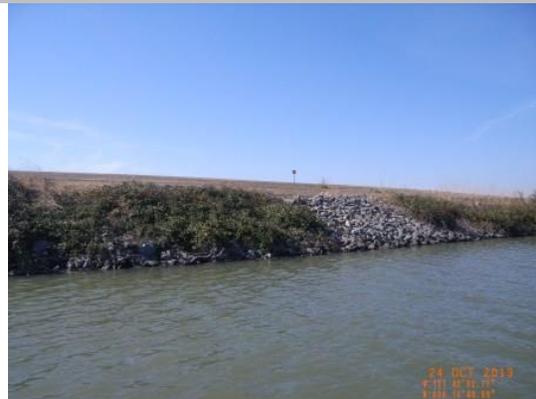
Photo 1 of 1 : SP_2015_RD2060_243_5_20150312_00003.jpg

LM Start	2.35	Rating **	M	Issue No.	5
LM End	2.53	Issue Type +	Ma	Location *	WS
Category	Supplemental			GPS Latitude/Longitude	
				Start	End
Item	USACE Erosion Survey			38.280356 °	38.278214 °
				-121.714697 °	-121.712857 °
DWR ID	DWR_RD2060_03_f_2014_5				
Action/Comments					
Inspector Comments: 2008 - Small scour pockets and mid-slope wave wash. 2010 - More vegetation growth, could be fixed through maintenance. 2011 - Site extended downstream and new erosion. 2013: No observed changes. [2013 Site ID: CHS_22-6_R]

USACE 2013 Photo #1

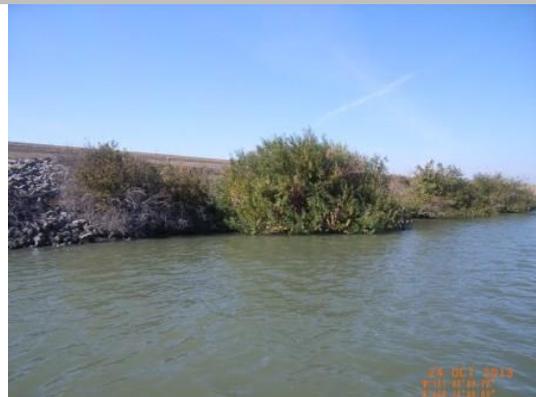
Photo 1 of 1 : SP_2015_RD2060_243_4_20150312_00002.jpg

LM Start	2.55	Rating **	M	Issue No.	4
LM End	2.58	Issue Type +	Ma	Location *	WS
Category	Supplemental			GPS Latitude/Longitude	
				Start	End
Item	USACE Erosion Survey			38.278109 °	38.277754 °
				-121.712671 °	-121.712144 °
DWR ID	DWR_RD2060_03_f_2014_4				
Action/Comments					
Inspector Comments: 2013: Erosion pockets into the levee toe. [2013 Site ID: CHS_22-5_R]

USACE 2013 Photo #1

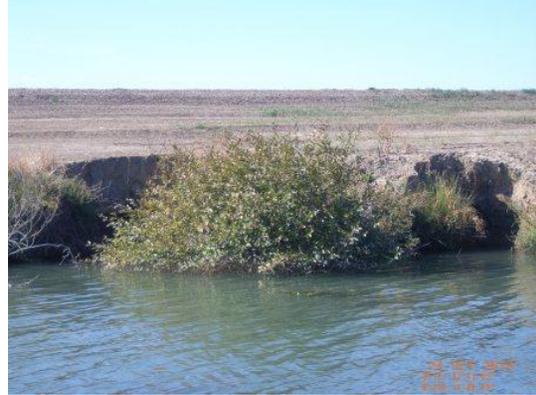
Photo 1 of 1 : SP_2015_RD2060_243_1_20150312_00001.jpg

LM Start	3.78	Rating **	M	Issue No.	1
LM End	4.09	Issue Type +	Ma	Location *	WS
Category	Supplemental			GPS Latitude/Longitude	
				Start	End
Item	USACE Erosion Survey			38.264585 °	38.260593 °
				-121.698868 °	-121.696403 °
DWR ID	DWR_RD2060_03_f_2014_1				
Action/Comments					
Inspector Comments: 2011 - Several pockets of erosion from rotational failure and slumping toe. 2013: Site extended downstream to include new erosion pockets. [2013 Site ID: CHS_21-1_R]

USACE 2013 Photo #1
