**Flood Control Project Maintenance
Levee Inspections**

Maintenance Issue Types Only, Levee Inspection Report By Mile - Spring 2016

Reclamation District No. 2060 Hastings

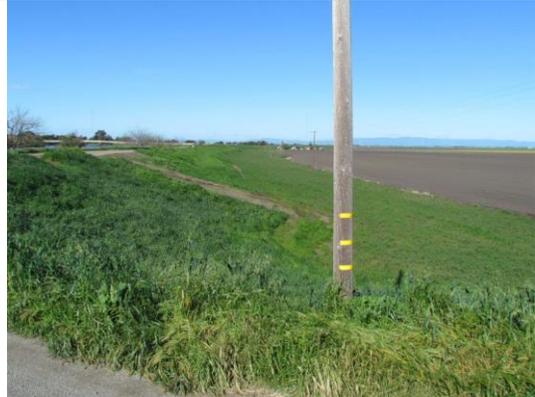
Photo 1 of 1 : SP_2016_RD2060_241_10_20160328_00006.jpg

LM Start	0.05	Rating **	M	Issue No.	10
LM End	2.03	Issue Type +	Ma	Location *	LS
Category	Earthen Levee		GPS Latitude/Longitude		
			Start	End	
Item	Vegetation		38.247232 °	38.258917 °	
			-121.697075 °	-121.725188 °	
DWR ID	DWR_RD2060_01_s_2016_10				
Comment Code					
V1 : Control annual grass and weeds on the levee slopes and easements.					
Inspector Comment

Looking downstream from levee mile 0.00 Unit 1 RD 2060. Weeds present on the landside slope.

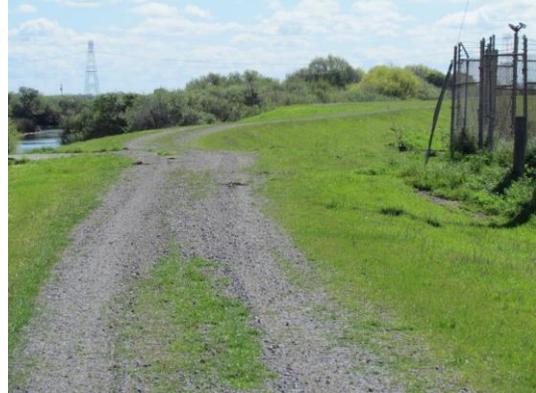
Photo 1 of 1 : SP_2016_RD2060_243_13_20160328_00016.jpg

LM Start	0.61	Rating **	A	Issue No.	13
LM End	1.44	Issue Type +	Ma	Location *	LS
Category	Earthen Levee		GPS Latitude/Longitude		
			Start	End	
Item	Vegetation		38.292018 °	38.289470 °	
			-121.740227 °	-121.726227 °	
DWR ID	DWR_RD2060_03_s_2016_13				
Comment Code					
V1 : Control annual grass and weeds on the levee slopes and easements.					
Inspector Comment					
No unwanted weeds present on the levee section 0.61-1.41.

Looking downstream from levee mile 0.61 -1.44 Unit 3 RD 2060.

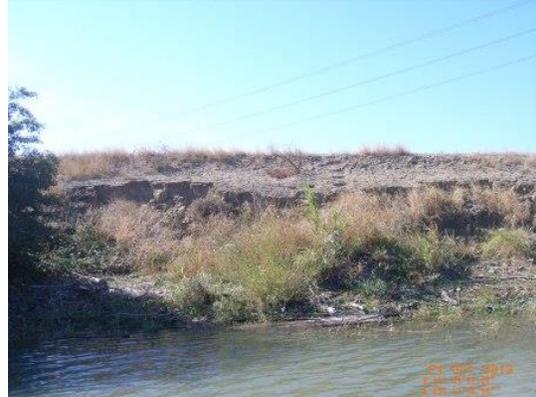
Photo 1 of 1 : SP_2016_RD2060_243_8_20160223_00007.jpg

LM Start	1.52	Rating **	M	Issue No.	8
LM End	1.74	Issue Type +	Ma	Location *	WS
Category	Supplemental		GPS Latitude/Longitude		
			Start	End	
Item	2015 USACE Erosion Survey, DRAFT		38.288598 °	38.286051 °	
			-121.725184 °	-121.722818 °	
DWR ID	DWR_RD2060_03_s_2016_8				
Comment Code					
Inspector Comment					
Site added in 1997 and removed in 2003. 2005 - Put back in the inventory. 2006 - Stone repair at the middle of the site. 2011 - Some rock place at toe in the past year. 2013 - Site extended both upstream and downstream to include new erosion pockets. 2015: No observed changes. [2015 Site ID: CHS_23-6_R]

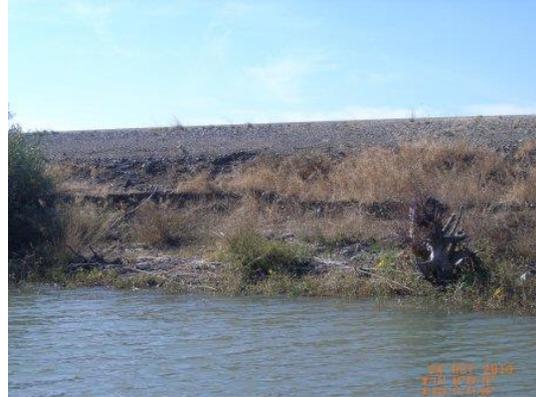
Photo 1 of 1 : SP_2016_RD2060_243_1_20160223_00001.jpg

LM Start	2.02	Rating **	M	Issue No.	1
LM End	2.08	Issue Type +	Ma	Location *	WS
Category	Supplemental		GPS Latitude/Longitude		
			Start	End	
Item	2015 USACE Erosion Survey, DRAFT		38.284105 °	38.283302 °	
			-121.718471 °	-121.717814 °	
DWR ID	DWR_RD2060_03_s_2016_1				
Comment Code					
Inspector Comment					
2010 - Small maintenance site. 2015: No observed changes. [2015 Site ID: CHS_23-0_R]

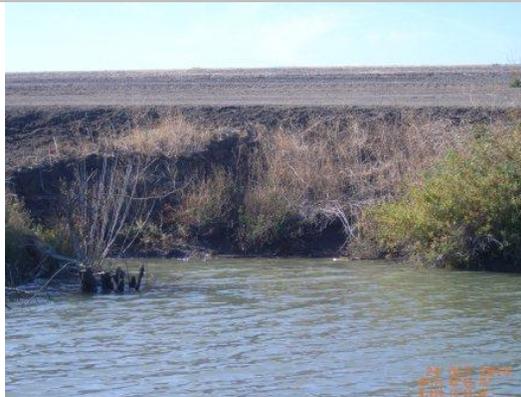
Photo 1 of 1 : SP_2016_RD2060_243_7_20160223_00006.jpg

LM Start	2.18	Rating **	M	Issue No.	7
LM End	2.23	Issue Type +	Ma	Location *	WS
Category	Supplemental			GPS Latitude/Longitude	
				Start	End
Item	2015 USACE Erosion Survey, DRAFT			38.282100°	38.281510°
				-121.716817°	-121.716319°
DWR ID	DWR_RD2060_03_s_2016_7				
Comment Code					
Inspector Comment					
2007 - Geotechnical failure of midside slope and wave wash/scalloping in toe area. Stone revetment upstream and downstream of site. Similar sites are present all along the right bank downstream of this site, most could be repaired with some maintenance. 2010 - Minor new erosion. 2015: No observed changes. [2015 Site ID: CHS_22-8_R]

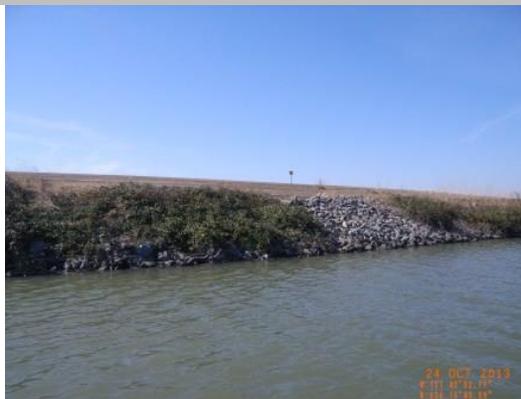
Photo 1 of 1 : SP_2016_RD2060_243_4_20160223_00003.jpg

LM Start	2.35	Rating **	M	Issue No.	4
LM End	2.53	Issue Type +	Ma	Location *	WS
Category	Supplemental			GPS Latitude/Longitude	
				Start	End
Item	2015 USACE Erosion Survey, DRAFT			38.280377°	38.278306°
				-121.714633°	-121.712722°
DWR ID	DWR_RD2060_03_s_2016_4				
Comment Code					
Inspector Comment					
2008 - Small scour pockets and mid-slope wave wash. 2010 - More vegetation growth, could be fixed through maintenance. 2011 - Site extended downstream and new erosion. 2015: No observed changes. [2015 Site ID: CHS_22-6_R]

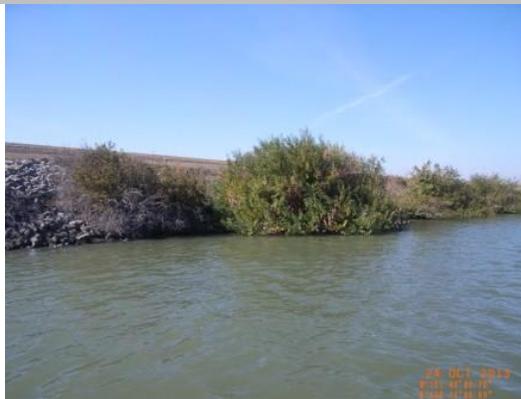
Photo 1 of 1 : SP_2016_RD2060_243_5_20160223_00004.jpg

LM Start	2.55	Rating **	M	Issue No.	5
LM End	2.58	Issue Type +	Ma	Location *	WS
Category	Supplemental			GPS Latitude/Longitude	
				Start	End
Item	2015 USACE Erosion Survey, DRAFT			38.278145°	38.277774°
				-121.712609°	-121.712137°
DWR ID	DWR_RD2060_03_s_2016_5				
Comment Code					
Inspector Comment					
2013 - Erosion pockets into the levee toe. 2015: Erosion pockets have increased in size. [2015 Site ID: CHS_22-5_R]

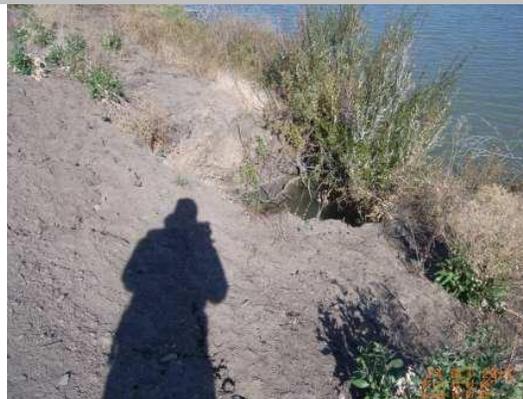
Photo 1 of 1 : SP_2016_RD2060_243_6_20160223_00005.jpg

LM Start	2.79	Rating **	M	Issue No.	6
LM End	2.79	Issue Type +	Ma	Location *	LS
Category	Earthen Levee		GPS Latitude/Longitude		
			Start	End	
Item	Slope Stability		38.275302°	38.275302°	
			-121.710130°	-121.710127°	
DWR ID	DWR_RD2060_03_s_2016_6				
Comment Code					
S1 : Repair slope instability.					
Inspector Comment
