**Flood Control Project Maintenance  
Levee Inspections**  
**LMA District Cover Sheet**  
**Spring 2009 Levee Inspection Results**

**Reclamation District No. 2062**

**Levee Inspection Report By Mile - Spring 2009**

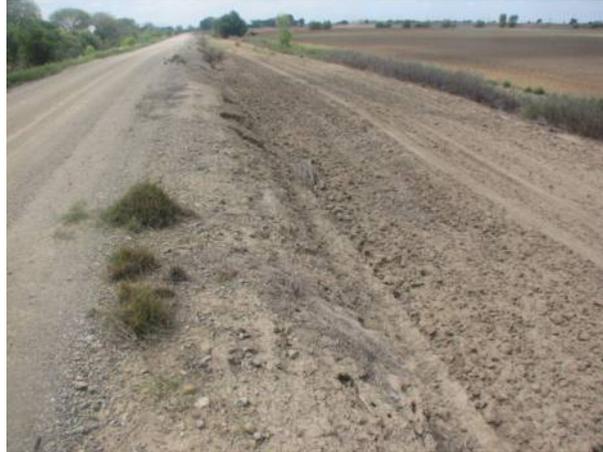
Levee Mile Report Line	4
Start Levee Mile	2.54
End Levee Mile	3.94
Location	Land Side
Category	Earthen Levee
Item	Encroachments
Looking downstream at landside toe agricultural tilling.

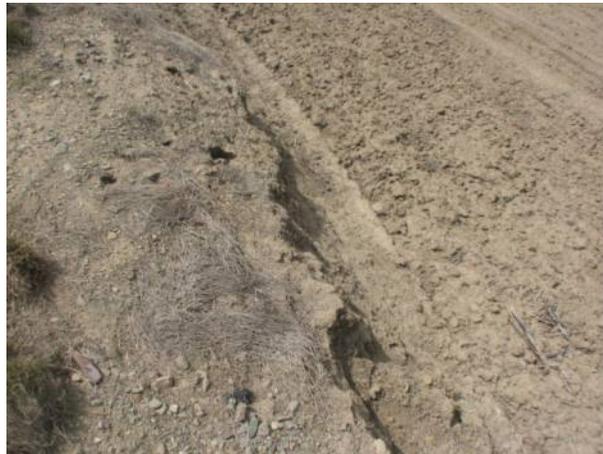
Levee Mile Report Line	4
Start Levee Mile	2.54
End Levee Mile	3.94
Location	Land Side
Category	Earthen Levee
Item	Encroachments
Looking from the top of levee at tilling on landside toe.

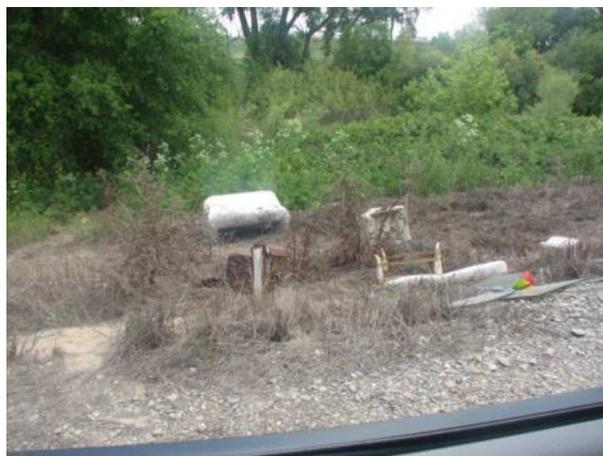
Levee Mile Report Line	5
Start Levee Mile	2.81
End Levee Mile	2.81
Location	Water Side
Category	Earthen Levee
Item	Encroachments
Garbage on waterside toe & berm

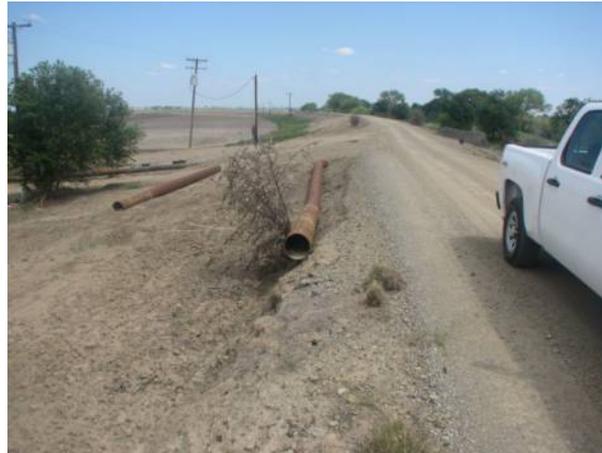
Levee Mile Report Line	6
Start Levee Mile	3.29
End Levee Mile	3.29
Location	Land Side
Category	Earthen Levee
Item	Encroachments
Looking upstream at abandoned pipe on landside shoulder.

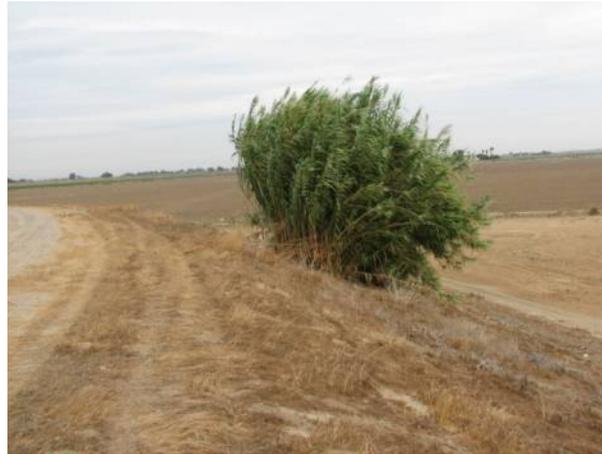
Levee Mile Report Line	5
Start Levee Mile	0.41
End Levee Mile	0.41
Location	Land Side
Category	Earthen Levee
Item	Vegetation
RD 2062: LS bush/tree that should be removed ASAP. This levee is in great condition, would not want this vegetation to spread.
