**Flood Control Project Maintenance
Levee Inspections**
LMA District Cover Sheet
Spring 2010 Levee Inspection Results

Reclamation District No. 2062 Stewart

Levee Inspection Report By Mile - Spring 2010

Waterway					Bank	Unit Miles	Inspection Start/End	Inspector
Unit No. 01 San Joaquin River					Left	2.69	05/04/2010 05/04/2010	John Paasch

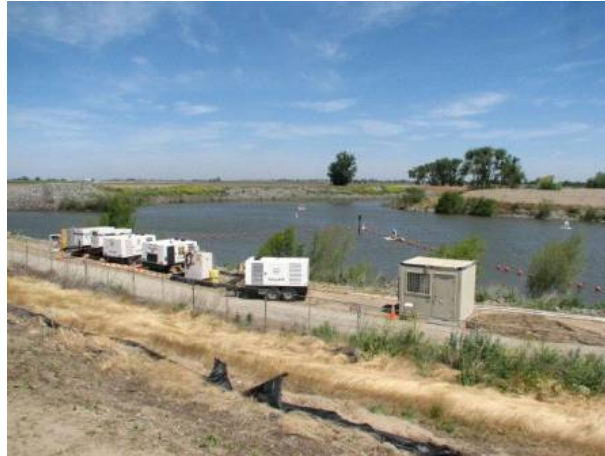
Levee Mile Report Line	2
Start Levee Mile	0.06
End Levee Mile	0.06
Location	Water Side
Category	Earthen Levee
Item	Encroachments
DFG fish screen at Old River and San Joaquin River junction.	
jpaasch_s_20100510_393.jpg

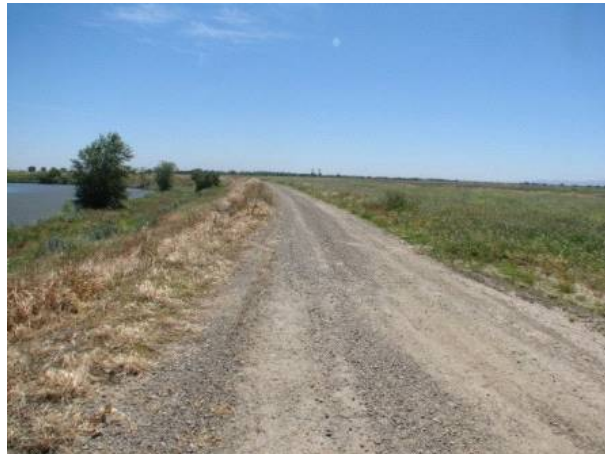
Levee Mile Report Line	3
Start Levee Mile	0.13
End Levee Mile	1.51
Location	Land Side
Category	Earthen Levee
Item	Vegetation
Annual grasses on levee slope.	
jpaasch_s_20100510_394.jpg

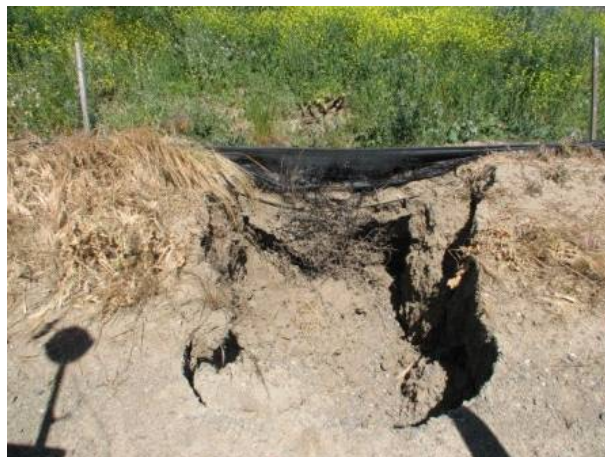
Levee Mile Report Line	5
Start Levee Mile	0.49
End Levee Mile	0.49
Location	Water Side
Category	Earthen Levee
Item	Erosion / Bank Caving
Erosion at waterside hinge point has created a large cavity.	
jpaasch_s_20100510_395.jpg

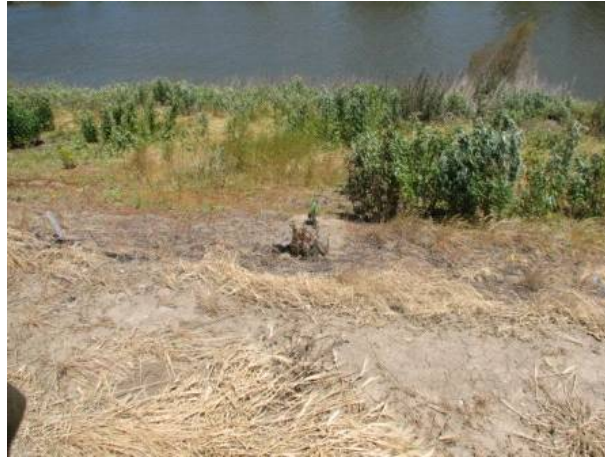
Levee Mile Report Line	6
Start Levee Mile	0.81
End Levee Mile	0.81
Location	Water Side
Category	Earthen Levee
Item	Trim / Thin Trees

Tree stump on levee slope.

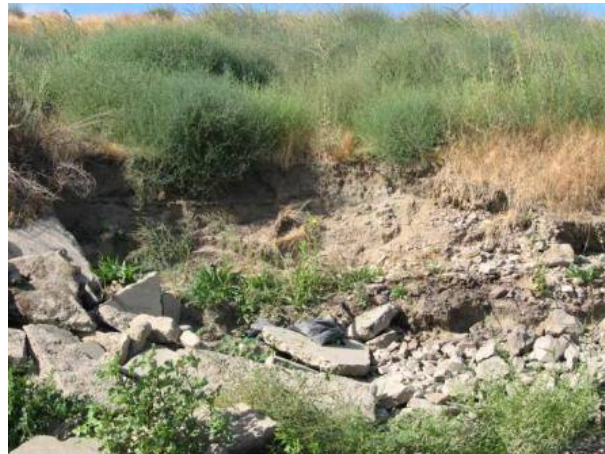
Levee Mile Report Line	8
Start Levee Mile	0.91
End Levee Mile	0.91
Location	Water Side
Category	Supplemental
Item	DWR Erosion Survey

2009: landside ground surface has been raised to the height of the levee crown; sloughing of the existing rip rap revetment on the lower slope, creating a pocket; site # is the same as RM54.34, LM1.08; previously rated "M" [2009 SiteID:RD2062U1RM54.14]

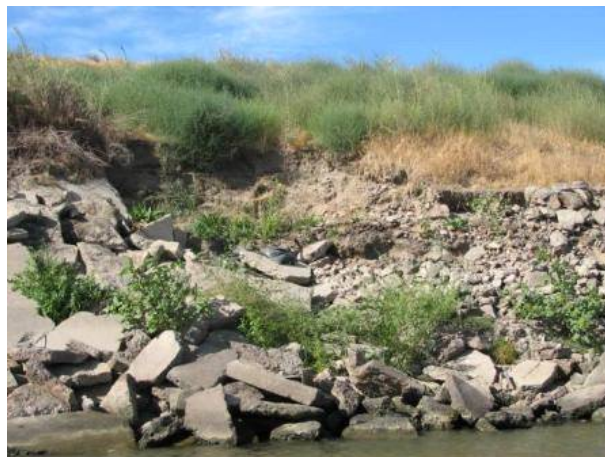
Levee Mile Report Line	8
Start Levee Mile	0.91
End Levee Mile	0.91
Location	Water Side
Category	Supplemental
Item	DWR Erosion Survey

2009: landside ground surface has been raised to the height of the levee crown; sloughing of the existing rip rap revetment on the lower slope, creating a pocket; site # is the same as RM54.34, LM1.08; previously rated "M" [2009 SiteID:RD2062U1RM54.14]

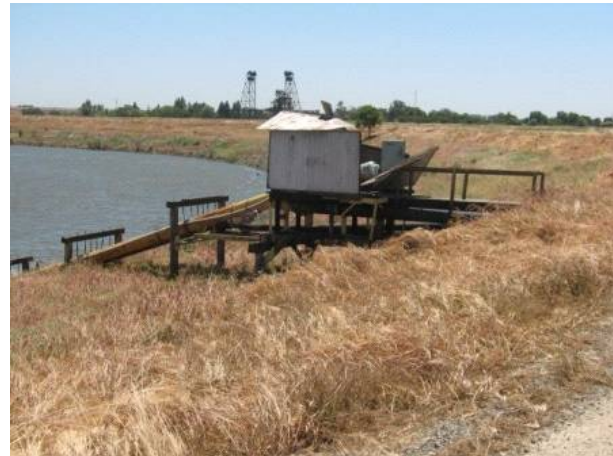
Levee Mile Report Line	10
Start Levee Mile	1.67
End Levee Mile	1.67
Location	Water Side
Category	Earthen Levee
Item	Encroachments

Intake pipe and pump house on San Joaquin River.

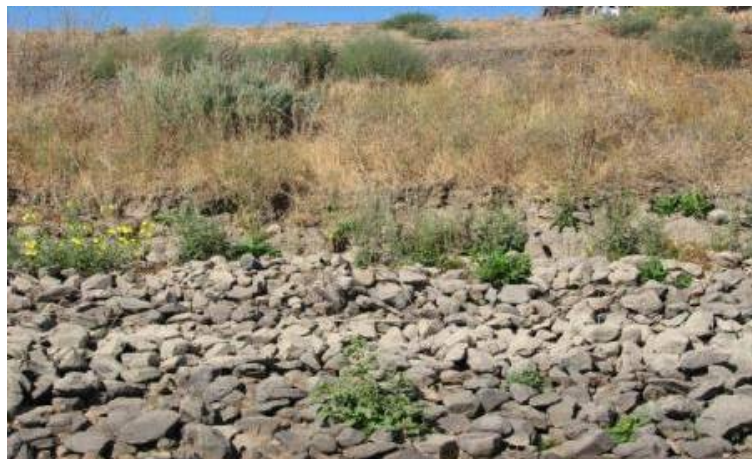
Levee Mile Report Line	13
Start Levee Mile	2.24
End Levee Mile	2.26
Location	Water Side
Category	Supplemental
Item	DWR Erosion Survey

2009: Portion of the rip rap has slipped, leaving an exposed section; there is dense vegetation surrounding site; landside ground surface has been raised to height of levee crown; site # same as RM55.75, LM2.25; previously rated "U" [2009 SiteID:RD2062U1RM55.57]

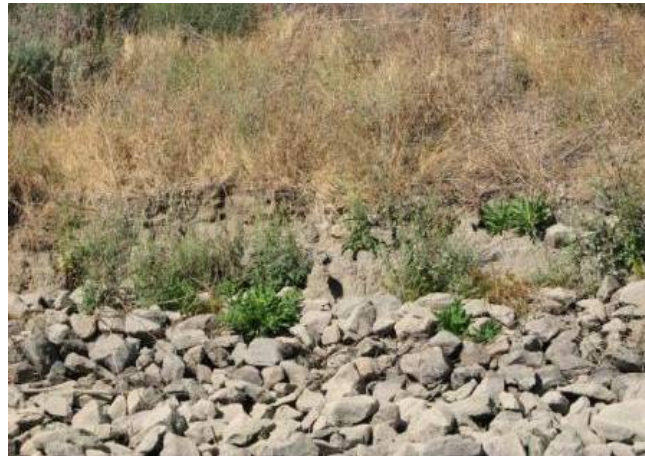
Levee Mile Report Line	13
Start Levee Mile	2.24
End Levee Mile	2.26
Location	Water Side
Category	Supplemental
Item	DWR Erosion Survey

2009: Portion of the rip rap has slipped, leaving an exposed section; there is dense vegetation surrounding site; landside ground surface has been raised to height of levee crown; site # same as RM55.75, LM2.25; previously rated "U" [2009 SiteID:RD2062U1RM55.57]

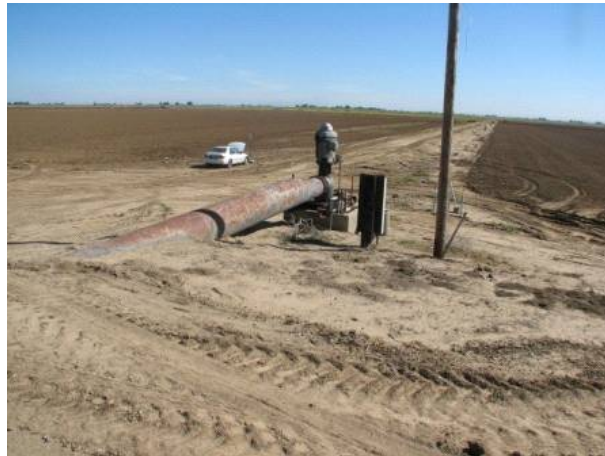
Levee Mile Report Line	3
Start Levee Mile	0.57
End Levee Mile	0.57
Location	Land Side
Category	Earthen Levee
Item	Encroachments

Drainage discharge into Paradise Cut.

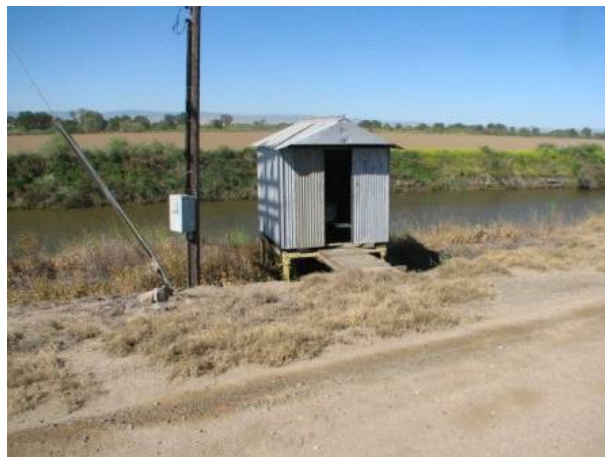
Levee Mile Report Line	5
Start Levee Mile	0.76
End Levee Mile	0.76
Location	Water Side
Category	Earthen Levee
Item	Encroachments

Irrigation intake from Paradise Cut.

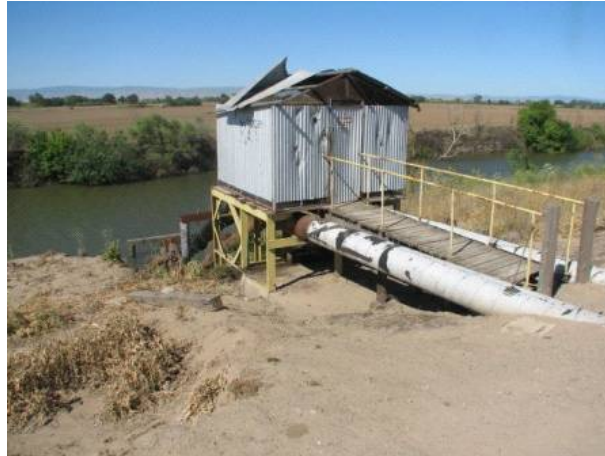
Levee Mile Report Line	8
Start Levee Mile	1.67
End Levee Mile	1.67
Location	Water Side
Category	Earthen Levee
Item	Encroachments
Twin irrigation intake pumps and pipe from Paradise Cut.	
jpaasch_s_20100510_373.jpg

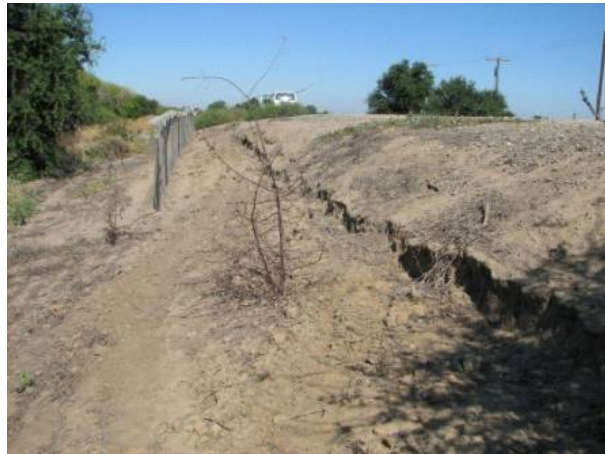
Levee Mile Report Line	15
Start Levee Mile	3.27
End Levee Mile	3.28
Location	Water Side
Category	Supplemental
Item	DWR Erosion Survey
2009: 1-2 ft of vertical scarp on the levee toe; damage was most likely caused by agricultural equipment during clearing operation; maintenance issue [2009 SiteID:RD2062U2RM2.14]	
SJR2009_RM2.14U2 072709a.jpg

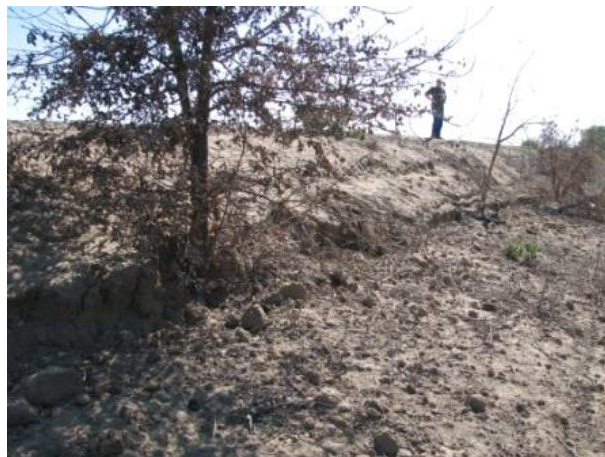
Levee Mile Report Line	15
Start Levee Mile	3.27
End Levee Mile	3.28
Location	Water Side
Category	Supplemental
Item	DWR Erosion Survey
2009: 1-2 ft of vertical scarp on the levee toe; damage was most likely caused by agricultural equipment during clearing operation; maintenance issue [2009 SiteID:RD2062U2RM2.14]	
SJR2009_RM2.14U2 072709B.jpg

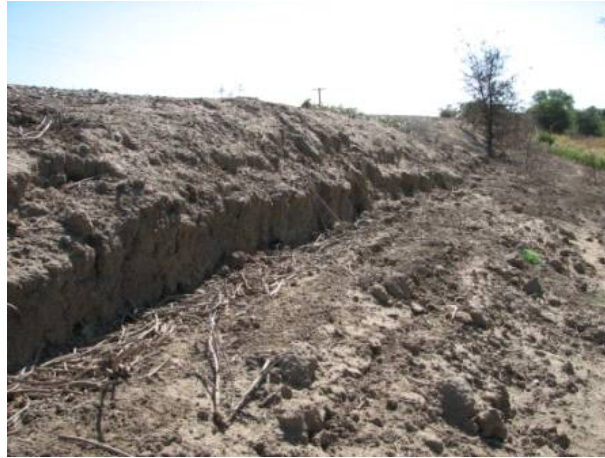
2009: 1-2 ft of vertical scarp on the levee toe; damage was most likely caused by agricultural equipment during clearing operation; maintenance issue [2009 SiteID:RD2062U2RM2.14]

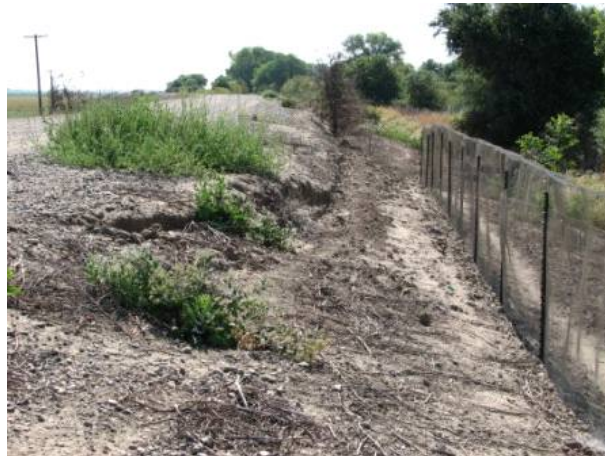
Levee Mile Report Line	15
Start Levee Mile	3.27
End Levee Mile	3.28
Location	Water Side
Category	Supplemental
Item	DWR Erosion Survey

2009: 1-2 ft of vertical scarp on the levee toe; damage was most likely caused by agricultural equipment during clearing operation; maintenance issue [2009 SiteID:RD2062U2RM2.14]

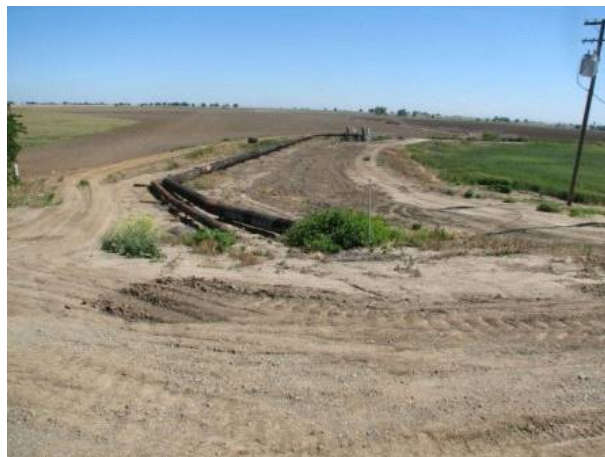
Levee Mile Report Line	16
Start Levee Mile	3.30
End Levee Mile	3.30
Location	Land Side
Category	Earthen Levee
Item	Encroachments

Drainage discharge pipes into Paradise Cut.

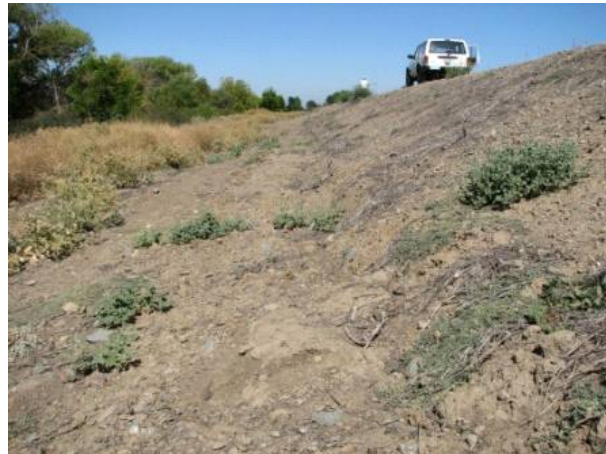
Levee Mile Report Line	17
Start Levee Mile	3.44
End Levee Mile	3.53
Location	Water Side
Category	Supplemental
Item	DWR Erosion Survey

2009: 1-2 ft. of vertical scarp on levee toe; damage was most likely caused by farming equipment during clearing operation; [2009 SiteID:RD2062U2RM1.94]

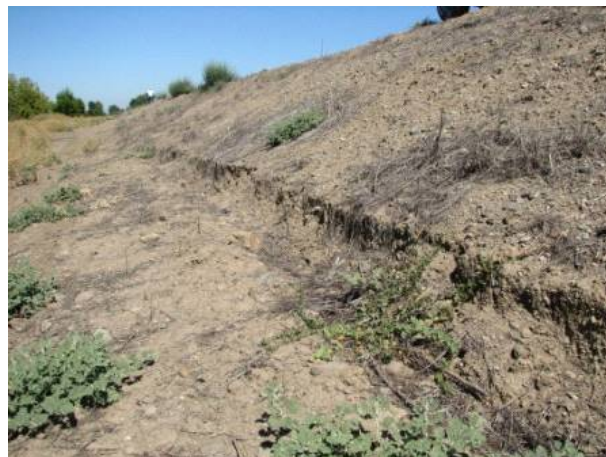
Levee Mile Report Line	17
Start Levee Mile	3.44
End Levee Mile	3.53
Location	Water Side
Category	Supplemental
Item	DWR Erosion Survey

2009: 1-2 ft. of vertical scarp on levee toe; damage was most likely caused by farming equipment during clearing operation; [2009 SiteID:RD2062U2RM1.94]

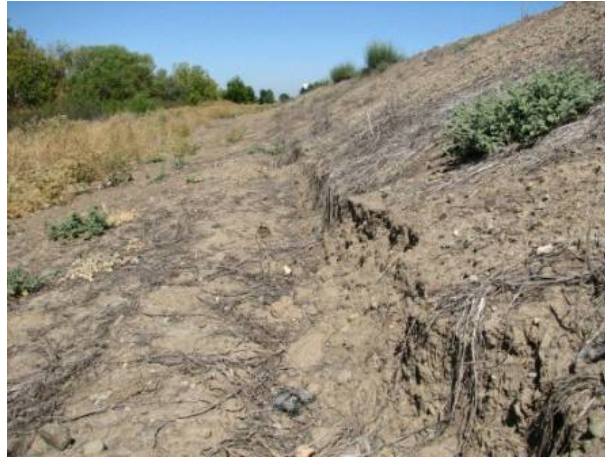
2009: 1-2 ft. of vertical scarp on levee toe; damage was most likely caused by farming equipment during clearing operation; [2009 SiteID:RD2062U2RM1.94]

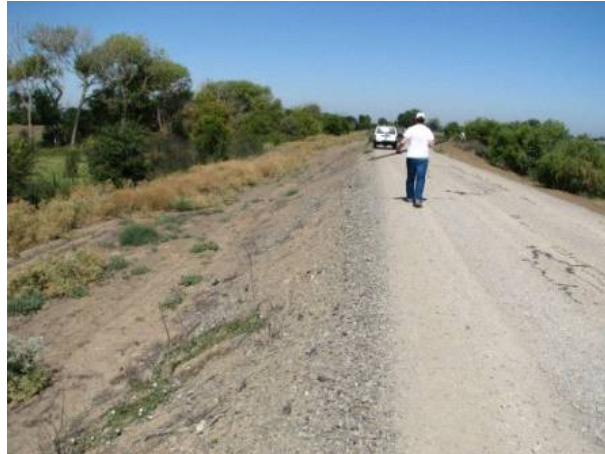
Levee Mile Report Line	17
Start Levee Mile	3.44
End Levee Mile	3.53
Location	Water Side
Category	Supplemental
Item	DWR Erosion Survey

2009: 1-2 ft. of vertical scarp on levee toe; damage was most likely caused by farming equipment during clearing operation; [2009 SiteID:RD2062U2RM1.94]

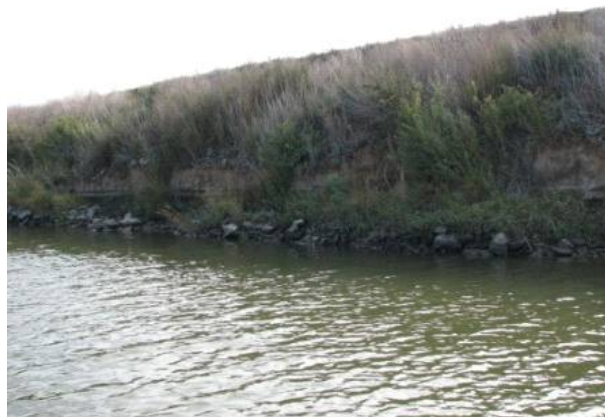
Levee Mile Report Line	3
Start Levee Mile	0.23
End Levee Mile	0.32
Location	Water Side
Category	Supplemental
Item	DWR Erosion Survey

2009: No major change observed; pocket erosion & vertical scarp; site was combined with RM 30.13 and 30.02 with total erosion length of 465 ft; recommend annual assessment & monitoring of site, per CLRO CES Evaluation 2008 Report; previously rated "M" [2009 SiteID:RD2062U3RM30.19]

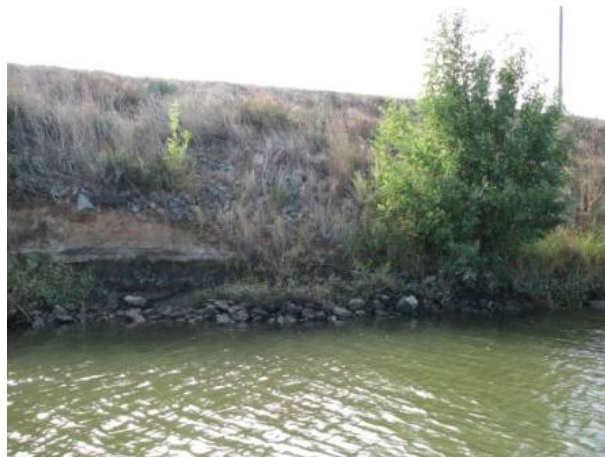
Levee Mile Report Line	3
Start Levee Mile	0.23
End Levee Mile	0.32
Location	Water Side
Category	Supplemental
Item	DWR Erosion Survey

2009: No major change observed; pocket erosion & vertical scarp; site was combined with RM 30.13 and 30.02 with total erosion length of 465 ft; recommend annual assessment & monitoring of site, per CLRO CES Evaluation 2008 Report; previously rated "M" [2009 SiteID:RD2062U3RM30.19]

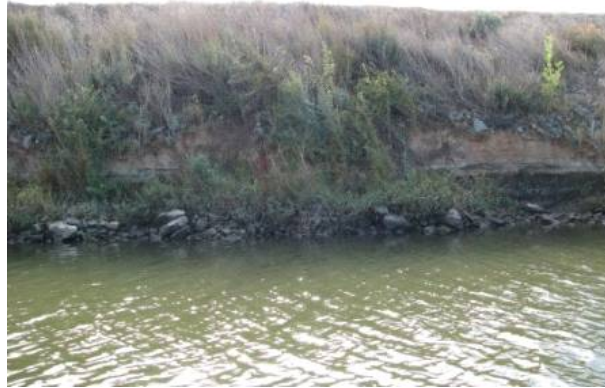
2009: No major change observed; pocket erosion & vertical scarp; site was combined with RM 30.13 and 30.02 with total erosion length of 465 ft; recommend annual assessment & monitoring of site, per CLRO CES Evaluation 2008 Report; previously rated "M" [2009 SiteID:RD2062U3RM30.19]

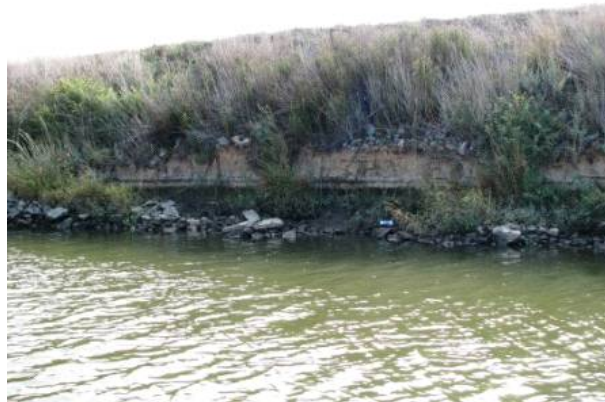
Levee Mile Report Line	3
Start Levee Mile	0.23
End Levee Mile	0.32
Location	Water Side
Category	Supplemental
Item	DWR Erosion Survey

2009: No major change observed; pocket erosion & vertical scarp; site was combined with RM 30.13 and 30.02 with total erosion length of 465 ft; recommend annual assessment & monitoring of site, per CLRO CES Evaluation 2008 Report; previously rated "M" [2009 SiteID:RD2062U3RM30.19]

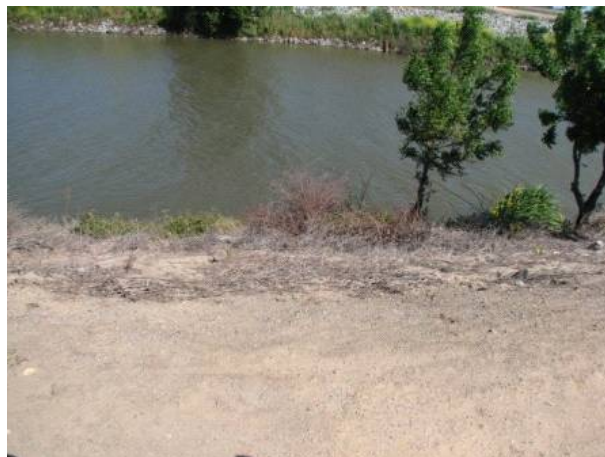
Levee Mile Report Line	5
Start Levee Mile	0.30
End Levee Mile	0.30
Location	Water Side
Category	Earthen Levee
Item	Trim / Thin Trees

Tree stumps on levee slope.

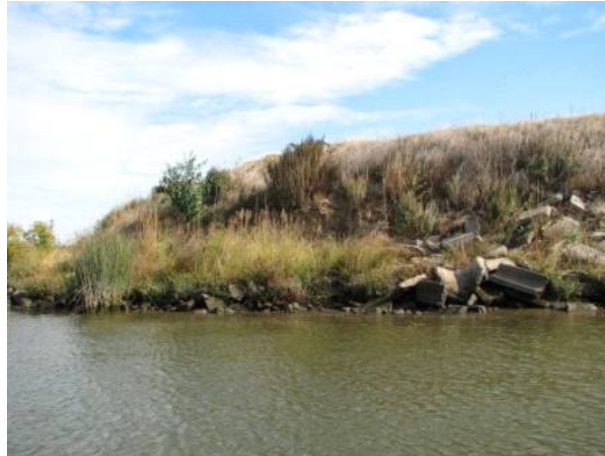
2009; no major change observed; section of the rip rap has slipped, exposing a levee section that has eroded; recommend as local maintenance issue, per CLRO CES Evaluation 2008 Report; site # same as RM30.43,LM0.63; previously rated "U" [2009 SiteID:RD2062U3RM30.43]

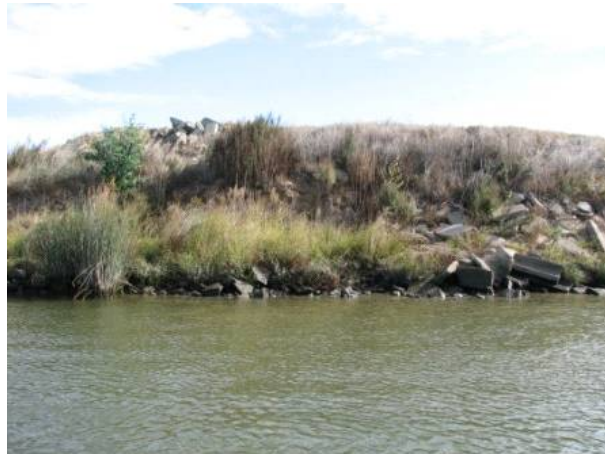
Levee Mile Report Line	7
Start Levee Mile	0.56
End Levee Mile	0.57
Location	Water Side
Category	Supplemental
Item	DWR Erosion Survey

2009; no major change observed; section of the rip rap has slipped, exposing a levee section that has eroded; recommend as local maintenance issue, per CLRO CES Evaluation 2008 Report; site # same as RM30.43,LM0.63; previously rated "U" [2009 SiteID:RD2062U3RM30.43]

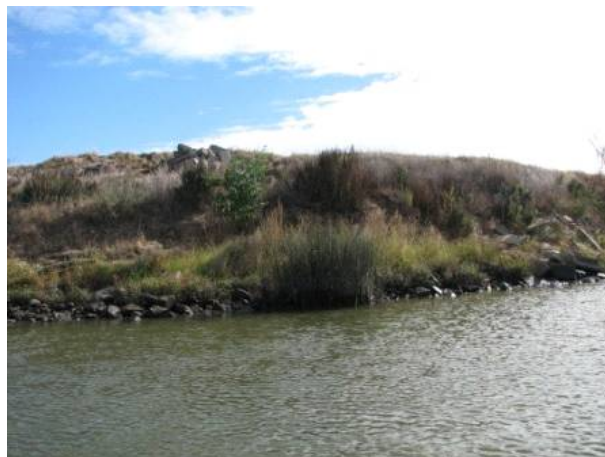
Levee Mile Report Line	7
Start Levee Mile	0.56
End Levee Mile	0.57
Location	Water Side
Category	Supplemental
Item	DWR Erosion Survey

2009; no major change observed; section of the rip rap has slipped, exposing a levee section that has eroded; recommend as local maintenance issue, per CLRO CES Evaluation 2008 Report; site # same as RM30.43,LM0.63; previously rated "U" [2009 SiteID:RD2062U3RM30.43]

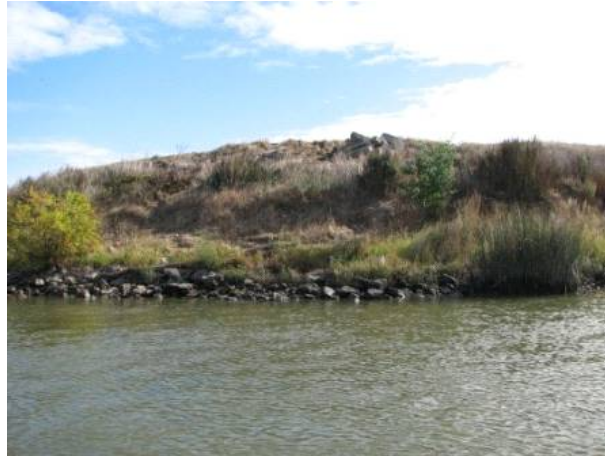
2009; no major change observed; section of the rip rap has slipped, exposing a levee section that has eroded; recommend as local maintenance issue, per CLRO CES Evaluation 2008 Report; site # same as RM30.43, LM0.63; previously rated "U" [2009 SiteID:RD2062U3RM30.43]

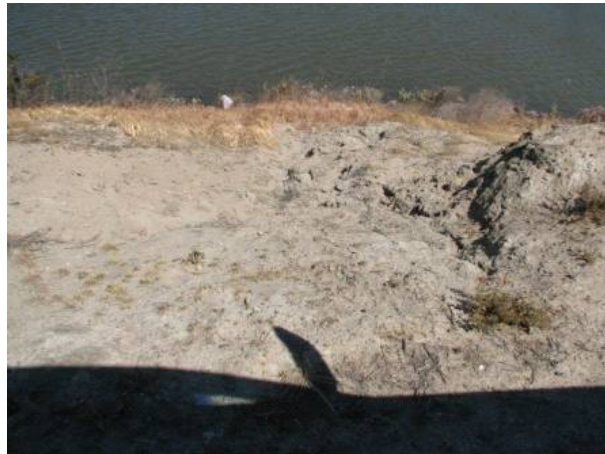
Levee Mile Report Line	11
Start Levee Mile	0.82
End Levee Mile	0.82
Location	Water Side
Category	Earthen Levee
Item	Erosion / Bank Caving

9	0.72	0.72	Earthen Levee	Erosion / Bank Caving	WS	M	Inspector Comments: Surface erosion of levee slope next to rock slope protection. Likely due to crown runoff.	37.816483 ° -121.380524 °	37.816483 ° -121.380524 °	12
10	0.78	0.82	Earthen Levee	Animal Control	WS	M	No rodents visible, but rodent burrows visible; need to backfill and compact or grout borrows.	37.815611 ° -121.381606 °	37.816314 ° -121.381590 °	10
11	0.82	0.82	Earthen Levee	Erosion / Bank Caving	WS	M	Schedule repair of erosion site prior to the next inspection.	37.816315 ° -121.381587 °	37.816315 ° -121.381587 °	11 Y
12	1.06	1.06	Earthen Levee	Animal Control	LS	M	No rodents visible, but rodent burrows visible; need to backfill and compact or grout borrows.	37.819371 ° -121.377999 °	37.819371 ° -121.377999 °	948
13	1.08	1.11	Earthen Levee	Animal Control	LS	C	No rodents visible, but rodent burrows visible; need to backfill and compact or grout borrows.	37.818127 ° -121.378739 °	37.818604 ° -121.378986 °	949

Slope erosion from crown runoff.

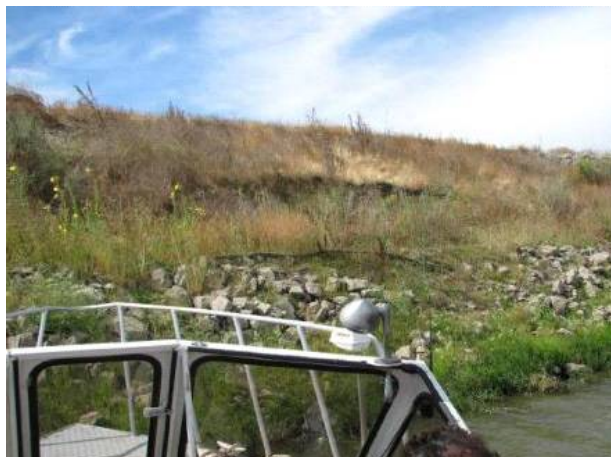
Levee Mile Report Line	14
Start Levee Mile	1.20
End Levee Mile	1.21
Location	Water Side
Category	Supplemental
Item	DWR Erosion Survey

2009: No major change observed; section of rip rap has slipped, creating a terraced effect; dense vegetation growth recommend as a local maintenance issue, per CLRO CES Evaluation 2008 Report; site # same as RM31.12, LM1.25; previously rated U [2009 SiteID:RD2062U3RM31.12]

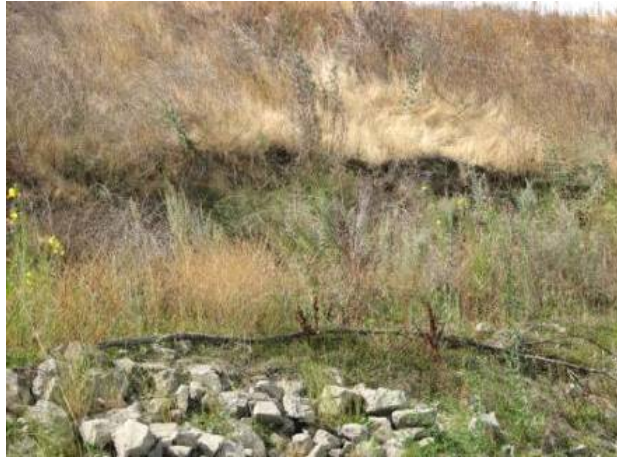
2009: No major change observed; section of rip rap has slipped, creating a terraced effect; dense vegetation growth recommend as a local maintenance issue, per CLRO CES Evaluation 2008 Report; site # same as RM31.12,LM1.25; previously rated U [2009 SiteID:RD2062U3RM31.12]

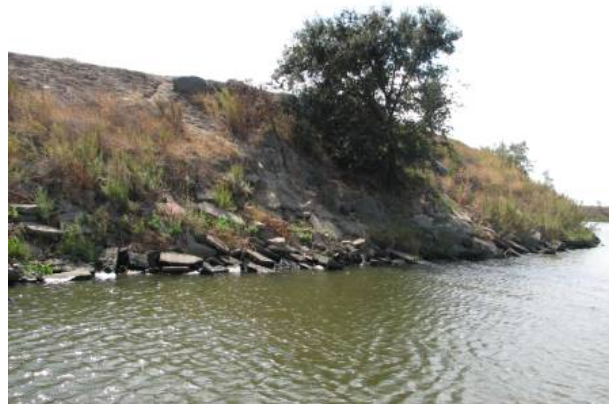
Levee Mile Report Line	16
Start Levee Mile	1.42
End Levee Mile	1.43
Location	Water Side
Category	Supplemental
Item	DWR Erosion Survey

2009: No major change; sliding of the rip rap at the base; there is visible man-made trail leading from crown to toe; recommend as a local maintenance issue, per CLRO CES Evaluation 2008 Report; site # same as RM31.3,LM1.45; previously rated "M" [2009 SiteID:RD2062U3RM31.28]

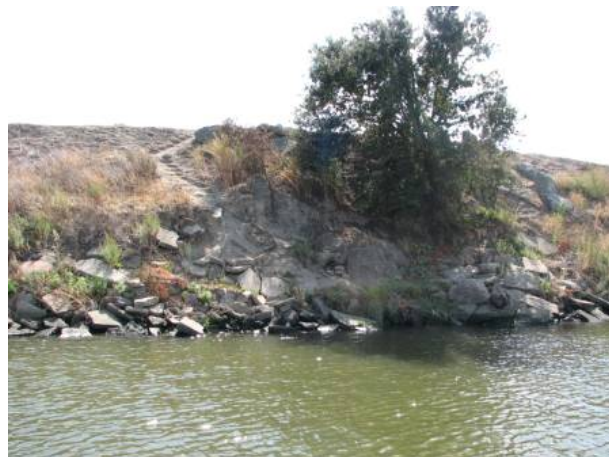
Levee Mile Report Line	16
Start Levee Mile	1.42
End Levee Mile	1.43
Location	Water Side
Category	Supplemental
Item	DWR Erosion Survey

2009: No major change; sliding of the rip rap at the base; there is visible man-made trail leading from crown to toe; recommend as a local maintenance issue, per CLRO CES Evaluation 2008 Report; site # same as RM31.3,LM1.45; previously rated "M" [2009 SiteID:RD2062U3RM31.28]

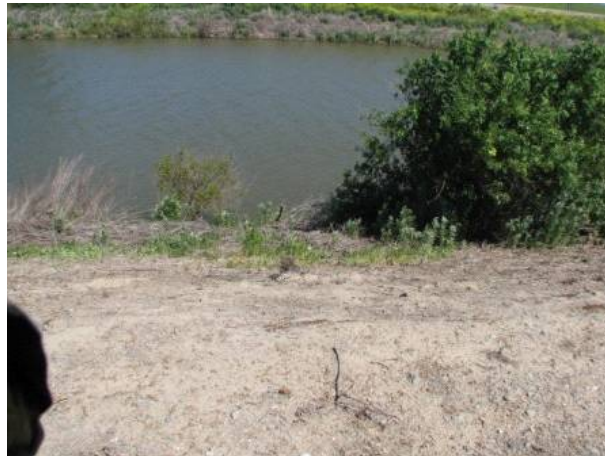
Levee Mile Report Line	20
Start Levee Mile	1.67
End Levee Mile	1.67
Location	Water Side
Category	Earthen Levee
Item	Trim / Thin Trees

Small stumps on levee slope.

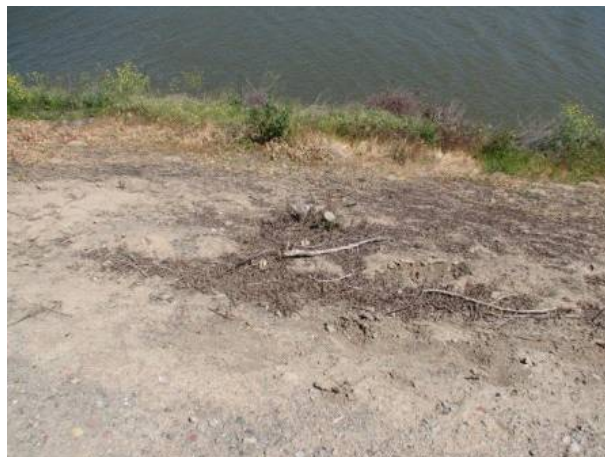
Levee Mile Report Line	21
Start Levee Mile	1.78
End Levee Mile	1.78
Location	Water Side
Category	Earthen Levee
Item	Trim / Thin Trees

Small stumps on levee slope.

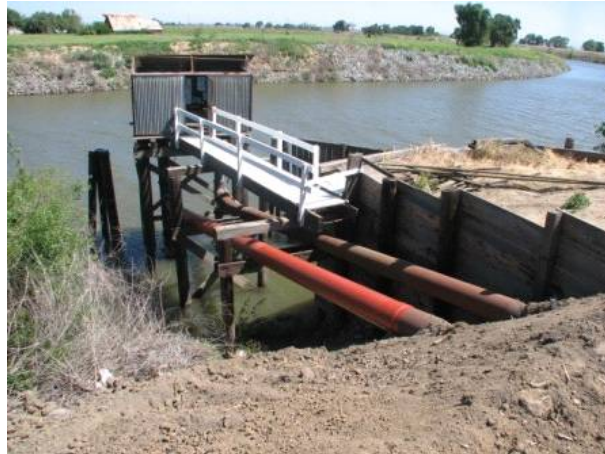
Levee Mile Report Line	26
Start Levee Mile	2.80
End Levee Mile	2.80
Location	Water Side
Category	Earthen Levee
Item	Encroachments

Recently repaired Irrigation intake from Old River.

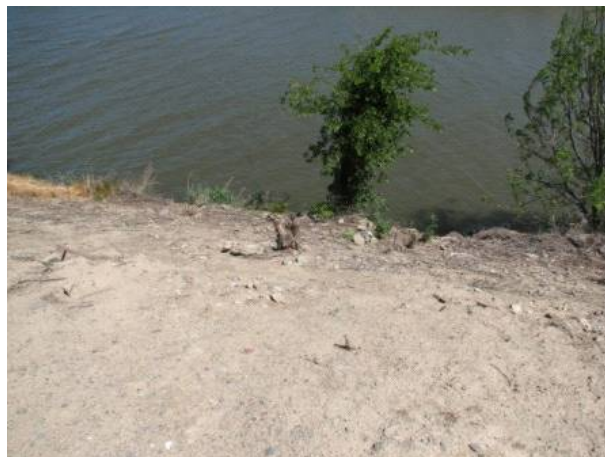
Levee Mile Report Line	27
Start Levee Mile	2.83
End Levee Mile	2.83
Location	Water Side
Category	Earthen Levee
Item	Trim / Thin Trees

Stump on levee slope.
