**Flood Control Project Maintenance  
Levee Inspections  
LMA District Cover Sheet  
Spring 2011 Levee Inspection Results**

**Reclamation District No. 2062 Stewart**

**Spring 2011 Levee Inspection Results**

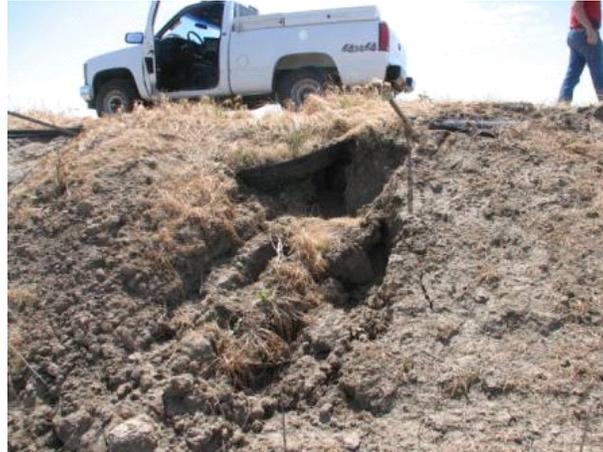
Levee Mile Report Line	1
Start Levee Mile	0.50
End Levee Mile	0.50
Location	Water Side
Category	Earthen Levee
Item	Erosion / Bank Caving
05/11/2011 Erosion at crown, vegetation shown at top of erosion is being supported by silt fence.	
jeto_s_20110513_479.jpg

LMR No.	Levee Mile		Category	Item	Location	Rating	Action/Comment	GPS Latitude/Longitude		Issue No. Photo
	Start	End						Start	End	
1	0.50	0.50	Earthen Levee	Erosion / Bank Caving	WS	M	Schedule repair of erosion site prior to the next inspection. Inspector Comments: Erosion taking place at edge of crown.	37.804716 ° -121.320511 °	37.804716 ° -121.320511 °	3 Y
2	0.57	0.57	Earthen Levee	Erosion / Bank Caving	WS	M	Schedule repair of erosion site prior to the next inspection. Inspector Comments: Levee crown is approximately 100' at this point.	37.805106 ° -121.319154 °	37.805106 ° -121.319154 °	6 Y
3	0.81	0.81	Earthen Levee	Trim / Thin Trees	WS	N	Tree stumps.	37.804747 ° -121.315183 °	37.804747 ° -121.315183 °	7
4	0.84	0.84	Earthen Levee	Crown Surface / Depressions / Rutting	CR	M	Regrade the crown roadway for proper drainage.	37.804580 ° -121.314720 °	37.804580 ° -121.314720 °	8
5	0.85	0.92	Earthen Levee	Vegetation	CR	M	Control annual grass and weeds on the levee slopes and easements.	37.804512 ° -121.314585 °	37.803862 ° -121.313699 °	4 Y

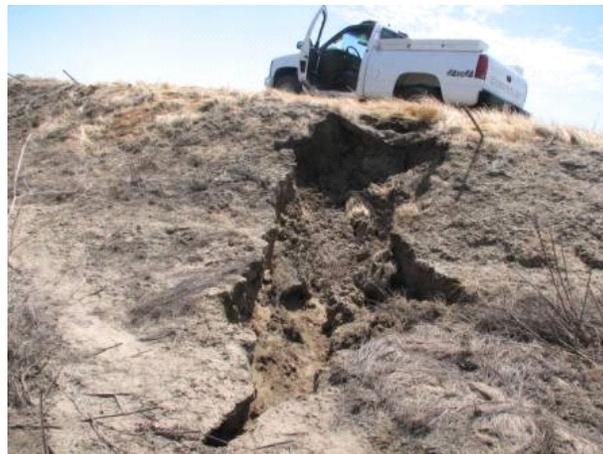
Levee Mile Report Line	2
Start Levee Mile	0.57
End Levee Mile	0.57
Location	Water Side
Category	Earthen Levee
Item	Erosion / Bank Caving
05/11/2011 Erosion begins at crown, stakes shown in photo are supporting a silt fence. Silt fence is supporting soil and vegetation at crown.	
jeto_s_20110513_480.jpg

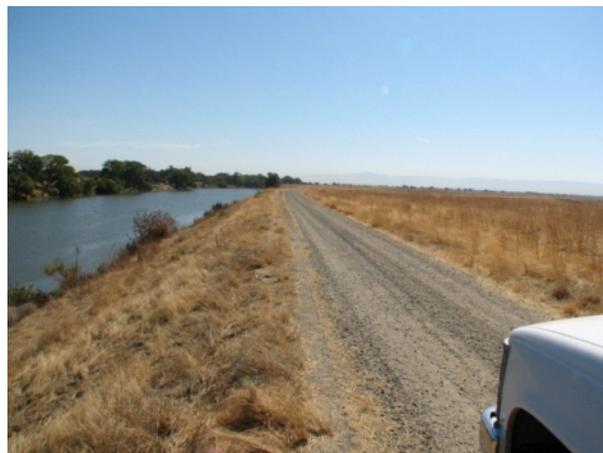
Levee Mile Report Line	5
Start Levee Mile	0.85
End Levee Mile	0.92
Location	Crown
Category	Earthen Levee
Item	Vegetation
Annual grasses on levee crown should be mowed to improve visibility down the levee slope.	
jeto_s_20110301_157.jpg

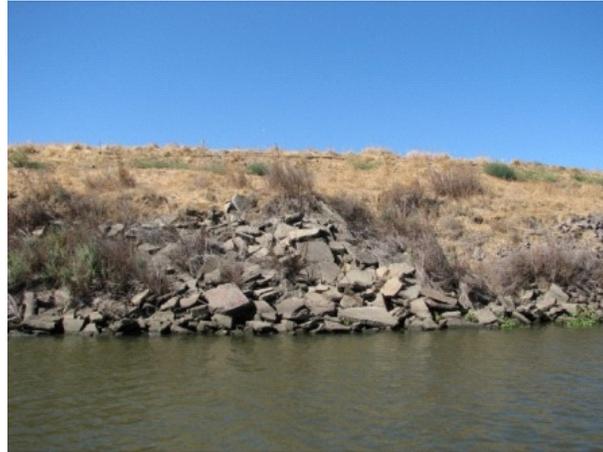
Levee Mile Report Line	6
Start Levee Mile	0.91
End Levee Mile	0.91
Location	Water Side
Category	Supplemental
Item	DWR Erosion Survey
<p>Front view of site where portion of the rip rap revetment has sloughed, creating a pocket erosion.</p>	
<p>jeto_s_20110301_149.jpg</p>

6	0.91	0.91	Supplemental	DWR Erosion Survey	WS	M	Inspector Comments: 09/07/2010: No significant changes observed on site. Sloughing of the existing rip rap revetment on the lower slope has developed into an erosion pocket. There is moderate annual grass growth on the slope. 08/06/2010: Recommended as local maintenance issue, per CLRO. 03/09/2010: Per Michael Moncrief of MBK, site is scheduled for repair this year. [2010 SiteID: RD2062U01RM54.14]	37.804080 ° -121.314060 °	37.804080 ° -121.314060 °	1 Y
7	1.55	1.55	Earthen Levee	Animal Control	WS	M	No rodents visible, but rodent burrows visible; need to backfill and compact or grout burrows.	37.795102 ° -121.315068 °	37.795102 ° -121.315068 °	9
8	1.67	1.67	Earthen Levee	Encroachments	WS	W	Pipe	37.793516 ° -121.315335 °	37.793516 ° -121.315335 °	10
9	1.83	1.83	Earthen Levee	Animal Control	WS	M	No rodents visible, but rodent burrows visible; need to backfill and compact or grout burrows.	37.791873 ° -121.313350 °	37.791873 ° -121.313350 °	11

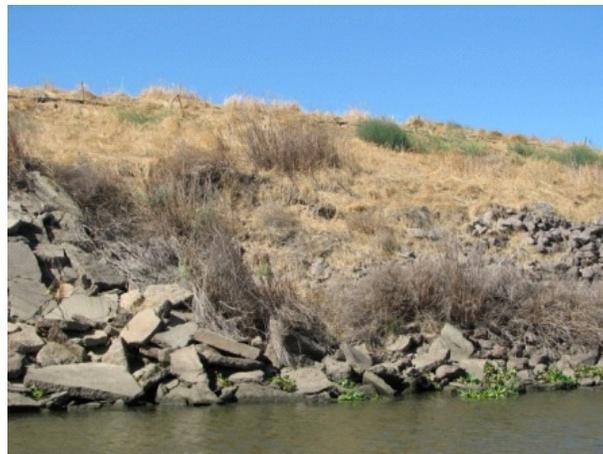
Levee Mile Report Line	6
Start Levee Mile	0.91
End Levee Mile	0.91
Location	Water Side
Category	Supplemental
Item	DWR Erosion Survey
<p>Front view of the rip rap that has sloughed.</p>	
<p>jeto_s_20110301_150.jpg</p>

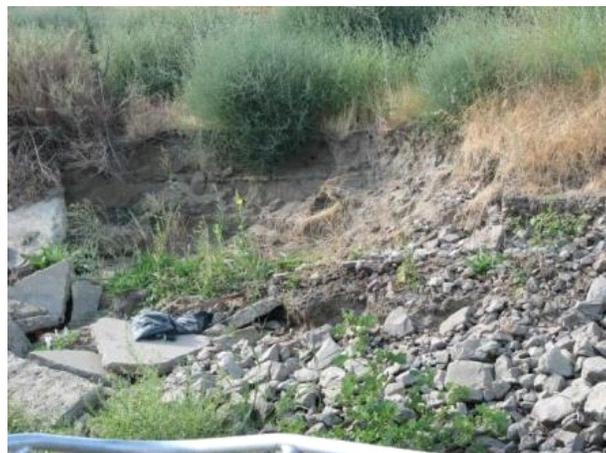
Levee Mile Report Line	6
Start Levee Mile	0.91
End Levee Mile	0.91
Location	Water Side
Category	Supplemental
Item	DWR Erosion Survey
<p>Photograph taken in 2006. View of the portion of rip rap that has slipped, exposing the underlying soils.</p>	
<p>jeto_s_20110301_151.jpg</p>

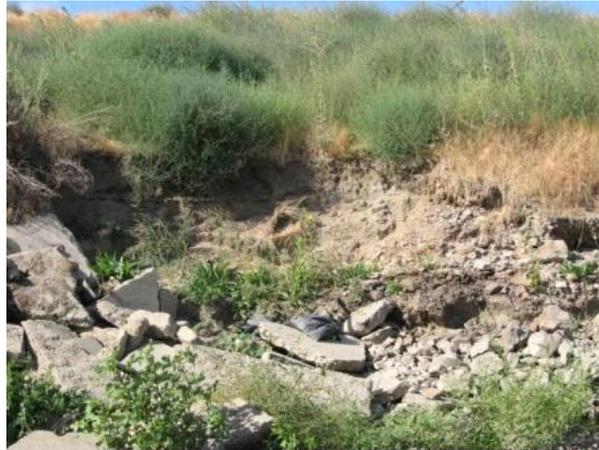
Levee Mile Report Line	6
Start Levee Mile	0.91
End Levee Mile	0.91
Location	Water Side
Category	Supplemental
Item	DWR Erosion Survey
Photograph taken in 2006. Close-up view of the pocket erosion.	
jeto_s_20110301_152.jpg

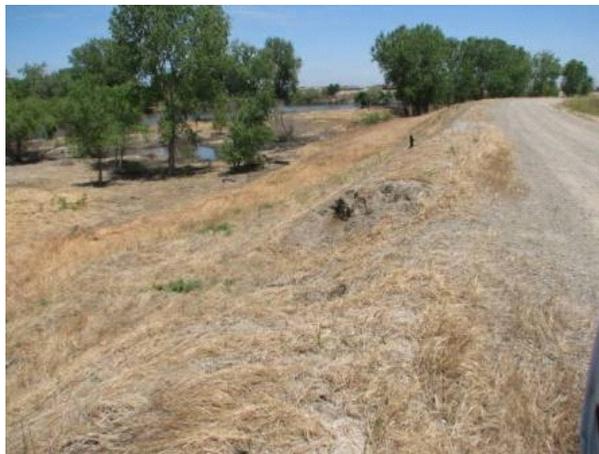
Levee Mile Report Line	11
Start Levee Mile	2.10
End Levee Mile	2.10
Location	Water Side
Category	Earthen Levee
Item	Slope Stability
05/11/2011 Damage seen in photo continues down the slope as if area was being used by equipment to access the bank.	
jeto_s_20110513_481.jpg

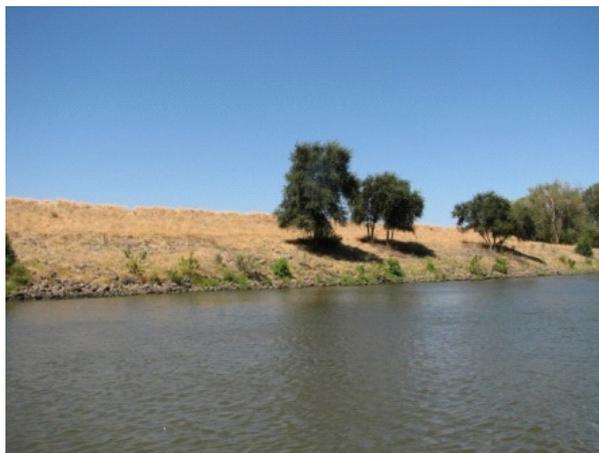
Levee Mile Report Line	14
Start Levee Mile	2.24
End Levee Mile	2.26
Location	Water Side
Category	Supplemental
Item	DWR Erosion Survey
Downstream view of site. Note the wide bench.	
jeto_s_20110301_153.jpg

LMR No.	Levee Mile		Category	Item	* Location	** Rating	Action/Comment	GPS Latitude/Longitude		Issue No. Photo
	Start	End						Start	End	
14	2.24	2.26	Supplemental	DWR Erosion Survey	WS	W	Inspector Comments: 09/07/2010: After further review of site, it will be removed from the inventory. Erosion is minimal. There is sufficient berm to provide levee protection. Annual vegetation also provides added protection. 08/06/2010: Recommended for annual assessment and	37.793120 °	37.793120 °	2
								-121.308110 °	-121.308110 °	Y

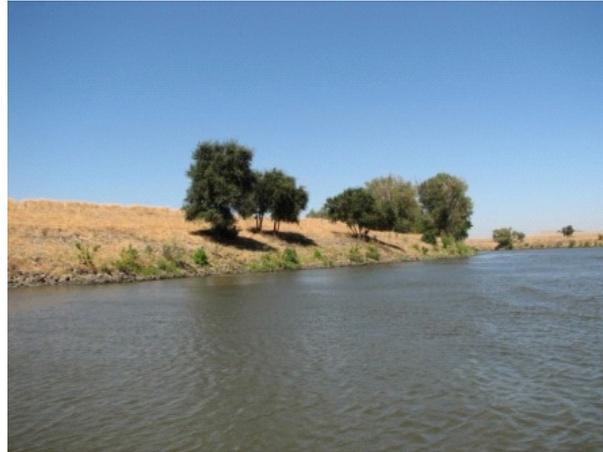
Levee Mile Report Line	14
Start Levee Mile	2.24
End Levee Mile	2.26
Location	Water Side
Category	Supplemental
Item	DWR Erosion Survey
Downstream view of site.	
jeto_s_20110301_154.jpg

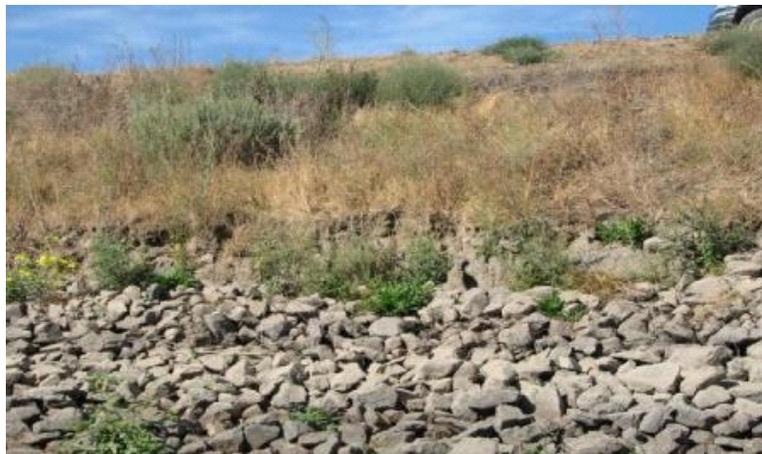
Levee Mile Report Line	14
Start Levee Mile	2.24
End Levee Mile	2.26
Location	Water Side
Category	Supplemental
Item	DWR Erosion Survey
Photograph taken in 2006. Close up view of scarp just above the lower slope revetment.	
jeto_s_20110301_155.jpg

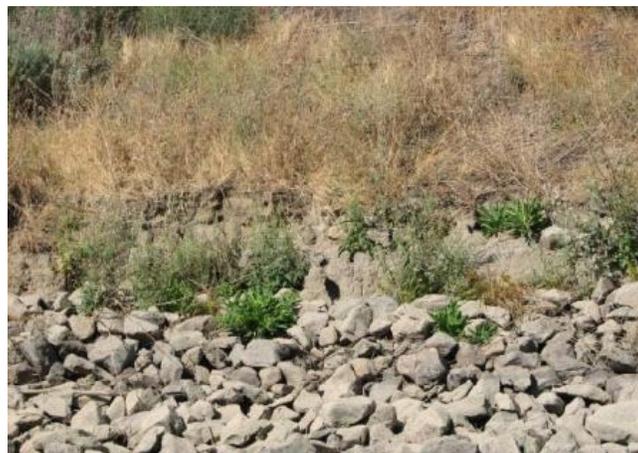
Levee Mile Report Line	14
Start Levee Mile	2.24
End Levee Mile	2.26
Location	Water Side
Category	Supplemental
Item	DWR Erosion Survey
Photograph taken in 2006. Front view of scarp above the lower slope revetment.	
jeto_s_20110301_156.jpg

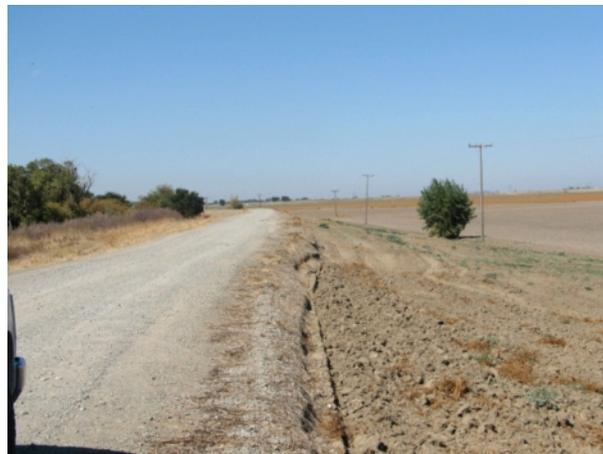
Levee Mile Report Line	7
Start Levee Mile	2.54
End Levee Mile	3.94
Location	Land Side
Category	Earthen Levee
Item	Encroachments
Discing on levee slopes has created a substantial vertical scarp.	
jeto_s_20110301_168.jpg

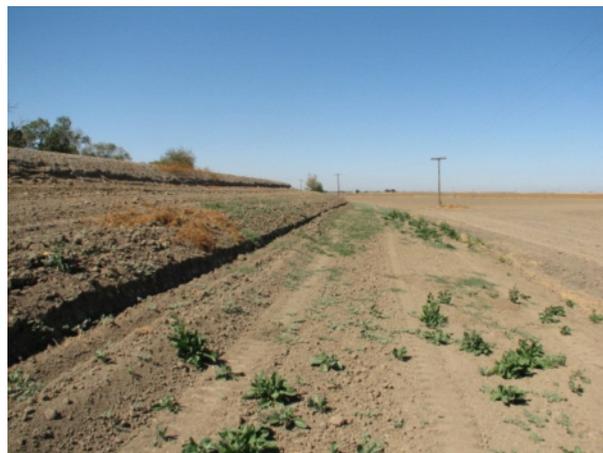
Levee Mile Report Line	7
Start Levee Mile	2.54
End Levee Mile	3.94
Location	Land Side
Category	Earthen Levee
Item	Encroachments
Discing on levee slopes has created two substantial vertical scarps.	
jeto_s_20110301_169.jpg

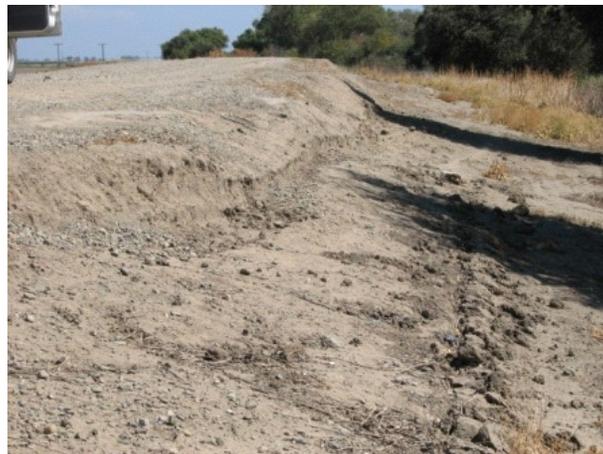
Levee Mile Report Line	13
Start Levee Mile	3.27
End Levee Mile	3.28
Location	Water Side
Category	Supplemental
Item	DWR Erosion Survey
Upstream view of scarp caused by a maintenance equipment.	
jeto_s_20110301_159.jpg

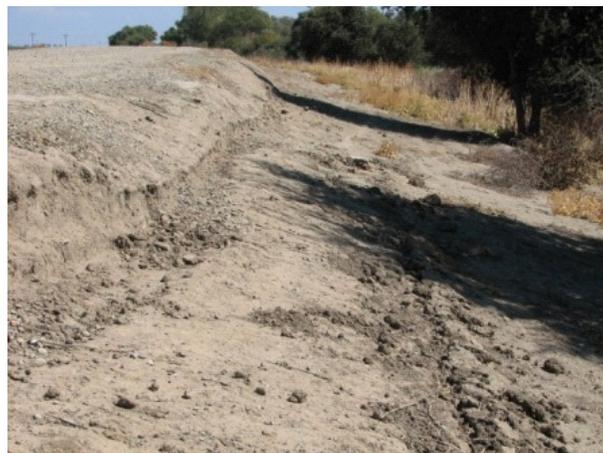
Levee Mile Report Line	13
Start Levee Mile	3.27
End Levee Mile	3.28
Location	Water Side
Category	Supplemental
Item	DWR Erosion Survey
Upstream view of scarp. Note on the right of the picture signs of where the wired fence used to be.	
jeto_s_20110301_160.jpg

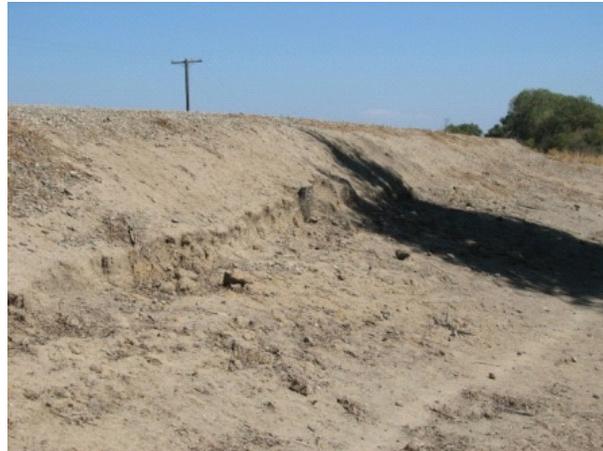
Levee Mile Report Line	13
Start Levee Mile	3.27
End Levee Mile	3.28
Location	Water Side
Category	Supplemental
Item	DWR Erosion Survey
Upstream view of site. Note the tree stump on the scarp.	
jeto_s_20110301_162.jpg

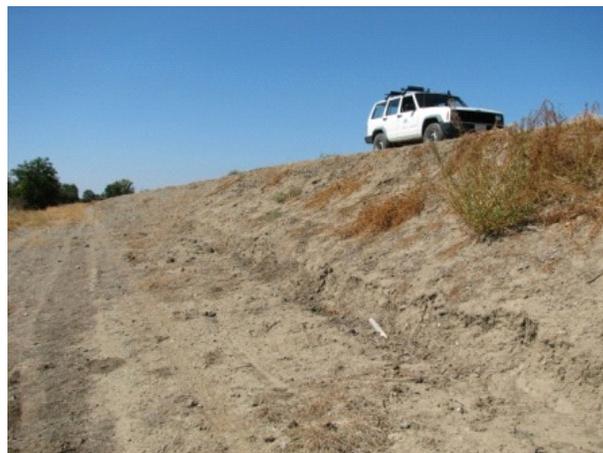
Levee Mile Report Line	15
Start Levee Mile	3.44
End Levee Mile	3.53
Location	Water Side
Category	Supplemental
Item	DWR Erosion Survey
Downstream view of site. Note the vertical scarp at the toe.	
jeto_s_20110301_163.jpg

LMR No.	Levee Mile		Category	Item	* Location	** Rating	Action/Comment	GPS Latitude/Longitude		Issue No. Photo
	Start	End						Start	End	
15	3.44	3.53	Supplemental	DWR Erosion Survey	WS	M	Inspector Comments: 09/22/2010: No significant changes observed on site. The foot-high near-vertical scarp still exists on levee toe. There is little to no vegetation on the slope. 03/09/2010: As discussed with Michael Moncrief of MBK, site will be addressed this year. [20	37.805422 ° -121.383173 °	37.805422 ° -121.383173 °	2 Y
16	3.68	3.68	Earthen Levee	Trim / Thin Trees	WS	N	Tree stumps. Inspector Comments: Small stump on slope.	37.806231 ° -121.386209 °	37.806231 ° -121.386209 °	9 Y

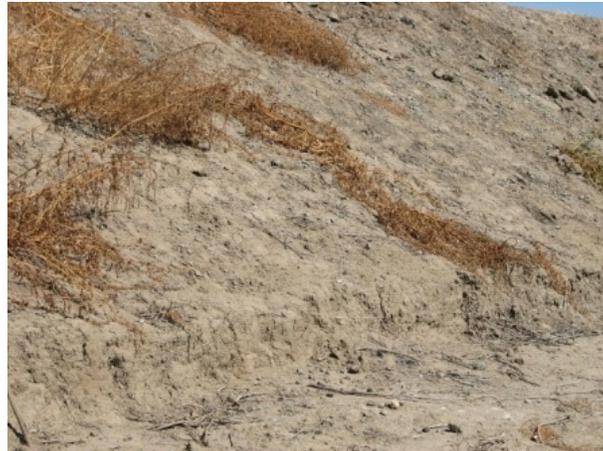
Levee Mile Report Line	15
Start Levee Mile	3.44
End Levee Mile	3.53
Location	Water Side
Category	Supplemental
Item	DWR Erosion Survey
Upstream view of site.	
jeto_s_20110301_165.jpg

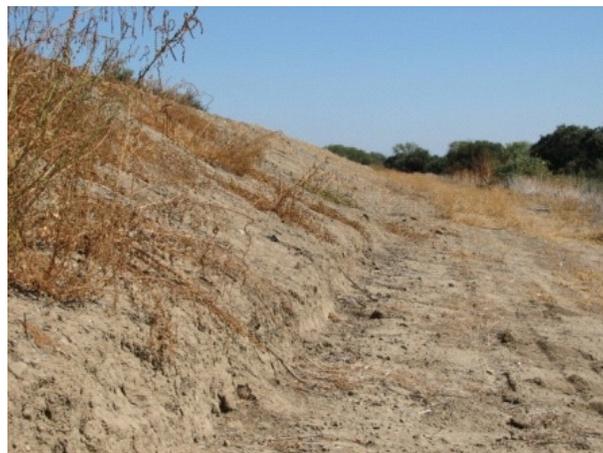
Levee Mile Report Line	15
Start Levee Mile	3.44
End Levee Mile	3.53
Location	Water Side
Category	Supplemental
Item	DWR Erosion Survey
Upstream view of site.	
jeto_s_20110301_166.jpg

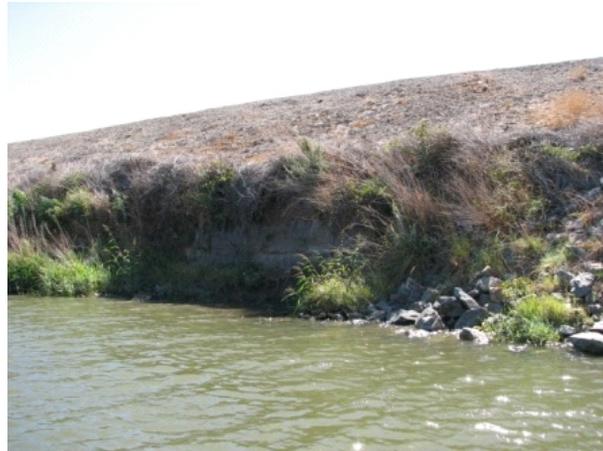
Levee Mile Report Line	3
Start Levee Mile	0.23
End Levee Mile	0.32
Location	Water Side
Category	Supplemental
Item	DWR Erosion Survey
<p>Upstream view of a 5-ft vertical scarp .</p>	
<p>jeto_s_20110301_174.jpg</p>

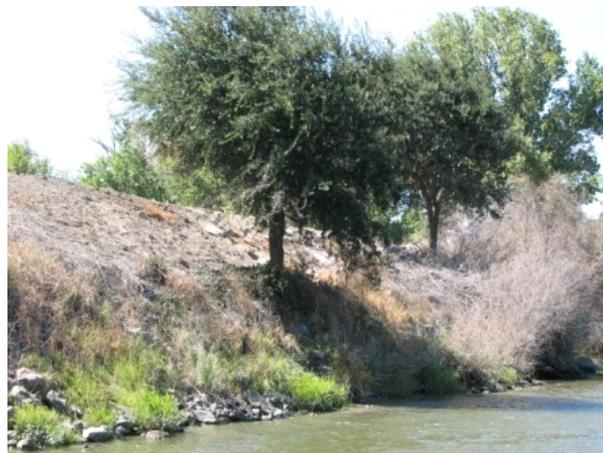
Levee Mile Report Line	3
Start Levee Mile	0.23
End Levee Mile	0.32
Location	Water Side
Category	Supplemental
Item	DWR Erosion Survey
<p>Downstream view of medium-sized tree where stability may be compromised due to a bank caving just below it.</p>	
<p>jeto_s_20110301_175.jpg</p>

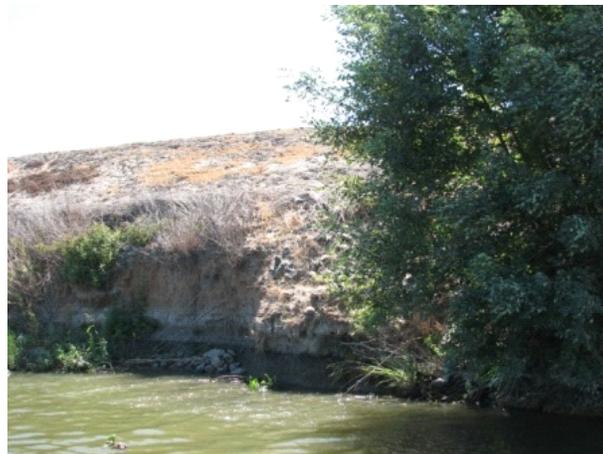
Levee Mile Report Line	3
Start Levee Mile	0.23
End Levee Mile	0.32
Location	Water Side
Category	Supplemental
Item	DWR Erosion Survey
Upstream view of another 6-ft vertical scarp upstream.	
jeto_s_20110301_177.jpg

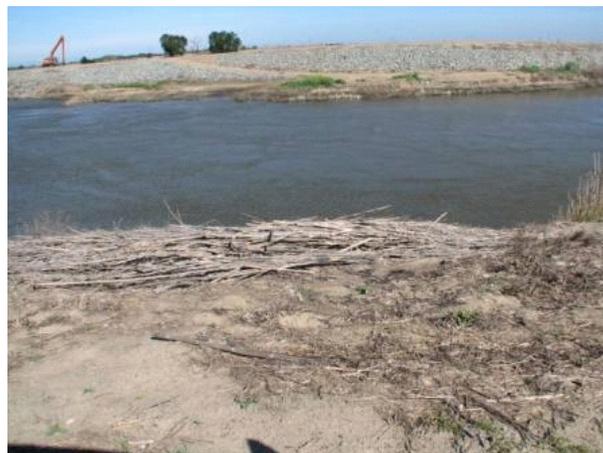
Levee Mile Report Line	5
Start Levee Mile	0.46
End Levee Mile	0.46
Location	Water Side
Category	Earthen Levee
Item	Encroachments
05/11/2011 Bambo prunings have not been removed. This item was noted in the Fall 2010 inspection.	
jeto_s_20110513_475.jpg

4	0.30	0.30	Earthen Levee	Trim / Thin Trees	WS	C	Tree stumps.	37.810837 ° -121.385365 °	37.810837 ° -121.385365 °	7
5	0.46	0.46	Earthen Levee	Encroachments	WS	M	Prunings Inspector Comments: Bamboo prunings left on levee slope. 05/11/2011 Prunings are still present, item first noted in Fall 2010 inspection.	37.811805 ° -121.382932 °	37.811805 ° -121.382932 °	8 Y
6	0.56	0.57	Supplemental	DWR Erosion Survey	WS	U	Inspector Comments: 09/07/2010: No significant changes observed on site. Much of the placed rip rap revetment has slid. It is no longer adequately protecting the slope. 08/06/2010: Recommended as local maintenance issue, per CLRO Report. 03/09/2010: As discussed with Michael Moncrief of MBK, site will be 'addressed' this year. [2010 SiteID: RD2062U03RM30.43]	37.813070 ° -121.383100 °	37.813070 ° -121.383100 °	4 Y
7	0.56	0.56	Earthen Levee	Encroachments	WS	M	Debris Inspector Comments: Trash and debris needs to be removed.	37.813214 ° -121.382989 °	37.813214 ° -121.382989 °	9 Y

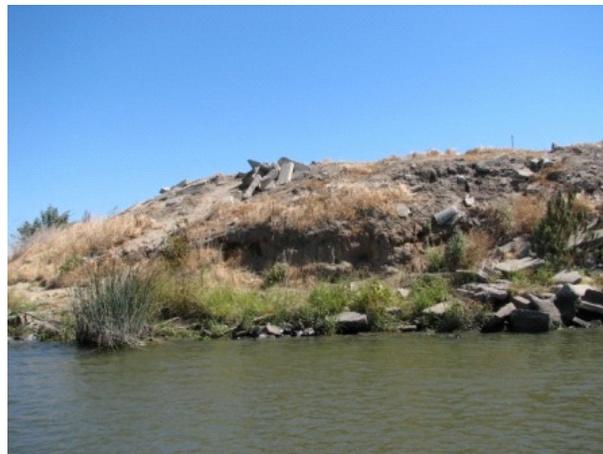
Levee Mile Report Line	6
Start Levee Mile	0.56
End Levee Mile	0.57
Location	Water Side
Category	Supplemental
Item	DWR Erosion Survey
Front view of site. Previously placed rip rap slipped, exposing the underlying soils and creating a pocket.	
jeto_s_20110301_180.jpg

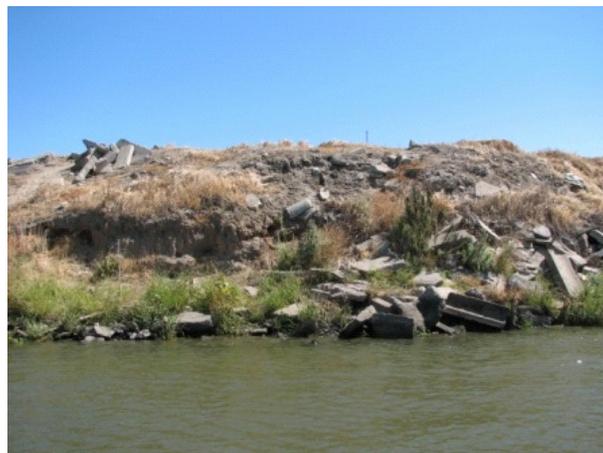
Levee Mile Report Line	6
Start Levee Mile	0.56
End Levee Mile	0.57
Location	Water Side
Category	Supplemental
Item	DWR Erosion Survey
Front view of site. Rip rap no longer adequately protecting levee slope.	
jeto_s_20110301_181.jpg

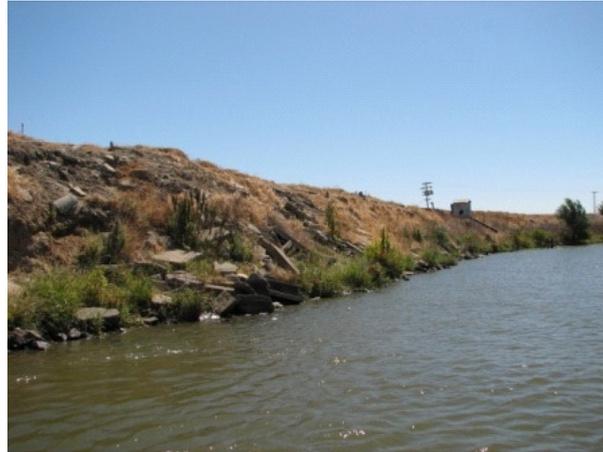
jeto\_s\_20110301\_182.jpg

Downstream view of site.

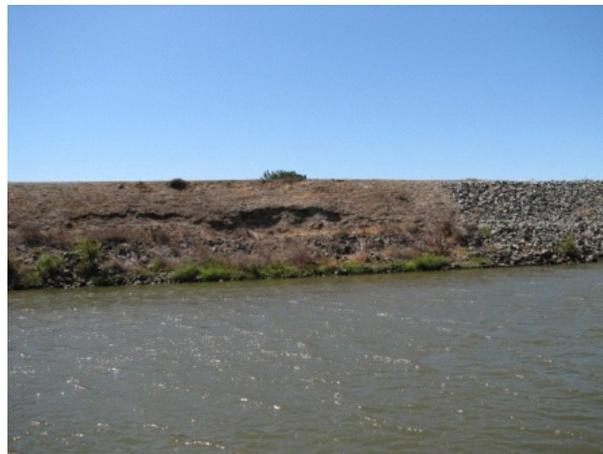
Levee Mile Report Line	12
Start Levee Mile	1.20
End Levee Mile	1.21
Location	Water Side
Category	Supplemental
Item	DWR Erosion Survey
Front view of site. Existing scalloped erosion is immediately downstream of rip rap section.	
jeto_s_20110301_183.jpg

LMR No.	Levee Mile		Category	Item	Location	Rating	Action/Comment	GPS Latitude/Longitude		Issue No. Photo
	Start	End						Start	End	
12	1.20	1.21	Supplemental	DWR Erosion Survey	WS	M	Inspector Comments: 09/07/2010: No significant changes observed on site. Much of the seasonal grass along the slope was cleared. Site consists of an existing scalloped erosion approximately 30 feet long by 5 feet wide at its widest opening. The lateral crack is extended outwards along the middle slope. There is a 1 to 2 feet of differential settlement that could further develop into a shallow slide. 08/06/2010: Recommended as local maintenance issue, per CLRO. 03/09/2010: As discussed with Michael Moncrief of MBK Engineer, site will be 'addressed' this year. [2010 SiteID: RD2062U03RM31.12]	37.819290 ° -121.378880 °	37.819290 ° -121.378880 °	5 Y
13	1.27	1.27	Earthen Levee	Encroachments	LS	M	Prunings Inspector Comments: Tree prunings on landside levee slope.	37.819711 ° -121.377490 °	37.819711 ° -121.377490 °	36 Y

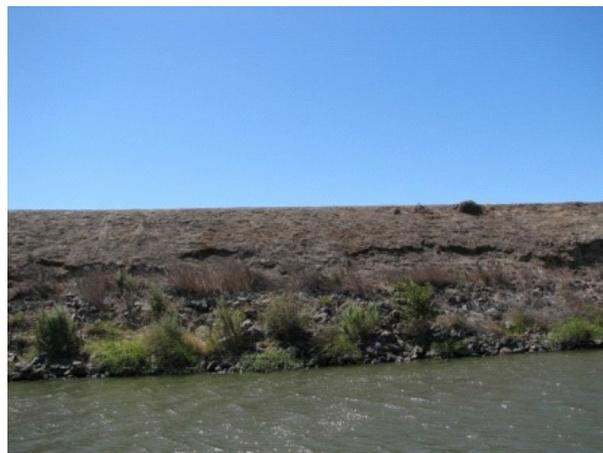
Levee Mile Report Line	12
Start Levee Mile	1.20
End Levee Mile	1.21
Location	Water Side
Category	Supplemental
Item	DWR Erosion Survey
Upstream view of site where 1 to 2 feet of differential settlement has started to form.	
jeto_s_20110301_184.jpg

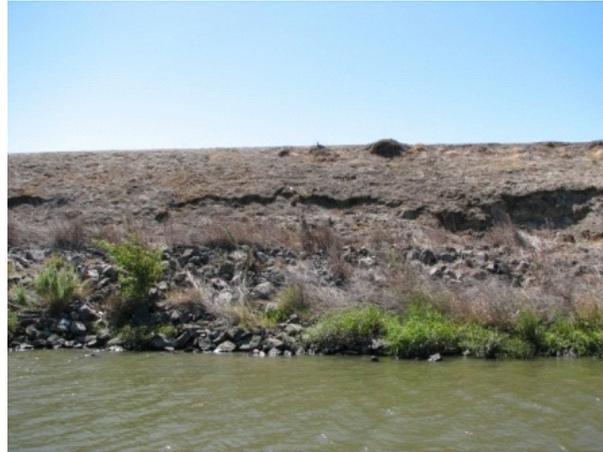
Levee Mile Report Line	12
Start Levee Mile	1.20
End Levee Mile	1.21
Location	Water Side
Category	Supplemental
Item	DWR Erosion Survey
Front view of site. Note the lateral crack along the middle slope	
jeto_s_20110301_185.jpg

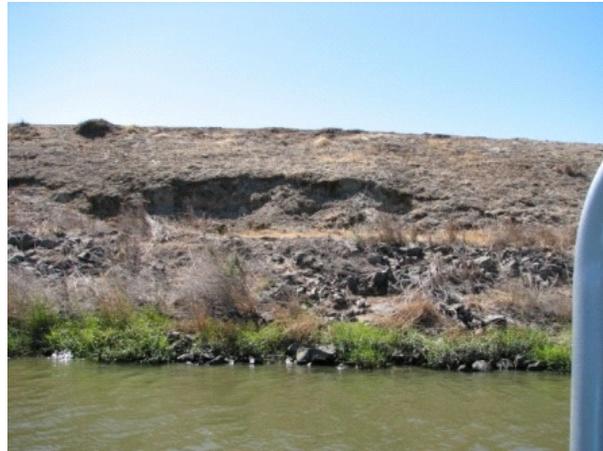
Levee Mile Report Line	12
Start Levee Mile	1.20
End Levee Mile	1.21
Location	Water Side
Category	Supplemental
Item	DWR Erosion Survey
Front view of site just above existing rip rap.	
jeto_s_20110301_186.jpg

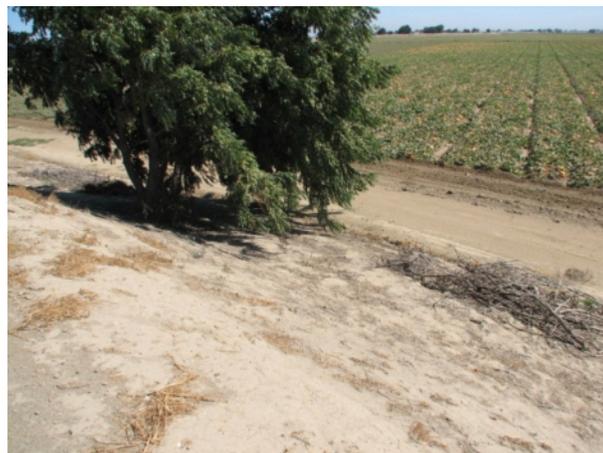
Levee Mile Report Line	13
Start Levee Mile	1.27
End Levee Mile	1.27
Location	Land Side
Category	Earthen Levee
Item	Encroachments
Tree prunings on levee slope should be removed.	
jeto_s_20110301_190.jpg

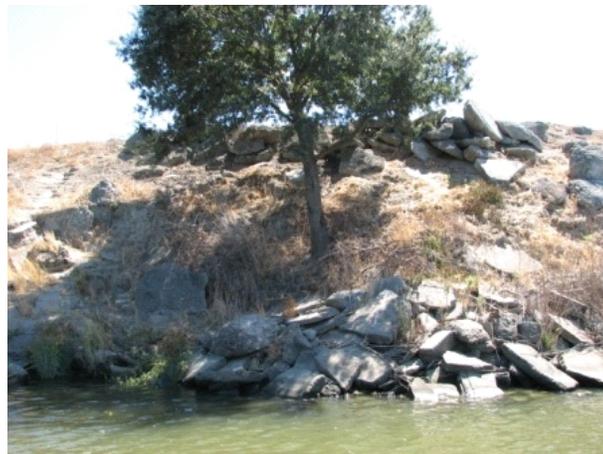
Levee Mile Report Line	16
Start Levee Mile	1.42
End Levee Mile	1.43
Location	Water Side
Category	Supplemental
Item	DWR Erosion Survey
Front view of site where a small to medium sized Oak tree is located.	
jeto_s_20110301_170.jpg

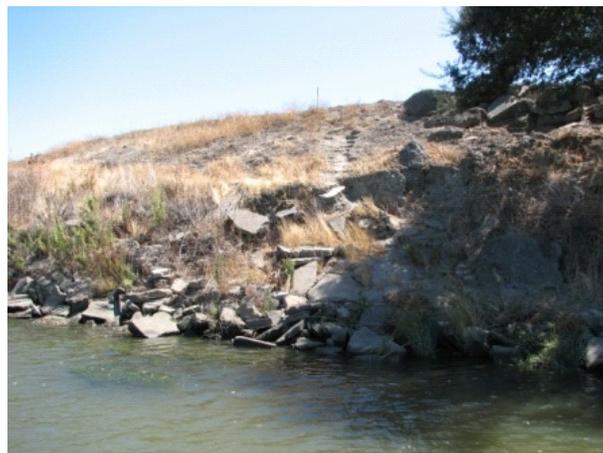
Levee Mile Report Line	16
Start Levee Mile	1.42
End Levee Mile	1.43
Location	Water Side
Category	Supplemental
Item	DWR Erosion Survey
Upstream view of site where erosion pocket and foot traffic exists.	
jeto_s_20110301_171.jpg

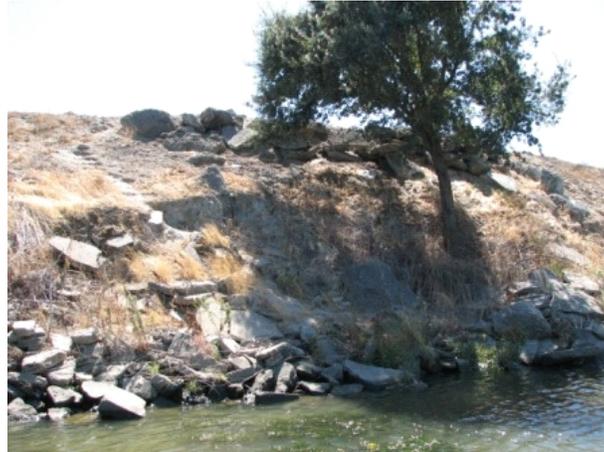
Levee Mile Report Line	16
Start Levee Mile	1.42
End Levee Mile	1.43
Location	Water Side
Category	Supplemental
Item	DWR Erosion Survey
Downstream view of site. Note existing broken concrete on the upper slope as well as on the lower slope and at the toe.	
jeto_s_20110301_172.jpg

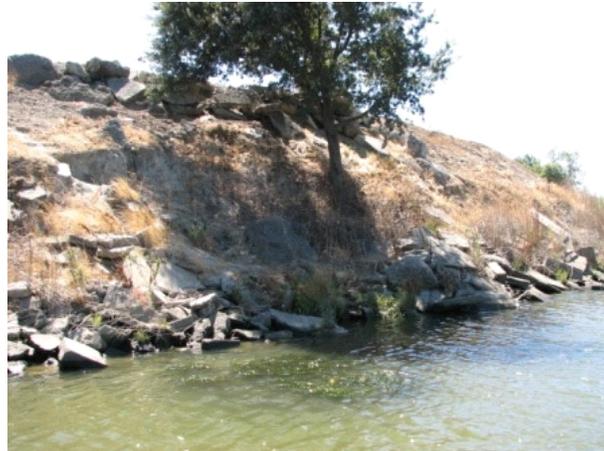
Levee Mile Report Line	16
Start Levee Mile	1.42
End Levee Mile	1.43
Location	Water Side
Category	Supplemental
Item	DWR Erosion Survey
Downstream view of site.	
jeto_s_20110301_173.jpg

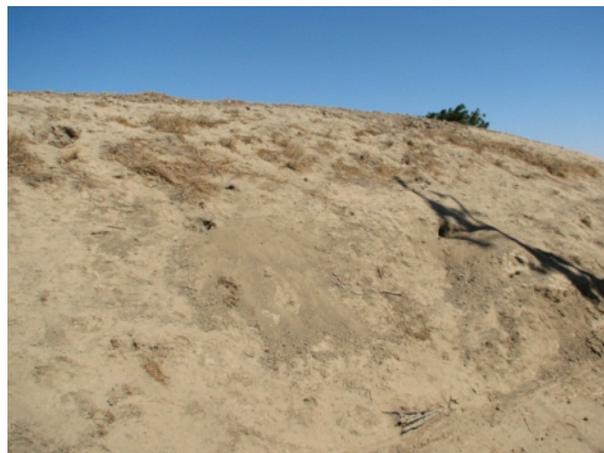
Levee Mile Report Line	28
Start Levee Mile	2.84
End Levee Mile	2.87
Location	Land Side
Category	Earthen Levee
Item	Animal Control
Large animal burrows on landside levee slope.	
jeto_s_20110301_193.jpg

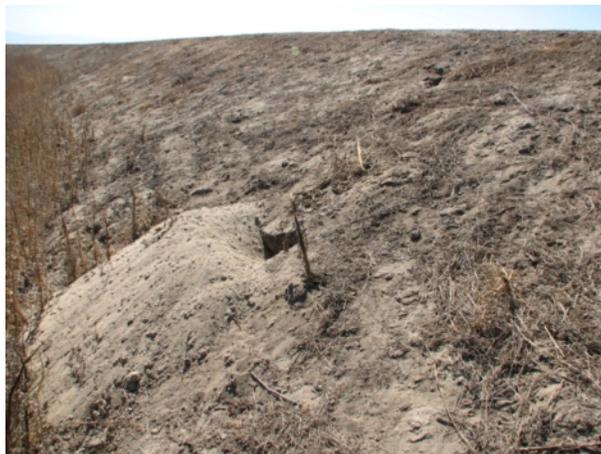
Levee Mile Report Line	38
Start Levee Mile	4.83
End Levee Mile	4.83
Location	Water Side
Category	Earthen Levee
Item	Animal Control
Animal burrow on levee slope.	
jeto_s_20110301_196.jpg

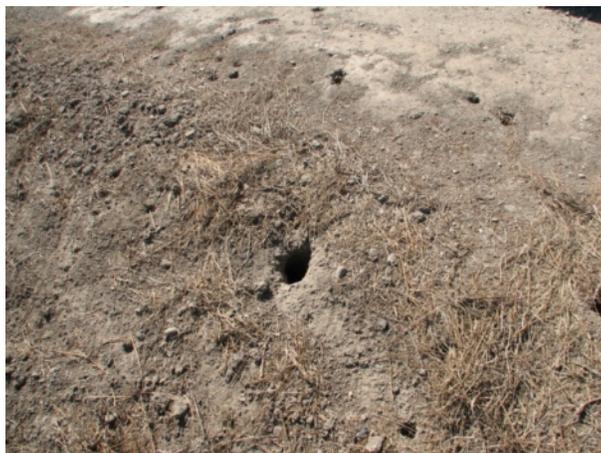
Levee Mile Report Line	38
Start Levee Mile	4.83
End Levee Mile	4.83
Location	Water Side
Category	Earthen Levee
Item	Animal Control
Animal burrows on levee slope.	
jeto_s_20110301_197.jpg
