**Flood Control Project Maintenance  
Levee Inspections****LMA District Cover Sheet****Spring 2012 Levee Inspection Results****Reclamation District No. 2062 Stewart**

**Spring 2012 Levee Inspection Results**

**Reclamation District No. 2062 Stewart**

Waterway				Bank	Unit Miles	Inspection Start/End	Inspector	
Unit No. 01 San Joaquin River				Left	2.69	05/17/2012 05/17/2012	Max Khashchuk

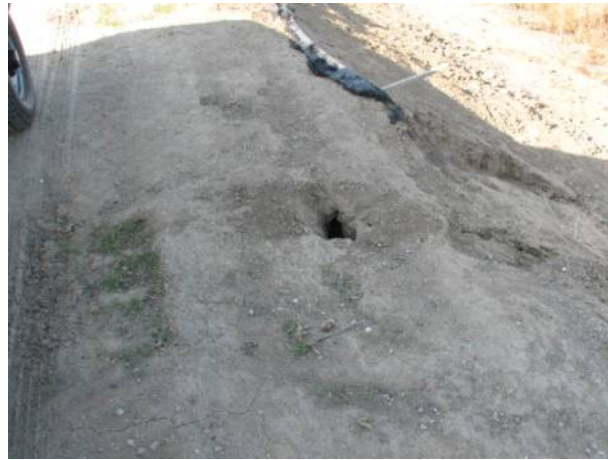
Levee Mile Report Line	4
Start Levee Mile	0.49
End Levee Mile	0.49
Location	Crown
Category	Earthen Levee
Item	Animal Control

10/21/2011 Photo of burrow on crown, photo was taken day after inspection.

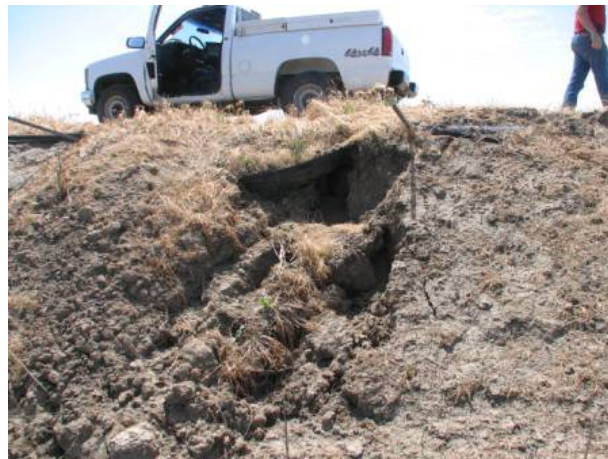
Levee Mile Report Line	5
Start Levee Mile	0.50
End Levee Mile	0.50
Location	Water Side
Category	Earthen Levee
Item	Erosion / Bank Caving

05/11/2011 Erosion at crown, vegetation shown at top of erosion is being supported by silt fence.

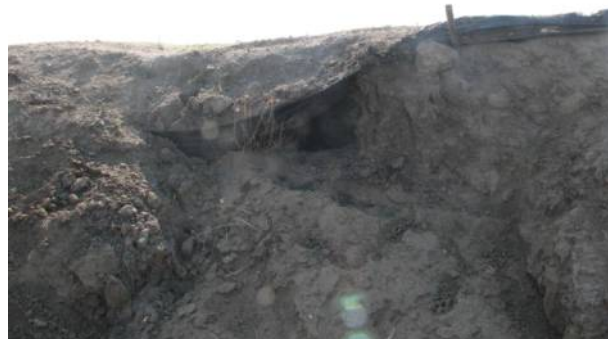
Levee Mile Report Line	5
Start Levee Mile	0.50
End Levee Mile	0.50
Location	Water Side
Category	Earthen Levee
Item	Erosion / Bank Caving

10/21/2011 Erosion at crown, issue first noted in Spring 2011 inspection.

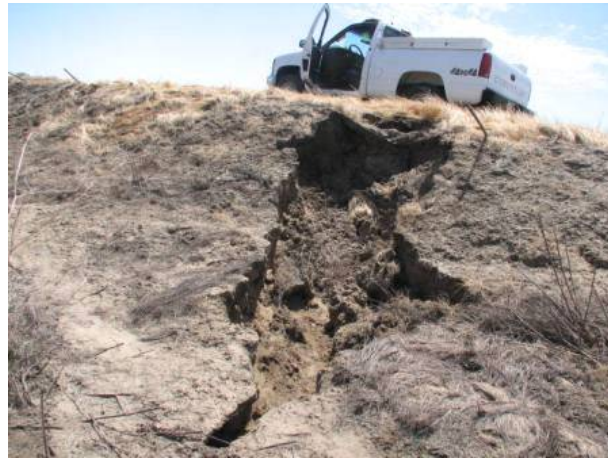
Levee Mile Report Line	6
Start Levee Mile	0.57
End Levee Mile	0.57
Location	Water Side
Category	Earthen Levee
Item	Erosion / Bank Caving

05/11/2011 Erosion begins at crown, stakes shown in photo are supporting a silt fence. Silt fence is supporting soil and vegetation at crown.

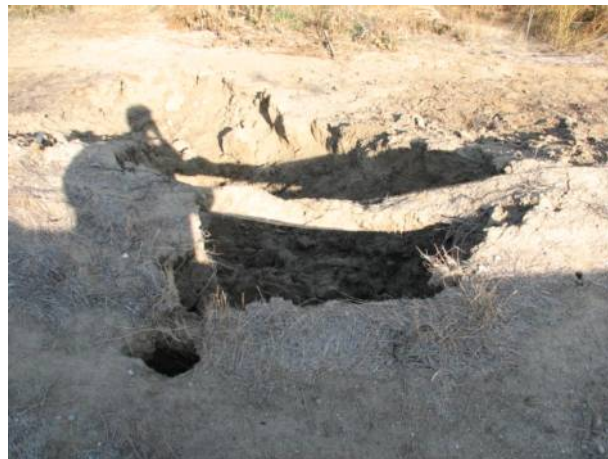
Levee Mile Report Line	6
Start Levee Mile	0.57
End Levee Mile	0.57
Location	Water Side
Category	Earthen Levee
Item	Erosion / Bank Caving

10/21/2011 Photo is taken from levee crown, issue has still not been addressed. Issue was noted in the Spring 2011 inspection.

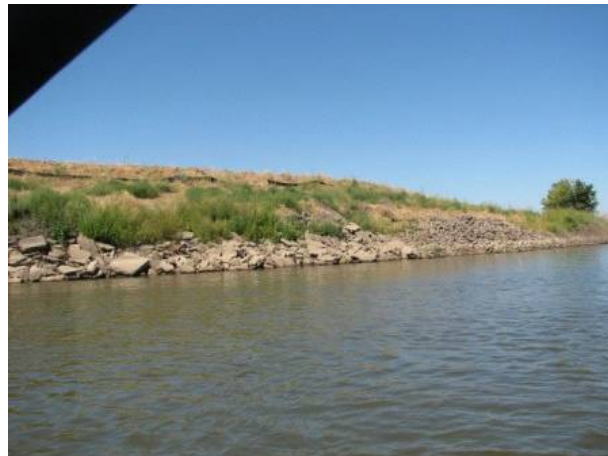
Levee Mile Report Line	8
Start Levee Mile	0.91
End Levee Mile	0.91
Location	Water Side
Category	Supplemental
Item	DWR Erosion Survey

Front view of the erosion

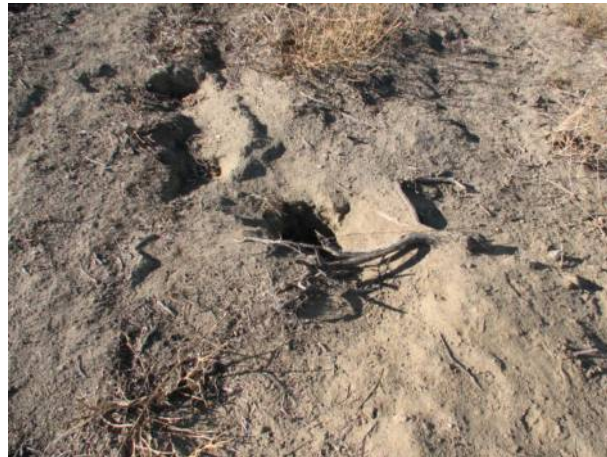
Levee Mile Report Line	11
Start Levee Mile	1.83
End Levee Mile	1.83
Location	Water Side
Category	Earthen Levee
Item	Animal Control
10/20/2011 Large burrow located on waterside slope of levee.	
mkhashch_s_20120511_189.jpg

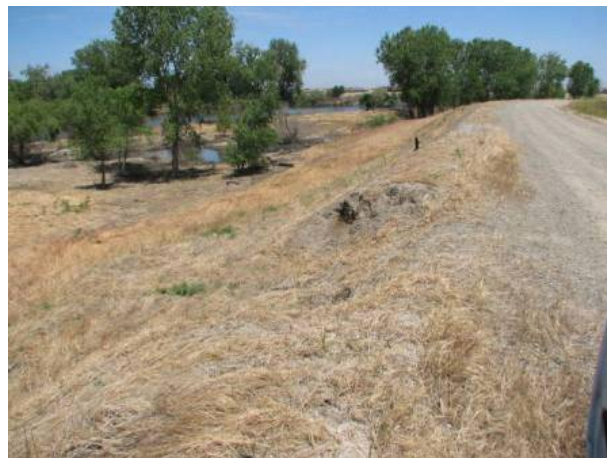
Levee Mile Report Line	14
Start Levee Mile	2.10
End Levee Mile	2.10
Location	Water Side
Category	Earthen Levee
Item	Slope Stability
05/11/2011 Damage seen in photo continues down the slope as if area was being used by equipment to access the bank.	
mkhashch_s_20120511_190.jpg

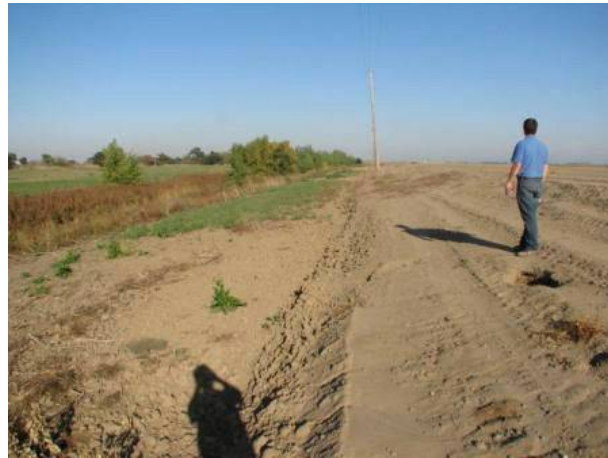
10/20/2011 Photo shows issue caused by discing (left side of photo) of the weeds on the waterside.

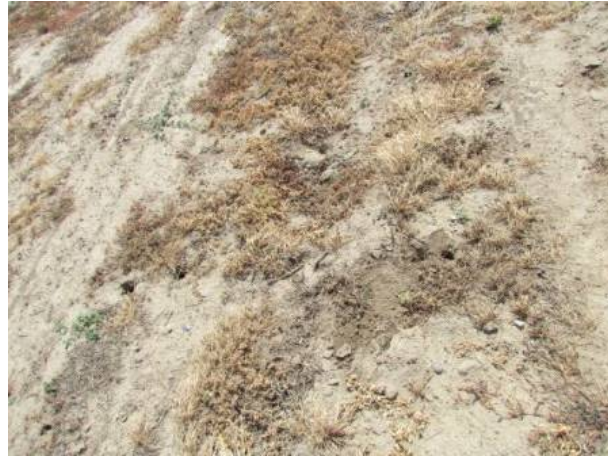
View of multiple burrow holes; the previously large burrow hole was not found at the time, but rodent activity is still present. 05/17/2012

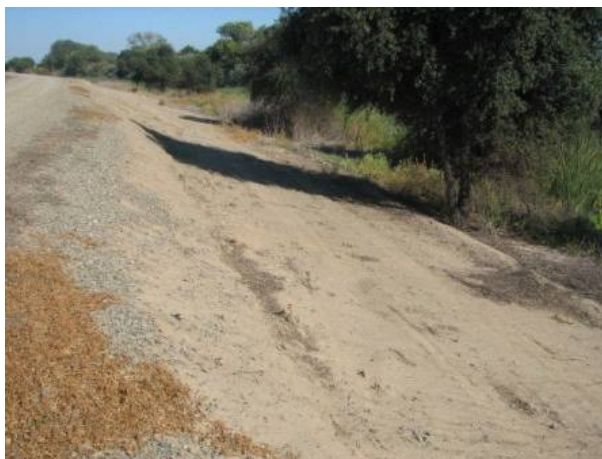
Levee Mile Report Line	18
Start Levee Mile	3.27
End Levee Mile	3.28
Location	Water Side
Category	Supplemental
Item	DWR Erosion Survey

Downstream view of scarp caused by a  
maintenance equipment.

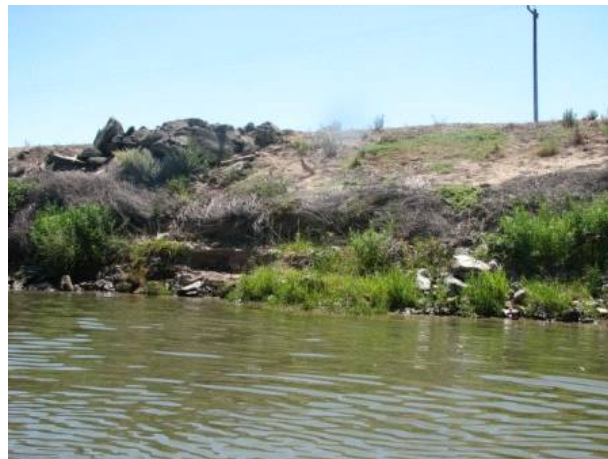
Levee Mile Report Line	6
Start Levee Mile	0.35
End Levee Mile	0.35
Location	Water Side
Category	Supplemental
Item	DWR Erosion Survey

Direct view of the erosion. Note the broken concrete near the site.

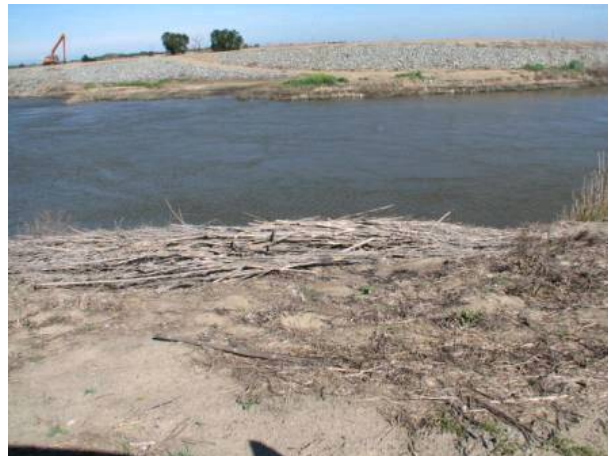
Levee Mile Report Line	7
Start Levee Mile	0.46
End Levee Mile	0.46
Location	Water Side
Category	Earthen Levee
Item	Encroachments

05/11/2011 Bambo prunings have not been removed. This item was noted in the Fall 2010 inspection.

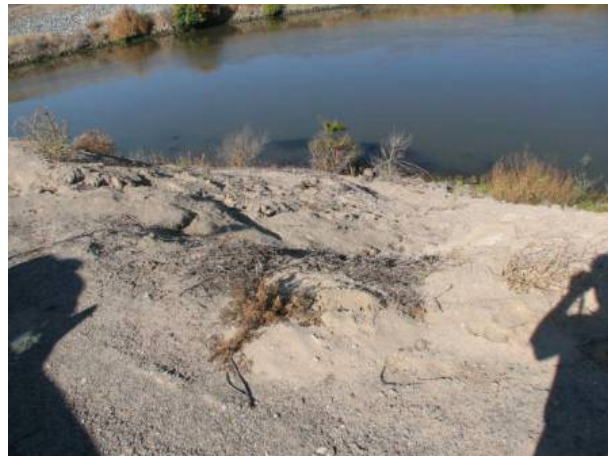
Levee Mile Report Line	13
Start Levee Mile	0.82
End Levee Mile	0.82
Location	Water Side
Category	Earthen Levee
Item	Erosion / Bank Caving

10/20/2011 Photo shows no change in condition since last reported in the Spring 2011 inspection.

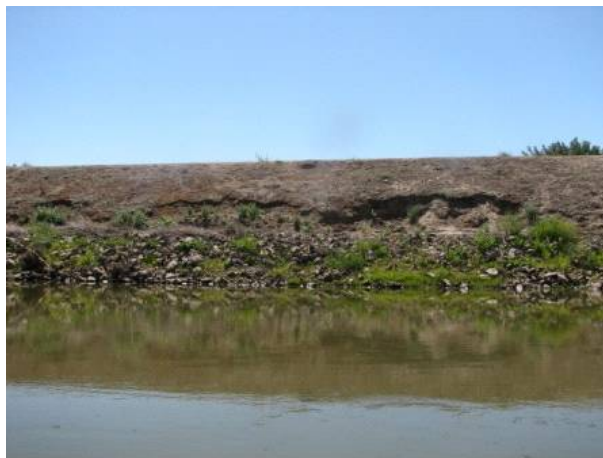
Levee Mile Report Line	14
Start Levee Mile	1.20
End Levee Mile	1.21
Location	Water Side
Category	Supplemental
Item	DWR Erosion Survey

Front view of the site. Note the lateral crack along the middle slope

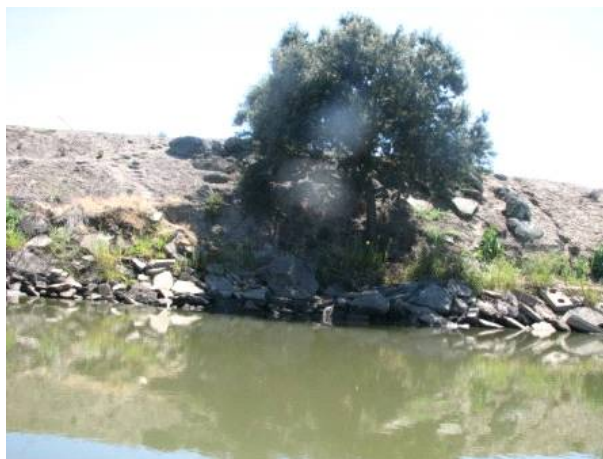
Levee Mile Report Line	17
Start Levee Mile	1.42
End Levee Mile	1.43
Location	Water Side
Category	Supplemental
Item	DWR Erosion Survey

Front view of the site. Note existing broken concrete on the upper slope as well as on the lower slope and at the toe.

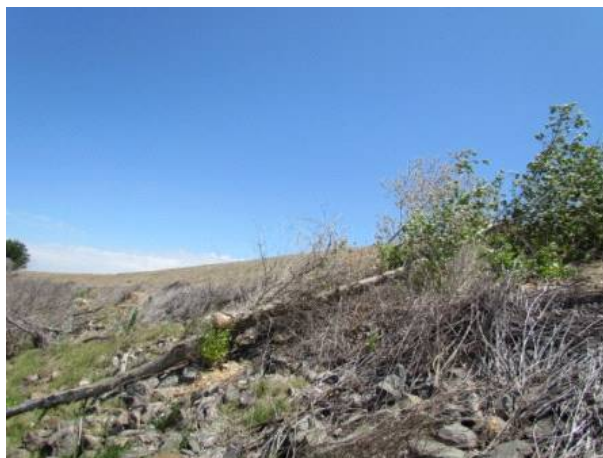
View of damaged tree by beaver on waterside slope. 05/17/2012
